Lake Goodwin Landfill
2013 1st Quarter Environmental
Monitoring Report

The following report presents the first quarter ground water monitoring results for 2013 at the Lake Goodwin Landfill (*Lake Goodwin Landfill, Site*). The site is located immediately west of Frank Waters Road in northwestern Snohomish County, about one and one half (1.5) miles northwest of Lake Goodwin and about five-(5) miles south of Stanwood (*T31N, R4E, sections 17, 20 Willamette Meridian*). The landfill is located at 18520 Frank Waters Road, Stanwood, Washington, 98292. The location of the site relative to existing municipal improvements is shown on the **Vicinity Map** (*figure 1*).

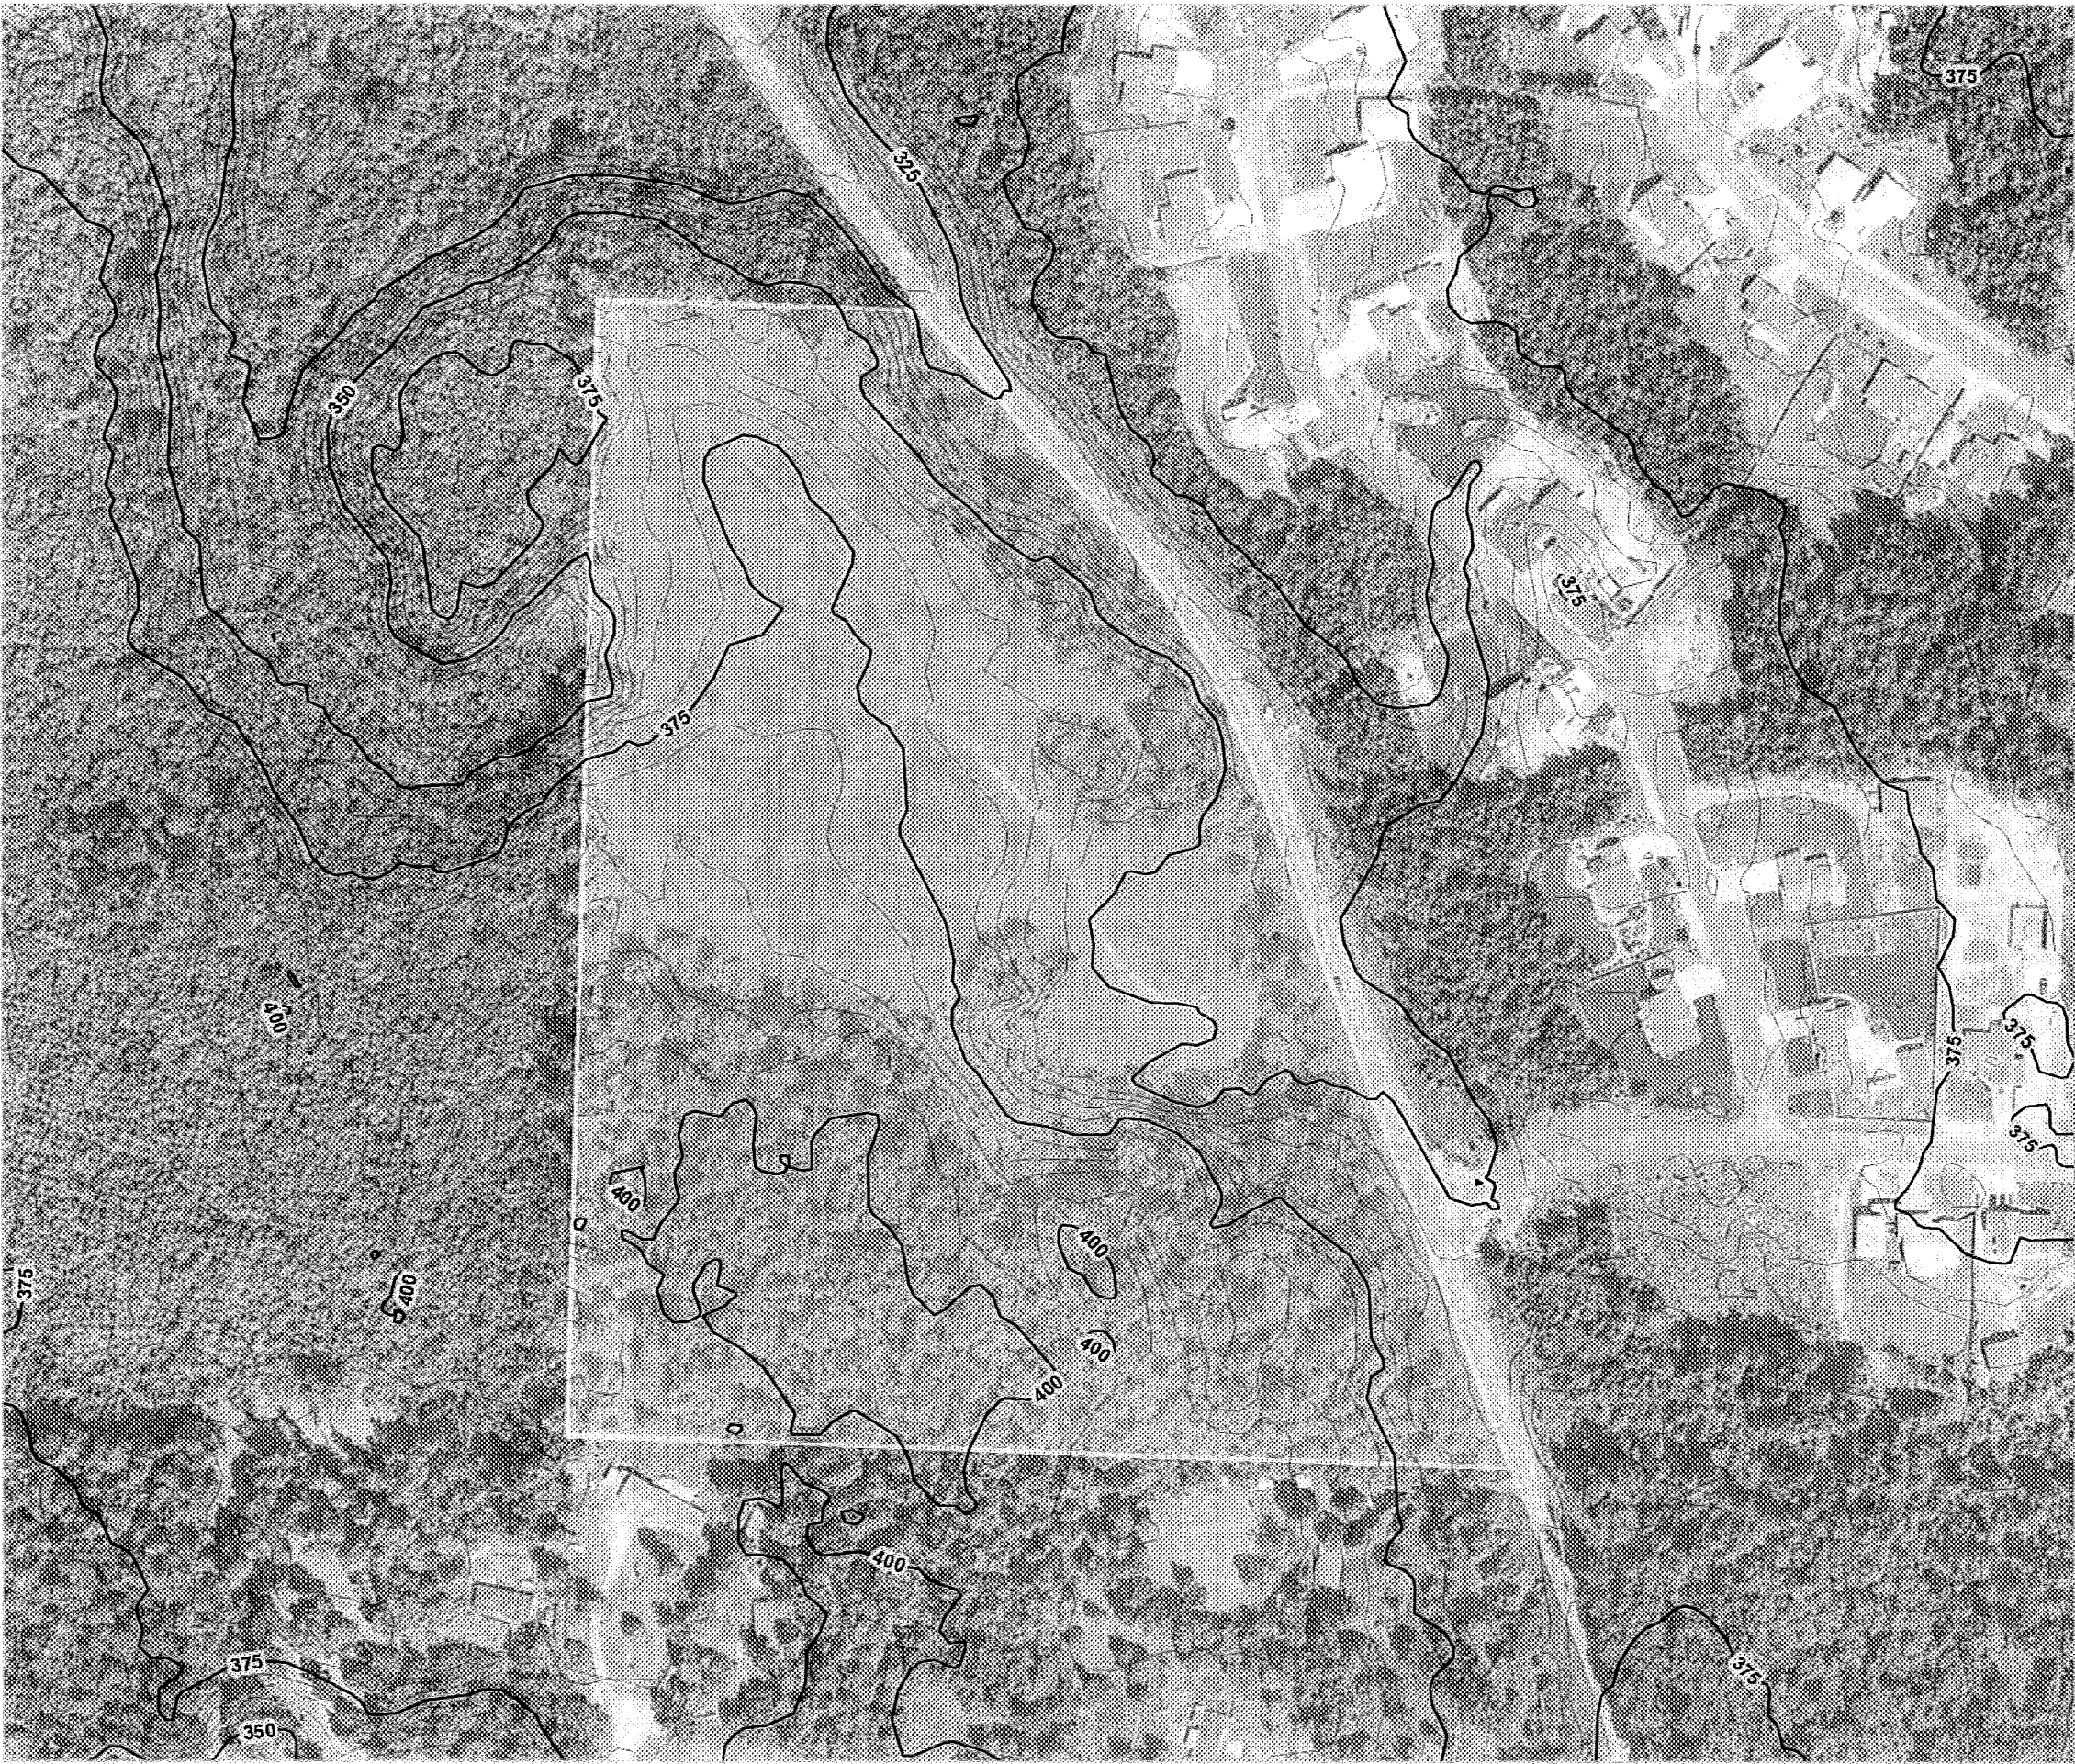
Figure 3

Lake Goodwin Landfill Topography

- Parcel Boundary
- Subject Property Boundary
- 5 Foot Contours

The Lake Goodwin Landfill is located on a topographic feature known as the Tulalip Plateau, a rolling upland area bounded by the Stillaguamish River to the north, the Puget Sound to the west and south, and by a topographic low called the Marysville Trough to the east. The general topography in the immediate vicinity of the site is typical of glaciated areas within western Washington State – gently rolling landscapes bisected by seasonal and/or year round drainages, creeks and rivers. Several small to medium sized lakes are found in the immediate vicinity of the site. Lake Martha, Lake Howard and Lake Goodwin are all located within a few miles of the Landfill. There are no named drainages, creeks or rivers located in the immediate vicinity of the site. Elevations in the immediate vicinity of the landfill range from approximately el. 320 to el. 380 feet above mean sea level. Relative to existing surrounding topography the landfill itself is approximately 60 ft high. It has been graded and slopes gently in a north to northeast direction. Site Topography is shown on the **Topographic Map** (*figure 3*). In most places the landfill cover is well vegetated with grass, clover and weeds. A few Douglas fir have naturally reseeded in the fill cover near the edge of the site. There are no stormwater detention ponds or leachate collection ponds located on the site.

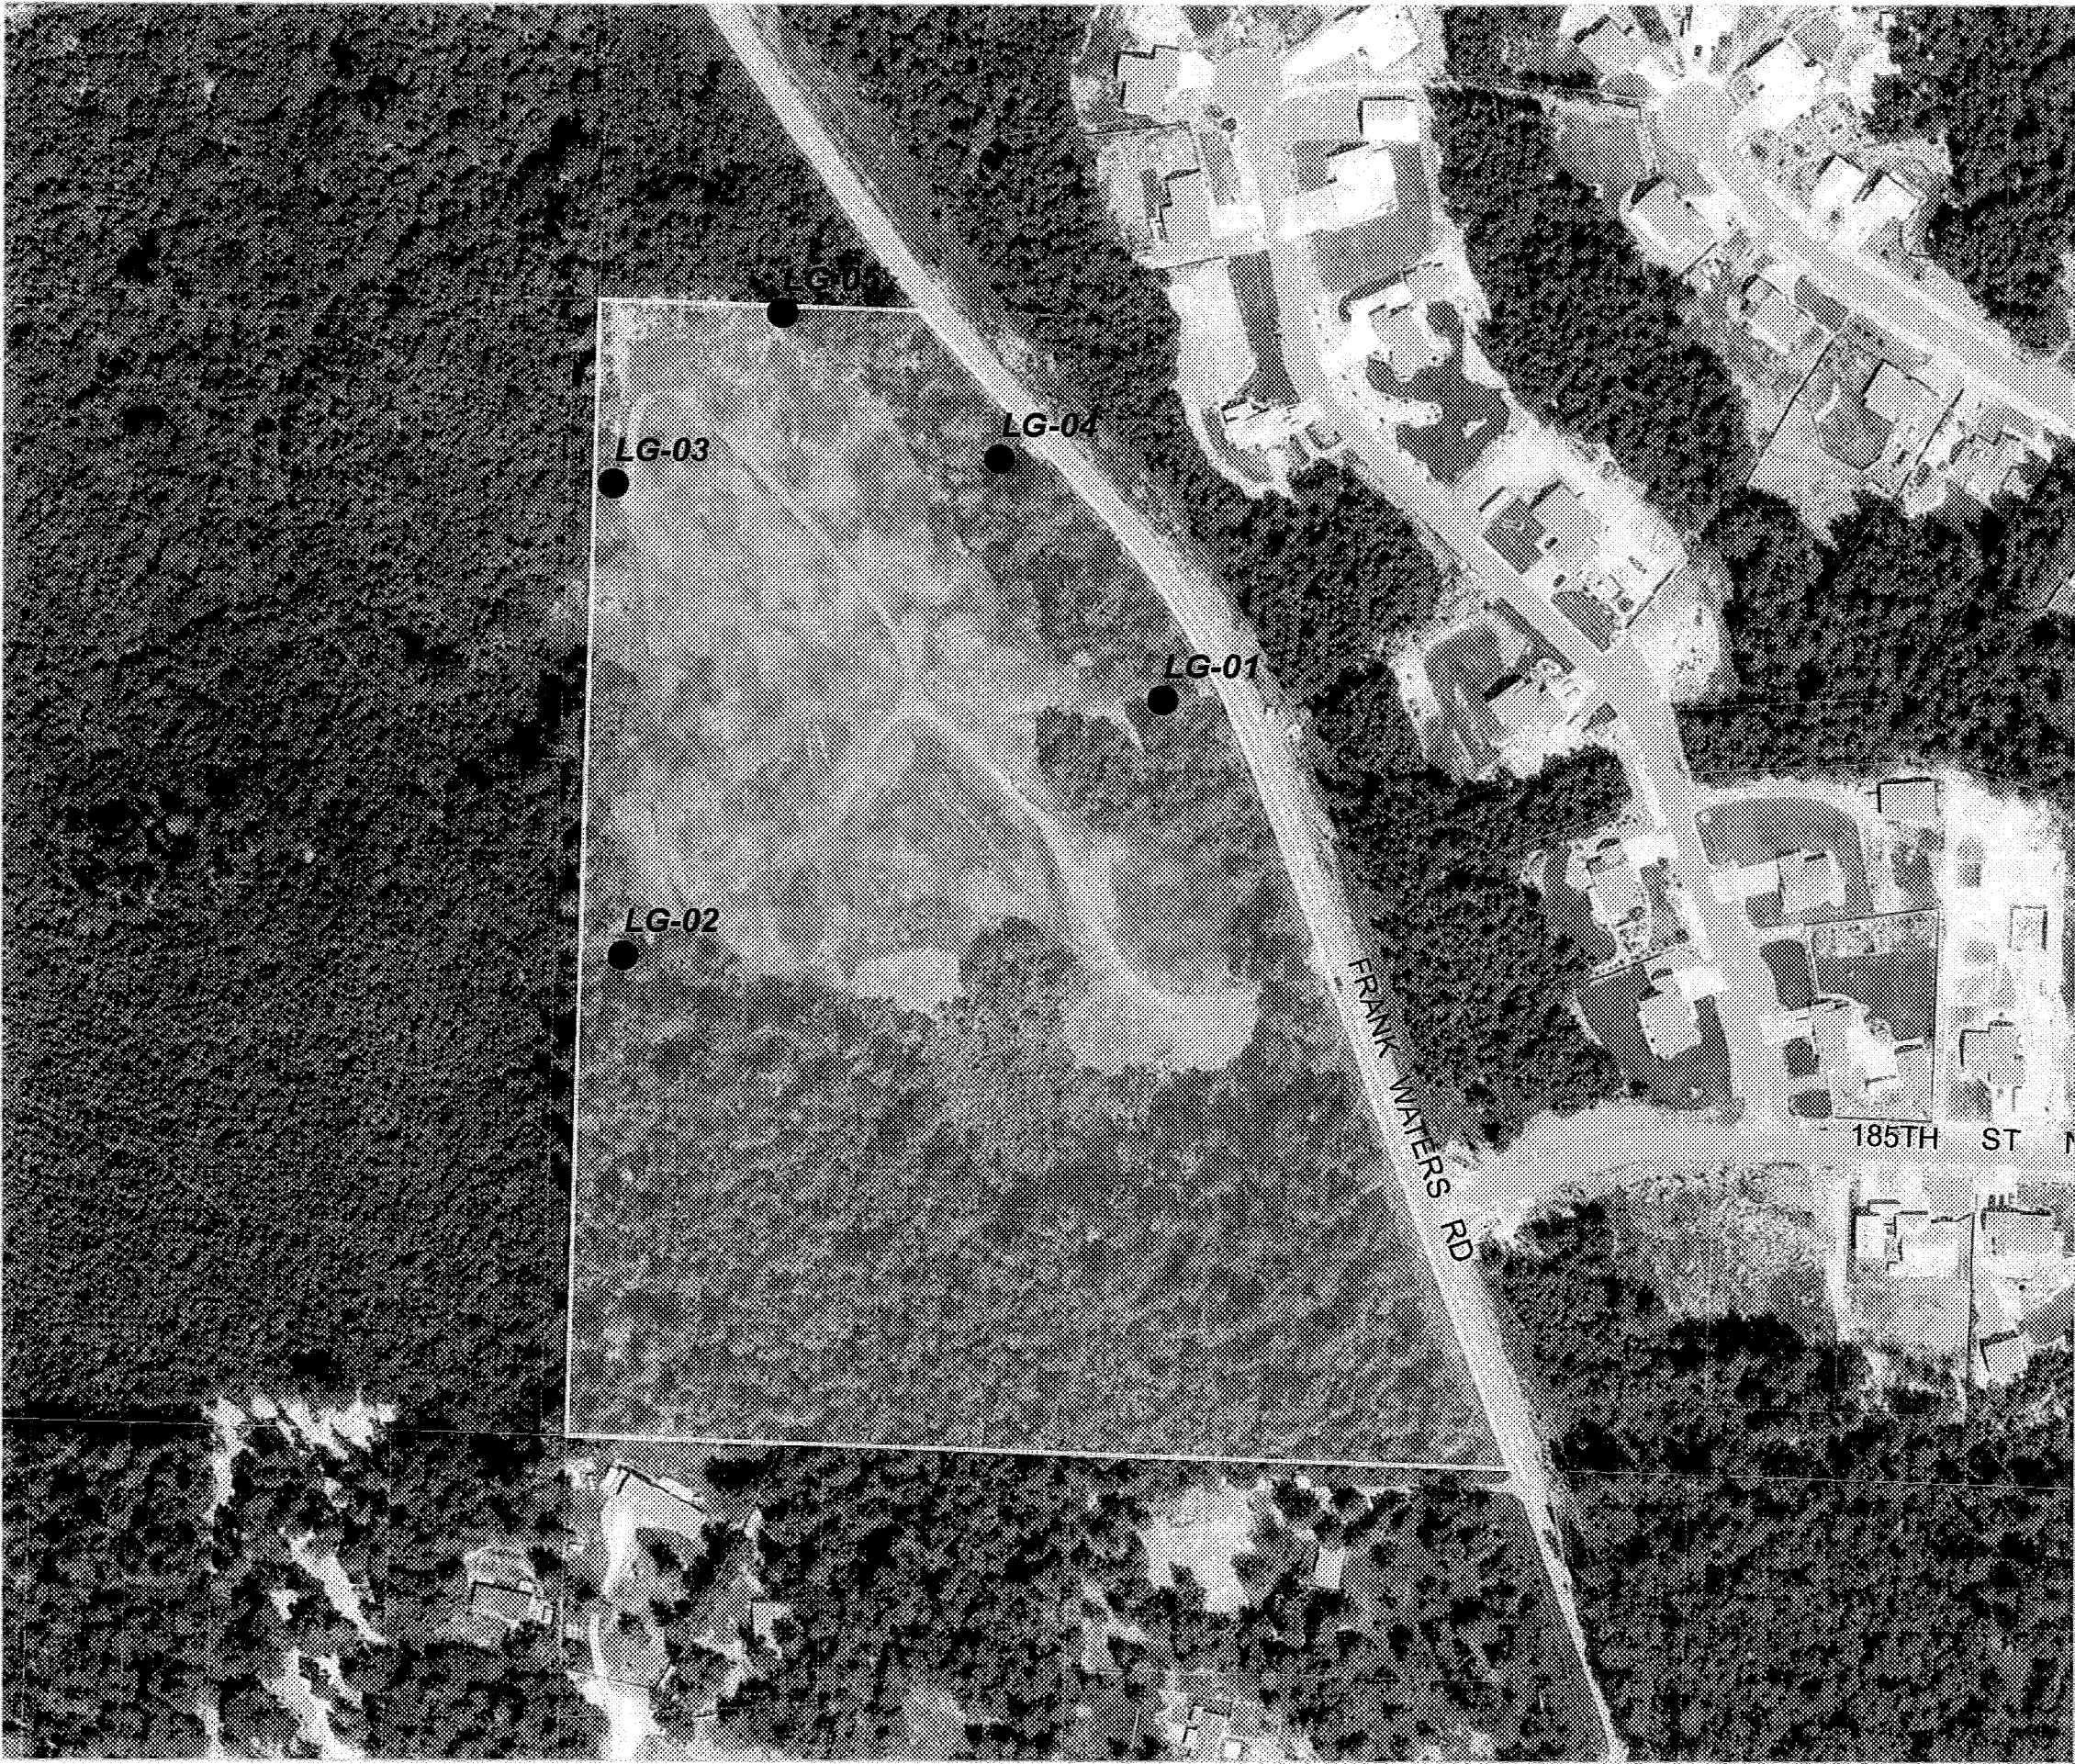
Figure 5

Lake Goodwin Landfill Groundwater Monitoring Network

As outlined in the Solid Waste Facility Permit SW-085, quarterly monitoring of ground water is required at the Lake Goodwin Landfill. There are currently four-(4) ground water monitoring wells (*LG-01*, *LG-02*, *LG-04*, and *LG-05*) at the Lake Goodwin Landfill site that are read on a quarterly basis. Well locations are shown on the **Network Monitoring Map** (*figure 5*). Of these wells, one-(1) is considered to be an up-gradient well monitoring background ground water conditions in the immediate vicinity of the site (*LG-02*). The remaining three-(3) wells are located in and/or down gradient of the landfill (*LG-01*, and *LG-04* and *LG-05*) and monitor ground water conditions that may be impacted from the site. First quarter monitoring results are discussed in section 2.0 below.

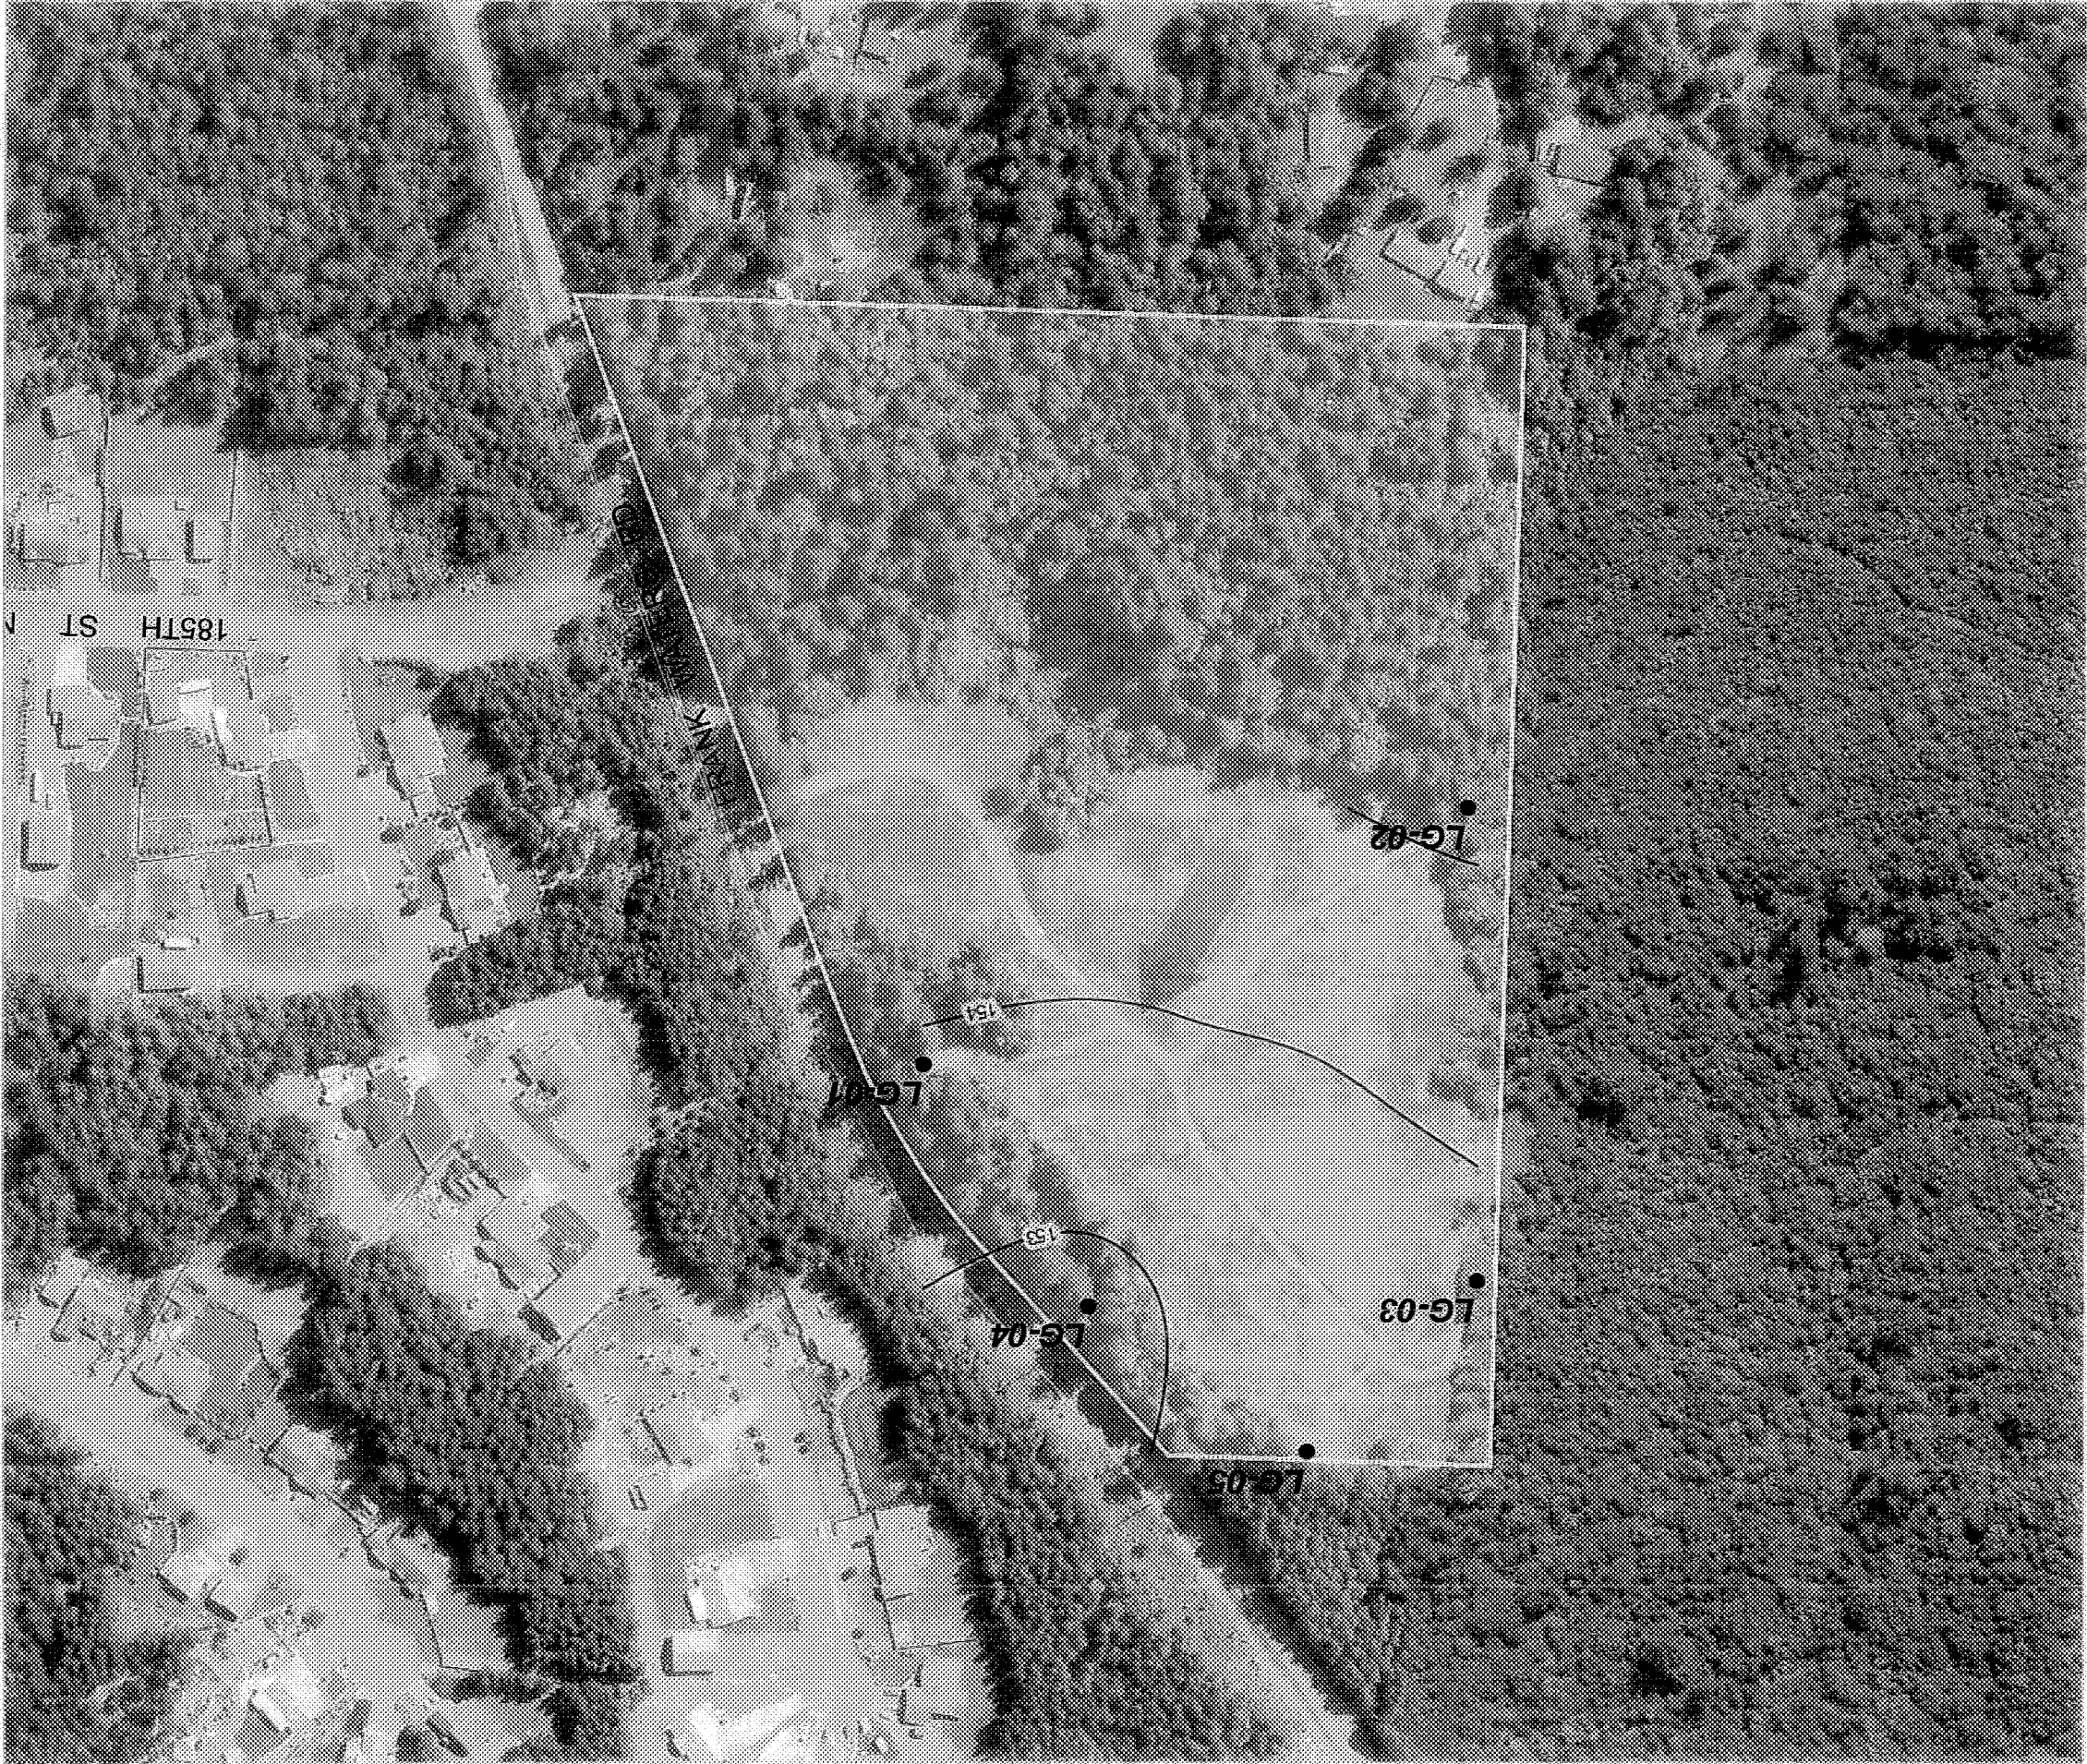
Figure 6

Water Elevation Contours

1st Quarter 2013

DIRECTION OF GROUNDWATER FLOW
1.10 ft/day
401 ft/year
60.52 degrees to the positive x-axis

WELL_ID	SAMP_DATE	MEAS_HEAD
LG-01	1/17/2013	153.87
LG-02	1/17/2013	155.17
LG-03	1/17/2013	153.76
LG-04	1/17/2013	152.79
LG-05	1/17/2013	153.59

Variances from fourth quarter measurements indicate two-(2) of the wells rose and two-(2) of the wells fell in elevation during the 1st quarter when compared to the 4th quarter 2012 readings. Readings confirm that the aquifer is unconfined in the immediate vicinity of the site. The **First Quarter Ground Water Contour Map** developed from the field data is shown in *Figure 6* of this report.
