*Lake Goodwin Landfill  
2013 2<sup>nd</sup> Quarter Environmental  
Monitoring Report*

The following report presents the second quarter ground water monitoring results for 2013 at the Lake Goodwin Landfill (*Lake Goodwin Landfill, Site*). The site is located immediately west of Frank Waters Road in northwestern Snohomish County, about one and one half (1.5) miles northwest of Lake Goodwin and about five-(5) miles south of Stanwood (*T31N, R4E, sections 17, 20 Willamette Meridian*). The landfill is located at 18520 Frank Waters Road, Stanwood, Washington, 98292. The location of the site relative to existing municipal improvements is shown on the **Vicinity Map** (*figure 1*).

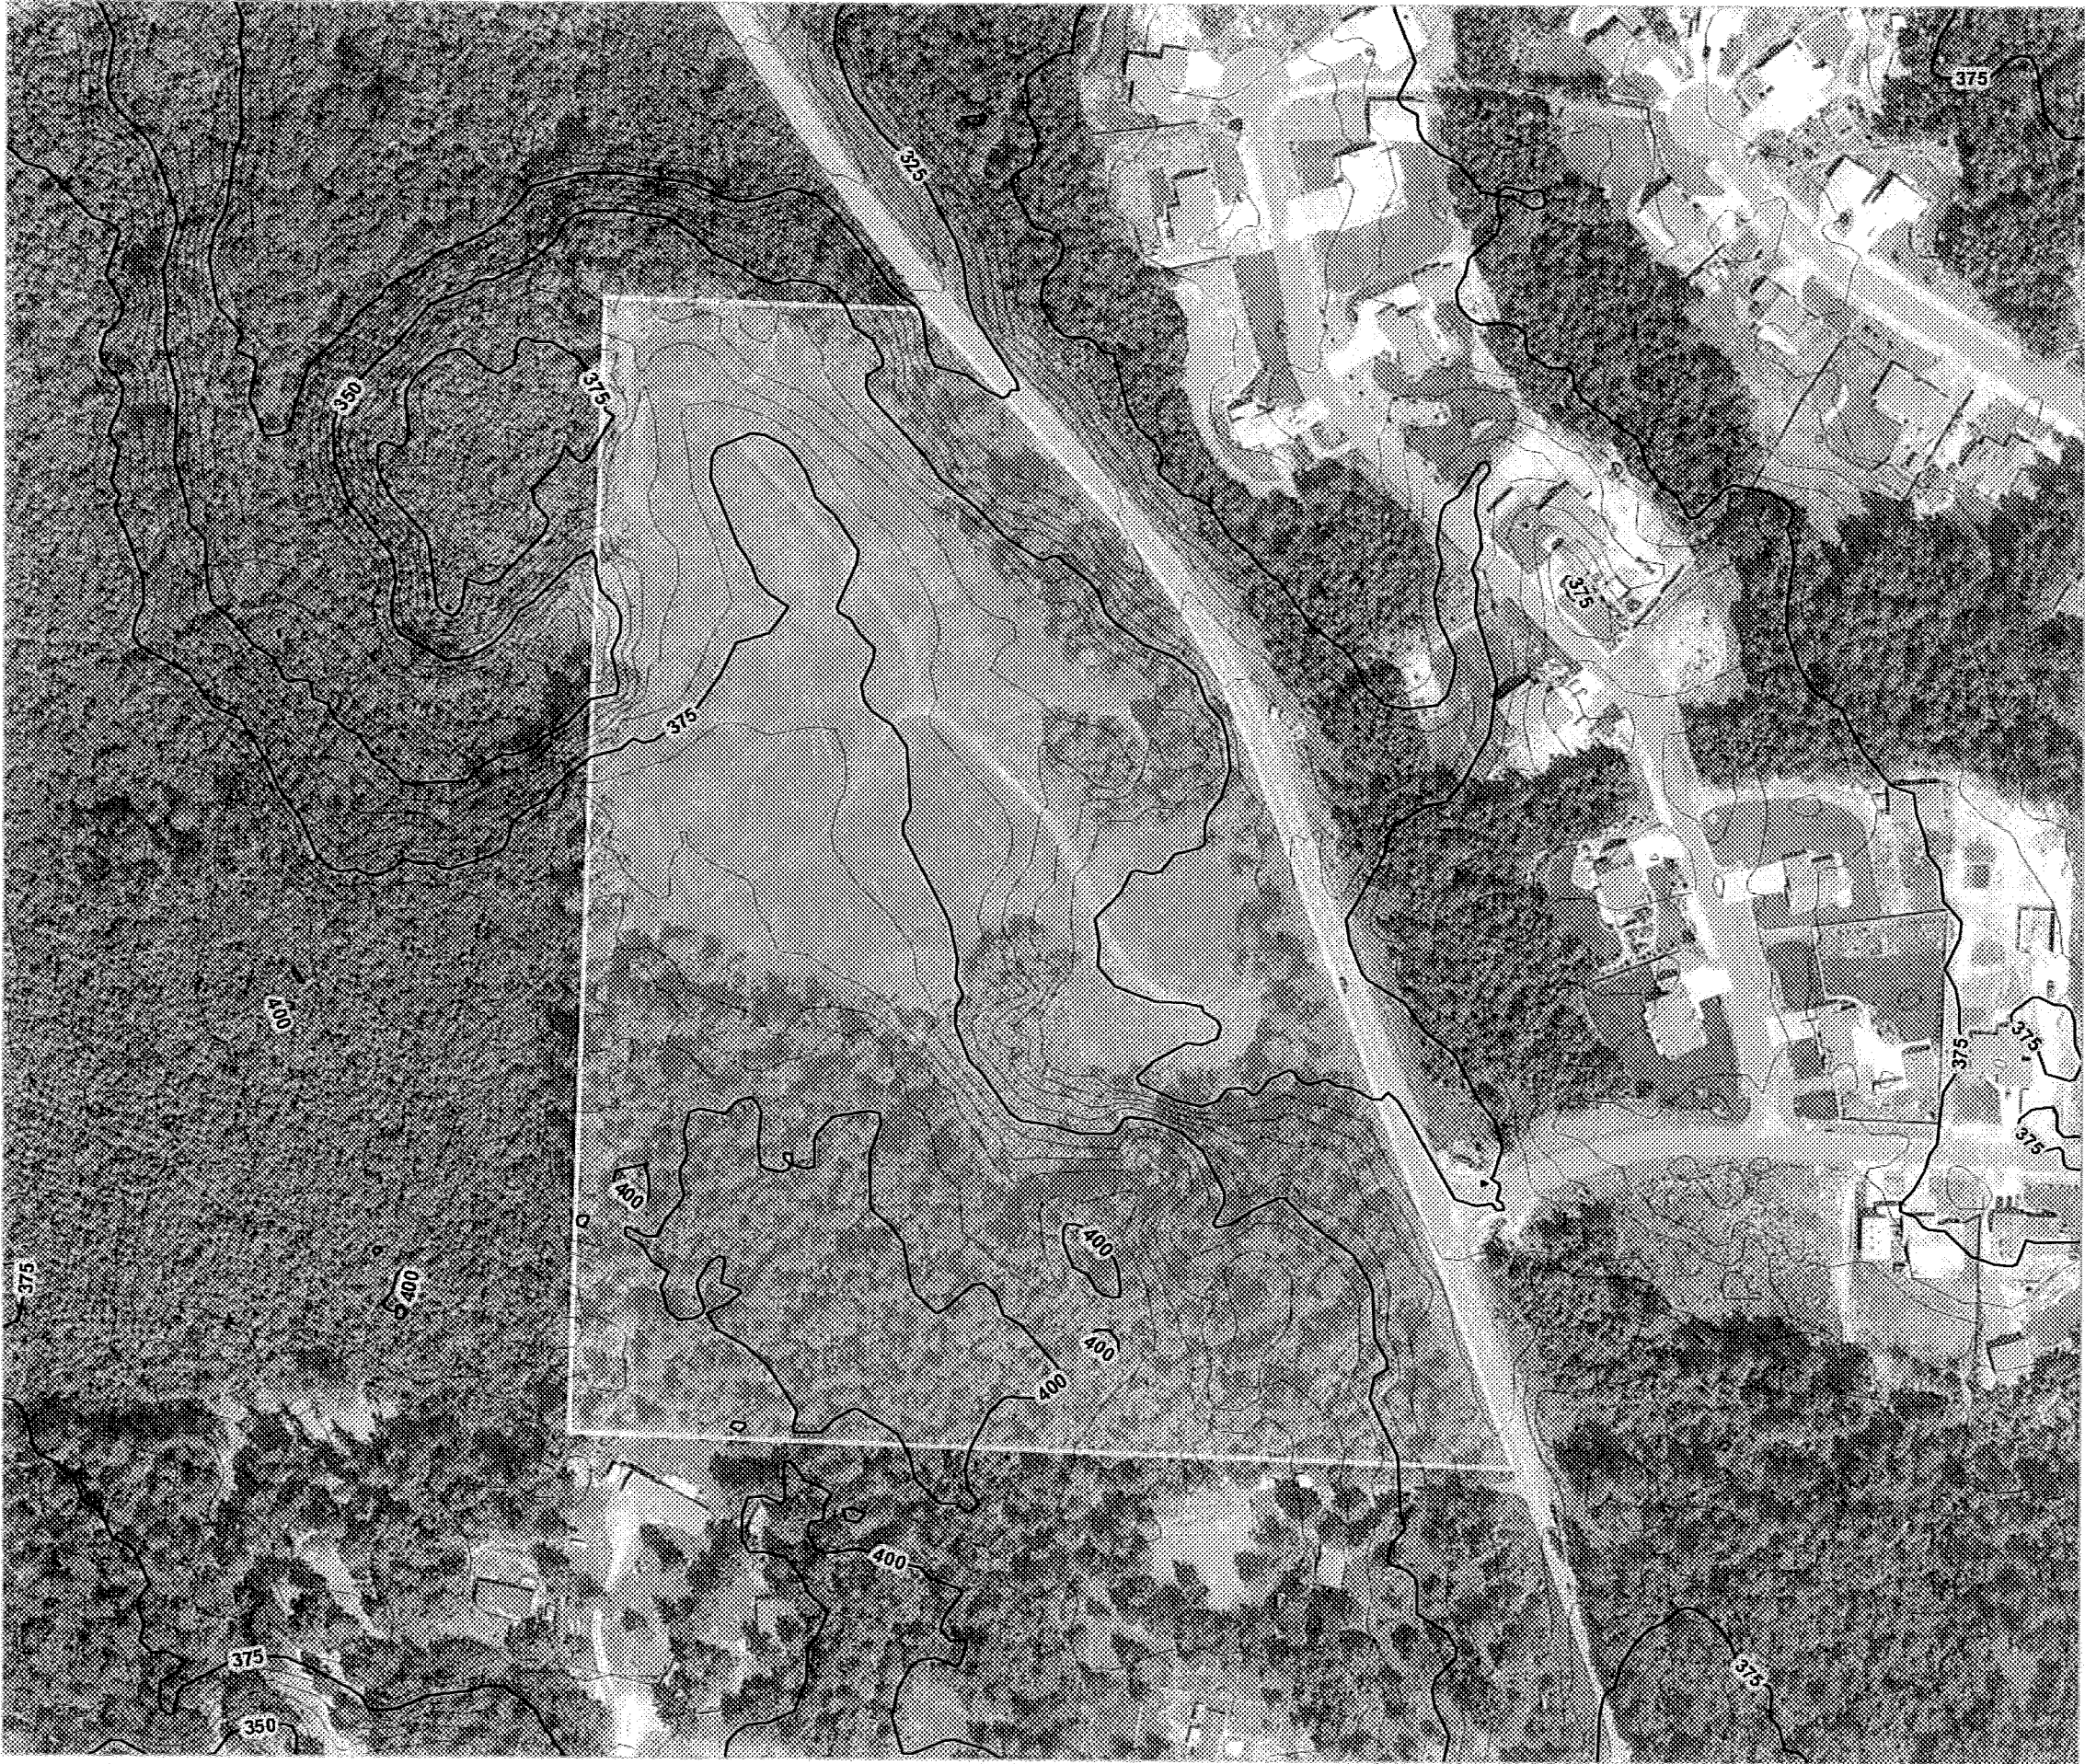
Figure 3

# Lake Goodwin Landfill Topography

The Lake Goodwin Landfill is located on a topographic feature known as the Tulalip Plateau, a rolling upland area bounded by the Stillaguamish River to the north, the Puget Sound to the west and south, and by a topographic low called the Marysville Trough to the east. The general topography in the immediate vicinity of the site is typical of glaciated areas within western Washington State – gently rolling landscapes bisected by seasonal and/or year round drainages, creeks and rivers. Several small to medium sized lakes are found in the immediate vicinity of the site. Lake Martha, Lake Howard and Lake Goodwin are all located within a few miles of the Landfill. There are no named drainages, creeks or rivers located in the immediate vicinity of the site. Elevations in the immediate vicinity of the landfill range from approximately el. 320 to el. 380 feet above mean sea level. Relative to existing surrounding topography the landfill itself is approximately 60 ft high. It has been graded and slopes gently in a north to northeast direction. Site Topography is shown on the **Topographic Map** (*figure 3*). In most places the landfill cover is well vegetated with grass, clover and weeds. A few Douglas fir have naturally reseeded in the fill cover near the edge of the site. There are no stormwater detention ponds or leachate collection ponds located on the site.

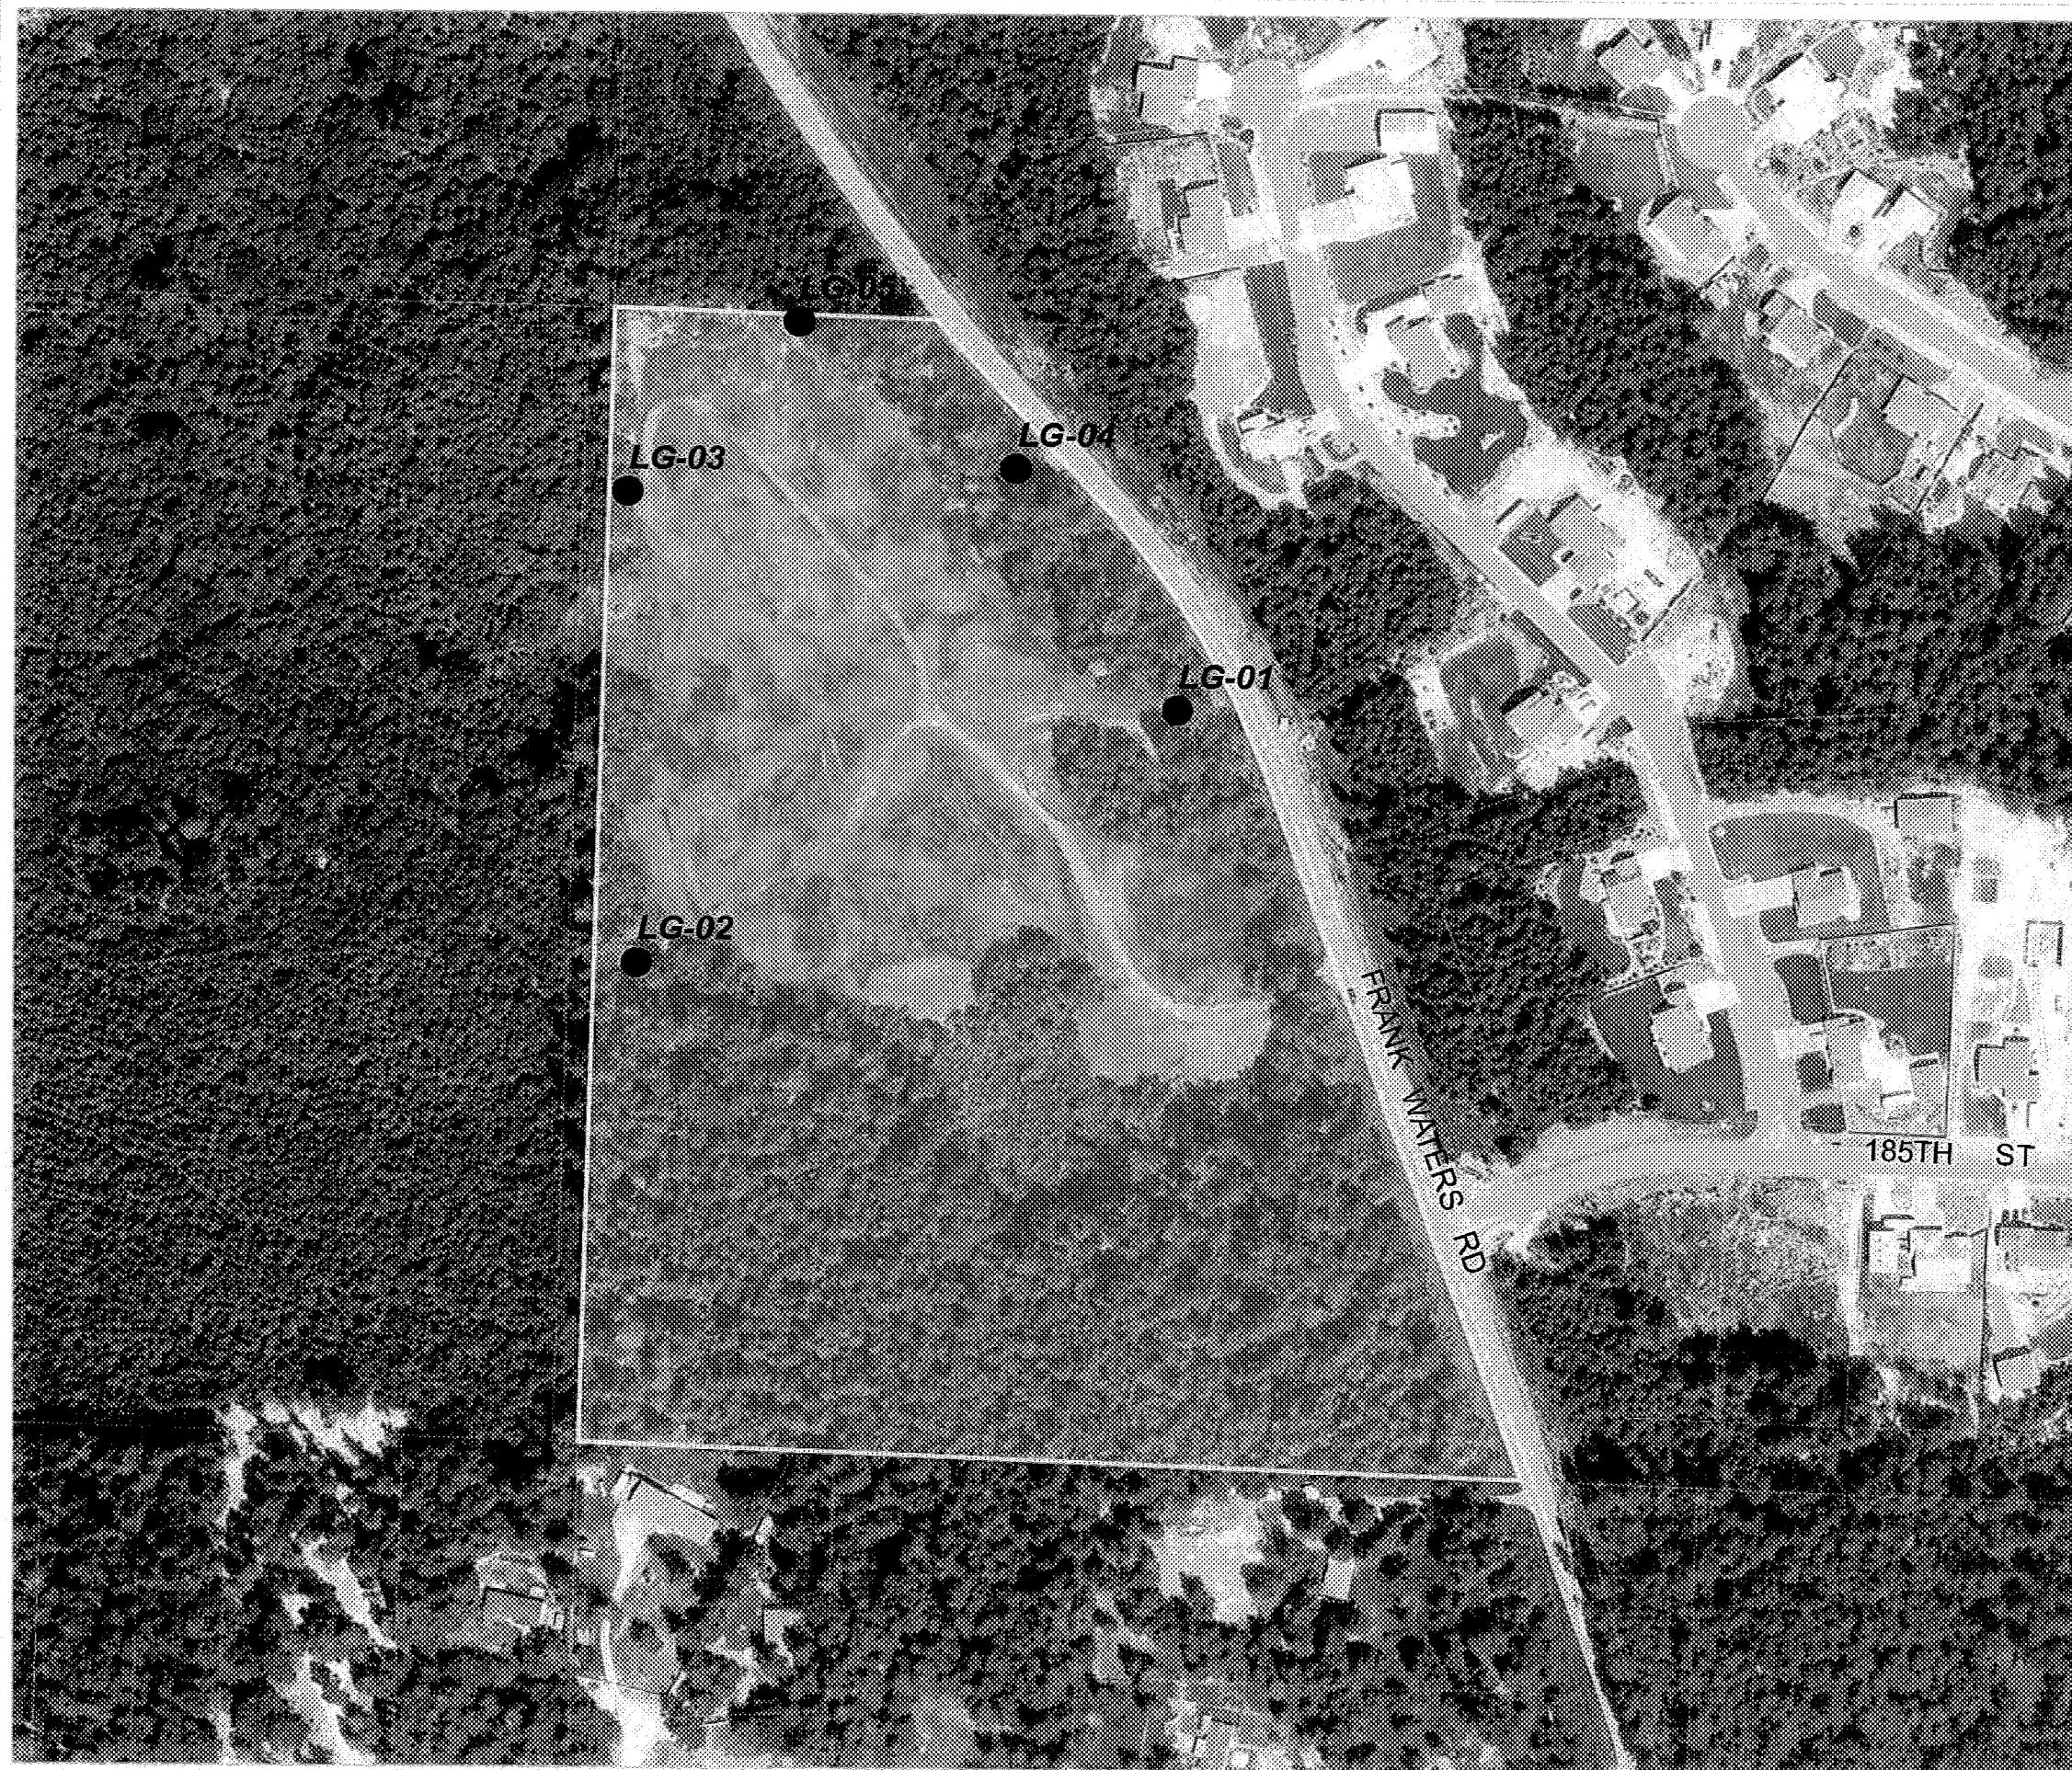
Figure 5

## Groundwater Monitoring Network

● Deep Aquifer

As outlined in the Solid Waste Facility Permit SW-085, quarterly monitoring of ground water is required at the Lake Goodwin Landfill. There are currently four-(4) ground water monitoring wells (*LG-01*, *LG-02*, *LG-04*, and *LG-05*) at the Lake Goodwin Landfill site that are read on a quarterly basis. Well locations are shown on the **Network Monitoring Map** (*figure 5*). Of these wells, one-(1) is considered to be an up-gradient well monitoring background ground water conditions in the immediate vicinity of the site (*LG-02*). The remaining three-(3) wells are located in and/or down gradient of the landfill (*LG-01*, and *LG-04* and *LG-05*) and monitor ground water conditions that may be impacted from the site. Second quarter monitoring results are discussed in section 2.0 below.

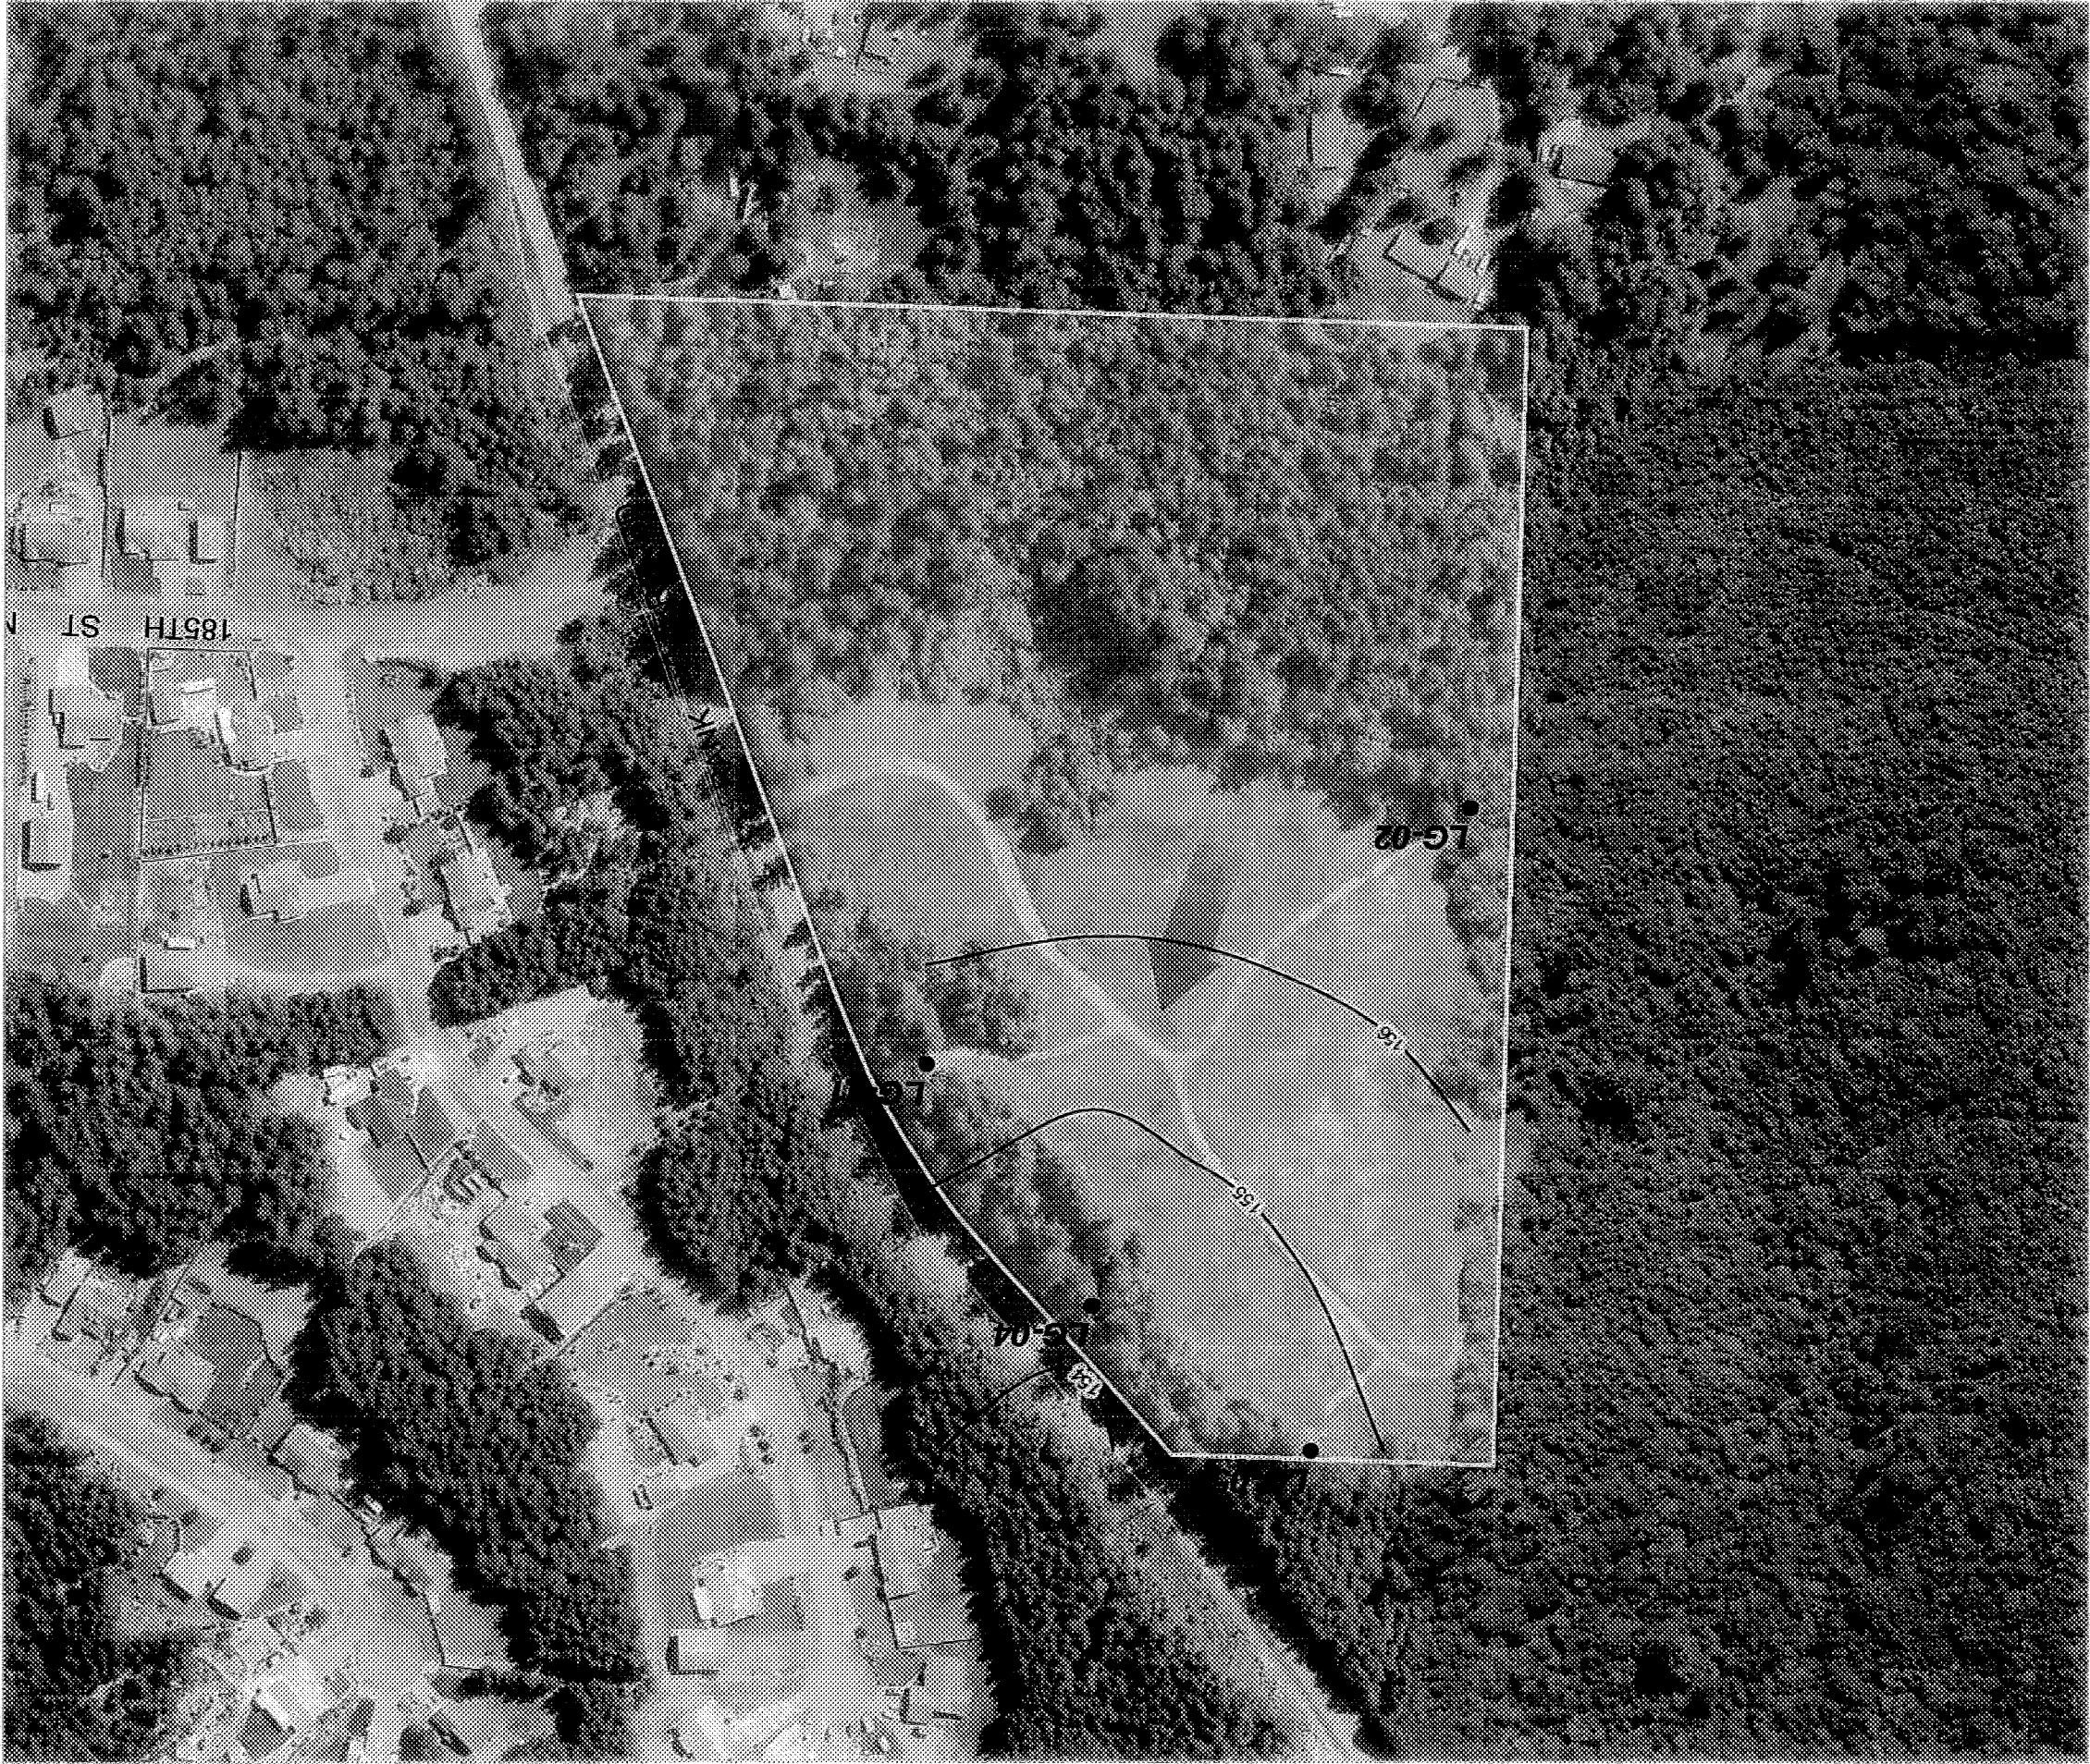
Figure 6

## Water Elevation Contours

### 3rd Quarter 2013

DIRECTION OF GROUNDWATER FLOW  
1.34 ft/day  
488 ft/year  
70.12 degrees to the positive x-axis

WELL_ID	SAMP_DATE	MEAS_HEAD
LG-01	7/9/2013	155.61
LG-02	7/9/2013	156.85
LG-04	7/9/2013	154.14
LG-05	7/9/2013	154.75

01 which dropped 4.56'. This may be an operator error. Readings confirm that the aquifer is unconfined in the immediate vicinity of the site. The **Second Quarter Ground Water Contour Map** developed from the field data is shown in *Figure 6* of this report.
