# *Lake Goodwin Landfill 2013 Annual Environmental Monitoring Report*

The following report summarizes the annual ground water monitoring results for 2013 at the Lake Goodwin Landfill (*Lake Goodwin Landfill, Site*). The site is located immediately west of Frank Waters Road in northwestern Snohomish County, about one and one half (1.5) miles northwest of Lake Goodwin and about five-(5) miles south of Stanwood (*T31N, R4E, sections 17, 20 Willamette Meridian*). The landfill is located at 18520 Frank Waters Road, Stanwood, Washington, 98292. The location of the site relative to existing municipal improvements is shown on the **Vicinity Map** (*figure 1*).

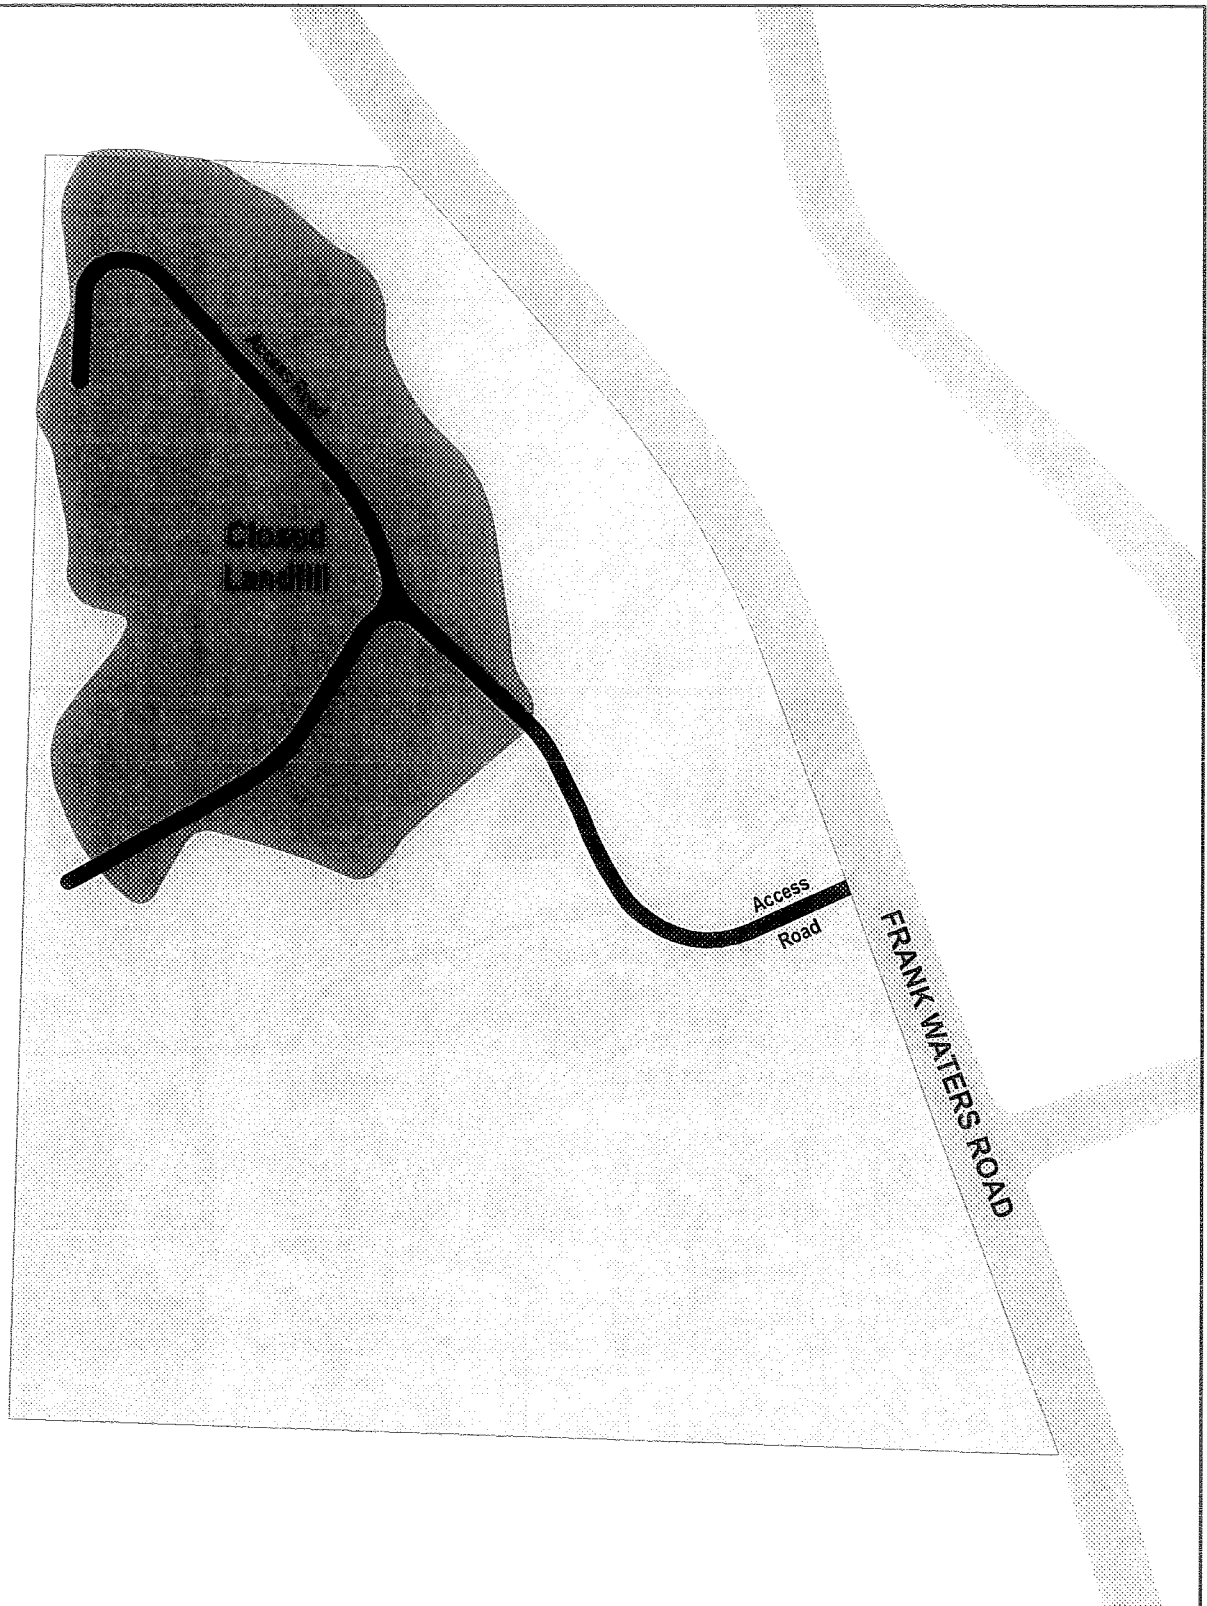
Figure 2

The closed landfill is approximately 11.5 acres in size and is part of a larger County owned parcel of land. The Lake Goodwin Landfill is bounded by private residential property or commercial forest to the south, west and north. The Frank Waters Road is located along the eastern side of the site. Access into the site is from a partially paved and partially graveled driveway off of the Frank Waters Road. Existing site improvements are shown on the **Site Map** (*figure 2*).

# Lake Goodwin Landfill Site Map

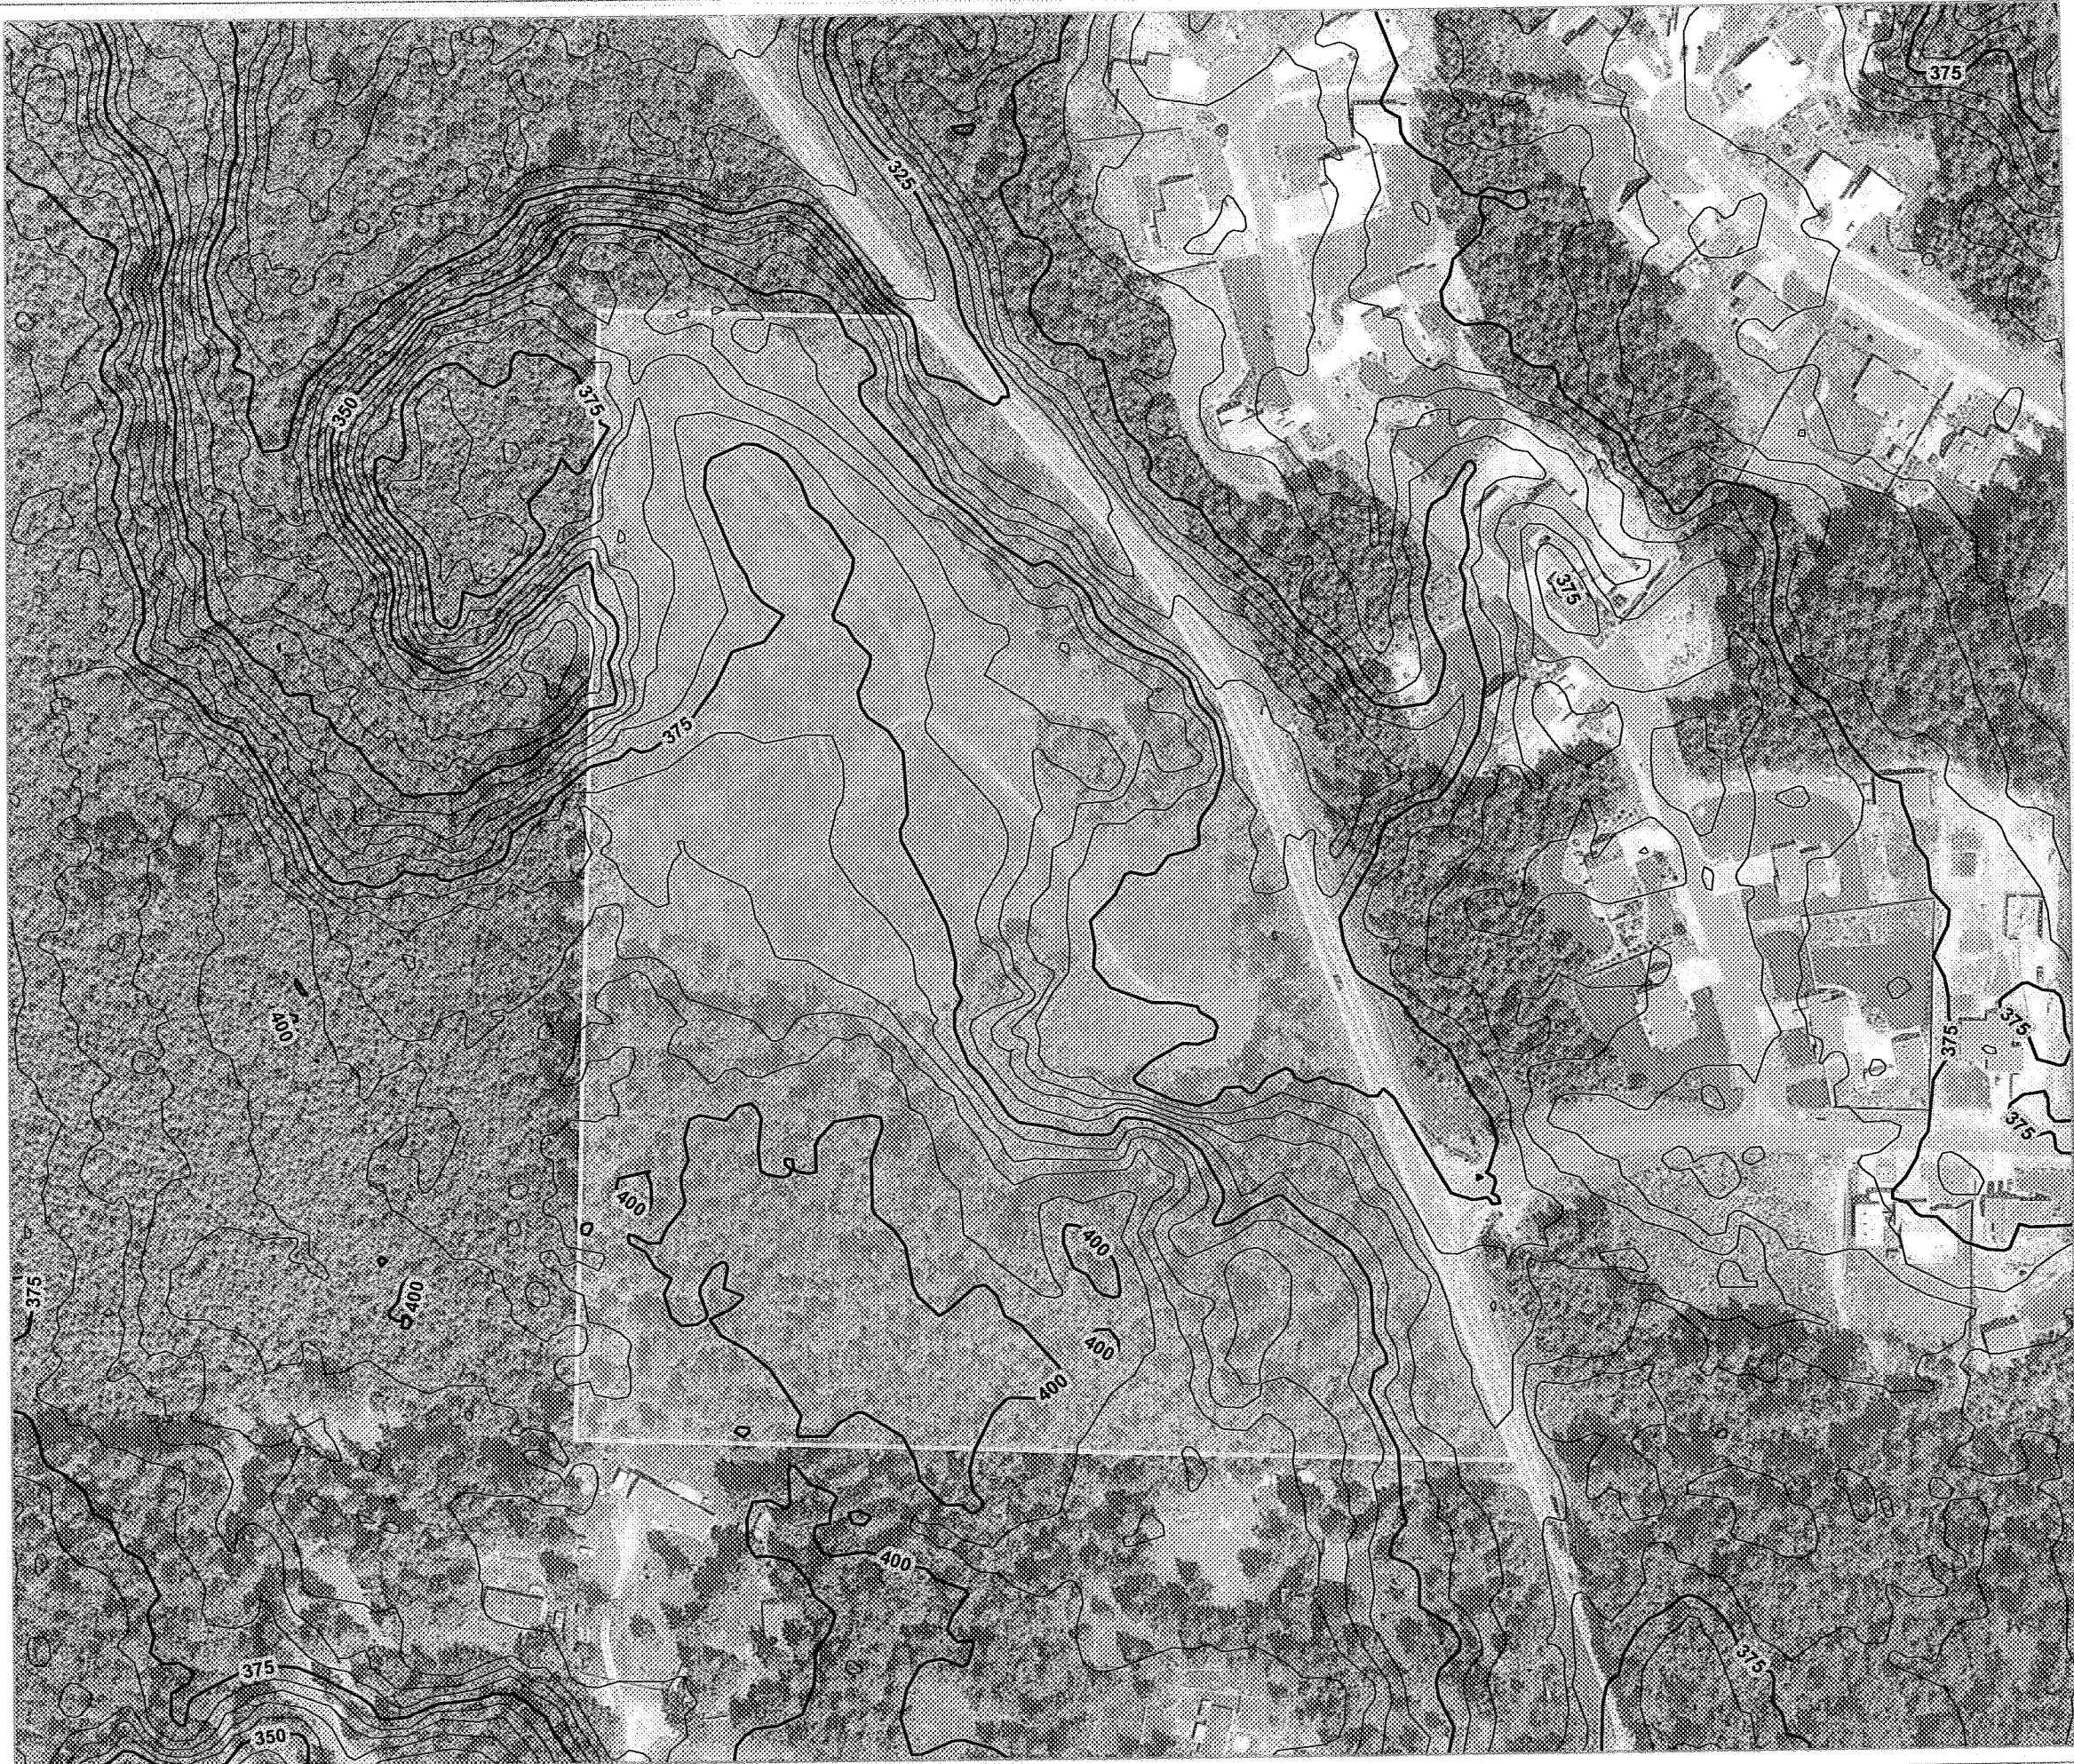
Figure 3

The Lake Goodwin Landfill is located on a topographic feature known as the Tulalip Plateau, a rolling upland area bounded by the Stillaquamish River to the north, the Puget Sound to the west and south, and by a topographic low called the Marysville Trough to the east. The general topography in the immediate vicinity of the site is typical of glaciated areas within western Washington State – gently rolling landscapes bisected by seasonal and/or year round drainages, creeks and rivers. Several small to medium sized lakes are found in the immediate vicinity of the site. Lake Martha, Lake Howard and Lake Goodwin are all located within 1.5 miles of the Landfill. There are no named drainages, creeks or rivers located in the immediate vicinity of the site. The Stillaquamish River is located approximately 3 miles north of the site. Elevations in the immediate vicinity of the landfill range from approximately el. 320 to el. 380 feet above mean sea level. Relative to existing surrounding topography the landfill itself is approximately 60 ft high. It has been graded and slopes gently in a north to northeast direction. Site Topography is shown on the **Topographic Map** (*figure 3*). In most places the landfill cover is well vegetated with grass, clover and weeds. A few Douglas fir have naturally reseeded in the fill cover near the edge of the site. There are no stormwater detention ponds or leachate collection ponds located on the site.

# Lake Goodwin Landfill Topography

5 Foot Contours

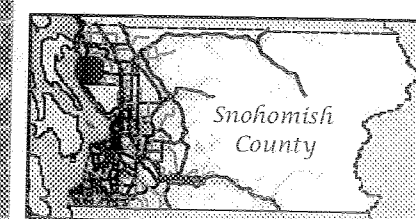
Figure 5

There are currently four-(4) ground water monitoring wells (*LG-01 and LG-02, and LG-04 and LG-05*) at the Lake Goodwin Landfill site that are monitored on a quarterly basis. Ground Water Monitoring Well locations are shown on the **Network Monitoring Map** (*figure 5*). Of these wells, one-(1) is considered to be an up-gradient well monitoring background ground water conditions in the immediate vicinity of the site (*LG-02*). The remaining three-(3) wells are located in and/or down gradient of the landfill (*LG-01, and LG-04, LG-05*) and monitor ground water conditions that may be impacted from the site. Ground water monitoring results are discussed in *section 2.0* below.

**Network Monitoring Map** (figure 5). This survey was performed on a monthly basis through March 2012 at which time vandals destroyed the bar hole probes. In November 2013, the crew reinstalled the gas probes in a tamper resistant structure. **Monitoring Results for Methane Gas** production is discussed in *section 3.0* below.

locations through the top of the biomass in 2011. Monthly methane gas monitoring of the Lake Goodwin Landfill was initiated during the 4<sup>th</sup> quarter of 2011. The probes were vandalized in March, 2012. A new set of three-(3) bar holes was installed in November, 2013. Existing bar hole probe locations are shown on the **Monitoring Network Map** (figure5). **Bar Hole Punch Gas Probe Installation Details** are shown in *table 4* below.

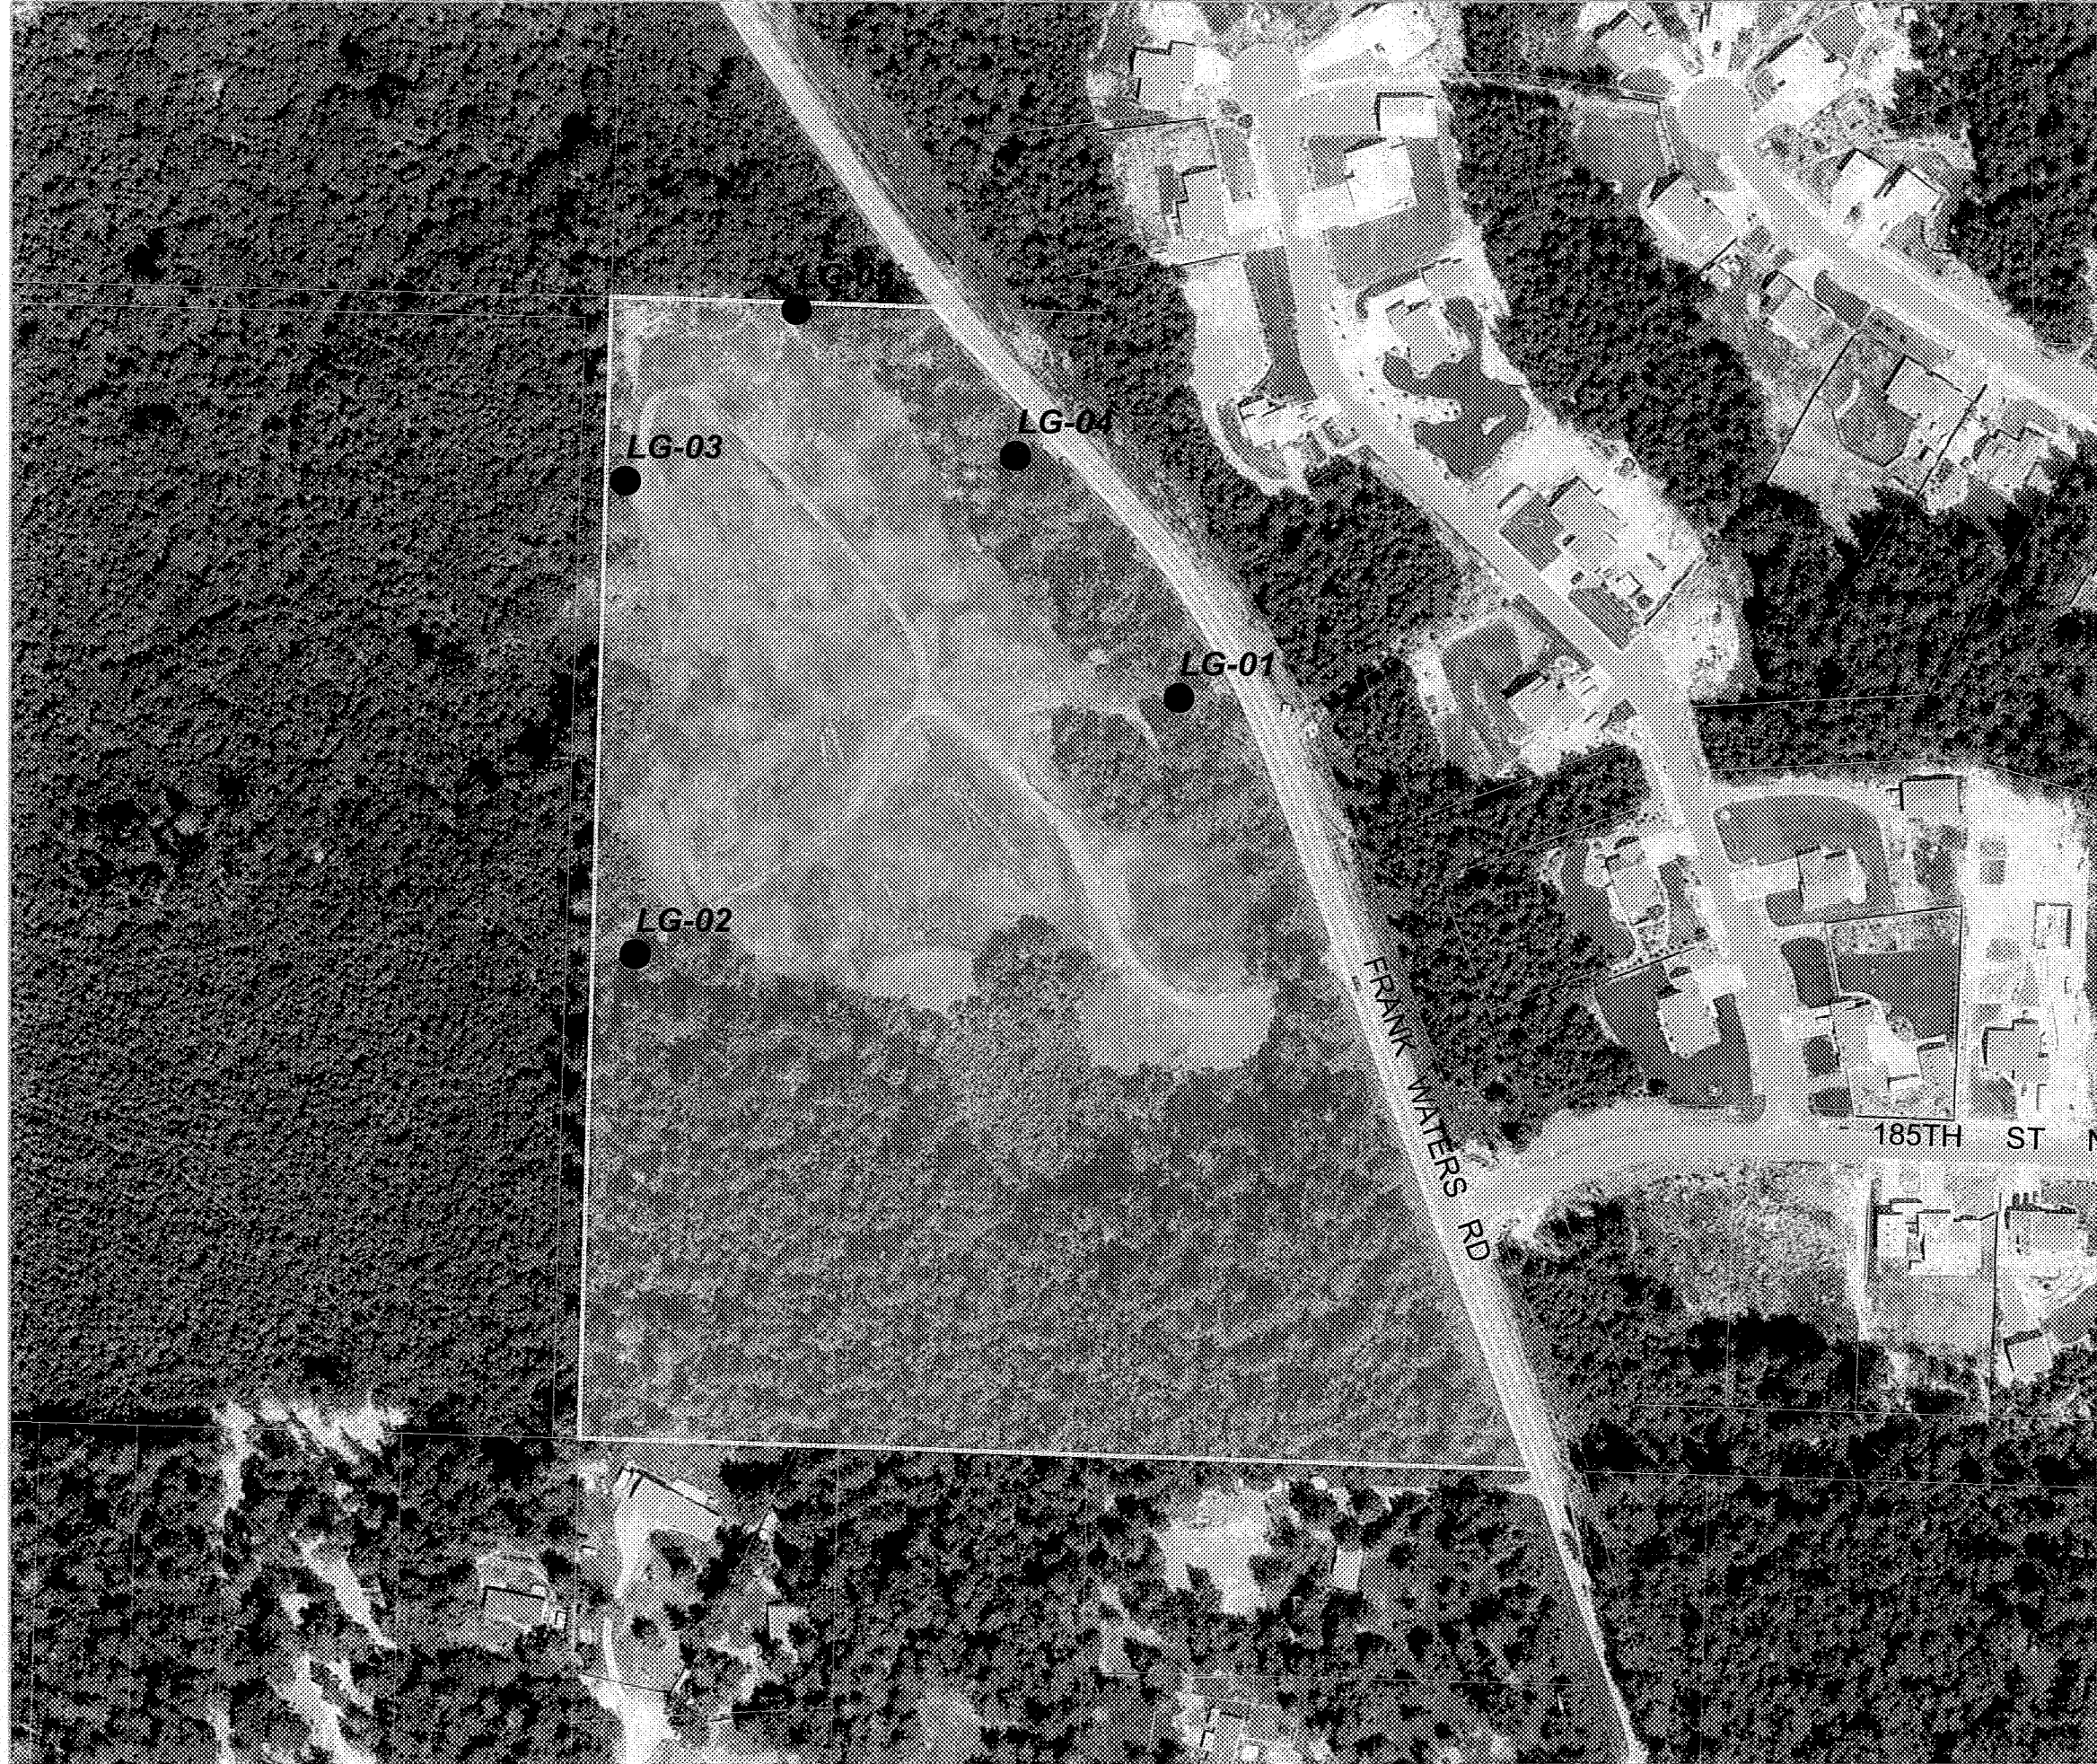
## Groundwater Monitoring Network

- Deep Aquifer

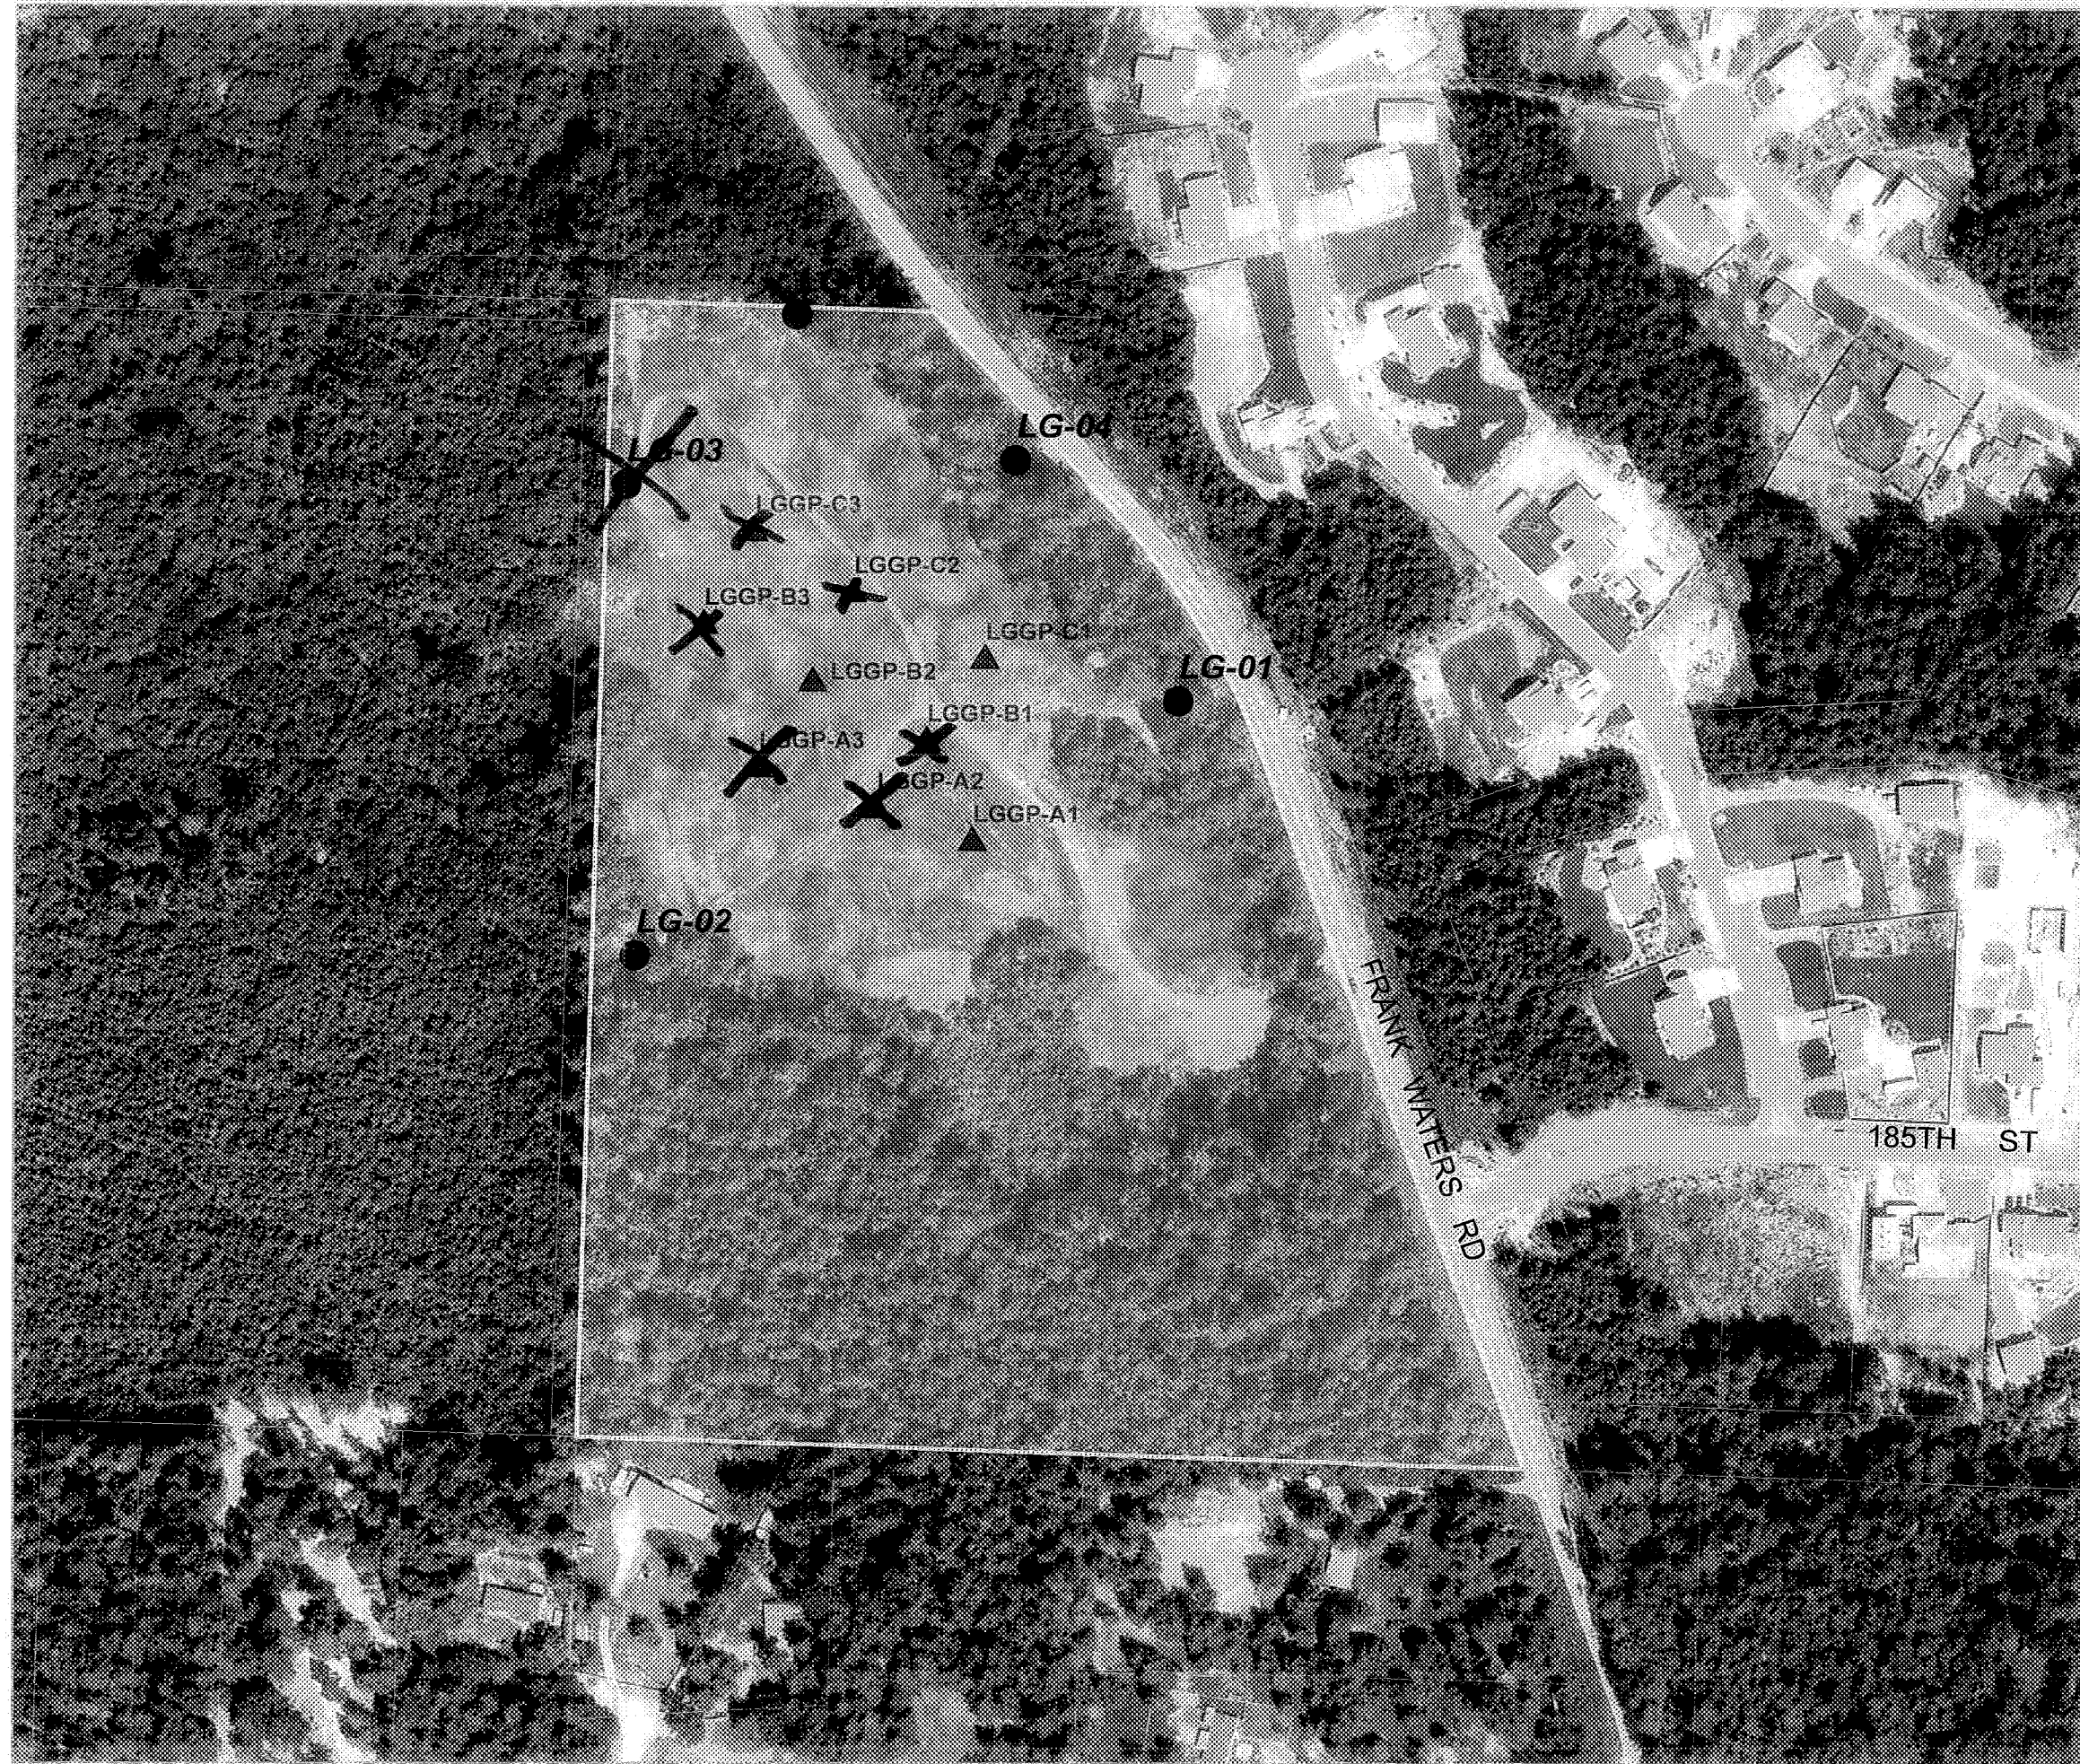
Figure 5

There is no methane gas collection system at the landfill. During the fourth quarter of 2011 a monthly methane gas monitoring program was initiated at the Lake Goodwin Landfill. Monitoring of methane gas production at the landfill is accomplished by a walking gas probe survey. Nine-(9) bar hole punch probe locations are shown on the

## Monitoring Network

▲ Bar Hole Punch Gas Probe

X = Non Existent

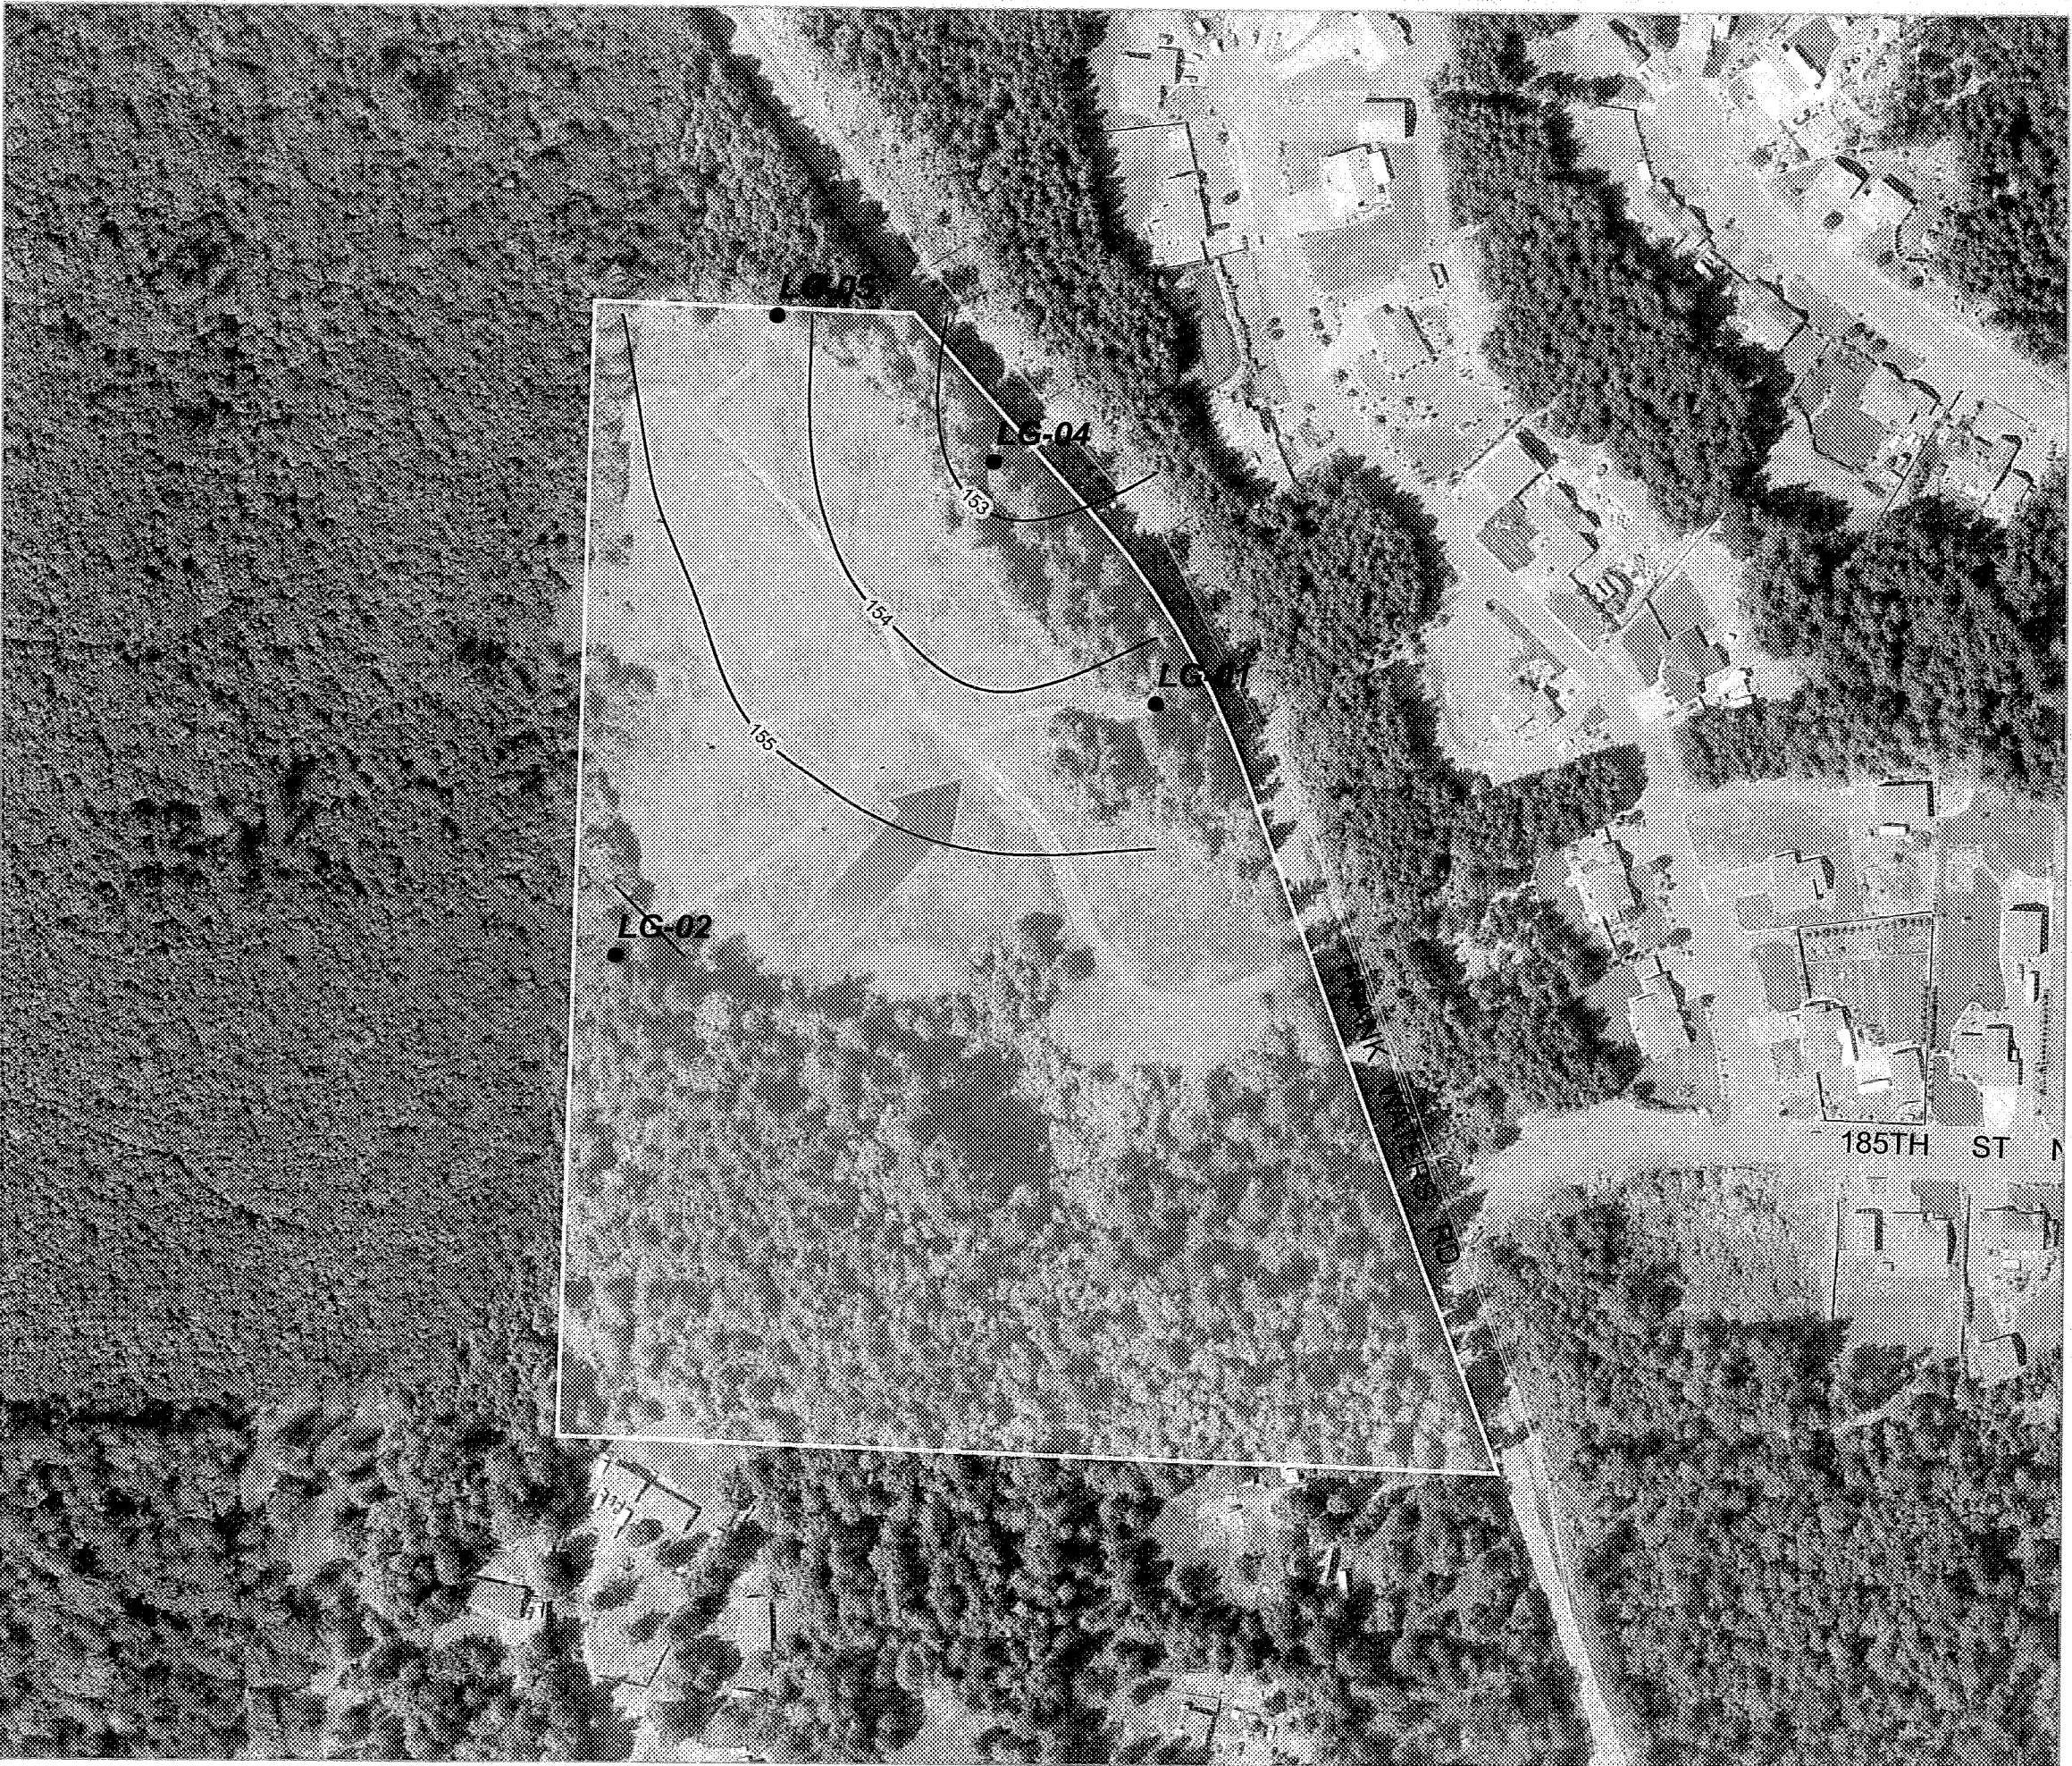
Figure 6

Multiple exceedances to the ground water standards during 2013 were observed in down gradient well LG-05 as shown on table 2 above. The constituent exceedances in well LG-05 were consistent throughout the year. As shown on the **Quarterly Ground Water Contour Map**, observation well LG-05 is located along the calculated ground water flow gradient directly down-gradient from the landfill.

Water Elevation Contours  
4th Quarter 2013

- DIRECTION OF GROUNDWATER FLOW  
1.52 ft/day  
555 ft/year  
48.07 degrees to the positive x-axis
- PARCEL BOUNDARY
- SUBJECT PROPERTY BOUNDARY
- 1 FT CONTOUR
- WELL LOCATION

WELL_ID	SAMP_DATE	MEAS_HEAD
LG-01	10/8/2013	154.37
LG-02	10/8/2013	156.17
LG-04	10/8/2013	152.77
LG-05	10/8/2013	154.25

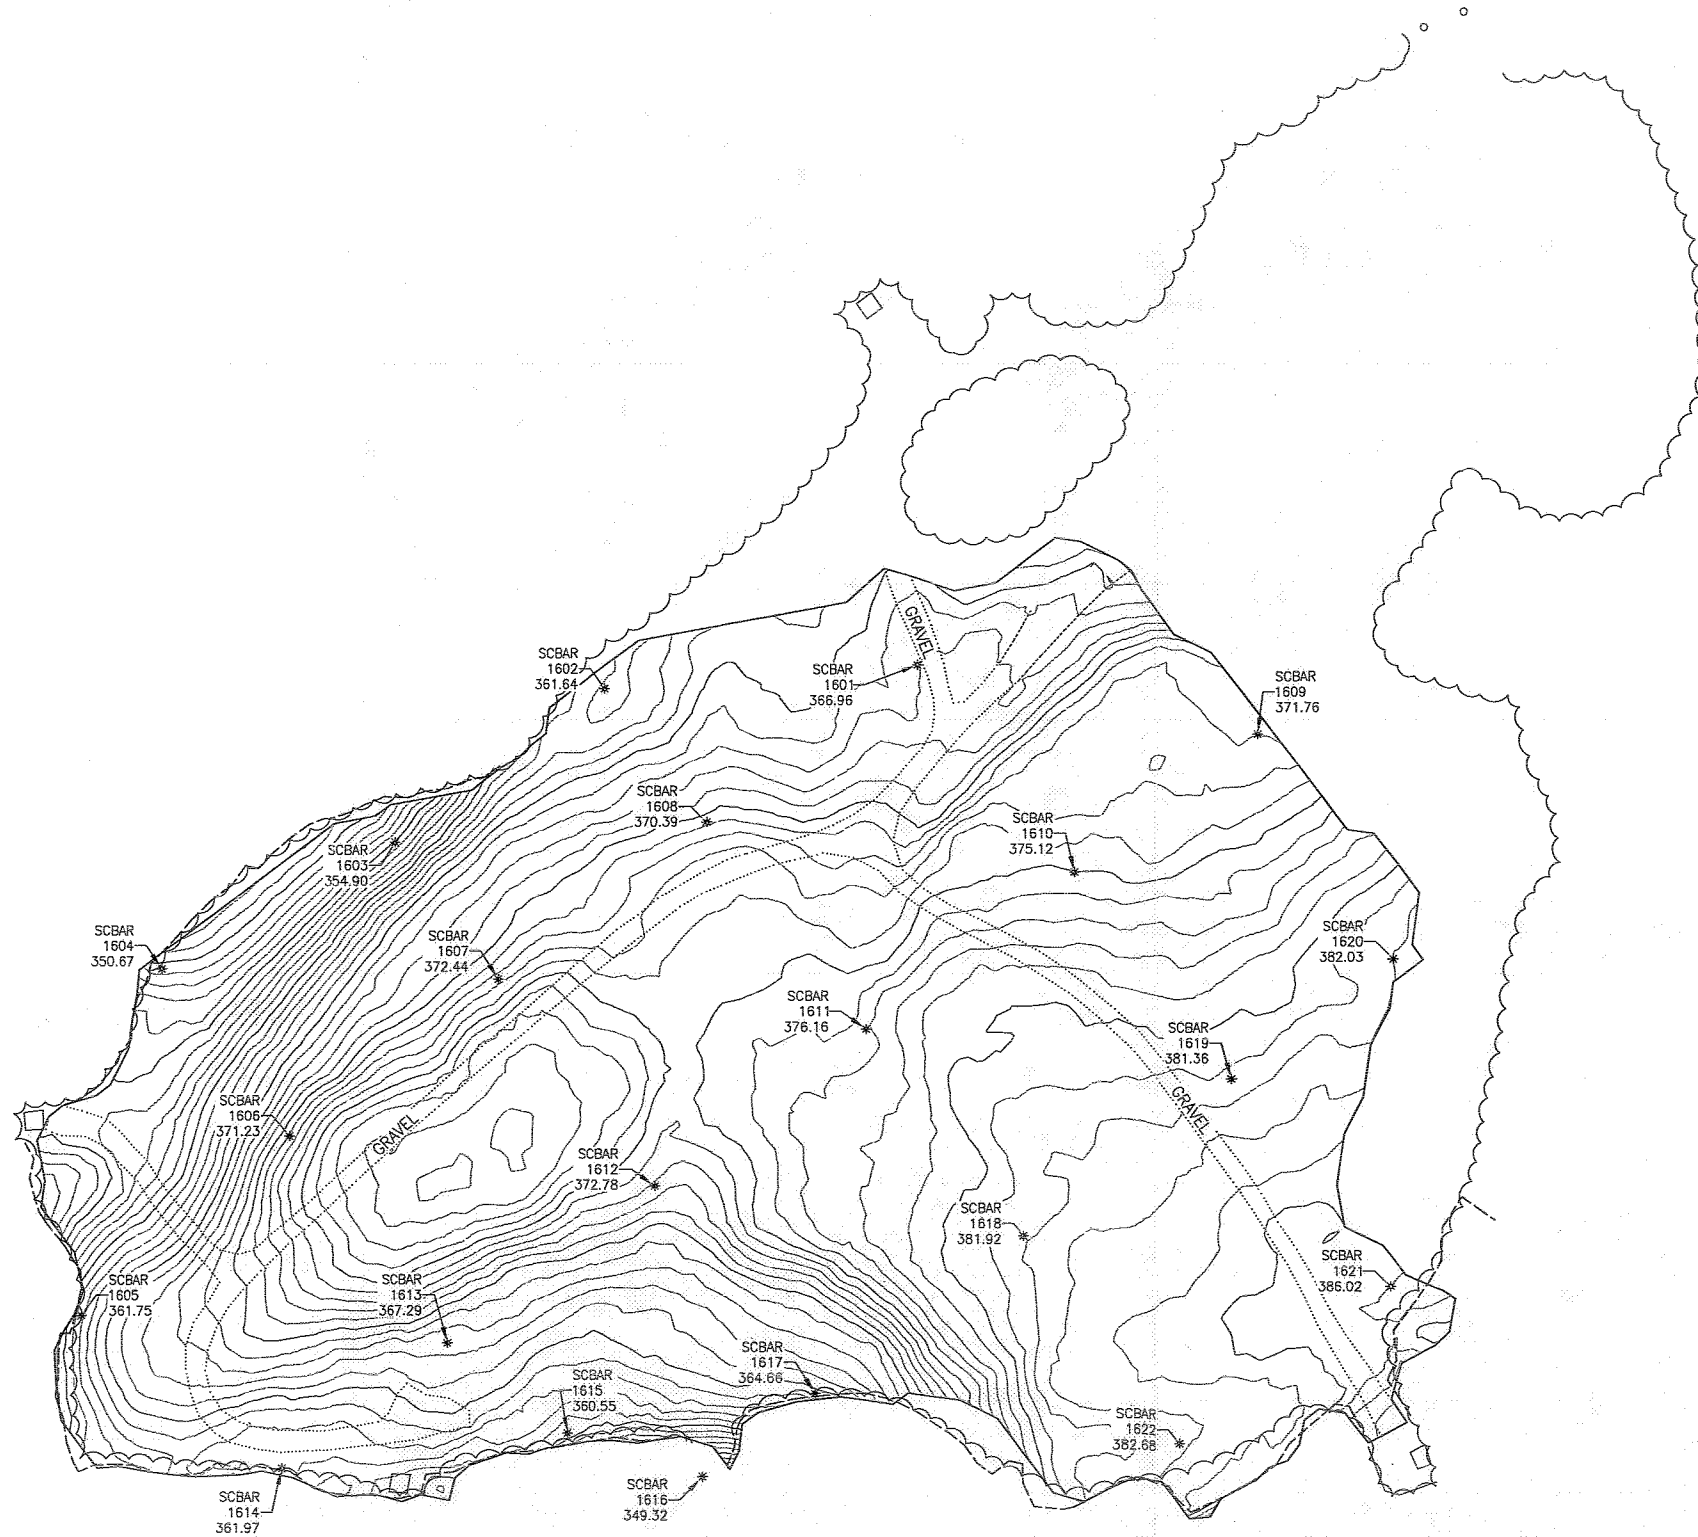
**10' GRID MAPPING SURVEY  
& MONITORING POINTS**

The third Lake Goodwin Landfill survey was completed by the *Snohomish County Public Works Survey Group* in December 2013. The third ground survey of the Lake Goodwin Landfill is not comparable to earlier surveys because of the new grid system. Current survey results are on the **Lake Goodwin Landfill Settlement and Monitoring Exhibit, Figure 6** of this report. It should be noted that if we were to compare the 2013 to the 2012 surveys we would see that landfill settlement between 2012 and 2013 was slight, less than 201 square feet showing a settlement of 0.50' during this time period. The **Slope Range Analysis** results from the 2013 annual survey are shown in *Figure 7*.

BASED ON:  
COUNTY FIELD MAPPING ON JANUARY, 2013.  
CONTOUR INTERVAL = 1 FOOT
