# *Lake Goodwin Landfill 2013 Annual Environmental Monitoring Report*

The following report summarizes the annual ground water monitoring results for 2013 at the Lake Goodwin Landfill (*Lake Goodwin Landfill, Site*). The site is located immediately west of Frank Waters Road in northwestern Snohomish County, about one and one half (1.5) miles northwest of Lake Goodwin and about five-(5) miles south of Stanwood (*T31N, R4E, sections 17, 20 Willamette Meridian*). The landfill is located at 18520 Frank Waters Road, Stanwood, Washington, 98292. The location of the site relative to existing municipal improvements is shown on the **Vicinity Map** (*figure 1*).

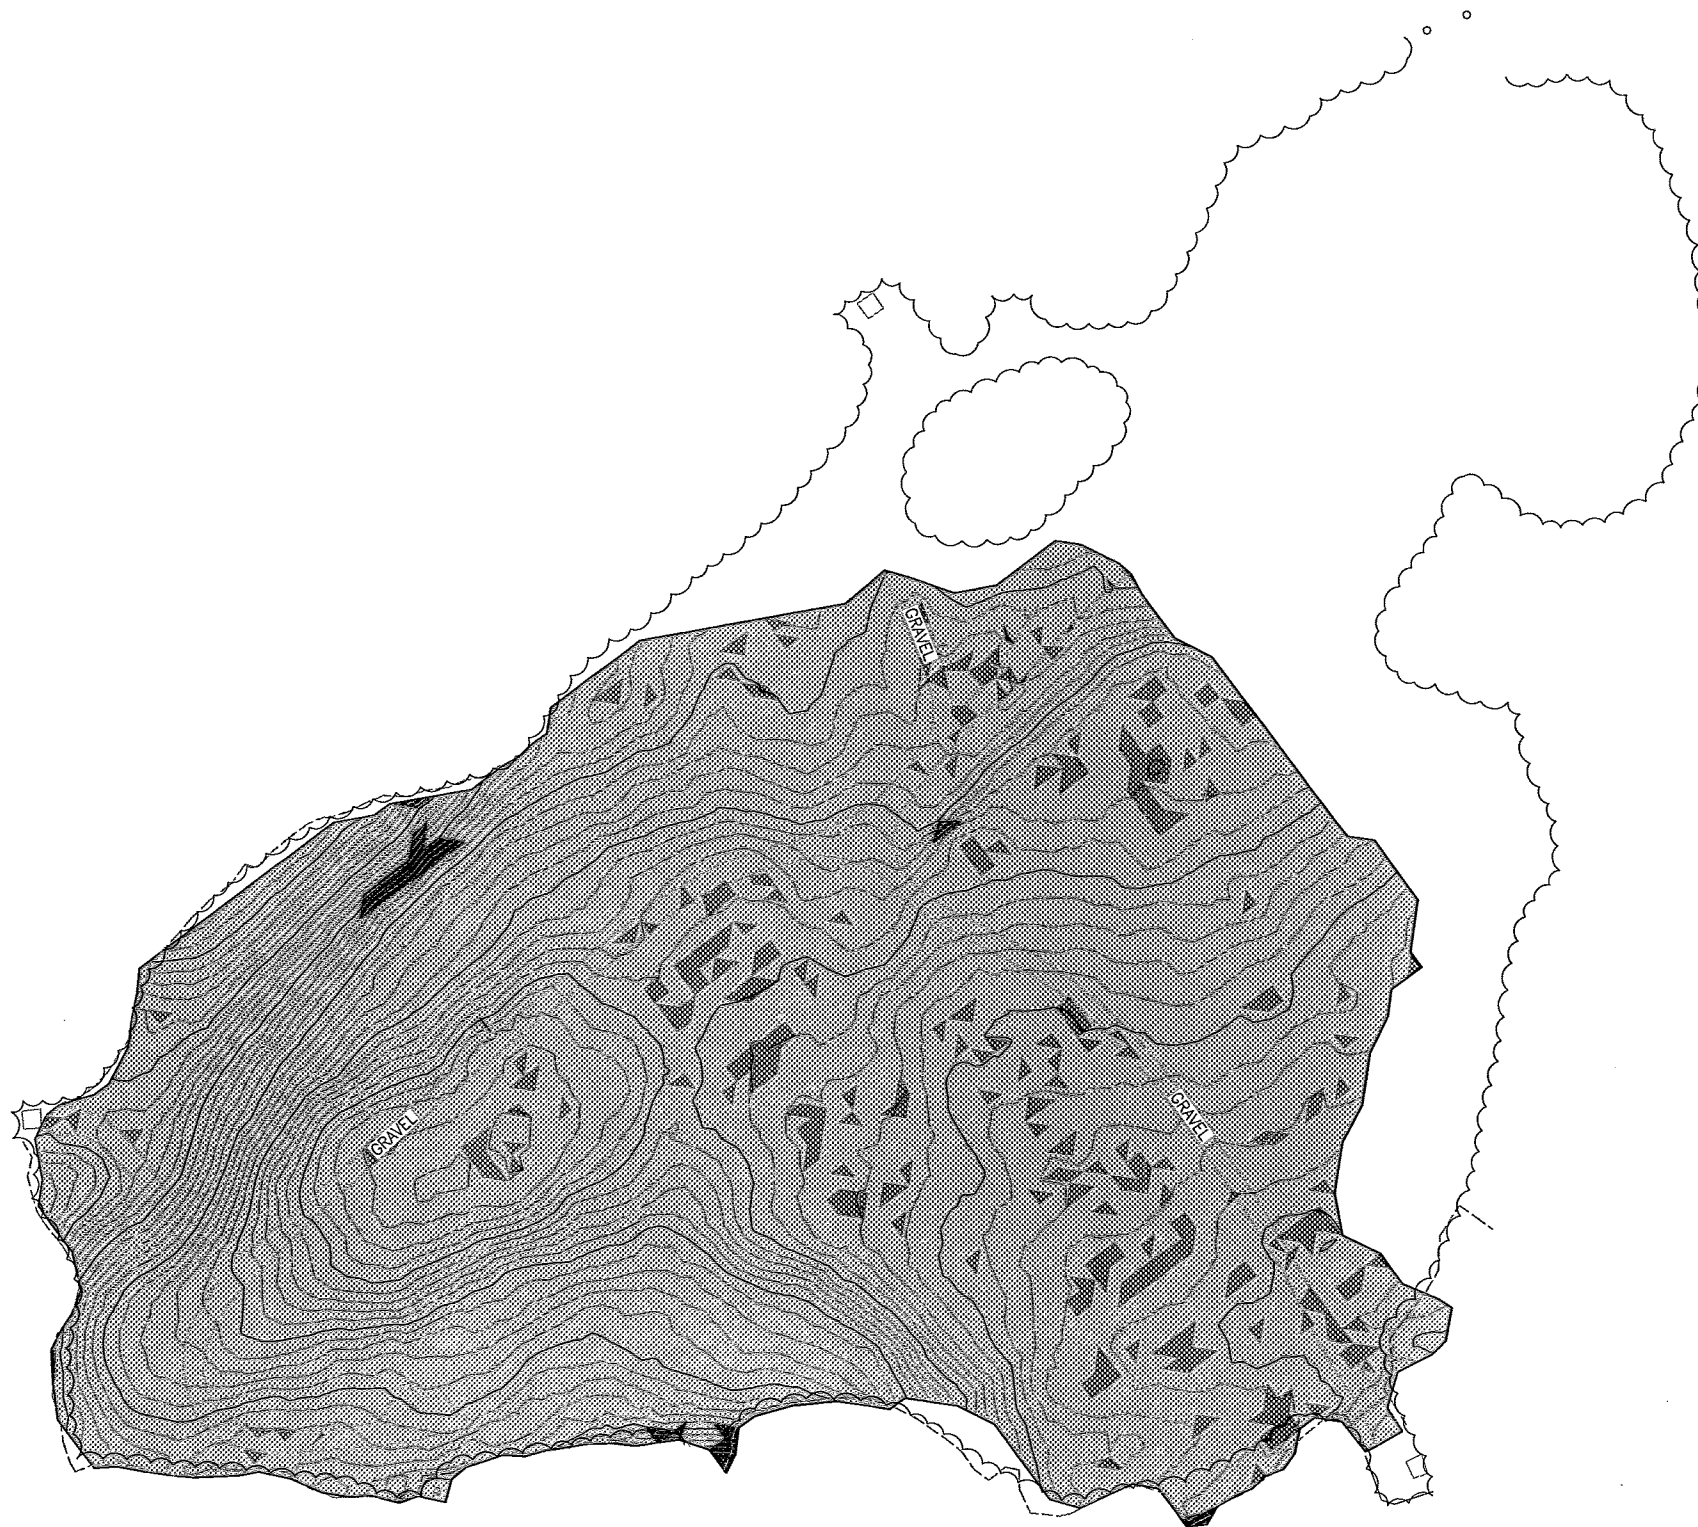
SNOHOMISH COUNTY DEPARTMENT OF PUBLIC WORKS  PROJECT NO. <u>RR 8019</u>	SURVEY NO. 3069
	FIELD BOOK(S): 1740
	DRAWN BY: ALJ
	UPI# 09-0064-1A
LAKE GOODWIN LANDFILL  SLOPE STUDY BASED ON 10' GRID MAPPING	REFERENCE SHEET NO.
	SHEET 1 OF 1 SHEETS

In order to comply with post closure requirements, cover surface slopes must remain between 2 and 5 percent grade, side slopes must remain below 33 percent slope and localized settlements must not impair cover drainage or cover integrity. Existing biomass stability will be determined based on these annual surveys.

Areas exceeding the maximum percent slope grades given in *section 4.1* above are highlighted and shown on an annual contour topographic map of the site.

The third Lake Goodwin Landfill survey was completed by the *Snohomish County Public Works Survey Group* in December 2013. The third ground survey of the Lake Goodwin Landfill is not comparable to earlier surveys because of the new grid system. Current survey results are on the **Lake Goodwin Landfill Settlement and Monitoring Exhibit, Figure 6** of this report. It should be noted that if we were to compare the 2013 to the 2012 surveys we would see that landfill settlement between 2012 and 2013 was slight, less than 201 square feet showing a settlement of 0.50' during this time period. The **Slope Range Analysis** results from the 2013 annual survey are shown in *Figure 7*.

Slope Range Table				
Number	Min. Slope Range	Max. Slope Range	Area (sq ft)	Color
1	0.10%	2.00%	14710	
2	2.00%	33.00%	262482	
3	33.00%	131.99%	1341

We recommend that monitoring of the Lake Goodwin Landfill continue through 2014 per the SAP.
