Lake Goodwin Landfill

2014 1st Quarter Environmental

Monitoring Report

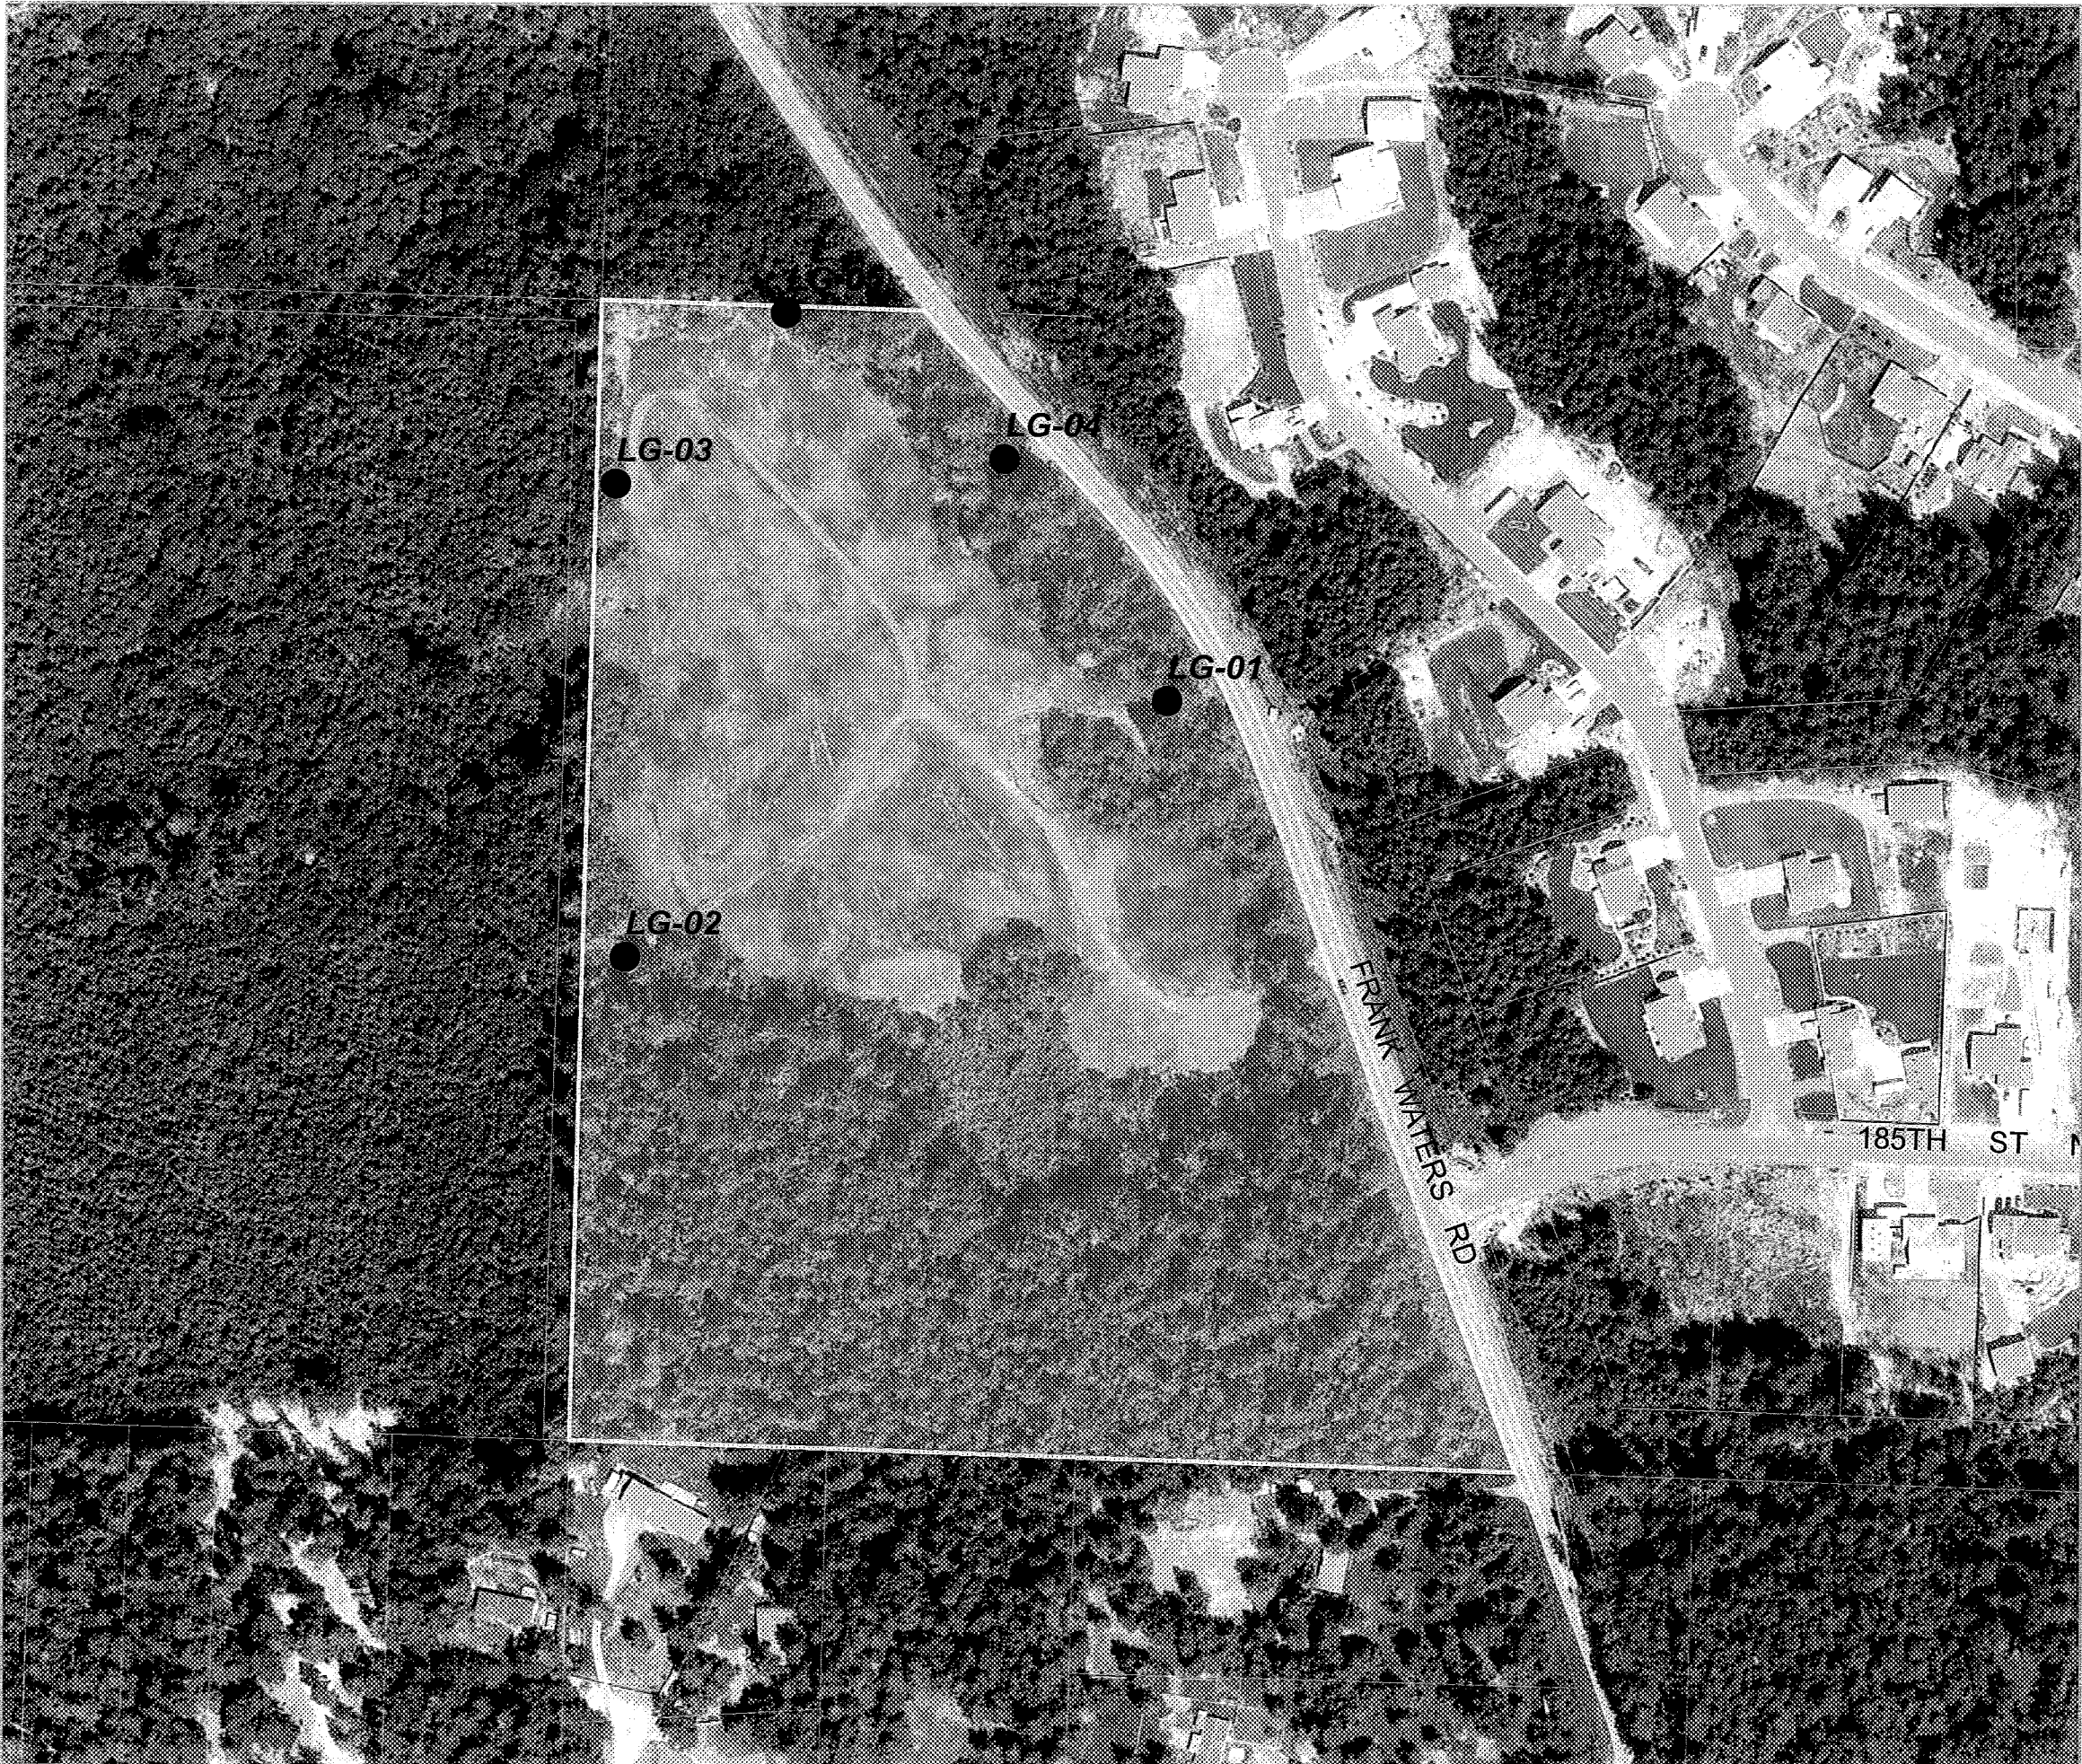
Figure 5

As outlined in the Solid Waste Facility Permit SW-085, quarterly monitoring of ground water is required at the Lake Goodwin Landfill. There are currently four-(4) ground water monitoring wells (LG-01, LG-02, LG-04, and LG-05) at the Lake Goodwin Landfill site that are read on a quarterly basis. Well locations are shown on the **Network Monitoring Map** (figure 5). Of these wells, one-(1) is considered to be an up-gradient well monitoring background ground water conditions in the immediate vicinity of the site (LG-02). The remaining three-(3) wells are located down gradient of the landfill (LG-01, and LG-04 and LG-05) and monitor ground water conditions that may be impacted from the site. First quarter monitoring results are discussed in section 2.0 below.

Groundwater Monitoring Network

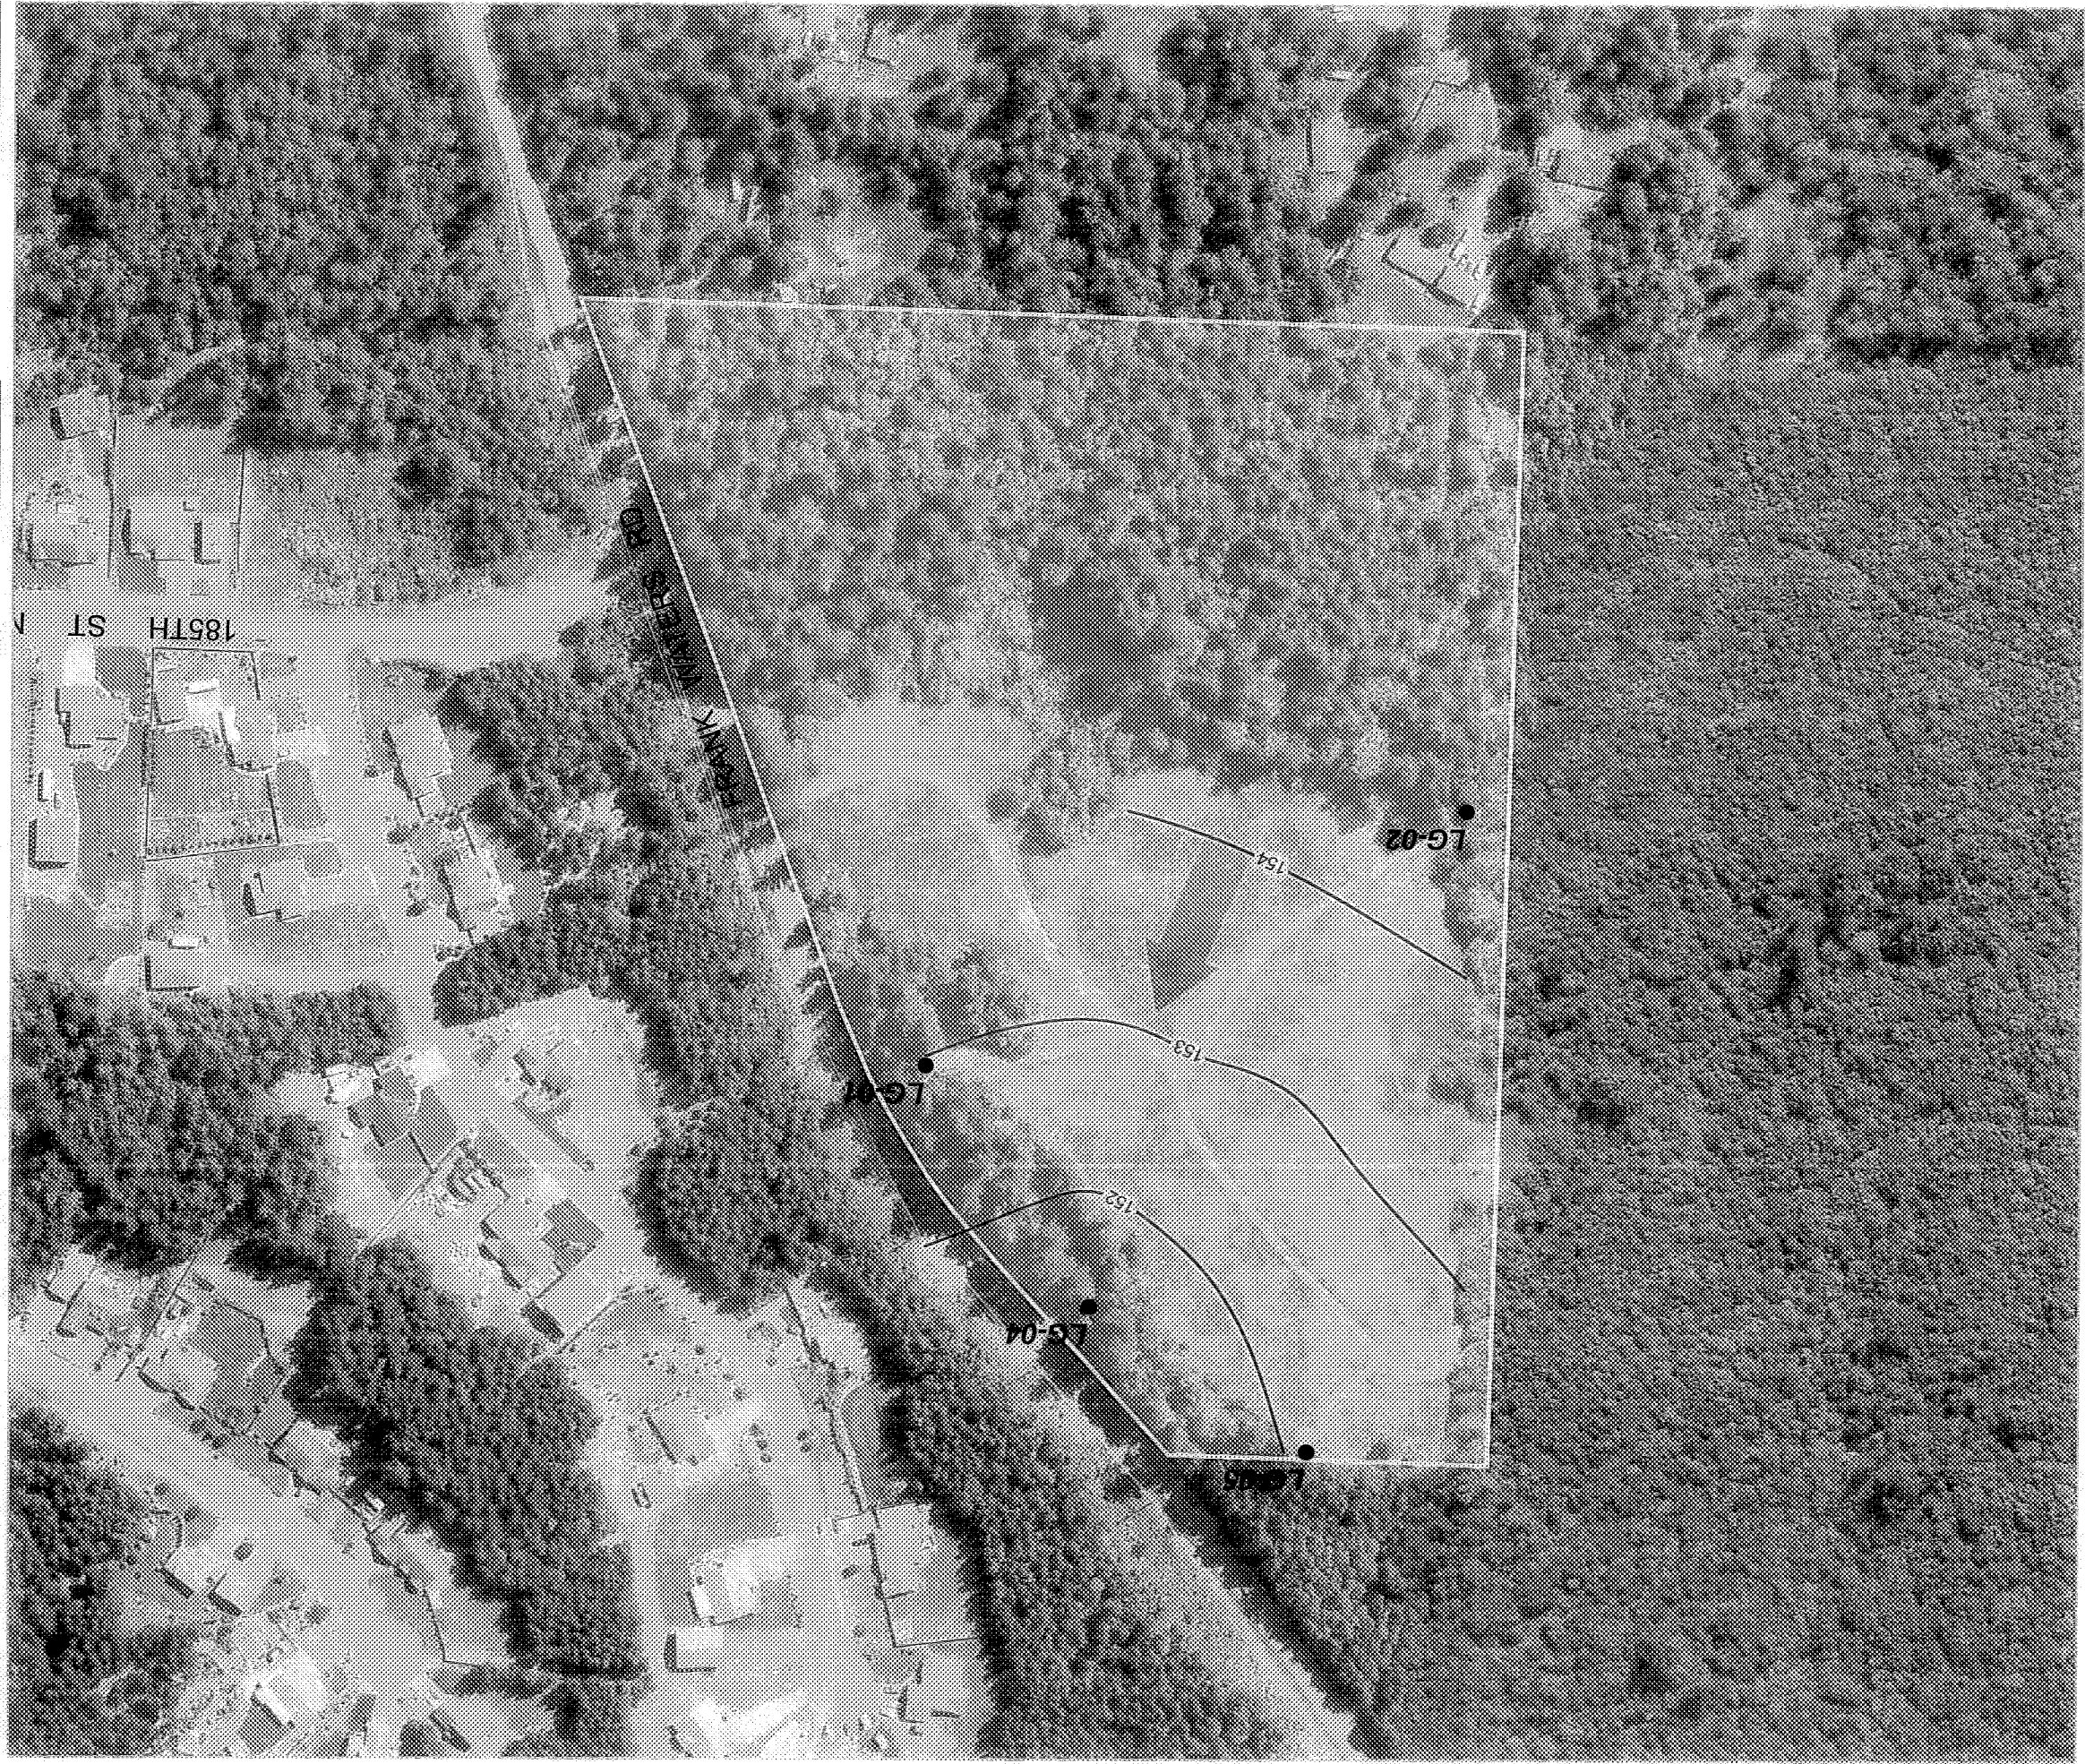
Figure 6

First Quarter Ground Water Measurements are shown in *Table 1* below. **Hydrographs** of the first quarter 2014 monitoring well readings are contained in *Appendix A* of this report. First quarter well readings show a general decrease in water levels in the wells. Readings confirm that the aquifer is unconfined in the immediate vicinity of the site. The **First Quarter Ground Water Contour Map** developed from the field data is shown in *Figure 6* of this report.

Water Elevation Contours

1st Quarter 2014

DIRECTION OF GROUNDWATER FLOW
1.53 ft/day
560 ft/year
66.64 degrees to the positive x-axis
