Lake Goodwin Landfill

2014 2nd Quarter Environmental

Monitoring Report

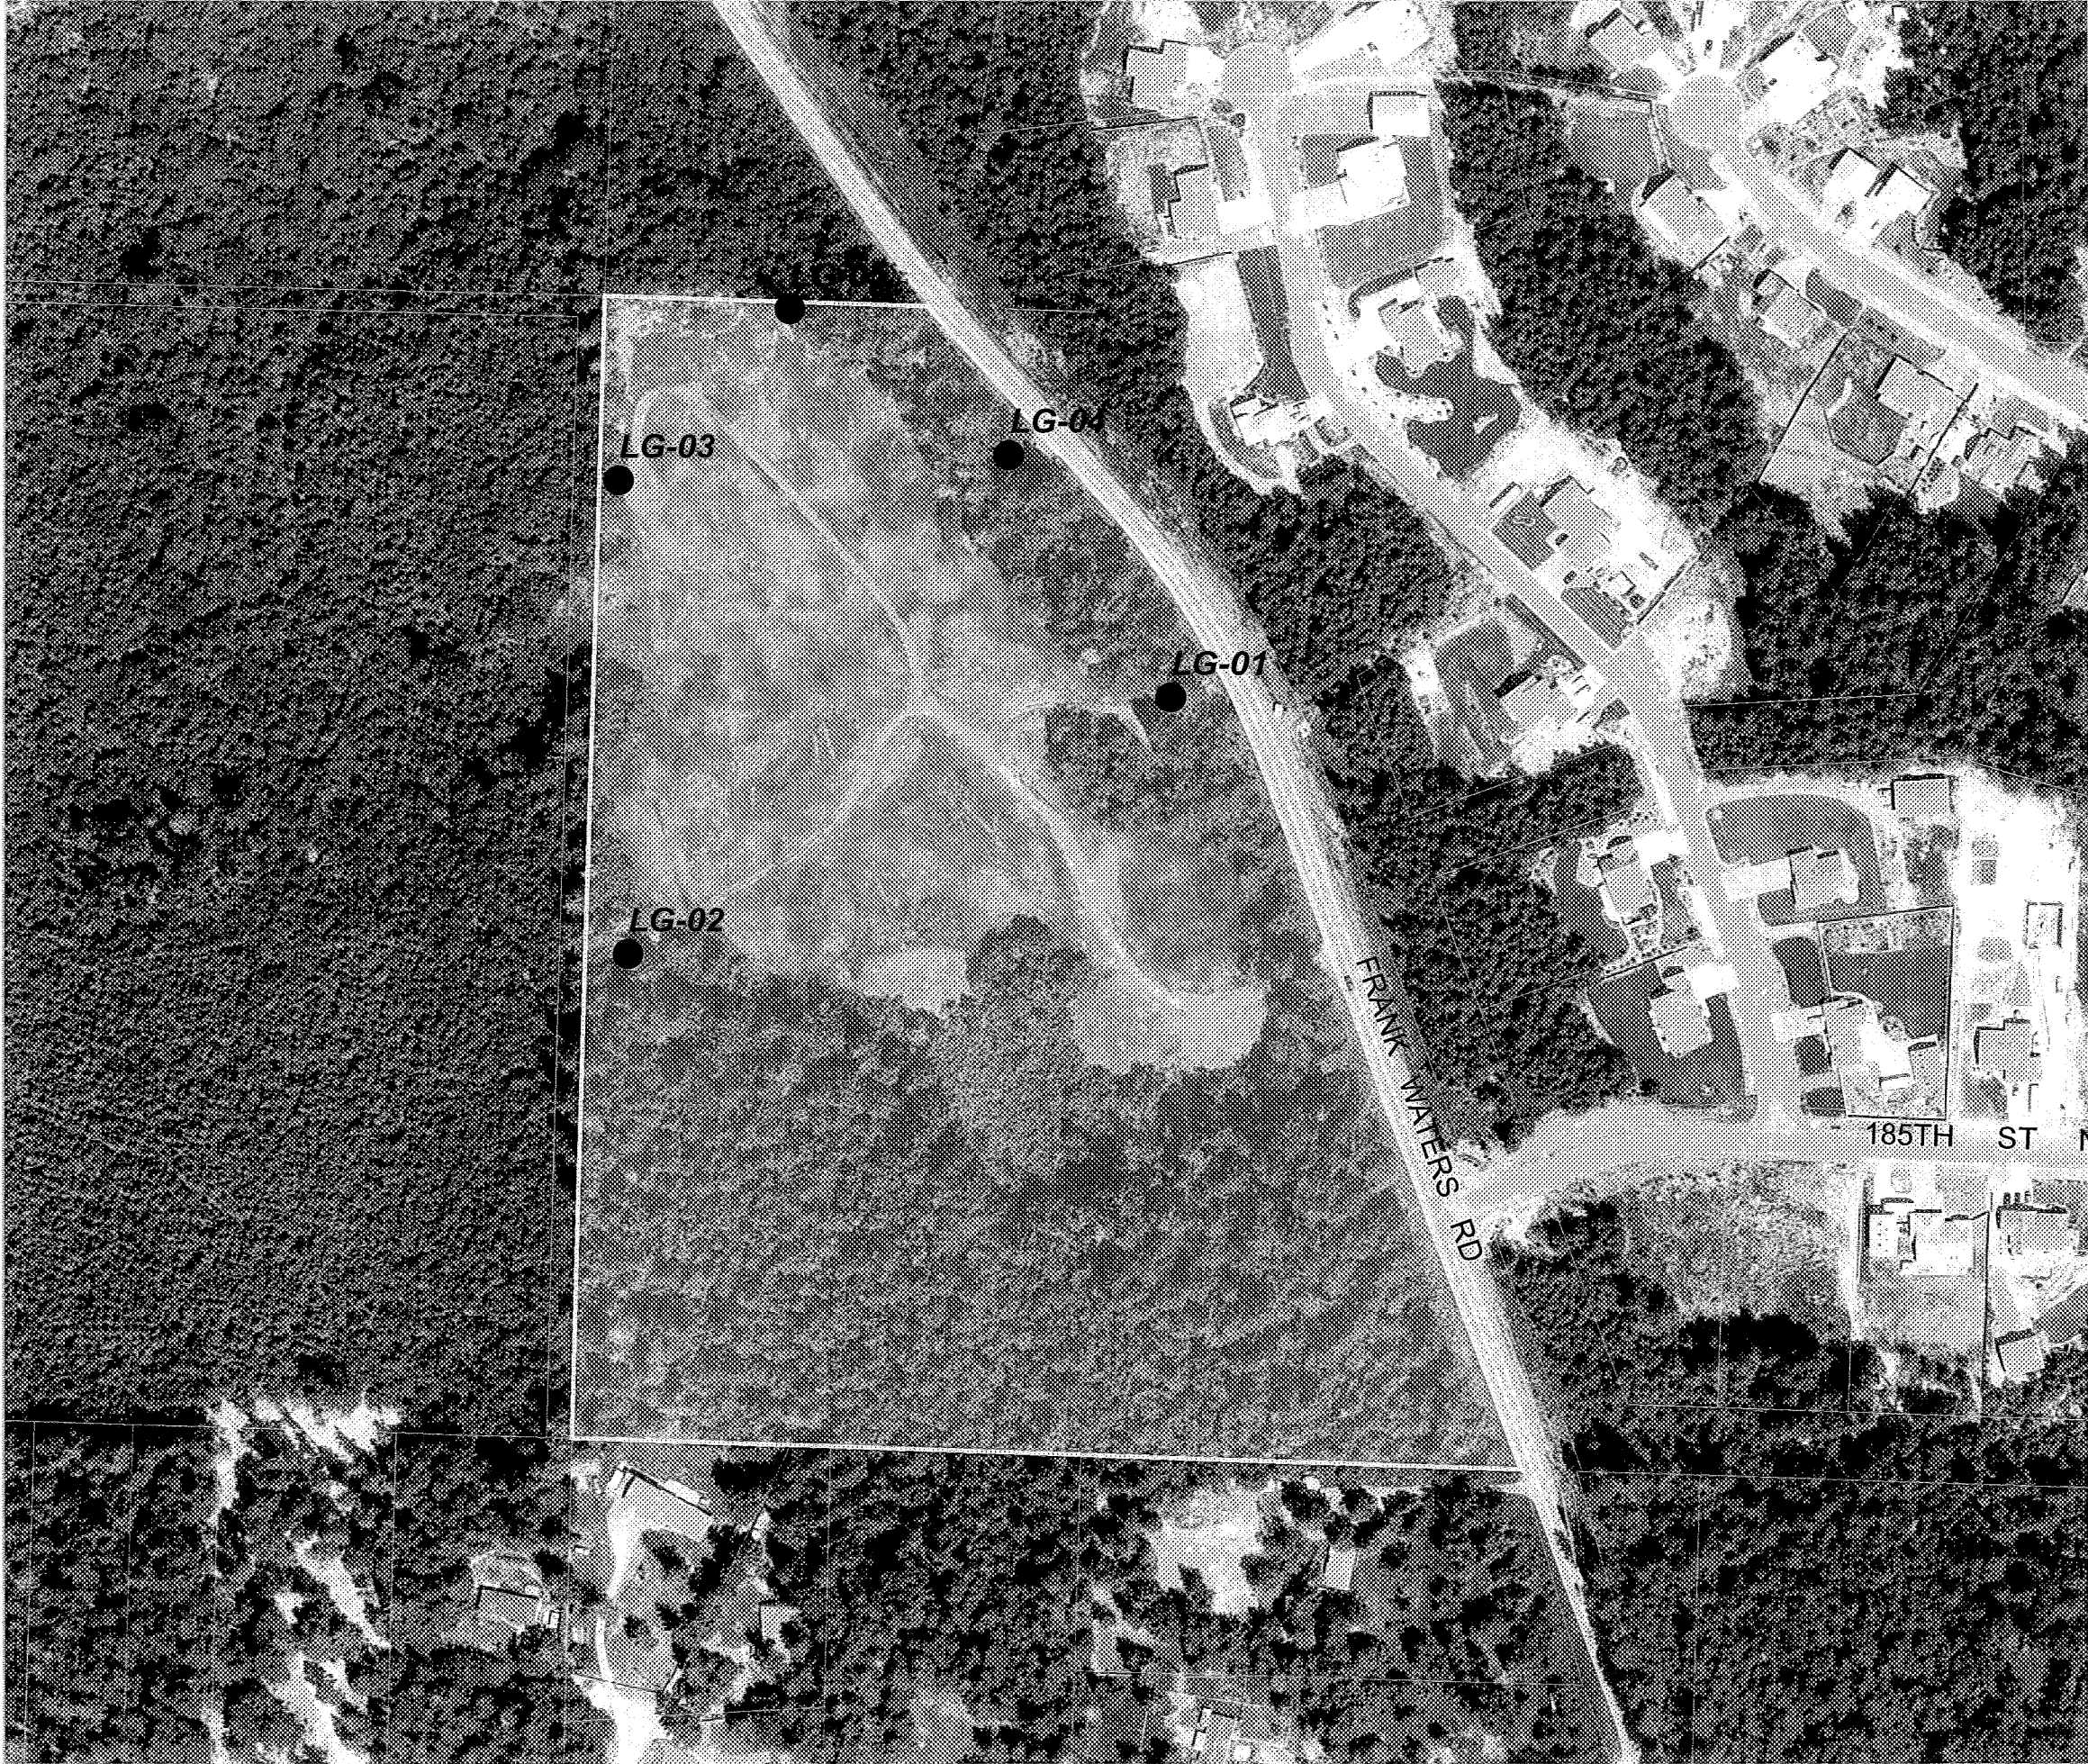
Figure 5

As outlined in the Solid Waste Facility Permit SW-085, quarterly monitoring of ground water is required at the Lake Goodwin Landfill. There are currently four-(4) ground water monitoring wells (LG-01, LG-02, LG-04, and LG-05) at the Lake Goodwin Landfill site that are read on a quarterly basis. Well locations are shown on the **Network Monitoring Map** (figure 5). Of these wells, one-(1) is considered to be an up-gradient well monitoring background ground water conditions in the immediate vicinity of the site (LG-02). The remaining three-(3) wells are located down gradient of the landfill (LG-01, and LG-04 and LG-05) and monitor ground water conditions that may be impacted from the site. Second quarter monitoring results are discussed in section 2.0 below.

Lake Goodwin Landfill

Groundwater Monitoring Network

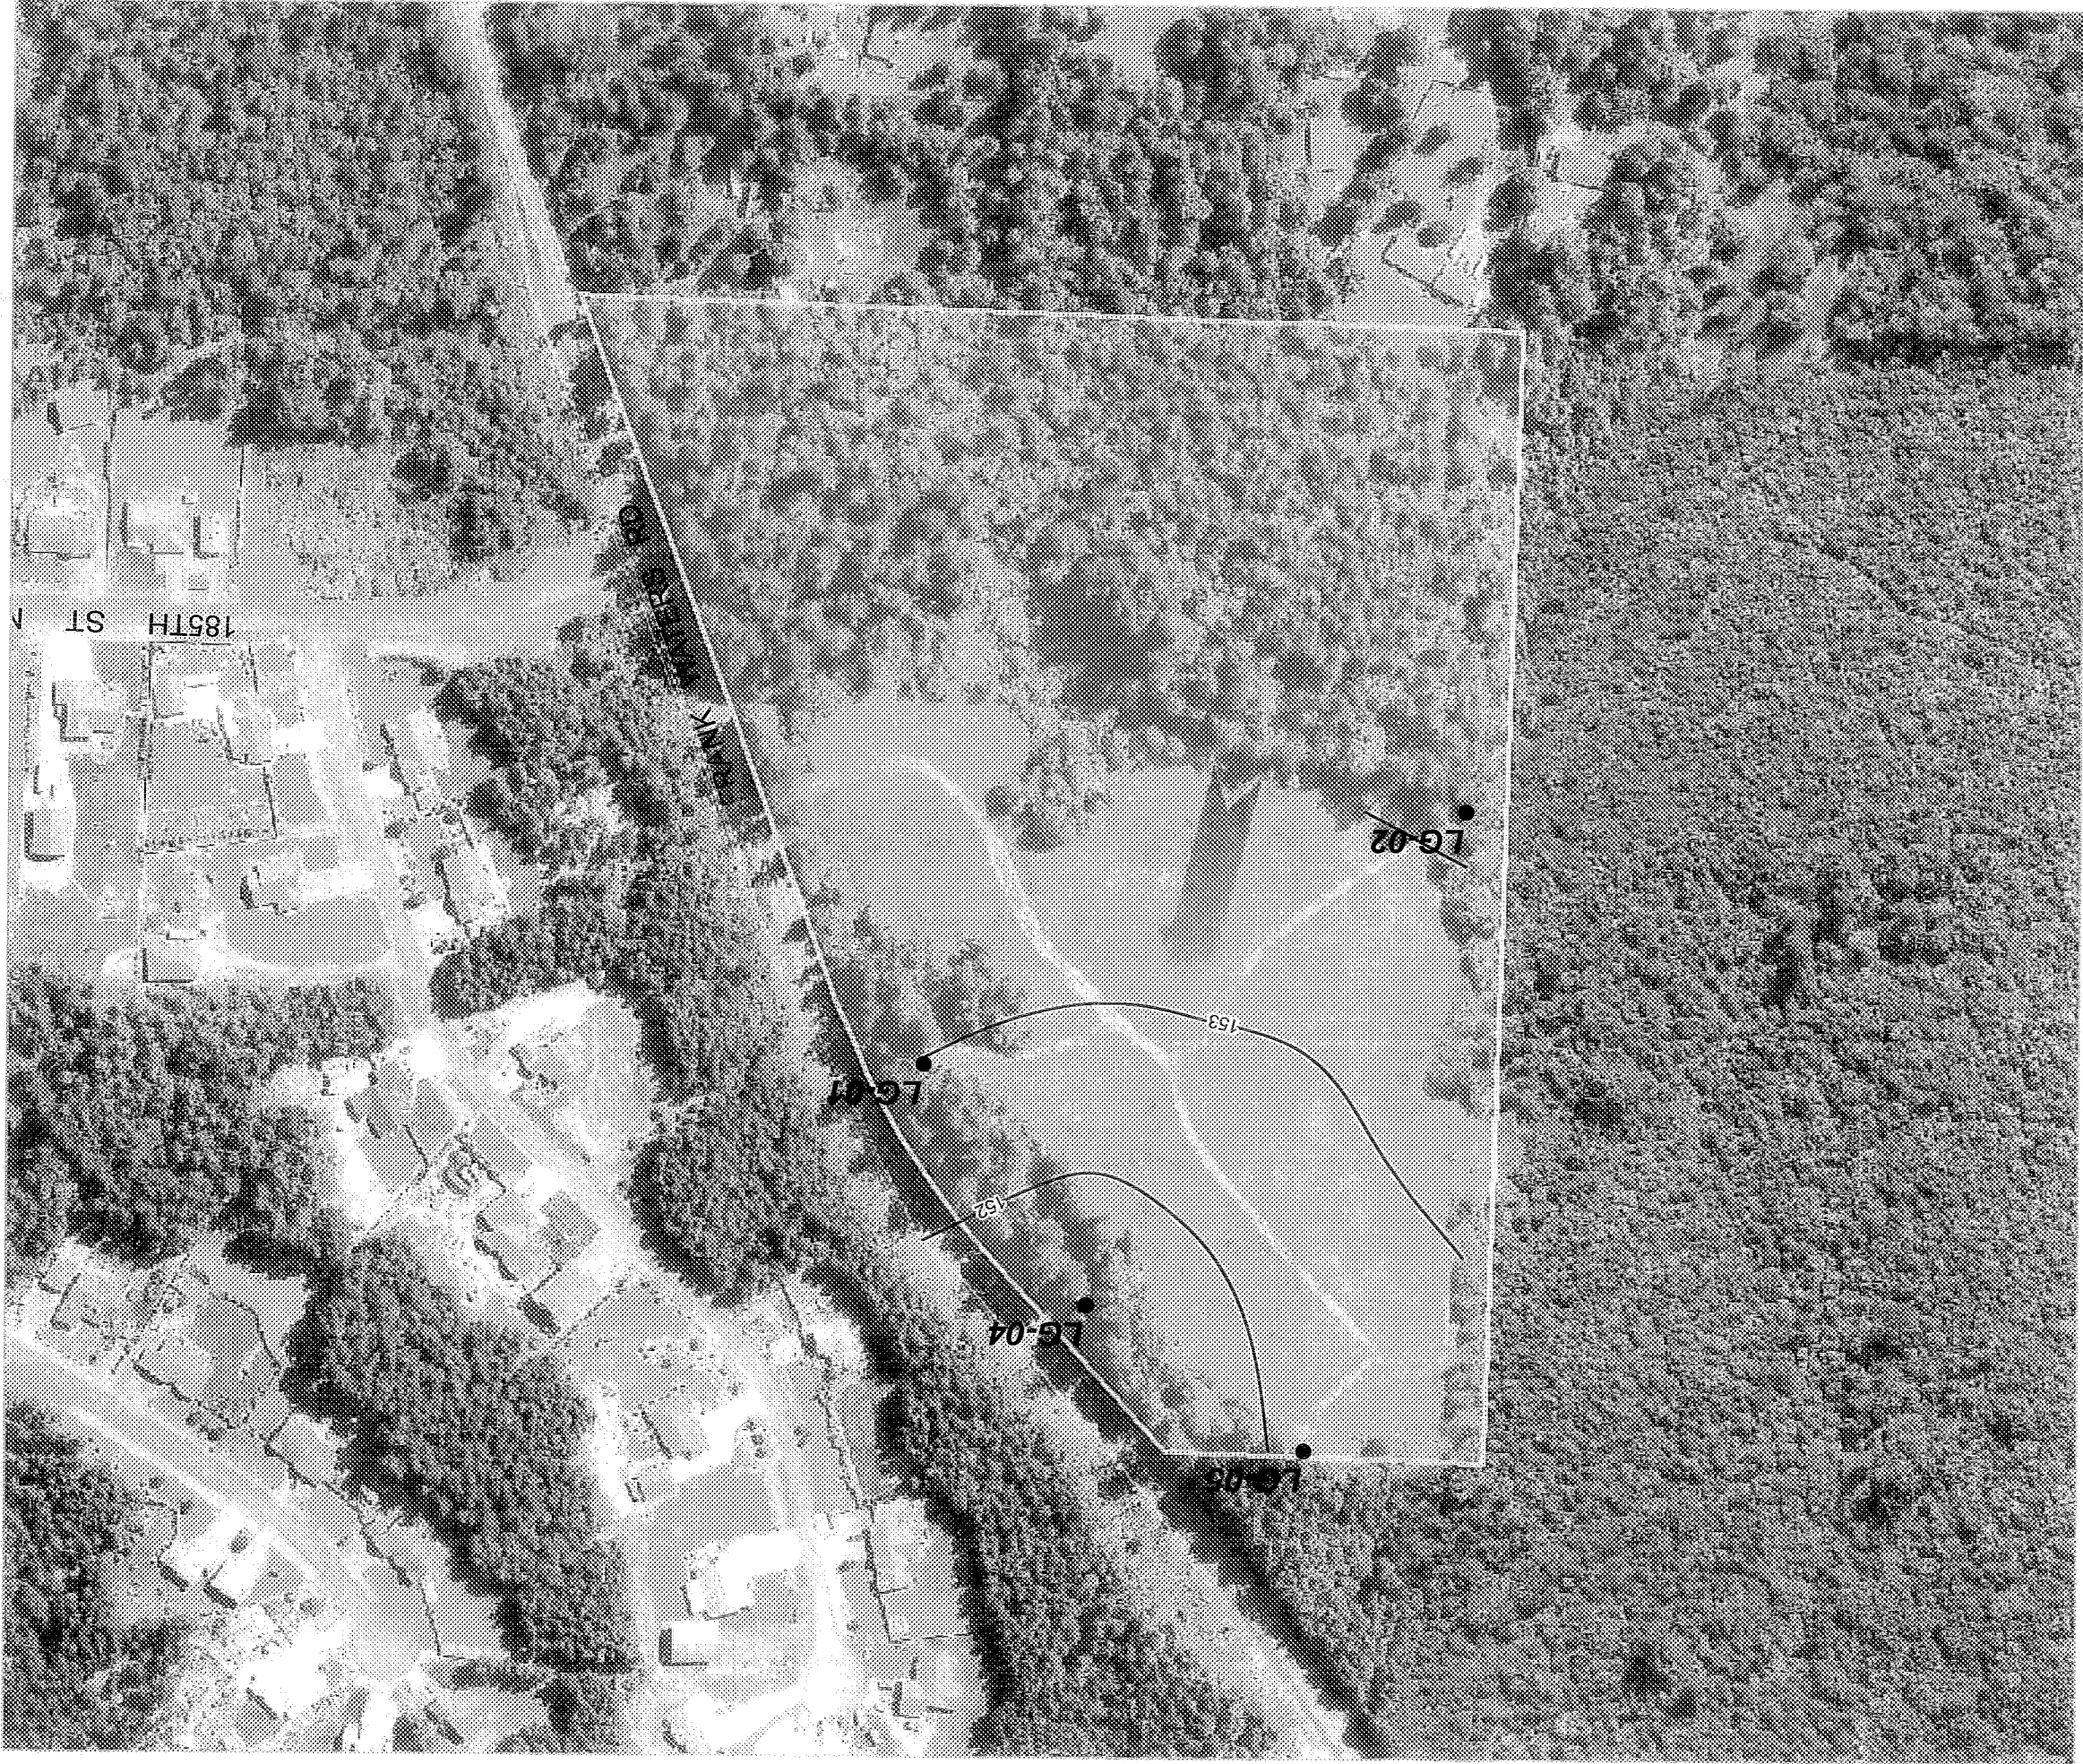
Figure 6

Second Quarter Ground Water Measurements are shown in *Table 1* below. **Hydrographs** of the second quarter 2014 monitoring well readings are contained in *Appendix A* of this report. Second quarter well readings show a general statistically insignificant decrease in water levels in the wells. Readings confirm that the aquifer is unconfined in the immediate vicinity of the site. The **Second Quarter Ground Water Contour Map** developed from the field data is shown in *Figure 6* of this report.

Lake Goodwin Landfill

Water Elevation Contours

2nd Quarter 2014

DIRECTION OF GROUNDWATER FLOW
1.30 ft / day
476 ft / year
69.01 degrees to the positive x - axis
