Lake Goodwin Landfill

2014 4th Quarter Environmental

Monitoring Report

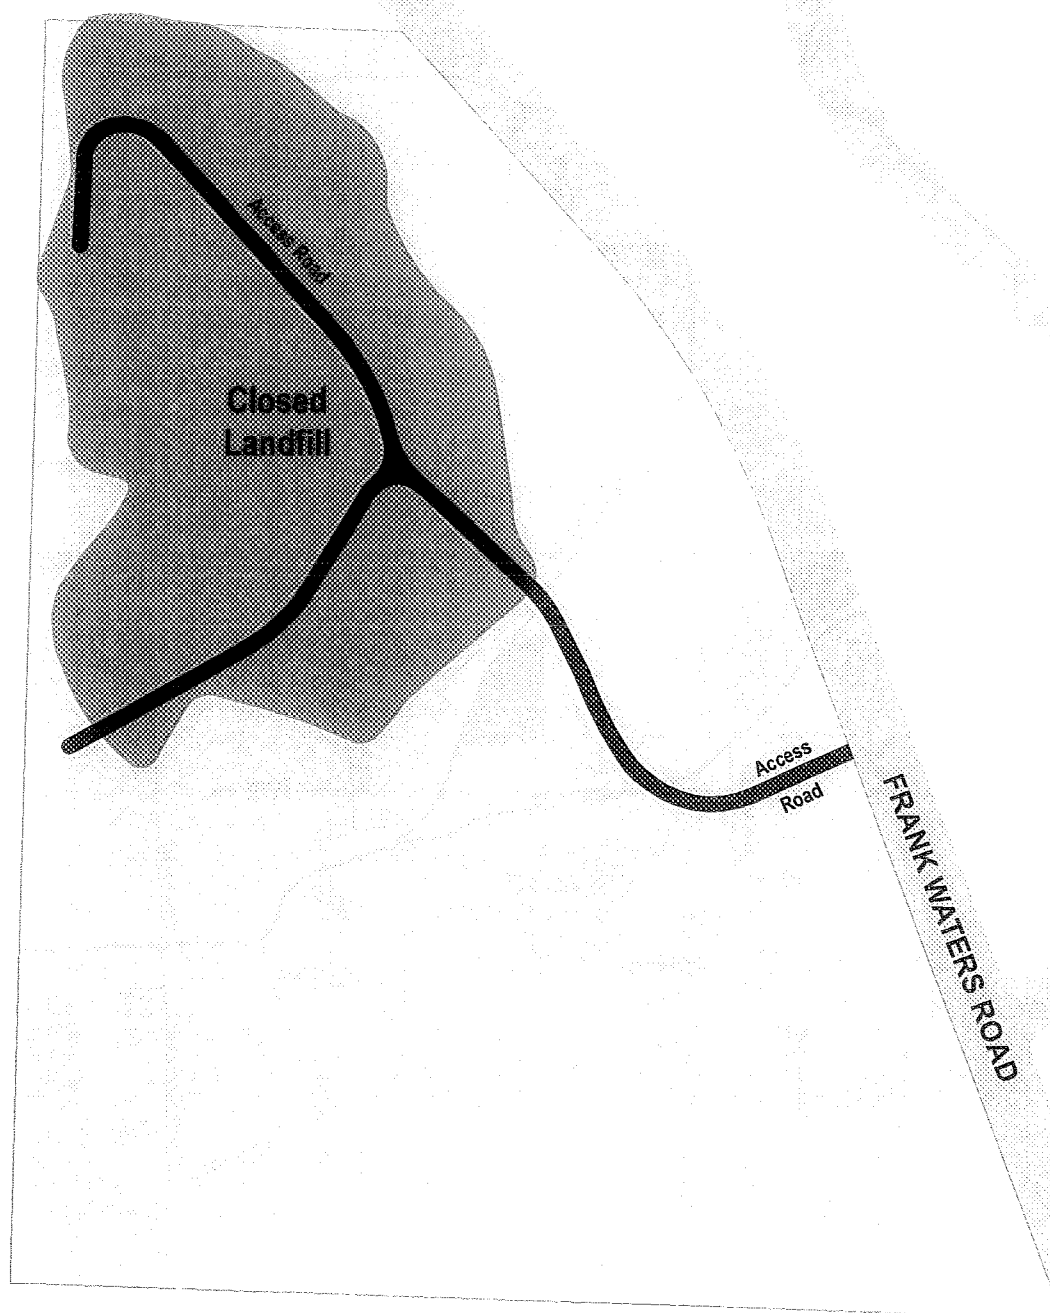
Figure 2

Lake Goodwin Landfill Site Map

The closed landfill is approximately 11.5 acres in size and is part of a larger County owned parcel of land. The Lake Goodwin Landfill is bounded by private residential property or commercial forest to the south, west and north. The Frank Waters Road is located along the eastern side of the site. Access into the site is from a partially paved and partially graveled driveway off of the Frank Waters Road. Existing site improvements are shown on the **Site Map** (*figure 2*).

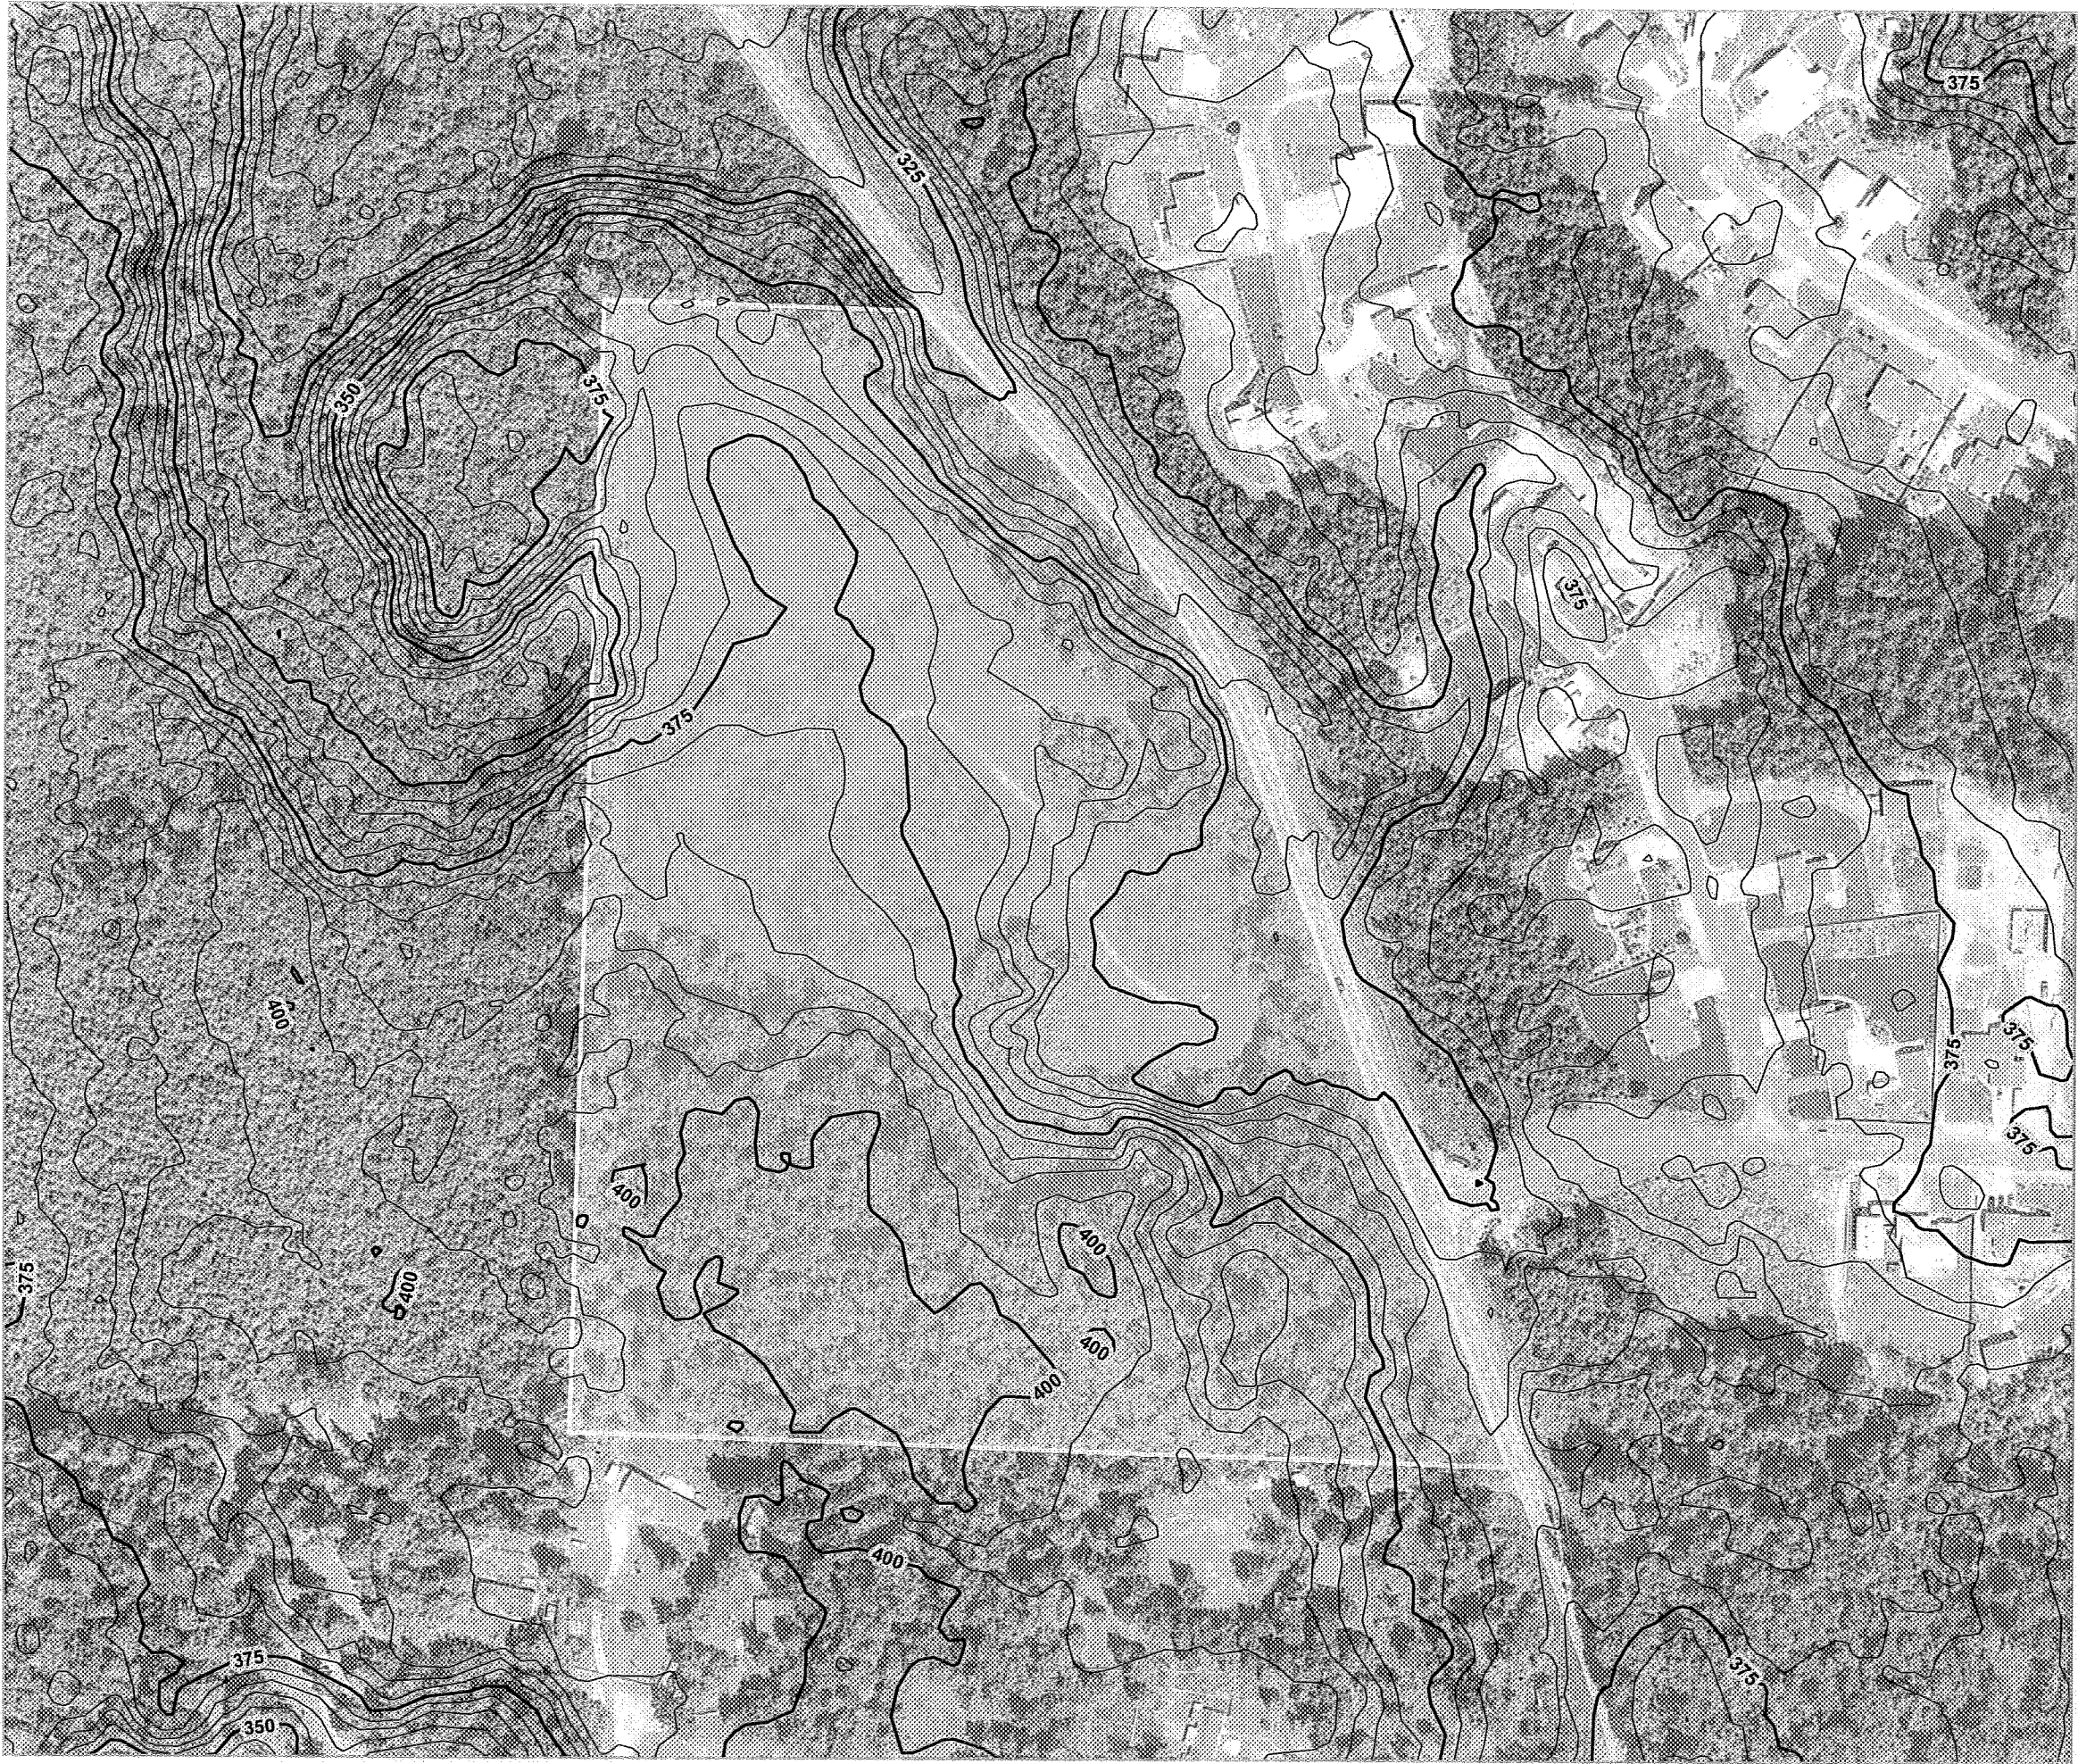
Figure 3

Lake Goodwin Landfill Topography

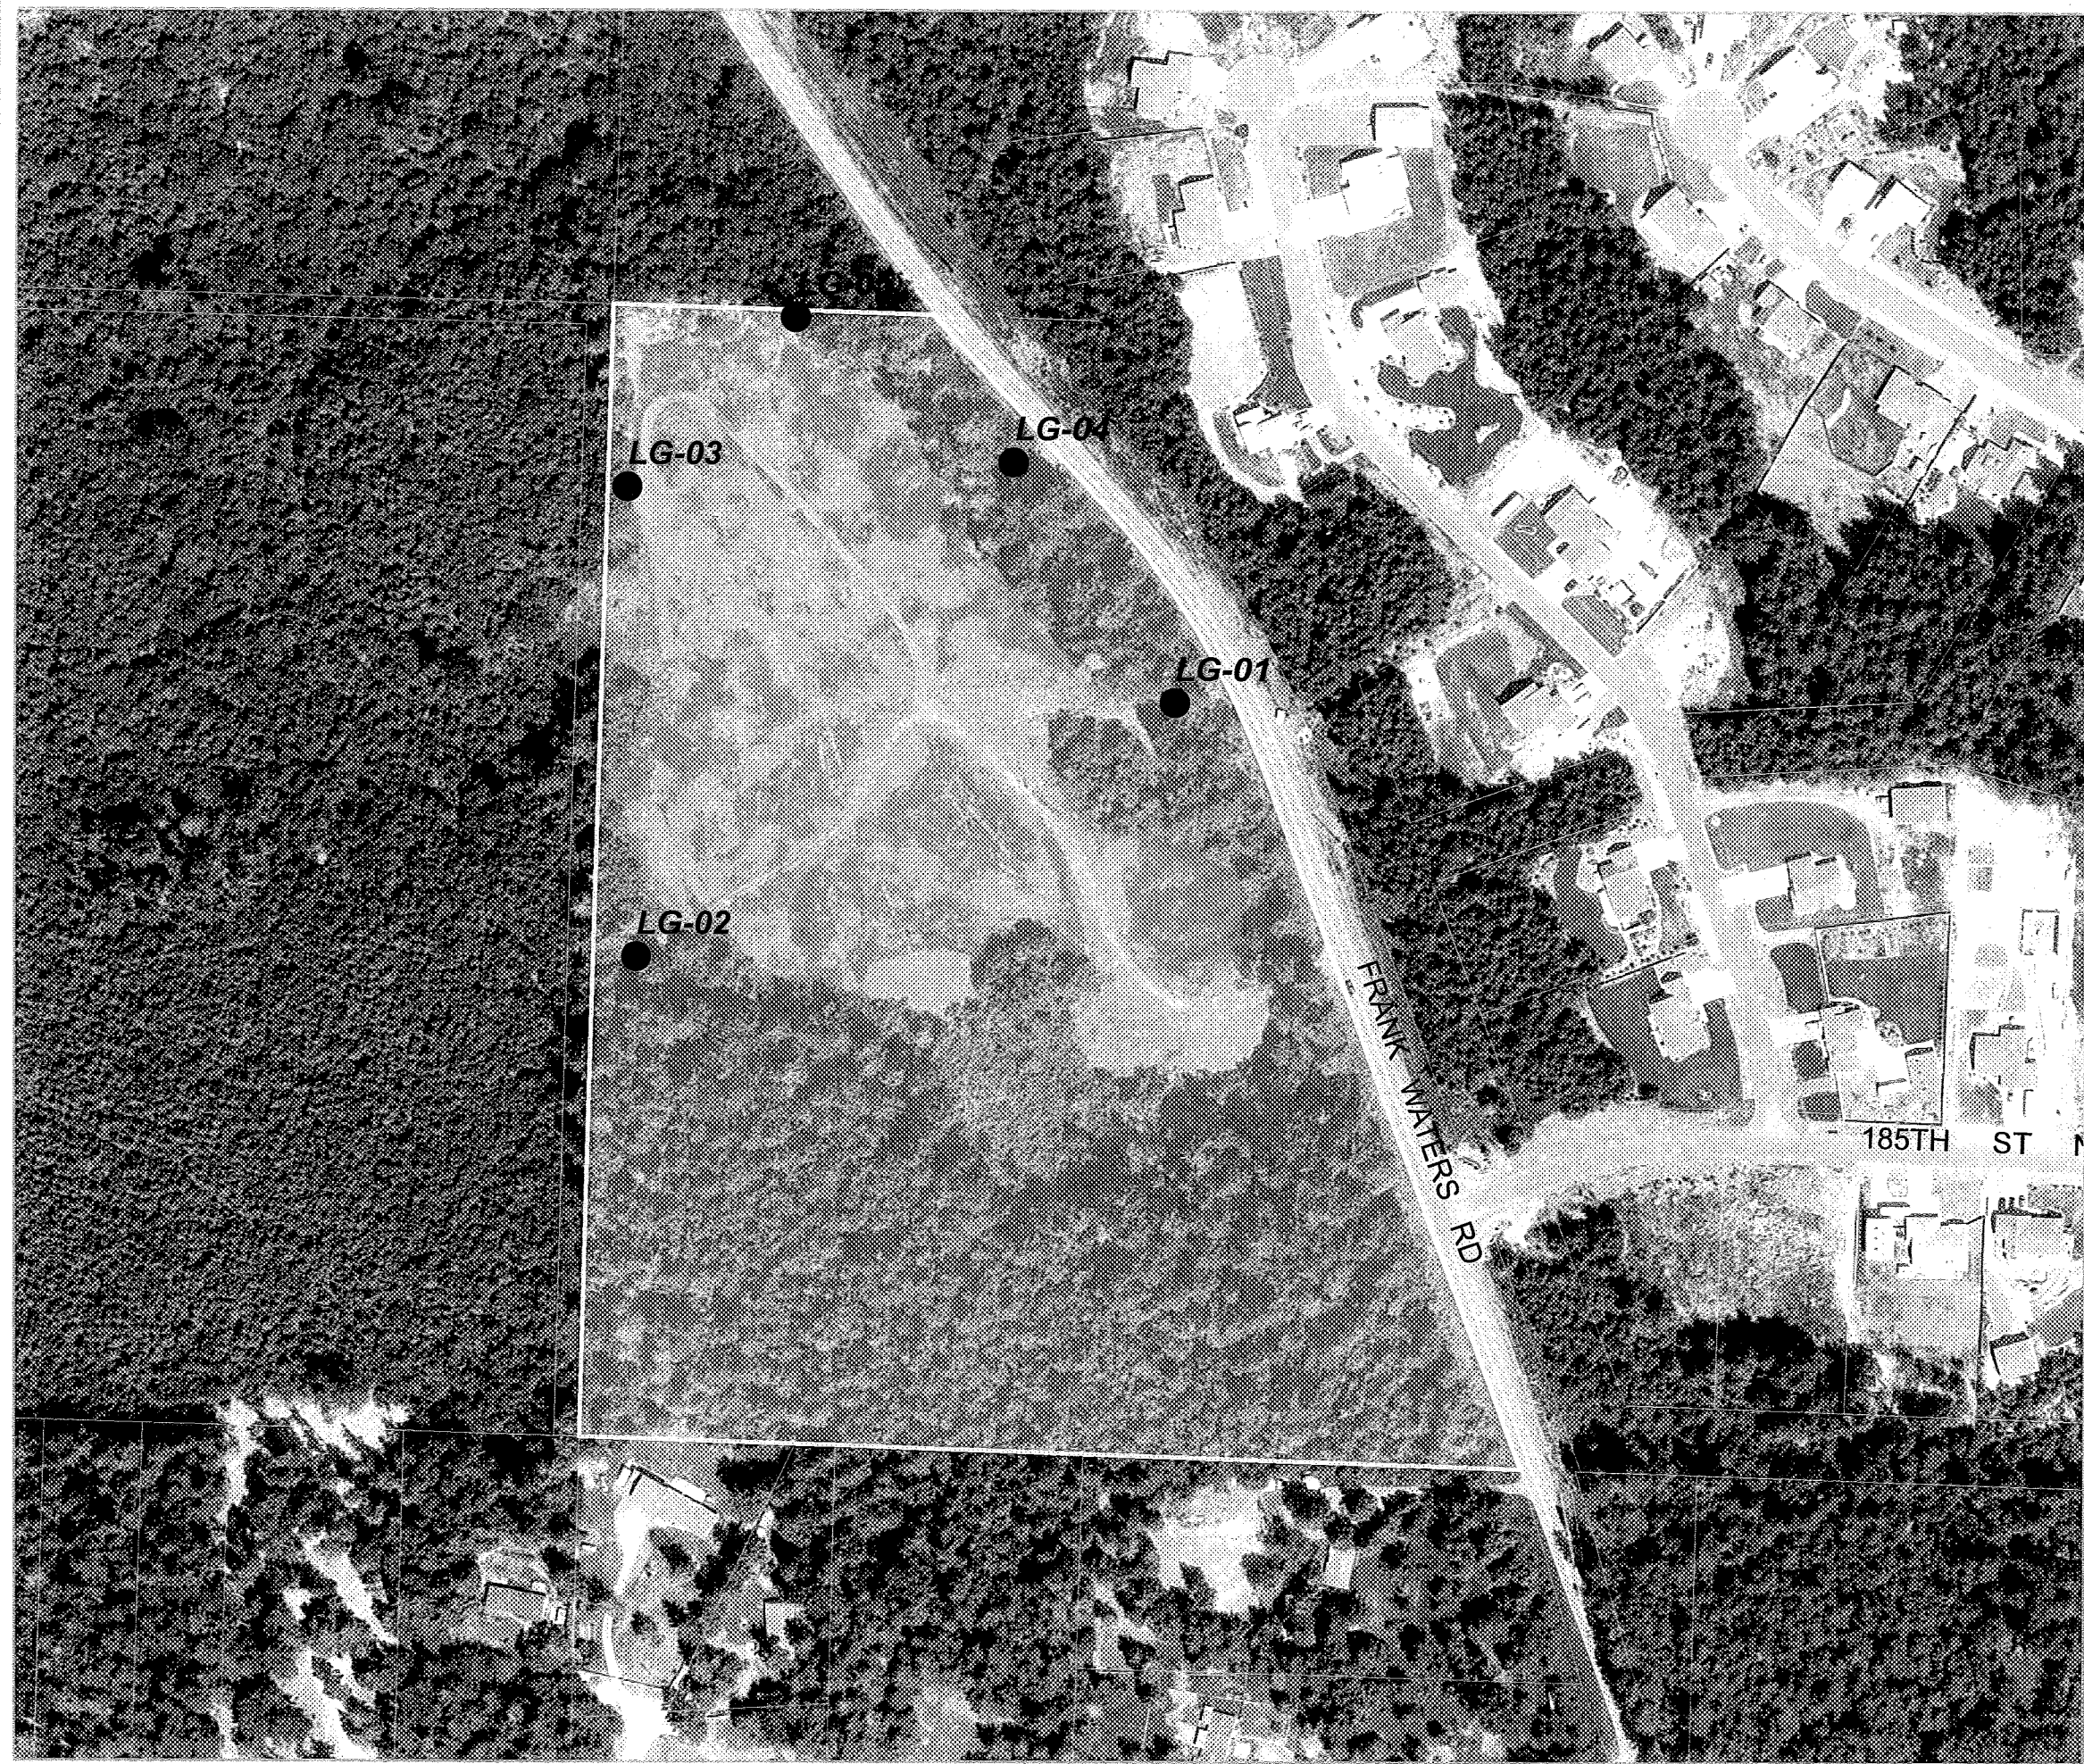
Figure 5

Lake Goodwin Landfill

Groundwater Monitoring Network

As outlined in the Solid Waste Facility Permit SW-085, quarterly monitoring of ground water is required at the Lake Goodwin Landfill. There are currently four-(4) ground water monitoring wells (LG-01, LG-02, LG-04, and LG-05) at the Lake Goodwin Landfill site that are read on a quarterly basis. Well locations are shown on the **Network Monitoring Map** (figure 5). Of these wells, one-(1) is considered to be an up-gradient well monitoring background ground water conditions in the immediate vicinity of the site (LG-02). The remaining three-(3) wells are located down gradient of the landfill (LG-01, and LG-04 and LG-05) and monitor ground water conditions that may be impacted from the site. Fourth quarter monitoring results are discussed in section 2.0 below.

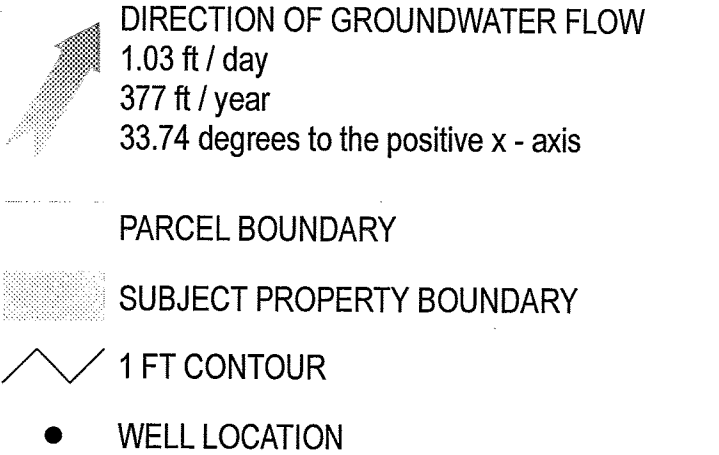
Figure 6

Water Elevation Contours 4th Quarter 2014

WELL_ID	SAMP_DATE	MEAS_HEAD
LG-01	10/21/2014	151.45
LG-02	10/21/2014	152.95
LG-04	10/21/2014	150.97
LG-05	10/21/2014	151.75

Fourth Quarter Ground Water Measurements are shown in *Table 1* below. **Hydrographs** of the fourth quarter 2014 monitoring well readings are contained in *Appendix A* of this report. Fourth quarter well readings show a general decrease in water levels. Readings confirm that the aquifer is unconfined in the immediate vicinity of the site. The **Fourth Quarter Ground Water Contour Map** developed from the field data is shown in *Figure 6* of this report.

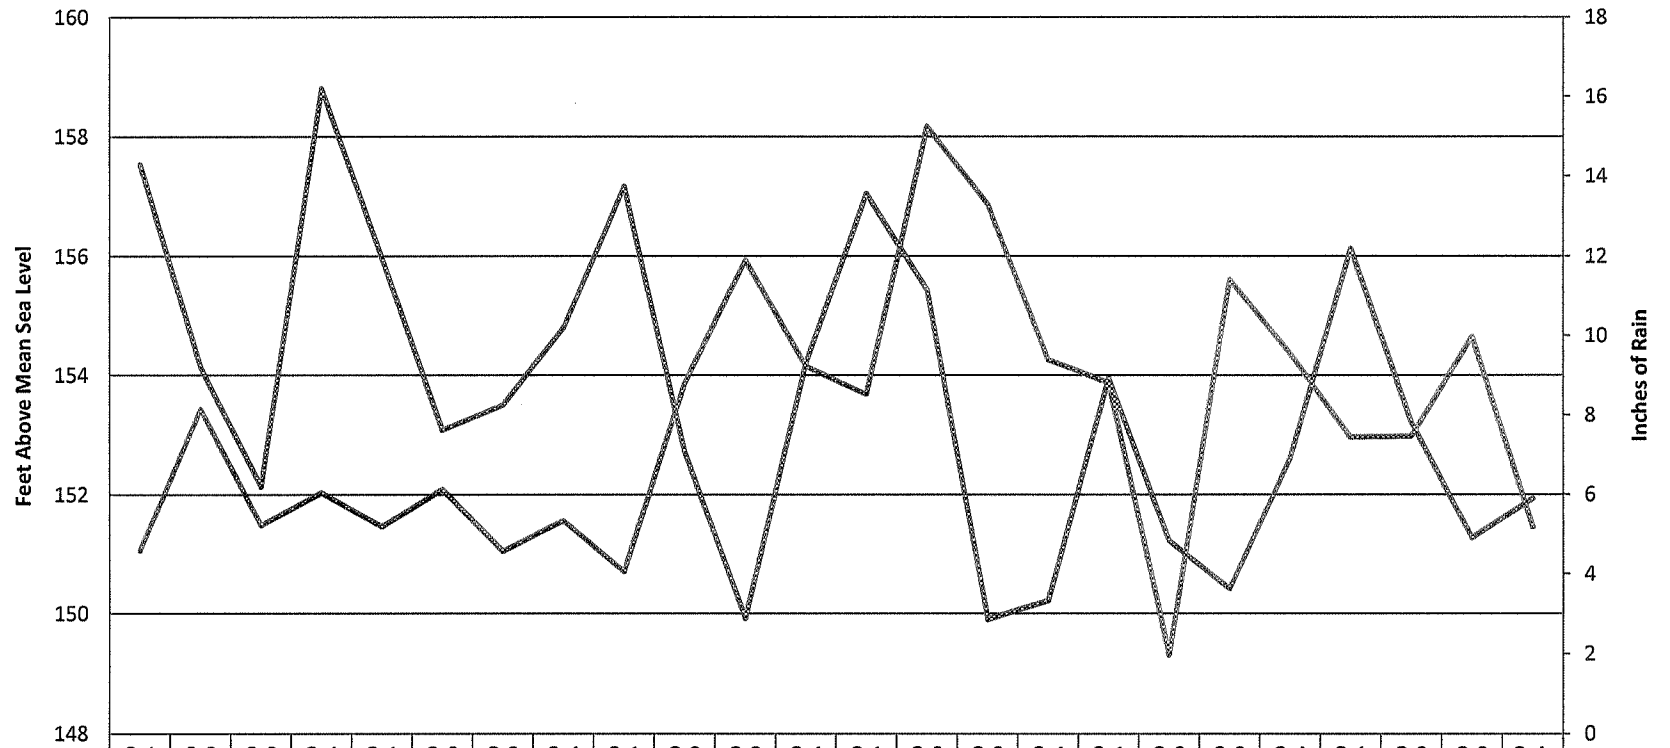
Lake Goodwin Well LG-01

Depth to Water	151.1	153.4	151.5	152	151.5	152.1	151.1	151.6	150.7	153.9	155.9	154.2	153.7	158.2	156.9	154.3	153.9	149.3	155.6	154.4	153	153	154.7	151.5
Precipitation	14.3	9.2	6.2	16.2	11.96	7.62	8.26	10.2	13.75	7.08	2.89	9.33	13.56	11.16	2.86	3.32	8.94	4.83	3.63	6.9	12.19	7.82	4.9	5.9

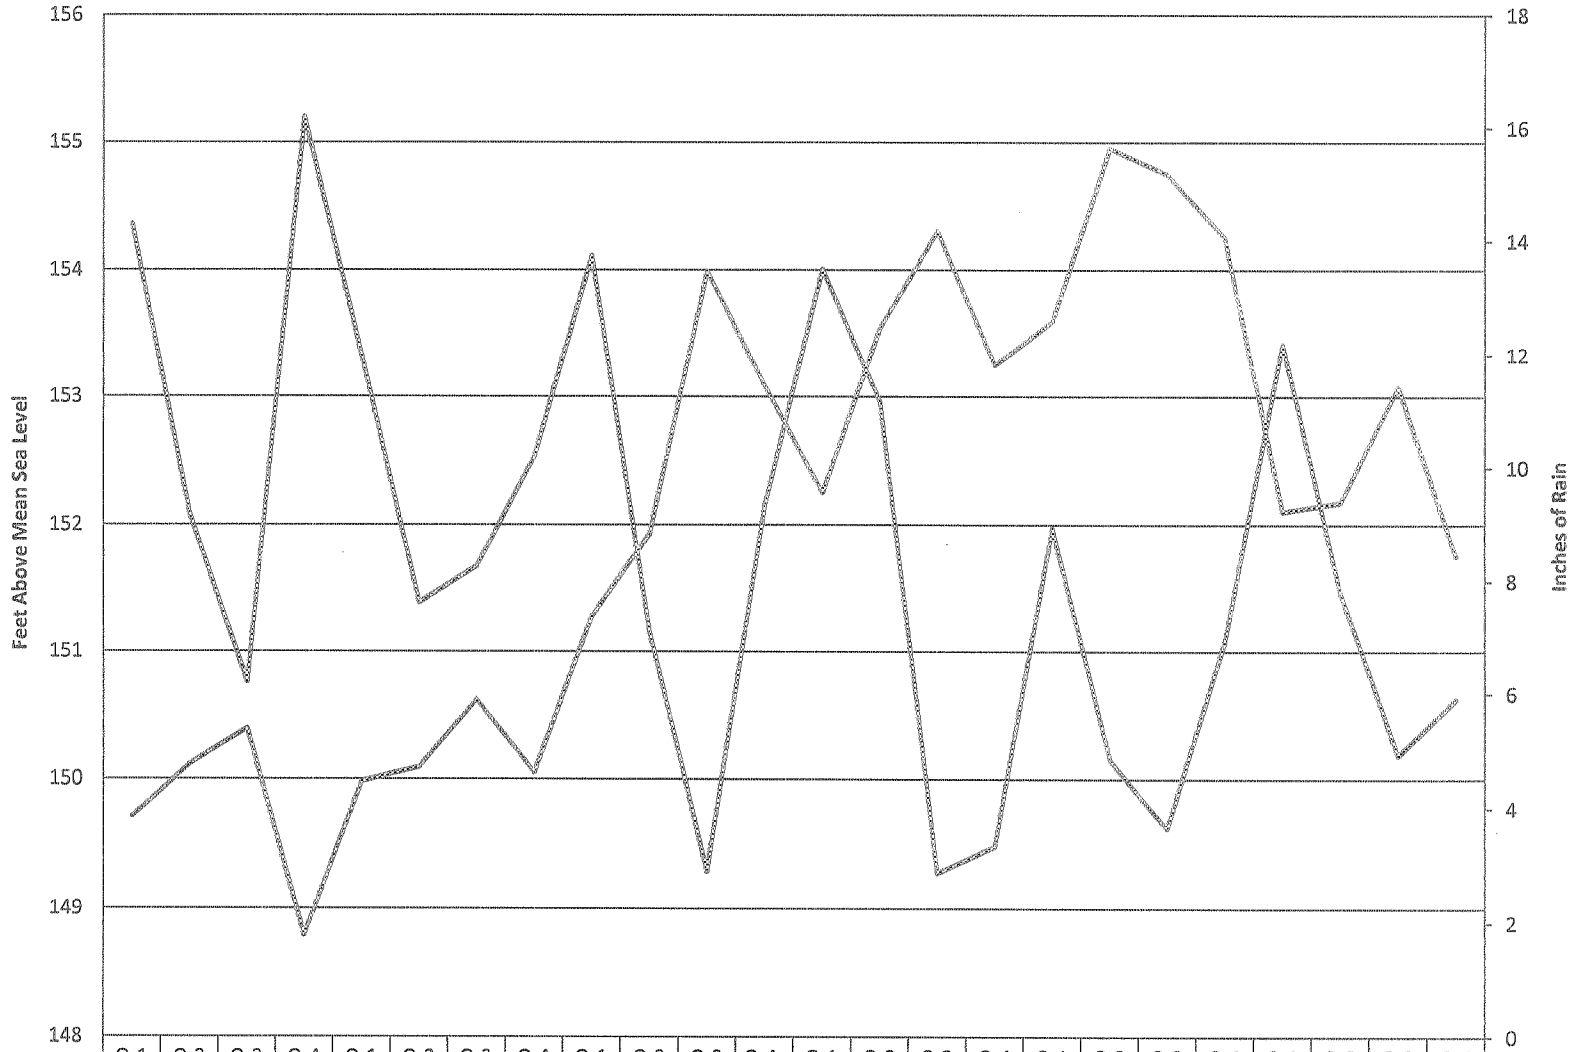
Lake Goodwin Well LG-05

Groundwater Elevation	149.7	150.1	150.4	148.8	150	150.1	150.6	150.1	151.3	151.9	154	153.1	152.3	153.5	154.3	153.3	153.6	155	154.8	154.3	152.1	152.2	153.1	151.8
Precipitation	14.3	9.2	6.2	16.2	11.96	7.62	8.26	10.2	13.75	7.08	2.89	9.33	13.52	11.16	2.86	3.32	8.94	4.83	3.63	6.9	12.19	7.82	4.9	5.9

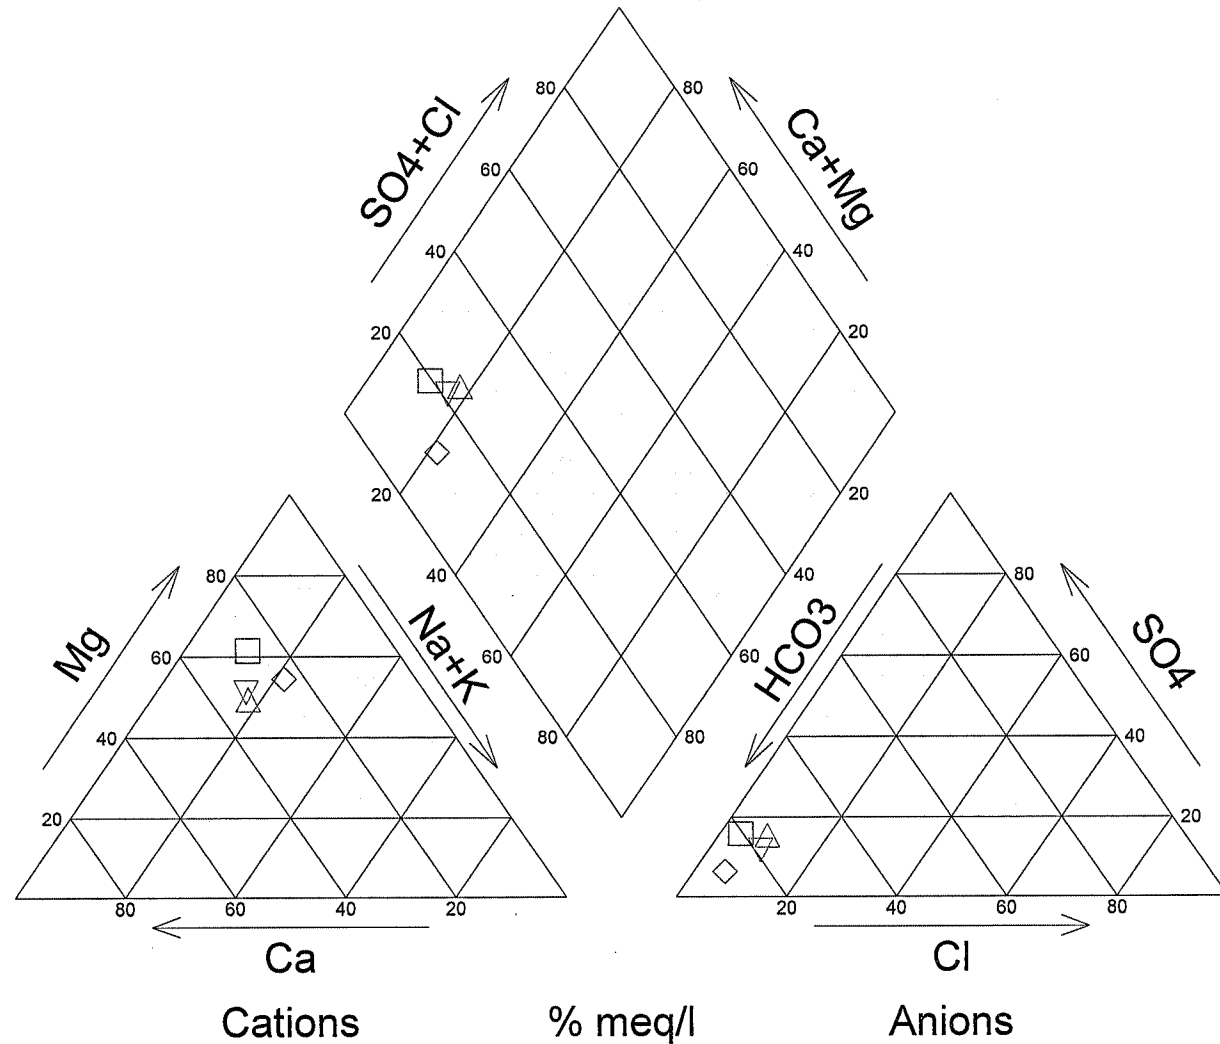
Q-4 2014 Goodwin Landfill

□ LG-01	10/21/2014 (10.4%, 331.8ppm)
△ LG-02	10/21/2014 (14.3%, 158.2ppm)
▽ LG-04	10/21/2014 (16.8%, 201.225ppm)
◇ LG-05	10/21/2014 (17.7%, 783.37ppm)

Stiff Diagrams, Trilinear Diagrams and Statistically Significant Trends Analyses results are included in *Appendix C* of this report.

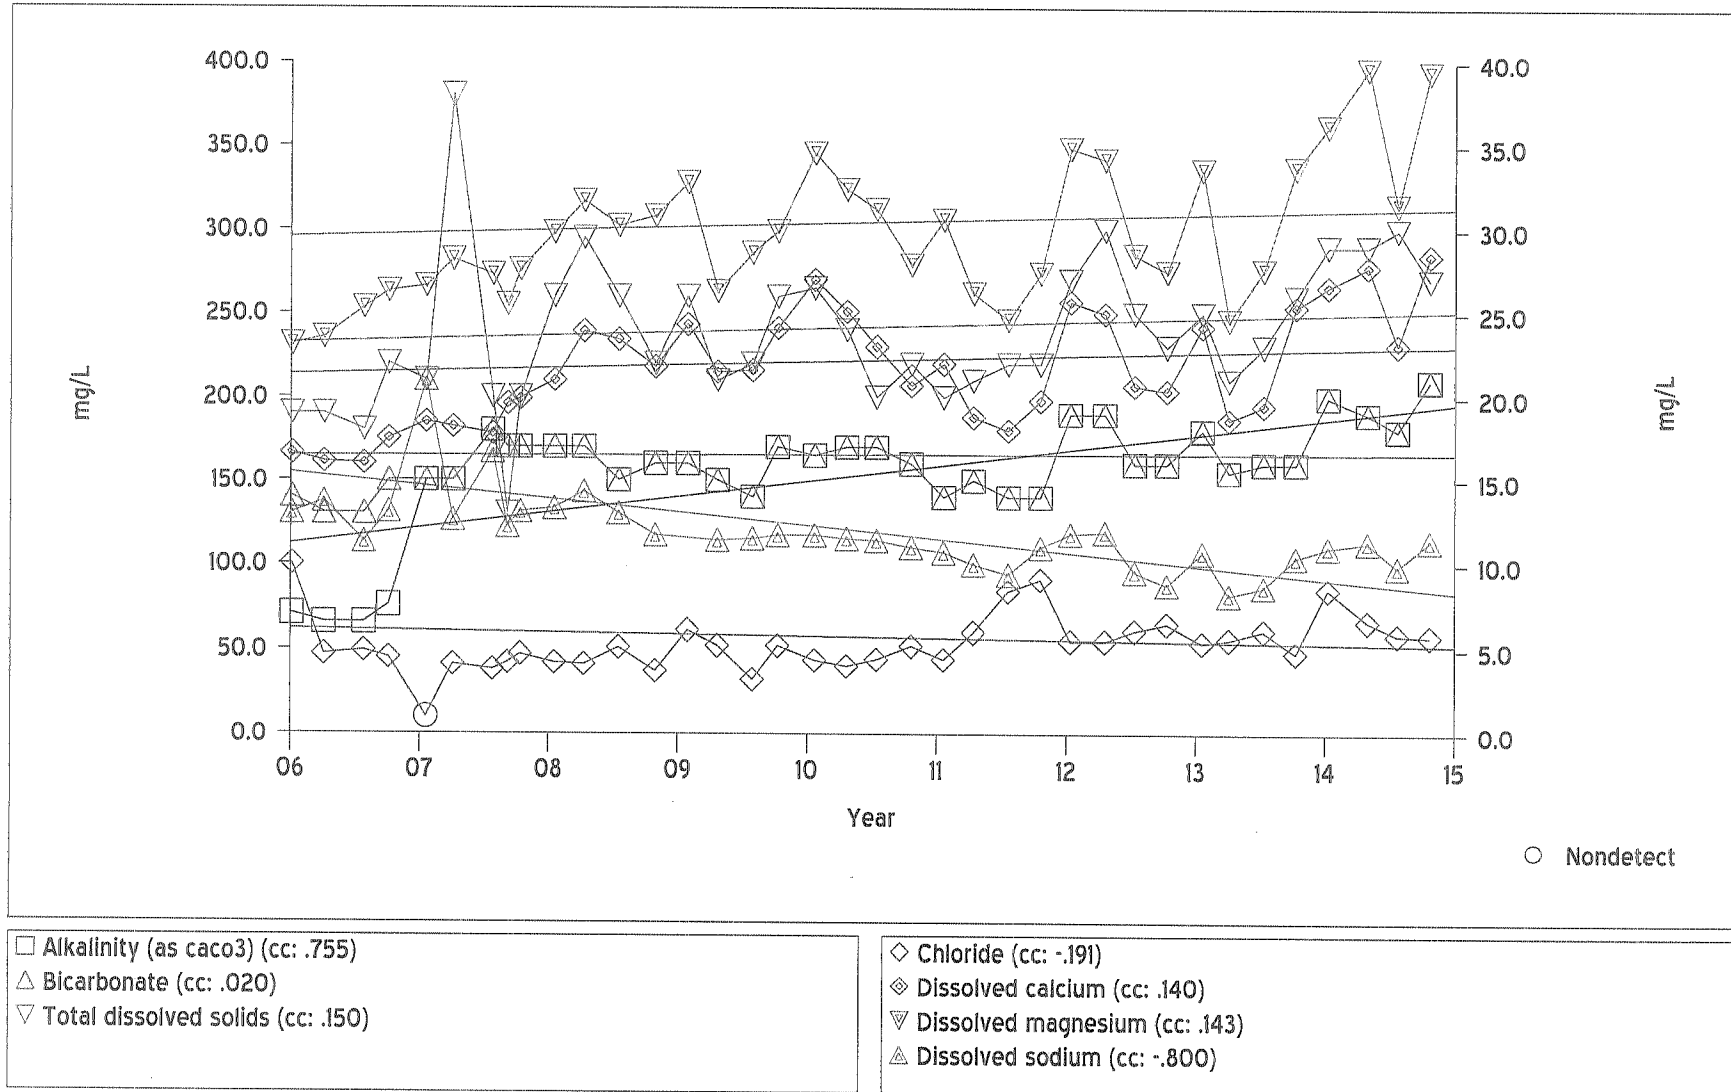
Time Series Plot for LG-01

Q-4 2014 Minerals Goodwin Landfill

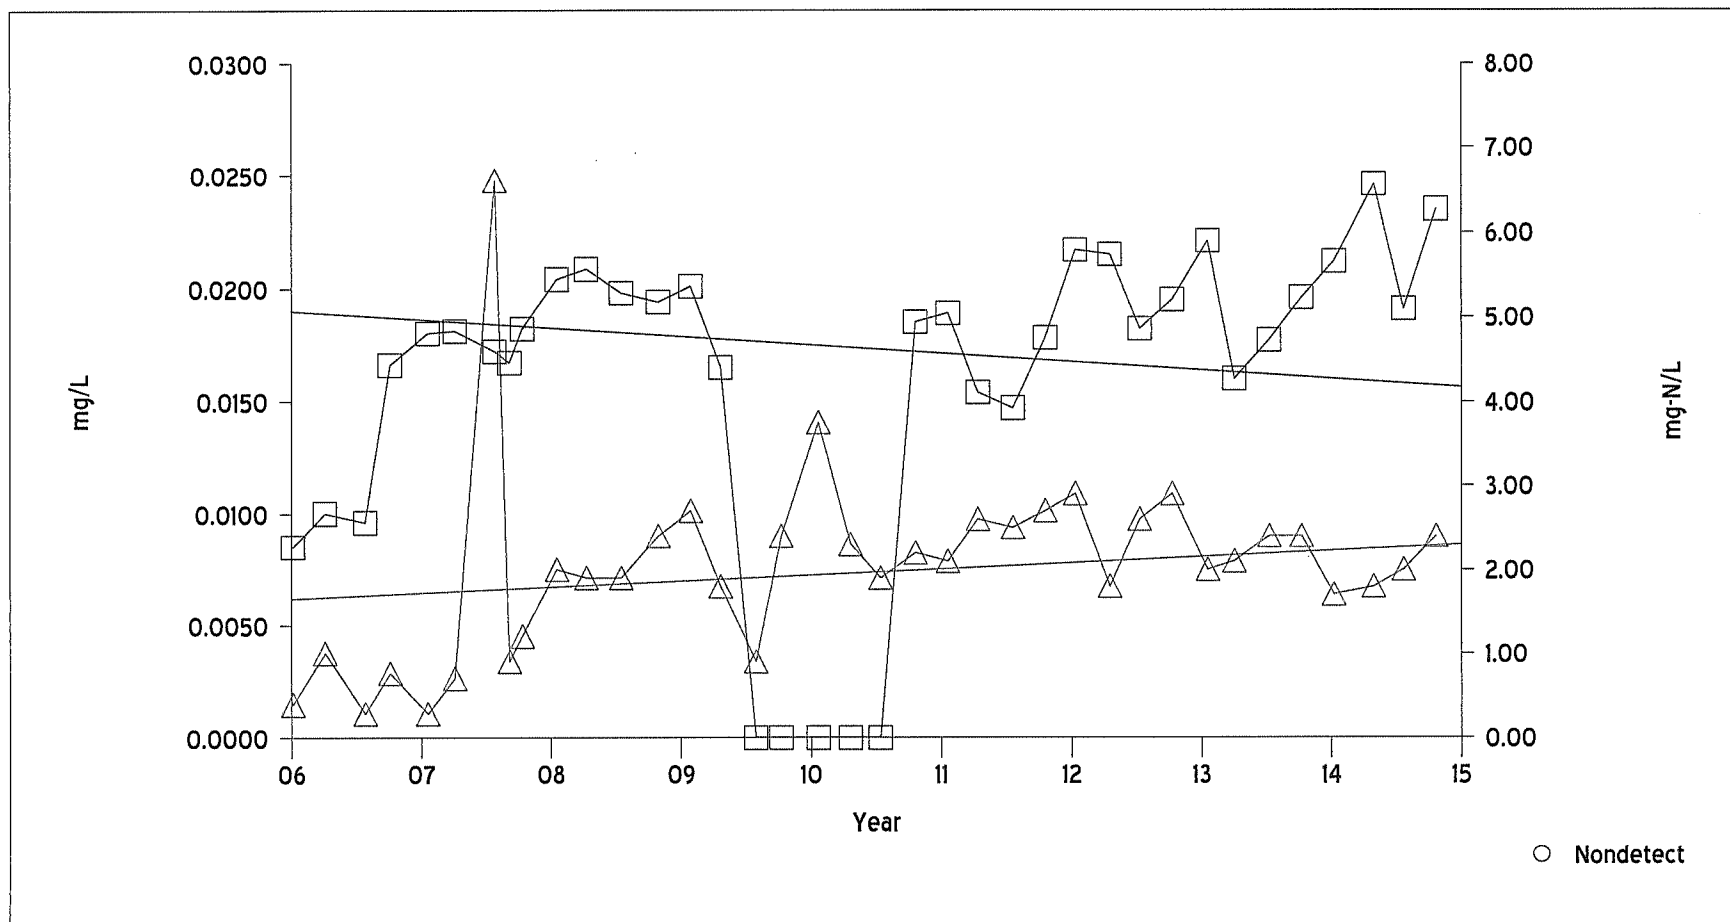
Time Series Plot for LG-01

Q-4 2014 Ba v. Nitrate Goodwin Landfill

□ Dissolved barium (cc: -.234)

△ Nitrate nitrogen (cc: .532)

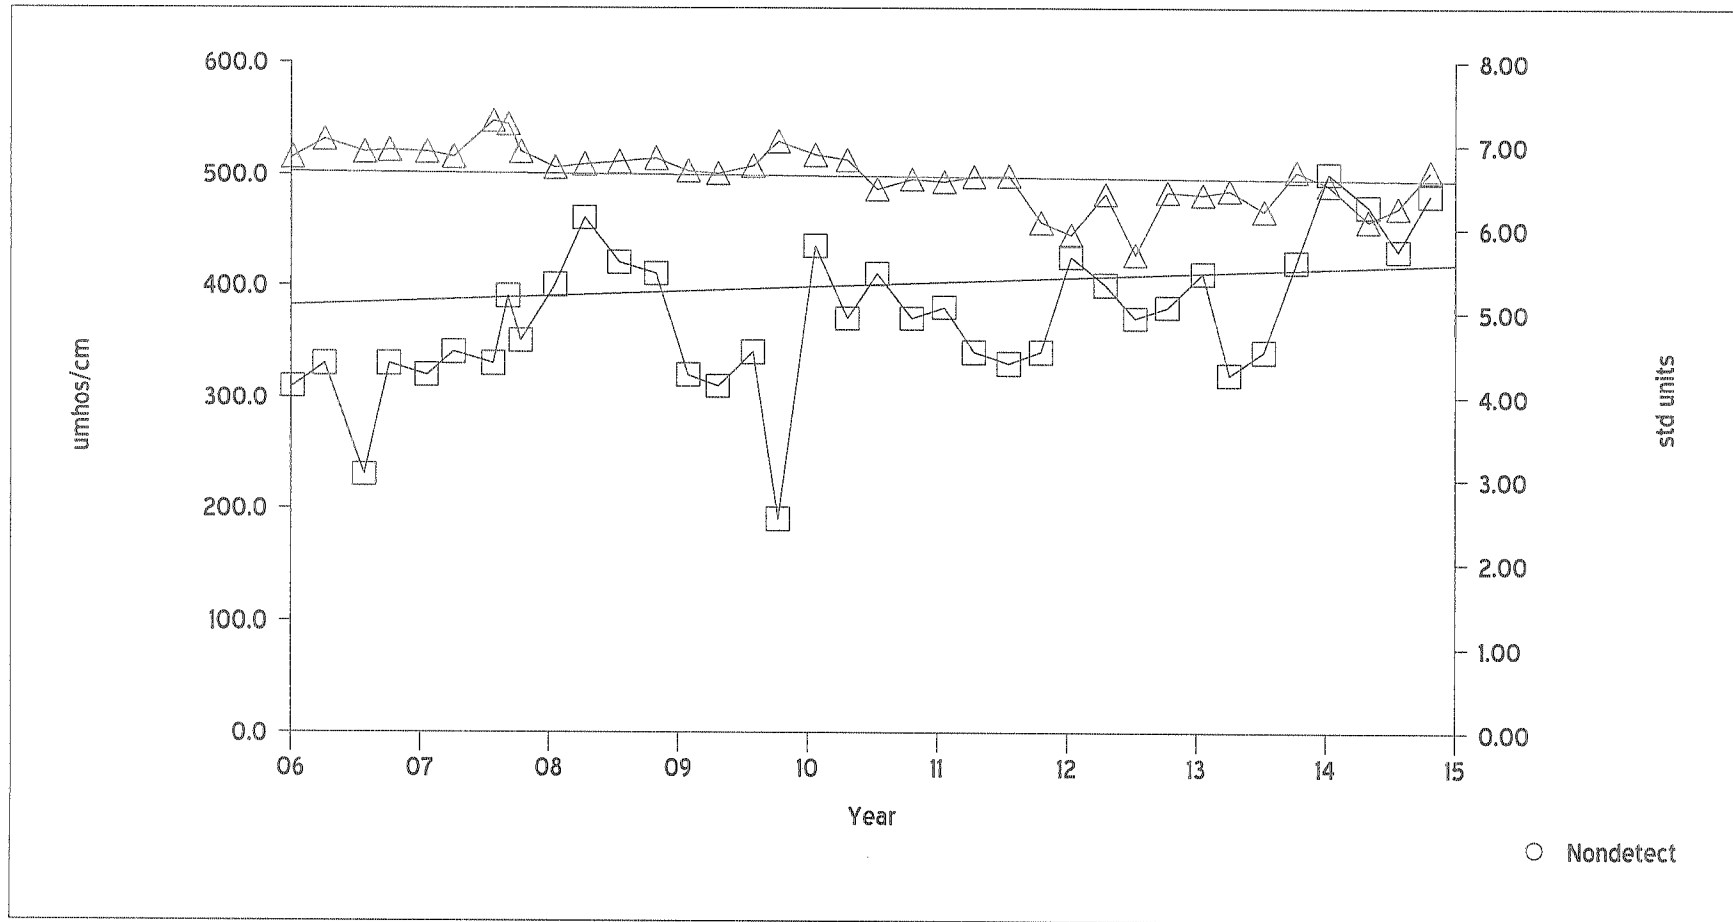
Time Series Plot for LG-01

Q-4 2014 Conductivity v pH Goodwin Landfill

□ Conductivity (cc: .230)

△ pH (cc: -.356)

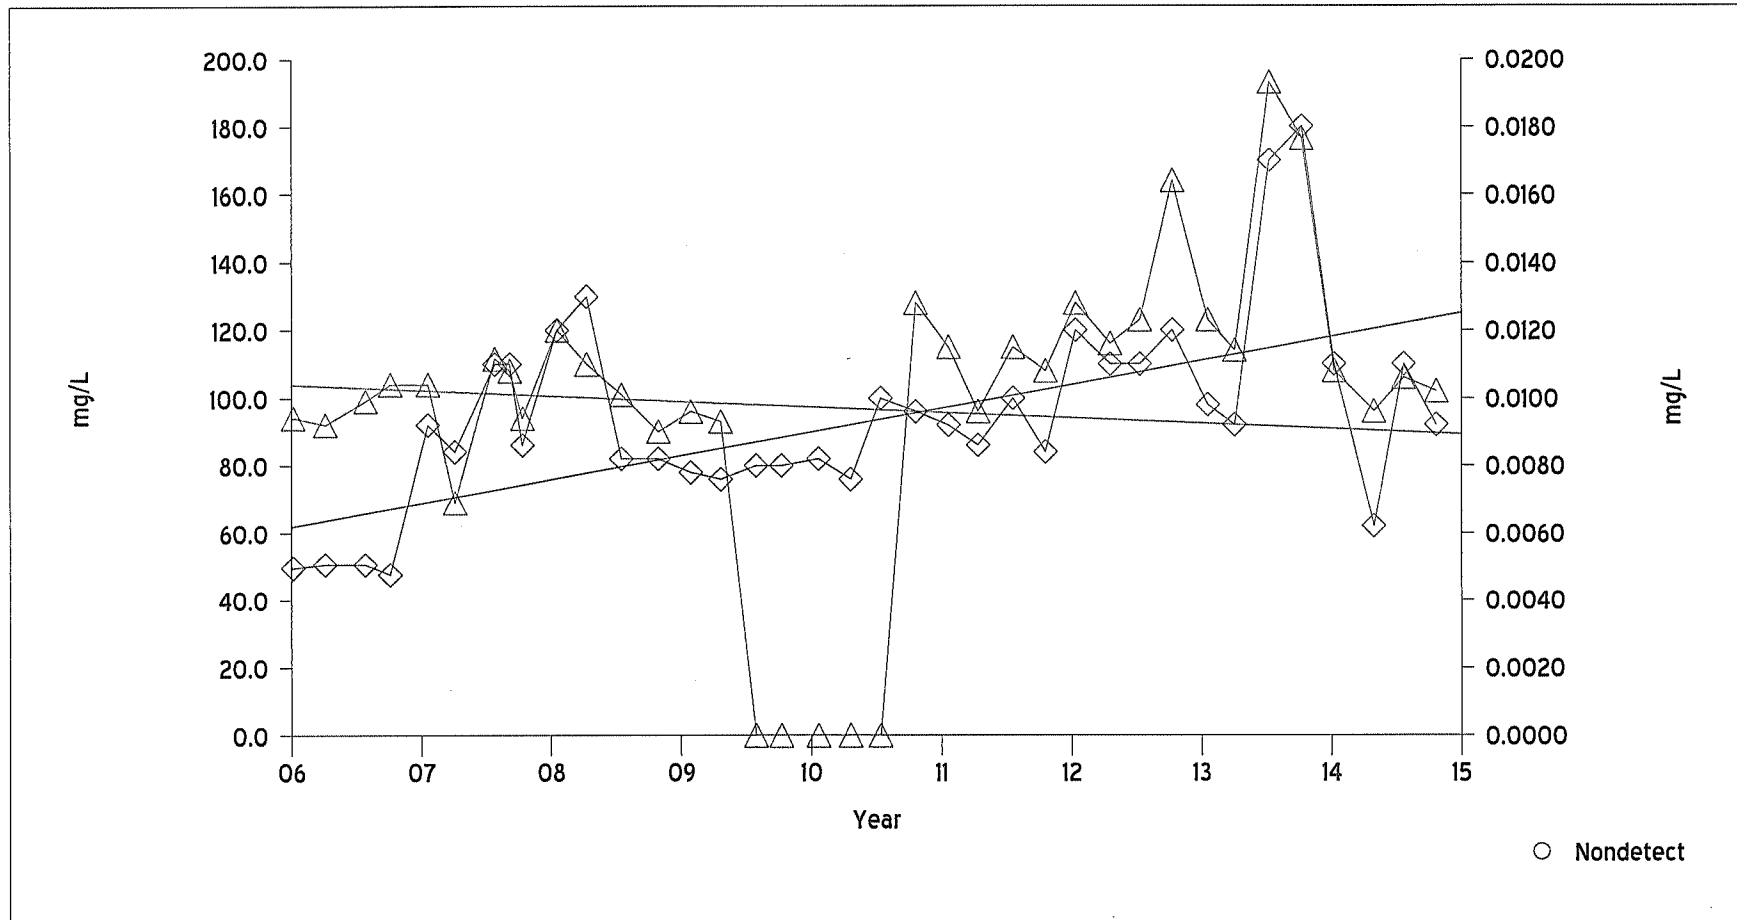
Time Series Plot for LG-02

Q-4 2014 Alkalinity v Ba Goodwin Landfill

◇ Alkalinity (as cac03) (cc: .729)

△ Dissolved barium (cc: -.230)

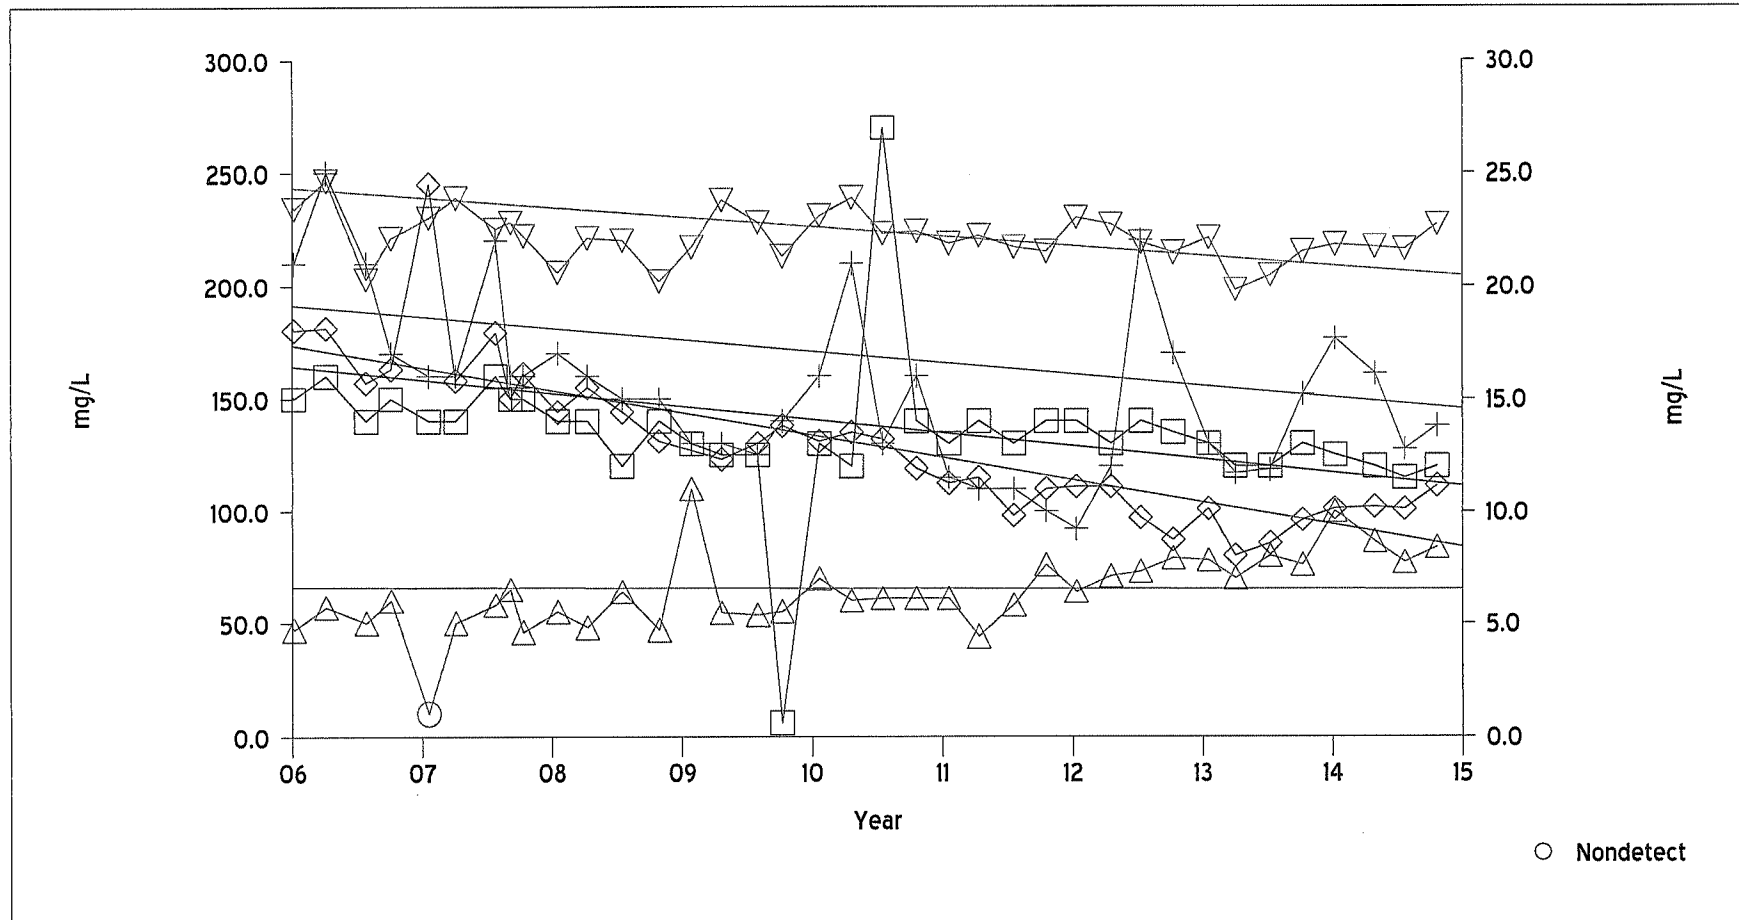
Time Series Plot for LG-04

Q-4 2014 Minerals Goodwin Landfill

□ Bicarbonate (cc: -.536)

△ Chloride (cc: -.045)

▽ Dissolved calcium (cc: -.455)

◇ Dissolved sodium (cc: -.821)

+ Sulfate (cc: -.329)
