Lake Goodwin Landfill

2014 4th Quarter Environmental

Monitoring Report

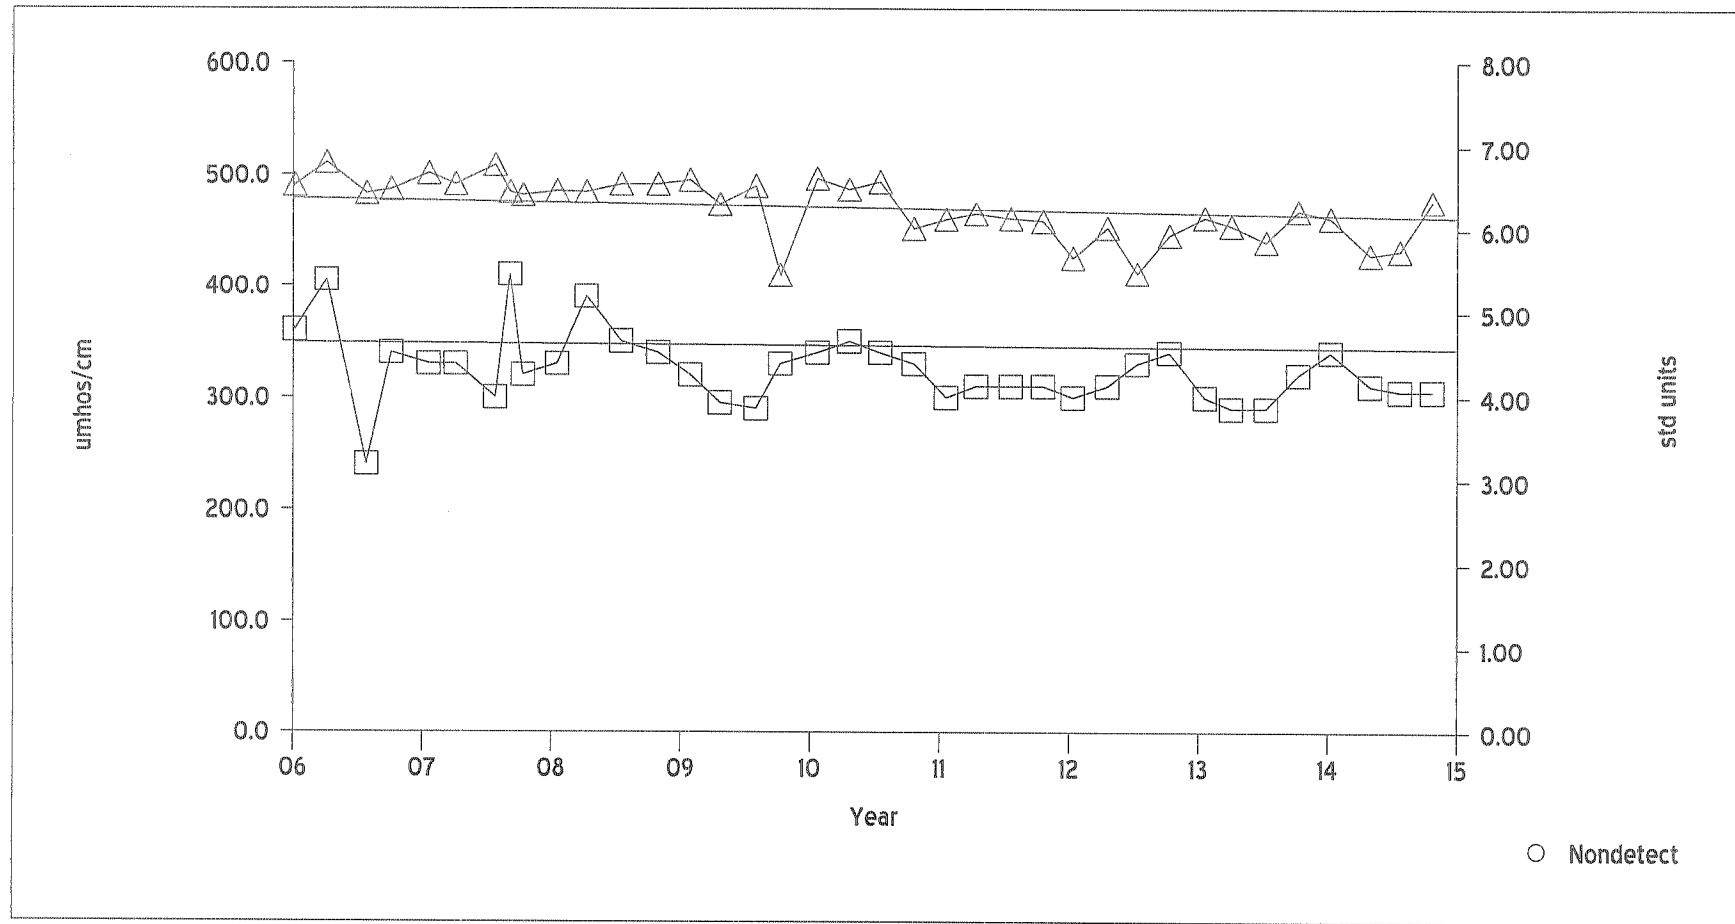
Time Series Plot for LG-04

Q-4 2014 Conductivity v pH Goodwin Landfill

□ Conductivity (cc: -.088)

△ pH (cc: -.591)

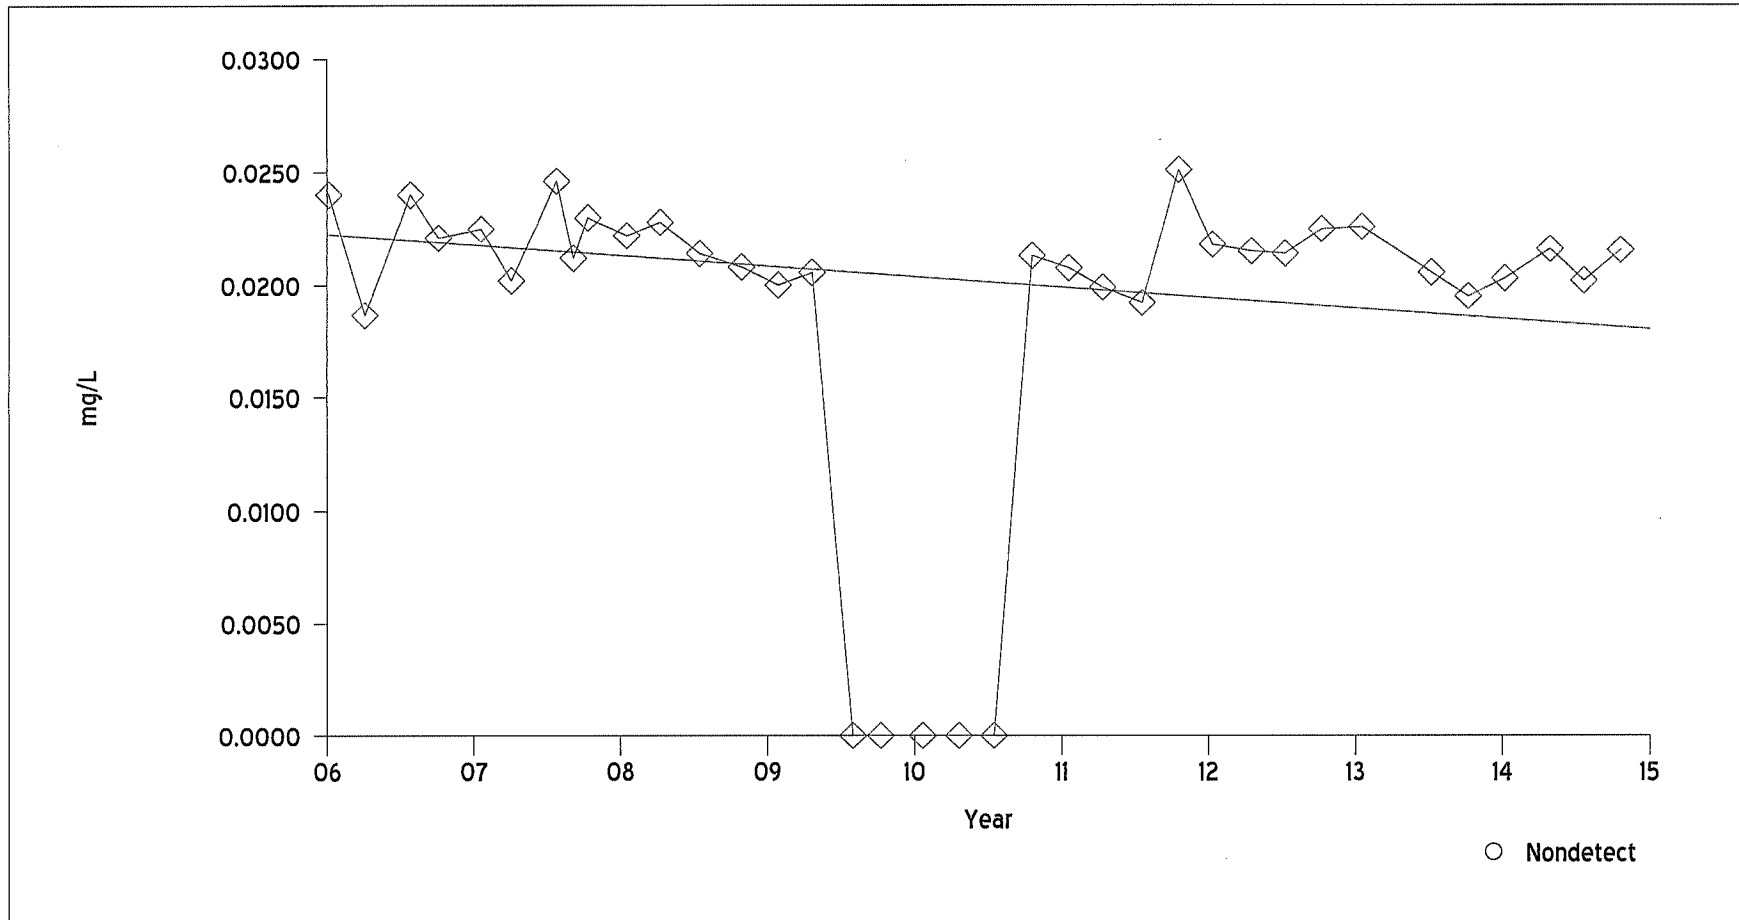
Time Series Plot for LG-04

Q-4 2024 Barium Goodwin Landfill

◇ Dissolved barium (cc: -.385)

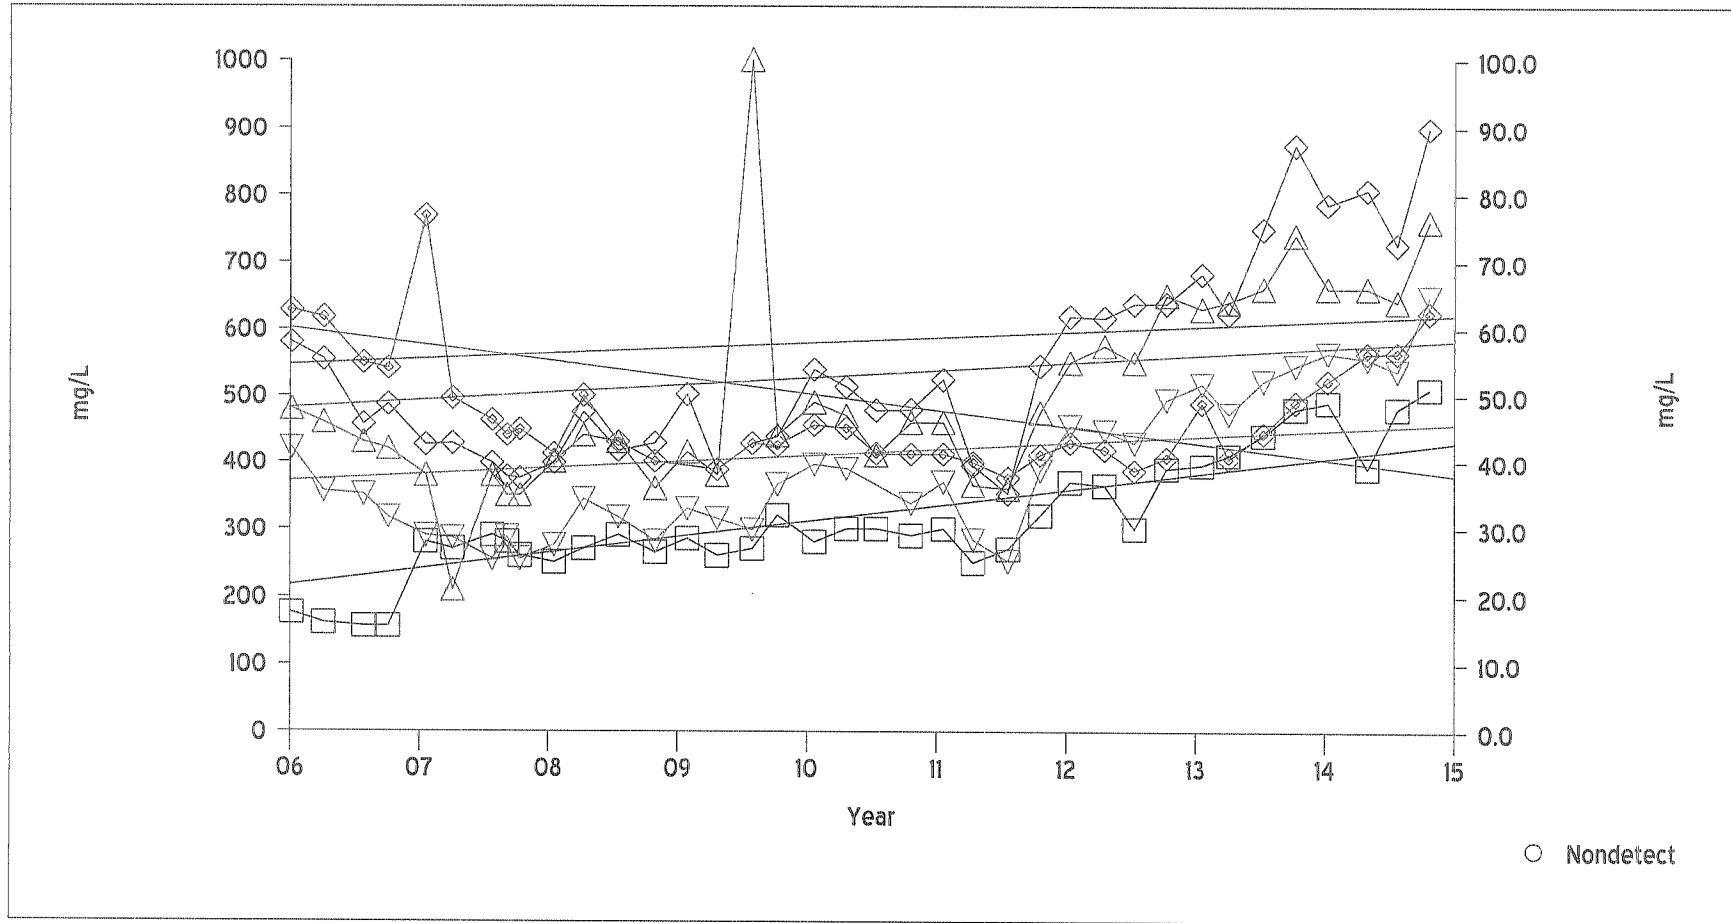
Time Series Plot for LG-05

Q-4 2014 Minerals Goodwin Landfill

□ Alkalinity (as CaCO_3) (cc: .873)
 △ Total dissolved solids (cc: .267)

▽ Dissolved calcium (cc: .308)
 ◇ Dissolved magnesium (cc: .190)
 ◆ Dissolved sodium (cc: .656)

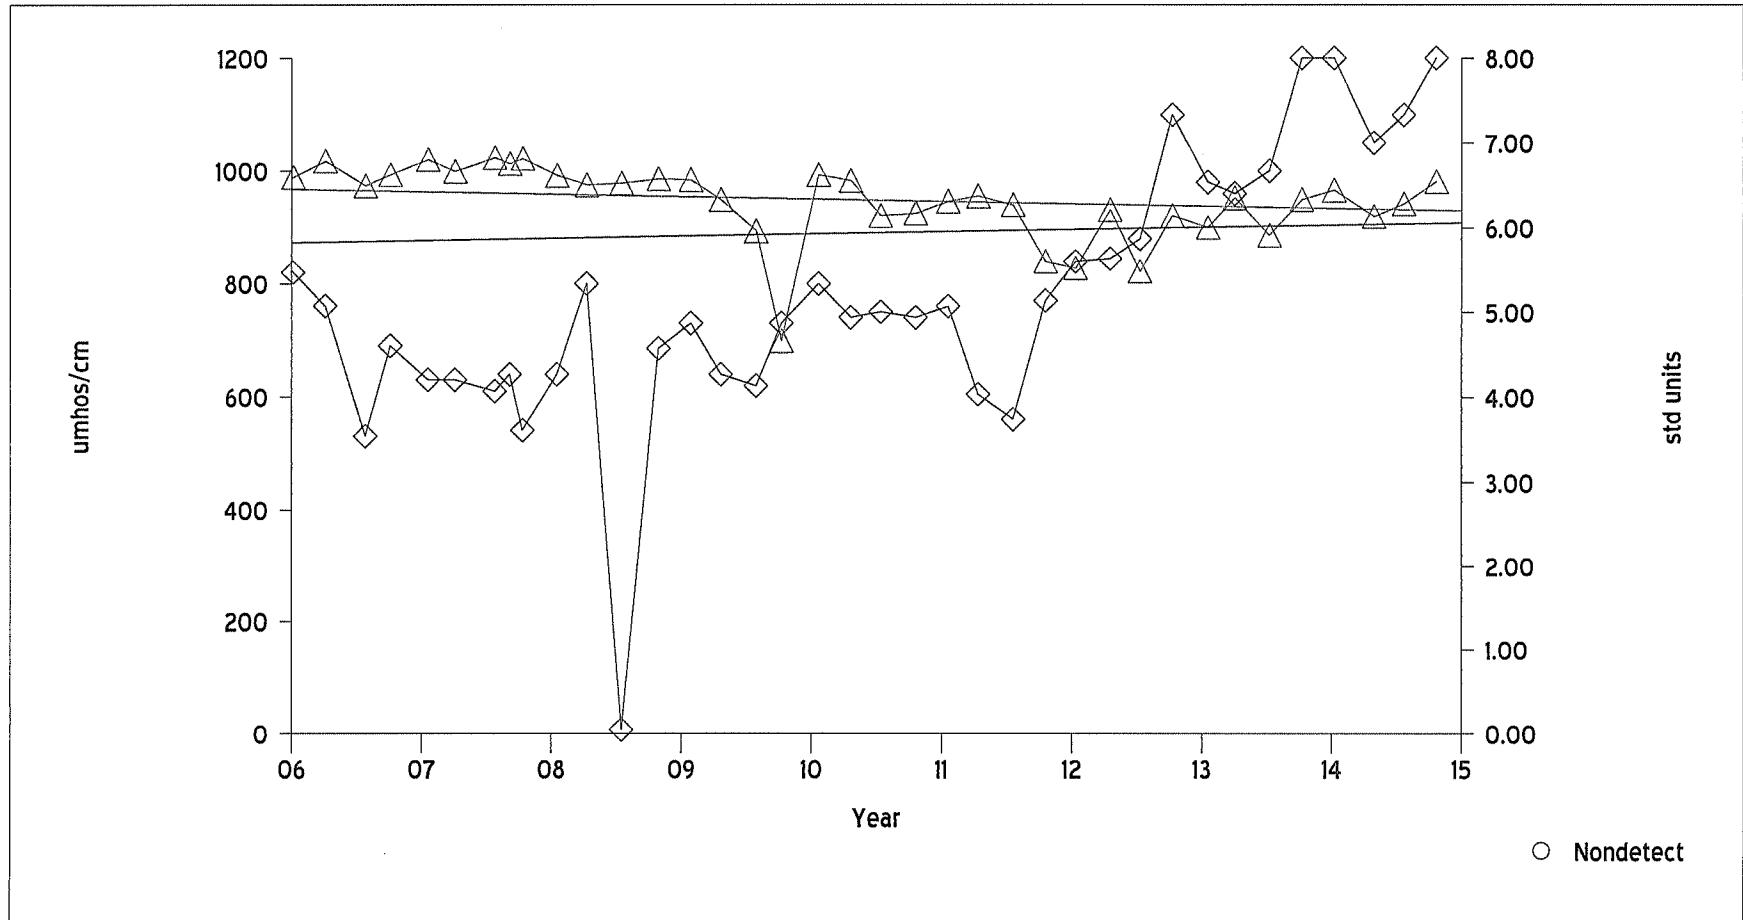
Time Series Plot for LG-05

Q-4 2014 Conductivity v. pH Goodwin Landfill

◇ Conductivity (cc: .113)

△ pH (cc: -.512)

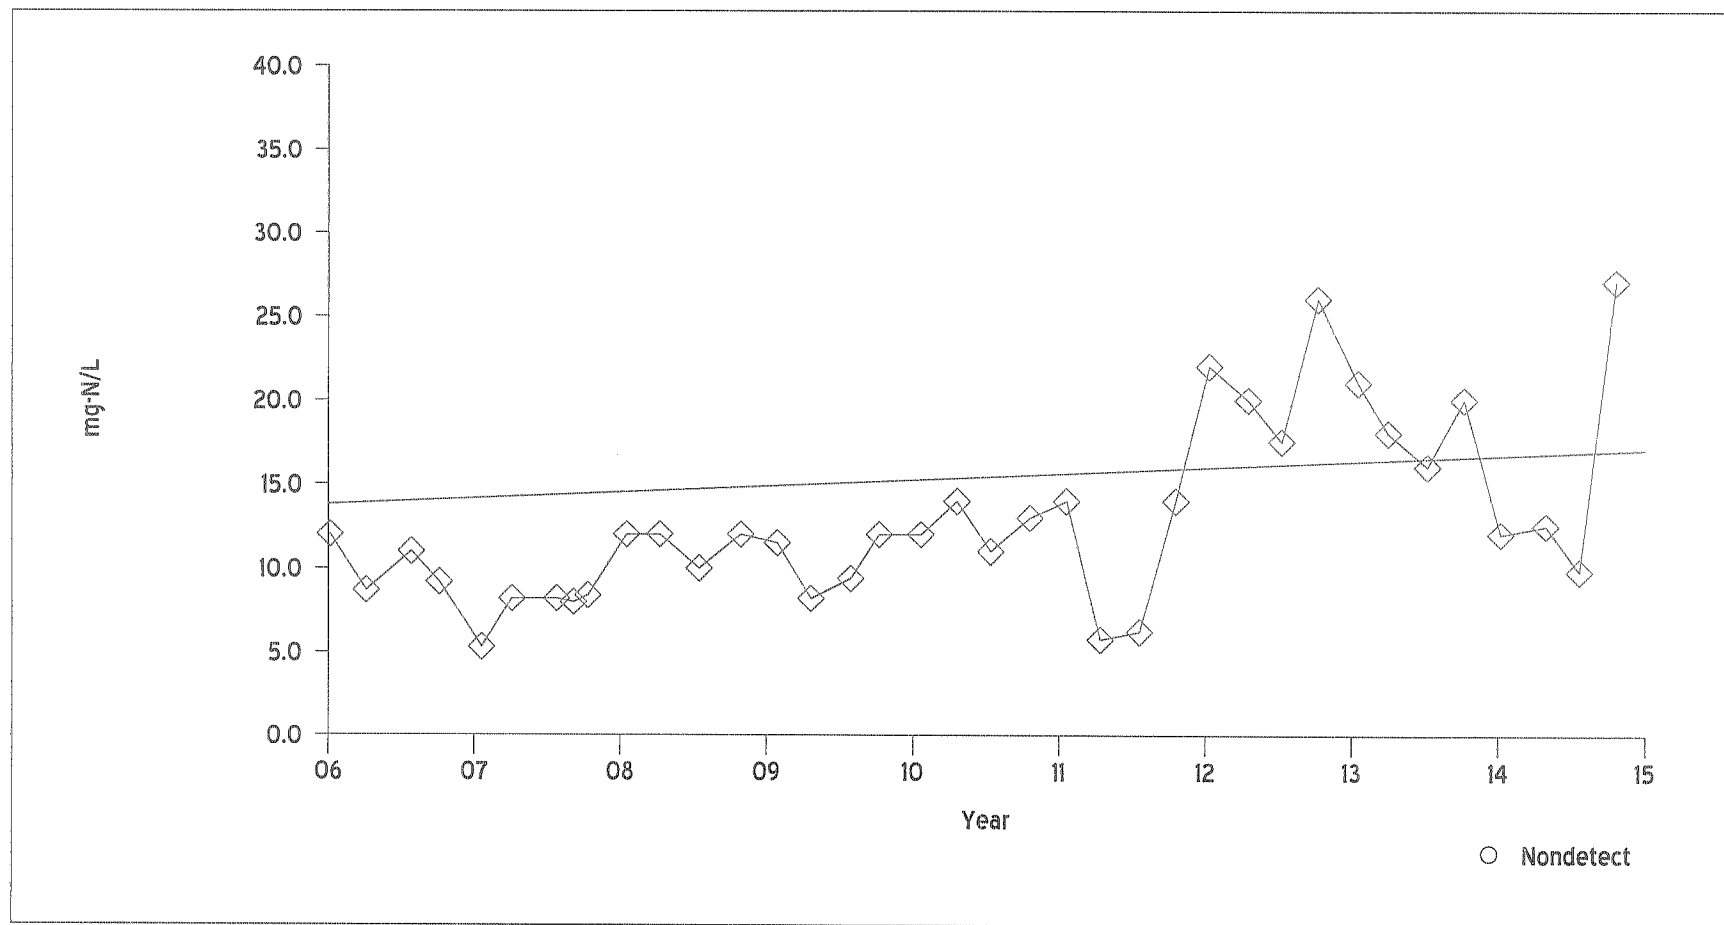
Time Series Plot for LG-05

Q-4 2014 Nitrate Goodwin Landfill

◇ Nitrate nitrogen (cc: .357)
