# HARTNETT REAL ESTATE LLC DEVELOPMENT

## REMEDIAL ACTION REPORT FOR LEAD- AND ARSENIC- CONTAMINATED FORMER ORCHARD SOILS

# Remedial Action Report

## Report Version: V.2 September 26, 2023

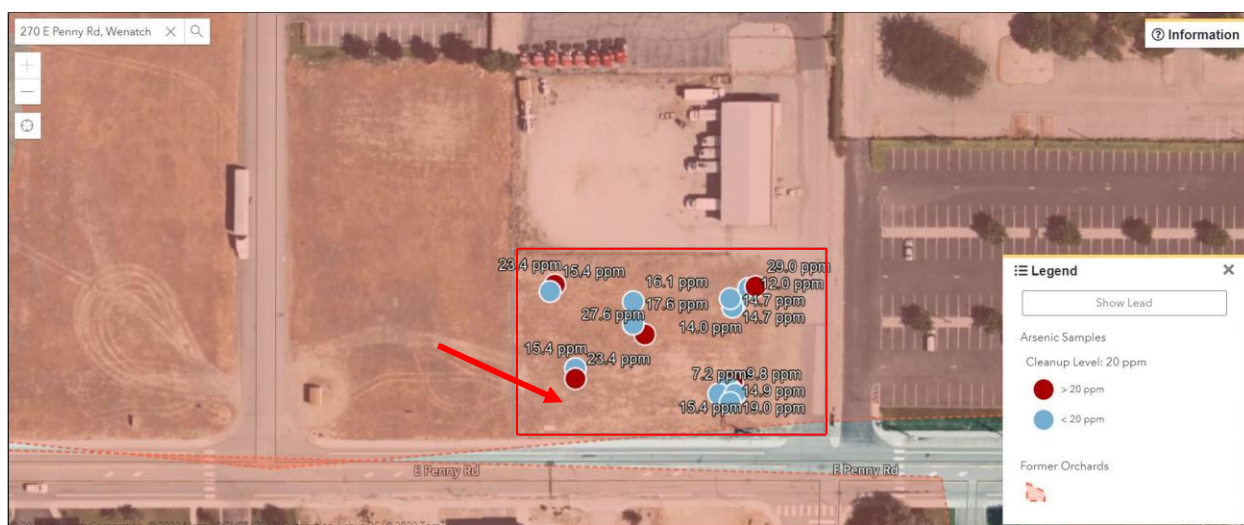
**Figure 3. Dirt Alert mapping of the subject parcel; Arsenic results.**

Historically, the parcel had been utilized as commercial orchard prior to 1991. A review of aerial photography of the site indicates that the parcel was cleared of orchard sometime between July of 1991 and August of 1998. Based on the Ecology Dirt Alert online mapping tool, the subject parcel may have been in commercial orchard production when lead arsenate was still utilized as a pesticide (1890-1950). Results posted on Dirt Alert are from initial site sampling by Ecology on May 10, 2022. Initial Ecology sampling results are included as Attachment A. Initial sampling results indicated that surface soils are contaminated with lead and arsenic above MTCA Method A cleanup levels. For the purpose of this project, it was assumed that all surface soils on the parcel were contaminated and required remediation based on the initial Ecology sampling data.

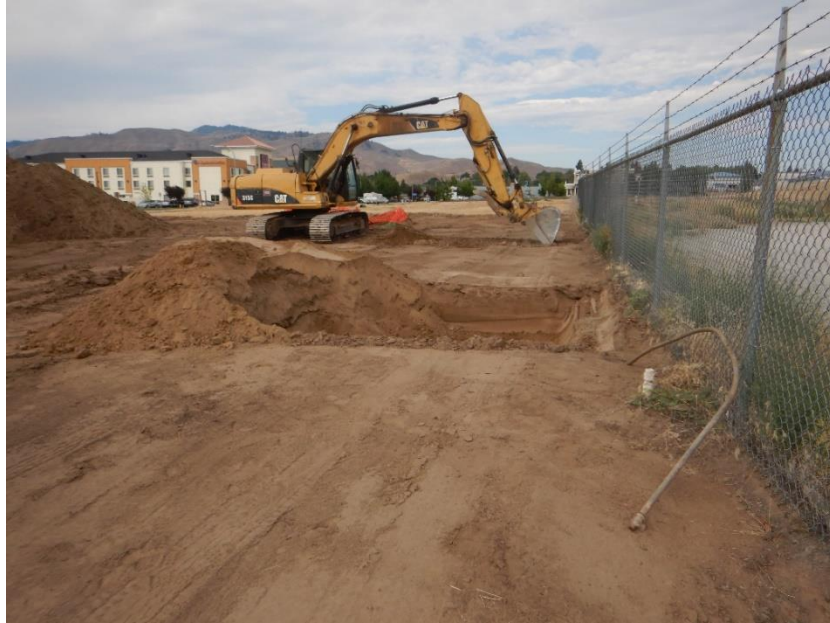
**Photograph 1. Seven test pits were excavated along the northern property line.**

Following the initial surface soil sampling by Ecology, the applicant arranged for the excavation of test pits along the north property line to determine the depth of lead and arsenic soil contamination at the site. Grette Associates, LLC was contracted to perform additional XRF testing during the depth investigation. The depth investigation occurred on August 1, 2022. Seven (7) test pits were dug to a depth between 24 and 40 inches from east to west along the north edge of the property on the morning of August 1st (Sheet 1; Photographs 1-2). Based on XRF results it was determined that the depth of contaminated soils ranged from 15 inches to 40 inches below grade depending on location; with most of the contaminated soils terminating a depth of 24 inches below grade.

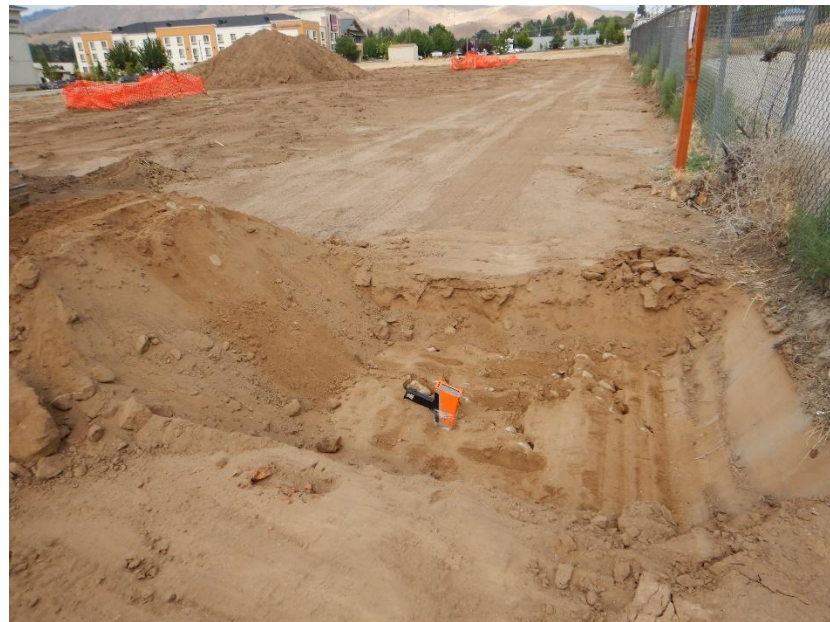
**Photograph 2. An XRF was used to evaluate soil contamination at the site.**

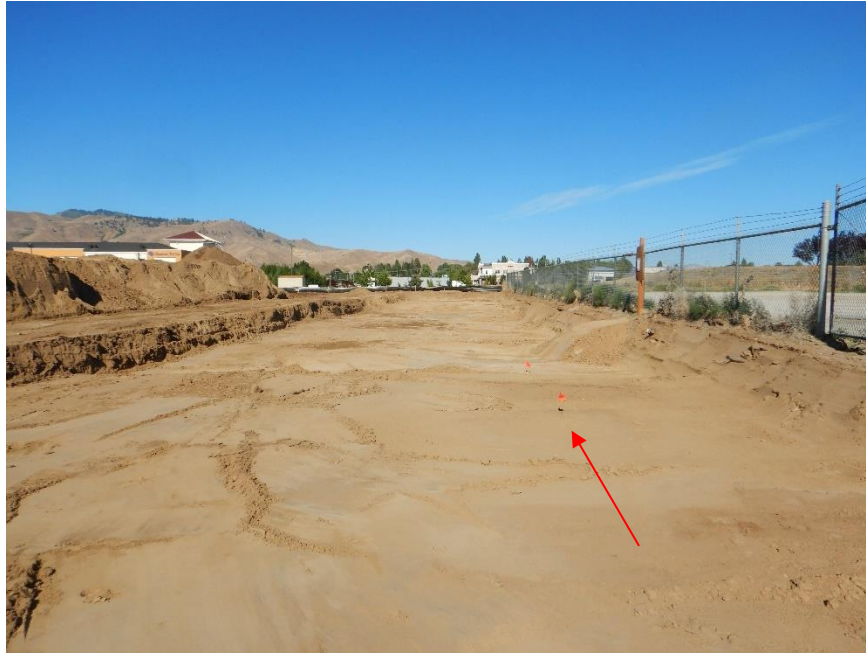
**Photograph 3. A 30 ft wide by 200 ft long trench was excavated 30 inches below grade along the northern property line and was compliance tested at 20 sample locations to determine if a clean soil horizon had been reached. Four sample locations did not pass for arsenic only and were marked with orange pin flags (red arrow). However, the average of compliance testing was below MTCA Method A clean up levels.**

On the afternoon of August 1<sup>st</sup> an excavator removed the top 24 inches of contaminated soil in an approximate 30 ft wide by 200 ft long trench from east to west across the parcel and stockpiled the dirty soils on the center of the property. Grette Associates performed an additional XRF compliance testing at 20 sampling locations within the trench to determine if excavation to a clean soil horizon had been achieved. Of the 20 sampling locations, 10 had been adequately excavated to clean soils and 10 required additional excavation. Based on this information, additional excavation to a depth of 30 inches below grade occurred in the trench in order to ubiquitously reach the horizon of clean soils along the northern property line.

On August 3, 2022 the 30-inch-deep excavated trench was compliance tested utilizing an XRF at the 20 fixed sampling locations. Results of the compliance testing are included as Attachment B. It was determined that clean soils had been reached at 30 inches in depth below grade at 16 of the 20 sampling locations. Four sampling locations did not pass the XRF compliance sampling at 30 inches in depth for arsenic only and include Sample 3, Sample 6, Sample 9, and Sample 10 (Sheet 2). However, the average arsenic level of the 20 compliance samples was 12 ppm (assuming 5 ppm for non-detect samples per the detection limit of the Olympus Vanta XRF) and was within the 20 ppm MTCA Method A clean up levels. Based on this information, it was assumed that deep clean soil excavation at the site could begin.

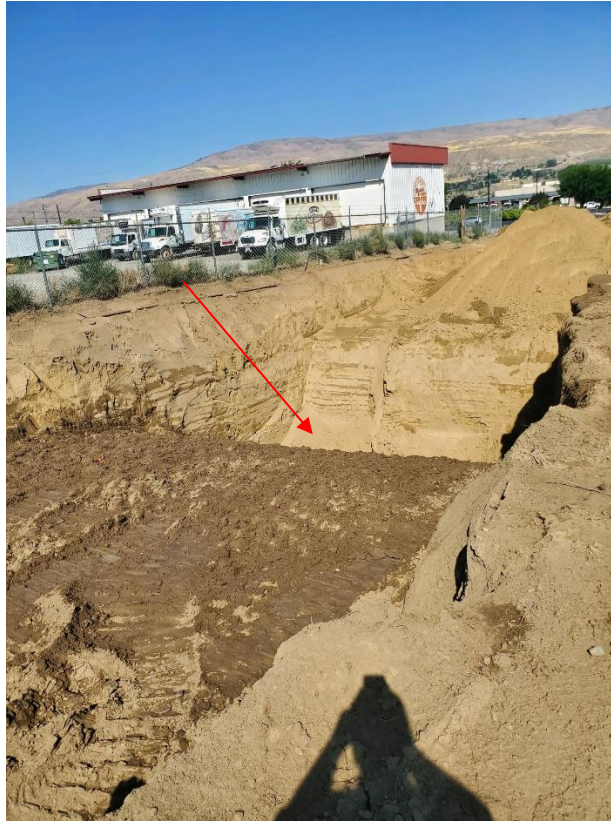
**Photograph 4. Clean soils were excavated from below the clean soil horizon within the trench and stockpiled separately from contaminated surface soils. The deep clean soils were lab tested to verify lead and arsenic levels were below MATCA Method A cleanup levels before being exported off-site for stockpile and reuse in the soft cap.**

Approximately 1,000 cu. yards of deep clean soil was excavated from below the clean soil horizon at 30 inches below grade (Sheet 3). The deep clean soil excavation measured approximately 150 ft long, 18 ft wide, and 10 ft deep from the bottom of the trench. This soil was stockpiled separate from contaminated soils at the site (Photograph 4). 14 composite samples were collected over two sampling events from the deep clean soils stockpile. The composite samples were sent to Cascade Analytical for verification that soils in the clean stockpile tested below prescribed MTCA Method

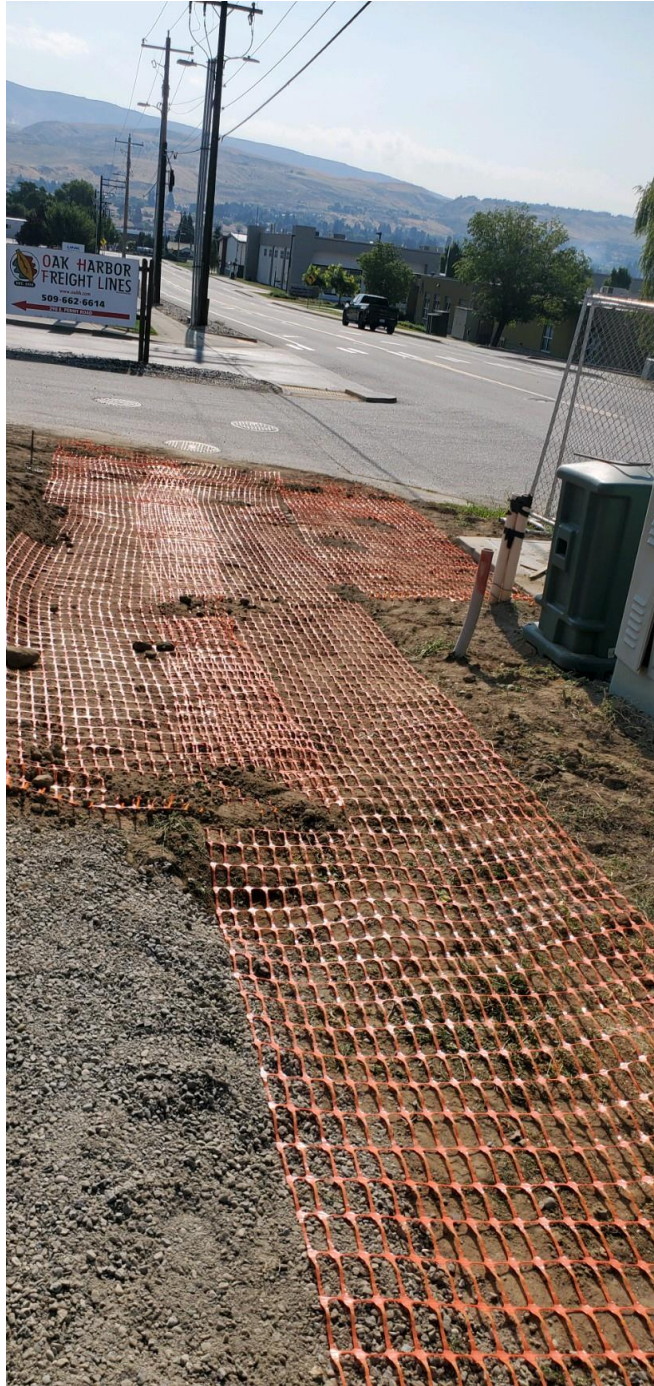
**Photograph 5. A marker barrier was applied in the landscaping areas.**

- The applicant applied a marker barrier over contaminated surface soils (Photograph 5). The marker barrier used as an underlayment is non-biodegradable and is of a bright color.
- More than 6 inches of clean soils from the deep excavation clean soil stockpile were placed over the marker barrier (Photographs 6 and 7). Clean soils were re-tested by the lab prior to application to ensure MTCA Method A compliance. Test results are included in Attachment D.
- Following application of the clean soils, the landscaping areas were covered with a surface layer of landscaping fabric followed by an additional layer of wood chips (Photographs 8, 9 and 10).

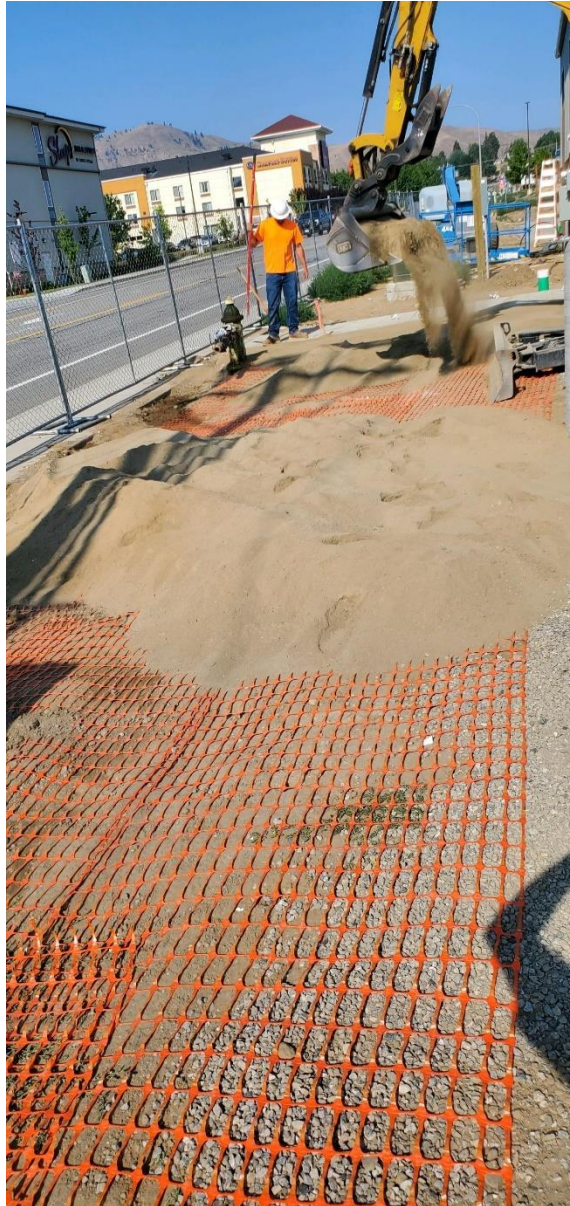
**Photograph 6. The marker barrier was capped with 6+ inches of clean soils from the deep excavation clean soil stockpile.**

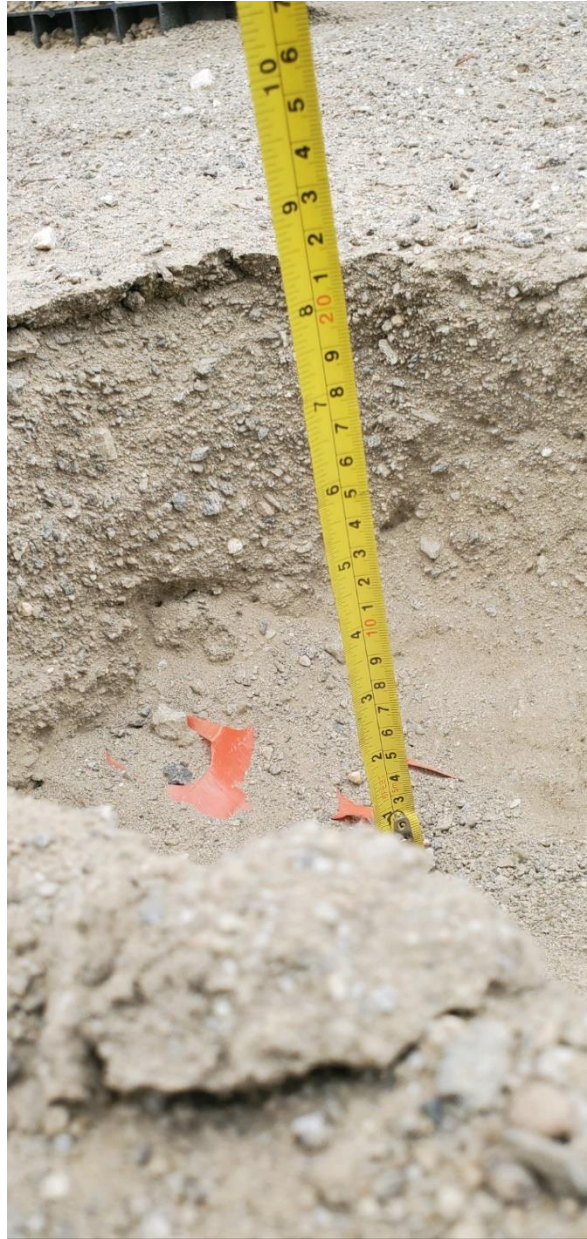
**Photograph 7. Depth of clean soils over the marker barrier exceeds 6 inches of depth.**

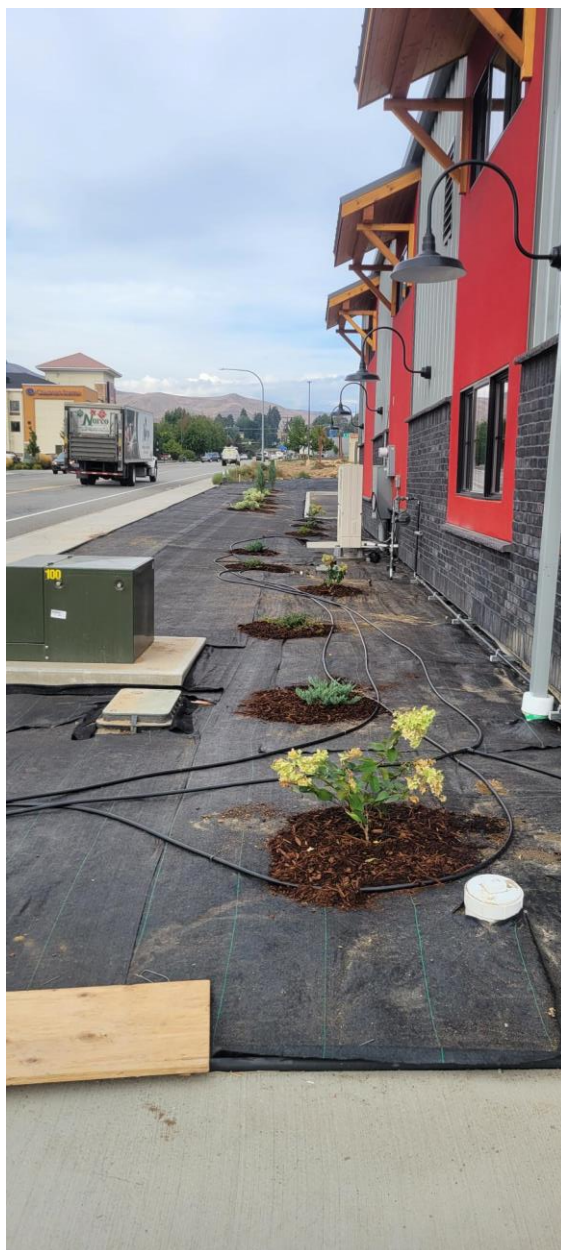
**Photograph 8. After installation of the marker material and 6+ inches of clean soils, landscaping areas were further covered with a surface layer of landscaping fabric prior to application of a bark mulch.**

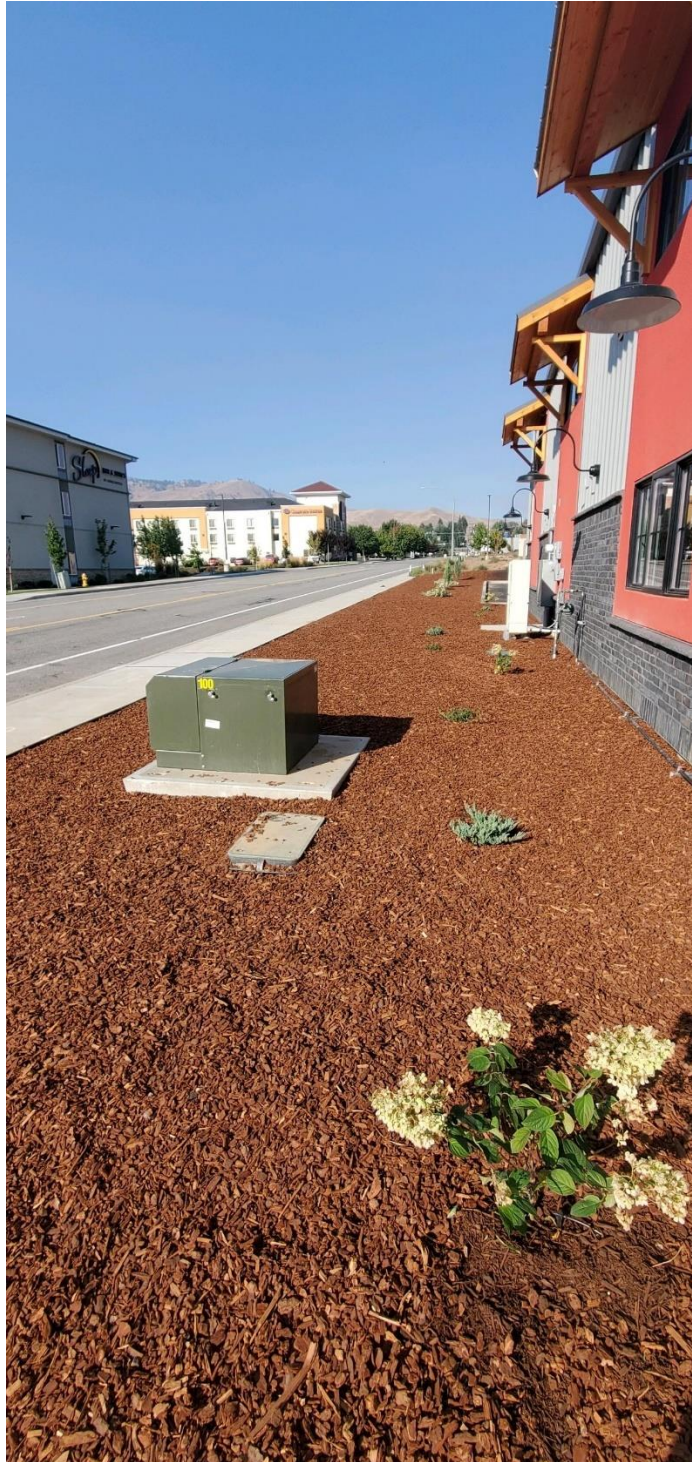
**Photograph 9. Several inches of bark mulch were installed over the surface layer of landscaping fabric.**

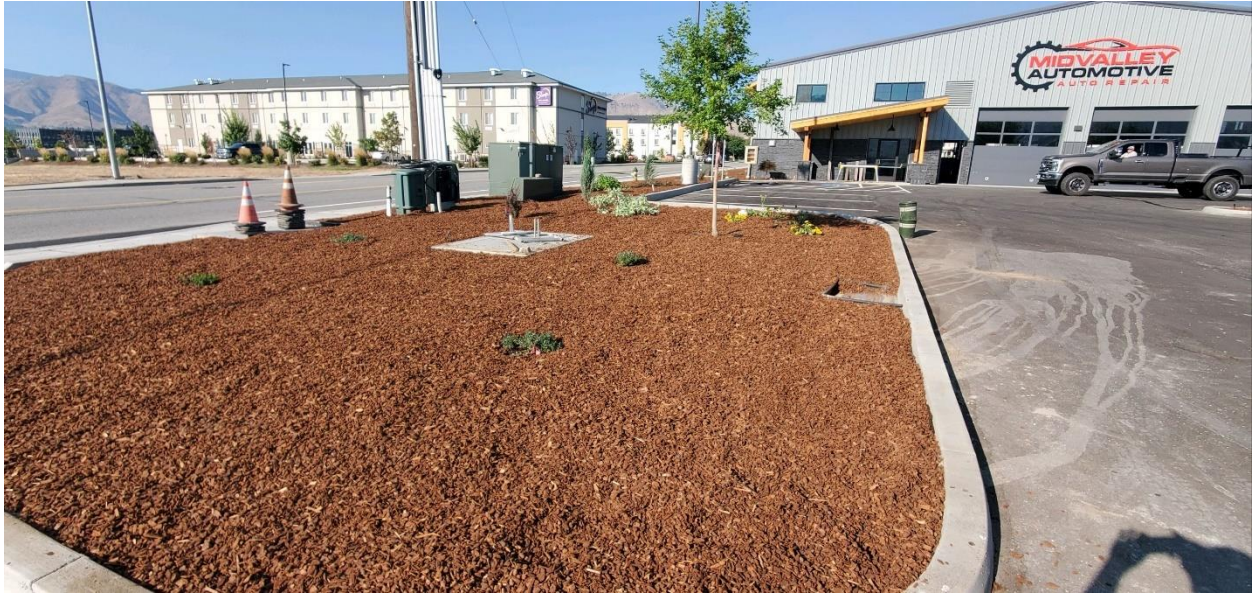
**Photograph 10. Final site with soft capped landscaping and hard capped pavement and building.**
