ADDITIONAL SITE CHARACTERIZATION AND PILOT SCALE TESTING PLAN

Tacoma Metals, Inc. Site
Tacoma, Washington

Final Plan – October 20, 2021 (Revised 12-7-21)

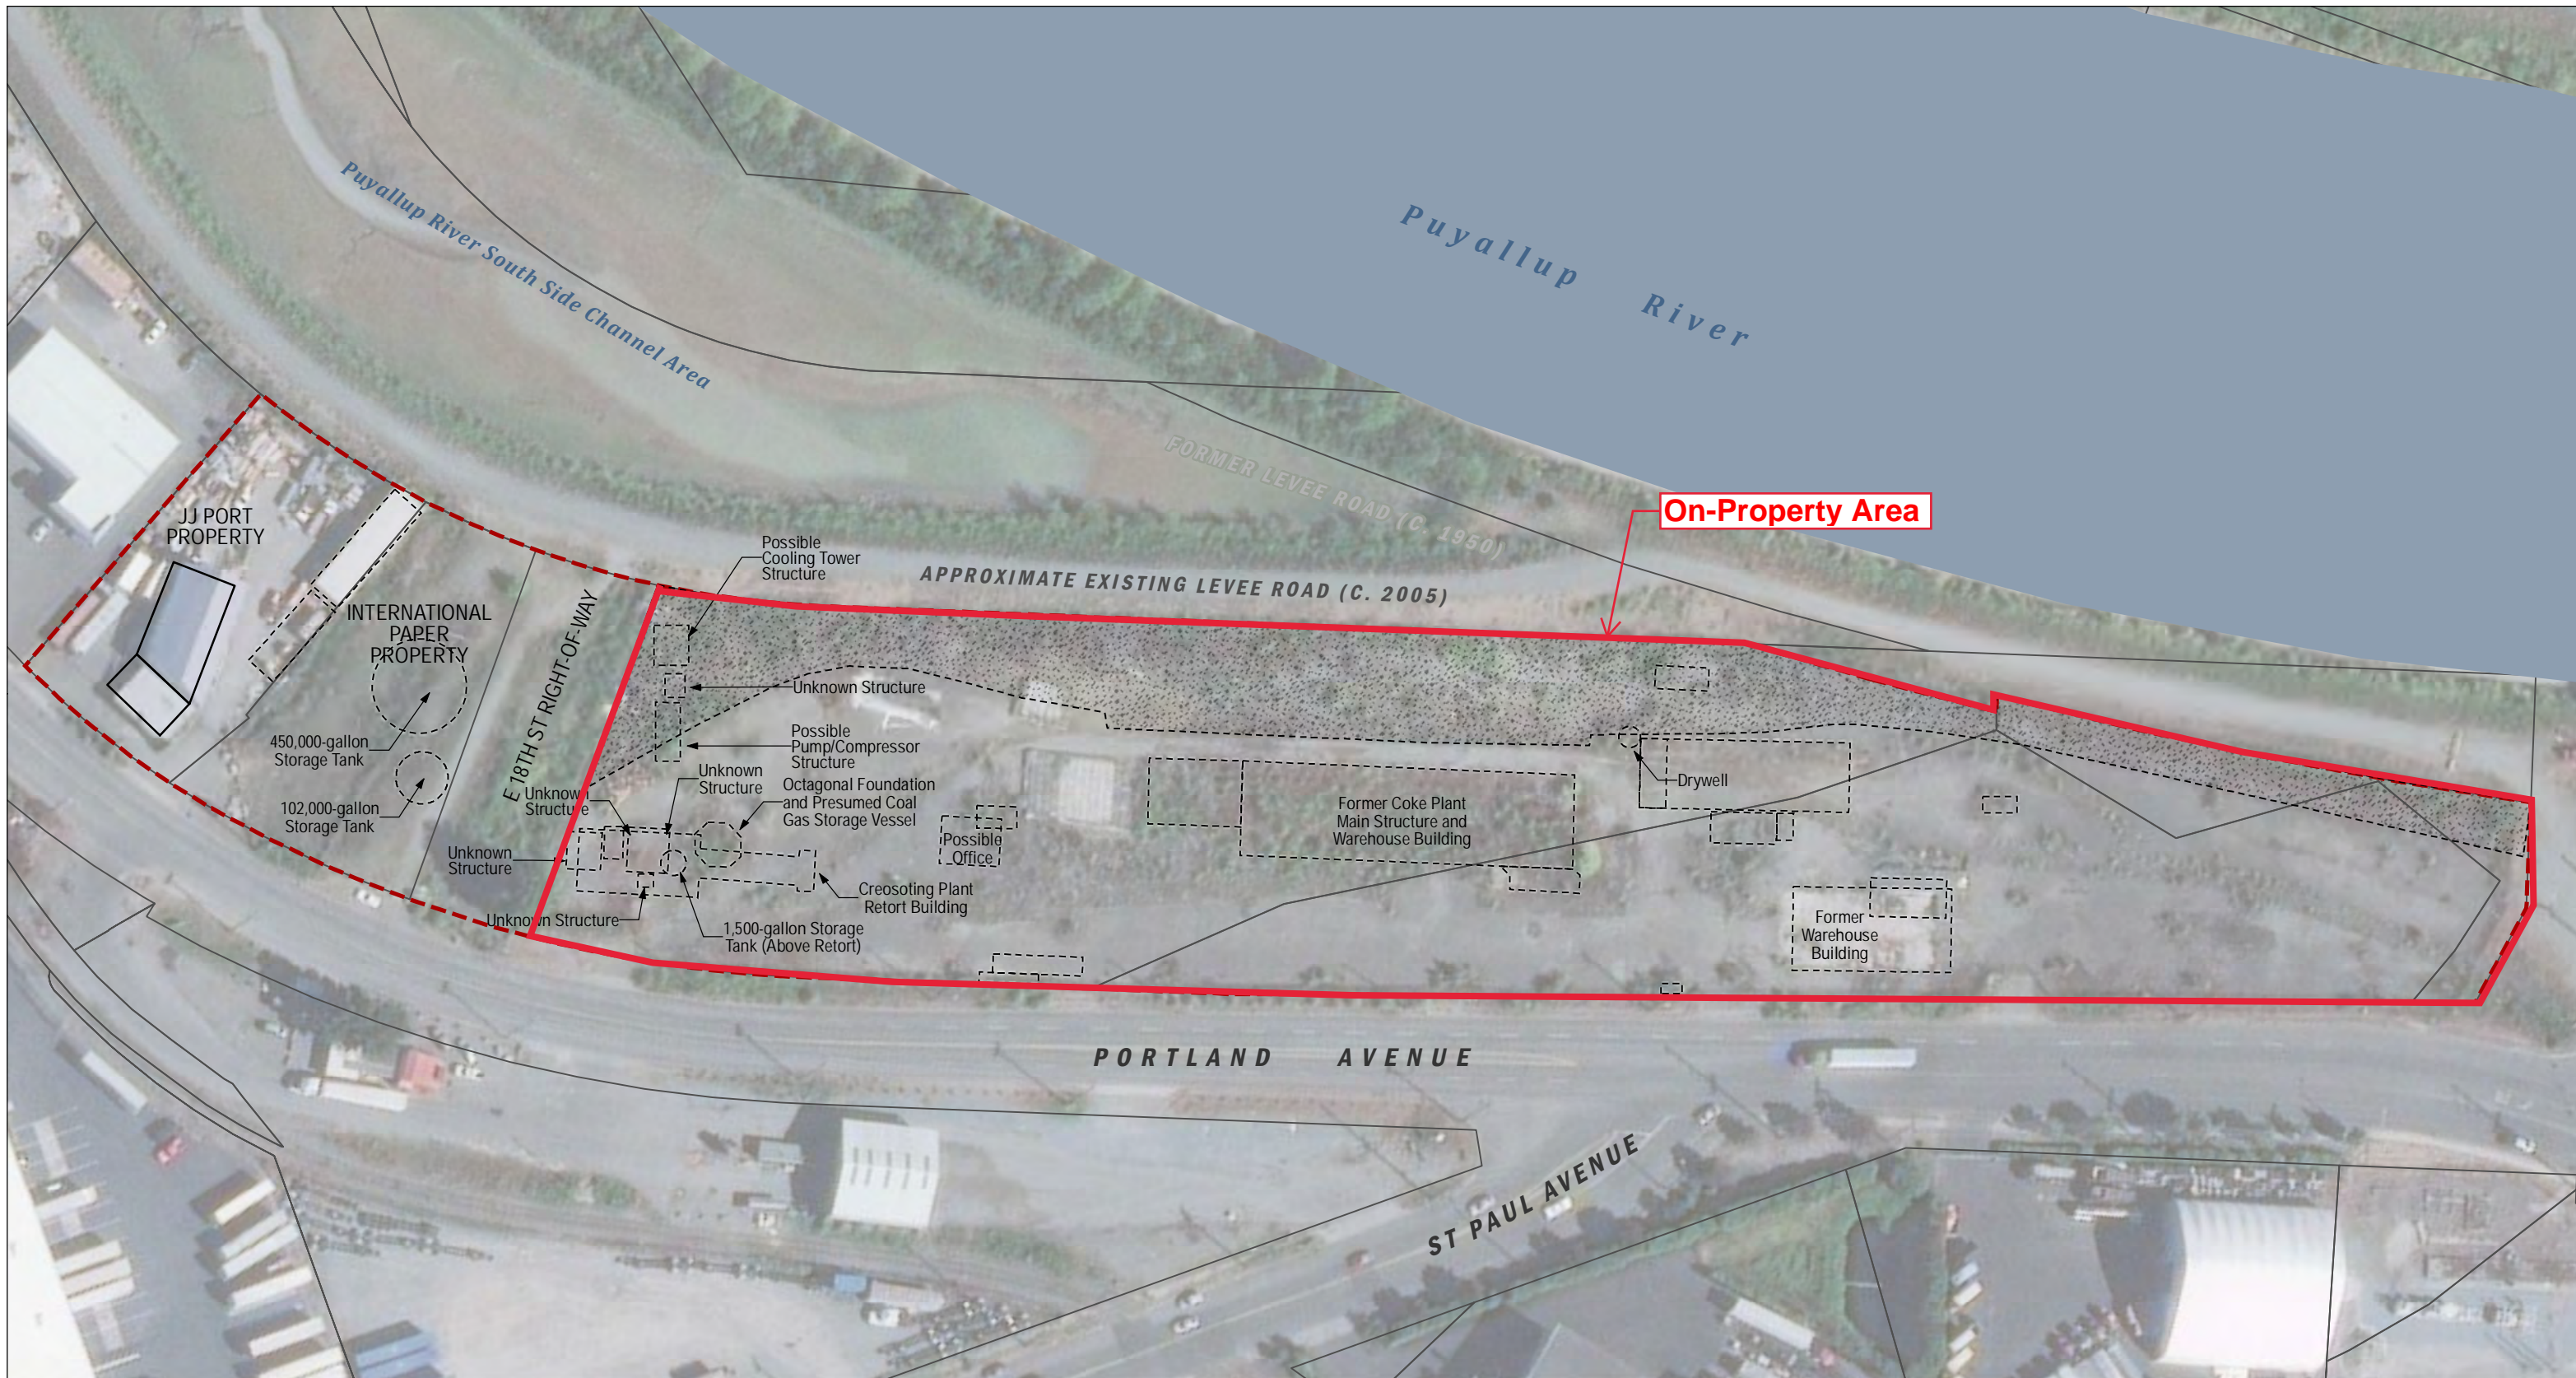
DOF - FIGURE 1 - June 2021

Historical Operations
 Revised Draft Remedial Investigation/Feasibility Study
 Tacoma Metals, Inc. Site
 Tacoma, Washington

In general, the Site consists of two areas with some overlap (Figure 1). These include 1) “*Off-Property Area*” including three property parcels (JJ Port Property, International Paper Property, and City of Tacoma Right of Way [E 18th St. Right-of-Way]) located on the northwest end of the property where releases of materials associated with a wood treating (creosote) operation occurred, and 2) “*On-Property Area*” where both wood treating and metal recycling activities occurred.

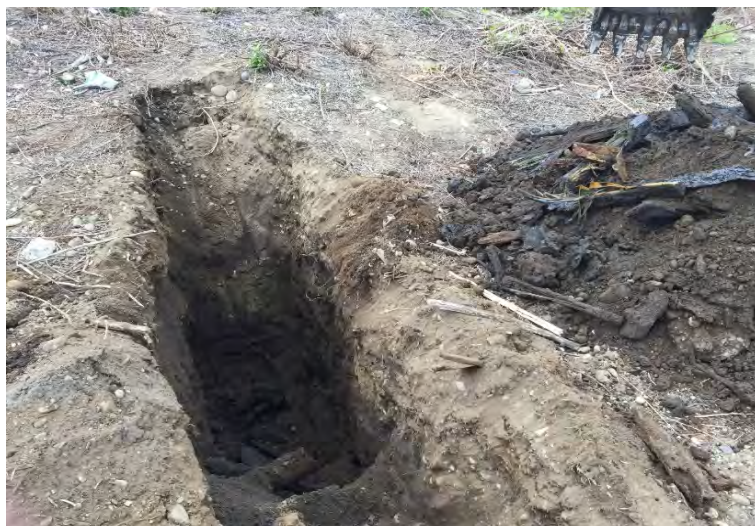
TEST PIT NO. **TP-B**

Groundwater Seepage @ 6'
Calving of Sidewalls above 6'

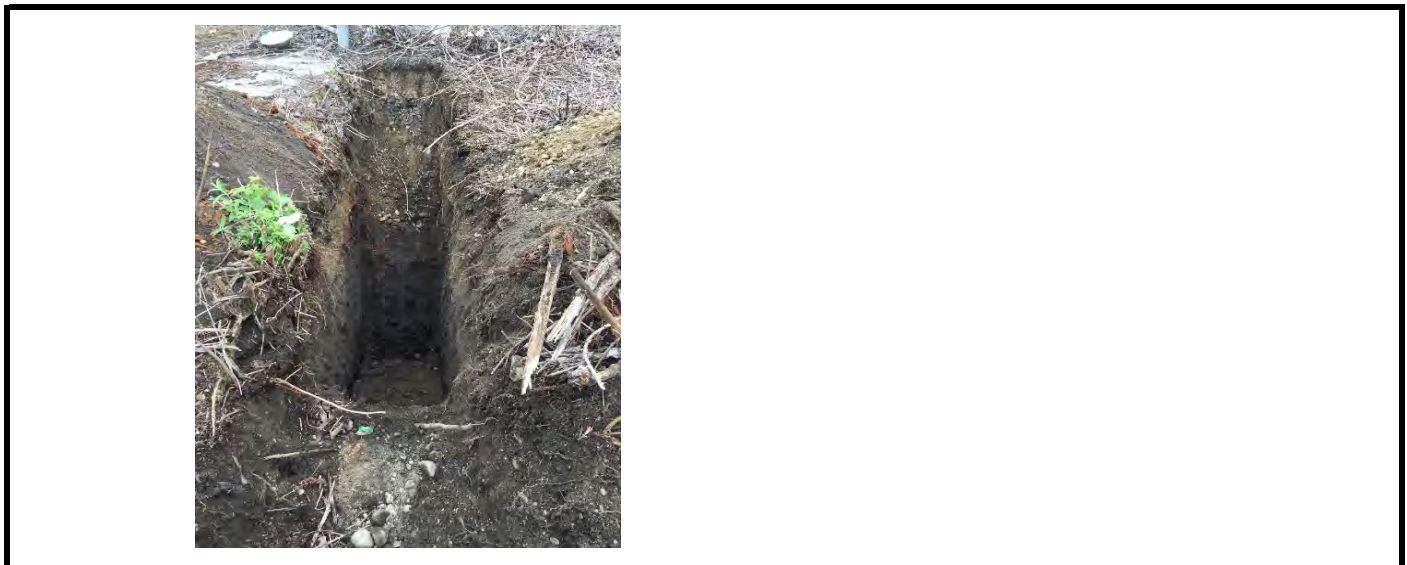
TEST PIT NO. **TP-C**
Date: 5/19/2020
Logged By: D. Cooper
Reviewed By: M. Dalton

No Groundwater Seepage No Sidewall Caving
--

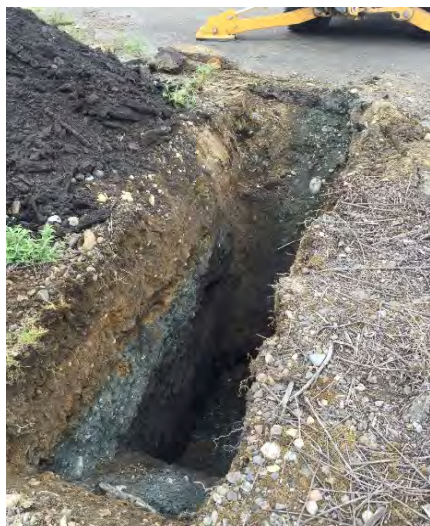
TEST PIT NO. **TP-D**
Date: 5/19/2020
Logged By: D. Cooper
Reviewed By: M. Dalton

Rapid Groundwater Seepage @ 8'
No Calving of Sidewalls

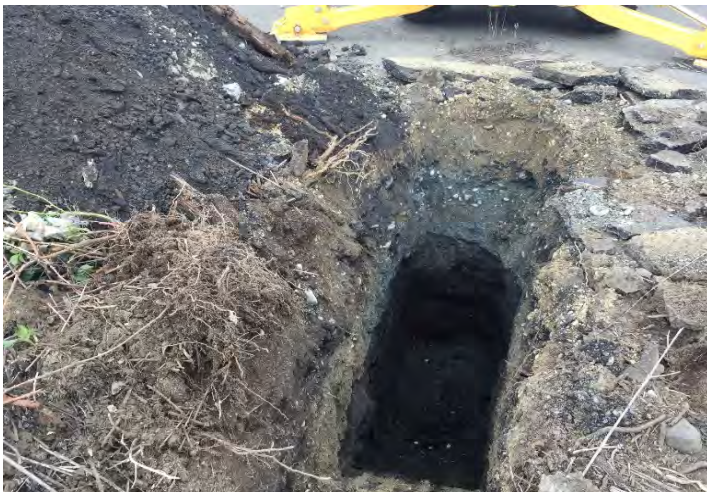
TEST PIT NO. **TP-E**
Date: 5/19/2020
Logged By: D. Cooper
Reviewed By: M. Dalton

Slight Groundwater Seepage @ 7'
No Calving of Sidewalls

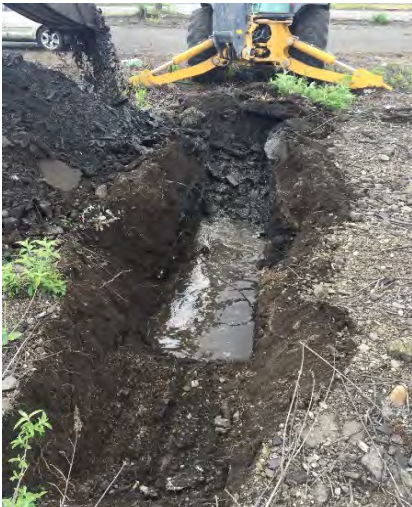
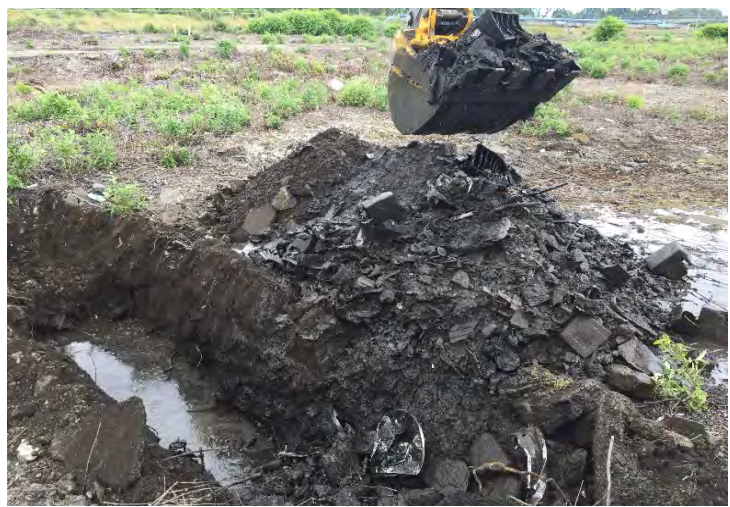
TEST PIT NO. **TP-F**
Date: 5/19/2020
Logged By: D. Cooper
Reviewed By: M. Dalton

Standing water @ 2.5' - likely flooded vault/basement
No Calving of Sidewalls

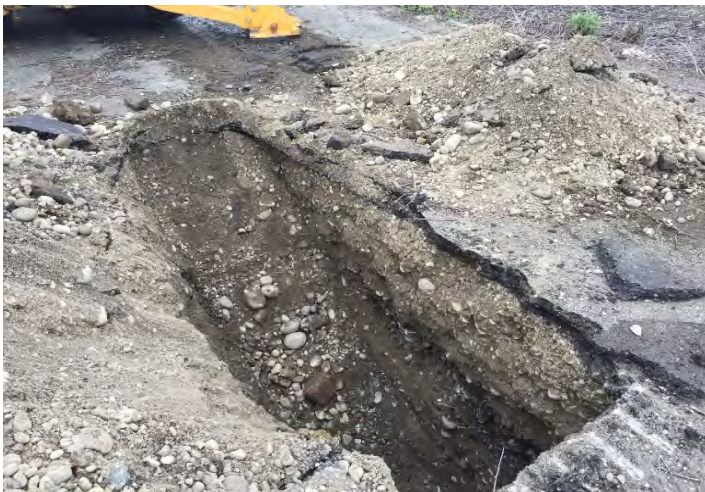
PHOTOGRAPH

Depth Ft.	Sample Number	Odors or Sheens	PID (ppm)	XRF-Pb (ppm)	USC	Visual Description
1		NO/NS	0	10		0-0.4 - Asphalt Concrete 0.4-2.5' Very dense, moist, light brown, gravelly, SAND no debris
2		NO/NS	0	<7	SP with Debris	2.5-3.5' Dense, Moist, Mottled brown, gravelly, SAND, with trace silt, 5% debris - wire, brick, metal, white precipitate
3	TP-F_2.5-3.5	NO/NS	0	1253 639		
4		NO/NS	0	<8		3.0-5.5' Dense, moist, brown, gravelly SAND, with trace silt, no debris
5		NO/NS	0	<10	SP	
6		NO/NS	0	<7		5.5-8.0' Dense, wet, red brown, gravelly SAND with silt scattered fire-brick
7					SP-SM	
8						
9						Bottom of exploration 8 feet
10

No Seepage
No Calving of Sidewalls

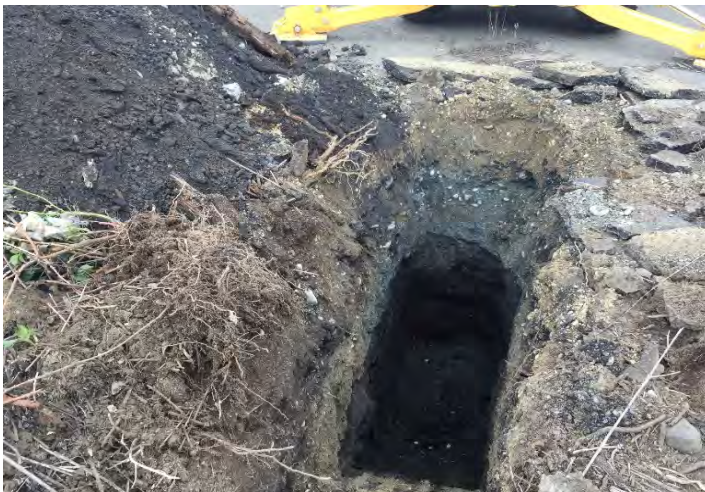
PHOTOGRAPH

Depth Ft.	Sample Number	Odors or Sheens	PID (ppm)	XRF-Pb (ppm)	USC	Visual Description
1	TP-G_0-2.5	NO/NS	0	3499 5329	SP with Debris	0-1' Loose, moist, brown, silty, SAND, with fine wood, roots, white precipitate
2		NO/NS	0	4663		1-2.5' As above, with higher fraction of blue-white precipitate
3		NO/NS	0	705		2.5-3.5' Loose, wet, dark brown, organic, silty, SAND
4	TP-G_2.5-3.5	NO/NS	0	936 56	SP	3.5-6.5' M Dense, wet, brown, gravelly SAND, with trace silt (* bucket sample, possible carry-down)
5		NO/NS	0	270*		
6		NO/NS	0	22		
7					SM	6.5-8.0' Loose, wet, dark brown, silty SAND, with organics, large woody debris - decomposed
8						
9						Bottom of exploration 8 feet
10

No Groundwater Seepage
Calving of Sidewalls above 6'

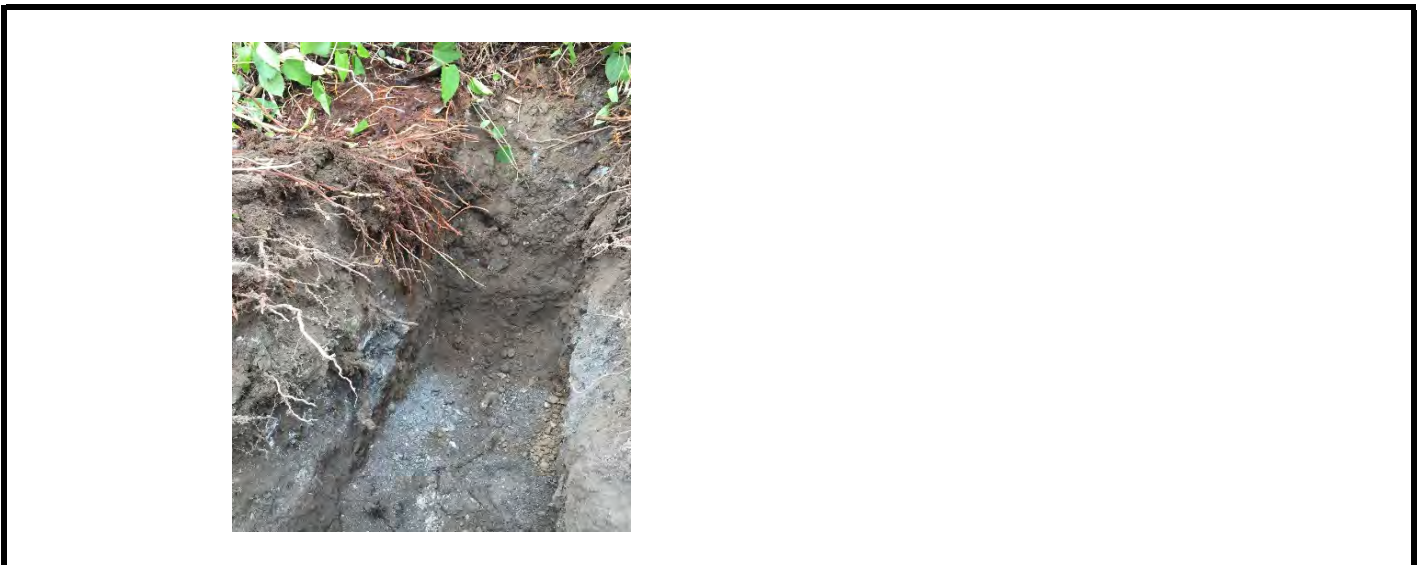
PHOTOGRAPH

Depth Ft.	Sample Number	Odors or Sheens	PID (ppm)	XRF-Pb (ppm)	USC	Visual Description
1	TP-H_0.5-2.0	NO/NS	0	2200	SP with Debris	0-0.5' Thick root mat
2	TP-H_2-3	NO/NS	0	2542		0.5-3.0' Loose, wet, mottled white-brown, silty, SAND, with gravel, many roots, scattered wood, metal, white-blue precipitate throughout
3		NO/NS	0	1863		
4		NO/NS	0	13.6	SP	3.0-6.0' Loose, wet, brown, gravelly, SAND, with trace silt, scattered wood
5		NO/NS	0	5.7		
6		NO/NS	0	6.5		
7					SP	6.0-8.0' Loose, wet, dark gray, Fine to medium SAND, with large WOODY DEBRIS
8						
9						Bottom of exploration 8 feet
10

No Groundwater Seepage
Slight Calving of Sidewalls

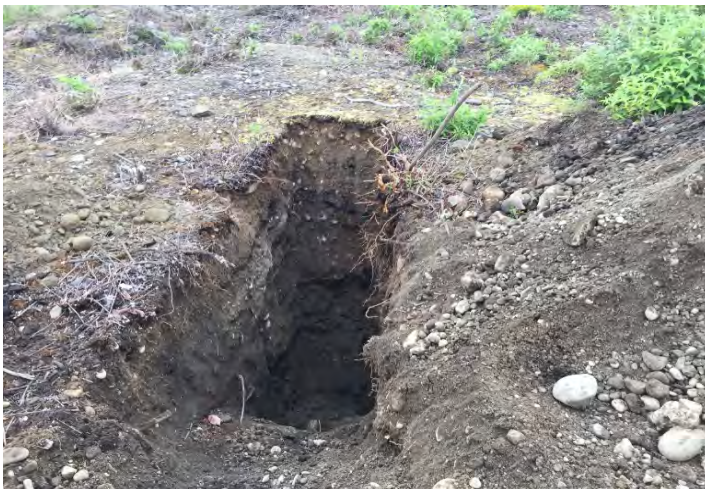
PHOTOGRAPH

Depth Ft.	Sample Number	Odors or Sheens	PID (ppm)	XRF-Pb (ppm)	USC	Visual Description
_1	TP-I_1-2	NO/NS	0	27	SP with Debris	0-0.3 Asphalt Concrete 0.3-1.3' Dense, moist, brown, gravelly SAND, with trace silt, no debris
_2	TP-I_2-3	NO/NS	0	894		1.3-3.4' Very dense, moist, mottled brown, gravelly SAND with silt, fine debris (10%) brick, glass, metal, asphalt
_3		NO/NS	0	129		
				85		
_4		NO/NS	0	9	SP	3.4-7.5' Dense, moist, brown, gravelly SAND, with trace silt no debris
_5		NO/NS	0	<6		
_6						
_7		NO/NS	0	<6		
_8					SM	7.5-8.0' loose, wet, dark brown, silty SAND, with organics
_9						Bottom of exploration 8 feet
_10

No Groundwater Seepage
No Calving of Sidewalls

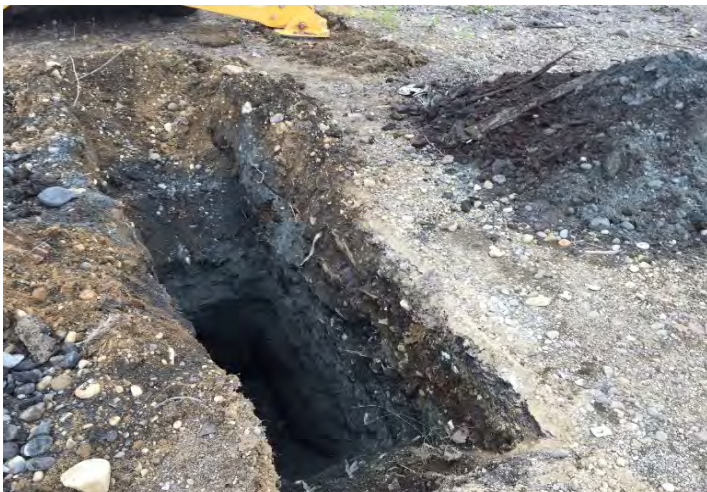
PHOTOGRAPH

Depth Ft.	Sample Number	Odors or Sheens	PID (ppm)	XRF-Pb (ppm)	USC	Visual Description
1	TP-J_0.5-1.5	NO/NS	0	2025	SP with Debris	0-0.4 Asphalt Concrete
2		SLO/NS	7.4	2296		0.4-1.6' Very dense, moist, dark brown, gravelly SAND, with silt, debris (30%) metal, gl;ass, car parts, large scrap
3	TP-J_2-3	SLO/NS	12.5	444		1.6-3.5' Very dense, moist, dark gray/black, larger car parts in a gravelly SAND matrix, slight heavy oil odor
4		NO/NS	1.5	7	SP	3.5-6' Dense, moist, blue-gray, gravelly SAND, with trace silt no debris
5		NO/NS	0	<6		
6		NO/NS	0	<6		
7						6-7' Medium dense, wet, gray, Fine to medium SAND
8					O	7-8' loose, wet, dark brown, WOODY DEBRIS / silty sand matrix
9						Bottom of exploration 8 feet
10

No Groundwater Seepage
No Calving of Sidewalls

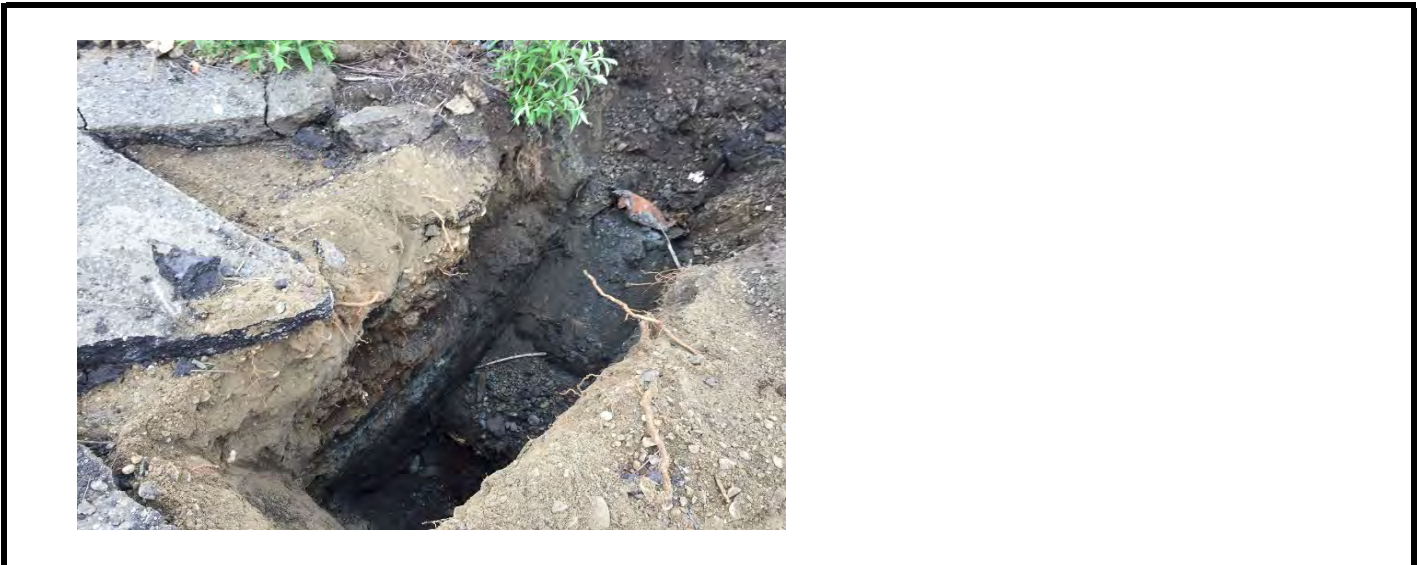
PHOTOGRAPH

Depth Ft.	Sample Number	Odors or Sheens	PID (ppm)	XRF-Pb (ppm)	USC	Visual Description
_1	TP-J_1.5-3.5	NO/NS	0	<5.6	SP with Debris	0-0.4 Asphalt Concrete 0.4-1.5' Medium dense, moist, light brown, gravelly, SAND, with trace silt, no debris
_2		NO/NS	0	1913		1.5-3.5' Dense, moist, dark brown, gravelly, SAND, with silt, 10-20% debris - large metal scrap, wire, glass, fire brick
_3		NO/NS	0	2228 1610		
_4		NO/NS	0	7	SP	3.5-4.5' Dense, moist, blue-gray, gravelly SAND, with trace silt, no debris
_5		NO/NS	0	16	SM	7-8' Medium dense, wet, silty, Fine SAND, with woody debris
_6						
_7						
_8						
_9						Bottom of exploration 8 feet
_10

No Groundwater Seepage
No Calving of Sidewalls

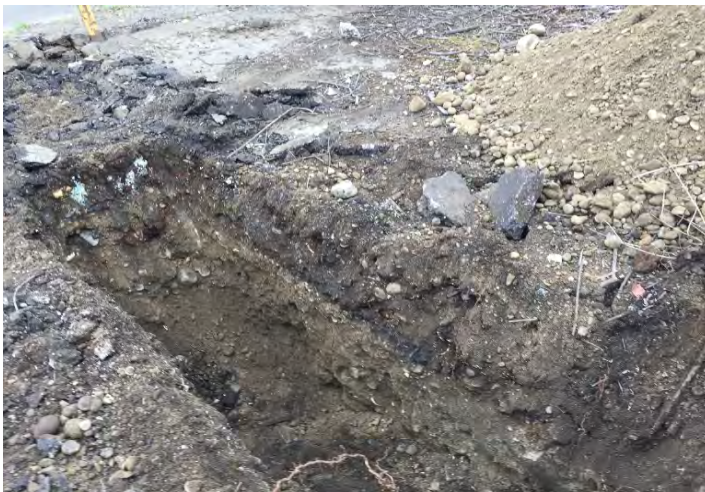
PHOTOGRAPH

Depth Ft.	Sample Number	Odors or Sheens	PID (ppm)	XRF-Pb (ppm)	USC	Visual Description
1	TP-L_0.4-1.4	NO/NS	0	1451	SP with Debris	0-0.4 Asphalt Concrete 0.4-1.4' Dense, moist, Dark brown, gravelly, SAND, with trace silt, 10% debris - metal swarf, wire, glass, white precipitate
2		NO/NS	0	<7	SP	1.4-5' Dense, moist, brown, gravelly SAND, with trace silt, no debris
3		NO/NS	0	<8		
4		NO/NS	0	<8		
5		NO/NS	0	19		
6		NO/NS	0	9.8	SM	5-8' Loose, wet, dark brown, silty, Fine SAND, with woody debris
7						
8						
9						
10						Bottom of exploration 8 feet

No Groundwater Seepage
No Calving of Sidewalls

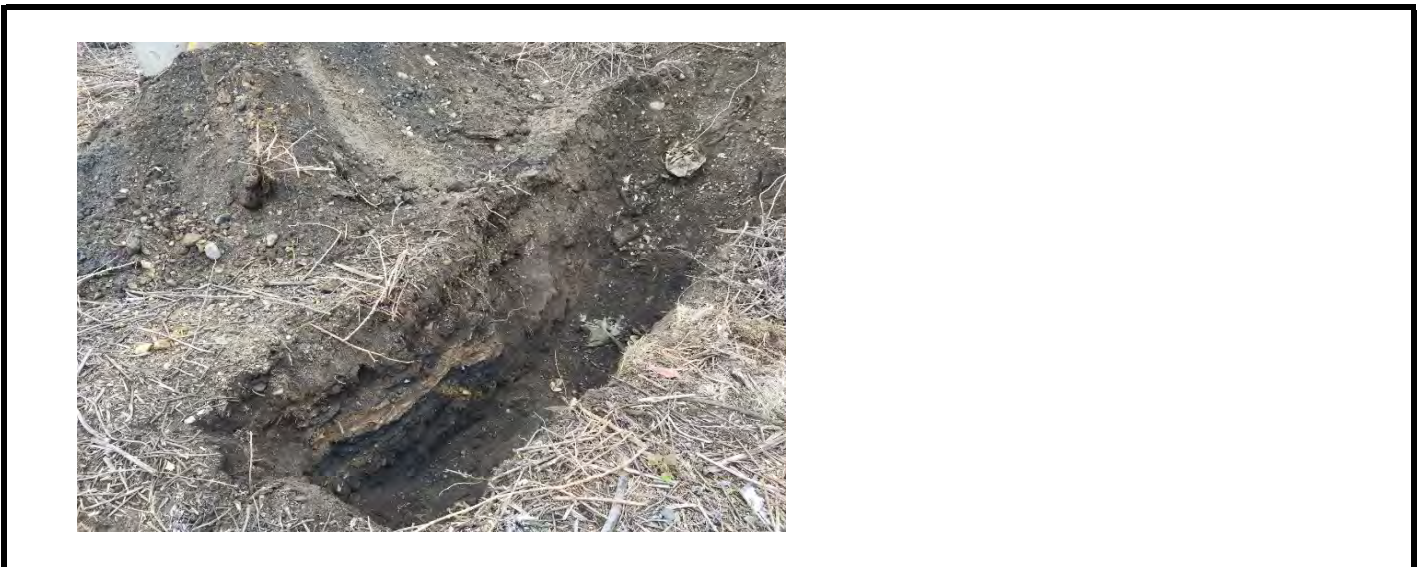
PHOTOGRAPH

No Groundwater Seepage
Calving of Sidewalls 1-2'

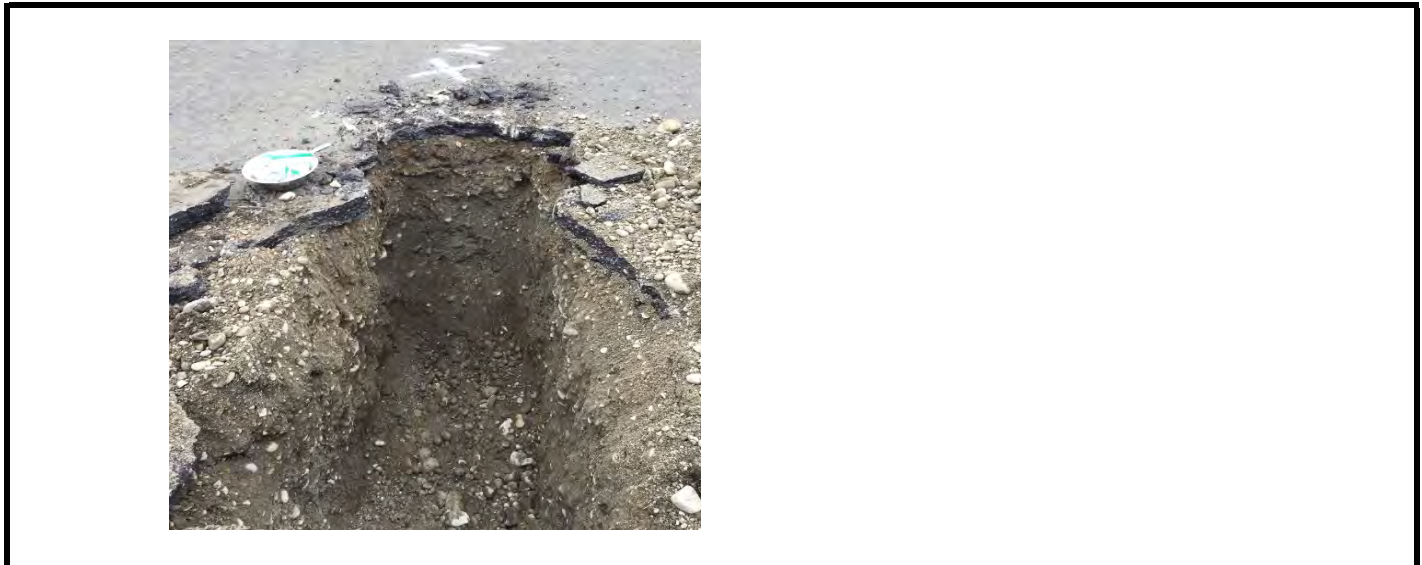
PHOTOGRAPH

No Groundwater Seepage
No Calving of Sidewalls

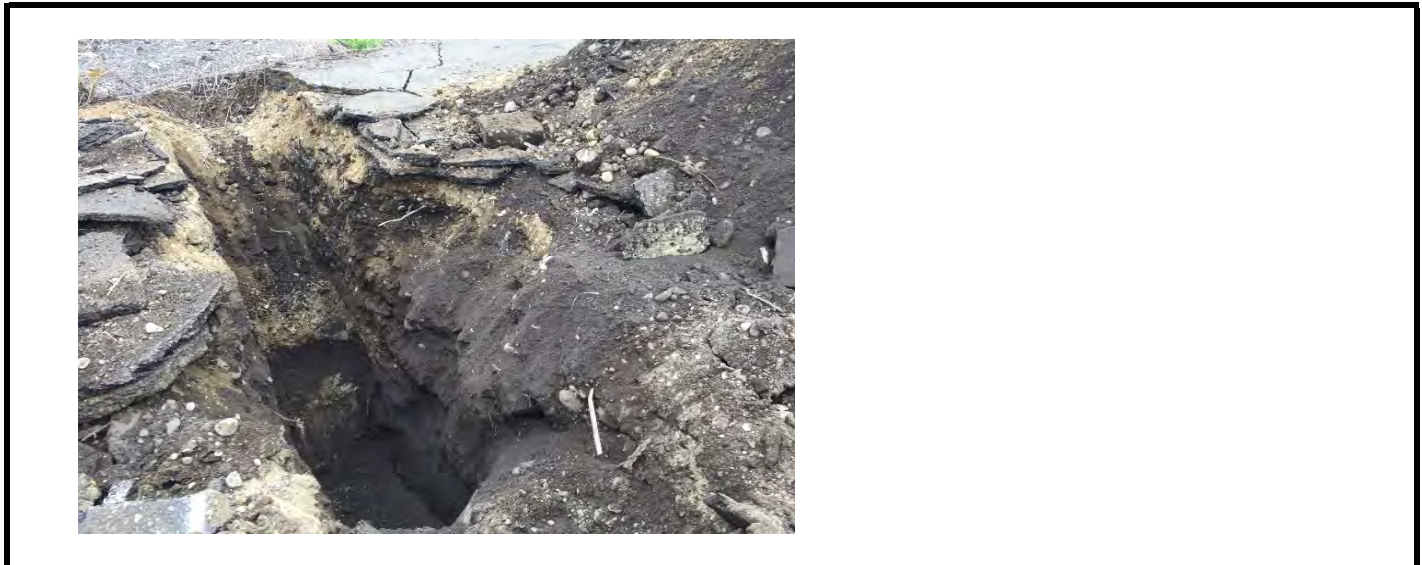
PHOTOGRAPH

No Groundwater Seepage
Slight Calving of Sidewalls

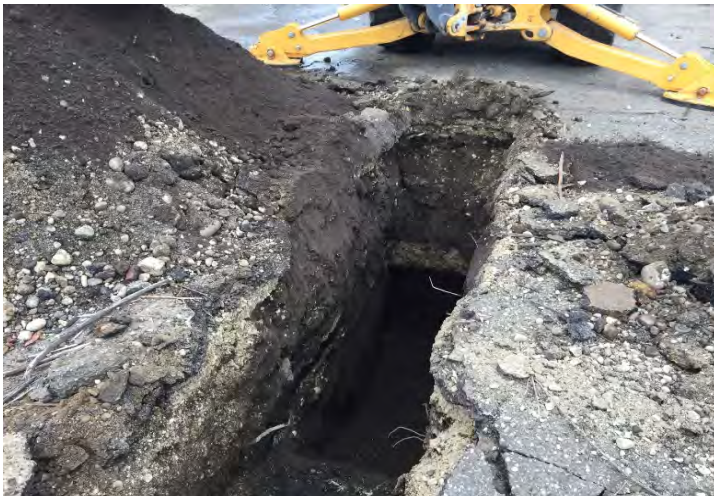
PHOTOGRAPH

No Groundwater Seepage
No Calving of Sidewalls

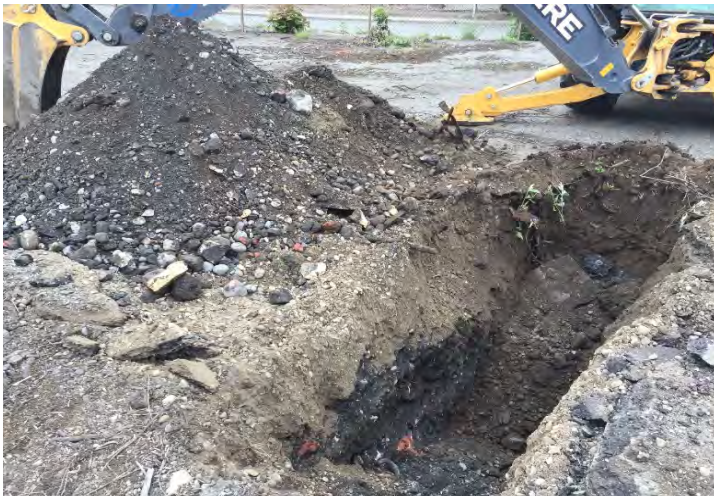
PHOTOGRAPH

No Groundwater Seepage
Calving of Sidewalls below 4'
