FINAL COMPLIANCE MONITORING REPORT

Remedial Excavations

8801 EAST MARGINAL WAY S., TUKWILA, WASHINGTON
AGREED ORDER NO. 6069

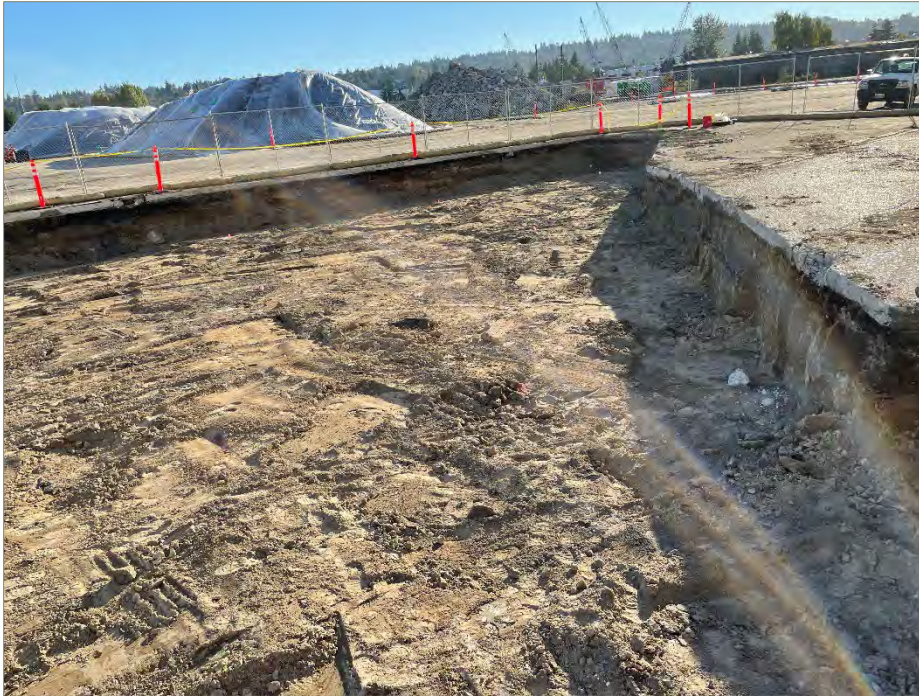
Exhibit 5-1: Photo of the Southwest Corner of Area 1 on September 21, 2021. View direction is southwest.

Imported gravel borrow was used as backfill in Area 1 from the base of the excavation to ground surface. The selection, placement, and compaction of backfill is discussed in Appendix E.

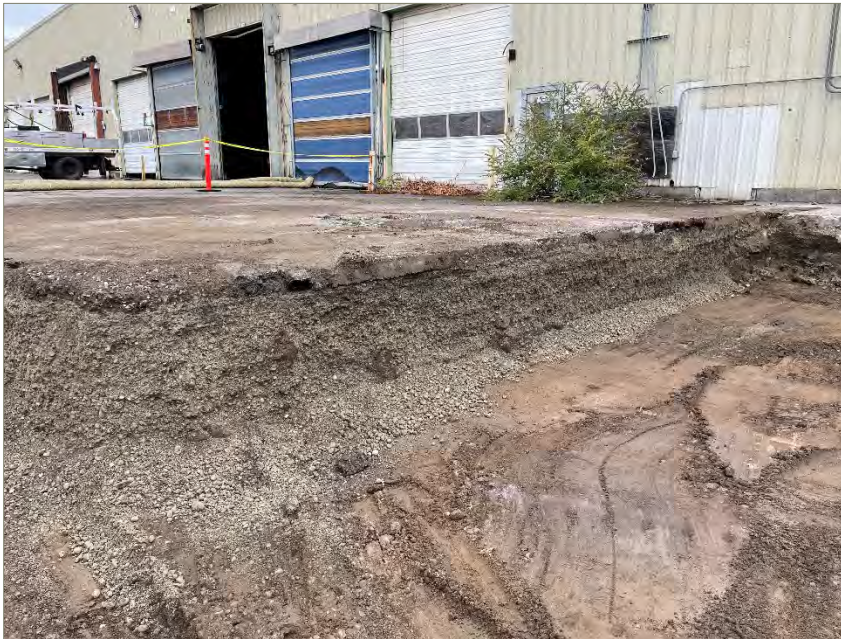
Imported backfill from a previous excavation completed in 2004 referred to as H4 (Kennedy/Jenks Consultants, 2004) was observed in the northeast and east sidewalls (noted in Figure 4) and therefore confirmation samples were not collected from the northeast and east sidewalls in accordance with the Compliance Monitoring Plan (Shannon & Wilson, 2021a). A photo of the northeast sidewall is provided in Exhibit 5-2 below.

Exhibit 5-2: Photo of the Northeast Sidewall of Area 2 on September 20, 2021. View direction is northeast. The northeast sidewall was observed to have apparent imported backfill from the previous H4 excavation.

After the final extents of the Area 2 remedial excavation were completed, a portion of the excavation was expanded vertically and backfilled with imported quarry spalls to provide a firm base for compaction of fill material. Imported crushed rock was used as backfill above the quarry spalls and the remainder of the excavation to ground surface. The selection, placement, and compaction of backfill is discussed in Appendix E.

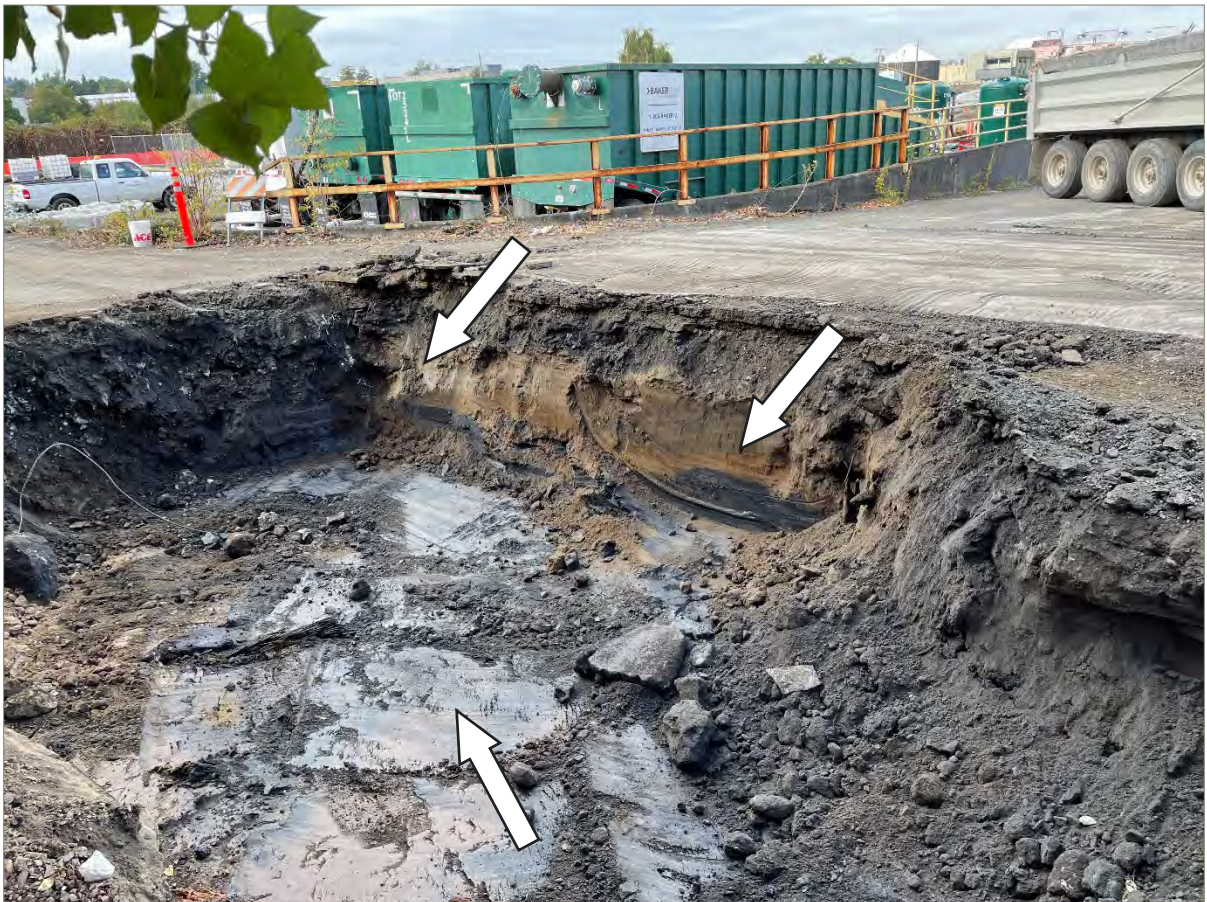
During excavation activities, an approximately 1-foot-thick, black-stained soil layer with a petroleum odor was observed at depths of approximately 2 to 6 feet throughout much of Area 3 to the east of the shoreline berm (Exhibit 5-3). Soil samples were collected from the black-stained soil and other soil layers. Some of the black-stained soil samples contained TPH-G at concentrations that exceeded the CUL, but others did not.

Exhibit 5-3: Photo of the North Portion of Area 3 on September 22, 2021. View direction is northwest. Black-stained soil was observed in the excavation sidewalls and bottom and are identified by white arrows in the photo. The black-stained soil was removed during subsequent expansion of the excavation.

Imported quarry spalls were used as backfill from the base of the excavation up to 5 feet depth. The quarry spalls were overlain by imported gravel borrow to ground surface. The selection, placement, and compaction of backfill is discussed in Appendix E.

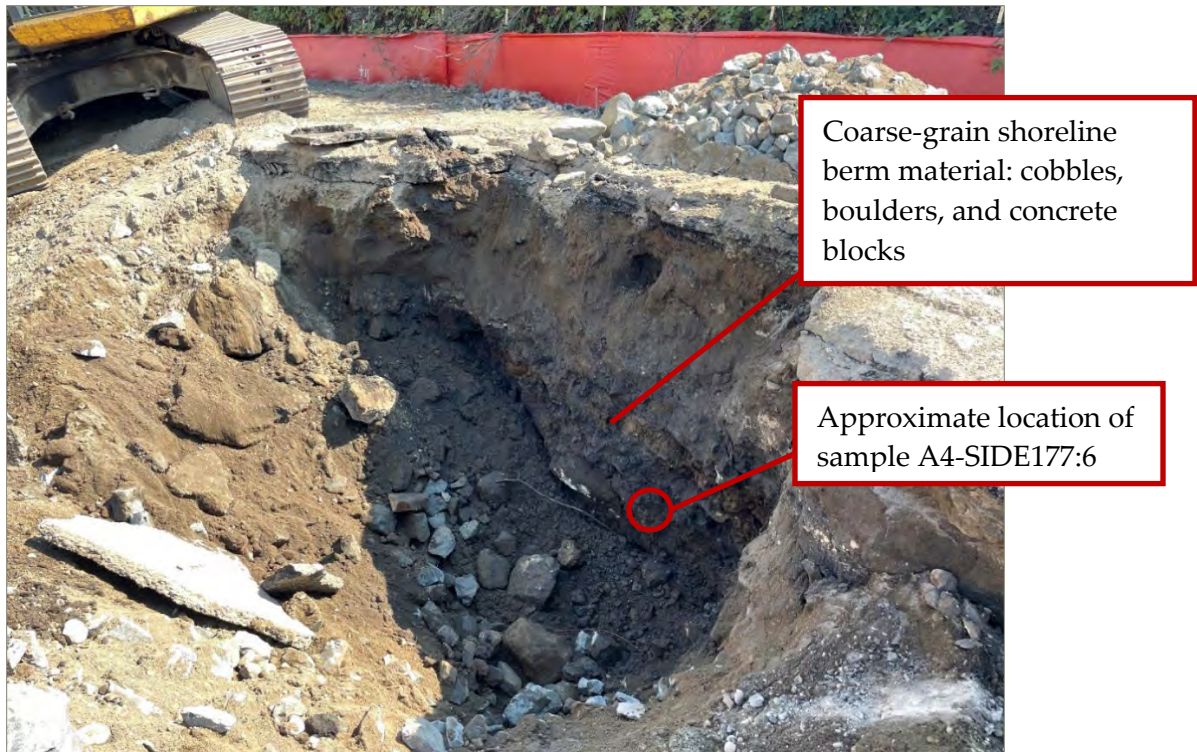
Exhibit 5-7: Excavation Activities at Sample A4-SIDE177:6. View direction is south. Photo taken on August 31, 2022.

After completion of the excavation, the excavation was backfilled with quarry spalls up to 5 feet bgs. The quarry spalls were overlain by imported gravel borrow to ground surface. The selection, placement, and compaction of backfill is discussed in Appendix E.

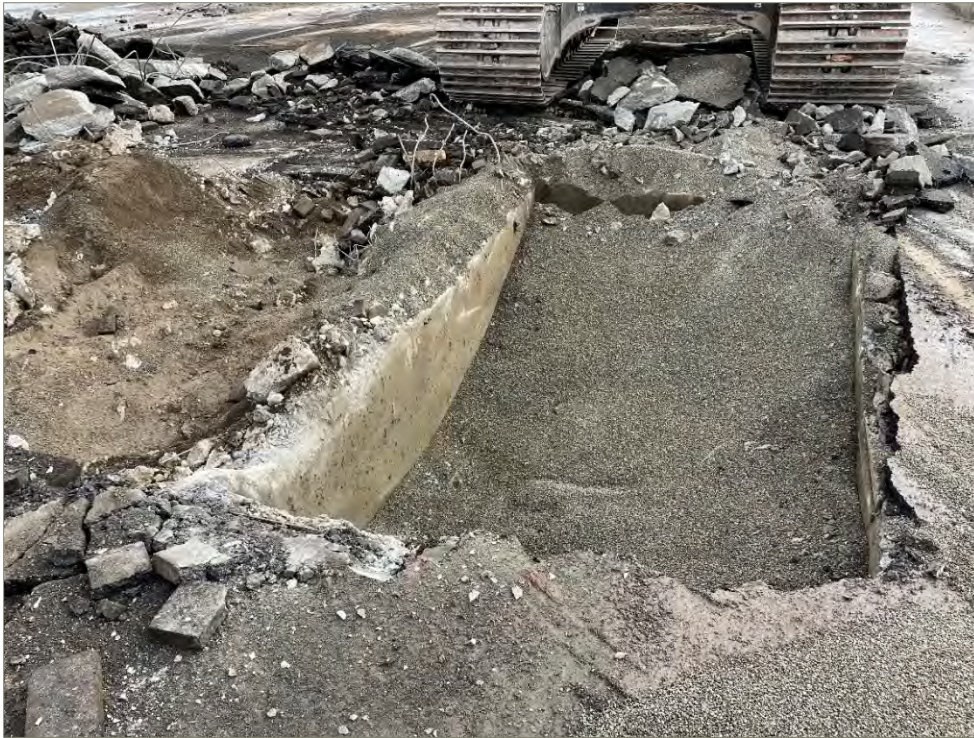
During excavation, a concrete vault was uncovered in the excavation area after pavement was removed. The concrete vault extended to 4 feet bgs and appeared to be filled with pea gravel and was paved over. The purpose of the vault was unknown. Visual and olfactory indications of contamination were not observed in the vault or in the soil immediately

surrounding the vault. The vault was removed during excavation activities. A photo of the vault is provided below in Exhibit 5-9.

Exhibit 5-9: Area 7 – View of the Vault Uncovered After Pavement Was Removed from the Excavation. Photo taken on October 4, 2021. View direction is east. A concrete vault filled with pea gravel is shown in the south (right) half of the excavation.

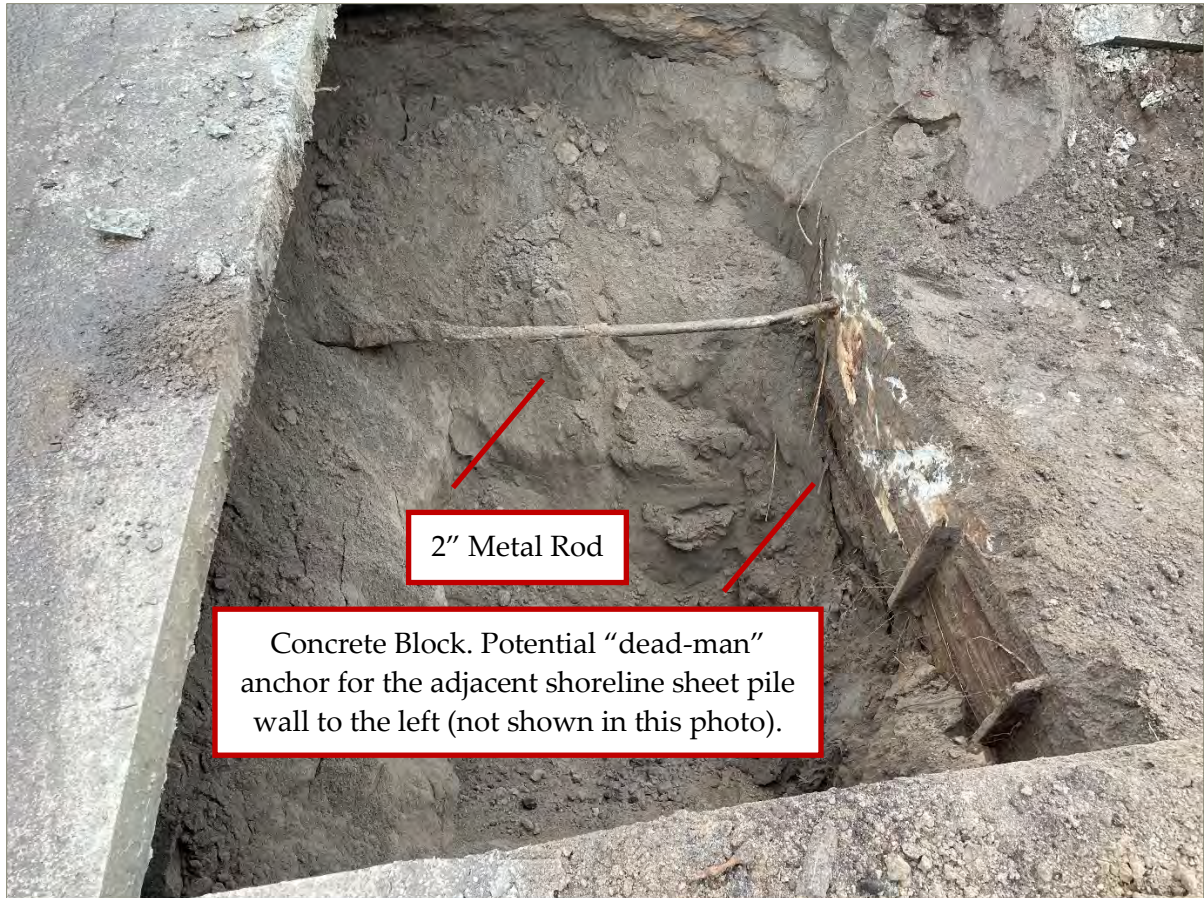
During excavation a metal rod and concrete block were uncovered and are suspected to be a “dead-man” anchor for the adjacent sheet pile wall. The metal rod and concrete block were left in place. A photo of the suspected dead-man anchor is provided below in Exhibit 5-10.

Exhibit 5-10: Photo of Area 8 on October 5, 2021. View direction is north. A 2-inch metal rod and concrete block were observed in the excavation and are possible structural components of a "dead-man" anchor for the shoreline sheet pile wall. A void was observed above the concrete block to ground surface.

Imported quarry spalls were used as backfill from the base of the excavation up to 5 feet depth. The quarry spalls were overlain by imported gravel borrow to ground surface. The selection, placement, and compaction of backfill is discussed in Appendix E.

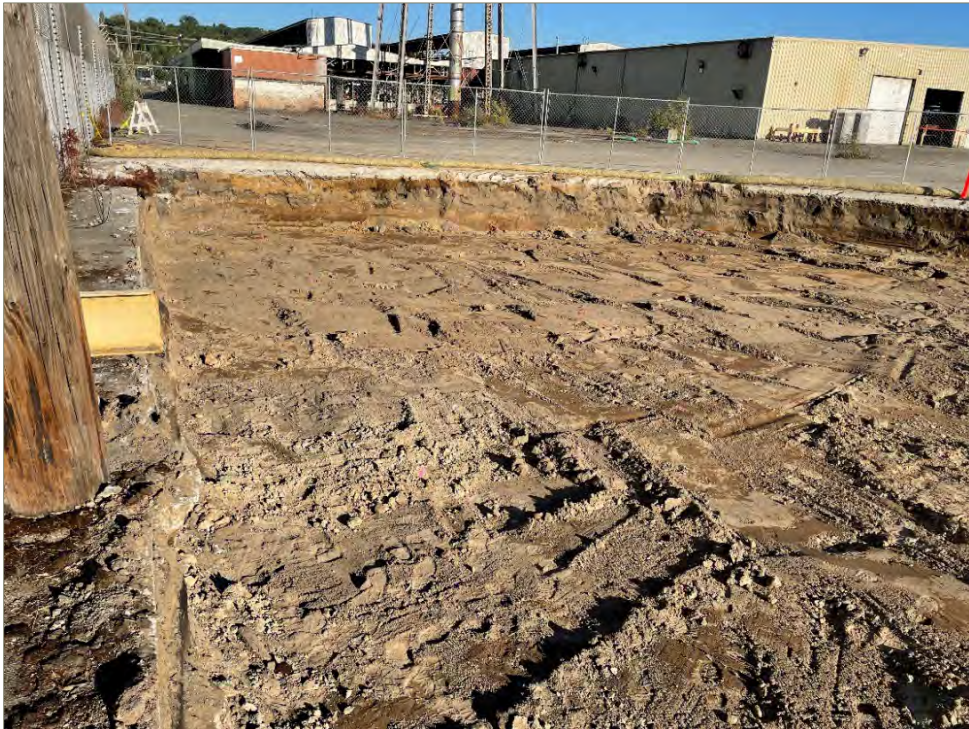
Exhibit A-1: Area 1 – Final Extent of Northeast Corner. Photo taken on September 21, 2021. View direction is east.

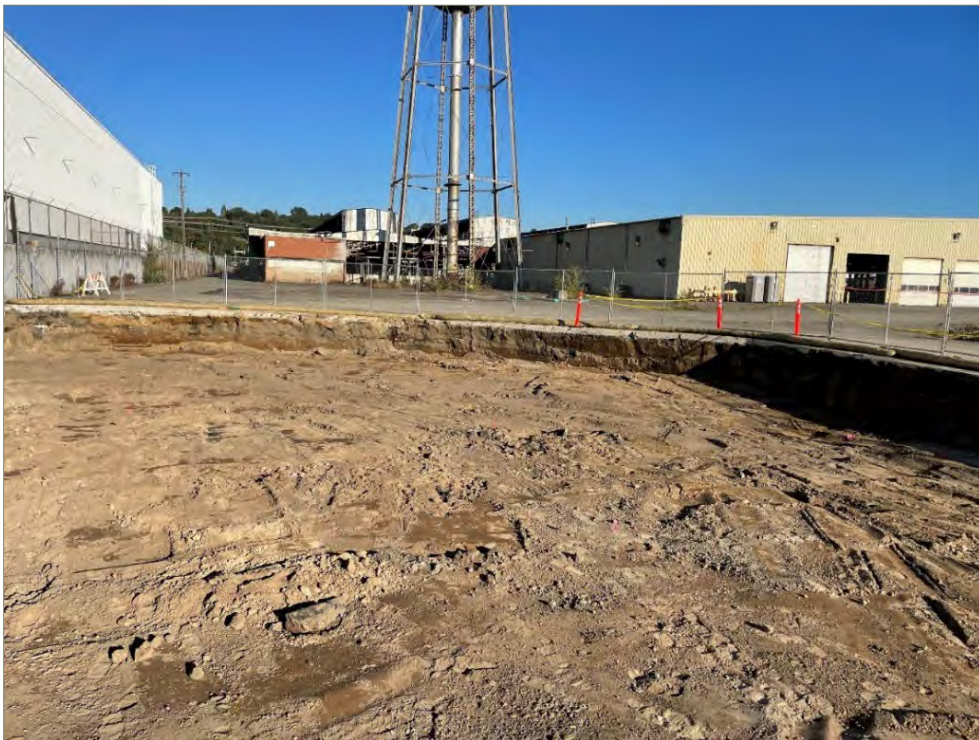
Exhibit A-2: Area 1 – Final Extent of Southeast Corner. Photo taken on September 21, 2021. View direction is east.

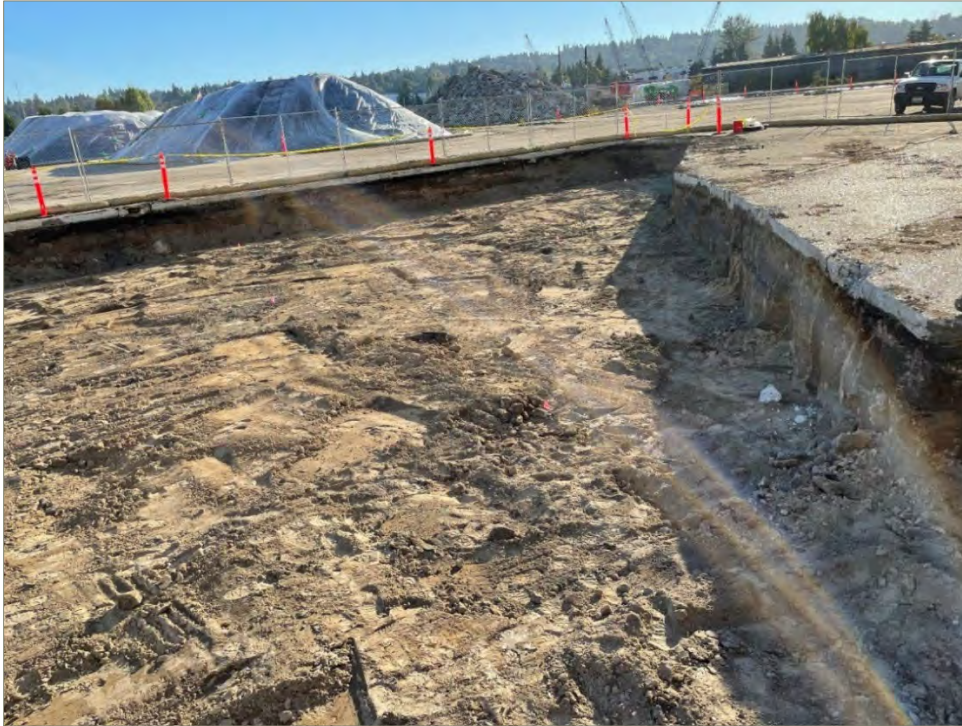
Exhibit A-3: Area 1 – Final Extent of Southwest Corner. Photo taken on September 21, 2021. View direction is southwest.

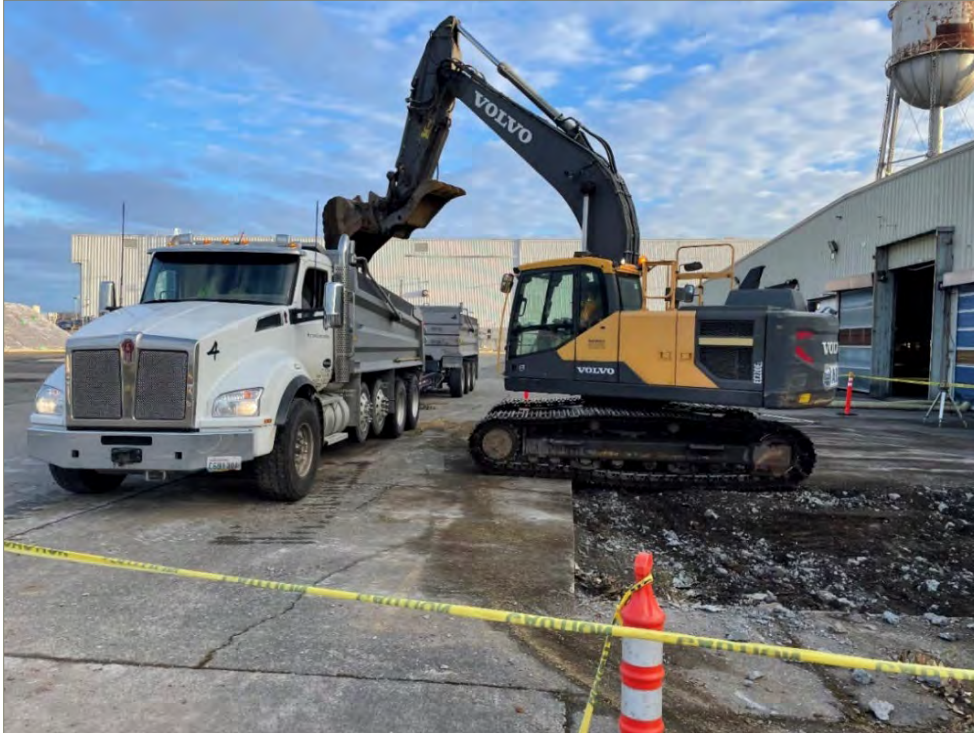
Exhibit A-4: Area 2 – Excavation and Hauling. Photo taken on September 20, 2021. View direction is north.

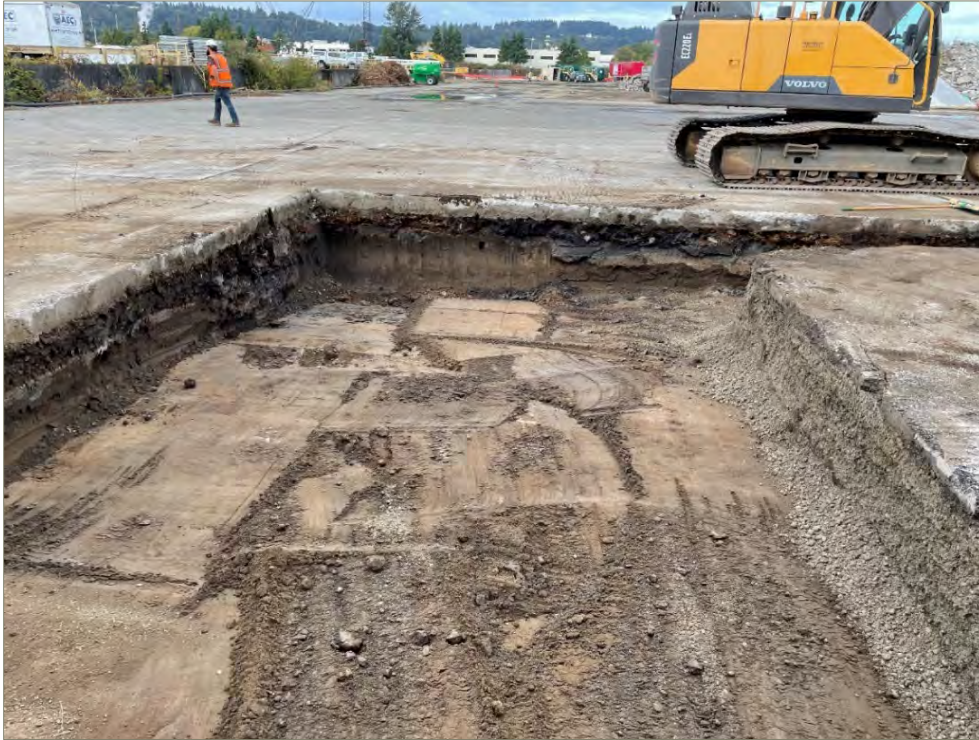
Exhibit A-5: Area 2 – View of the Southwest Portion of the Excavation. Photo taken on September 20, 2021. View direction is North. The shown excavation extents were later expanded.

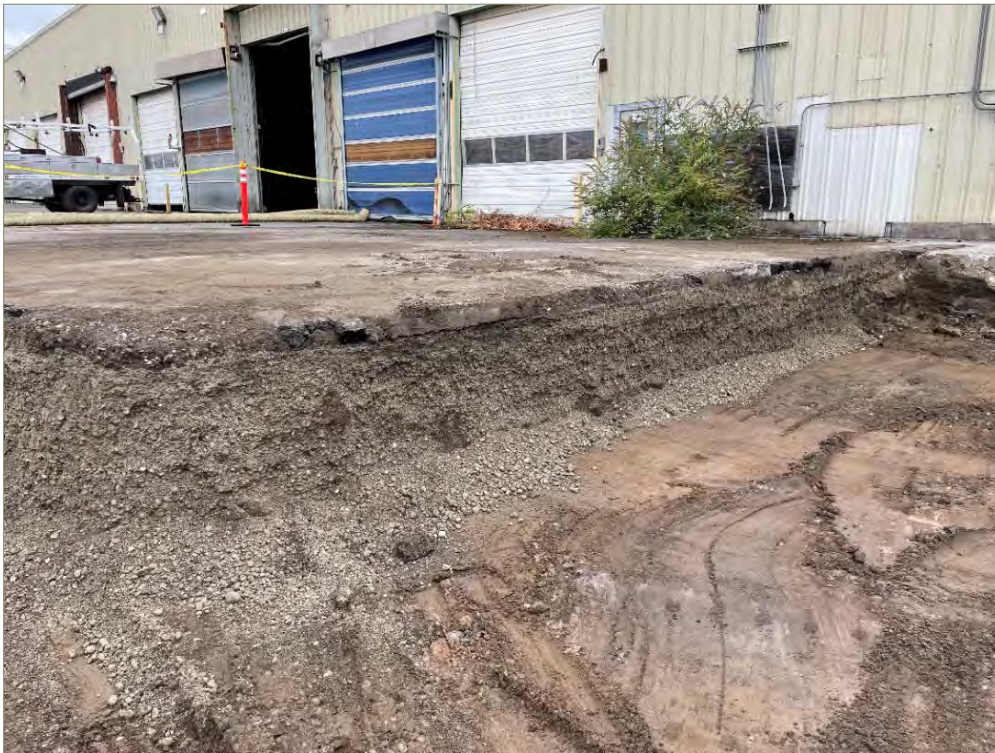
Exhibit A-6: Area 2 – View of the Northeast Portion of the Excavation. Photo taken on September 20, 2021. View direction is northeast.

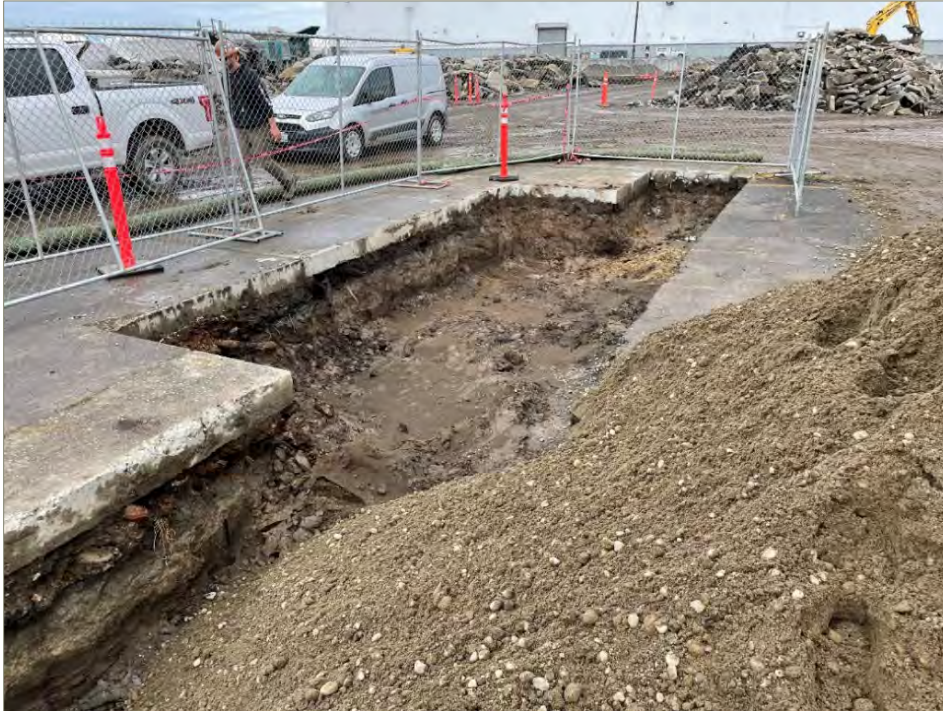
Exhibit A-7: Area 2 – View of the North Portion Final Extent of the Excavation. Photo taken on November 3, 2021. View direction is northwest. Imported Gravel Borrow is shown in the center and right foreground.

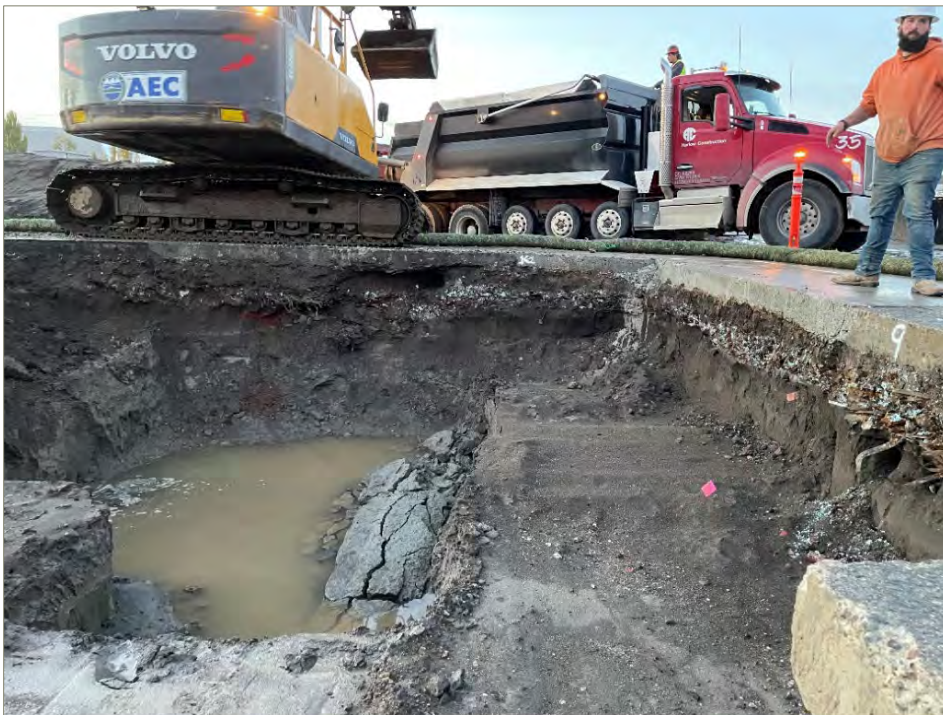
Exhibit A-8: Area 2 – View of the Southwest Portion Final Extent of the Excavation. Pink flags are sample locations. Photo taken on November 3, 2021. View direction is south. Water in the excavation is pooled rainwater and was removed prior to backfilling.

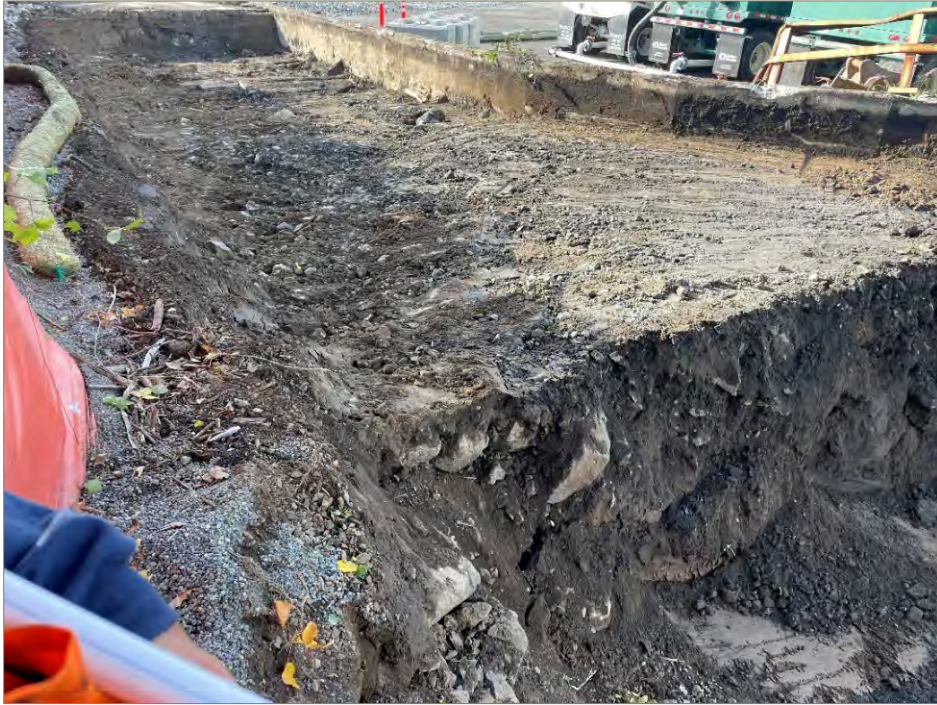
Exhibit A-9: Area 3 – View of the West Portion of the Excavation. Photo taken on September 28, 2021. View direction is northwest. The excavation was later expanded. Large rocks and concrete are visible in the sidewalls shown at the center of the photo and into the background. The large rocks and concrete are part of the shoreline berm.

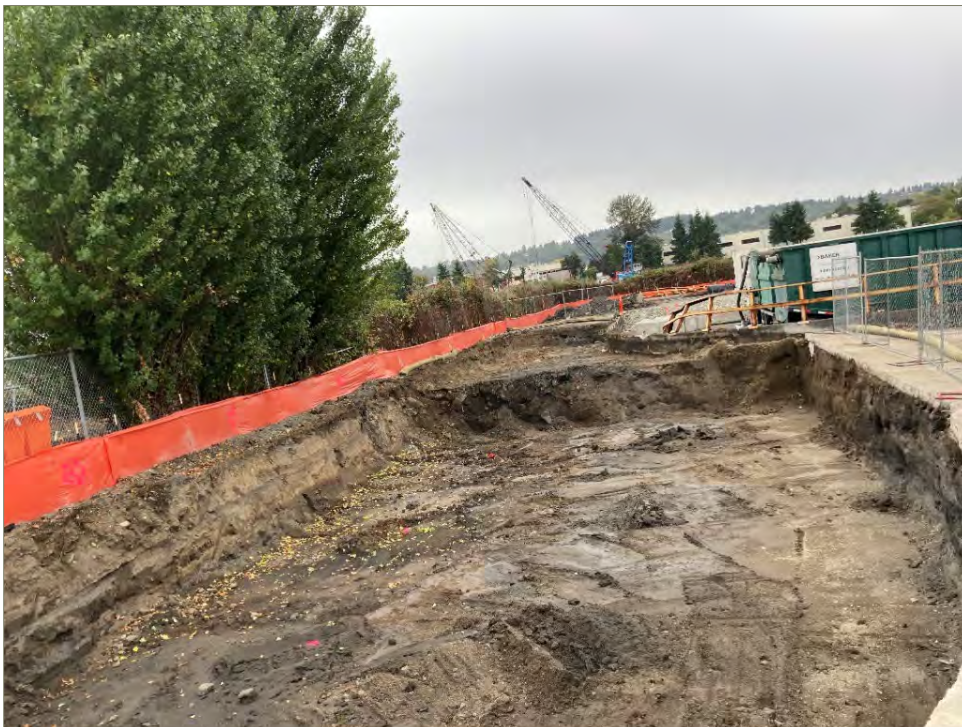
Exhibit A-10: Area 3 – View of the West Portion of the Excavation. Photo taken on September 29, 2021. View direction is west. The excavation was later expanded.

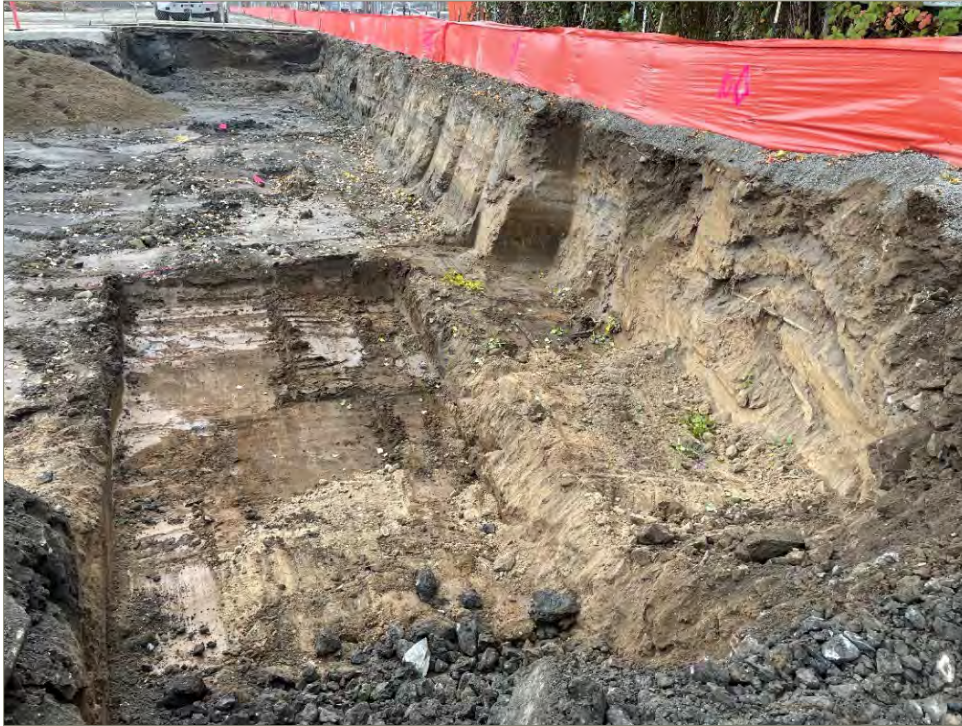
Exhibit A-11: Area 3 – View of the Central Portion of the Excavation. Photo taken on October 18, 2021. View direction is east. The southeast corner sidewall was expanded.

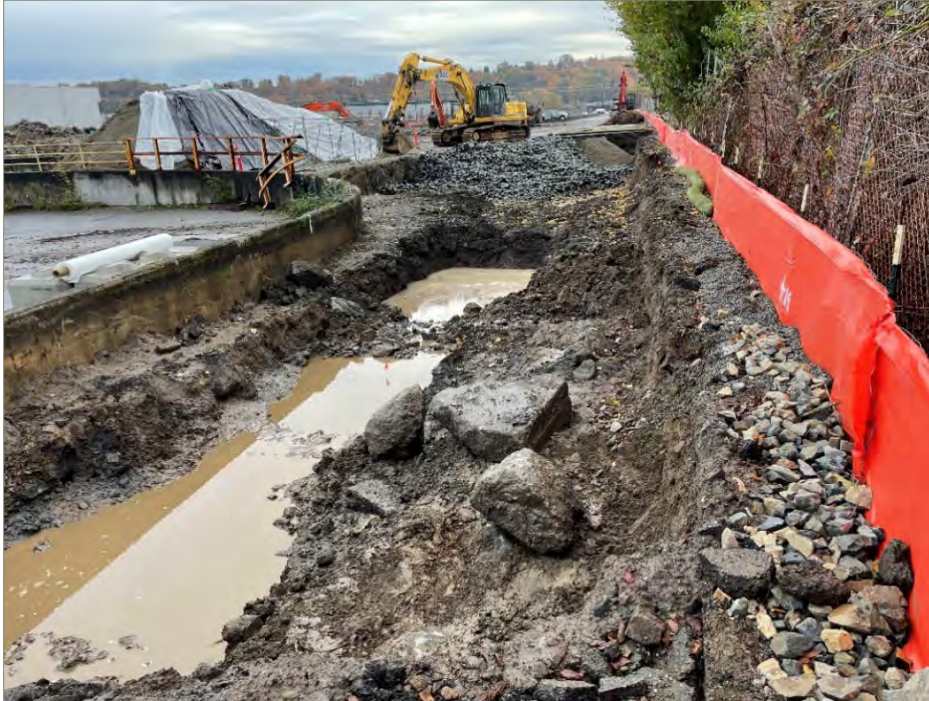
Exhibit A-12: Area 3 – View of the North Portion Final Extent of the Excavation. Photo taken on November 3, 2021. View direction is east. Water in the excavation is pooled rainwater that was removed prior to backfilling. Large rocks are part of the shoreline berm. Placement of backfill is occurring in the background.

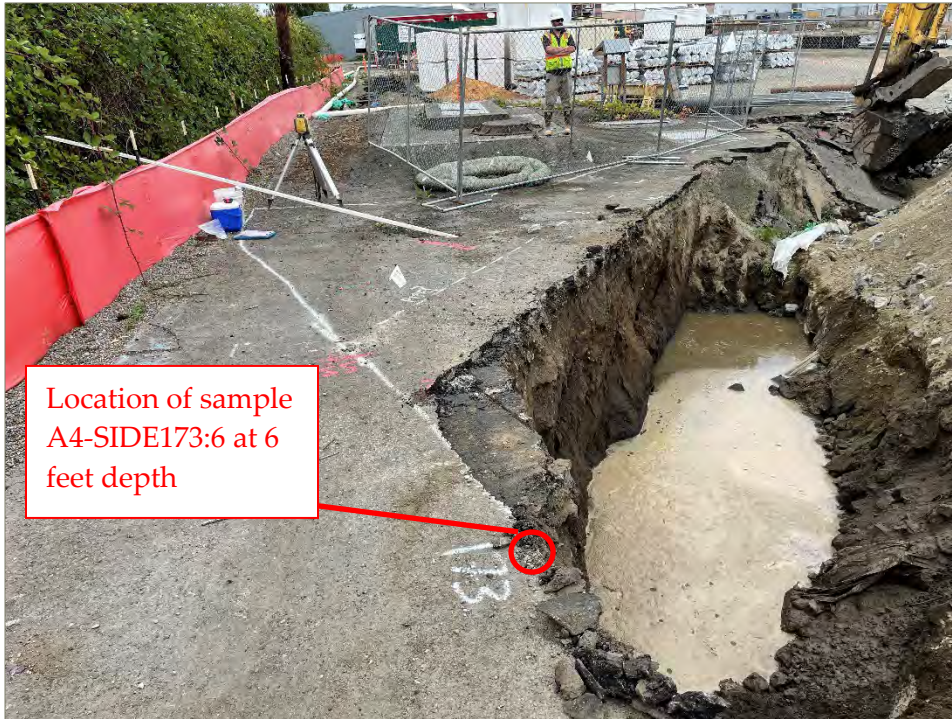
Exhibit A-13: Excavation Activities at Northwest Sidewall of Area 4. Photo taken on August 26, 2022. View direction is north.

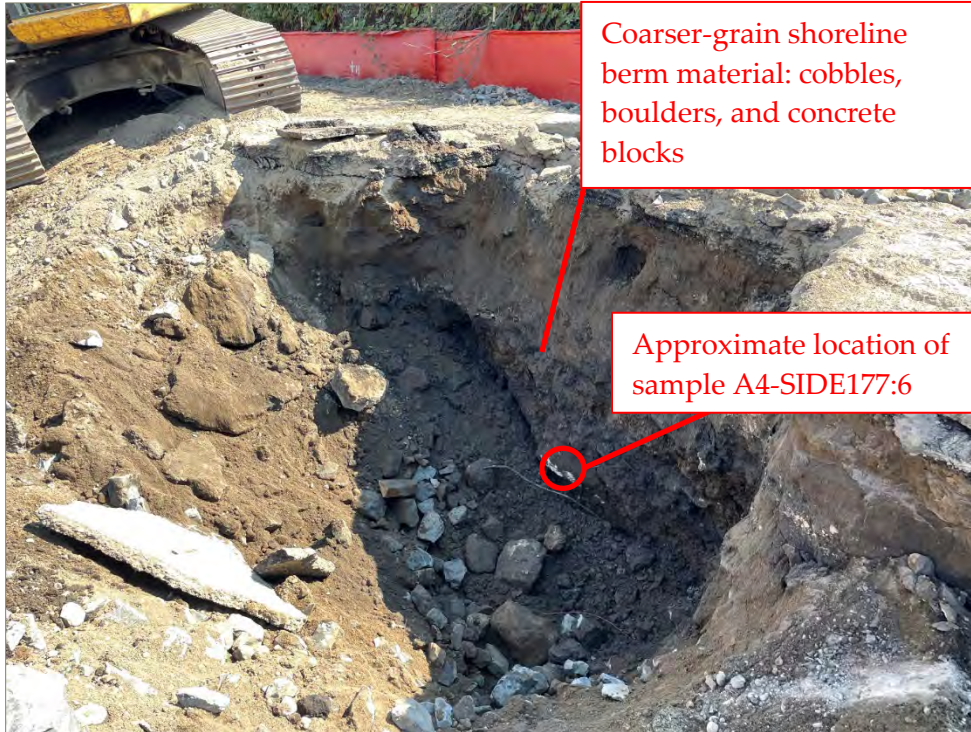
Exhibit A-15: Excavation Activities at Area 4 Sample A4-SIDE177:6. Photo taken on August 31, 2022. View direction is south.

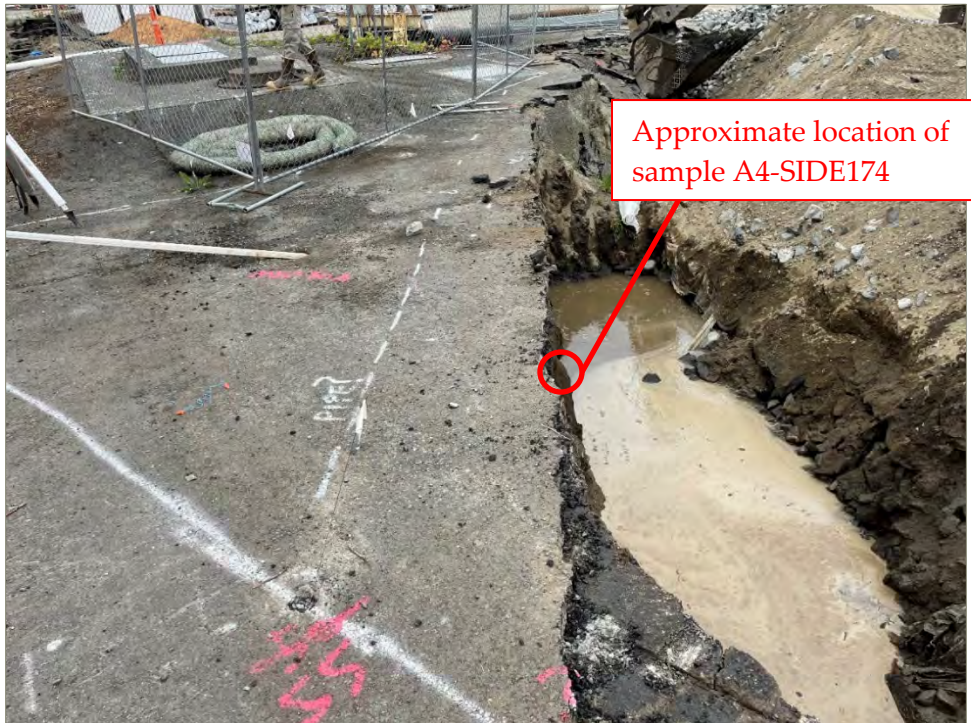
Exhibit A-16: View of West Sidewall Area 4 near Sample A4-SIDE174. Photo taken on August 26, 2022. View direction is north.

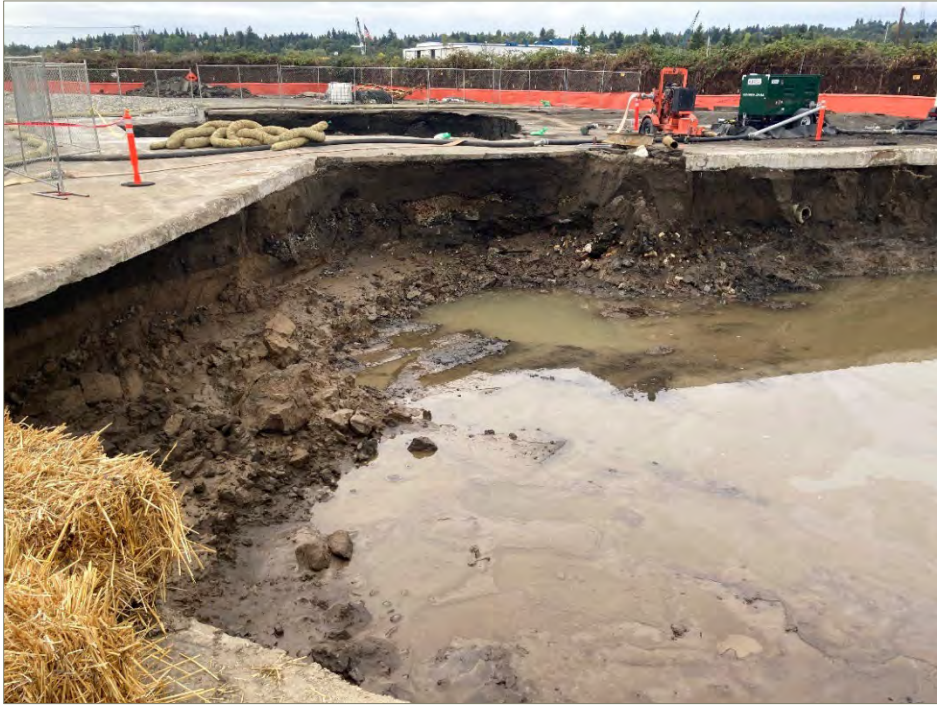
Exhibit A-17: Area 5 – View of the Southwest Portion of the Excavation. Photo taken on September 29, 2021. View direction is south. Water in the excavation is groundwater and was later removed and treated when the excavation was expanded.

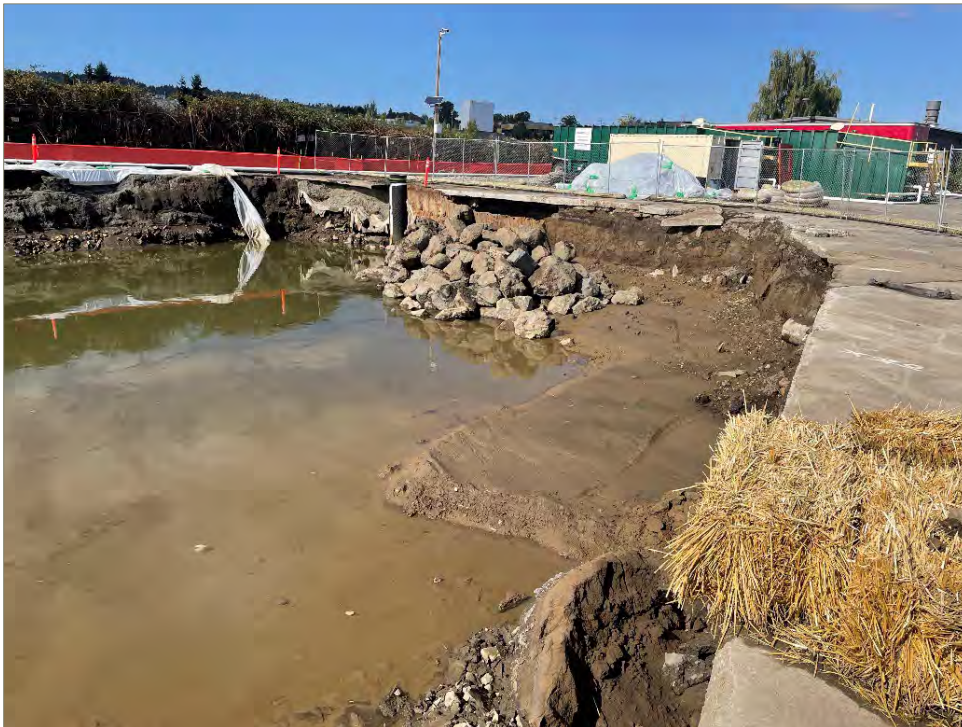
Exhibit A-18: Area 5 – View of the North Portion of the Excavation. Photo taken on October 1, 2021. View direction is northwest. Water in the excavation is groundwater and was later removed and treated. Rocks were part of support for the sheet pile wall that is in the north west corner of the excavation.

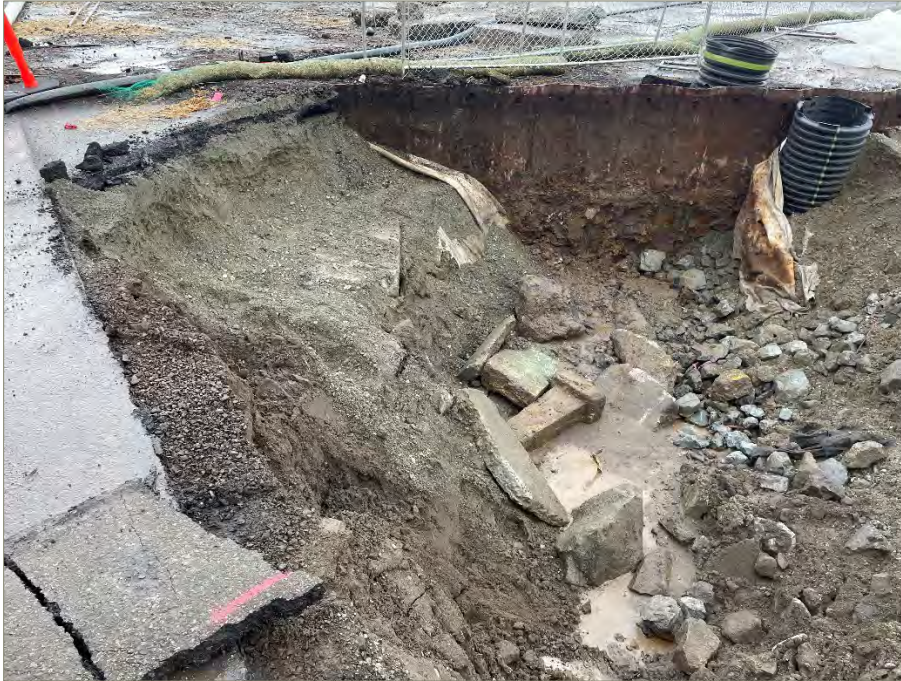
Exhibit A-19: Area 5 – View of the Northwest Corner Final Extent of the Excavation. Photo taken on November 4, 2021. View direction is north. The visible large rocks are concrete blocks that are part of the shoreline berm and were left in place. A portion of sheet pile wall is shown extending into the excavation. A plastic pipe for the sump is shown in the top right corner of the photo and was later removed. Imported Gravel Borrow is shown on the right side of the photo.

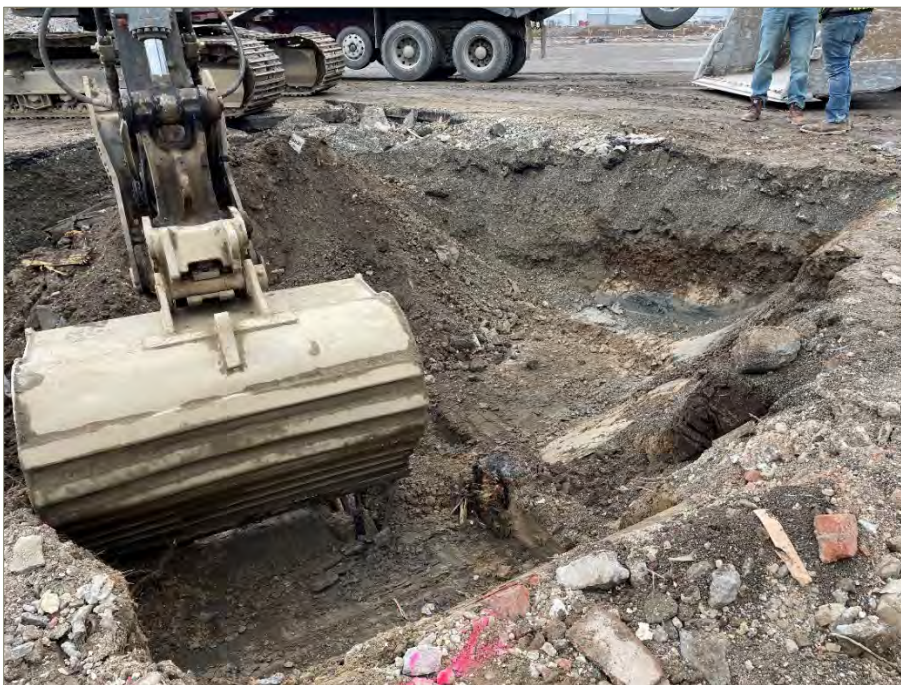
Exhibit A-20: Area 6 – View of Area 6 During Excavation on October 14, 2021. View direction is north.

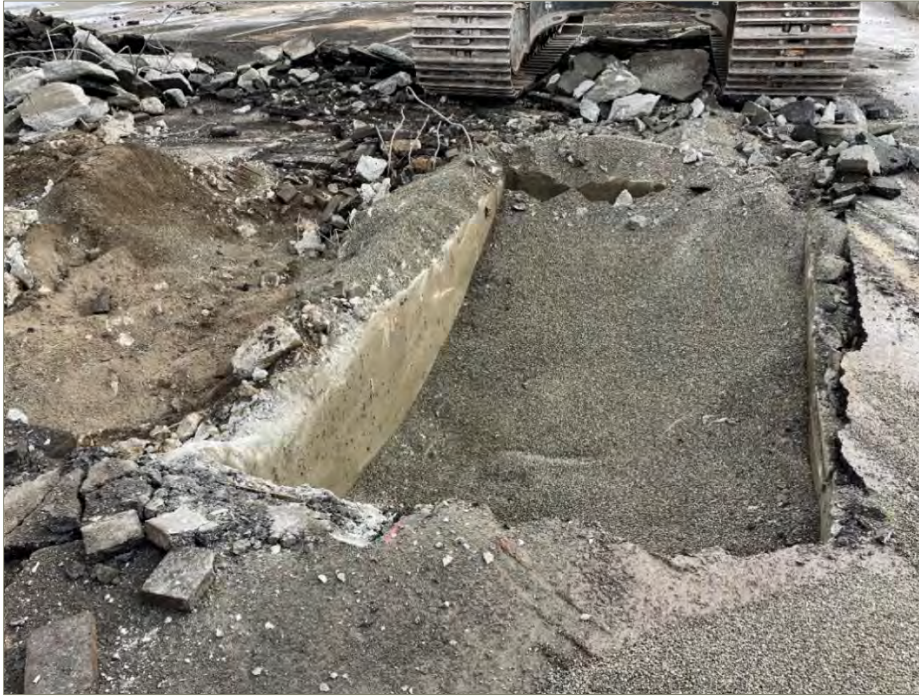
Exhibit A-21: Area 7 – View of the Pavement Removal Over the Excavation. Photo taken on October 4, 2021. View direction is east. A concrete vault filled with pea gravel is shown in the south (right) half of the excavation.

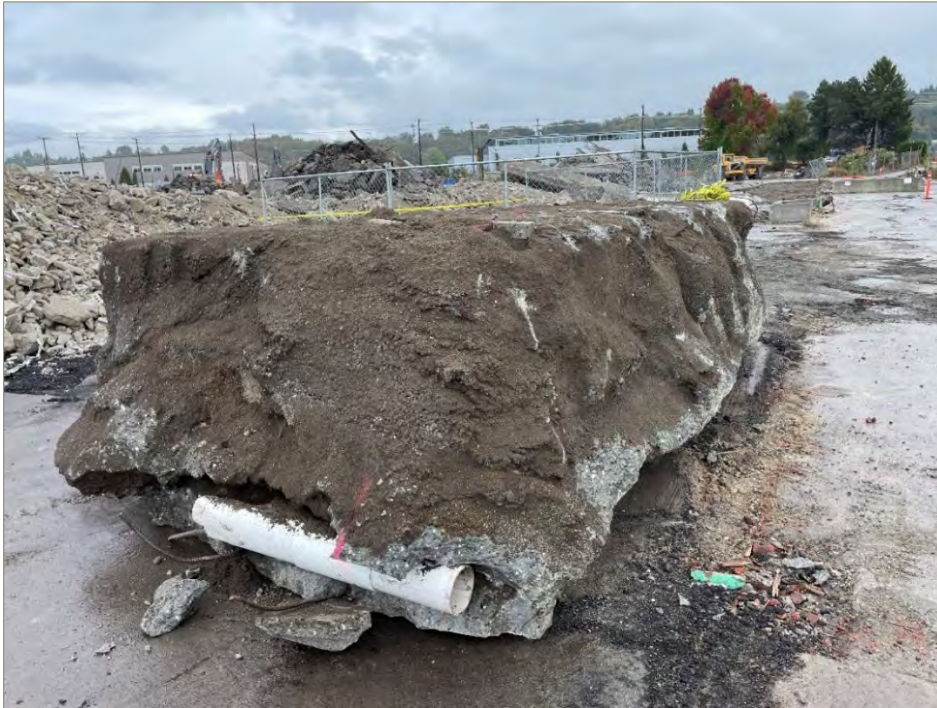
Exhibit A-22: Area 7 – View of the Concrete Vault (Upside Down) that was Removed from the Excavation. Photo taken on October 6, 2021.

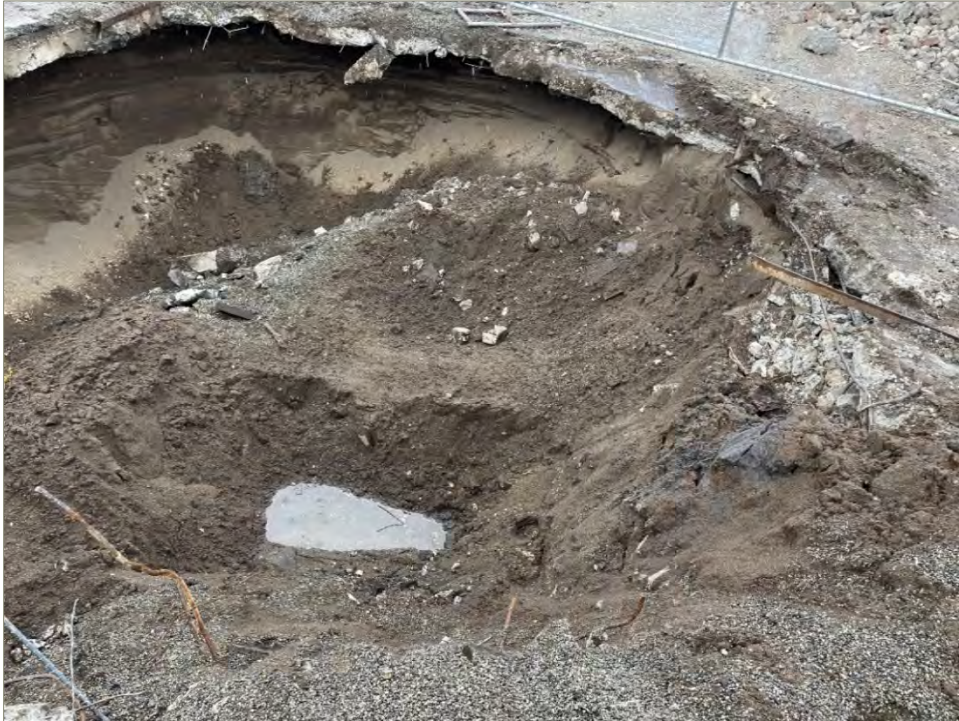
Exhibit A-23: Area 7 – View of the West Sidewall Final Extent. Photo taken on October 6, 2021. View direction is west. Groundwater was observed in the excavation bottom.

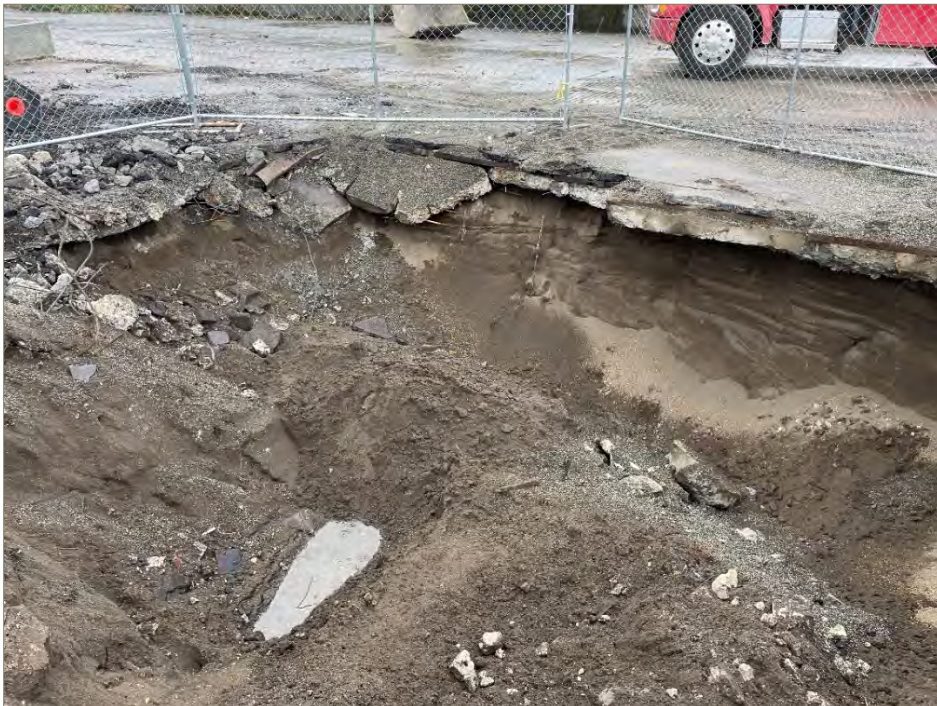
Exhibit A-24: Area 7 – View of the South Sidewall Final Extent. Photo taken on October 6, 2021. View direction is south. Groundwater was observed in the excavation bottom.
