FINAL COMPLIANCE MONITORING REPORT

Remedial Excavations

8801 EAST MARGINAL WAY S., TUKWILA, WASHINGTON
AGREED ORDER NO. 6069

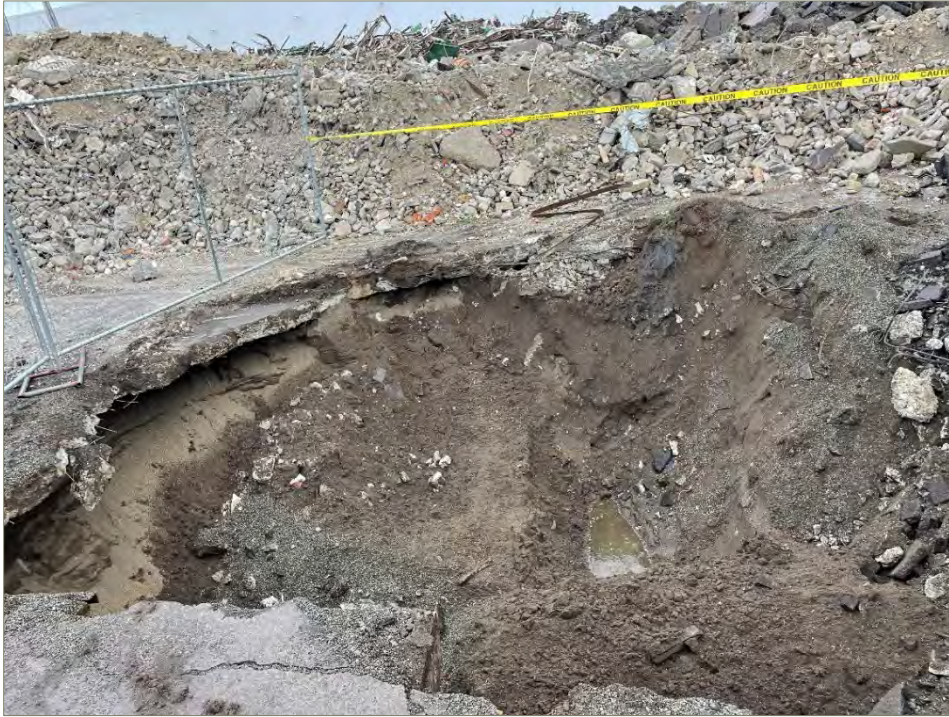
Exhibit A-25: Area 7 – View of the North Sidewall Final Extent. Photo taken on October 6, 2021. View direction is north. Groundwater was observed in the excavation bottom.

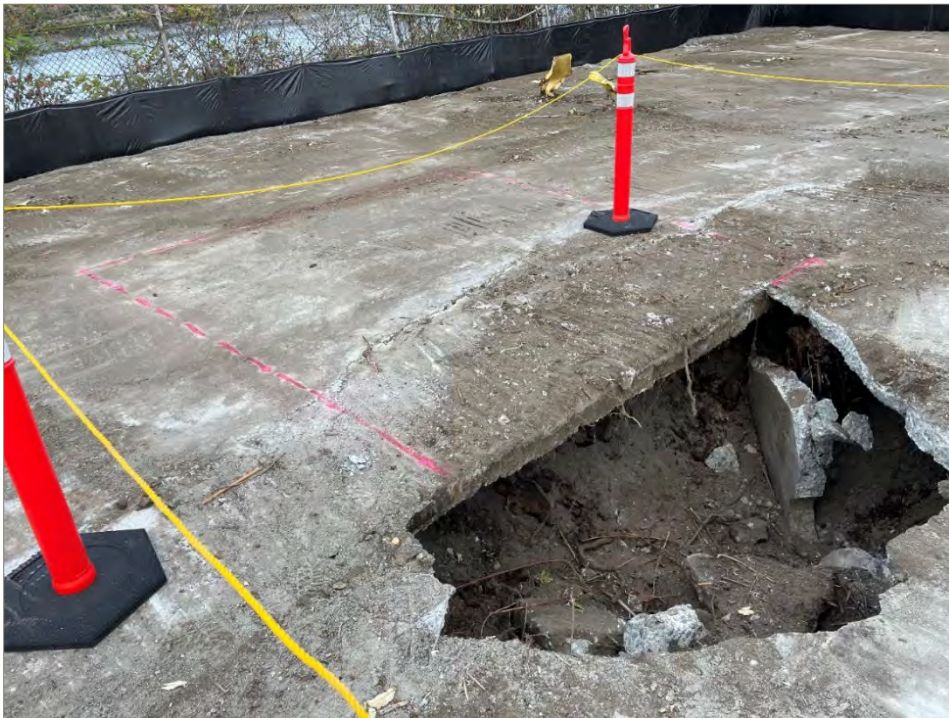
Exhibit A-26: Area 8 – View of the Void in the East Half of the Excavation. Photo taken on October 4, 2021. View direction is northwest. The pink outline shows the extent of that was excavated later.

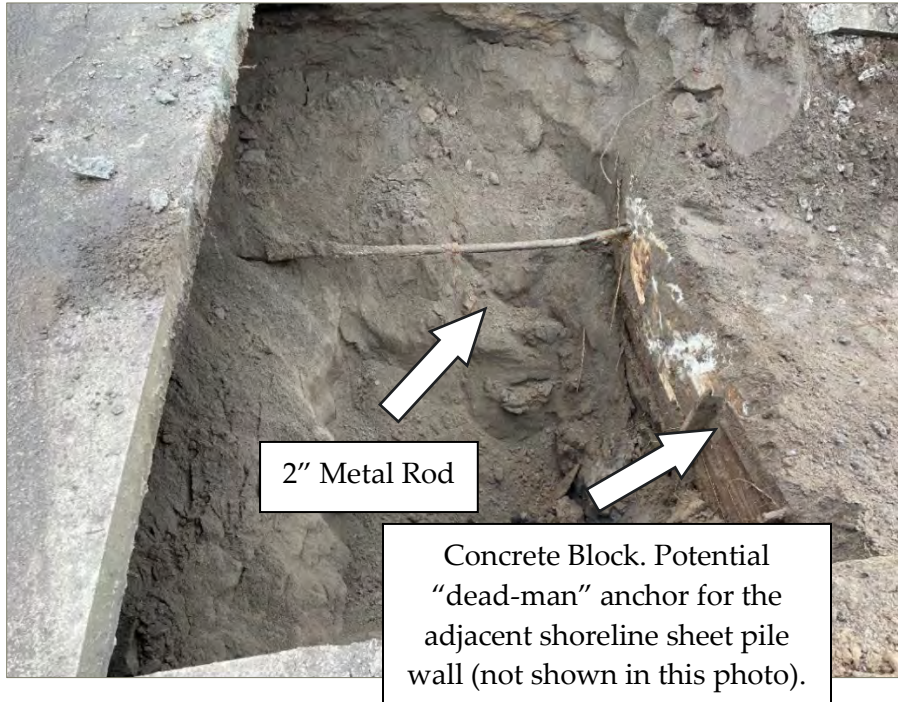
Exhibit A-27: Area 8 – View of the West Half Final Extent of the Excavation. Photo taken on October 5, 2021. View direction is north. A metal rod and concrete block were observed in the excavation and are potential structural components of the adjacent sheet pile wall.

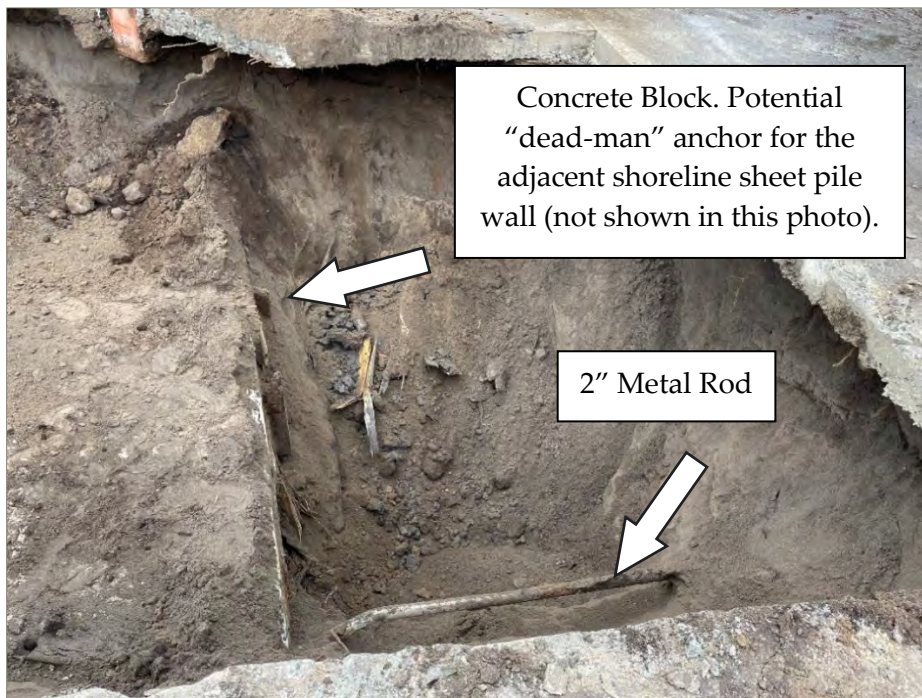
Exhibit A-28: Area 8 – View of the West Half Final Extent of the Excavation. Photo taken on October 5, 2021. View direction is south. A metal rod and concrete block were observed in the excavation and are potential structural components of the adjacent sheet pile wall.

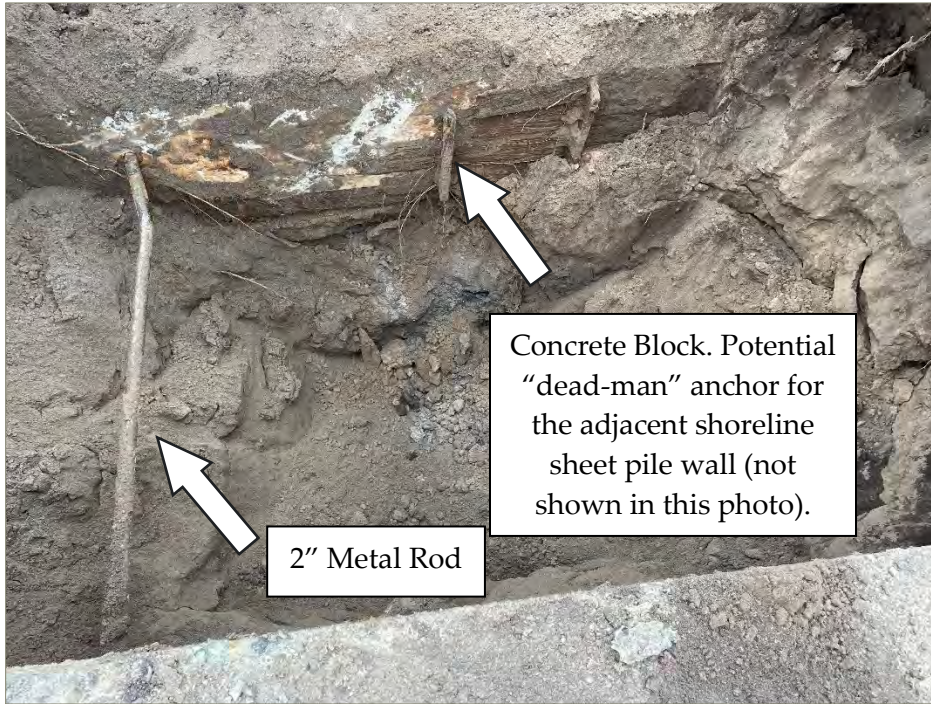
Exhibit A-29: Area 8 – View of the West Half Final Extent of the Excavation. Photo taken on October 5, 2021. View direction is east. A metal rod and concrete block were observed in the excavation and are potential structural components of the adjacent sheet pile wall.

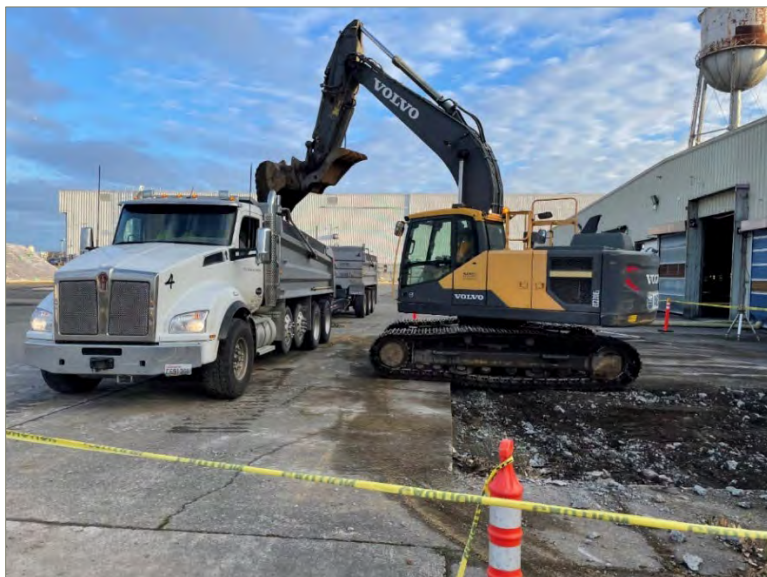
Soil was directly loaded into trucks for hauling offsite when practicable, otherwise the soil was stockpiled until being hauled offsite. A representative photo of excavation activities is provided as Exhibit B-1.

Exhibit B-1: Photo of Excavation at Area 2 on September 20, 2021. View Direction is North.

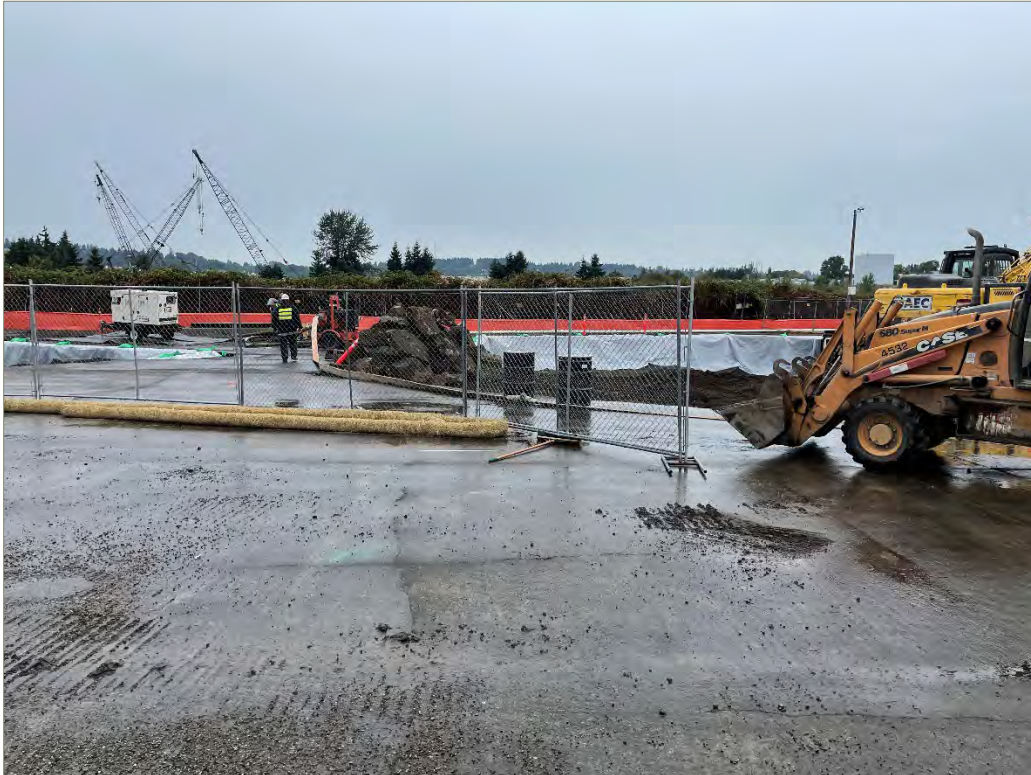
BMPs were inspected daily before remedial work commenced to check the integrity. If any deficiency was observed, a repair or replacement was made immediately. A representative photo of BMPs for temporary erosion and sediment control is provided below.

Exhibit B-4: Photo of Area 4 (left) and Area 5 (right) on September 17, 2021 View direction is west. Straw wattles are shown around the excavation perimeter. White plastic sheets are shown on excavation sidewalls. An orange silt fence is shown on the property boundary.

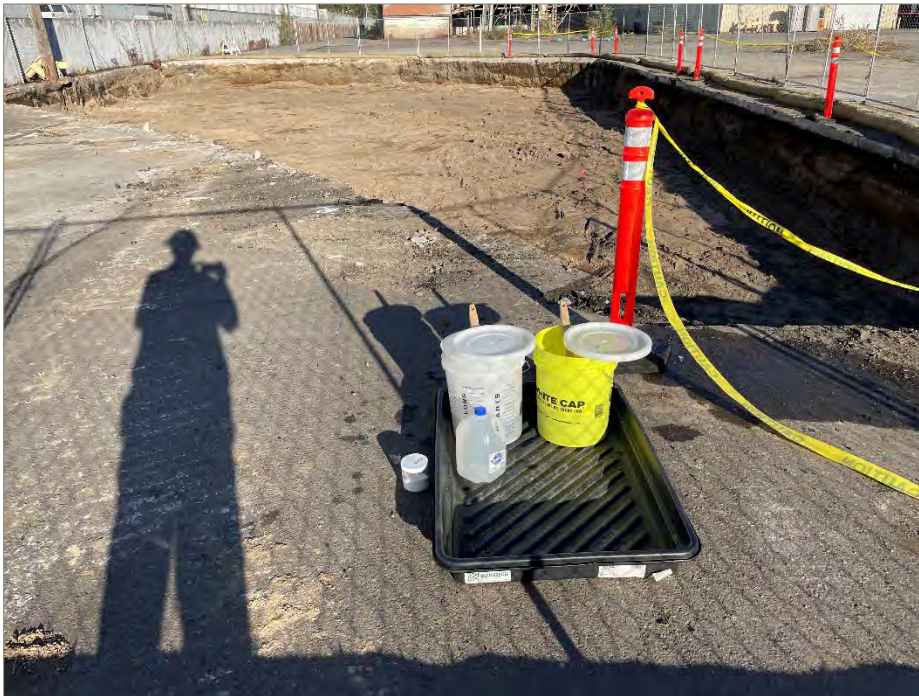
Decontamination water was disposed of with the excavated soil. A photo of the boot wash station is provided as Exhibit B-5.

Exhibit B-5: Photo of Area 1 with Boot Wash Station on September 21, 2021. View Direction is East.

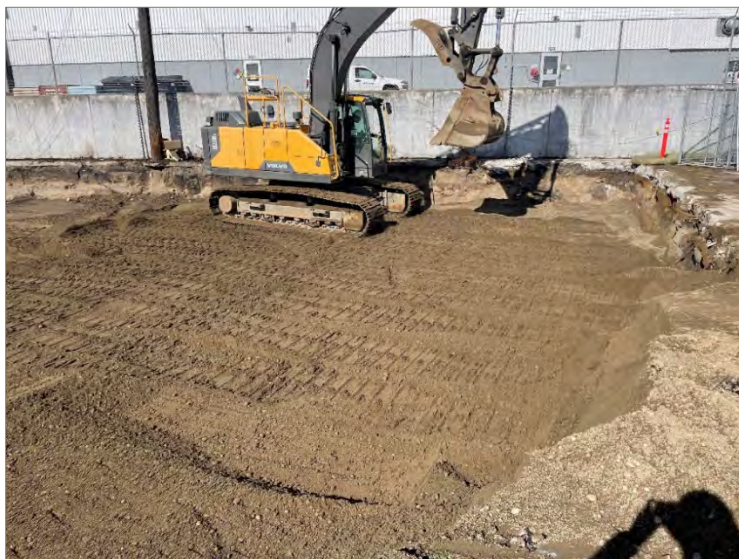
Results of gradation analysis of the gravel borrow were provided by the quarry (Attachment E-1) and the material was separately analyzed for gradation by HWA GeoSciences, Inc. (Attachment E-2). Based on the gradation results and visual observation, the material consisted of light brown, Poorly Graded Sand with Gravel. A photo of the gravel borrow is provided as Exhibit E-1.

Exhibit E-1: Photo of Gravel Borrow Delivered to Area 1 on the 8801 Property

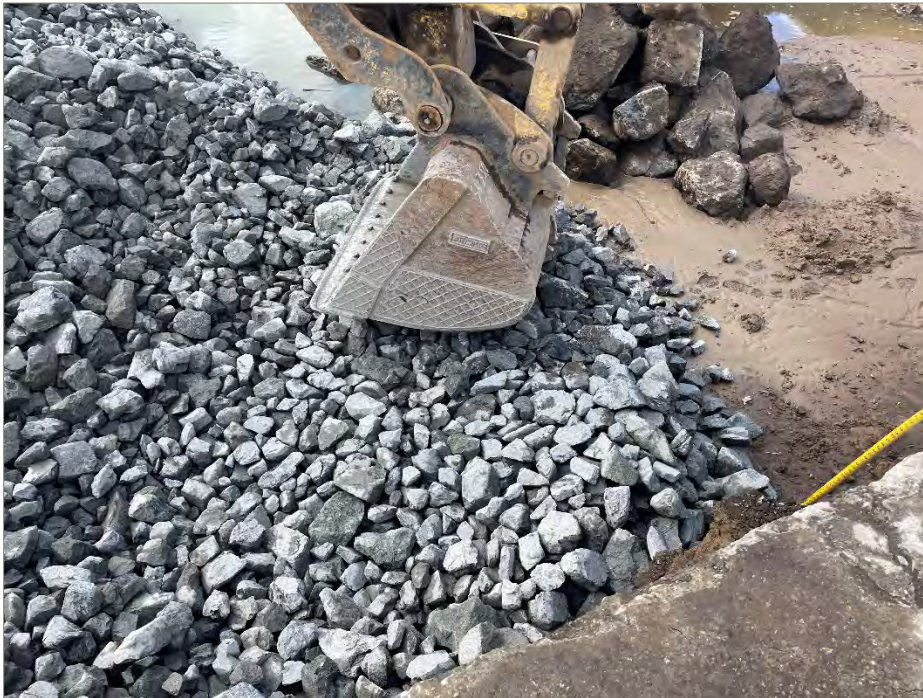
The quarry spalls were visually evaluated for gradation. The quarry spalls appeared to be predominantly bluish-gray, 2- to 8-inch angular rock with trace amounts of fine rock pieces. A photo of the quarry spalls is provided below (see Exhibit E-3).

Exhibit E-3: Photo of Quarry Spalls (Foreground) Delivered to Area 5 on the 8801 Property

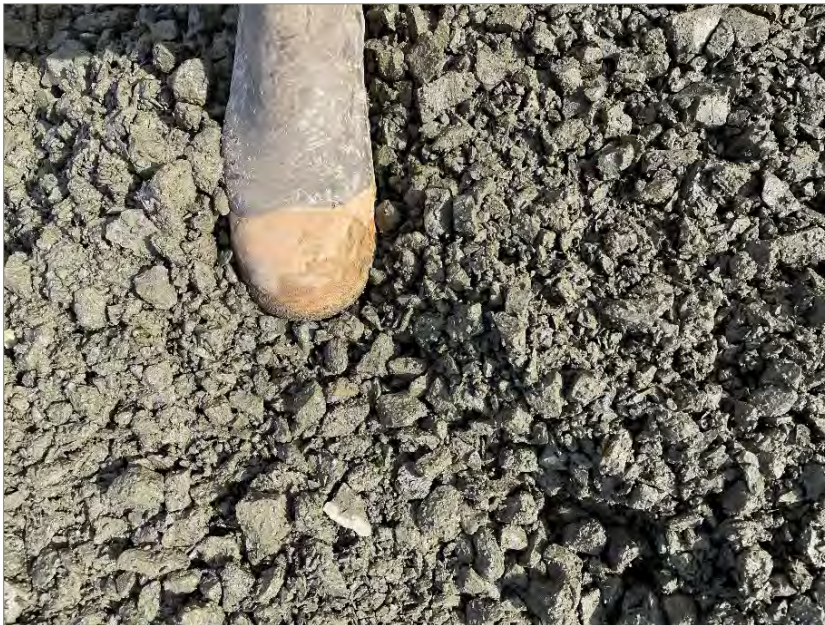
Samples of crushed rock were analyzed for gradation by three entities: the source quarry (Attachment E-16), Shannon & Wilson (Attachment E-17), and Krazan (Attachment E-18). Based on gradation results and visual observation, the material consisted of gray to brown, Well-Graded Gravel with Sand. A photo of the crushed rock is provided as Exhibit E-6.

Exhibit E-6: Photo of Crushed Rock Delivered to Area 2 on the 8801 Property

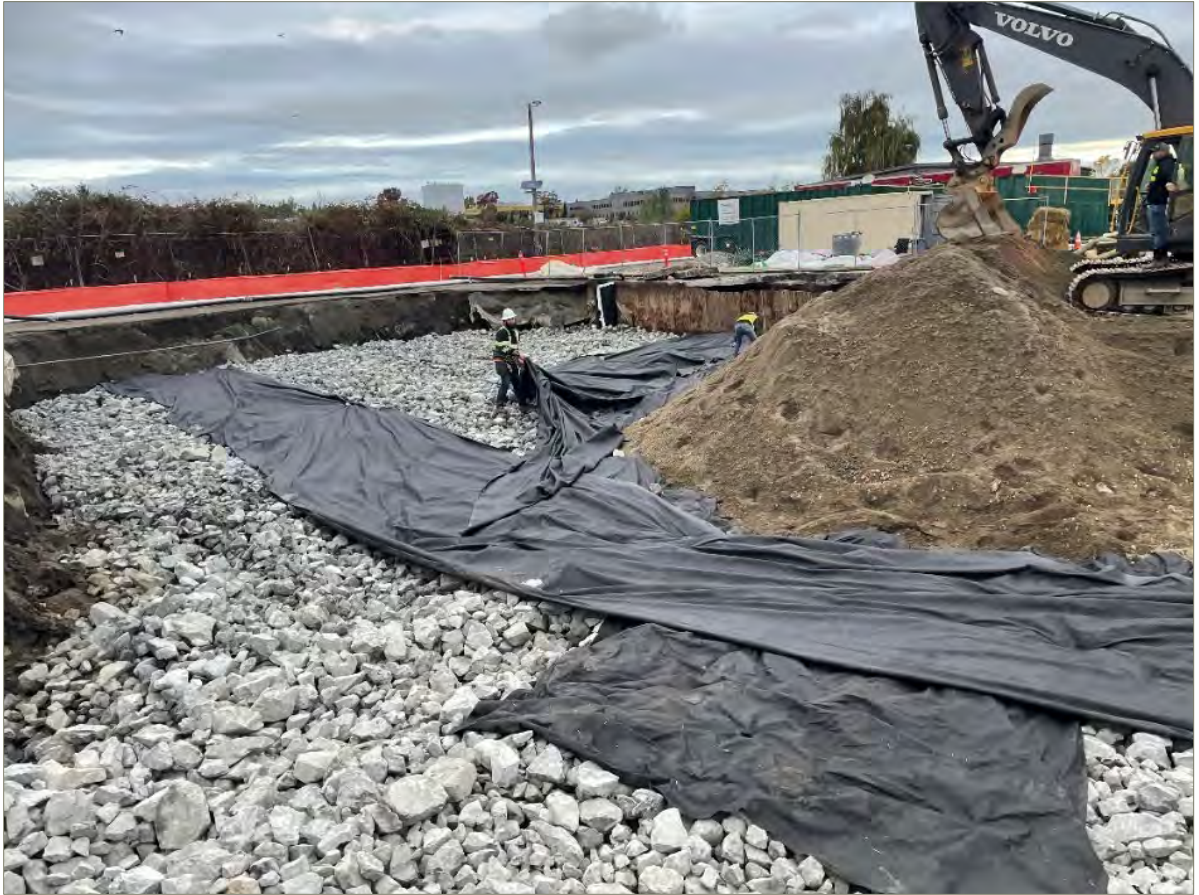
Geosynthetics. A product data sheet for Mirafi® 140N is provided as Attachment E-19. A representative photo of the placement of the geotextile is provided in the following Exhibit E-7.

Exhibit E-7: Photo of Quarry Spalls Overlain by Geotextile Overlain by Gravel Borrow at Area 5. View Direction is Northwest.

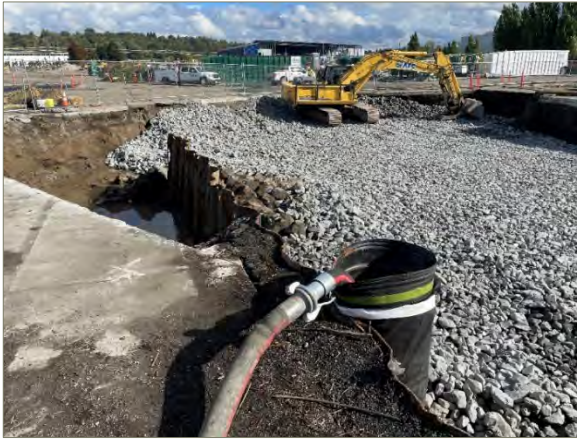
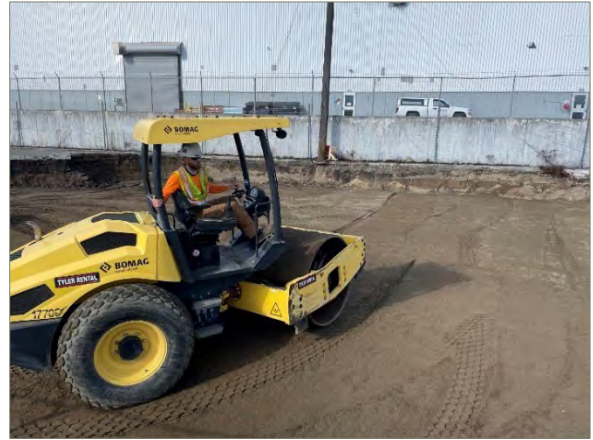
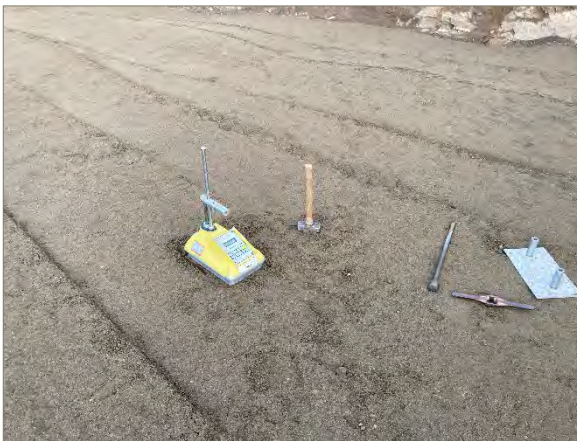
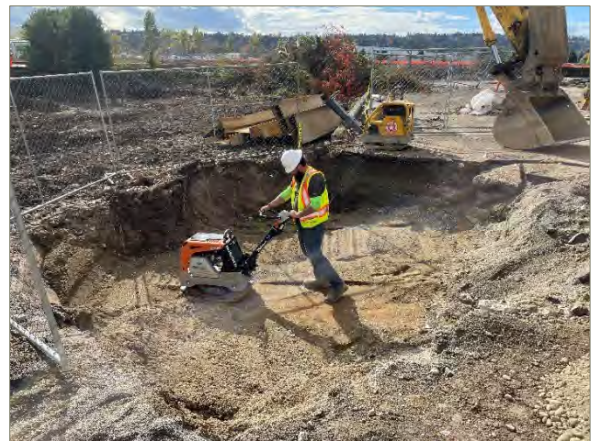
Exhibit E-9: Photos of Compaction Activities. Clockwise From Top-Left: Photo of Excavator Compacting Quarry Spalls in Area 5. View Direction is Southeast. Top-Right: Photo of Smooth-Drum Vibratory Roller in Area 1. View Direction is North. Bottom-Right: Photo of Walk-Behind Vibratory-Plate Compactor in Area 6. View Direction is Southwest. Bottom-Left: Photo of Nuclear Densometer in Area 1.
