SoundEarth Strategies, Inc.  
2811 Fairview Avenue East, Suite 2000  
Seattle, Washington 98102

October 15, 2019

**SUBJECT: SUBSURFACE INVESTIGATION REPORT**  
**Duwamish Yacht Property**  
**1801 South 93rd Street**  
**King County, Washington**  
**Project Number: 1419-001**

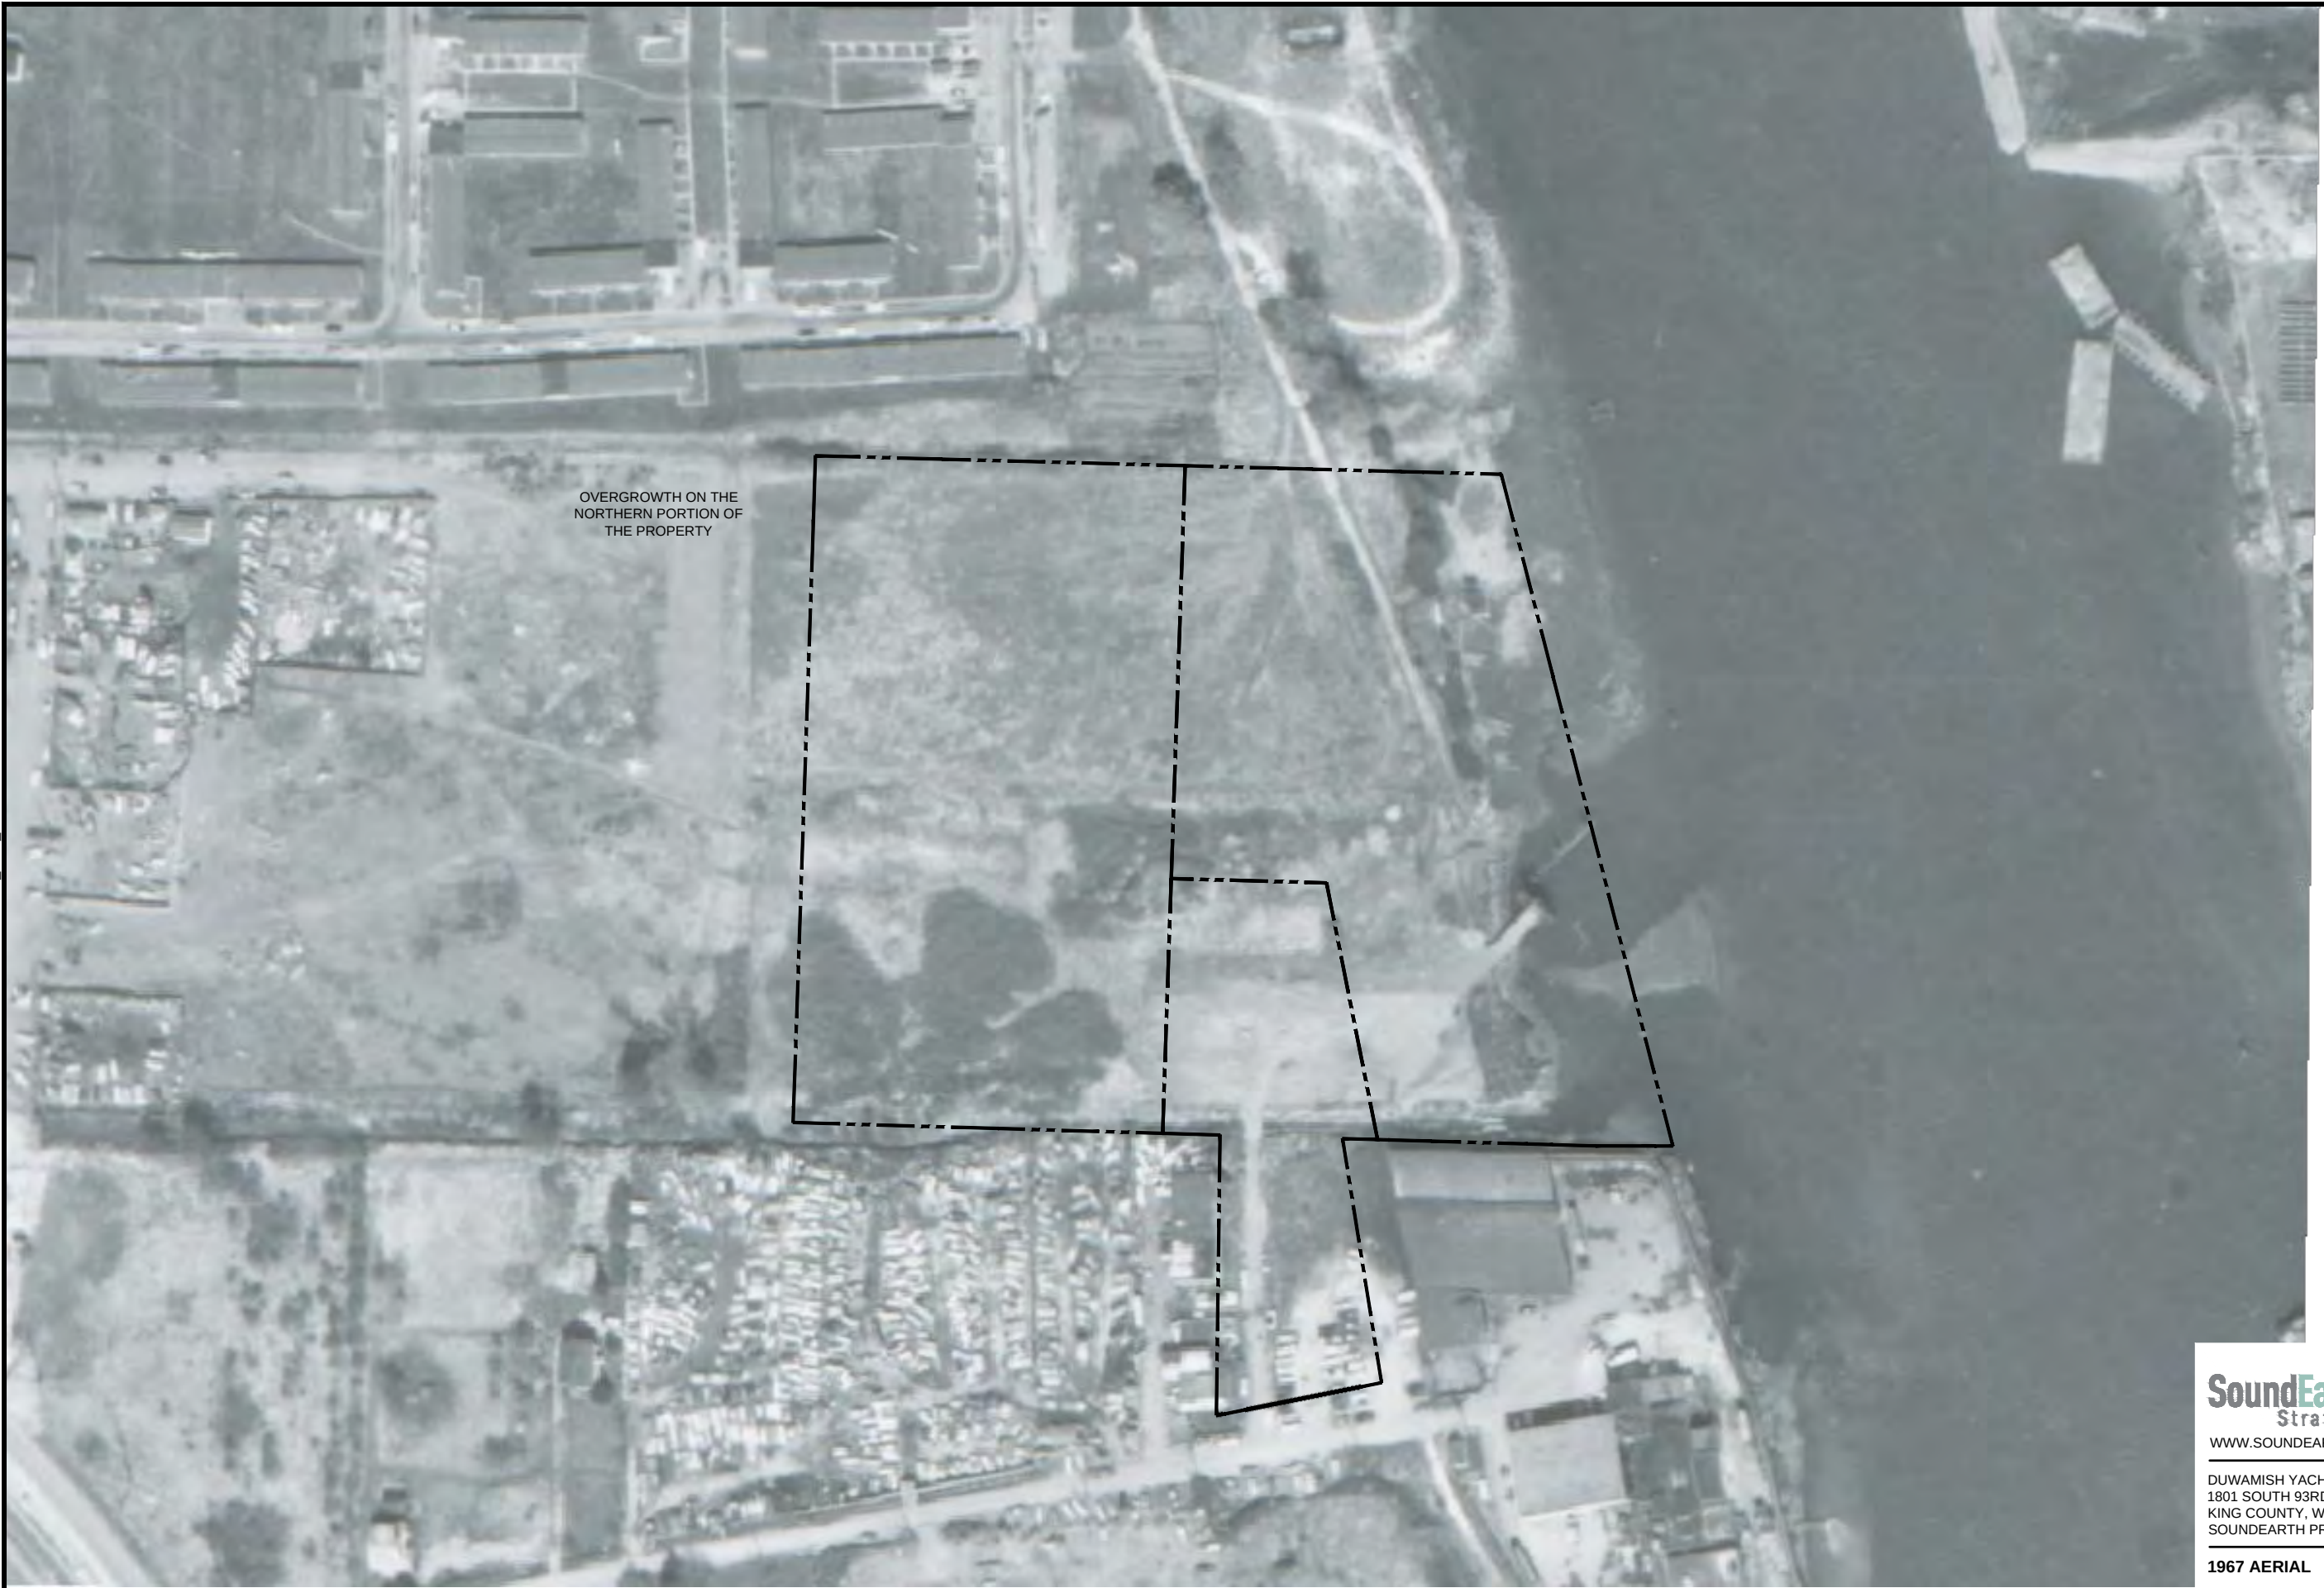
OVERGROWTH ON THE  
NORTHERN PORTION OF  
THE PROPERTY

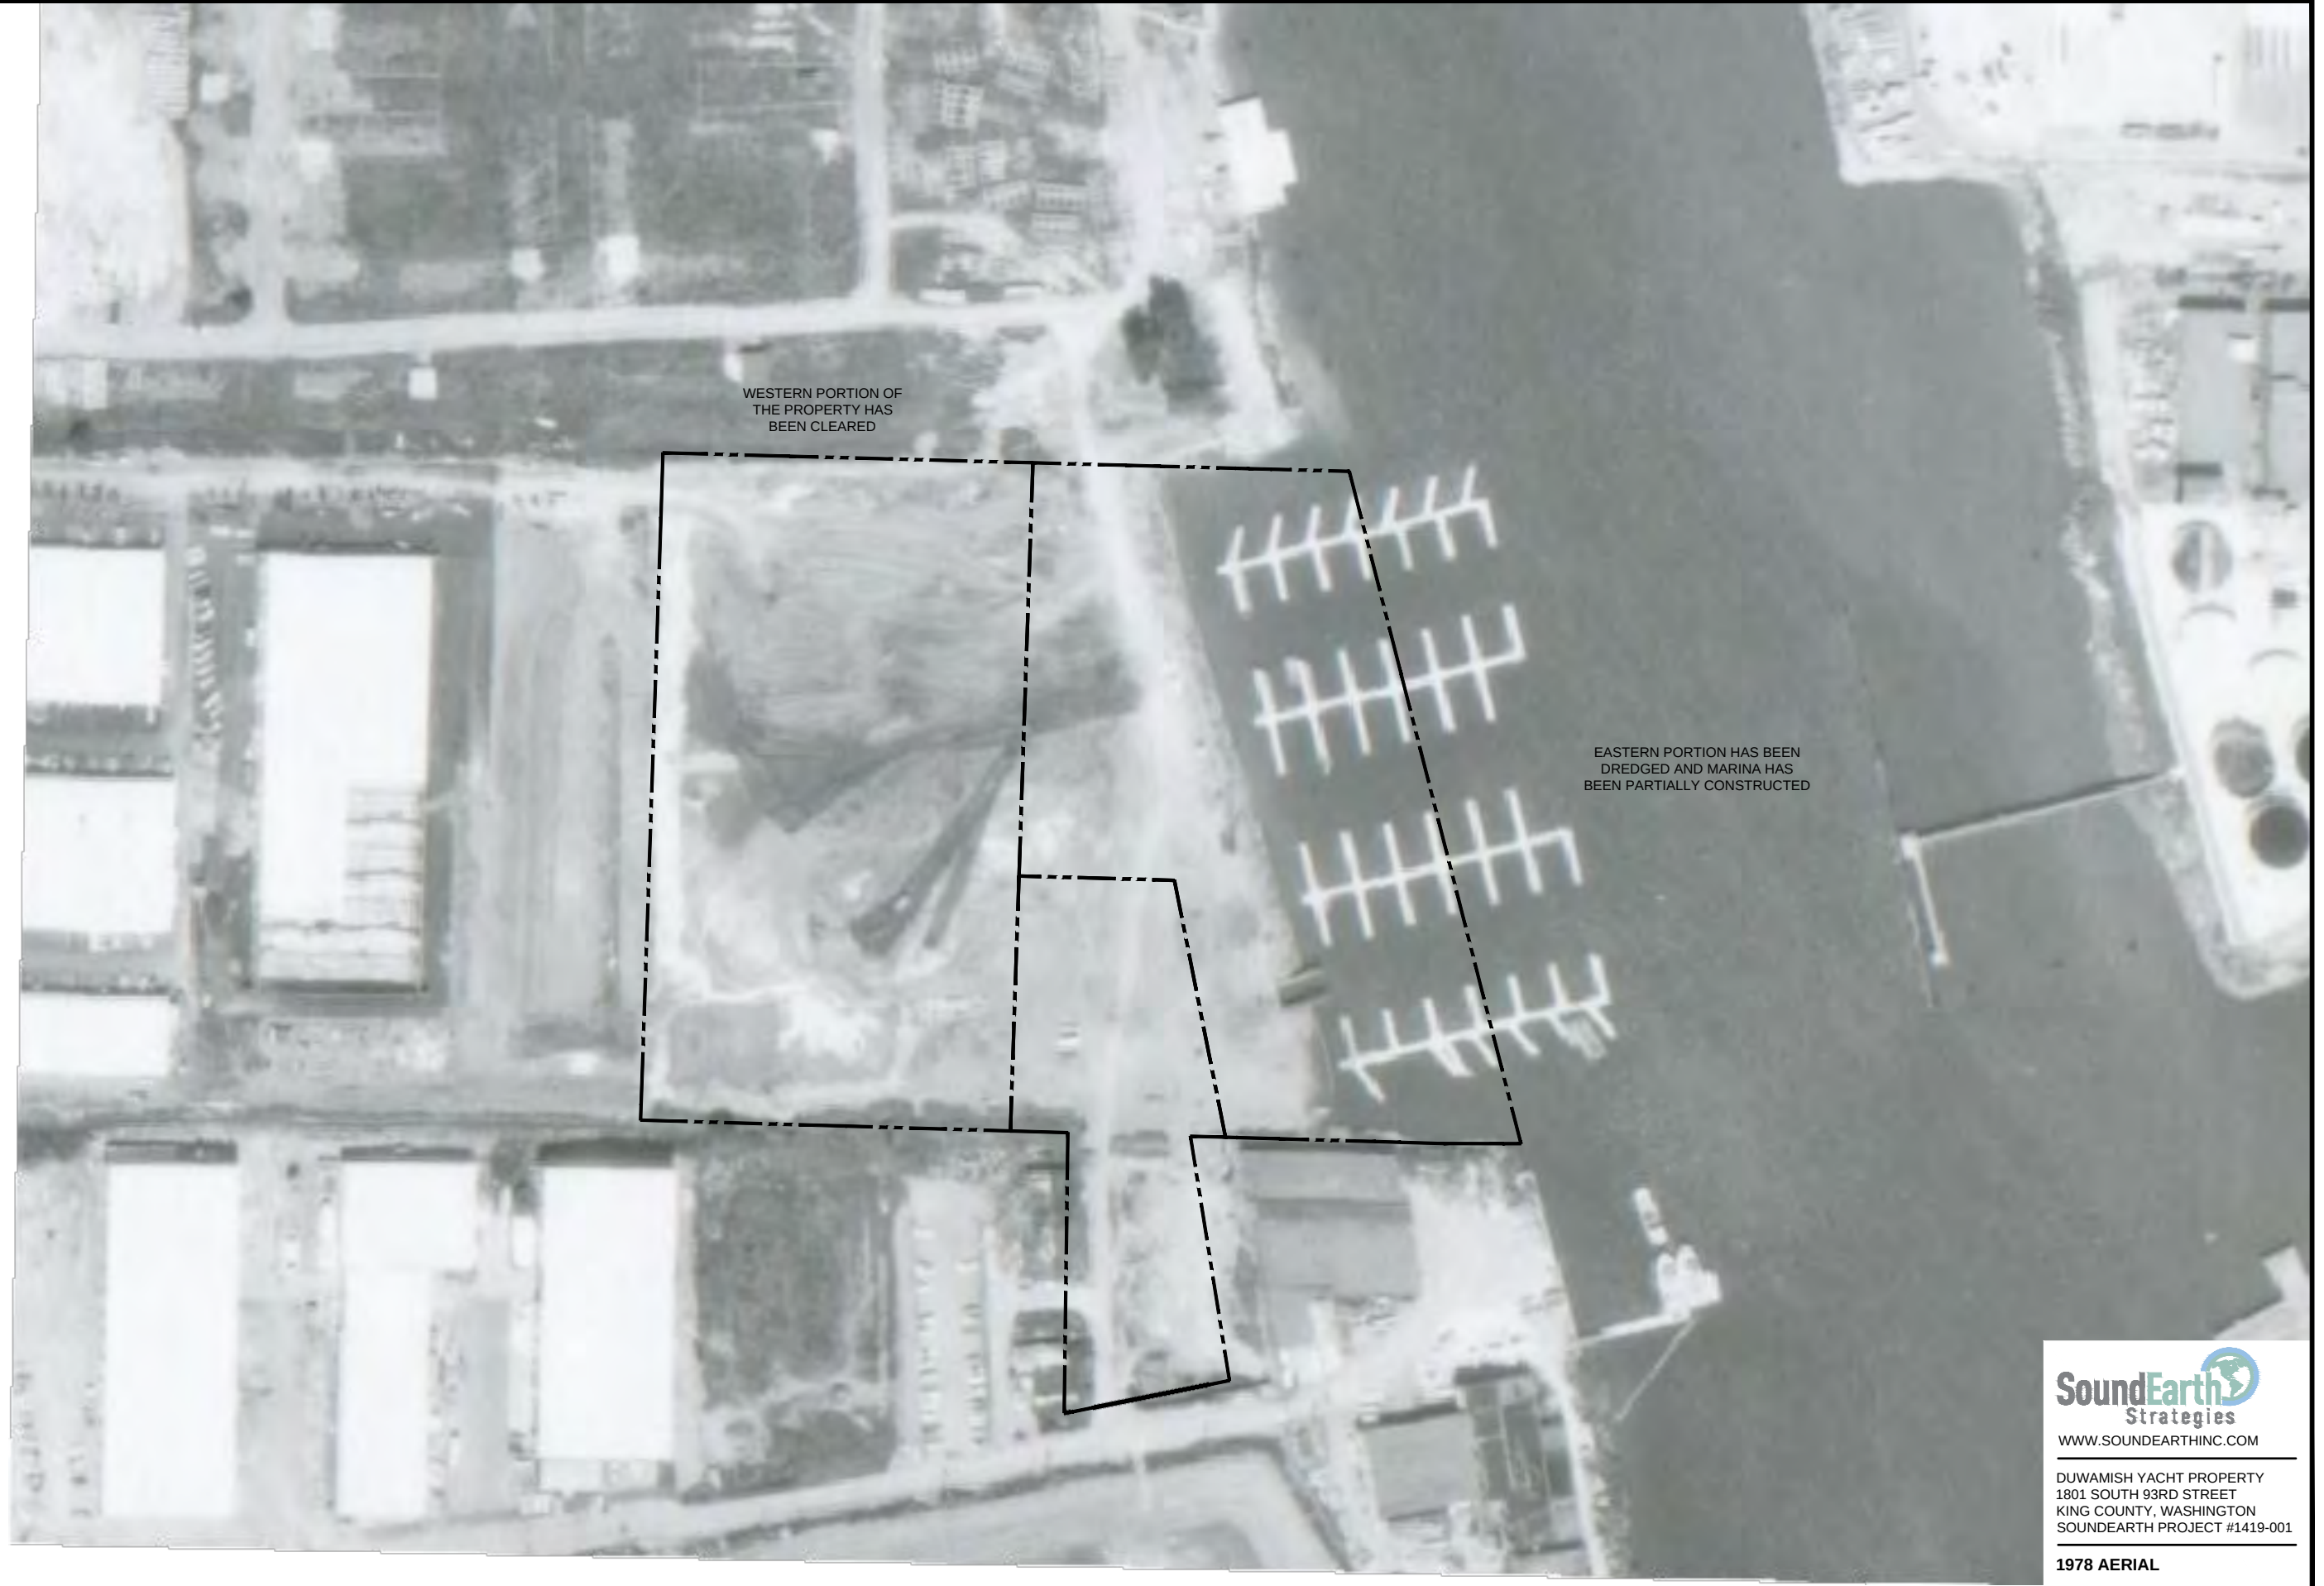
WESTERN PORTION OF  
THE PROPERTY HAS  
BEEN CLEARED

EASTERN PORTION HAS BEEN  
DREDGED AND MARINA HAS  
BEEN PARTIALLY CONSTRUCTED
