## PHASE I ENVIRONMENTAL SITE ASSESSMENT

John Perine Company Property  
820 South Adams Street  
Seattle, Washington

January 27, 2011

Project No.: 0783-001-01

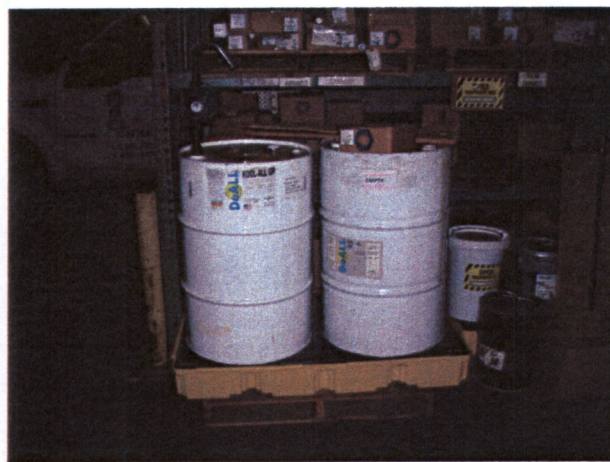
Photograph 2. Storage and waste containers for cutting oil in Building 1.

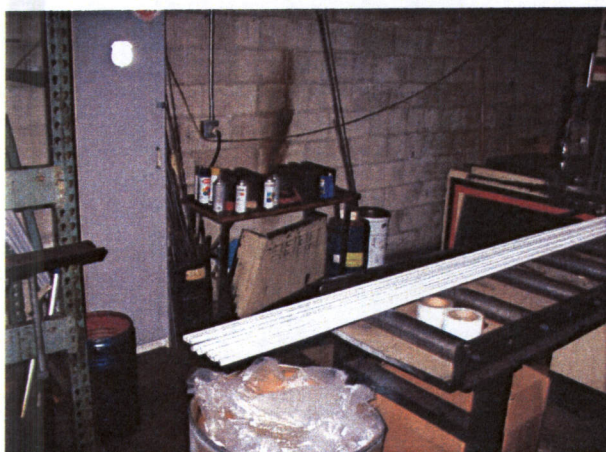
Photograph 3. Machining area conditions.

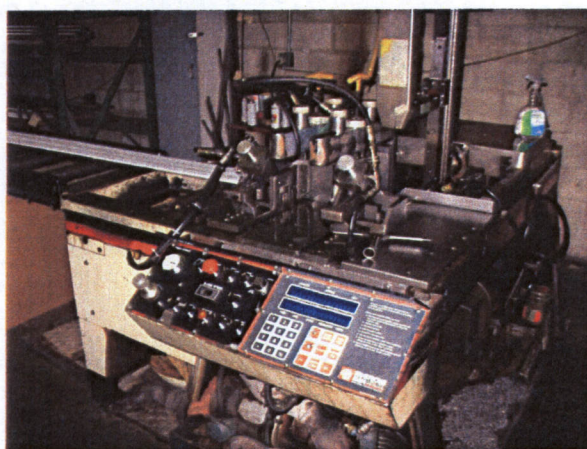
Photograph 4. A metal-cutting machine located in Building 1.

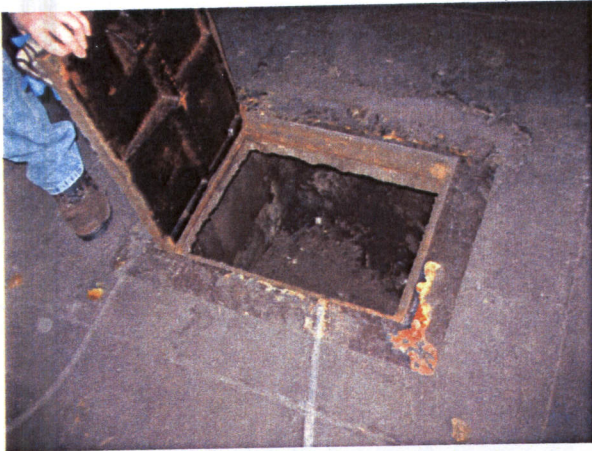
A utility monument was opened near the UST fill port. The interior of the monument included a dirt cavity and two pipes. Mr. Bartley informed SoundEarth that this and a number of other such monuments were part of the drainage and catchment basin system within Building 1. Cutting oil was stored in the central portion of the warehouse. DoAll KOOL-ALL semi-synthetic cutting oil was used to cool and lubricate the metal-cutting machines. Some cutting oil product was observed atop the containers, and some staining of the containers was observed. Secondary containment was located beneath the dispensing and waste containers. No stains were observed on the floors in the vicinity of the containers. In areas of the eastern portions of Building 1, fluorescent light tubes and computer monitors were stored. Mr. Bartley informed SoundEarth that all fluorescent lights were disposed of as recommended by the City of Seattle. Mr. Bartley also indicated that the current operational procedures concerning cutting oil and other wastes were implemented by him at his hire. Such procedure included adding secondary containment below cutting oil dispensing and the disposal station, maintaining proper disposal and dispensing equipment and procedures, and adding spill kits throughout the building. All other areas of the warehouse were in good condition. The southern portion of Building 1 was occupied

Photograph 7. A utility monument above a drain pipe located in Building 1.

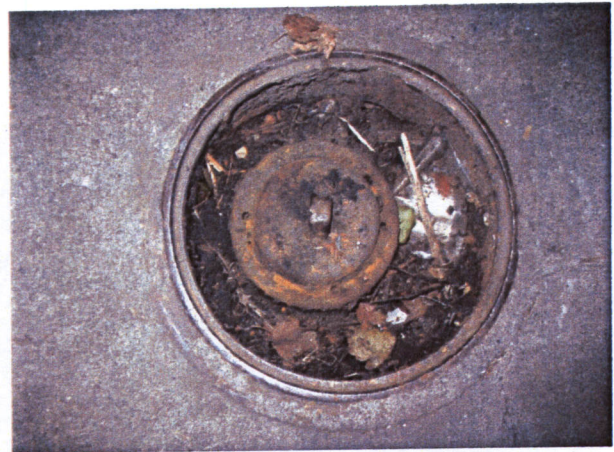
- A 1,000-gallon underground storage tank containing gasoline was installed on the Property in 1957. SoundEarth personnel confirmed the location of the tank during the Property reconnaissance and discovered it to be filled with water and several inches of what appeared to be weathered gasoline. The use and storage of gasoline at the Property is considered a recognized environmental condition with a high risk of impacts to the Property.
- The Property has been used for a variety of industrial purposes since the 1920s. The current and former use of the Property for industrial purposes is considered a recognized environmental condition with a moderate risk of impacts to the Property.

A gasoline- and water-filled UST was observed in the northeastern corner of Building 1, which has been used for the machining of metal fasteners since the 1960s. These potential issues of environmental concern are discussed further in Section 9.0.

Photograph 8. Condition of the UST fill port upon inspection.

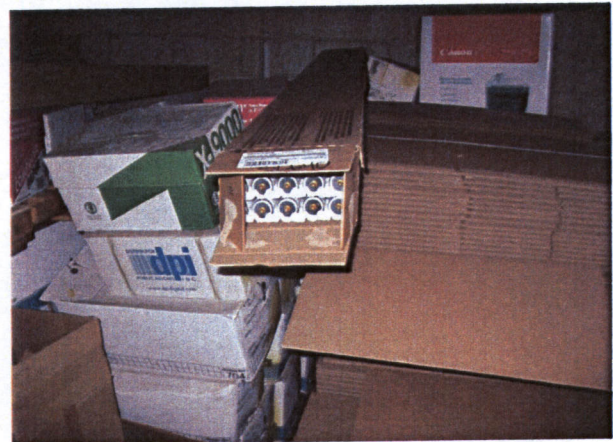
Photograph 10. Fluorescent bulbs stored in Building 1.

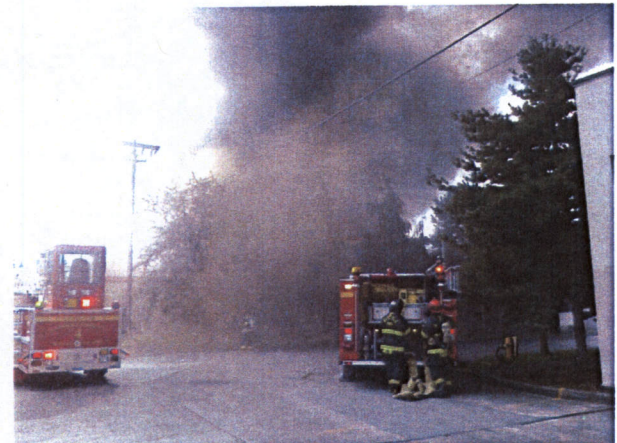
- Mr. Earnie Bartley accompanied SoundEarth on the site walk of the Property and was interviewed by SoundEarth personnel. Mr. Bartley indicated that he was hired in the past 2 years as operations manager. He indicated that prior to his hiring, the operations of the Property were more lax in regards to proper handling of waste materials and potentially hazardous materials. Mr. Bartley indicated that he instituted new procedures after his hire to create more environmental safeguards. These include the inclusion of secondary containment of all potentially hazardous storage containers, the inclusion of proper monuments above utility infrastructure within the Property, and the proper disposal of waste materials such as fluorescent bulbs. Mr. Bartley's assessment of the Sunny Jim fire agreed with the account given by Mr. Stuvland. Mr. Bartley provided SoundEarth with photographs of the September 2010 Sunny Jim fire.

Photograph 18. Photograph provided by Earnie Bartley taken in September 2010 of the South-adjointing SDOT facility fire. Photo facing south.
