PHASE I ENVIRONMENTAL  
SITE ASSESSMENT UPDATE  
LOT 8, AIRPORT 37 INDUSTRIAL PARK  
60TH AVENUE NORTHEAST  
AND 199TH STREET NORTHEAST  
ARLINGTON COUNTY, WASHINGTON

E-7062-3

August 14, 1998

PREPARED FOR  
DELTA PROPERTIES

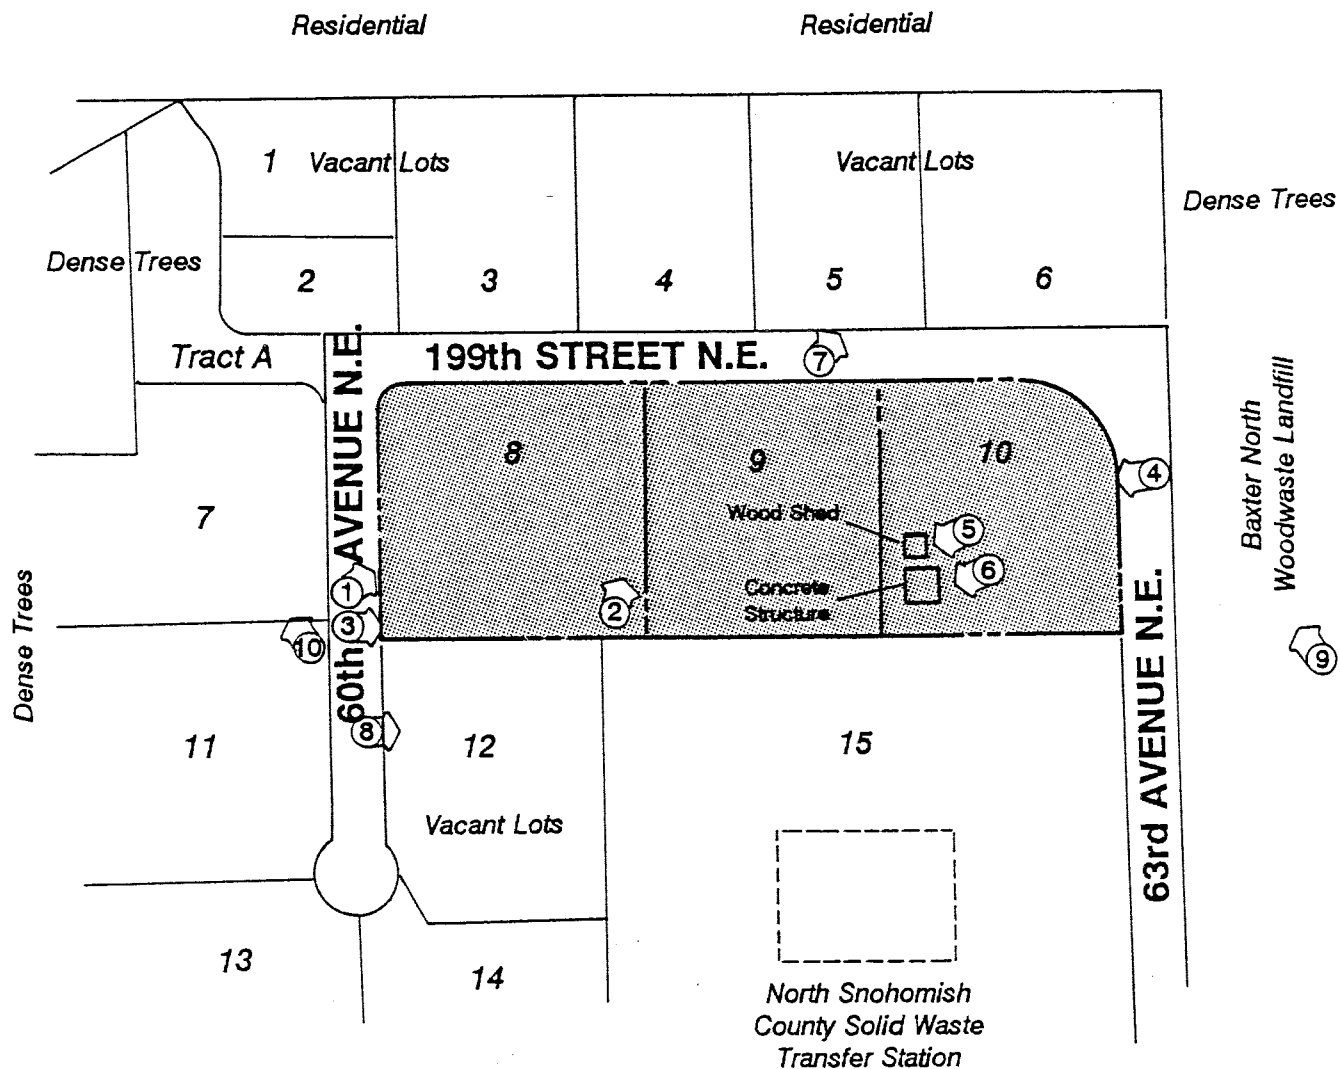
Plate 3

On December 15, 1995, an ECI representative visited the subject property to look for evidence that the site has been environmentally impacted by past or on-going activities. The focus of our reconnaissance was to identify obvious visual signs of potential environmental contamination caused by current and/or historical property activities. The site layout is shown on the Site Plan, Plate 3. Photographs of selected features at the site are included in Appendix A.

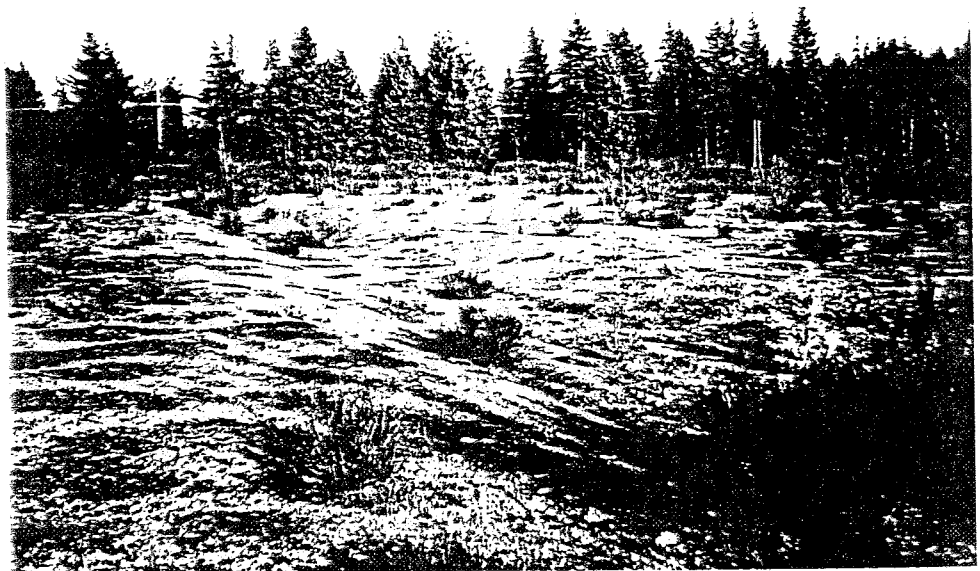
Photo 2 Drainage swale between Lots 8 and 9.

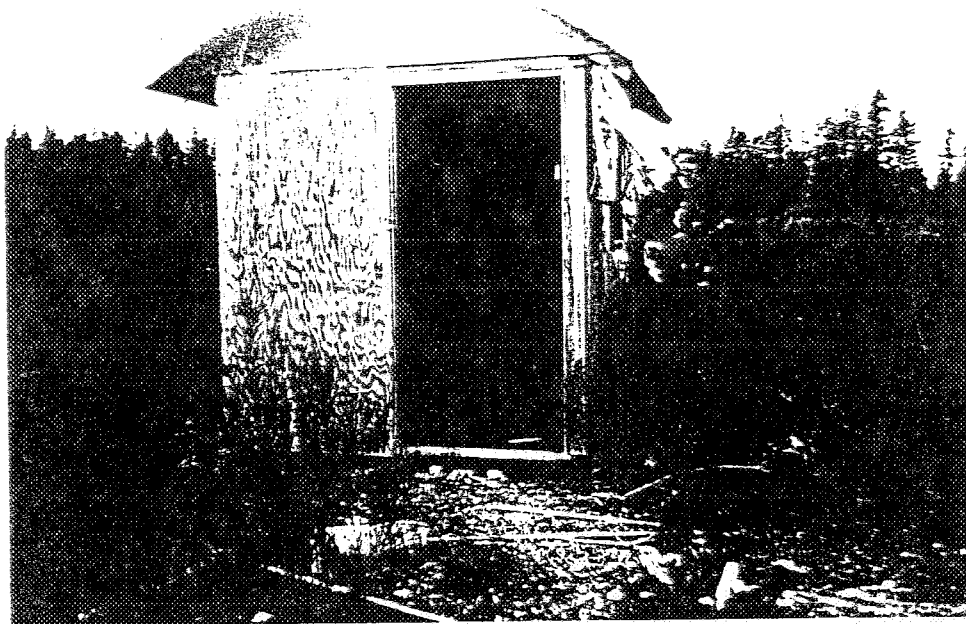
A small skid-mounted, wooden, equipment storage shed was observed in the southwest corner of Lot 10 (Photo 5). Construction debris including wood debris, bricks, two empty five gallon buckets, chain link fencing, black plastic tubing, fiberglass insulation, and a compressed air sprayer was strewn on the ground surface surrounding the shed. An open 55-gallon drum containing similar construction debris was observed northeast of the equipment storage shed. Other construction debris, including plastic sheeting, lumber, and paper litter were observed scattered throughout the site.

Photo 5      Wood Shed and construction debris in southwest portion of Lot 10.
