**Site Inspection Report for  
Per- and Polyfluoroalkyl Substances**

Naval Station Everett  
Everett, Washington

Naval Radio Station Jim Creek  
Arlington, Washington

Naval Recreation Complex Pacific Beach  
Pacific Beach, Washington

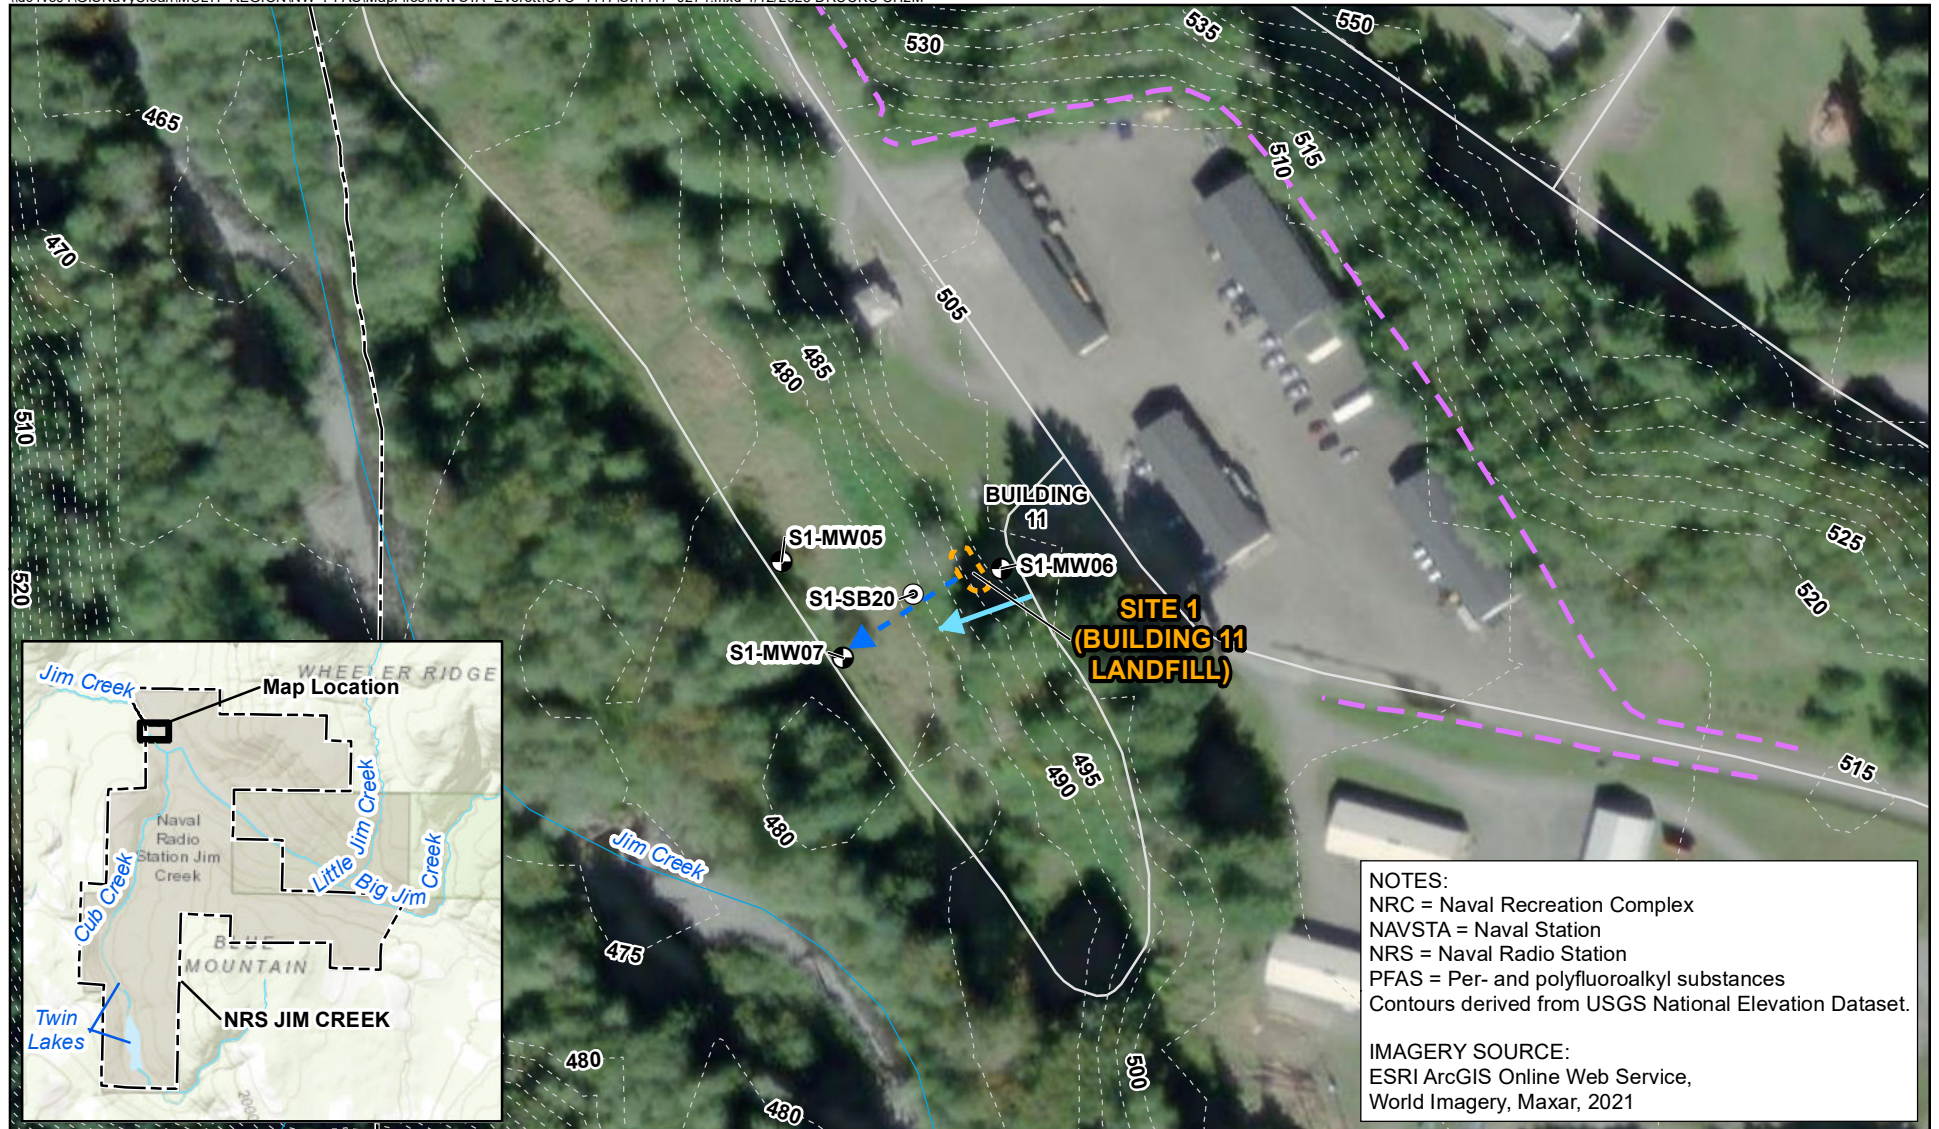
**Figure 2-6**  
 Site Layout and Sampling Locations: NRS Jim Creek, Site 1  
 Site Inspection for PFAS  
 NAVSTA Everett, NRS Jim Creek,  
 NRC Pacific Beach, Washington

- Monitoring Well and Soil Sampling Location
- Shallow Subsurface Soil Sample Location
- Groundwater Flow Direction
- Anticipated Overland Water Flow Direction
- Unpaved Ditch
- 5' Topographic Contours
- Surface Waterbodies
- Potential PFAS Release Area (assumed boundary)
- Installation Boundary

The PFAS PA (CH2M, 2021) identified Site 1 as a potential PFAS release area. Because waste did not leave the installation prior to 1991, it is possible that AFFF containers from Building 6 were disposed of at Site 1. Site 1 was previously evaluated for potential releases of chemicals not including PFAS during the 1990 PA (NEESA, 1990) but was not recommended for further investigation at the time.

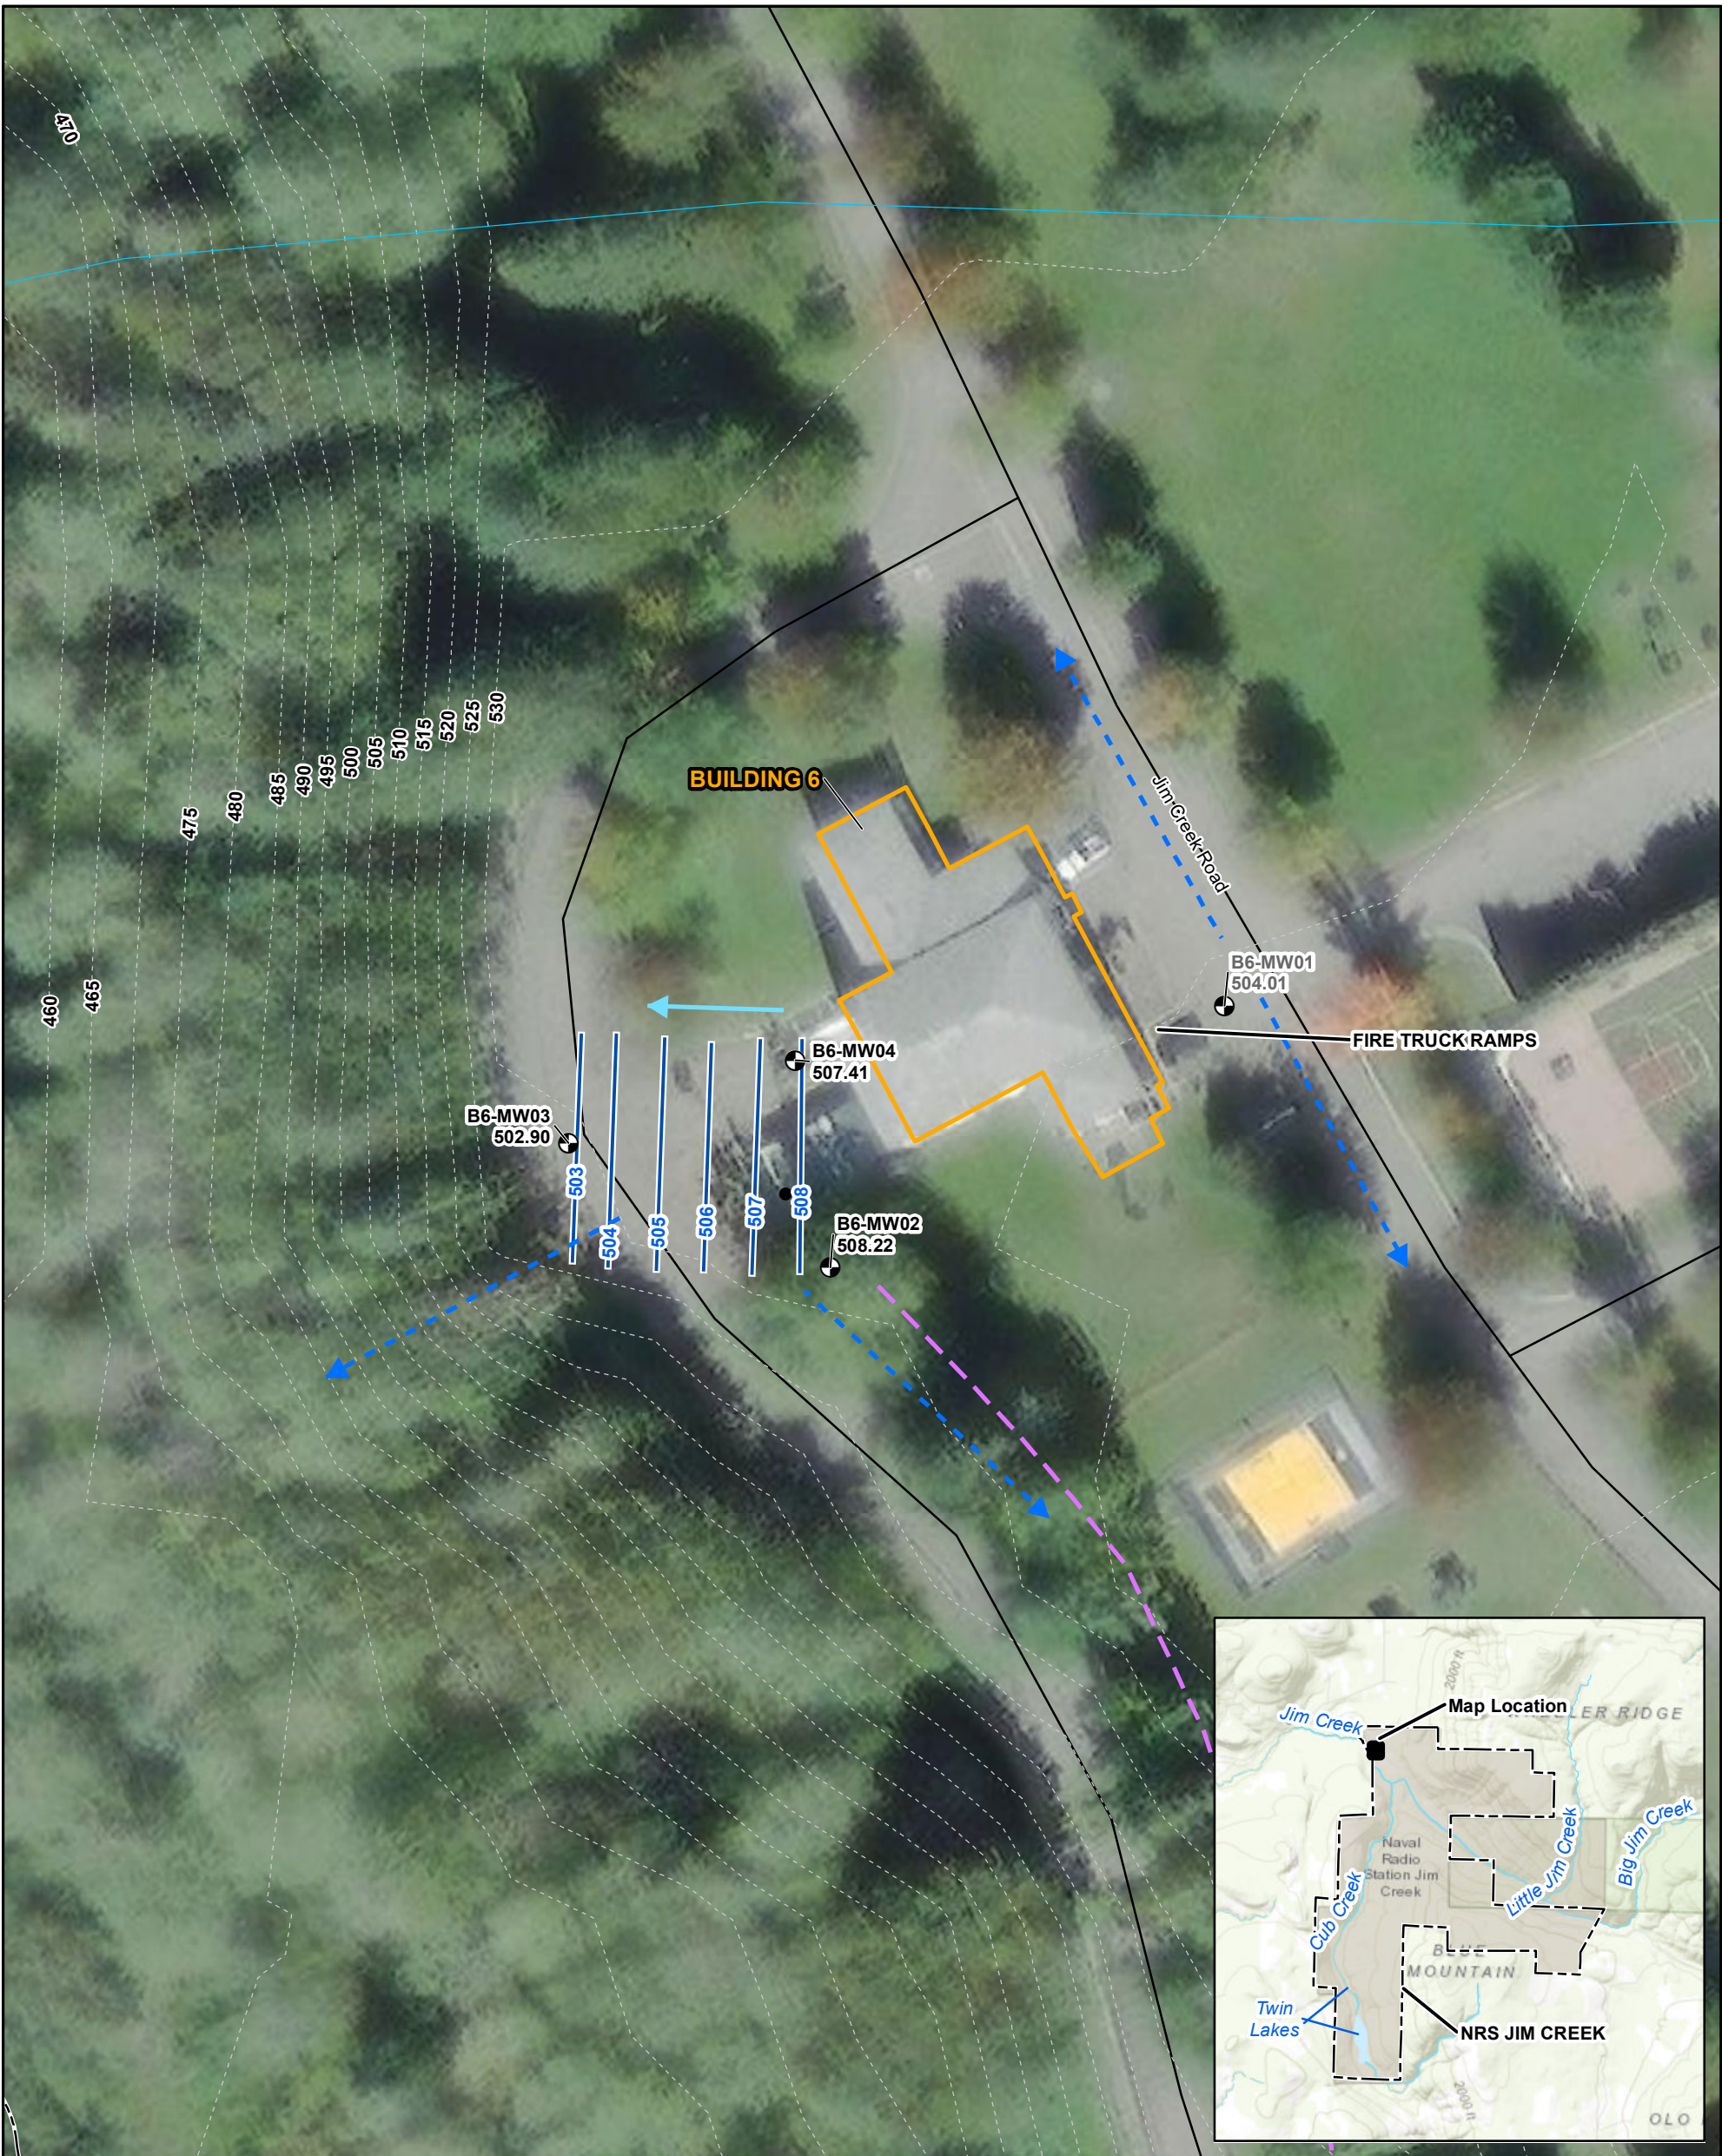
**Figure 3-2**  
Potentiometric Surface Map: NRS Jim Creek Building 6  
Site Inspection for PFAS  
NAVSTA Everett, NRS Jim Creek,  
NRC Pacific Beach, Washington

- Monitoring Well and Soil Sample Location
- Stormwater Catch Basin
- Unpaved Ditch
- Surface Waterbodies
- Groundwater Flow Direction
- Anticipated Overland Water Flow Direction
- Groundwater Elevation Contour
- 5' Topographic Contours
- Road Centerline
- Potential PFAS Release Area
- Installation Boundary

The PFAS PA (CH2M, 2021) identified Building 6 as a potential PFAS release area. Based on historical knowledge, AFFF containers that leaked were stored at Building 6 and were rinsed off outside of Building 6. Previous environmental investigations have not been performed at Building 6.

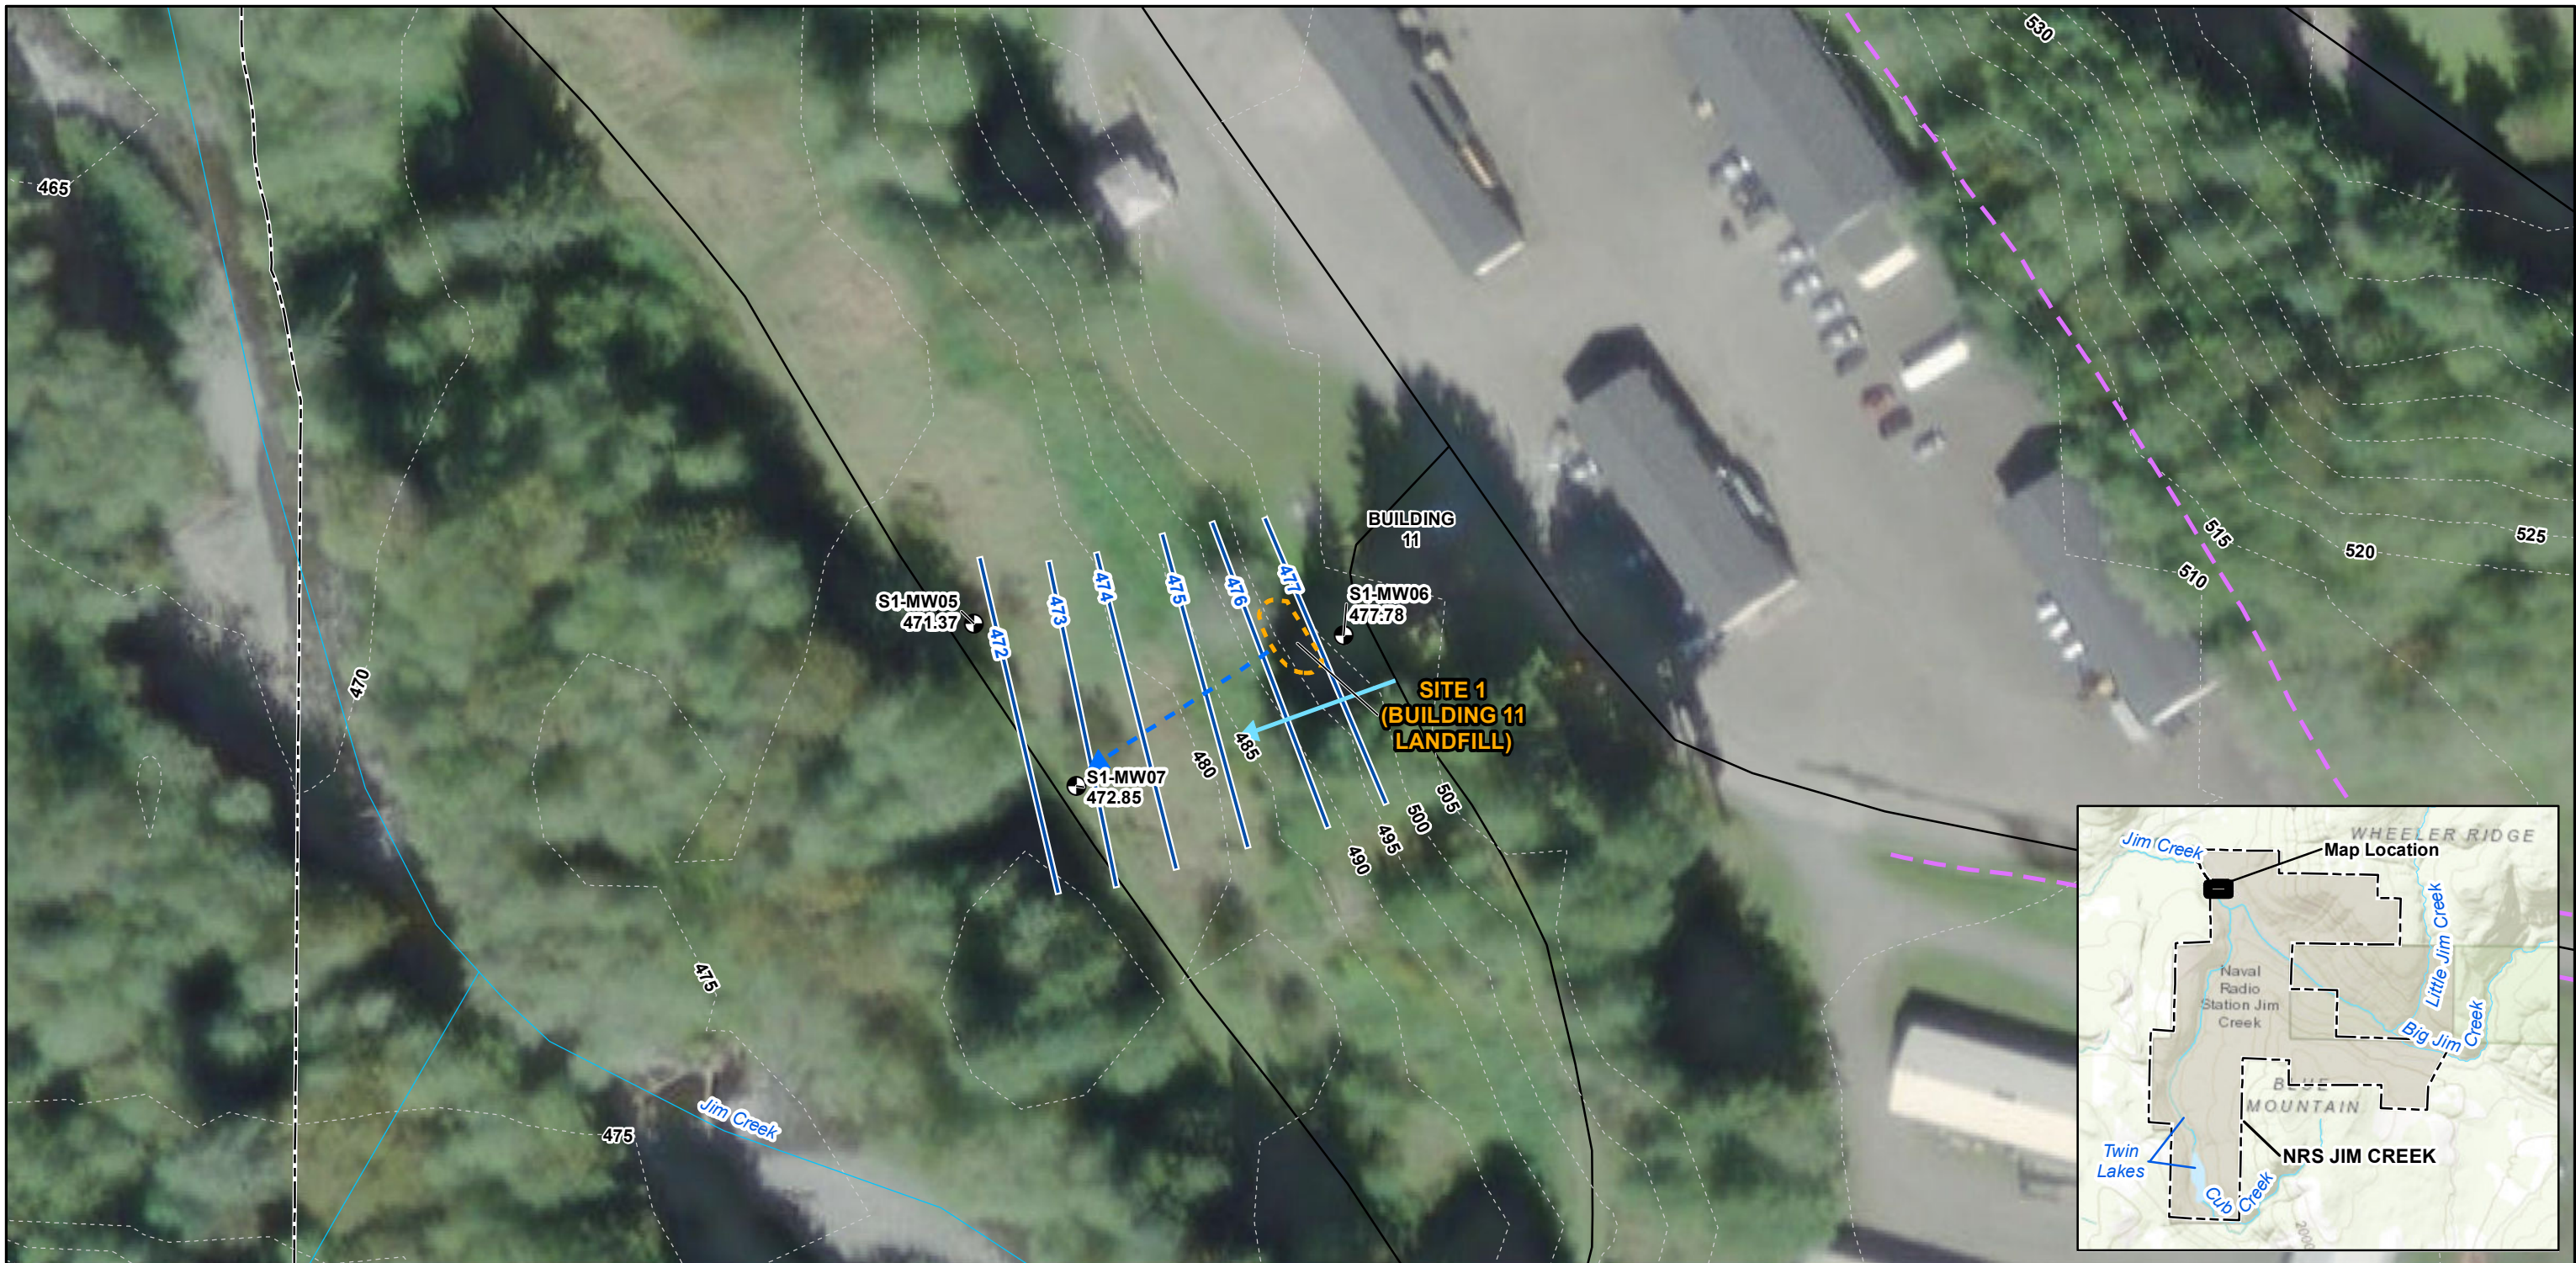
**Figure 3-3**  
Potentiometric Surface Map: NRS Jim Creek Site 1  
*Site Inspection for PFAS*  
NAVSTA Everett, NRS Jim Creek,  
NRC Pacific Beach, Washington

- Monitoring Well and Soil Sampling Location
- Unpaved Ditch
- Groundwater Flow Direction
- Anticipated Overland Water Flow Direction
- Groundwater Elevation Contour
- 5' Topographic Contours
- Surface Waterbodies
- Road Centerline
- Potential PFAS Release Area (assumed boundary)
- Installation Boundary

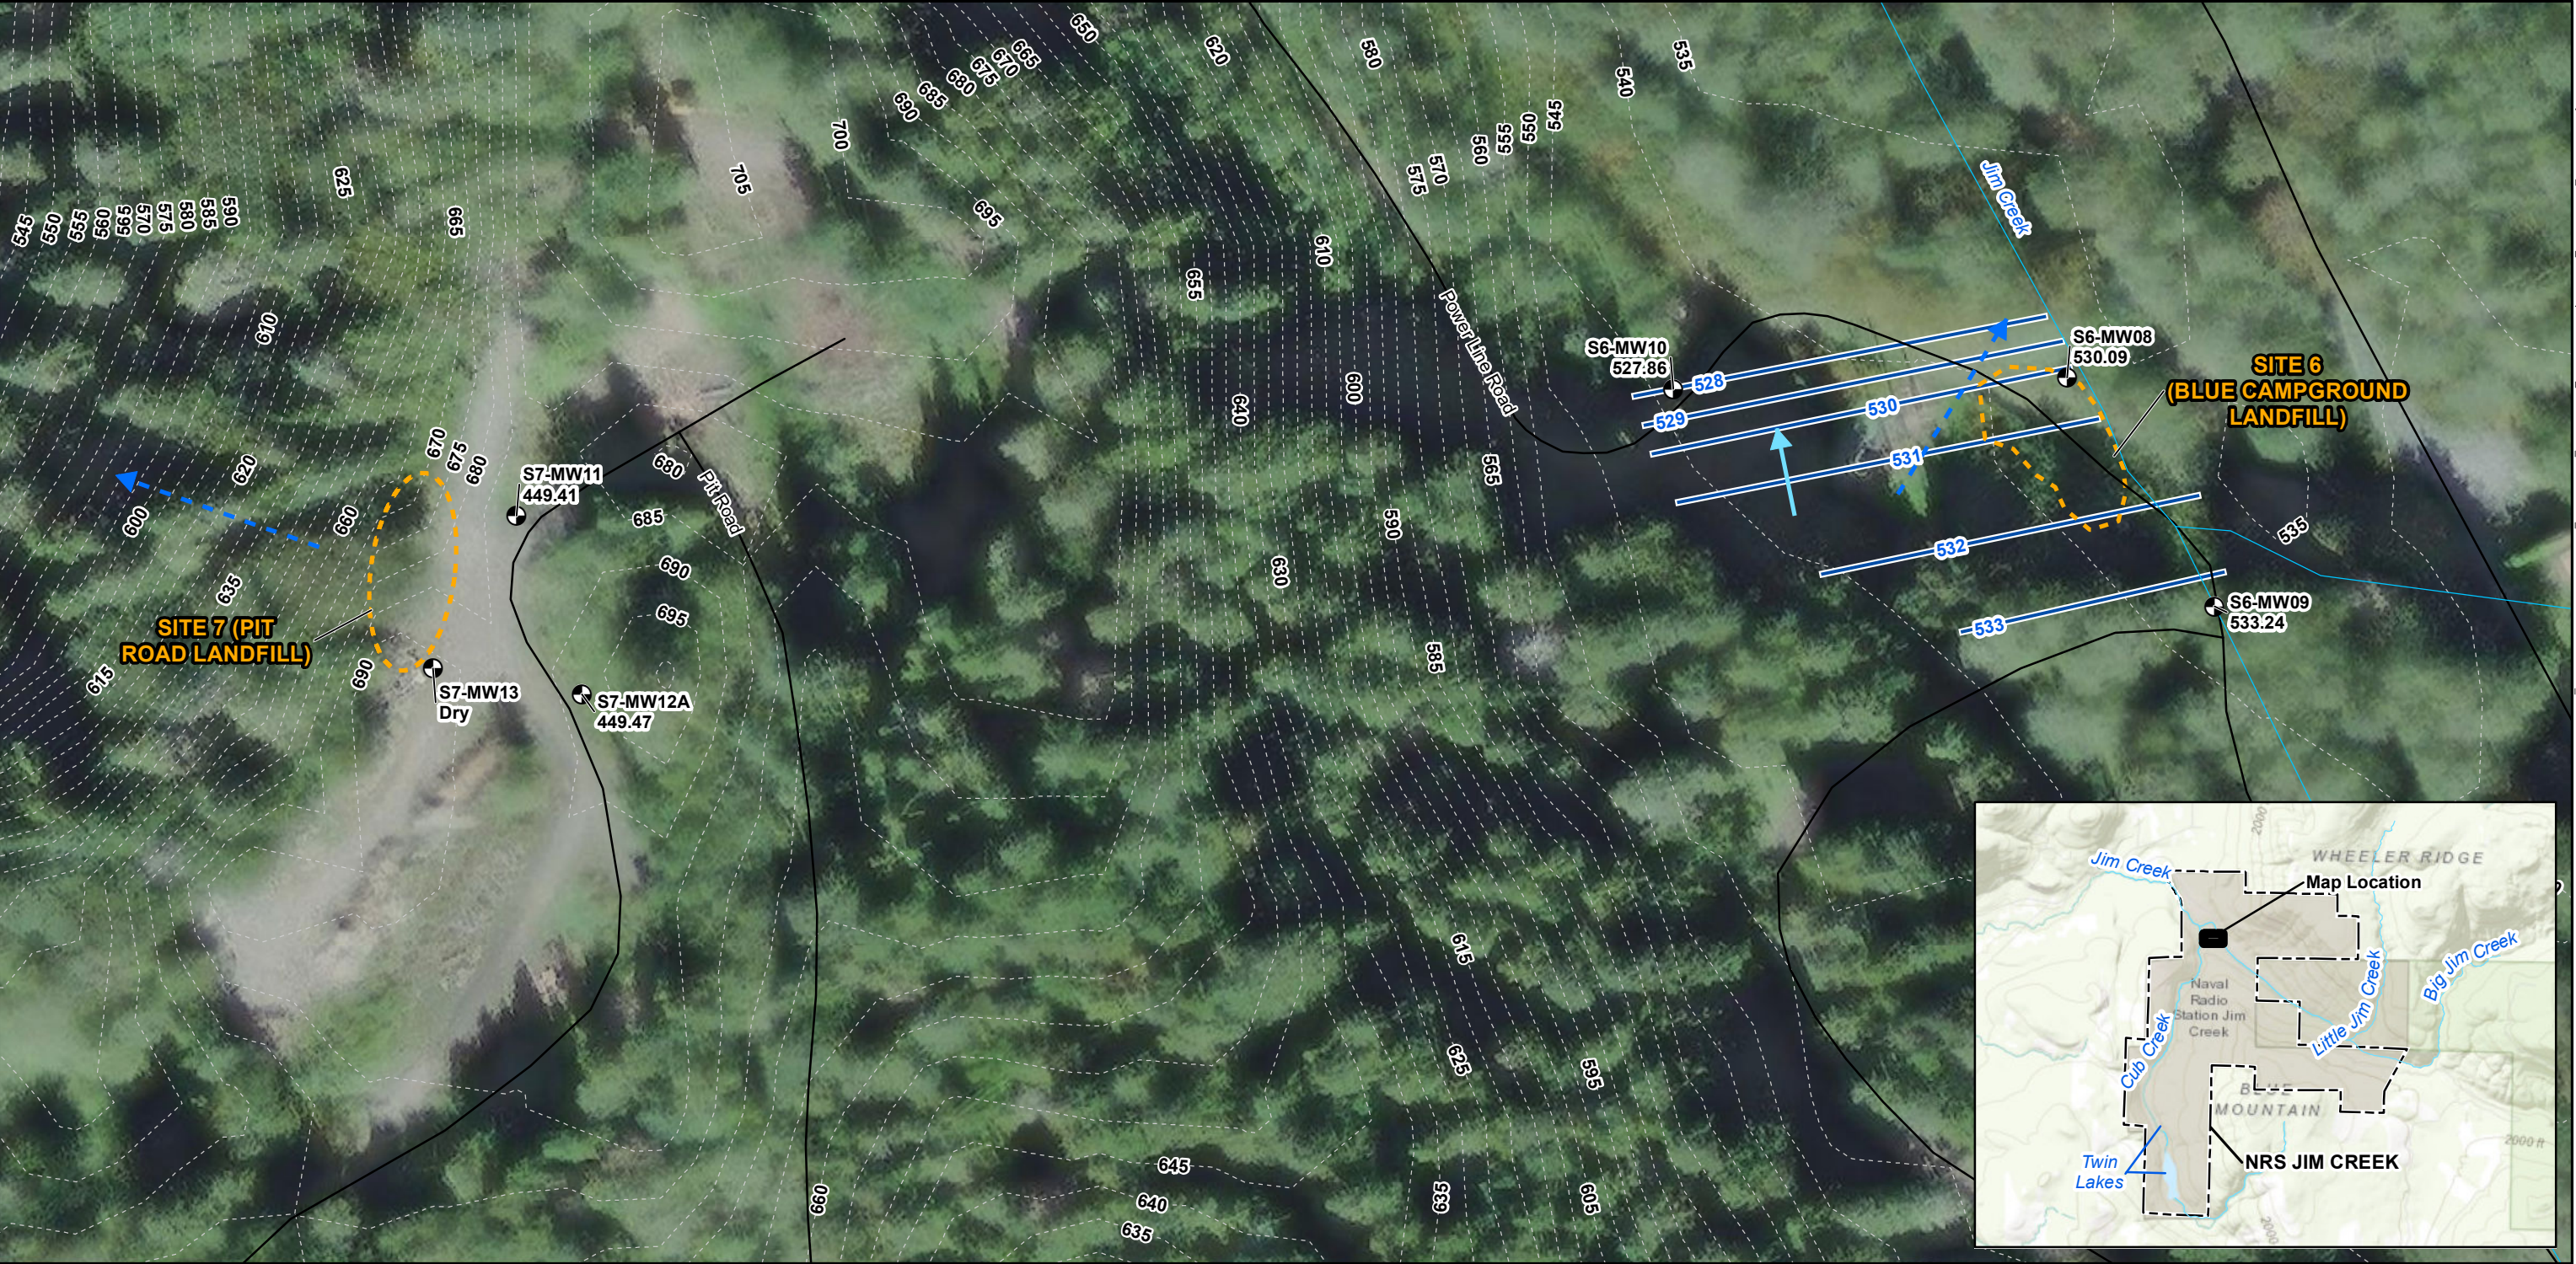
**Figure 3-4**  
Potentiometric Surface Map: NRS Jim Creek Sites 6 and 7  
Site Inspection for PFAS  
NAVSTA Everett, NRS Jim Creek,  
NRC Pacific Beach, Washington

- LEGEND**
- Monitoring Well and Soil Sample Location
  - Groundwater Flow Direction
  - Anticipated Overland Water Flow Direction
  - Groundwater Elevation Contour
  - Surface Waterbodies
  - 5' Topographic Contours
  - Road Centerline
  - Potential PFAS Release Area (assumed boundary)

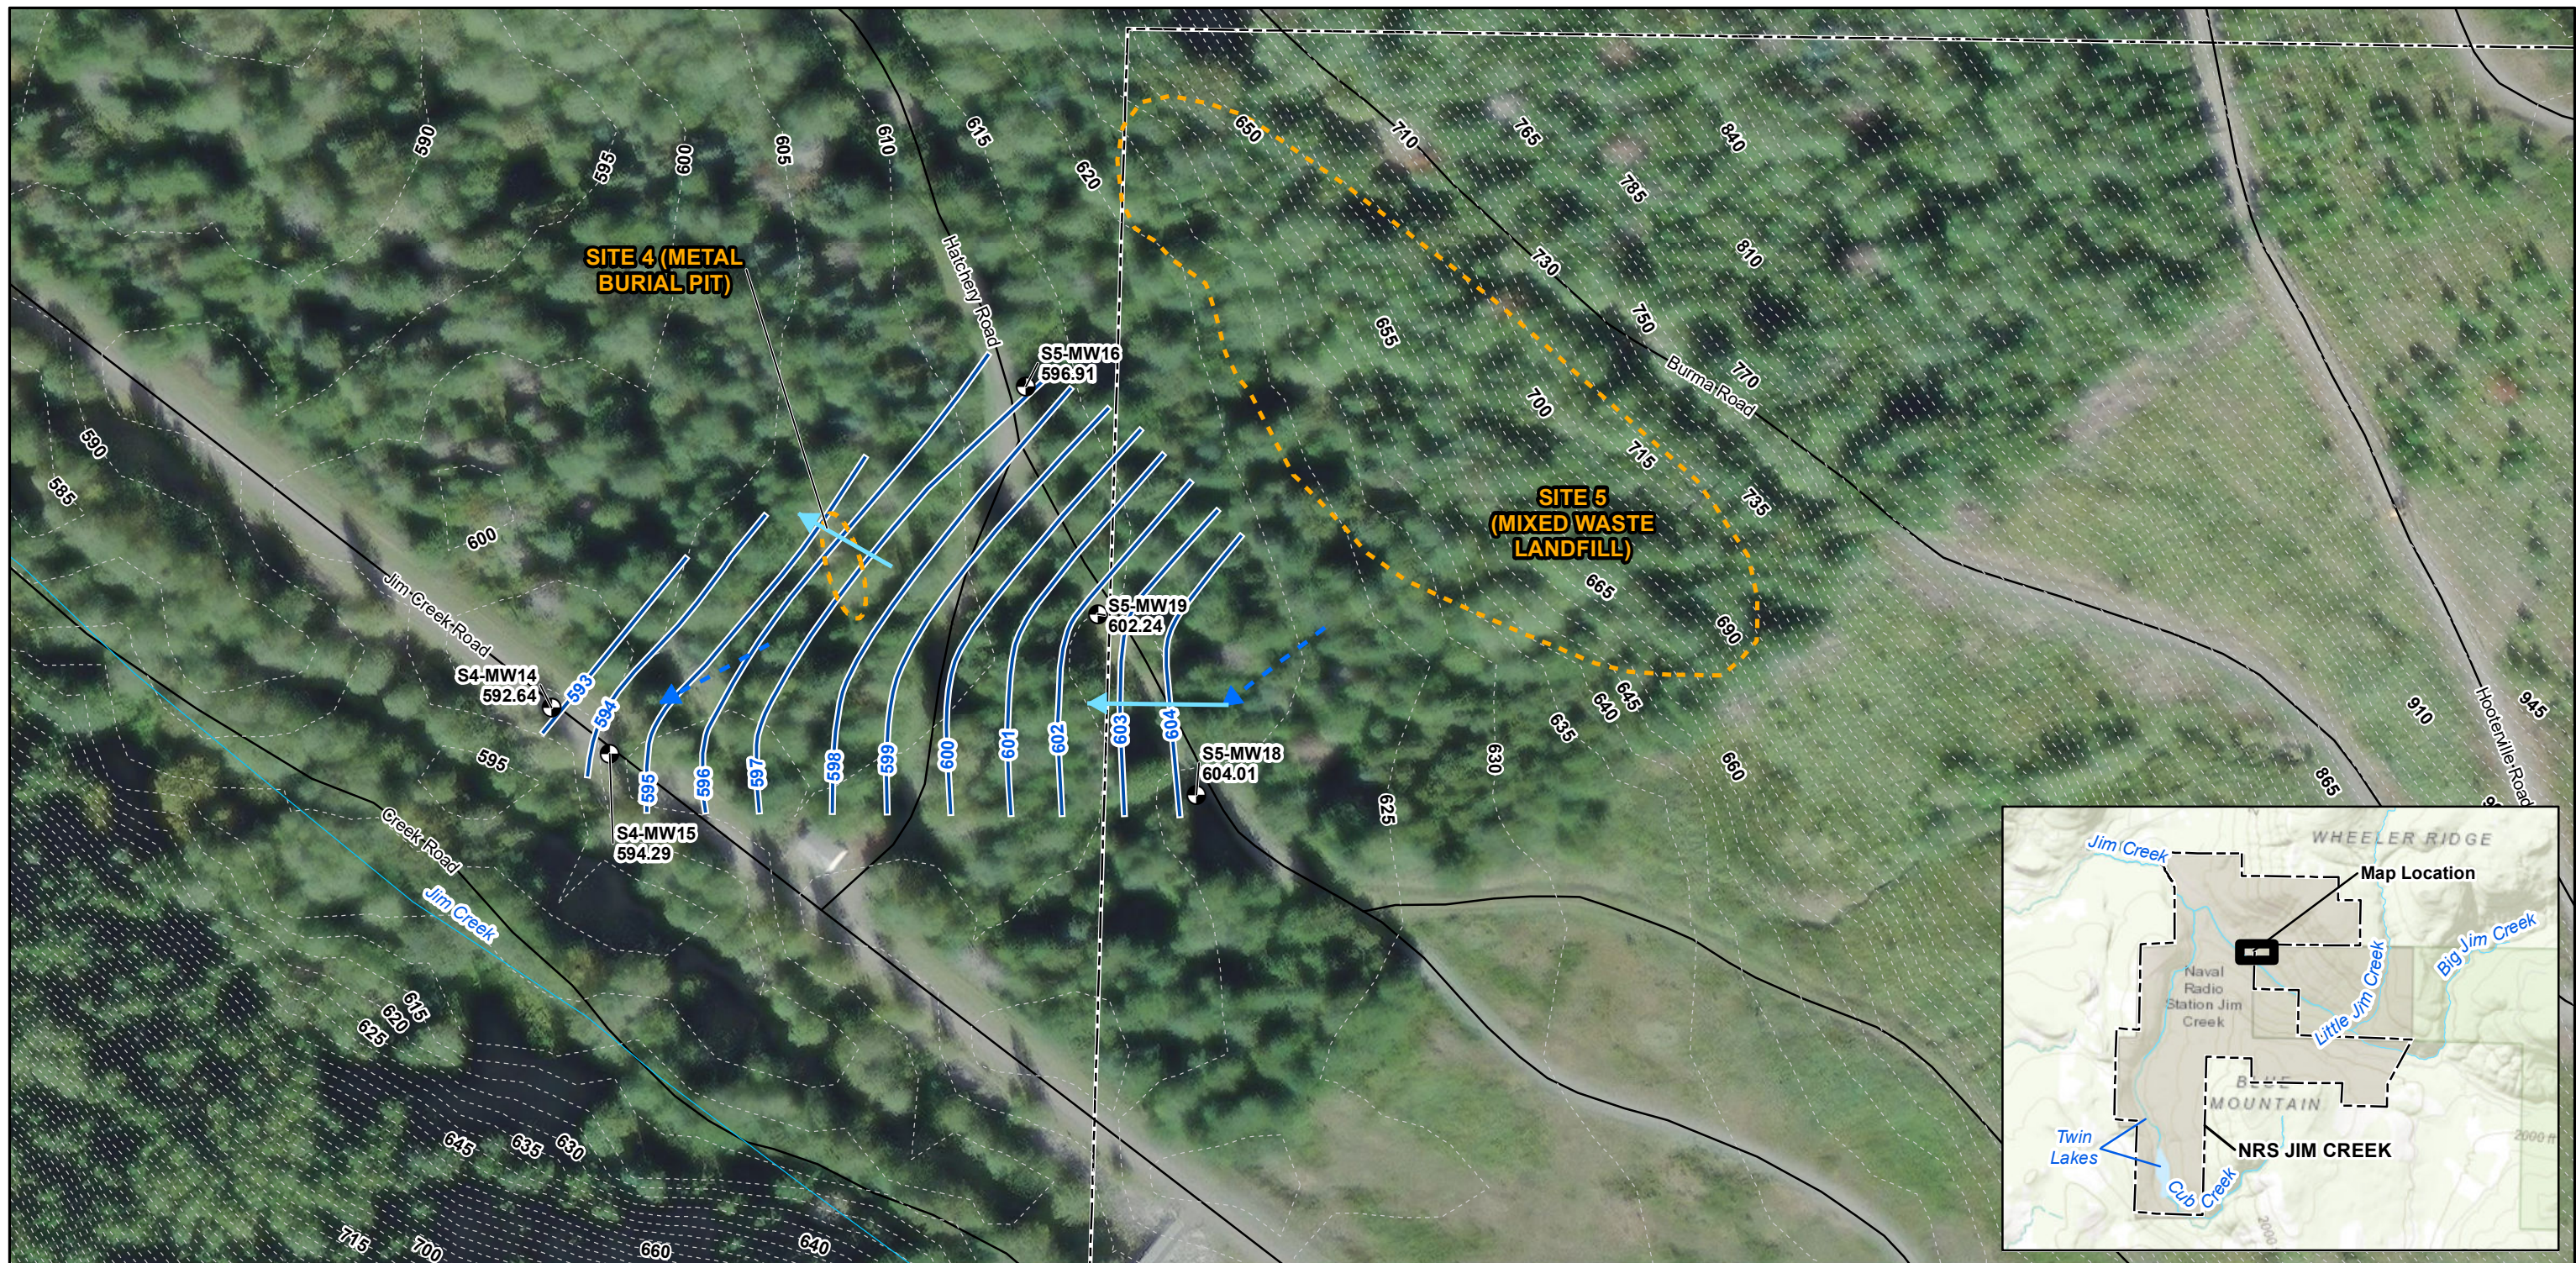
**Figure 3-5**  
Potentiometric Surface Map: NRS Jim Creek Sites 4 and 5  
*Site Inspection for PFAS*  
NAVSTA Everett, NRS Jim Creek,  
NRC Pacific Beach, Washington

- Monitoring Well and Soil Sampling Location
- Groundwater Flow Direction
- Anticipated Overland Water Flow Direction
- Groundwater Elevation Contour
- Surface Waterbodies
- 5' Topographic Contours
- Road Centerline
- Potential PFAS Release Area (assumed boundary)
- Installation Boundary

The PFAS PA (CH2M, 2021) identified Site 4 as a potential PFAS release area. Because waste did not leave the installation prior to 1991, it is possible that the AFFF containers from Building 6 were disposed of at Site 4. Site 4 was previously evaluated for potential releases of chemicals not including PFAS during the 1990 PA (NEESA, 1990) but was not recommended for further investigation at the time.
