Soil Assessment

Jerry's Custom Mechanics
Richland, Washington

for
Washington State Department of Ecology

June 27, 2019

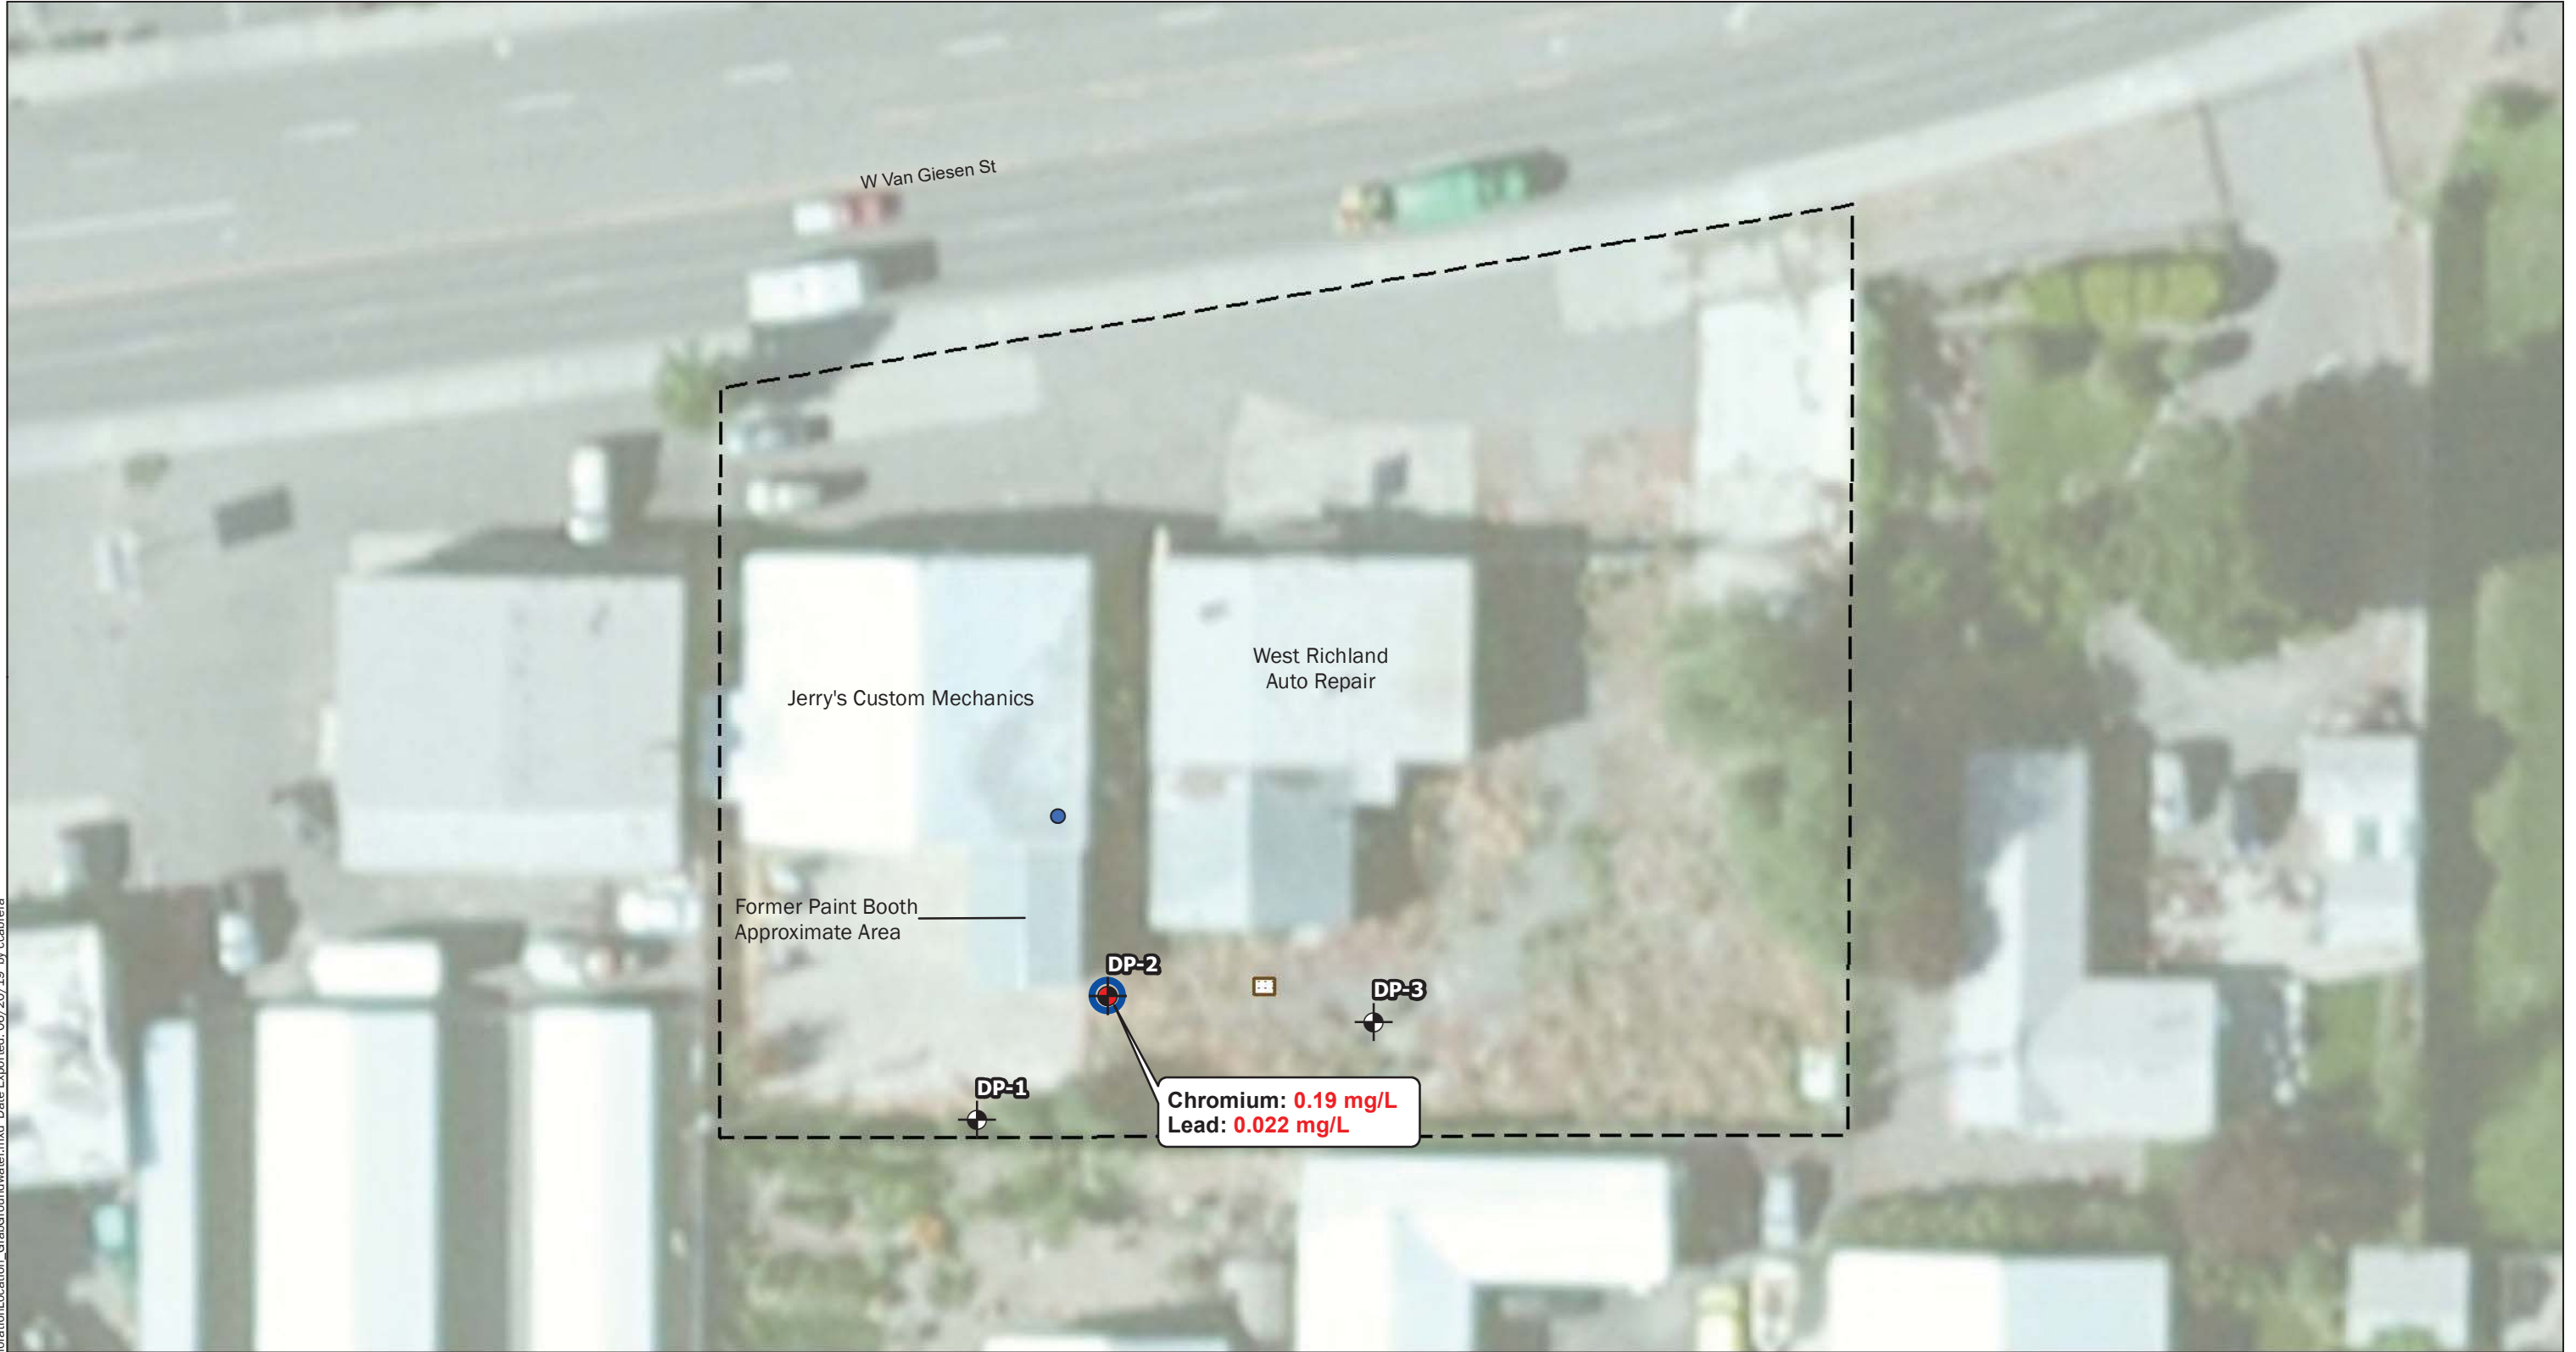
Exploration Locations - Grab Groundwater	
Jerry's Custom Mechanics West Richland, Washington	
	Figure 2

Subsurface conditions at the Jerry's Custom Mechanics site were explored on April 29, 2019, by advancing three direct-push borings at the approximate locations shown on Figure 2. Borings were advanced between 14 and 16 feet below existing site grade and using a direct-push drill rig. Boring locations were established in the field using a site plan and measurements from on-site structures. Consequently, exploration locations should be considered accurate to the degree implied by the method used.

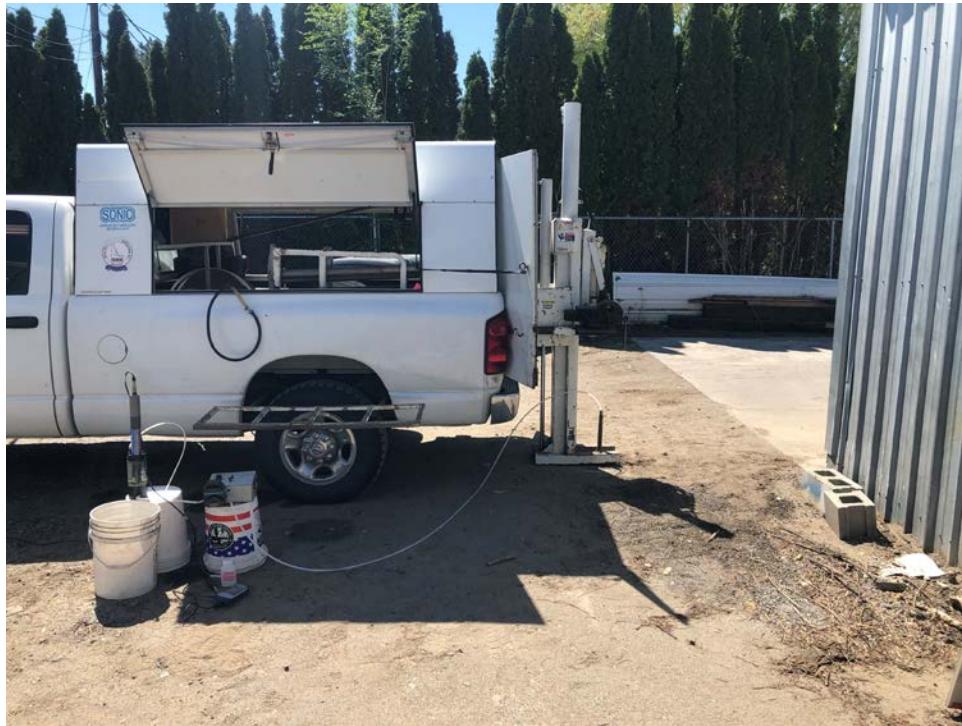
One groundwater sample was submitted to TestAmerica for the chemical analyses described in “Section 3.0 Scope of Services.” A photograph of well point sampling from boring GEI014-DP2 is depicted in Figure 3. Test America’s laboratory reports are included in Appendix B; chemical analytical results are summarized and compared to MTCA Method A groundwater cleanup levels below and in Table 3.

- Chromium was detected in the groundwater sample (GEI014-DP2:042919) at a concentration [0.19 milligrams per liter (mg/L)] greater than the MTCA Method A cleanup level (0.05 mg/L).
- Lead was detected in the groundwater sample (GEI014-DP2:042919) at a concentration (0.028 mg/L) greater than the MTCA Method A cleanup level (0.015).

Temporary well point sampling from boring GEI014-DP2 (view looking south).

Based on these assessment results, soil contamination was not identified in soil borings. Additional assessment would be needed to establish the nature and extent of the groundwater contamination. We recommend installing groundwater monitoring wells for the site and establishing a groundwater monitoring program. The groundwater monitoring program would include sampling for both chromium (III) and (VI) to confirm the valence state of chromium in the groundwater. Fully developed monitoring wells will provide more accurate groundwater sample results than grab samples to establish the nature and extent of the groundwater contamination.

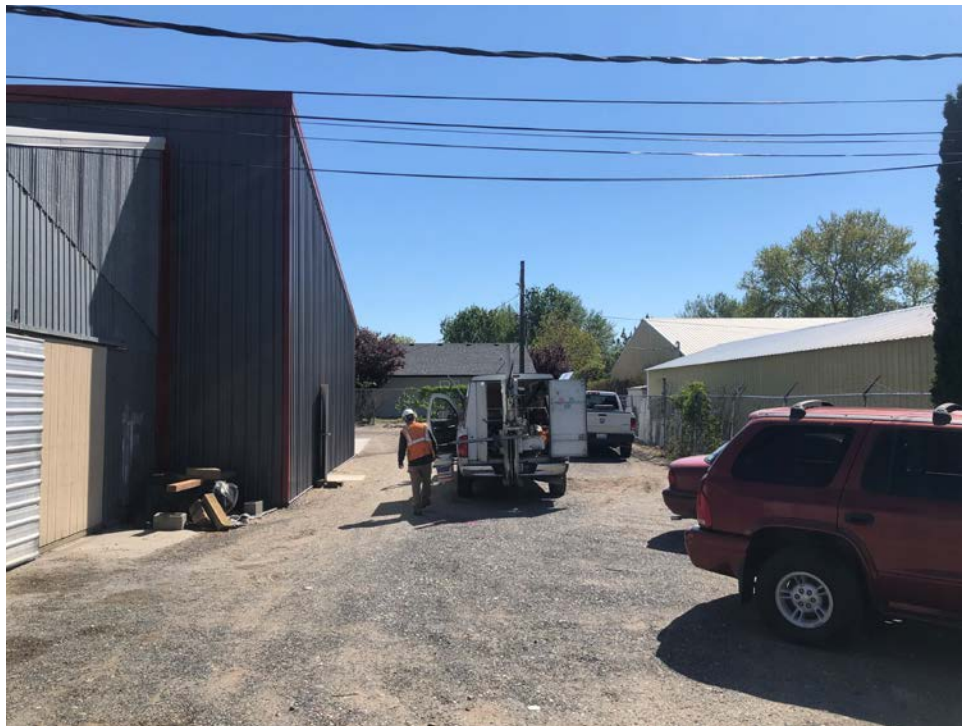
- Soil boring GEI014-DP3 was drilled east of the former paint booth location to approximately 14 feet bgs. DP3 was moved to the east due to underground and overhead utilities. Soil from six depth locations were screened for chromium and lead using the XRF instrument. Chromium was not detected from XRF soil testing. XRF soil testing indicated lead was detected at 20 mg/kg in the 9-foot depth. Three soil samples were retained for potential laboratory chemical analysis. A photograph of advancing boring DP3 is found in Figure 3.

Advancing boring location GEI014-DP3 (view looking east)
