PHASE II SITE INVESTIGATION

At
SINGER'S CHEVRON
7 E. Rose St.
Walla Walla, Washington

December 1, 2010

Blue Mountain Environmental Consulting Services
505 Willard St.
Waitsburg, WA 99361
509-520-4416

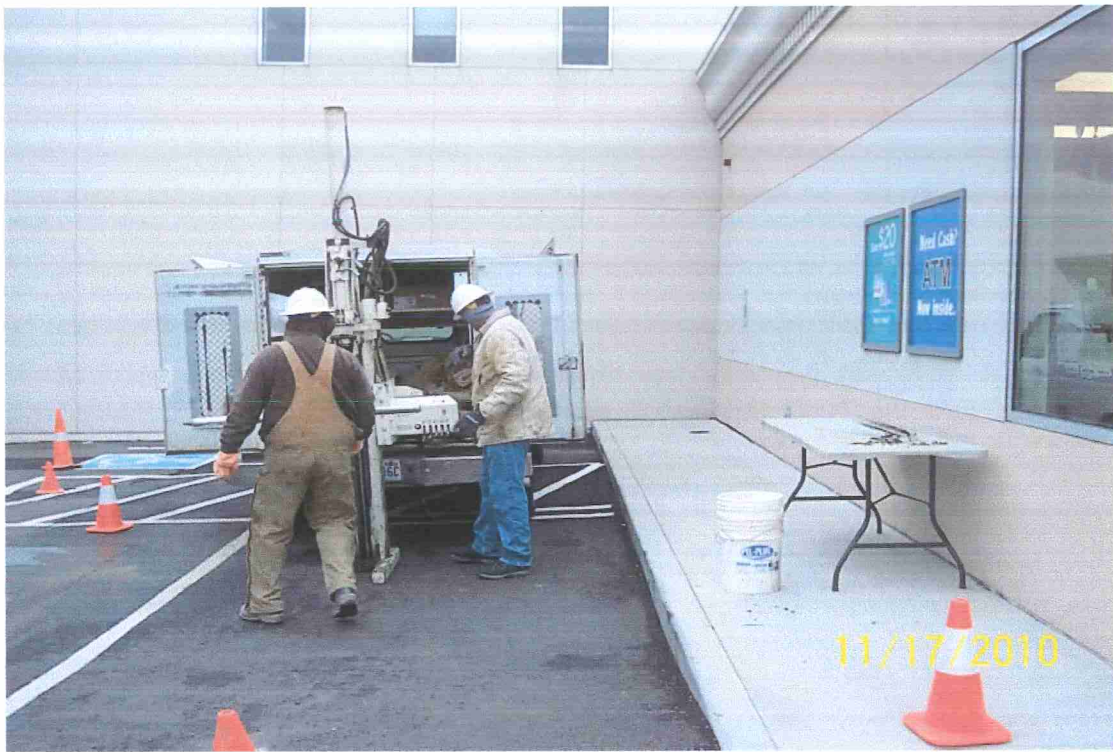
PUSH-PROBE SAMPLING AT THE FORMER HOT LOCATION .

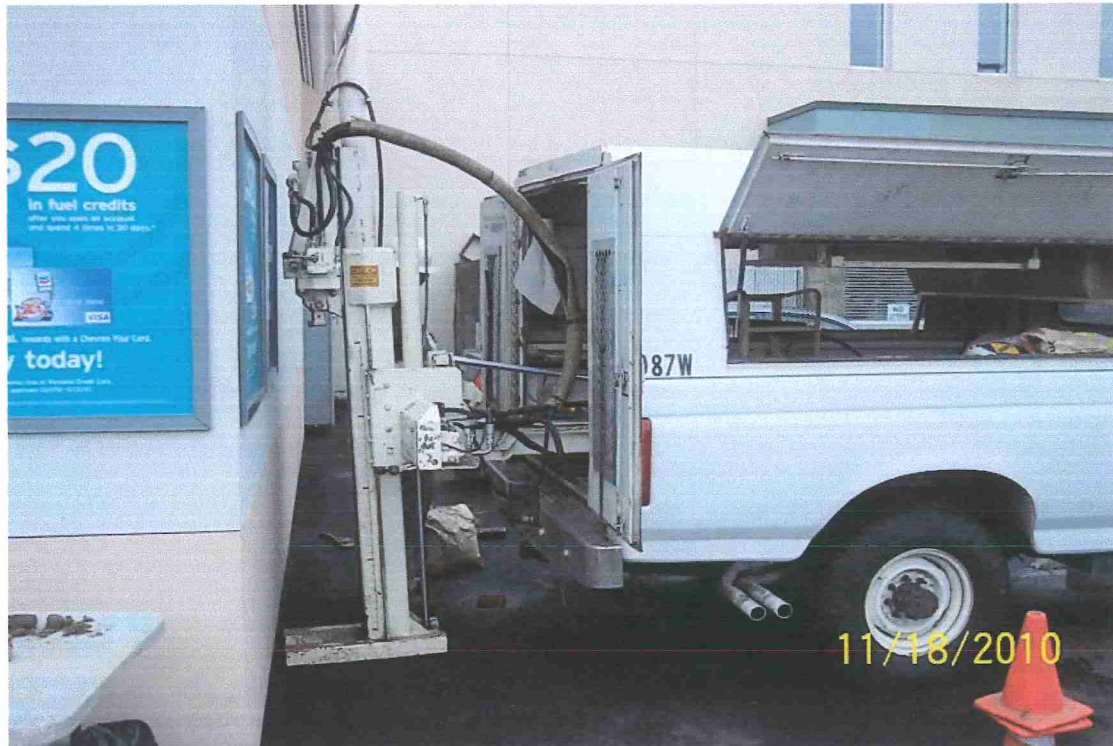
SAMPLING AT THE FORMER HYDRAULIC LIFT LOCATION.

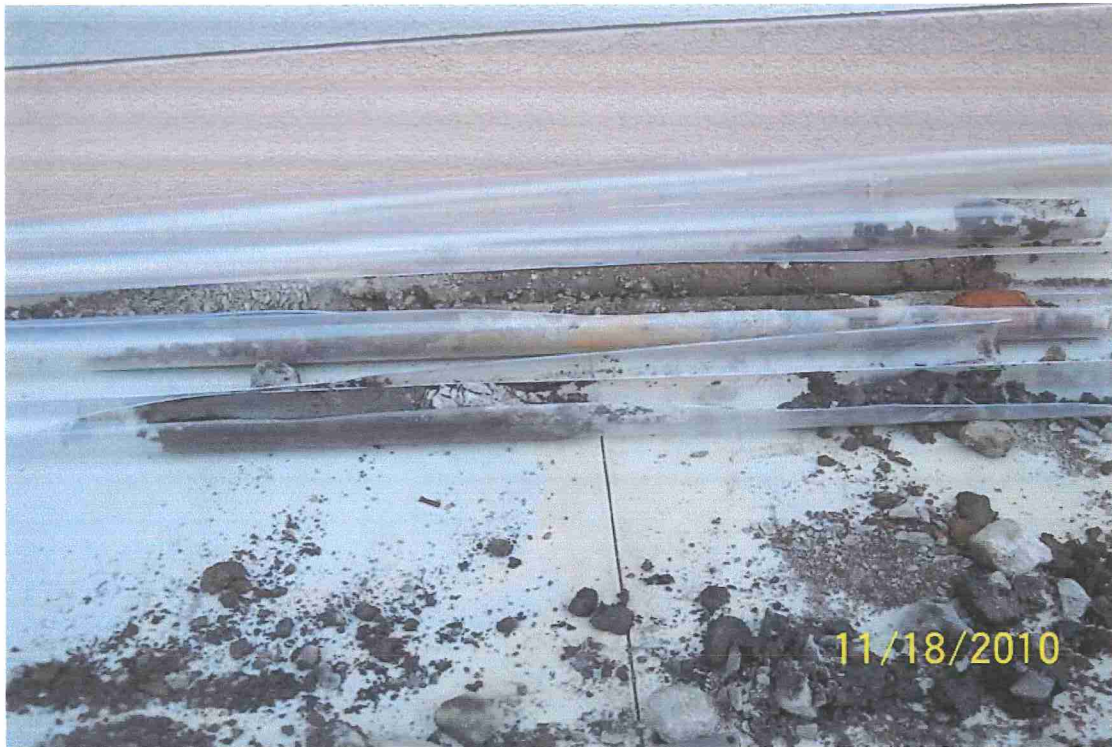
It should be noted that the characterization previously described is merely a generalization extrapolated from available soils and geologic data. Actually cuts and fills for roadways and underground utilities may have significantly altered the subsurface of the subject property. Soil conditions encountered during sampling showed rock and sand to a depth of 10-12 feet. (See photo documentation).

TYPICAL SOIL PROFILE TO 12 FEET BGS.

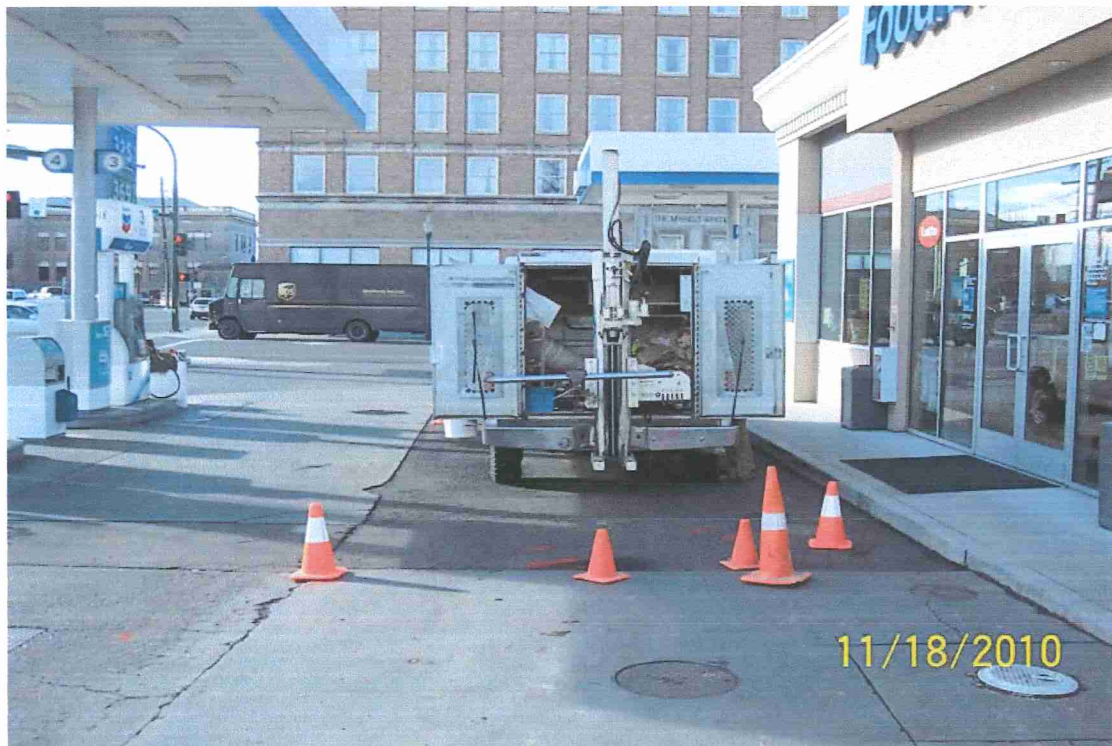
Laboratory analysis of soil samples in the former UST excavation indicated gasoline and BTEX constituents above MTCA cleanup levels. It is the opinion of BMEC, Inc. that the site should be properly reported as a contaminated site to the Washington Department of Ecology (DOE), and that a remediation plan should be developed and implemented for the site.

SAMPLING AT THE FORMER UST LOCATION.
