SITE CHARACTERIZATION/ FOCUSED FEASIBILITY STUDY REPORT

EXXONMOBIL/ADC PROPERTY, ECOLOGY SITE ID 2728
EVERETT, WASHINGTON
PROJECT # 6103180009
EXXONMOBIL OIL CORPORATION/AMERICAN DISTRIBUTING COMPANY

MAY 12, 2023

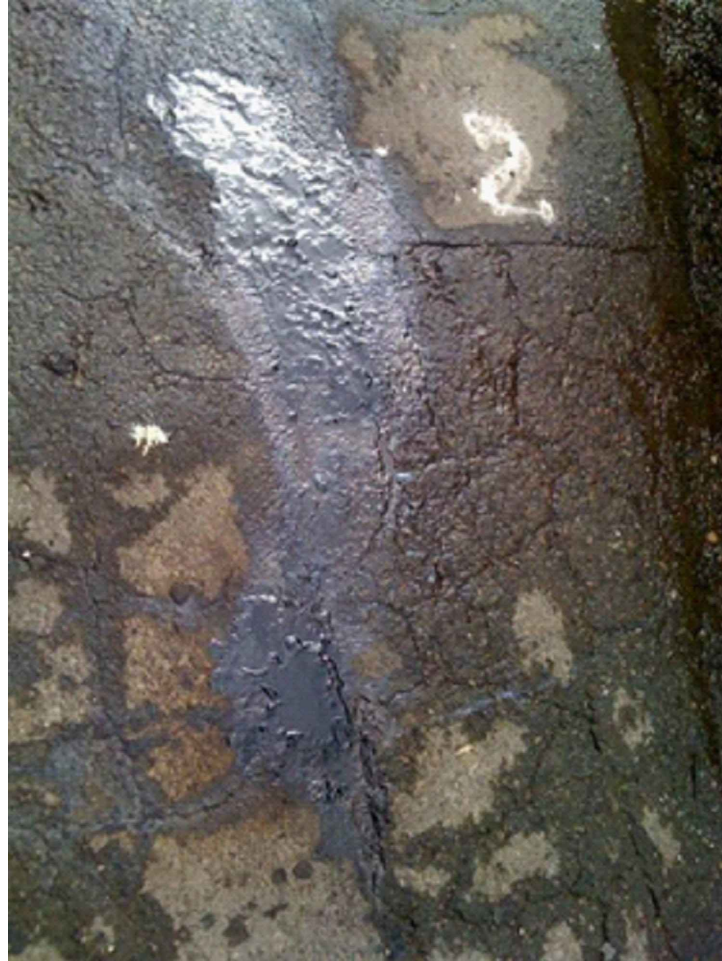
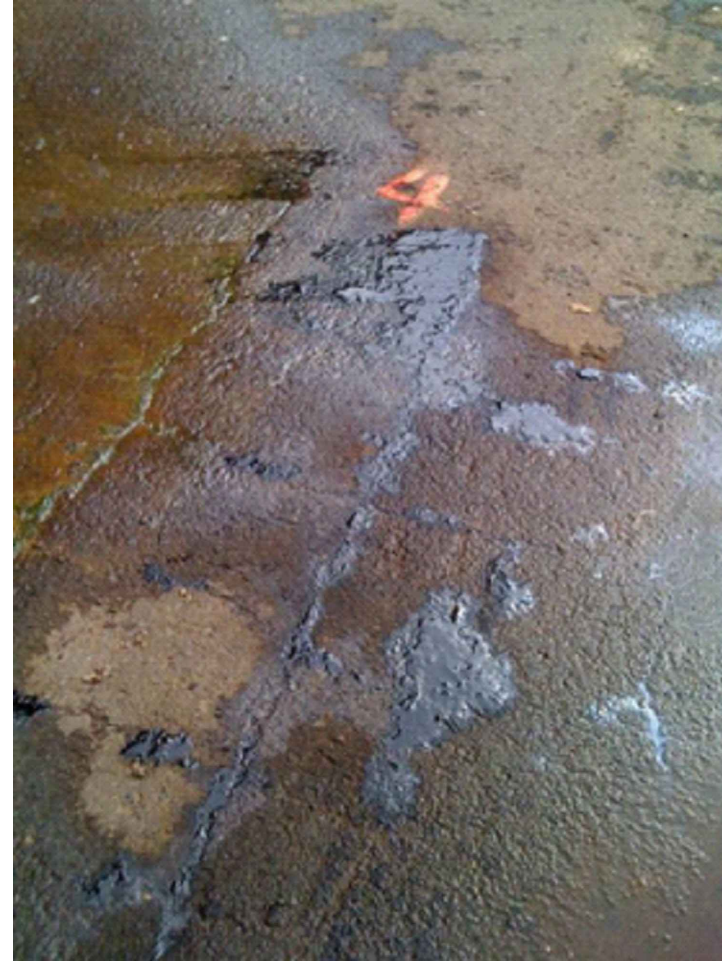
FIGURE No.
3-1

TITLE
**PHOTOGRAPHS OF EXAMPLE SEEPS
 OBSERVED ON FEDERAL AVENUE
 APRIL 28, 2011**

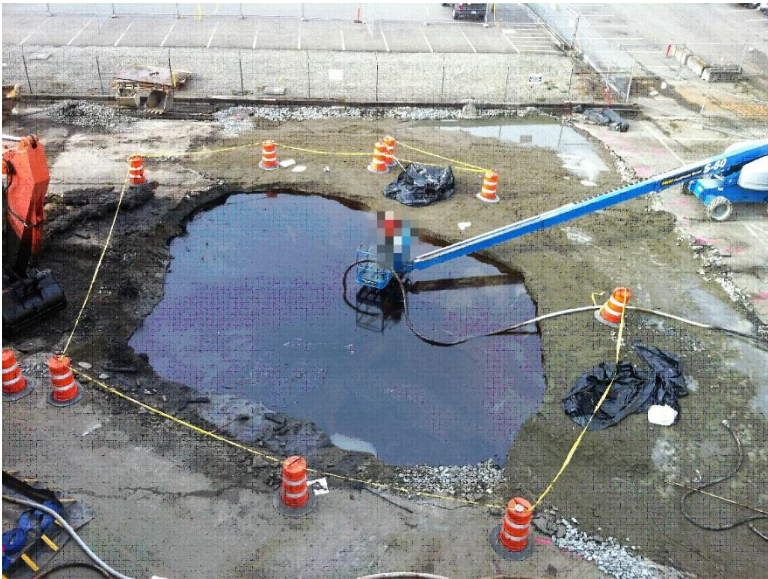
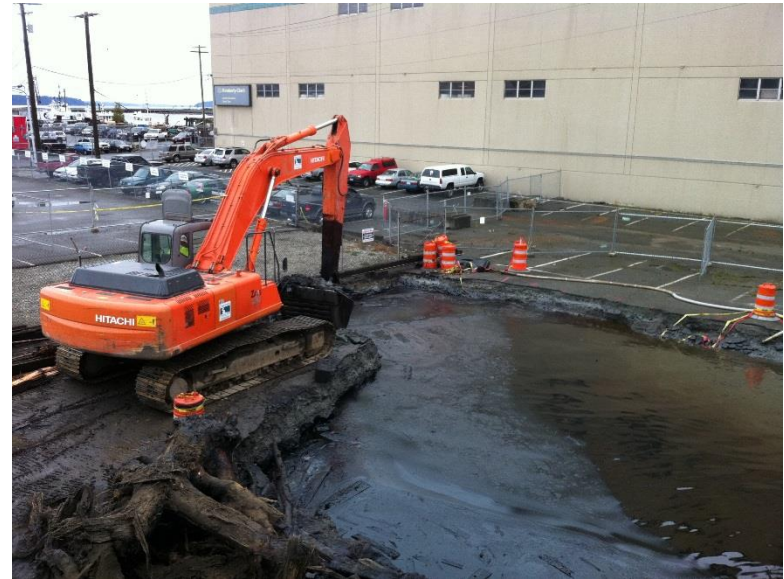
FIGURE 4-3

**PHOTOGRAPHS OF SOIL AND DEBRIS FROM 2011-2012 EXCAVATION
DECEMBER, 2011**

The excavation on the BNSF property was extended to the limit of available access, as shown on Figure 4-1. The vertical limit of excavation was extended until a visually clean bottom was exposed, which in most areas was between 8 and 10 feet bgs. LPH and petroleum hydrocarbon contamination was encountered at 3 to 4 feet bgs and extended to 8 to 10 feet bgs. Underlying the upper 2.5 to 3.5 feet of soil cover on the BNSF property was a layer 5 to 7 feet thick (extending to a total excavation depth of 8 to 10 feet bgs) of refuse and debris, consisting primarily of wood, soil, rocks, bottles, and other debris. This fill layer was impacted with petroleum hydrocarbons, including LPH. Figure 4-3 presents photographs of the soil and debris that were removed during the excavation.

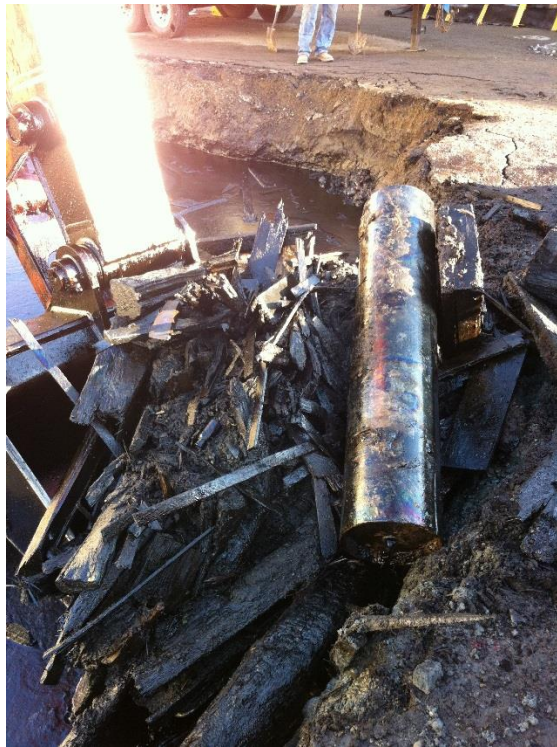
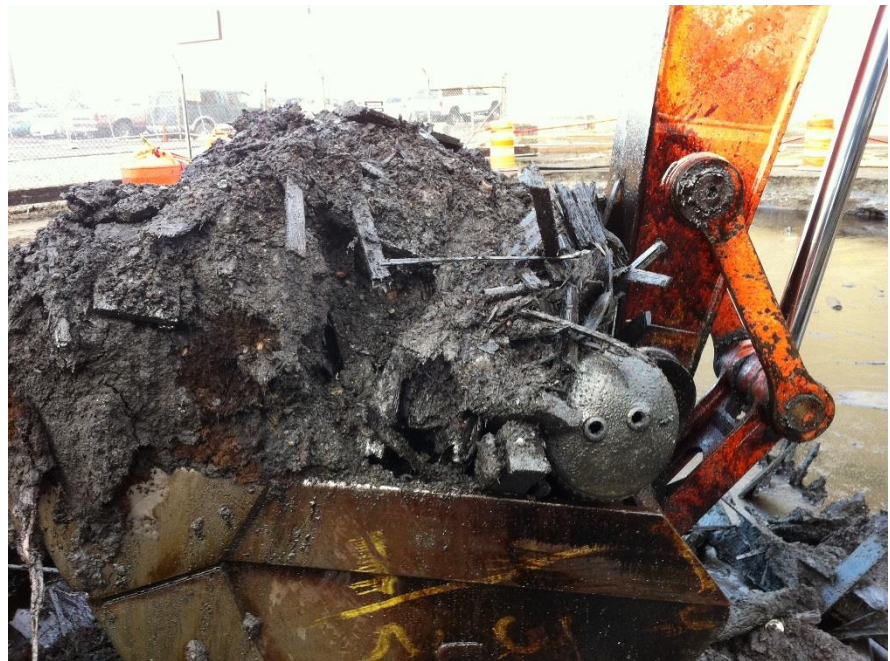
FIGURE 4-4

PHOTOGRAPHS OF BARRIER WALL CONSTRUCTION ALONG BNSF PROPERTY BOUNDARY FEBRUARY, 2012

Affected material was evident at all sidewall areas of the completed excavation on the BNSF property, and therefore no side wall samples were collected. A low-permeability barrier wall constructed of controlled density fill approximately 3 feet wide by 4 feet deep was placed in an east/west-trending strip running the approximate length of the excavation along the BNSF property boundary, as shown on Figure 4-1. This barrier wall was installed to limit further product migration from the BNSF property. Figure 4-4 presents photographs of the barrier wall installation.

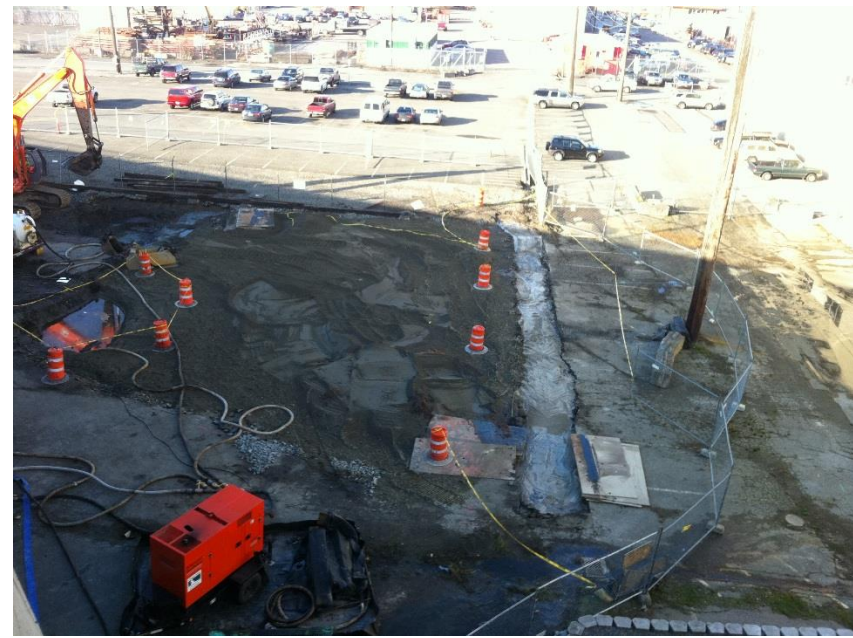
FIGURE 4-5

PHOTOGRAPHS KC PROPERTY EXCAVATION MARCH, 2012

The depths of the excavation on the former KC property were limited by utilities and varied from 3 to 5 feet bgs. The extent of the excavation was limited on the north side in order to maintain a free corridor of 12 feet between the excavation and the KC building. Approximately 725 tons of soil and debris were excavated from the former KC property (on the former Everett Avenue) and disposed of at a permitted off-Site landfill. Affected sidewalls were encountered to the north and east on the former KC property and left in place. Only LPH-affected soils were removed from the former KC property. Photographs from the excavation on the former KC property around the utility corridor are presented on Figure 4-5.

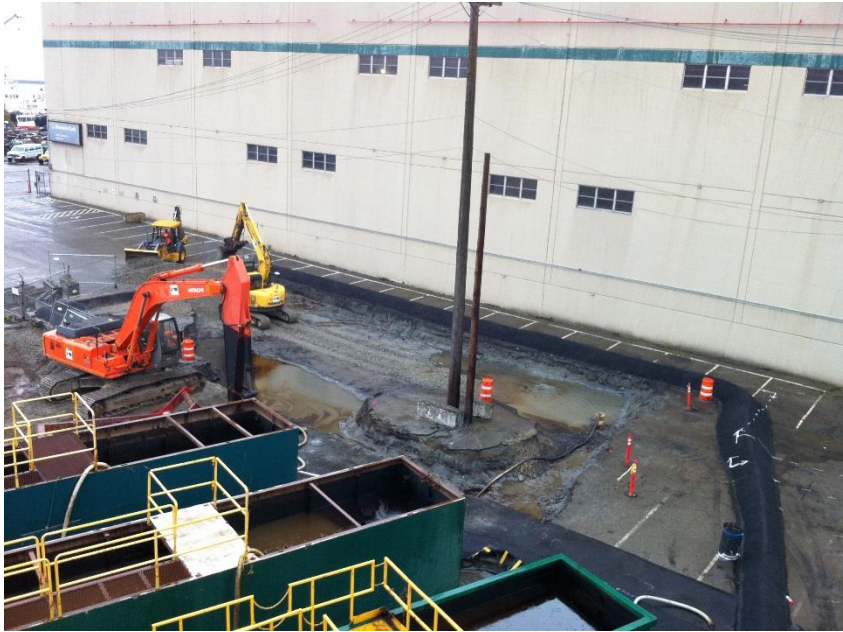
FIGURE 4-6

PHOTOGRAPHS OF BACKFILLING THE BNSF EXCAVATION JANUARY, 2012

The excavation on BNSF property was backfilled using quarry spalls, gravel borrow, and crushed rock. The excavation on the former KC property was backfilled using gravel borrow and crushed rock. The excavations were backfilled in lifts when placing the gravel borrow and crushed rock. Removed asphalt was replaced with asphalt in accordance with local roads standards. Photographs during backfill activities are presented on Figure 4-6.
