Final Groundwater Monitoring Well Construction Report

Simplot Grower Solutions
J.R. Simplot Company

Warden, Washington
October 2023

Prepared by:
HDR Engineering, Inc.
412 E. Parkcenter Blvd., Ste 100
Boise, Idaho 83706-6659

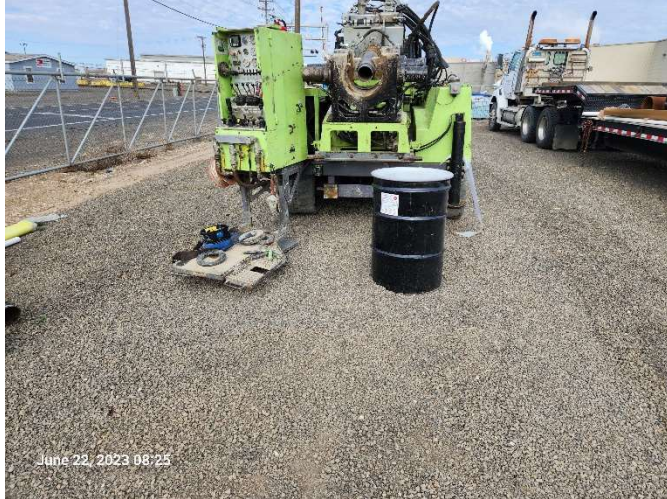
Photo 1. Drill rig setup/location at MW-11S

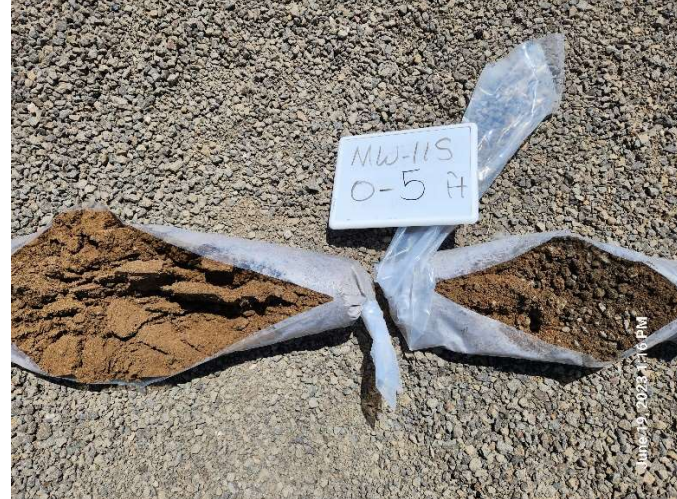
Photo 2. MW-11S soil cuttings; 0 to 5 feet

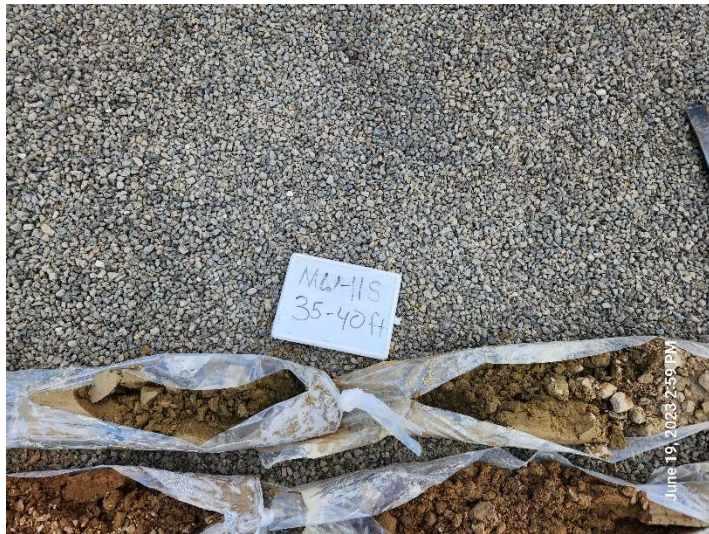
Photo 9. MW-11S soil cuttings; 35 to 40 feet

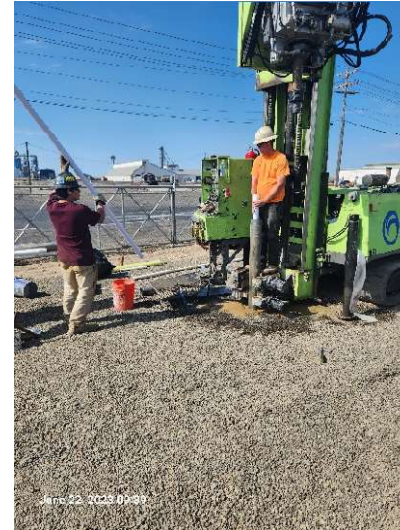
Photo 10. MW-11S PVC placement

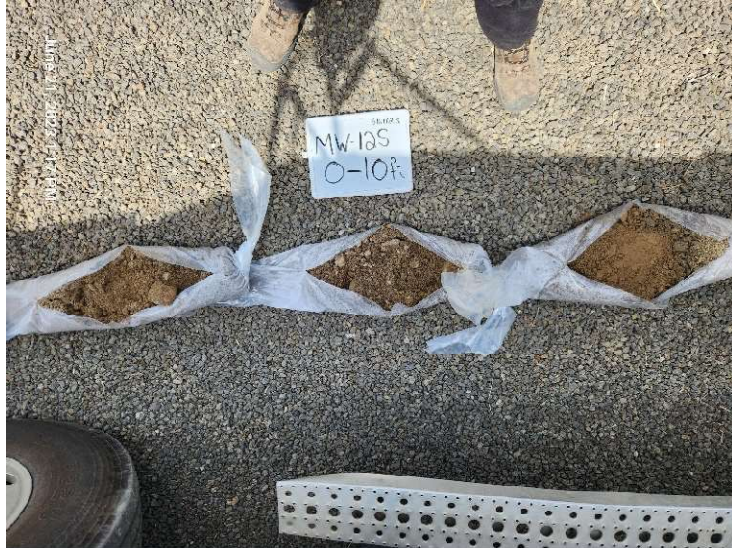
Photo 13. MW-12S soil cuttings; 0 to 10 feet

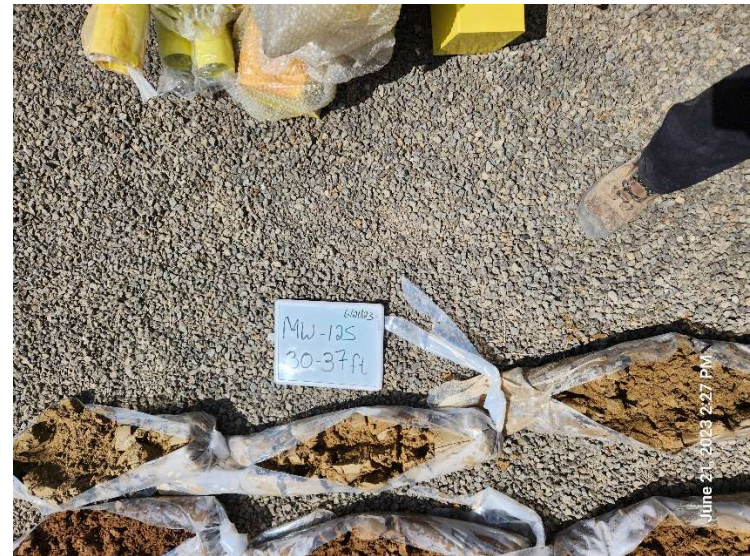
Photo 18. MW-12S soil cuttings; 30 to 37 feet

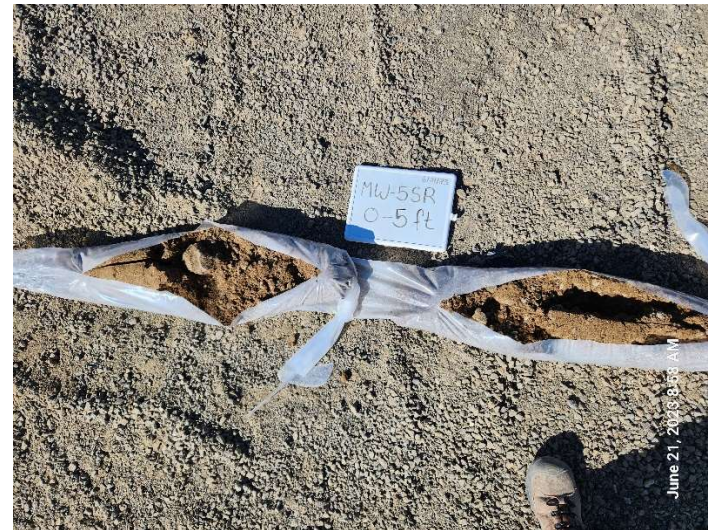
Photo 22. MW-5SR soil cuttings; 0 to 5 feet

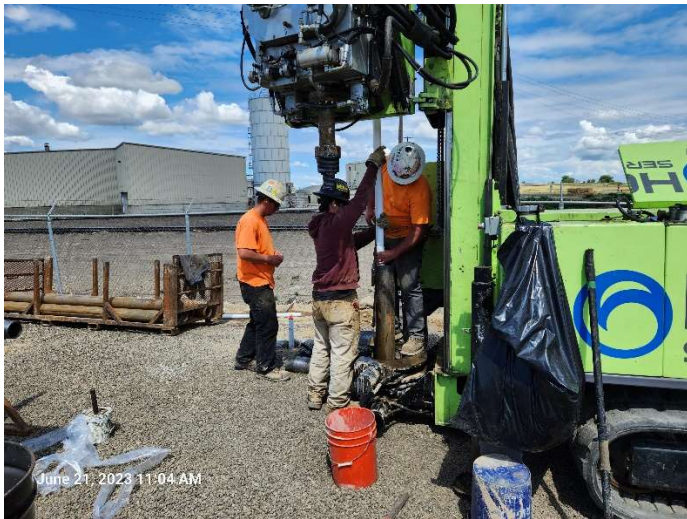
Photo 25. PVC placement at MW-5SR

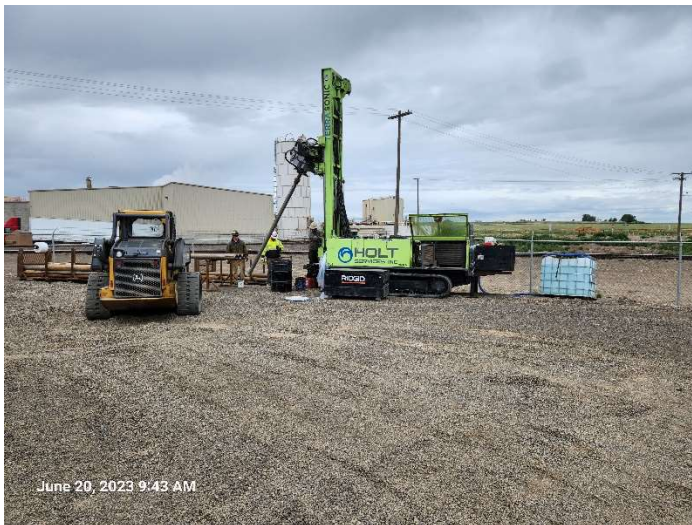
Photo 27. Drilling at MW-5DR

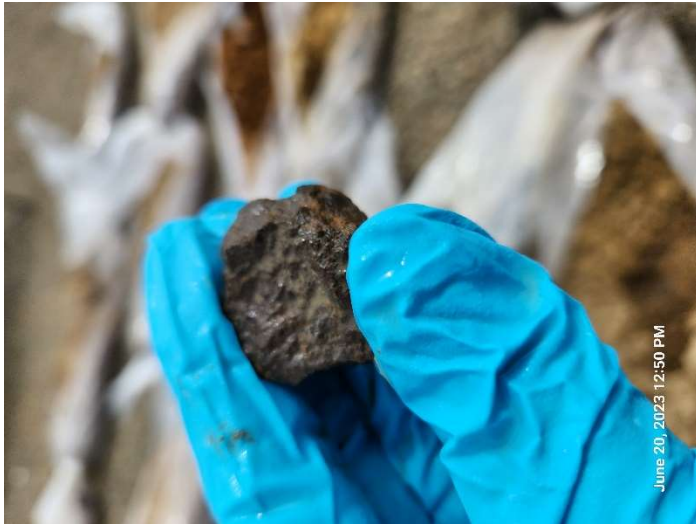
Photo 33. Piece of basalt from MW-5DR

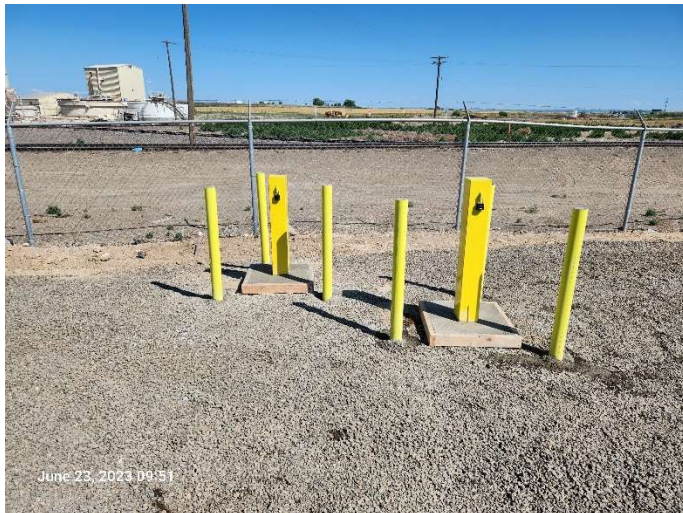
Photo 35. MW-5SR and MW-5DR monuments
