August 18, 2023

Project No. M0615.20.008

Re: Supplemental Investigation, Port Parcel 110  
Taylor Way and Alexander Avenue Fill Area

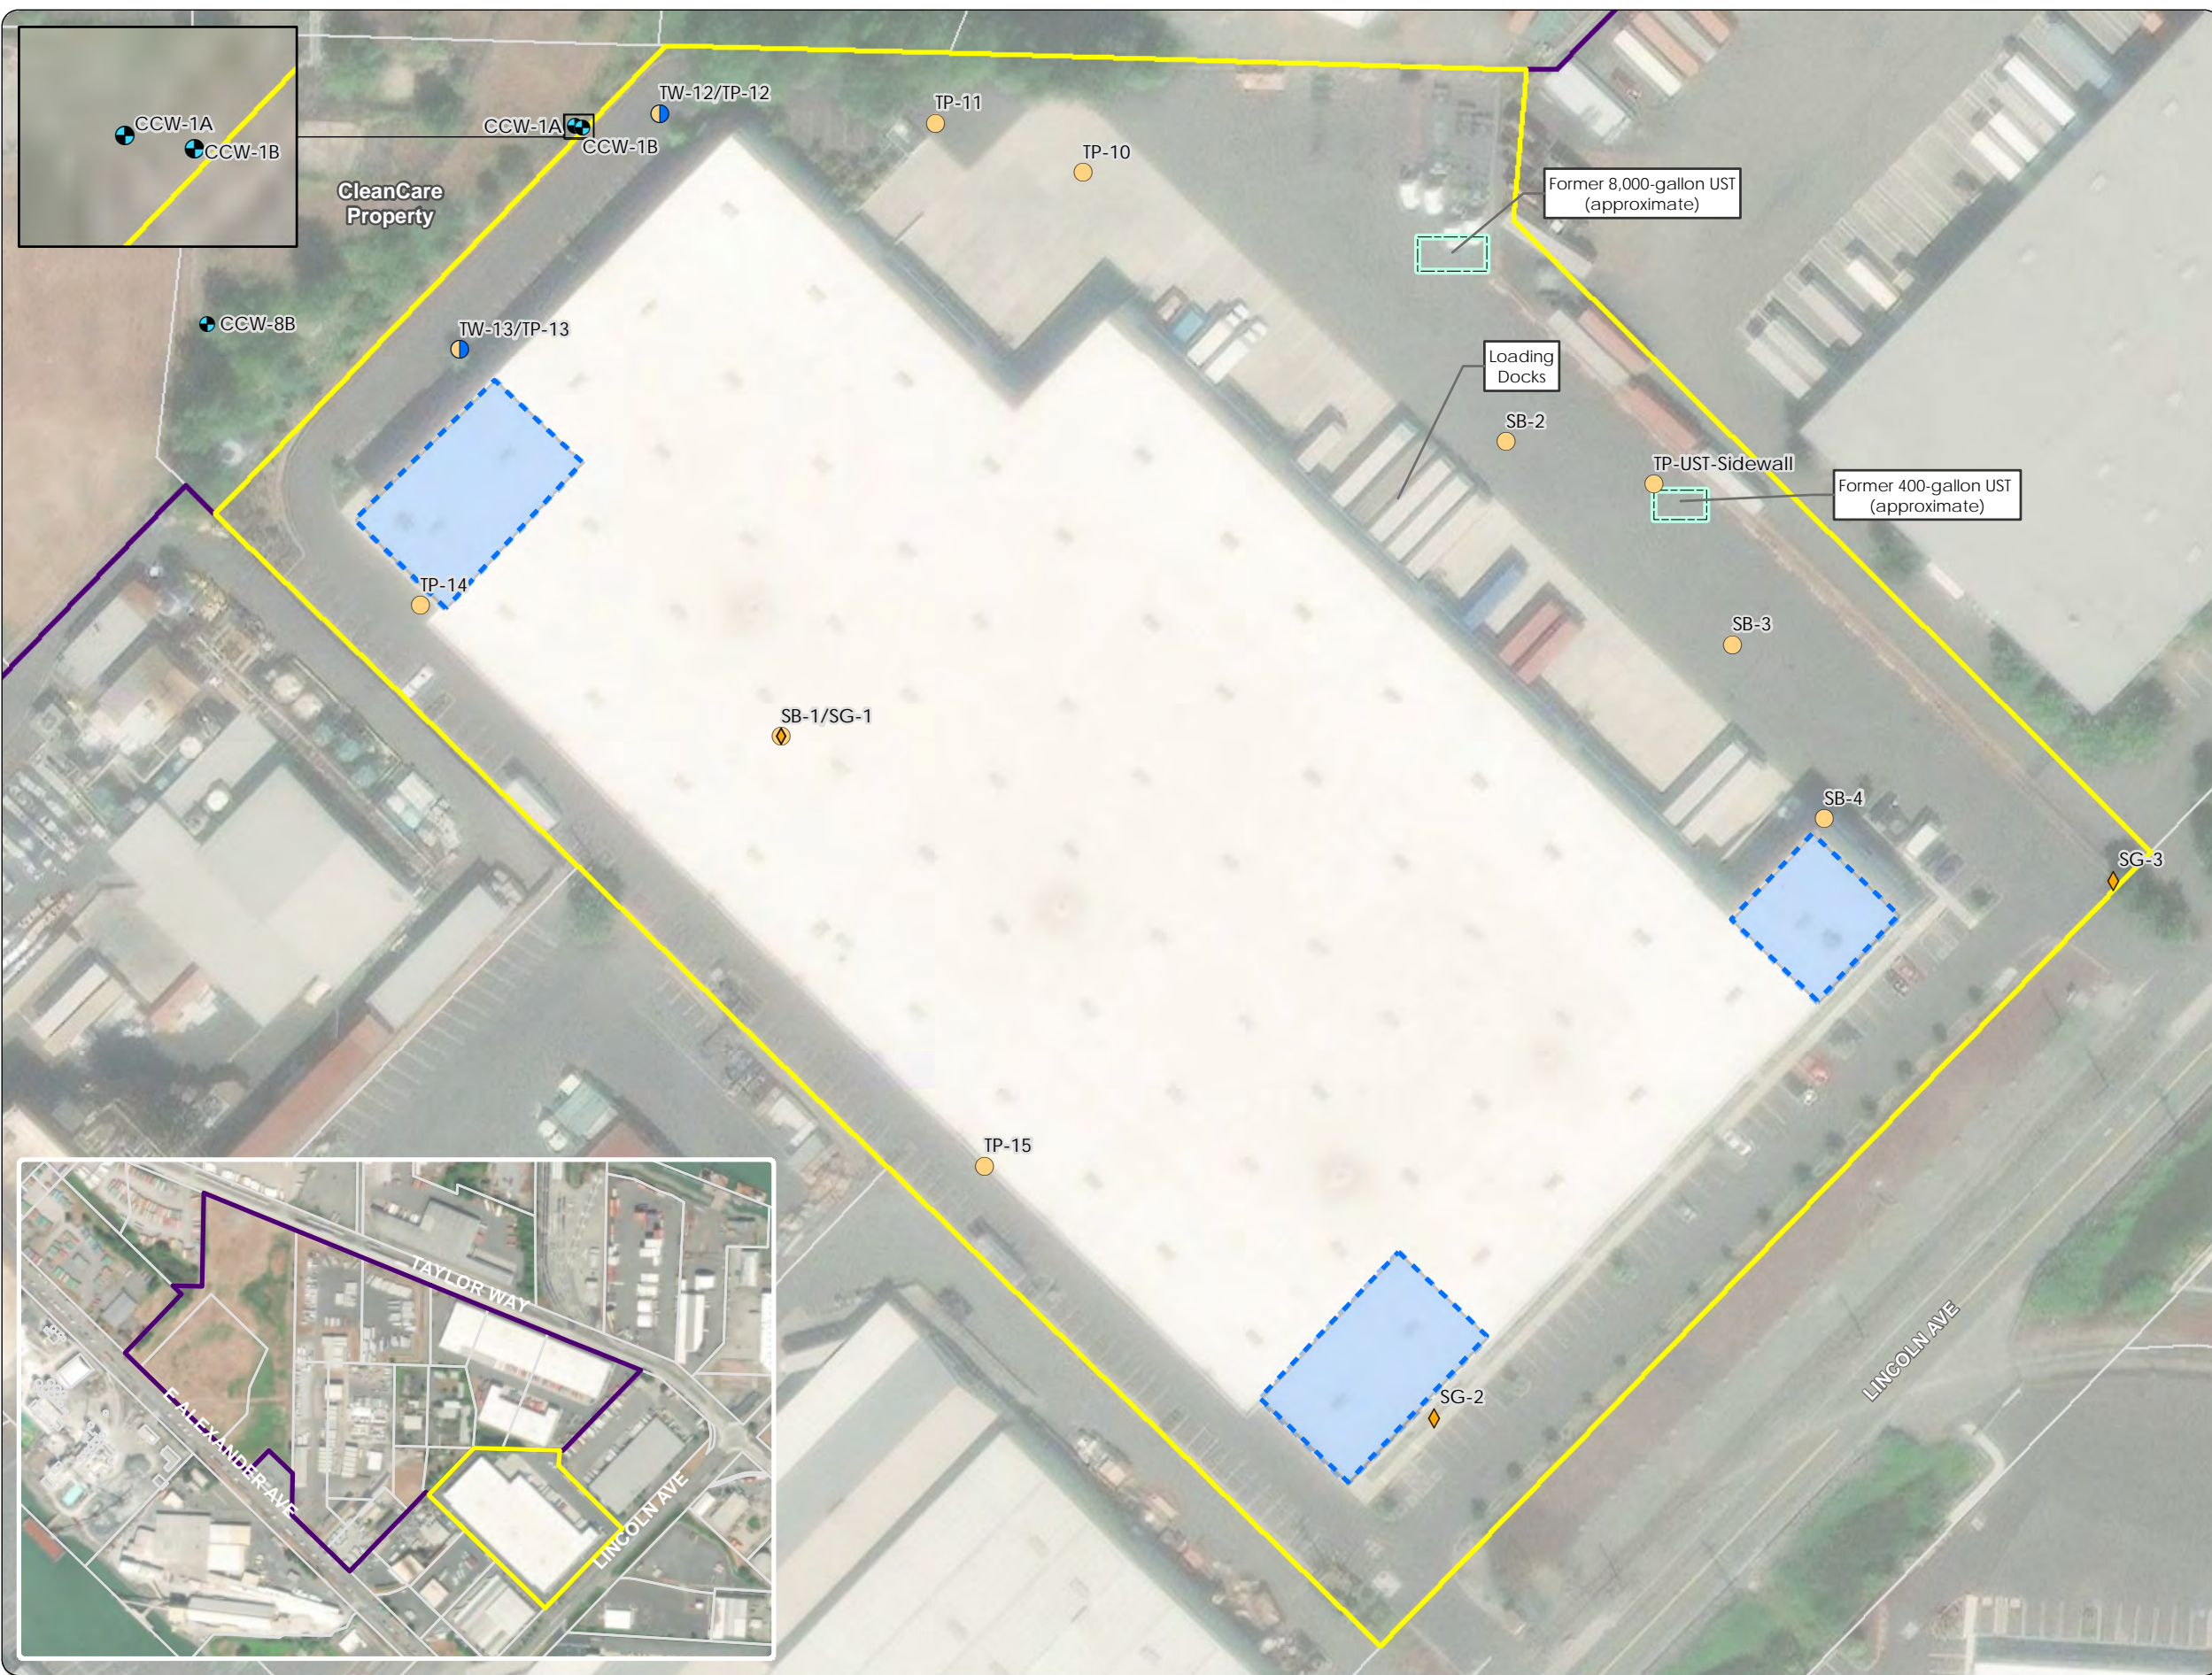
Figure 2  
Property Features  
Port of Tacoma  
Parcel 110  
3401 Lincoln Avenue  
Tacoma, Washington

The Parcel 110 Property (Pierce County tax parcel number 321351051) is an approximately 9-acre lot located southeast-adjacent to the TWAFA site (see Figures 1 and 2). Parcel 110 is occupied by

In 2019, the current warehouse building with a dedicated stormwater system was constructed on the Parcel 110 Property. The building was constructed with a 6-inch-thick concrete slab-on-grade foundation, with a sub-slab vapor barrier beneath the office areas (see Figure 2).

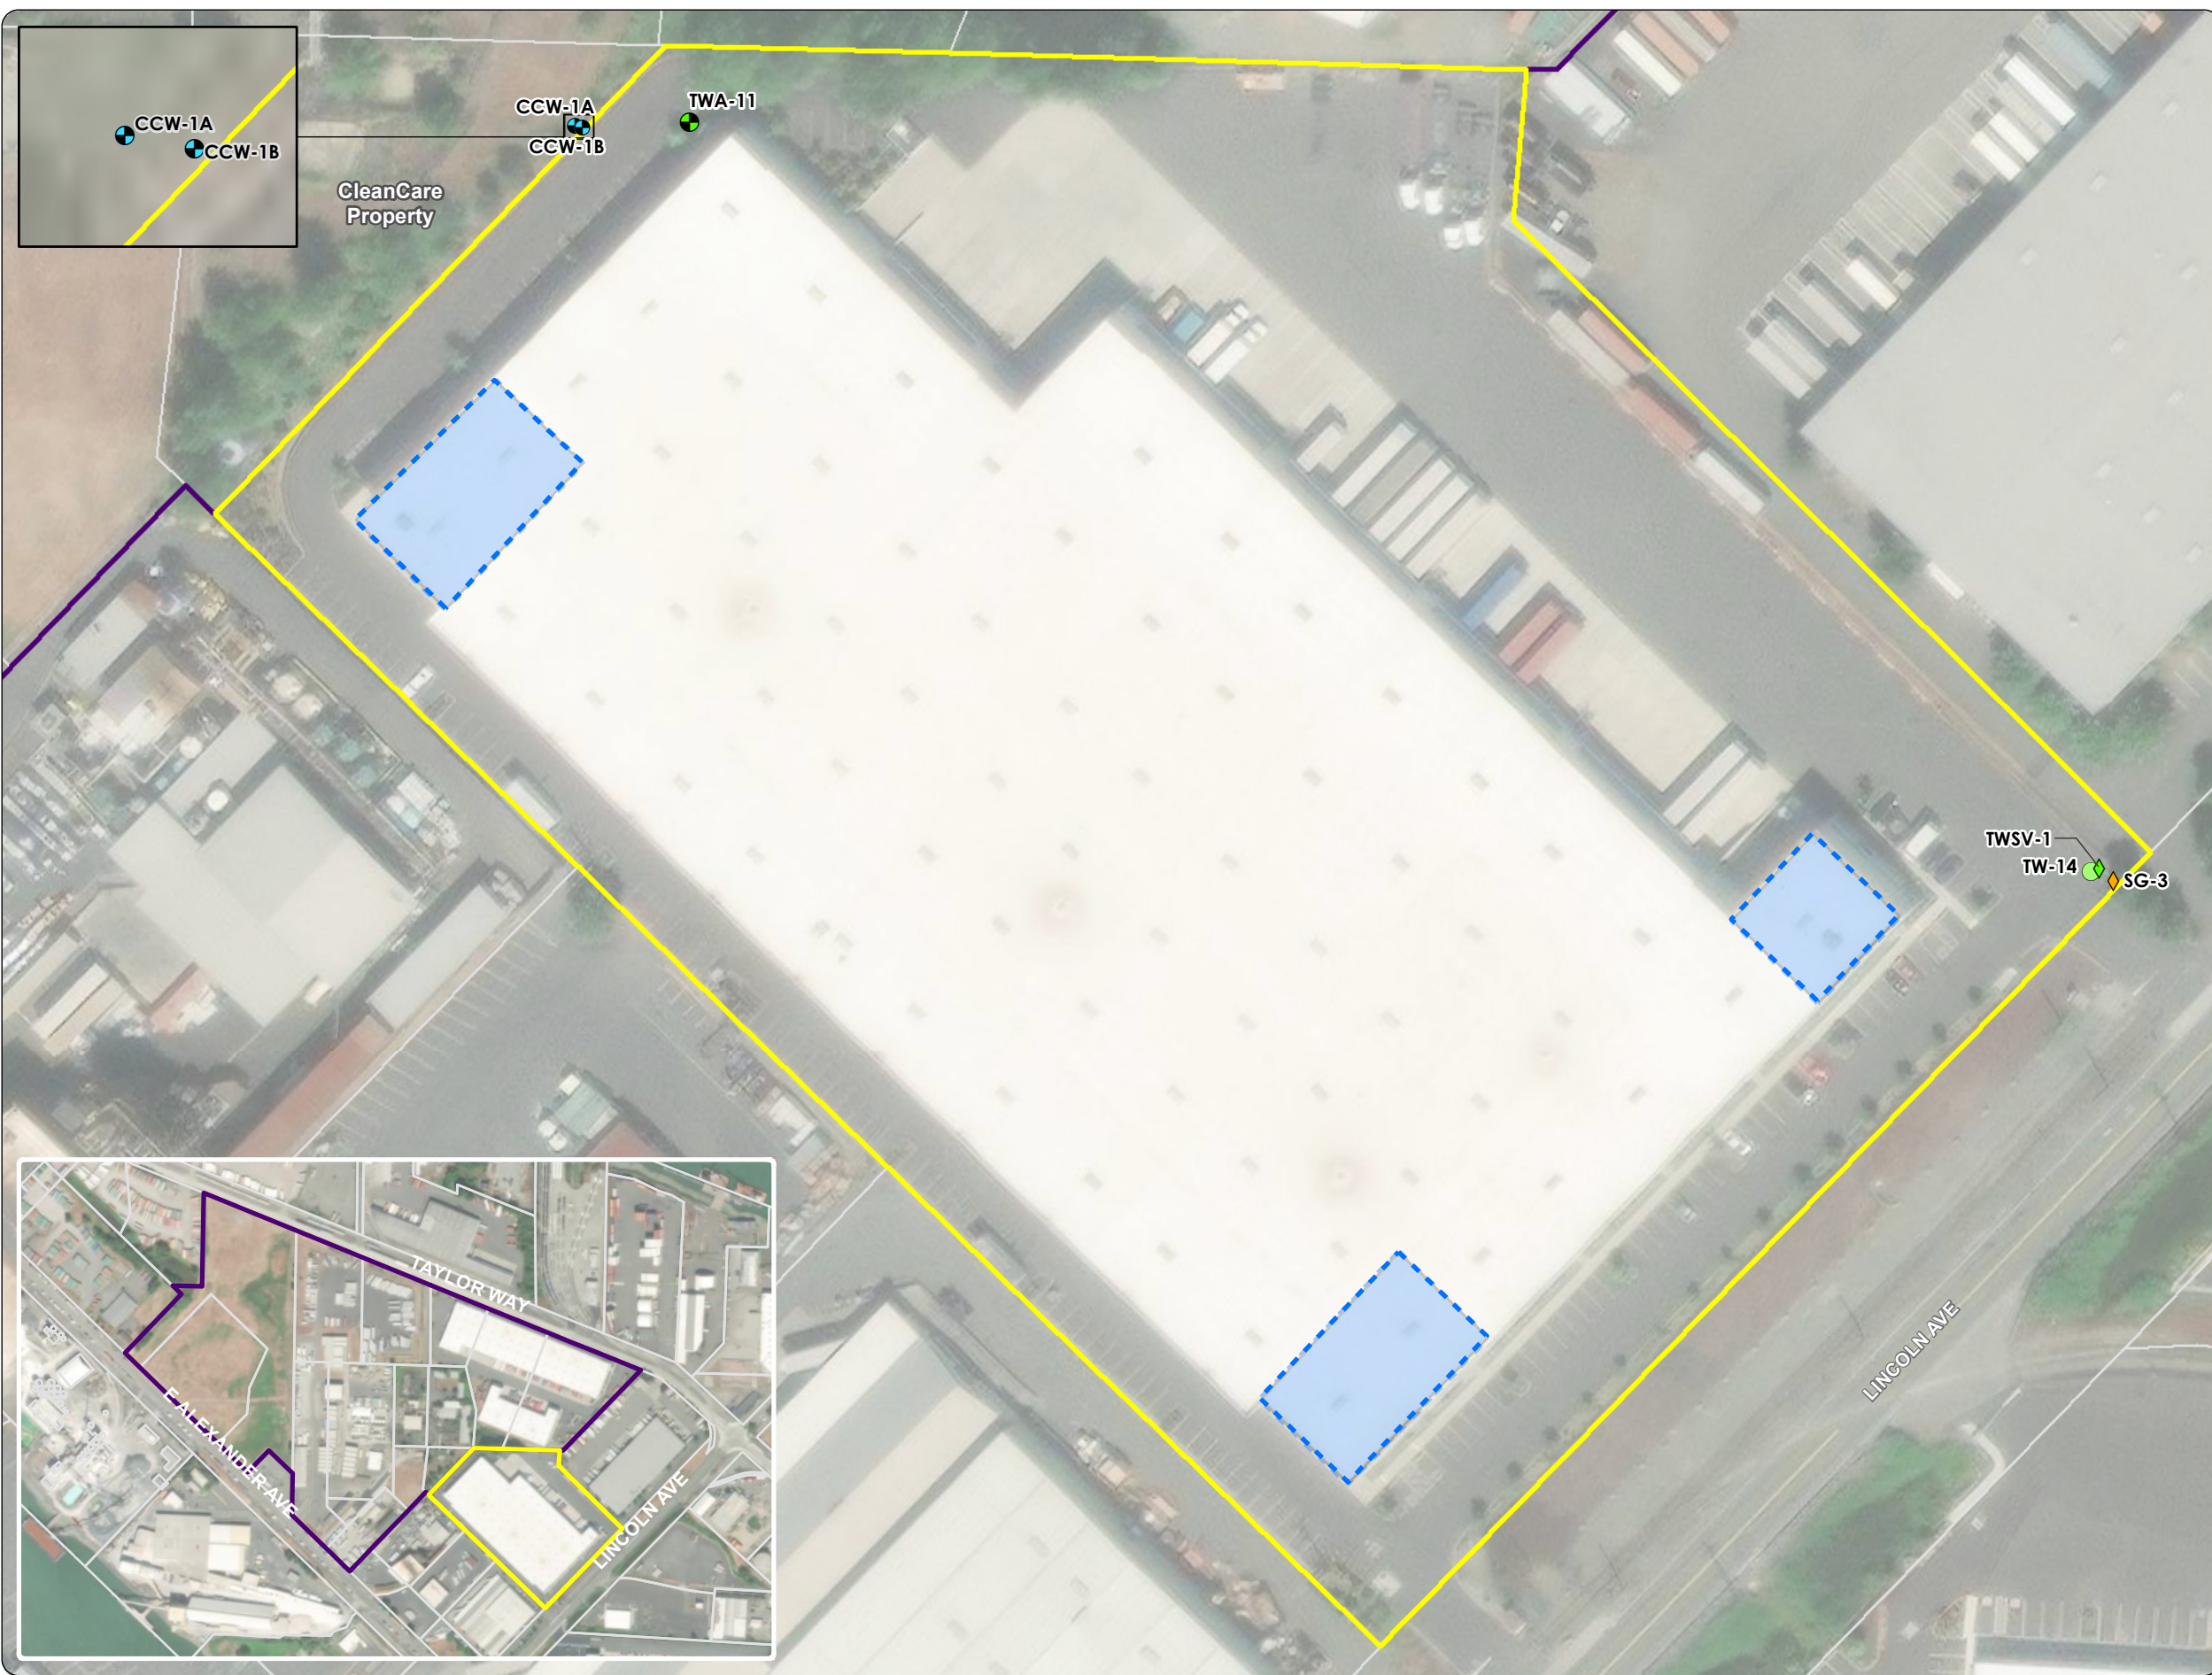
**Figure 3**  
**Sample Locations**  
Port of Tacoma  
Parcel 110  
3401 Lincoln Avenue  
Tacoma, Washington

In 2018, TCE exceeded the sub-slab soil gas MTCA Method C non-cancer screening level at a concentration of 210 ug/m<sup>3</sup> at sample location SG-3 (see Figure 3). However, as noted in the *Supplemental Investigation Work Plan* (MFA 2023), Floyd Snider collected the sample using post-run tubing methodology at a depth shallower than 5 feet bgs, likely due to the shallow groundwater table. The shallow sampling depth increases the likelihood for ambient air to be drawn into the sampling train. Further, Floyd Snider did not use a leak-check compound to evaluate sample train leaks or ambient air infiltration. During this 2023 investigation, TCE was detected at TWSV-1 at a

concentration of 6.5 ug/m<sup>3</sup>, well below the 2018 detection at SG-3, below the MTCA Method B and MTCA Method C screening levels, and below the short-term action limit.

Sample locations were measured in the field using a differential GPS device. Only detected CVOCs and associated concentrations are shown. Analytical data summaries are provided in Tables 1-3.

Additionally, CVOCs in the soil gas sample collected near the northeast corner of the Parcel 110 Property (in the vicinity of historical soil gas sample SG-3) were below screening levels; the historical exceedance near this location is not representative of current conditions.

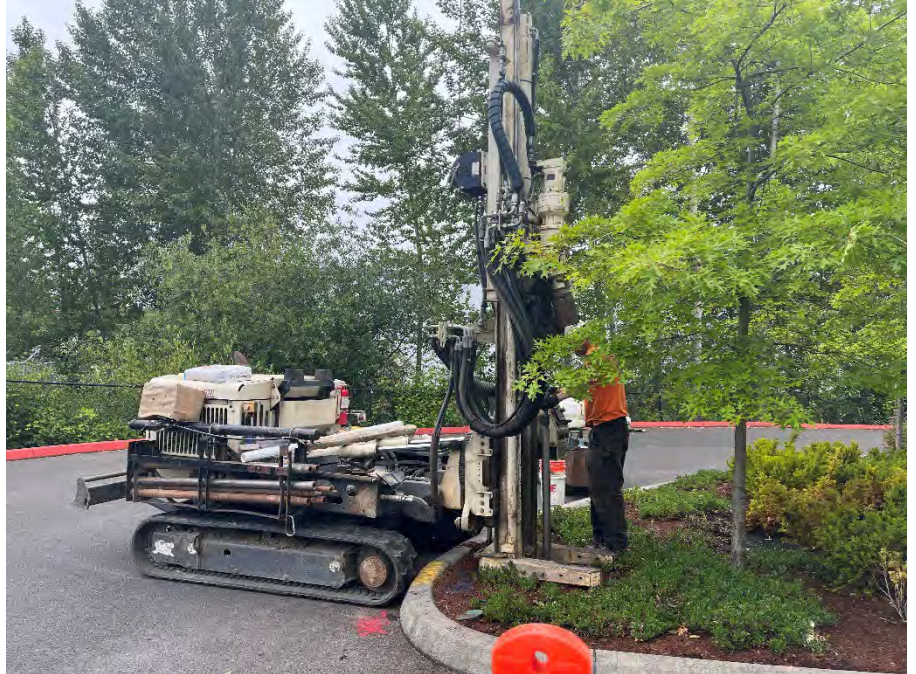
Geoprobe drill rig at location TWA-11 near the northern corner of 3401 Lincoln Avenue, Tacoma, Washington (the Parcel 110 Property). Photograph taken during field activities on June 27, 2023.

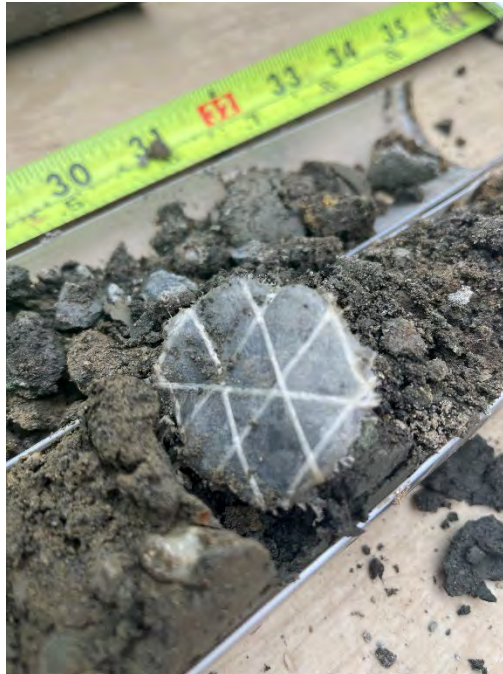
## Photo No. 2.

Unknown material (potentially a piece of textile fabric) observed at 2.5 feet below ground surface (bgs) from soil boring taken from TWA-11 on the northern portion of the Parcel 110 Property. Photograph taken during field activities on June 27, 2023.

1.7		60			@ 1.7 feet: Gray concrete chunk.
2.5					@ 2.5 feet: White textile liner.
3.0					3.0 to 5.0 feet: NO RECOVERY.
5.0					5.0 to 5.8 feet: SANDY SILTY GRAVEL (GM); grayish brown; 20% fines, low plasticity; 30% sand, fine to coarse; 50% gravel, fine to medium, subangular to subrounded; medium dense; no odor; moist.

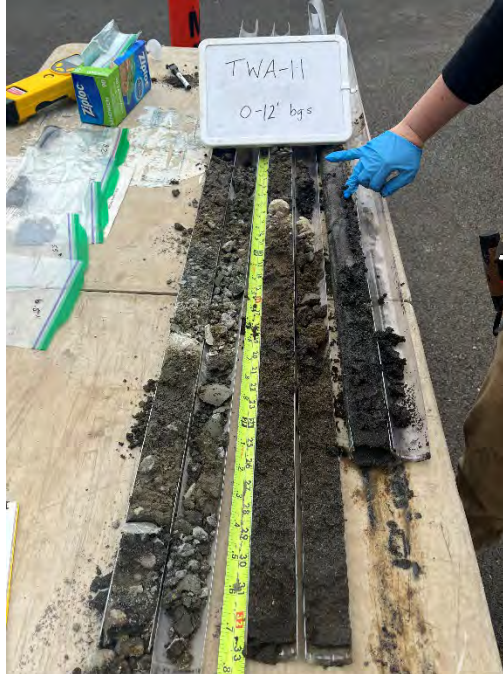
Soil core from 0 to 12 feet bgs taken from location TWA-11 on the northern portion of the Parcel 110 Property. Photograph taken during field activities on June 27, 2023.

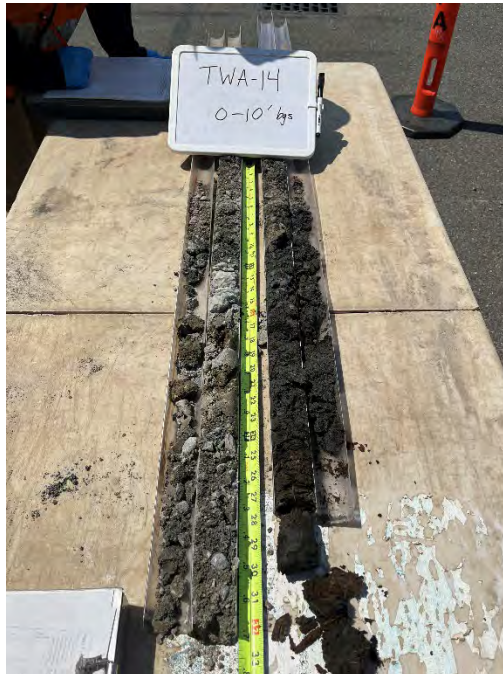
## Photo No. 4.

Soil core from 0 to 10 feet bgs taken from location TW-14 on the southeast portion of the Parcel 110 Property. Photograph taken during field activities on June 27, 2023.

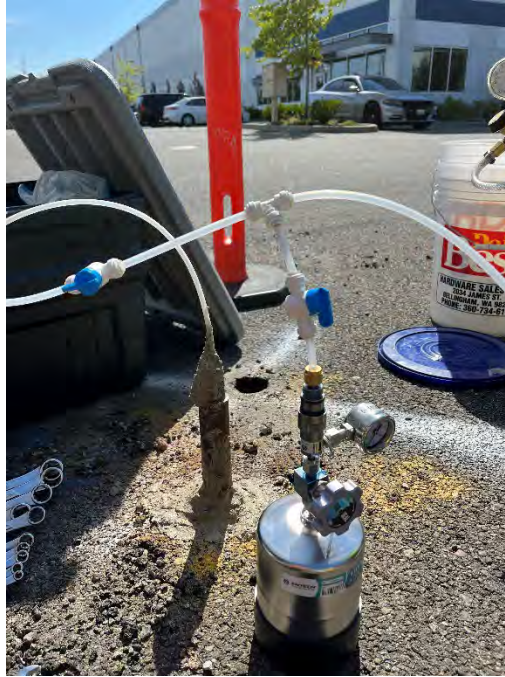
Soil vapor sample train at location TWSV-1 (stepped out approximately 1 foot from soil boring TW-14) on the southeast portion of the Parcel 110 Property. Photograph taken during field activities on June 27, 2023.

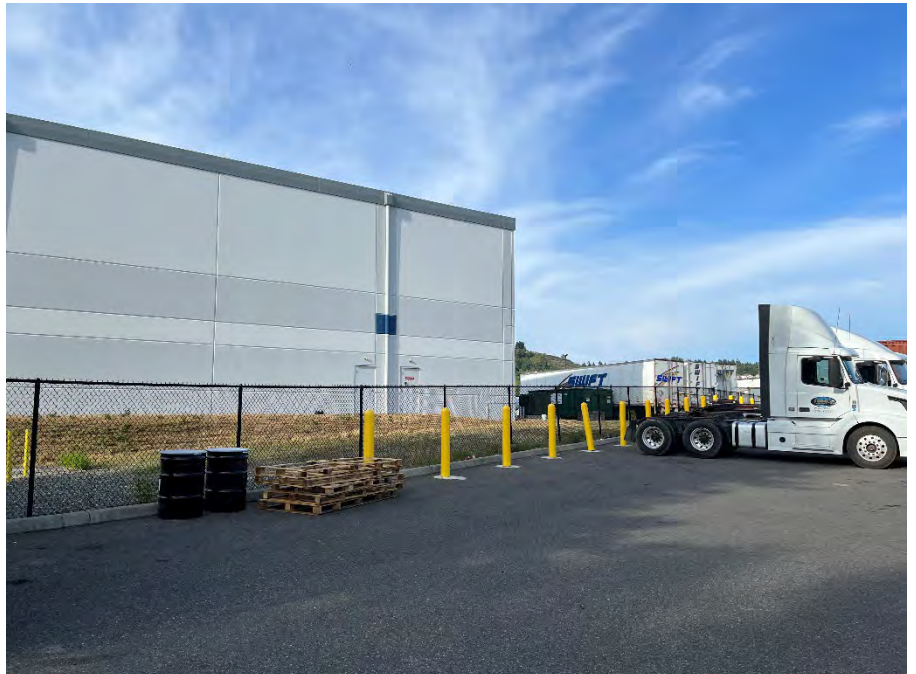
## Photo No. 6.

Investigation-derived waste (IDW) container locations on the eastern portion of the Parcel 110 Property. Photograph taken during field activities on June 27, 2023.

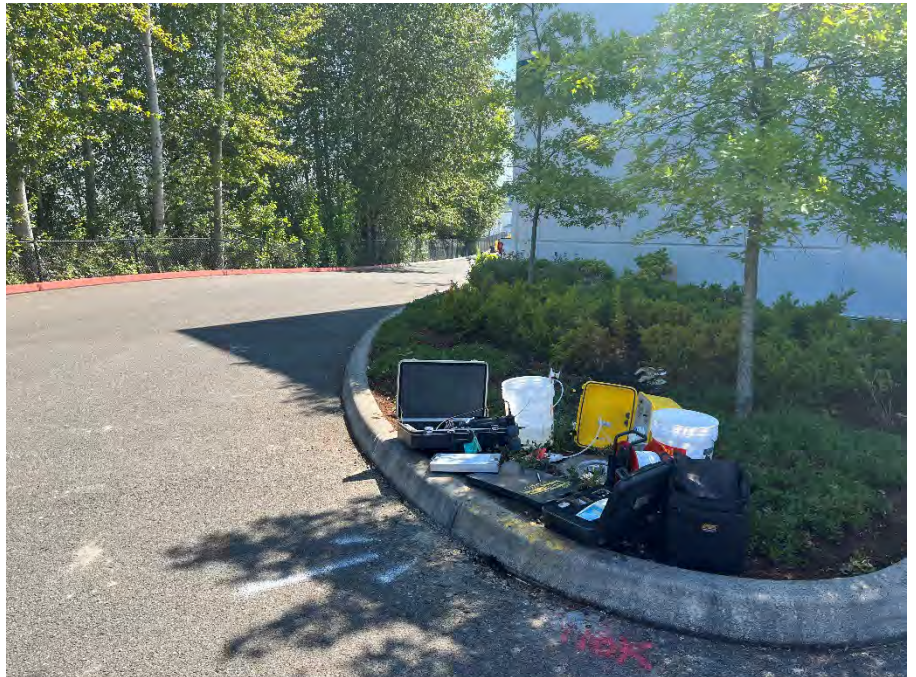
Groundwater sample collection set up at monitoring well TWA-11 on the northern portion of the Parcel 110 Property. Photograph taken during groundwater sampling on June 28, 2023.
