INITIAL INVESTIGATION FIELD REPORT

SITE INFORMATION

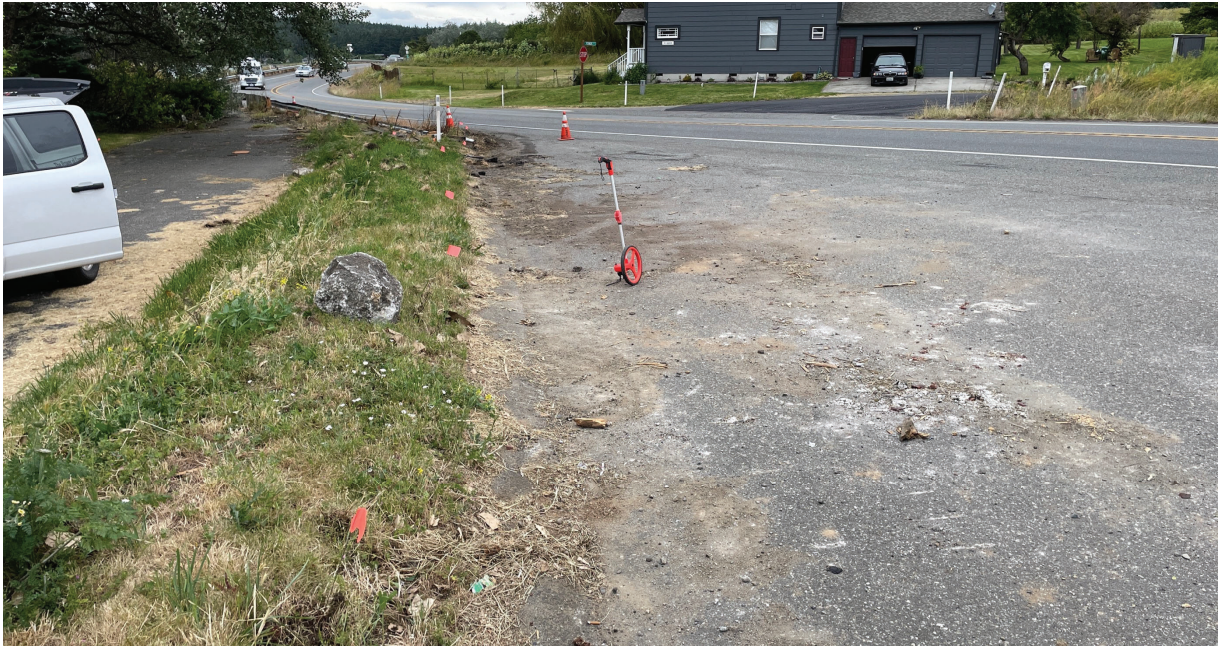
Photo 5 *View of soil screening locations along the shoulder of State Route 20 | Facing west | June 28, 2022*

On June 19, 2022, a truck carrying paper products was involved in a single-vehicle accident at Penn Cove Pottery in Coupeville, WA. GHD (the consultant) performed a site visit within 10 days of the accident and observed staining from hydrocarbons and absorbent materials in the area of the accident. The nearest water body, Penn Cove is 30 meters south of the accident location. Moderate levels of VOCs were present in photoionization detector (PID) readings. The readings provide an indication that there was a release, but it was not characterized.
