# DATA GAP REPORT AND REMEDIAL INVESTIGATION WORK PLAN

Sundberg Gravel Pit

Prepared for: Green Cove Park LLC

Project No. 210577 • June 1, 2023 PUBLIC-REVIEW DRAFT

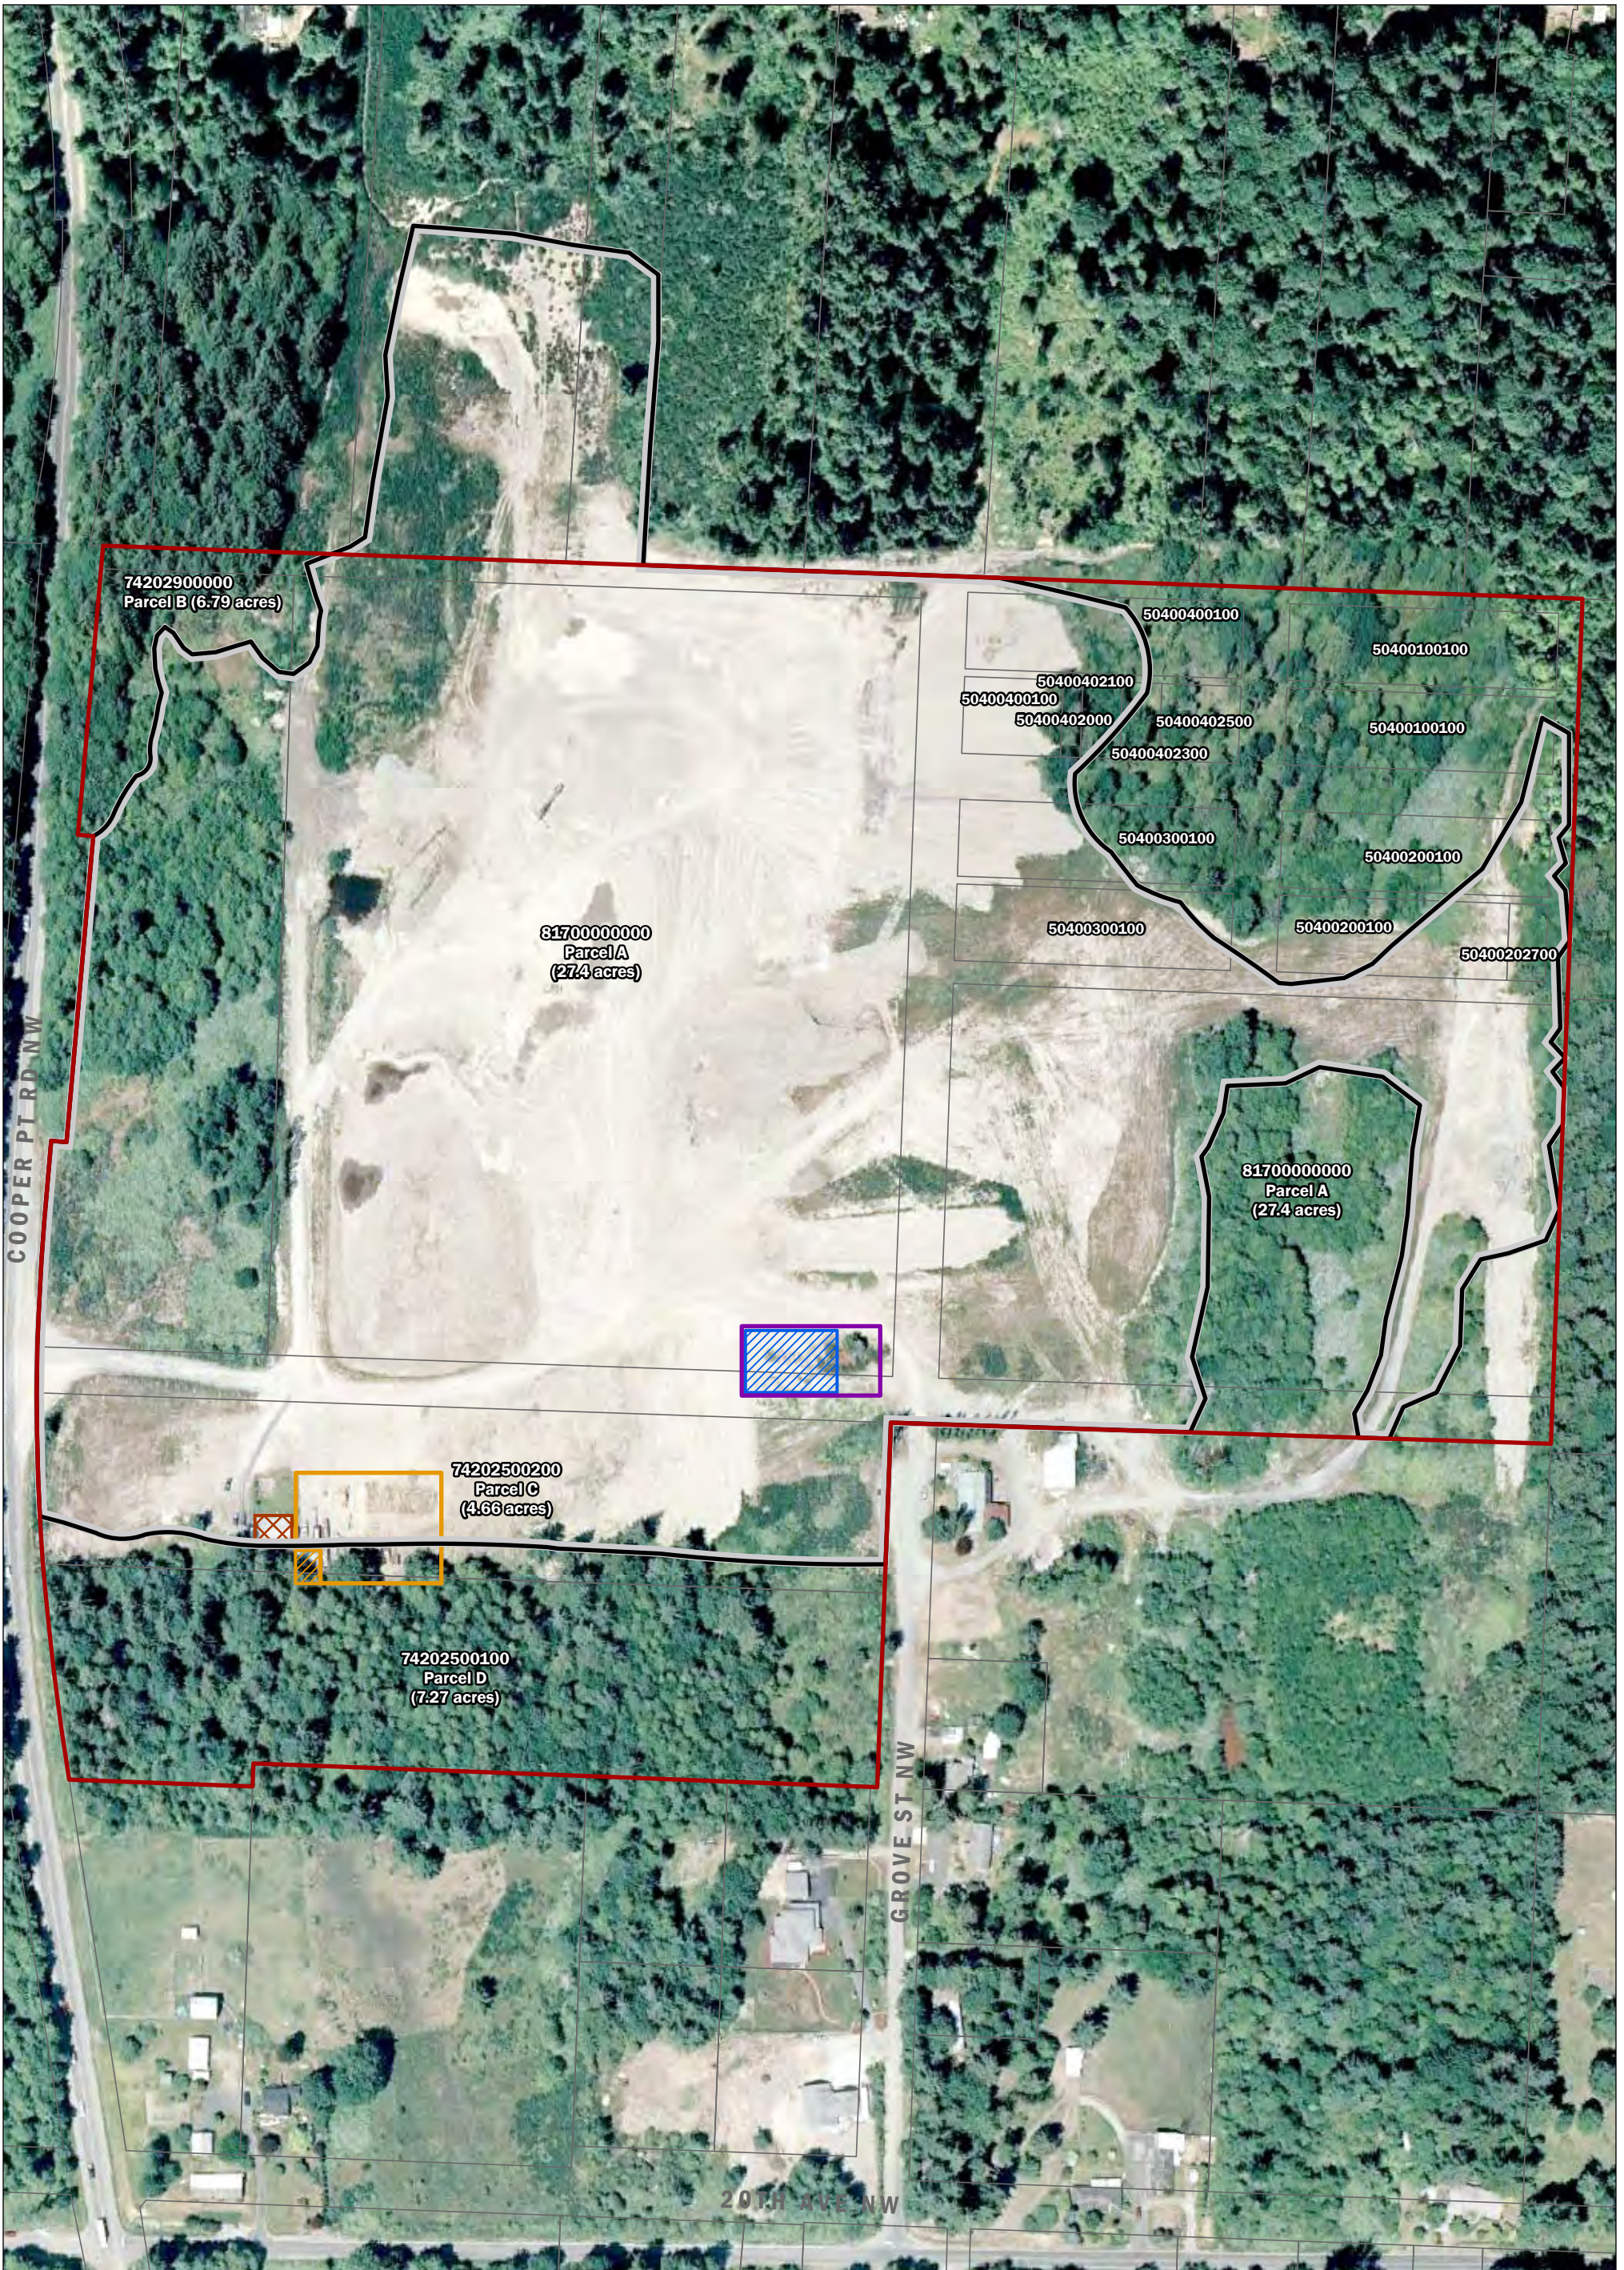
Approximate limits of historical land disturbance (inferred from LiDAR)	Approximate limits of former garage area	Thurston County Tax Parcel
Approximate location of former Underground Storage Tank (UST) and petroleum-impacted soil stockpile	Historical Shed/Shack Area (1960-1990)	N 0 100 200 Feet
Approximate limits of former garage (1980s-2010s)	Former Residence	
Subject Property	Subject Property

**Subject Property Map showing Historical Features**  
 Data Gaps Report and RI Work Plan  
 Sundberg Gravel Pit  
 Olympia, Washington

The largest tax parcel, herein referred to as Parcel A (Figure 2), along with adjoining portions of Parcels B and C, were used for intermittent sand and gravel mining beginning in approximately 1960 through the 1990s (AMEC, 2004; ENPRO, 2020). Although there are no available records, based on the observed fill conditions on the Subject Property, reclamation (filling of mined areas) appears to have also been intermittent, which is consistent with the requirements for segmental reclamation of surface mines (RCW 78.44.111).

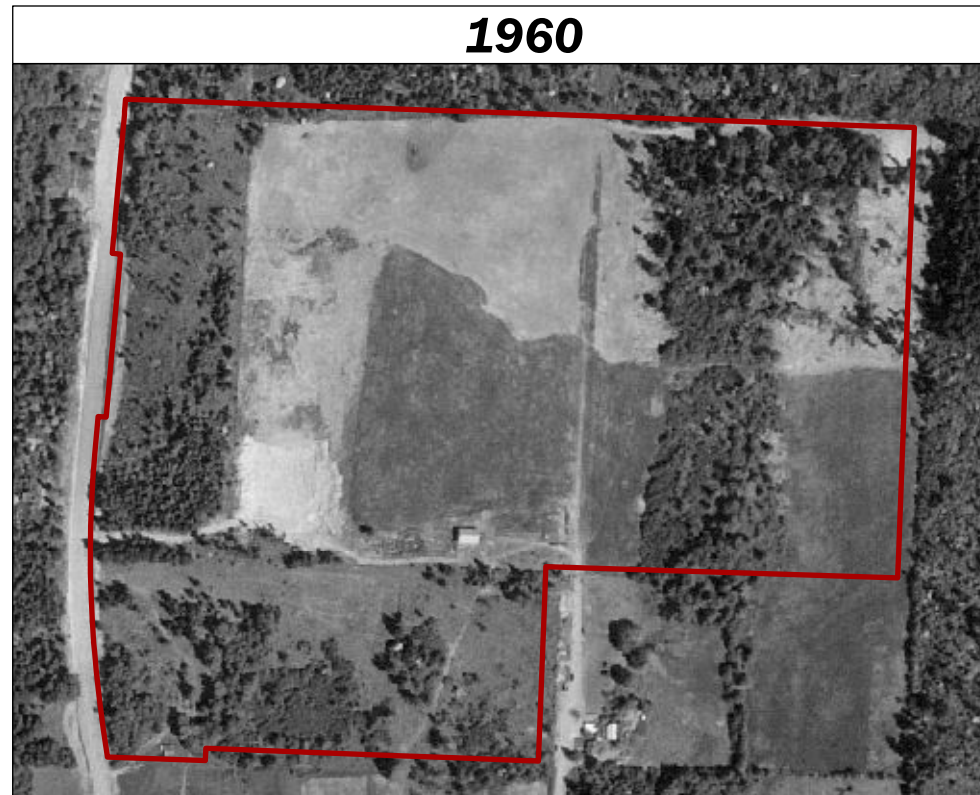
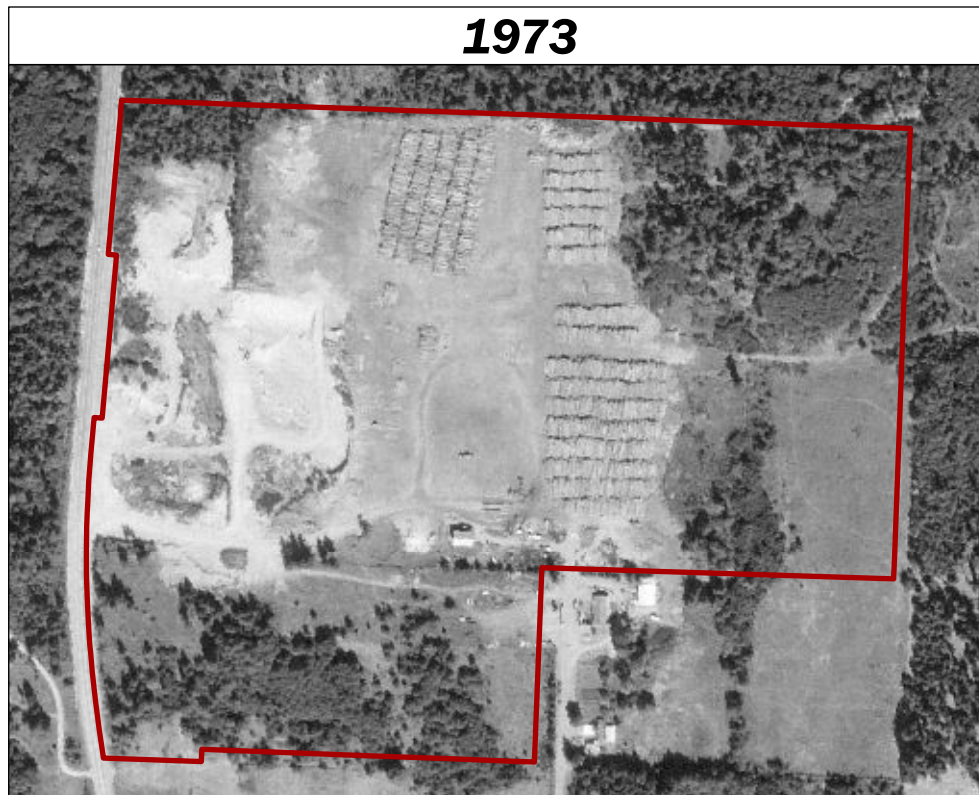
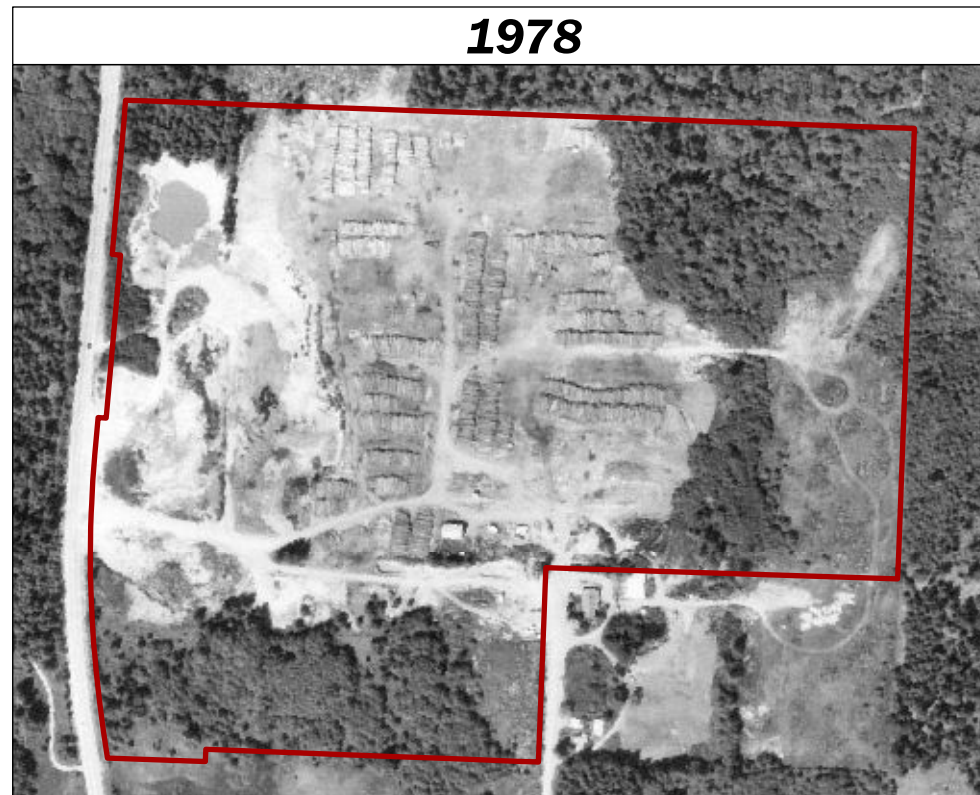
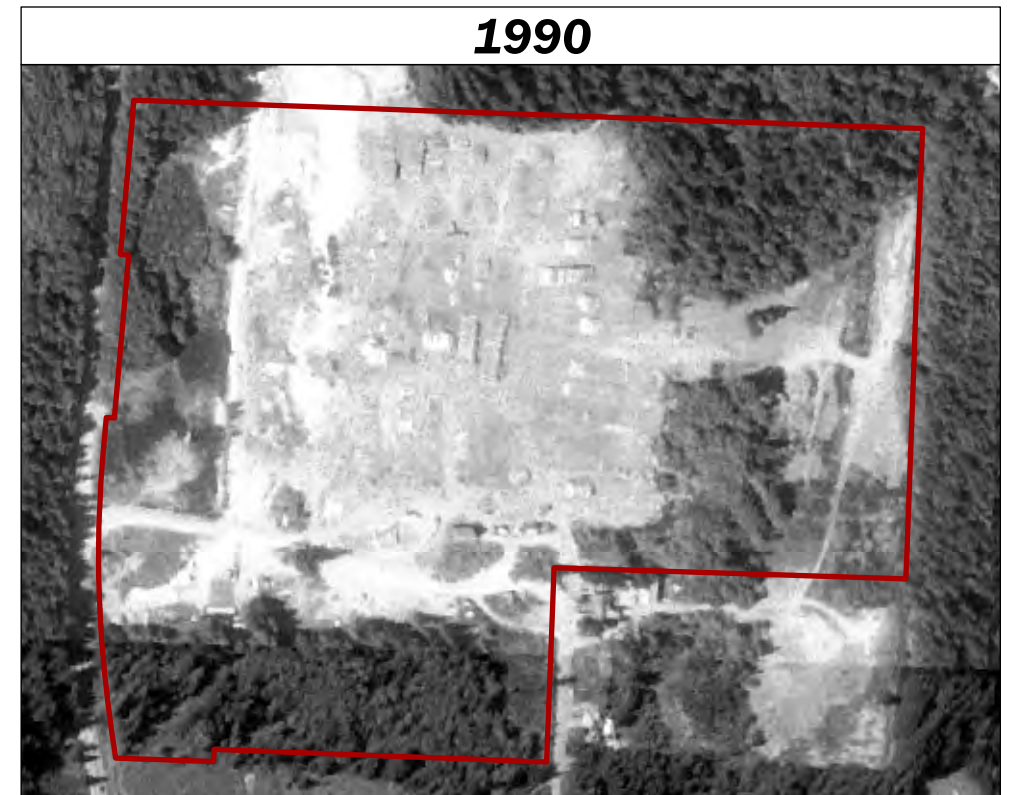
FIGURE NO.  
**5a**

**Aerial Photos 1942-1990**

A series of historical aerial photographs are provided on Figures 5a and 5b to depict Subject Property conditions over time. A 1942 aerial photograph shows the Subject Property primarily vacant and covered in vegetation except for a small structure located in the south-central portion of the Subject Property. Some clearing is evident in the 1960 aerial photograph along with a small area of land disturbance to the west of the 1942 structure, which is still visible. This is consistent with historical documentation of gravel mining commencing on the Subject Property around 1960. The 1965 aerial photograph shows expansion of land disturbance to the west and north. The 1973 aerial photograph shows further expanded grading and land disturbance to the north along the western Subject Property boundary and log piles in the central portion of the Subject Property. The 1978 aerial photograph shows similar conditions with grading along the western Subject Property boundary and log-pile storage in the central portion.

The 1990 aerial photograph shows reclamation along the western portion of the Subject Property, where previous aerial photographs showed evidence of grading. The small structure first observed in the 1942 aerial photograph is still present, and a new structure is shown in the southwest portion of the Subject Property. Log piles remain in the central portion of the Subject Property in the 1990 aerial photograph, but are fewer than previously depicted. Clearing is evident along the eastern Subject Property boundary in the 1990 aerial photograph. The 1990 aerial photograph also shows clearing and grading that appears to extend off the western portion of the Subject Property to the north. The 2003 aerial photograph shows the largest area of grading in the west-central portion of the Subject Property of any of the aerial photographs and is used to help determine the extent of land disturbance on the Subject Property (Figure 4). The small structure first seen in the 1942 aerial photograph is no longer present on the Subject Property in the 2003 aerial photograph. The aerial photographs dated between 2005 and 2018 show no evidence of additional land disturbance and depict similar conditions with vegetation growing over mined and reclaimed areas and a number of access roads and trails.

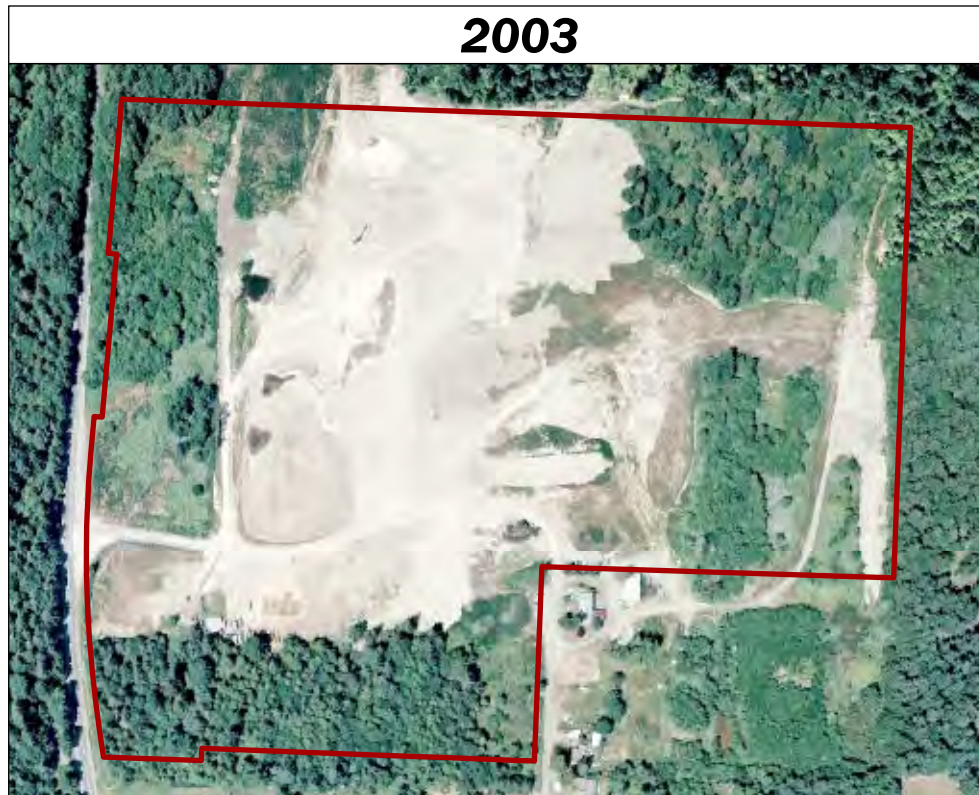
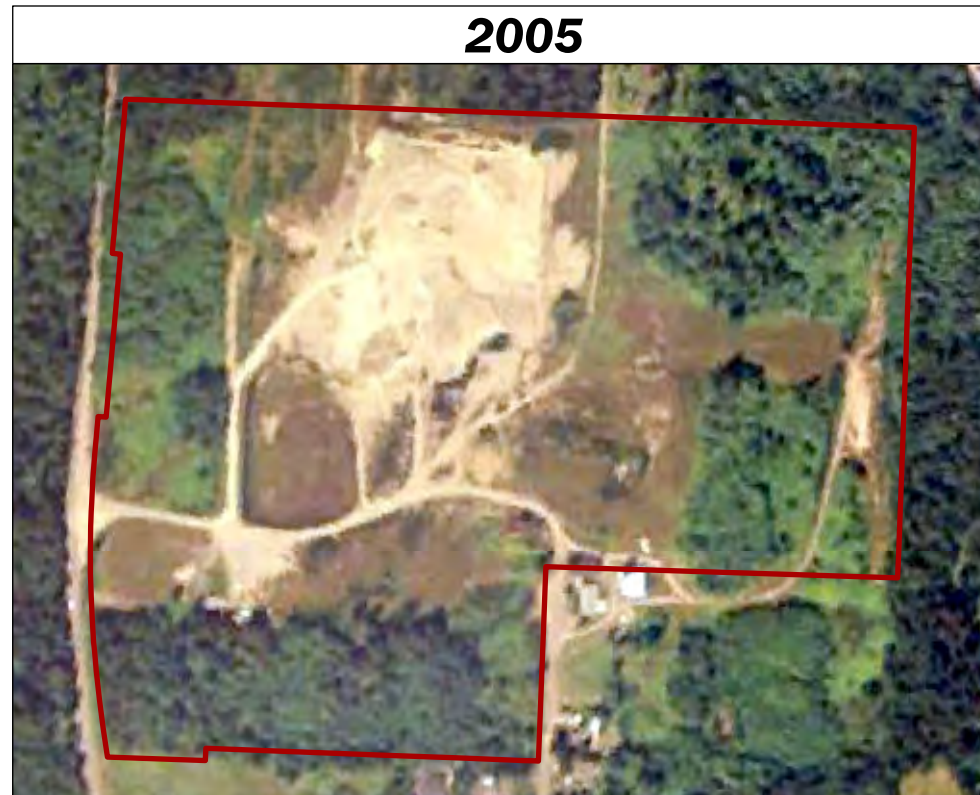
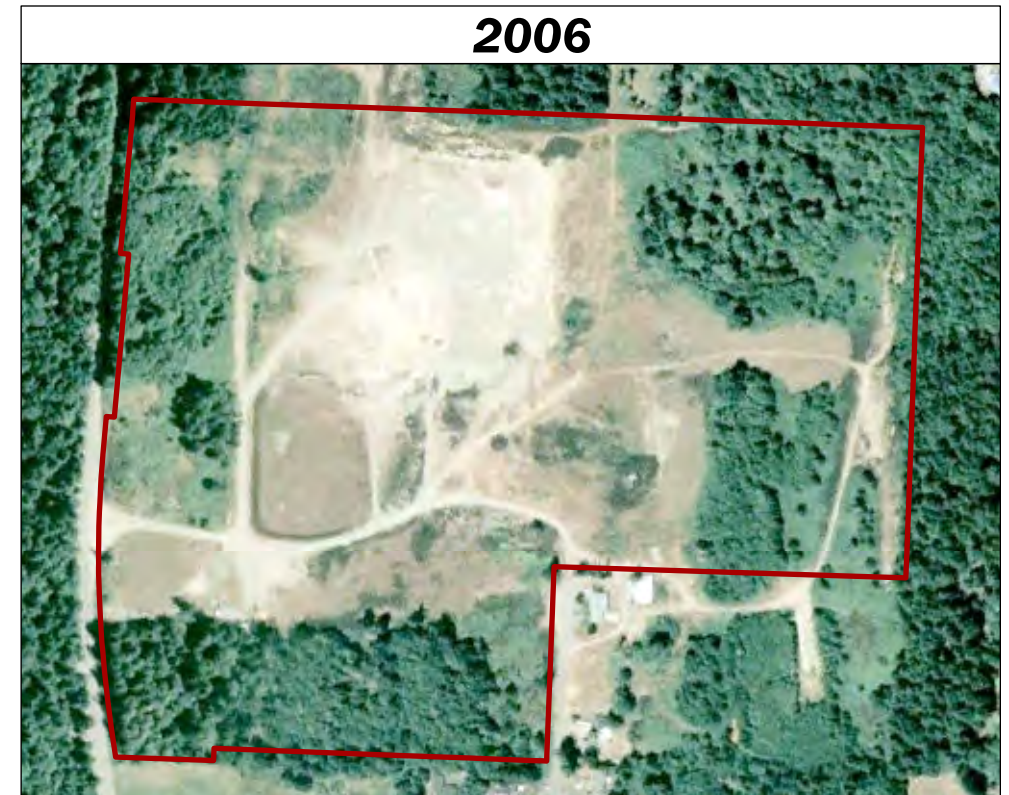
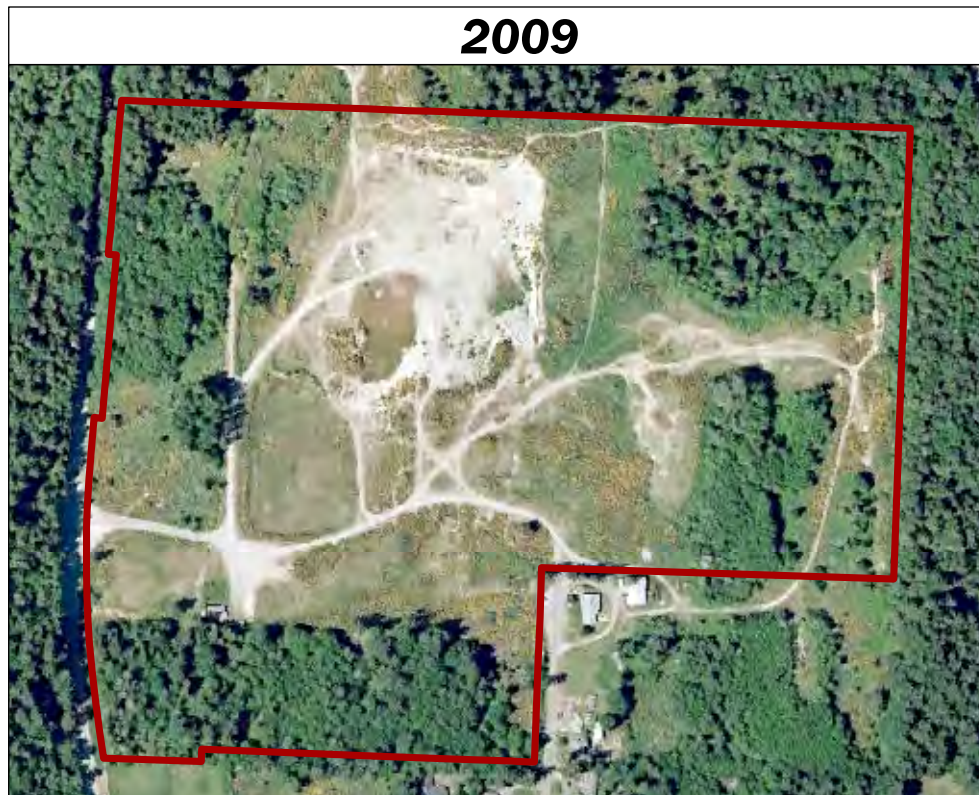
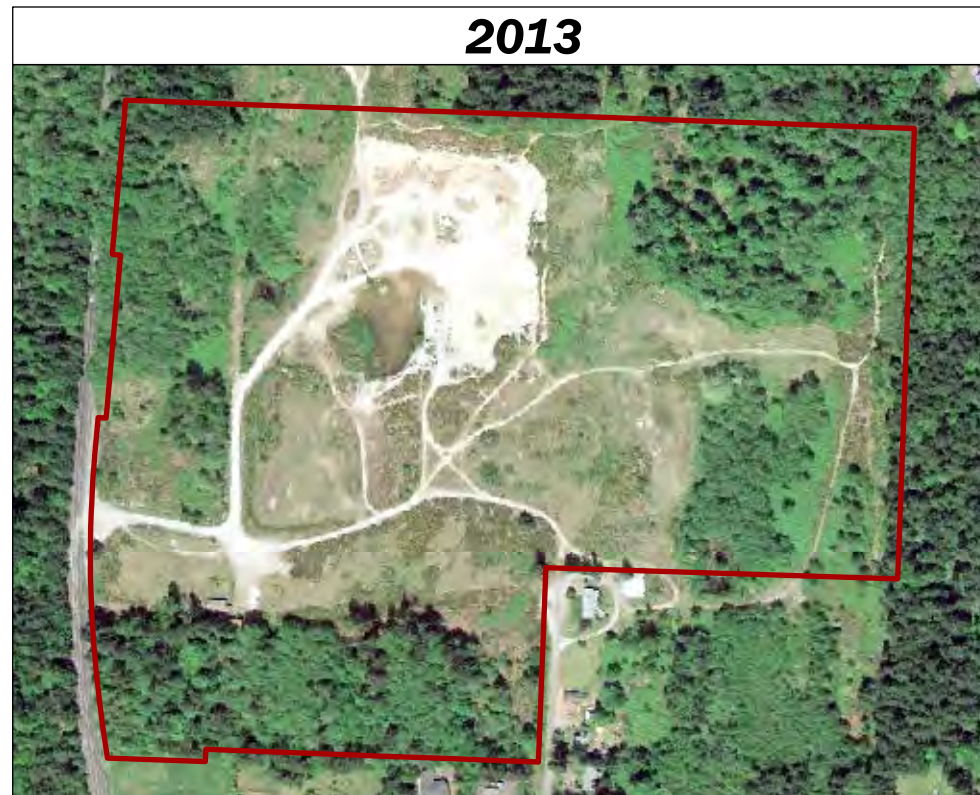
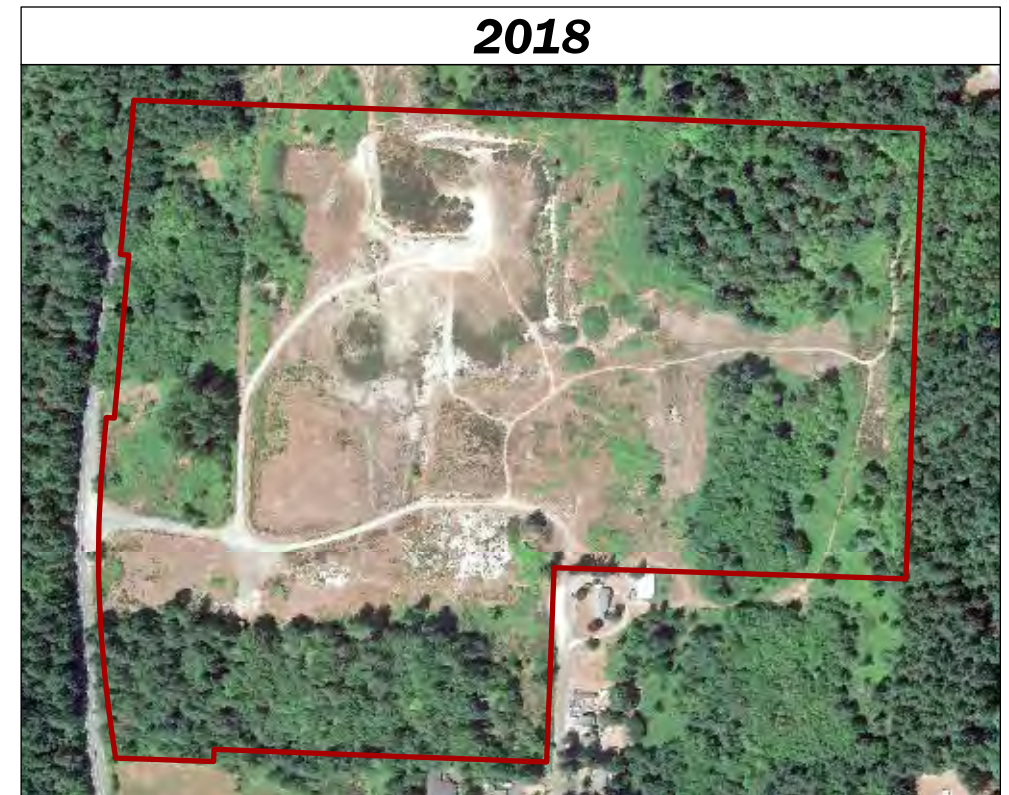
DEC-2022	BY: CEB / NLK	FIGURE NO. <b>5b</b>
	PROJECT NO. 210577	REVISED BY: --- / ---

**Aerial Photos 2003-2018**

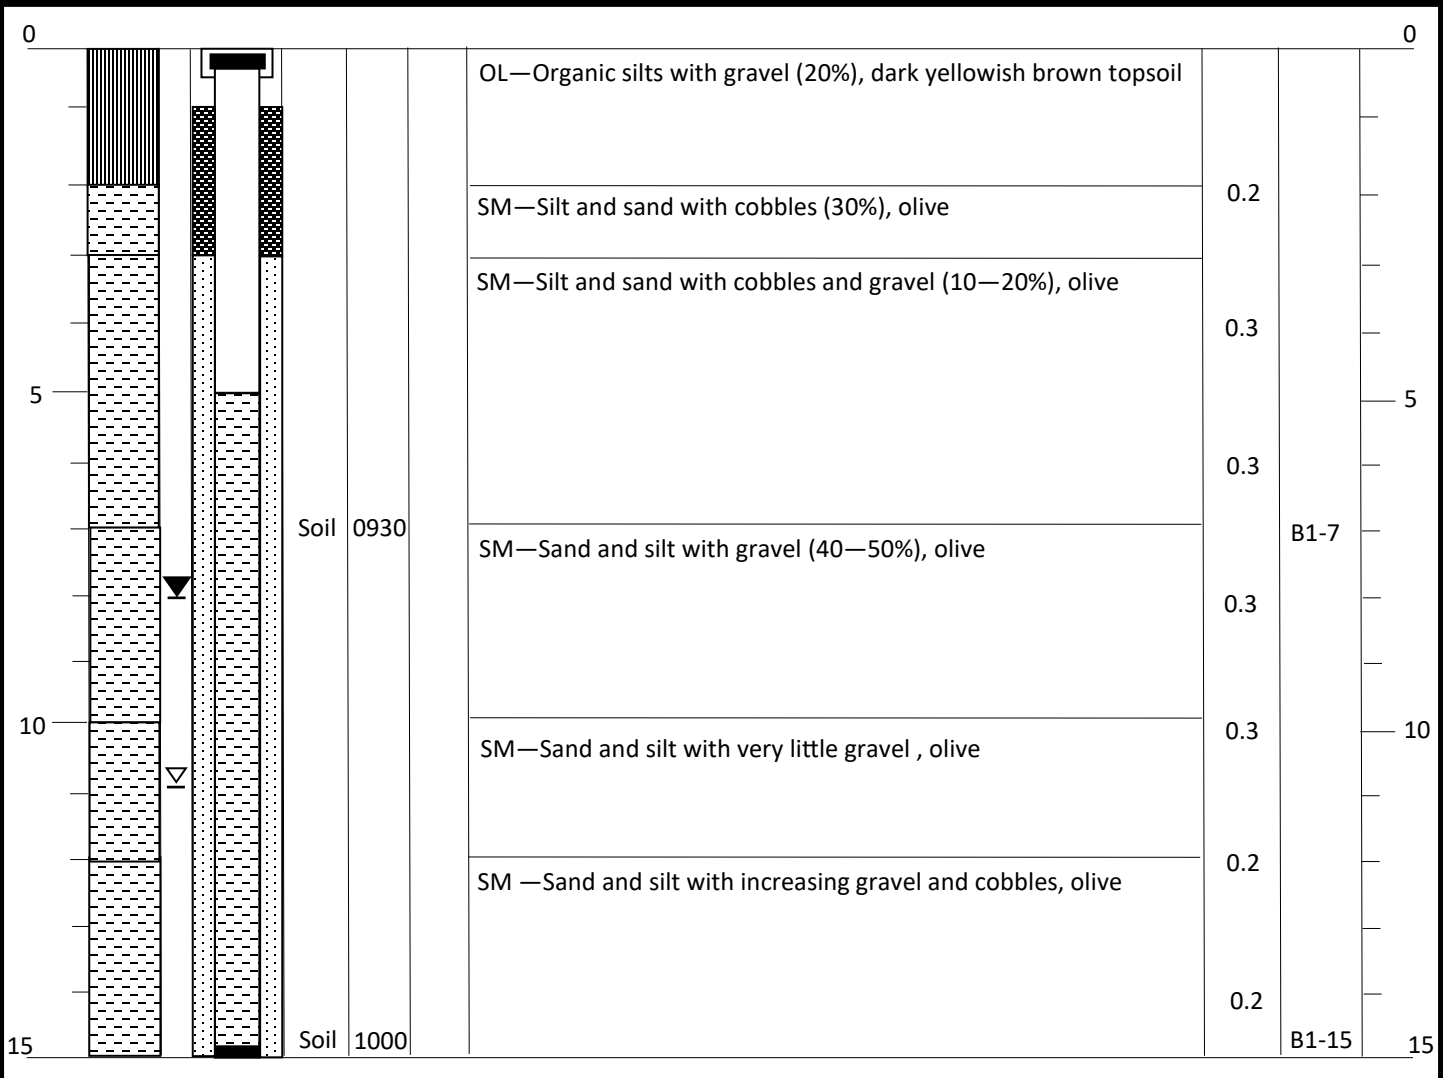
Start Date/Time: 11/09/20; 0830	Boring Depth (ft): 15	Well Depth (ft): 15
End Date/Time: 11/09/20; 0915	Boring Diameter (in): 6	Well Diameter (in): 2
Drilling Company: Cascade Env.	Sampling Method(s): Discrete (5035)	Screen Slot (in): 0.020
Drilling Method: Sonic	DTW During Drilling (ft): 8	Riser Material: PVC
Drilling Equipment: Longyear DB-100	DTW After Drilling (ft): 10.9	Screen Material: PVC
Driller: Rico Rodriguez	Top of Casing Elevation (ft): 241.9	Seal Material(s): Bentonite
Logged By: Ken Beal	Location (X, Y): 47.065914, -122.941671	Filter Pack: Monterey #2 sand

NOTES: Groundwater sample MW1-111220 collected 11/12/20 at 1500. Wellhead PID = 0.0 ppm and LEL = 0.0%.
