Interim Cleanup Action Report

Tanner Electric Cooperative, Transformer Spill Remediation
44711 Southeast North Bend Way
North Bend, Washington

Robinson Noble/Terraphase Engineering Inc.
17625 – 130th Avenue NE, Suite 102
Woodinville, Washington 98072

September 5, 2023

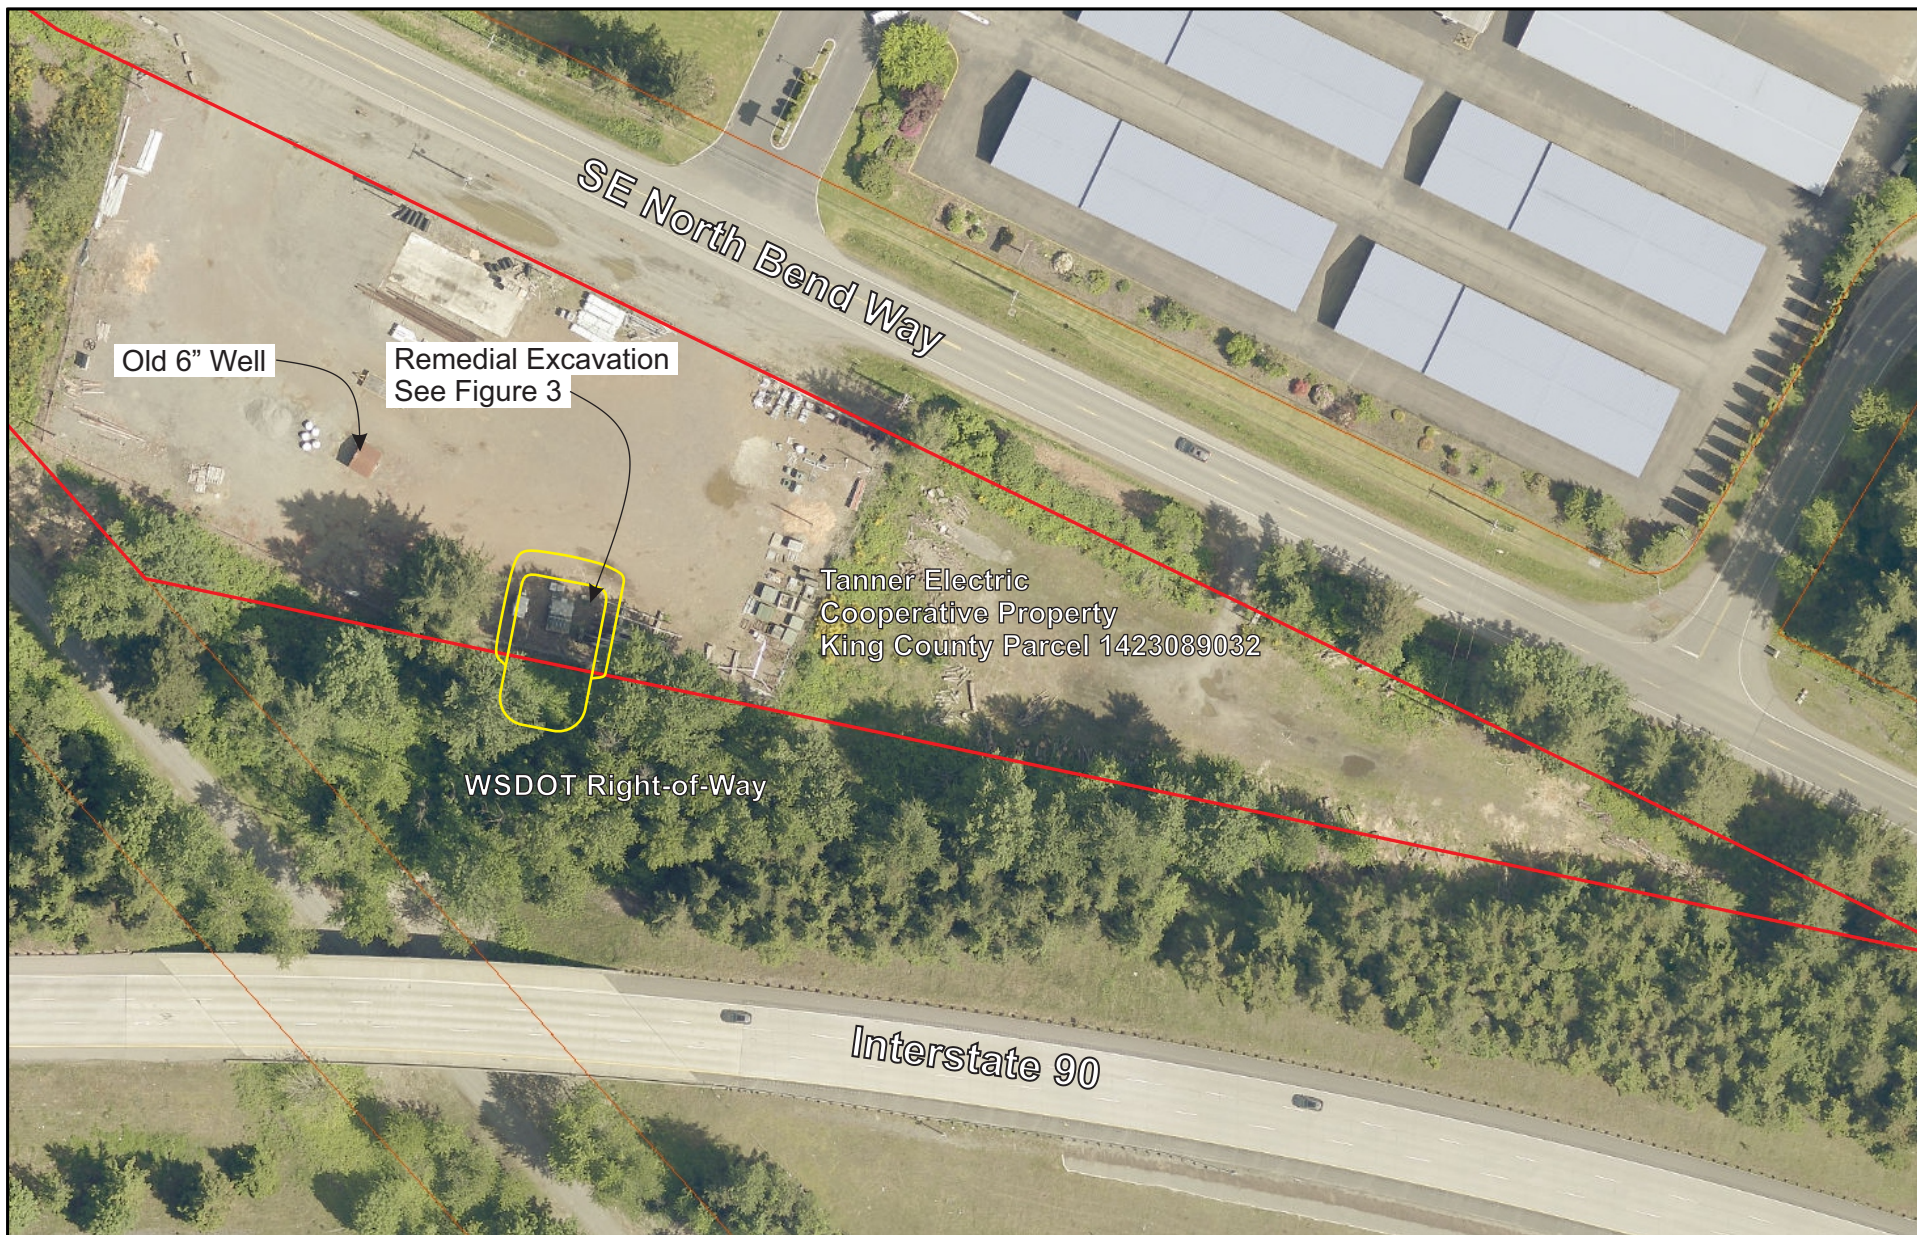
FIGURE 2

The storage yard property is presently undeveloped with any structures. The property is currently occupied by a large gravel parking area that is enclosed by a chain-link fence and used to store various electrical equipment and appurtenances (i.e., electrical transformers, power poles, etc.). As shown on

Figure 2 and discussed below in Section 1.3.1, there is an old 6-inch diameter water well on the property that was reportedly constructed by the previous owners for potable water supply.

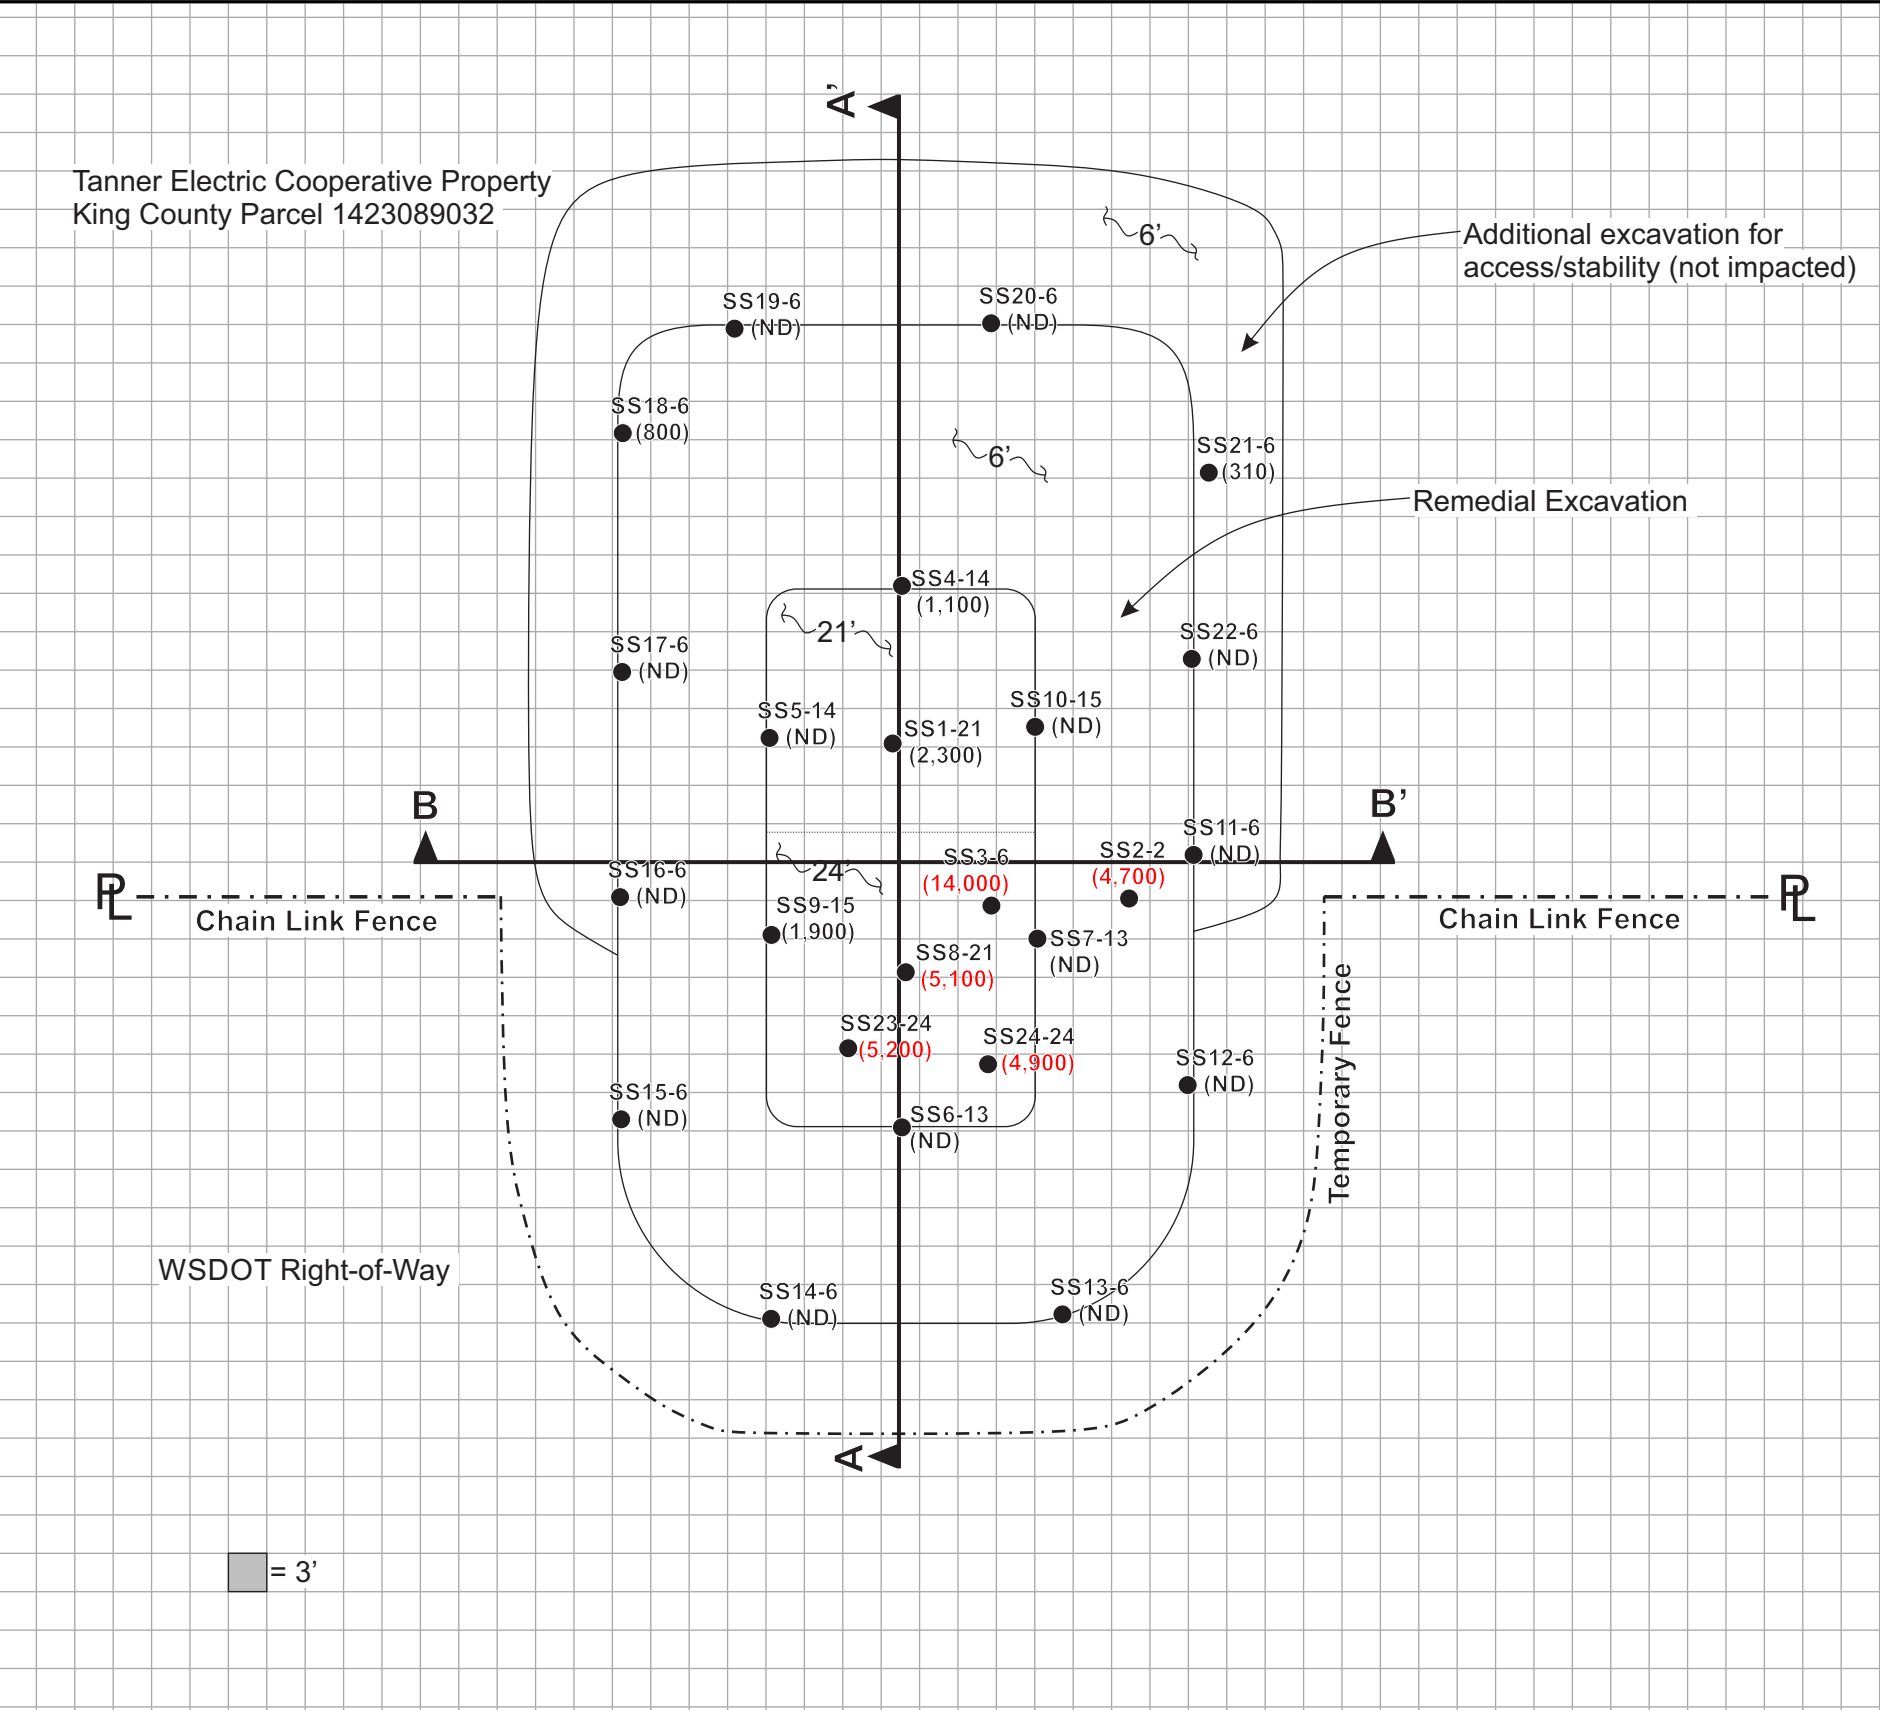
Figure 3 shows the aerial extent of the remedial excavation and the location of the conformation and performance samples collected during this project. Figure 4 shows two representative profiles (Cross Sections AA' and BB') that depict the vertical extent of the remedial excavation. As shown on Figures 3 and 4, the remedial excavation covers an area measuring approximately 45 x 78 feet and extends to a maximum depth of 24 feet near the center of the excavation. As also shown on Figures 3 and 4, additional "benching" areas were excavated outside of the impacted area to allow for stabilization of the excavation and access for deeper remedial excavation. It is estimated that a total of approximately 1,325 cubic yards of impacted soil was excavated and removed from the site.

As shown on Figures 3 and 4, remedial excavation was extended to the lateral margins of the impacted area. However, deeper mineral oil contamination near the center of the spill area could not be reached with excavation, so some residual impacts at depth (below 24 feet) were left in place. Rough mass balance calculations suggest that approximately half of the mineral released (~1,400 gallons) was recovered through remedial excavation. Considering the high porosity and hydraulic conductivity of the alluvial materials at the site, it is presumed that a large percentage of the mineral oil that was not recovered migrated vertically downward to the water table where it was then dispersed downgradient and is no longer recoverable.

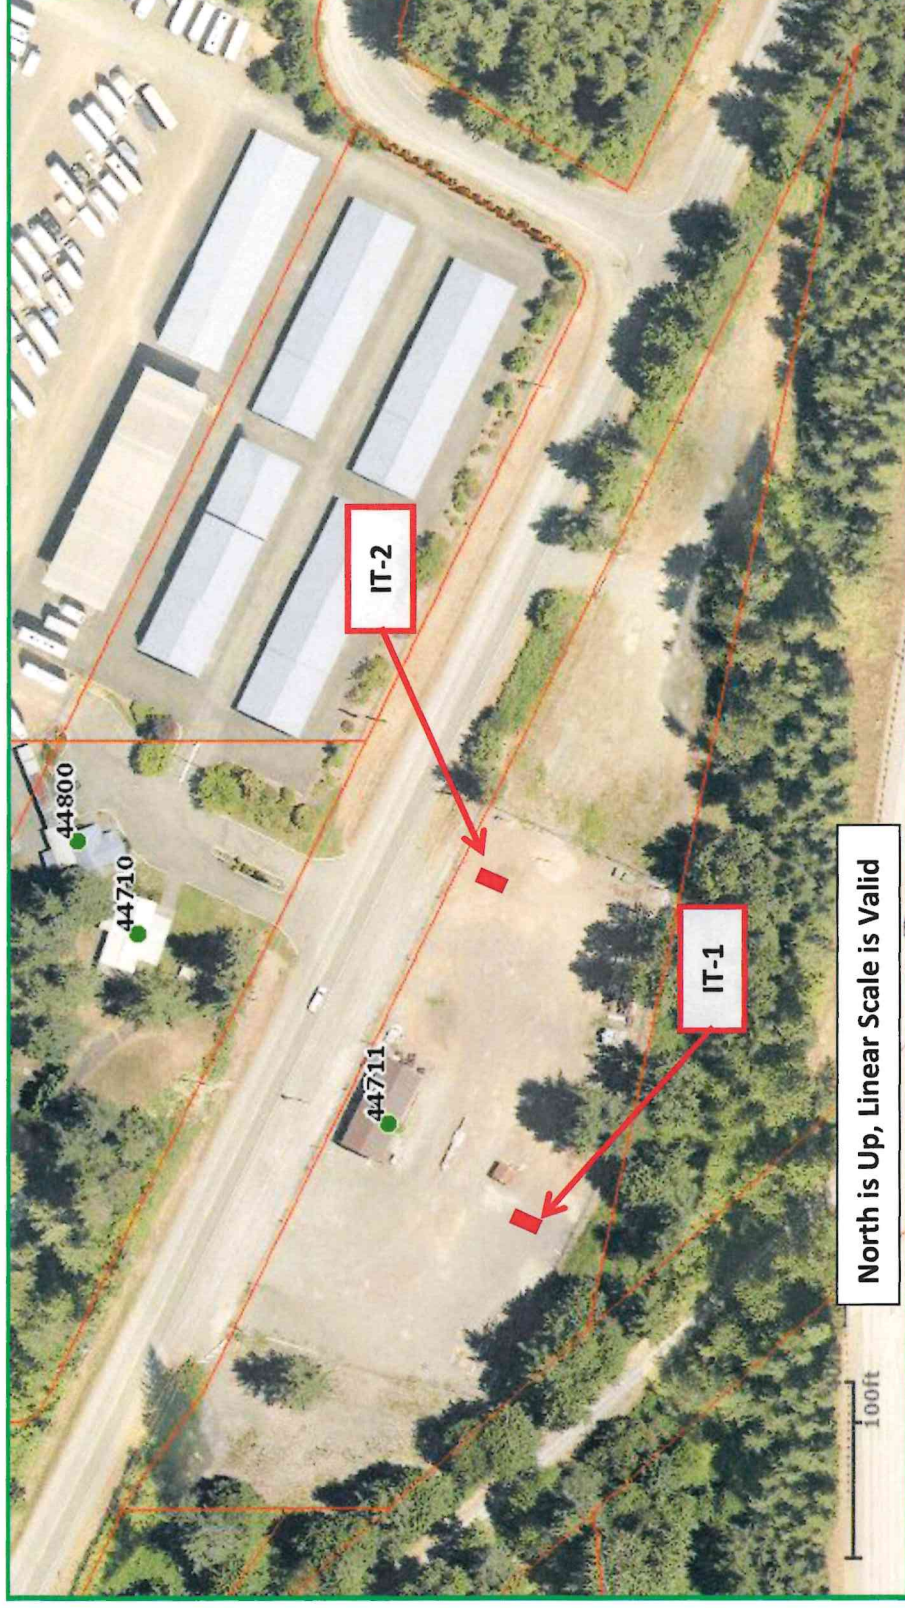
Exploration Pit/Infiltration Test Locations

South Fork Geosciences was onsite on March 8, 2019 to perform the infiltration testing. The excavations were made with a Cat 312D track mounted excavator and the water for the infiltration test was provided by a 5,000-gallon water truck, both provided by Northwest Excavation and Trucking Co., Inc. Two soil exploration pits were excavated and two pilot infiltration test (PIT) were performed on the subject property. The pilot infiltration test is a constant head infiltration test and the procedure is set forth in the referenced Department of Ecology Stormwater Manual. The locations of the soil explorations and tests and the associated soil logs are attached to this letter. We interpreted the native soils as Quaternary alluvial sediments. Our interpretation agrees with the referenced geologic mapping (Booth et al, 2007, and Dragovich et al, 2009) and the referenced geotechnical investigation.

As previously stated, two small-scale pilot infiltration tests (PIT) were performed in accordance with the procedure set forth in the referenced DOE Manual. The locations and soil logs of the exploration pits/infiltration tests are attached to this letter. The results of the infiltration tests are shown in the table below:

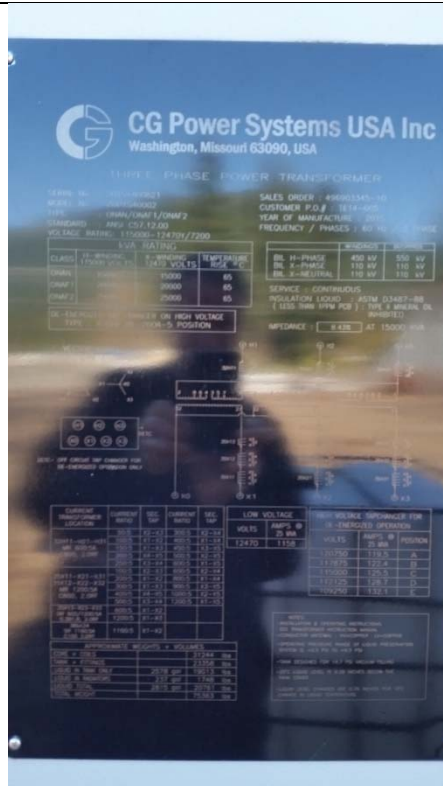
Photograph 1:

Transformer
Manufacturer's Placard

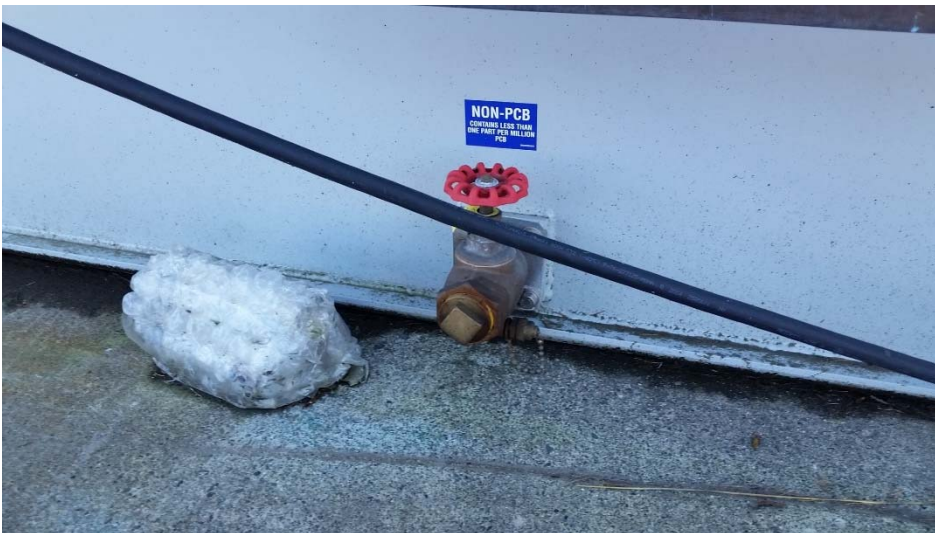
Photograph 2:

Transformer Placard
Near Drain

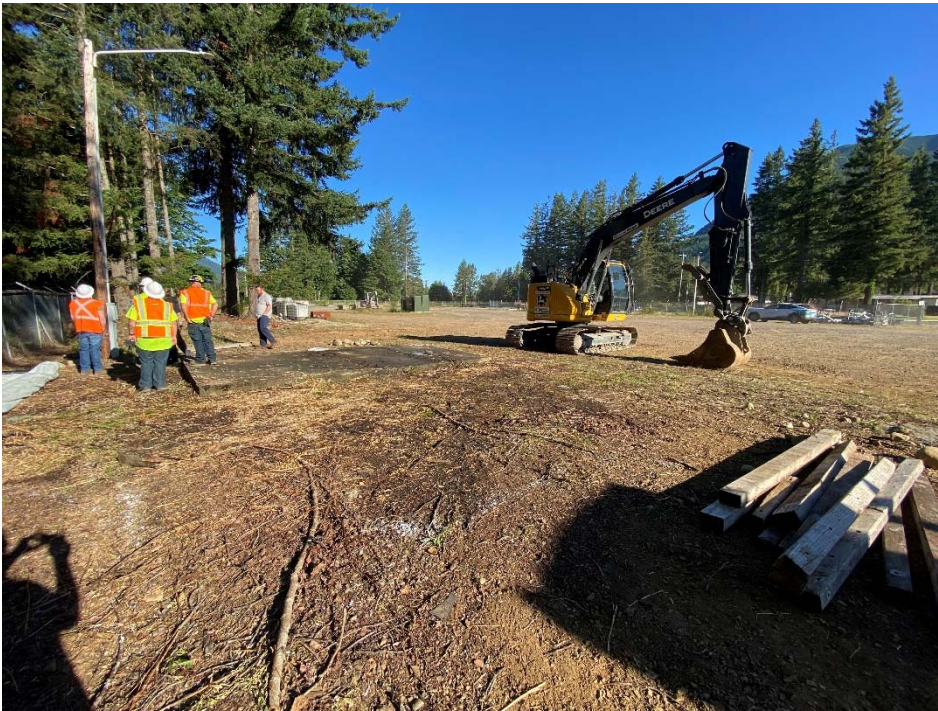
Photograph 3:

View of release area
prior to remedial
excavation

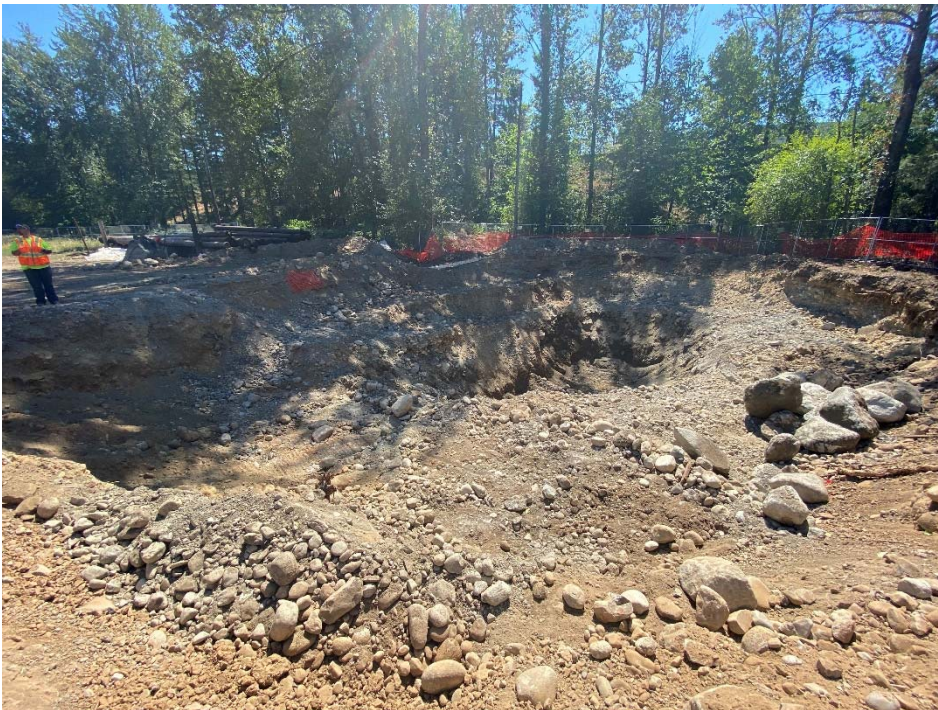
Photograph 4:

View of remedial
excavation looking
southeast

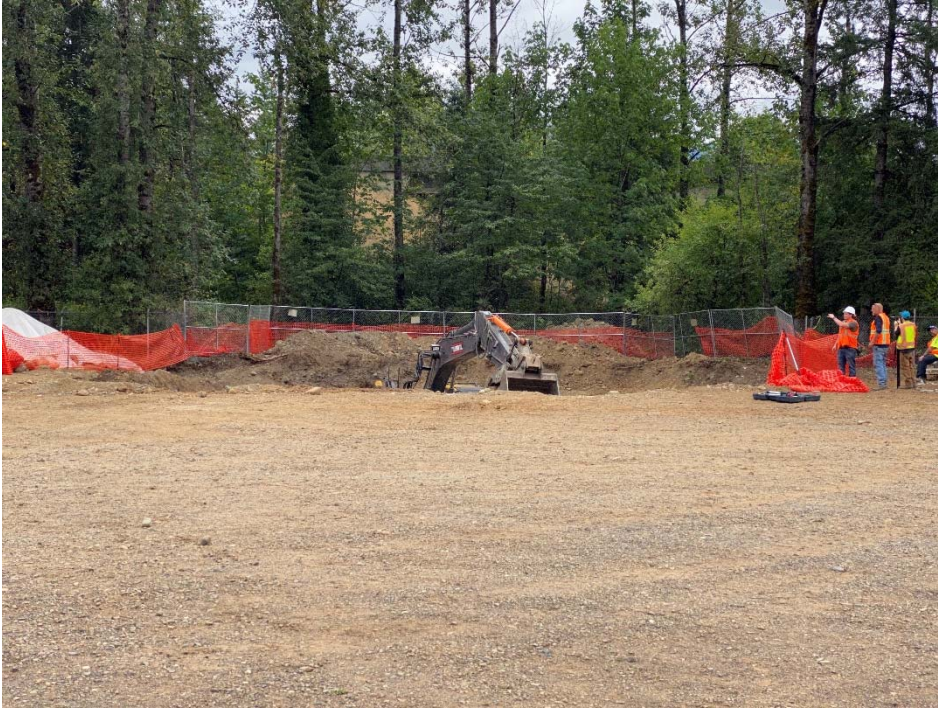
Photograph 5:

View of excavation from land surface toward the south (WSDOT right-of-way in the background)

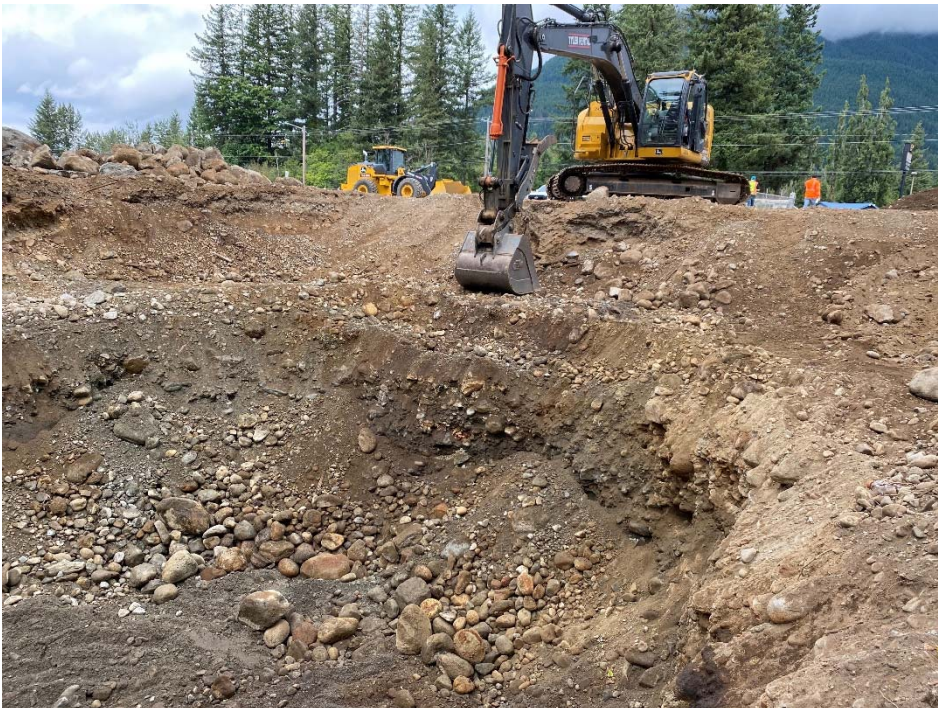
Photograph 6:

View of excavation looking up toward the northwest (note; typical alluvial materials)

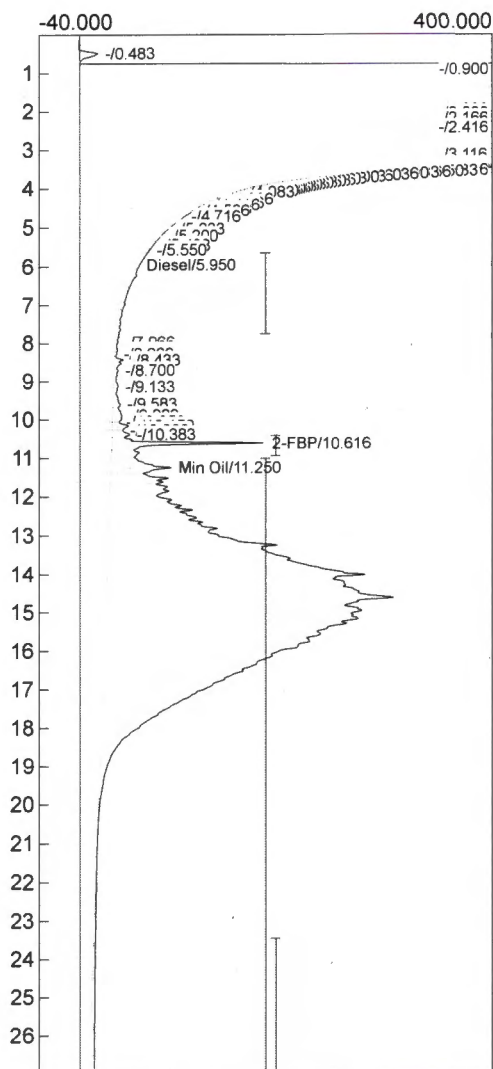
Sample: SS1-21

Component	Retention	Area	External	Units
Diesel	5.950	46.0780	2.1497	
2-FBP	10.616	845.4800	26.0148	
Min Oil	11.250	58317.2105	2656.6078	ppm
		59208.7685	2684.7722

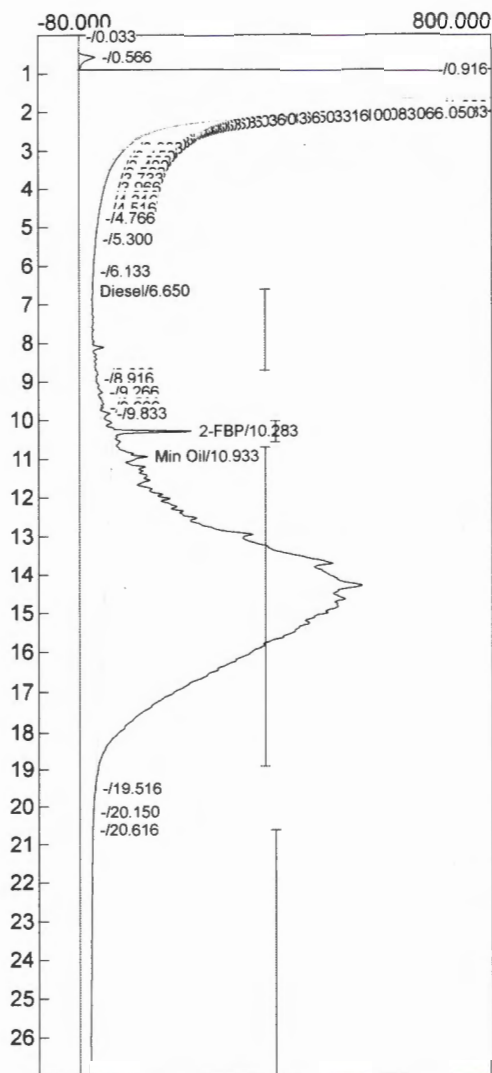
Lab name: Libby Environmental, Inc.
 Analysis date: 08/14/2023 10:49:36
 Method: GC-FID
 Lab ID: L23H049-01
 Description: Sam Ch 1
 Column: Rtx-5 #1632685
 Carrier: Nitrogen
 Data file: A7773.CHR ()
 Sample: SS 23-24
 Operator: KLI

Component	Retention	Area	External	Units
Diesel	6.650	202.1510	9.4310	
2-FBP	10.283	555.4950	17.0922	
Min Oil	10.933	104383.4900	4755.1312	ppm
		105141.1360	4781.6544
