## **Revised DRAFT CLEANUP ACTION PLAN**

### ExxonMobil/ADC

2717 & 2731 Federal Avenue Everett, Washington 98201

October 2023, Publication 23-09-072

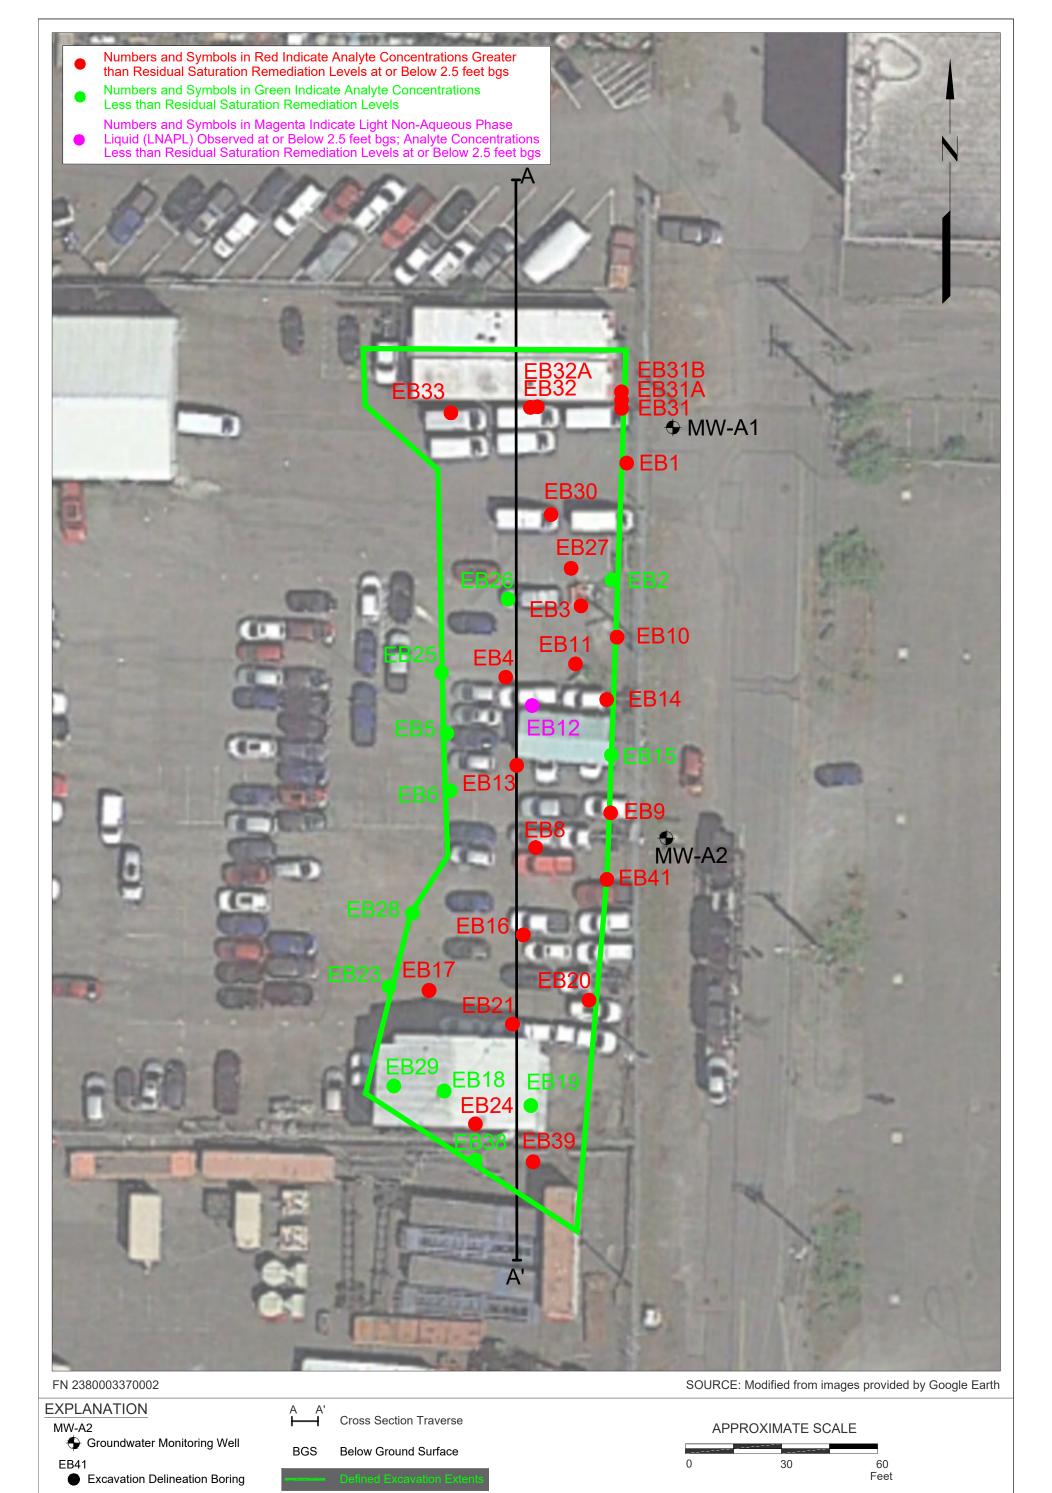
PLATE 6 LEC: 06/28/23

PORT OF EVERETT EXCAVATION DELINEATION MAP - 2.5 FEET BGS

On the southern end of the 2022-2023 Interim Action, soil exceeding the Site-specific residual saturation remediation levels was encountered between surface and approximately 5 feet bgs (Plates 6 and 7). As a result, the excavation was advanced to approximately 7.5 feet bgs, where soil less than the Site-specific residual saturation remediation levels was observed (Plate 8). Advancing northward, soil exceeding the Site-specific residual saturation remediation levels was encountered at approximately 7.5 feet bgs for about 125 linear feet. Consequently, the excavation along this section was advanced to approximately 10 feet bgs where soil less than Site-specific residual saturation remediation levels was observed (Plate 9). On the northern end of the 2022-2023 Interim Action, soil containing LNAPL and soil where analytical results exceeded the Site-specific residual saturation remediation levels was encountered between surface and approximately 17.5 feet bgs (Plates 6 through 13). The northern portion of the excavation was advanced to approximately 15 and 20 feet bgs where soil less than the Site-specific residual saturation remediation levels was observed (Plates 12 and 13). The depth of the excavation gradually decreased from north to south in this northernmost excavation section (Plates 6 through 15).

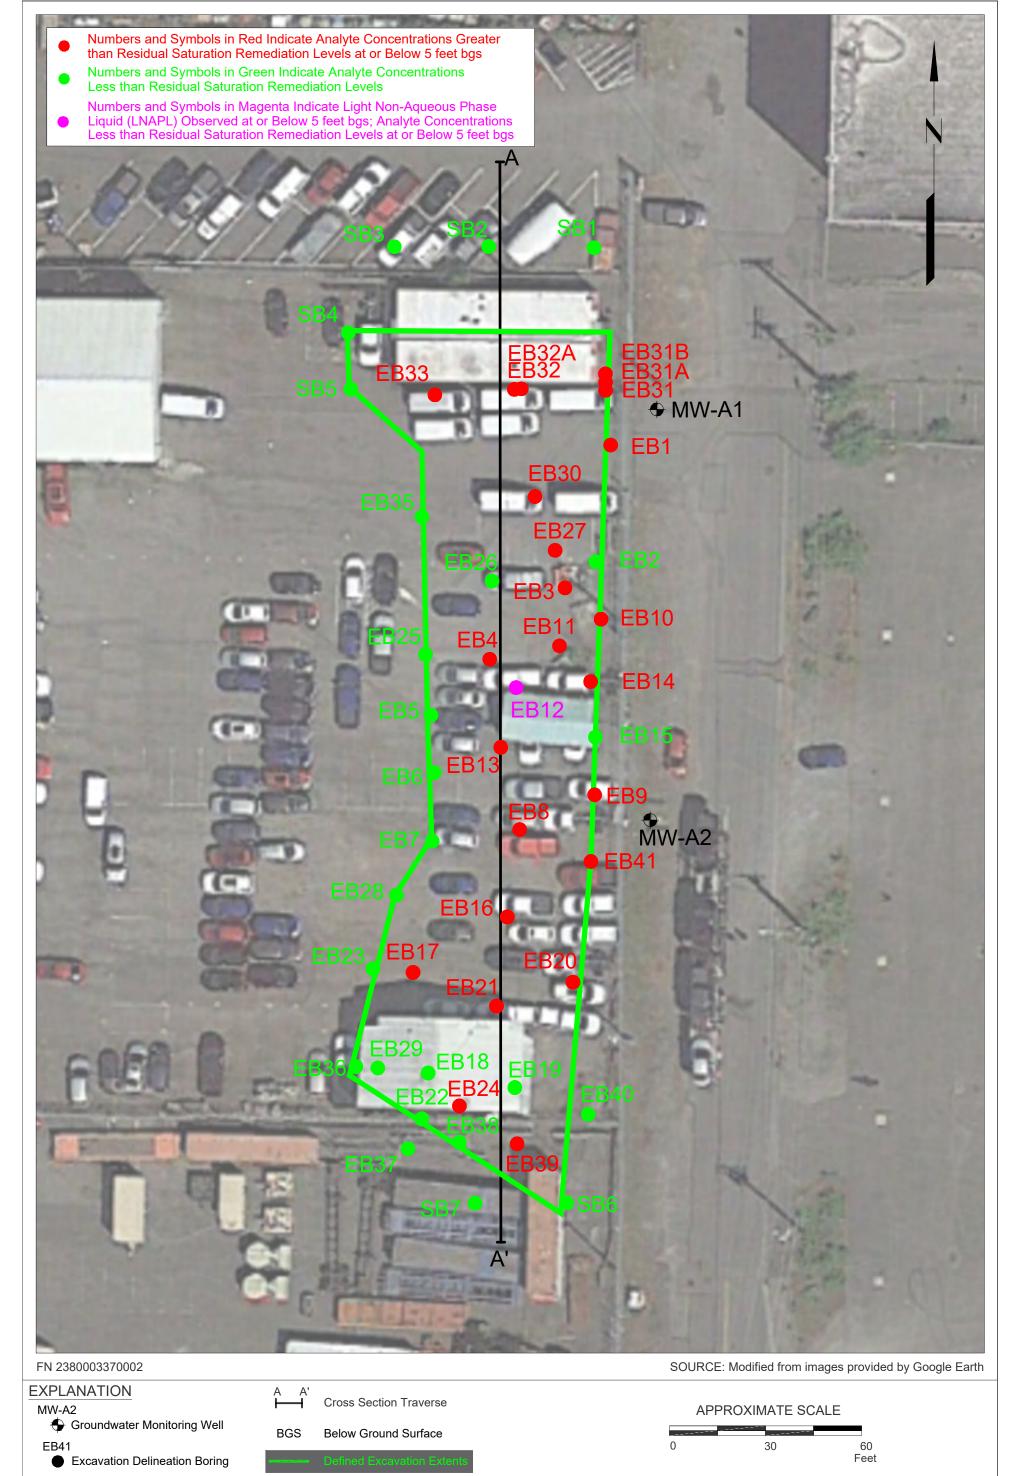
PLATE 7 LEC: 06/28/23

PORT OF EVERETT EXCAVATION DELINEATION MAP - 5 FEET BGS

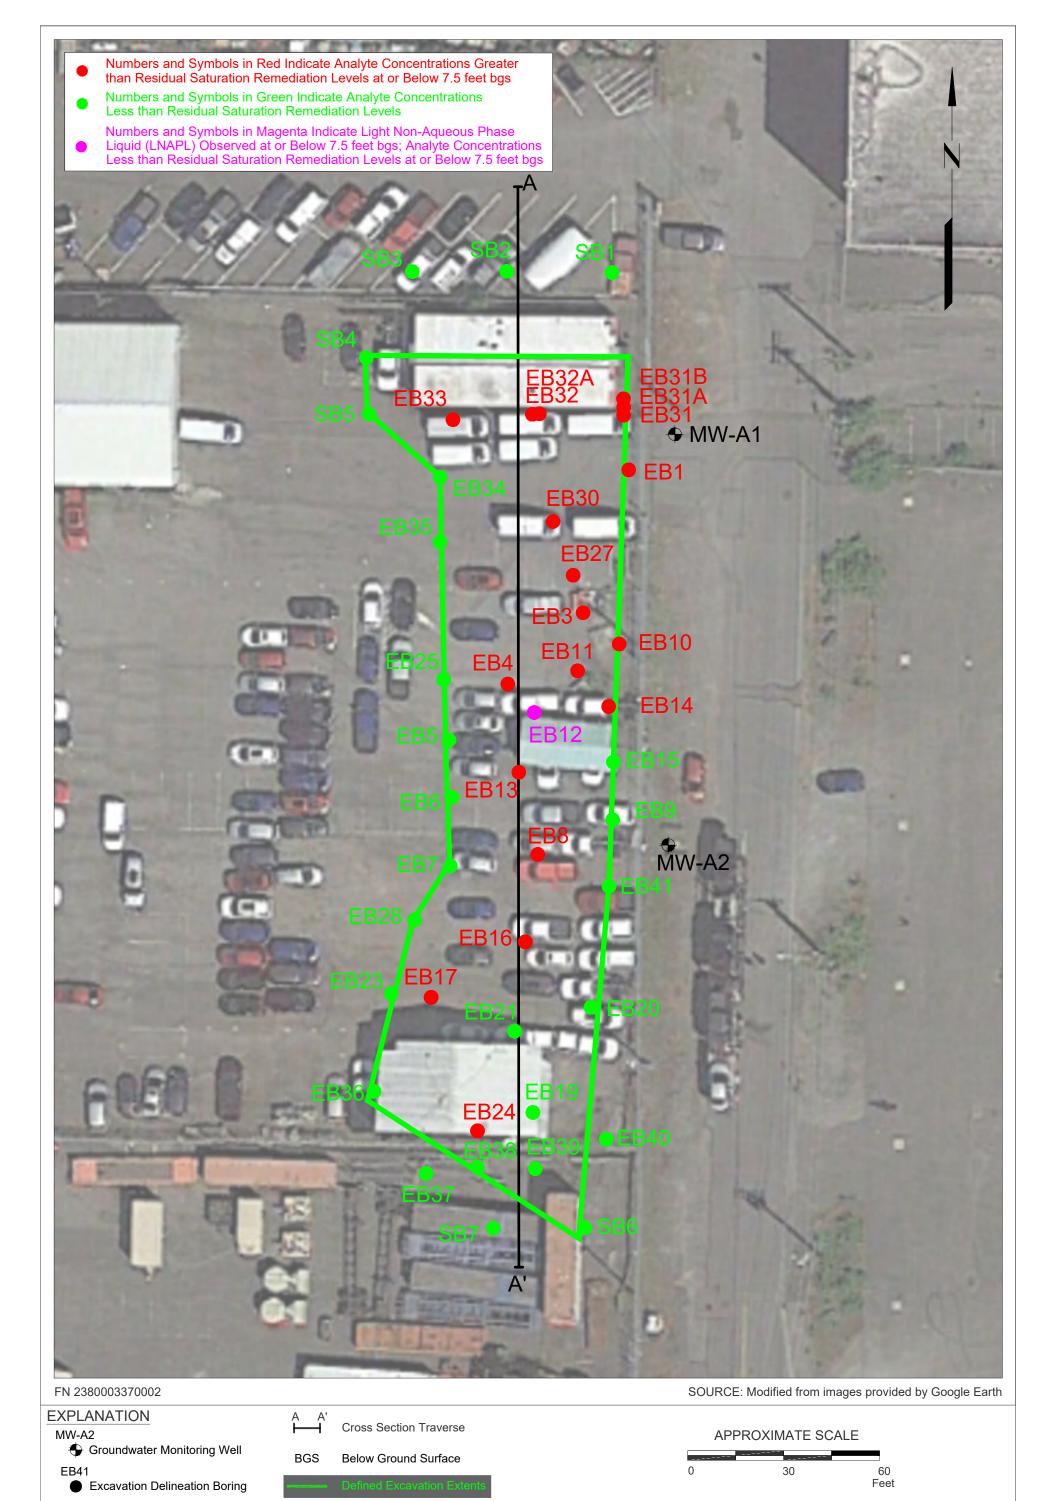
PLATE 8 LEC: 06/28/23

PORT OF EVERETT EXCAVATION DELINEATION MAP - 7.5 FEET BGS

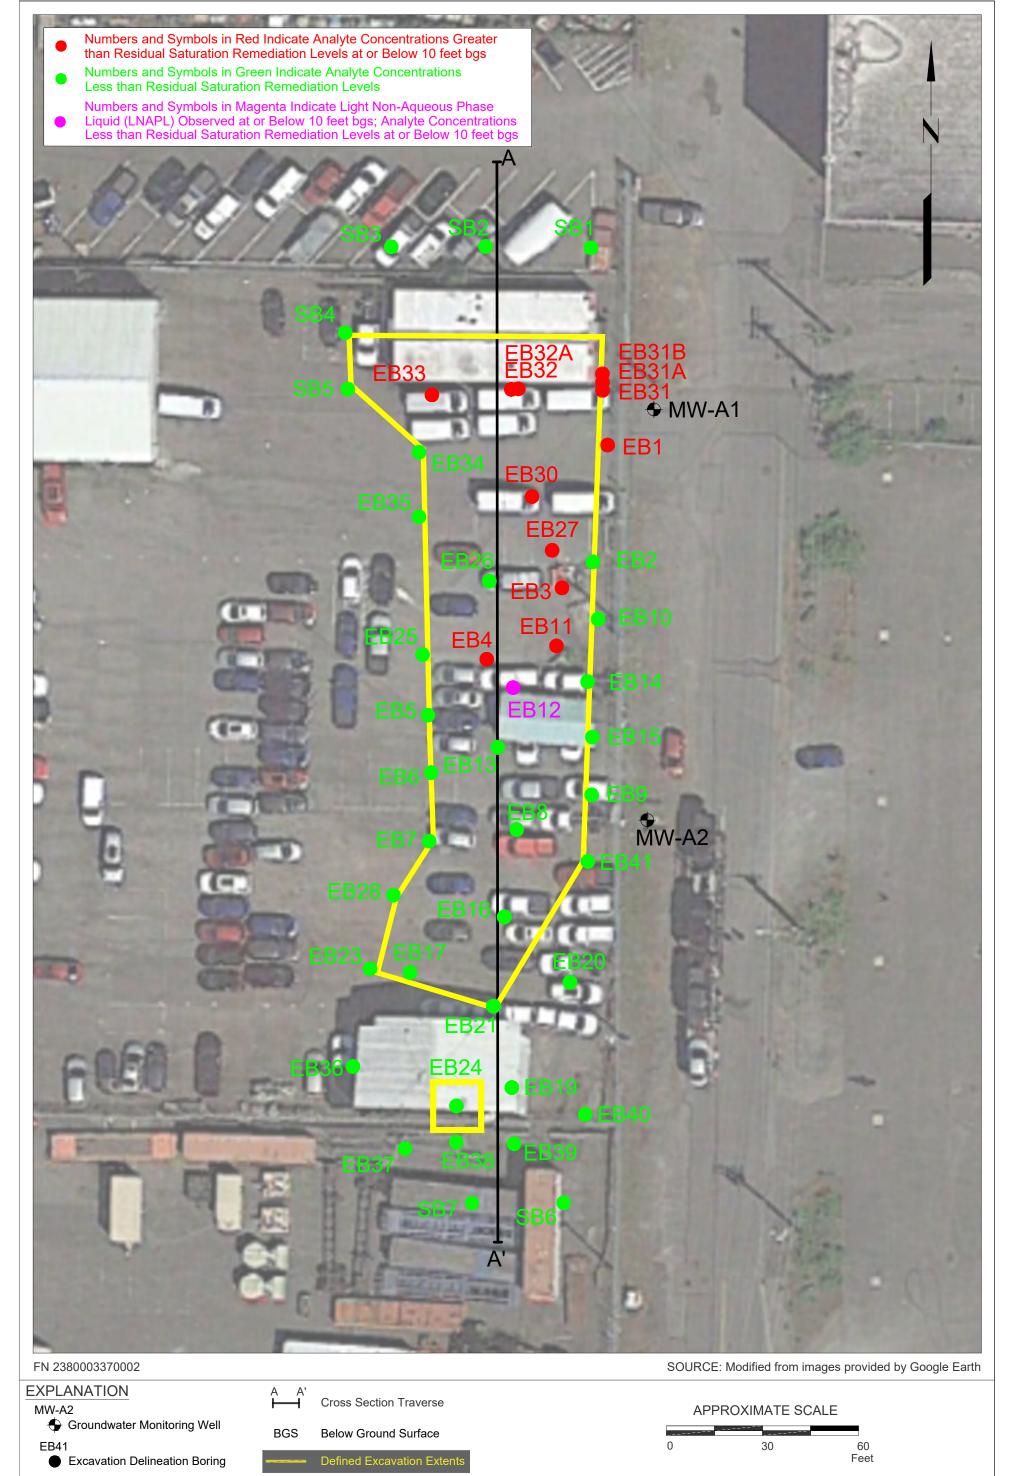
PLATE 9 LEC: 06/28/23

PORT OF EVERETT EXCAVATION DELINEATION MAP - 10 FEET BGS

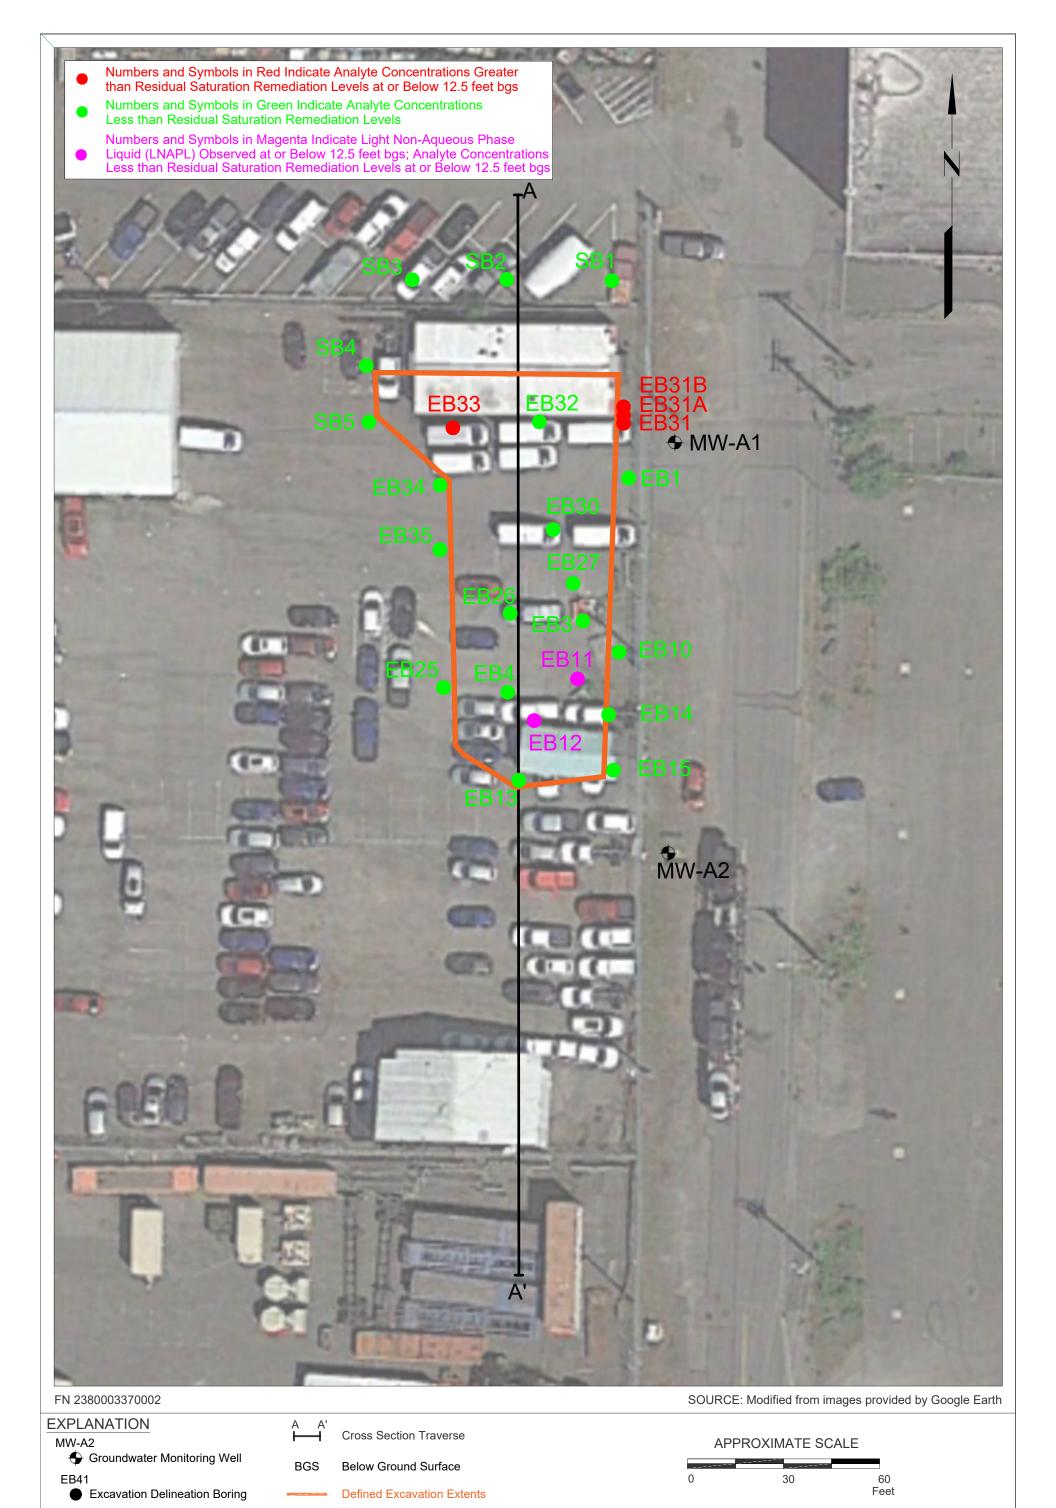
PLATE 10 LEC: 06/28/23

PORT OF EVERETT EXCAVATION DELINEATION MAP - 12.5 FEET BGS

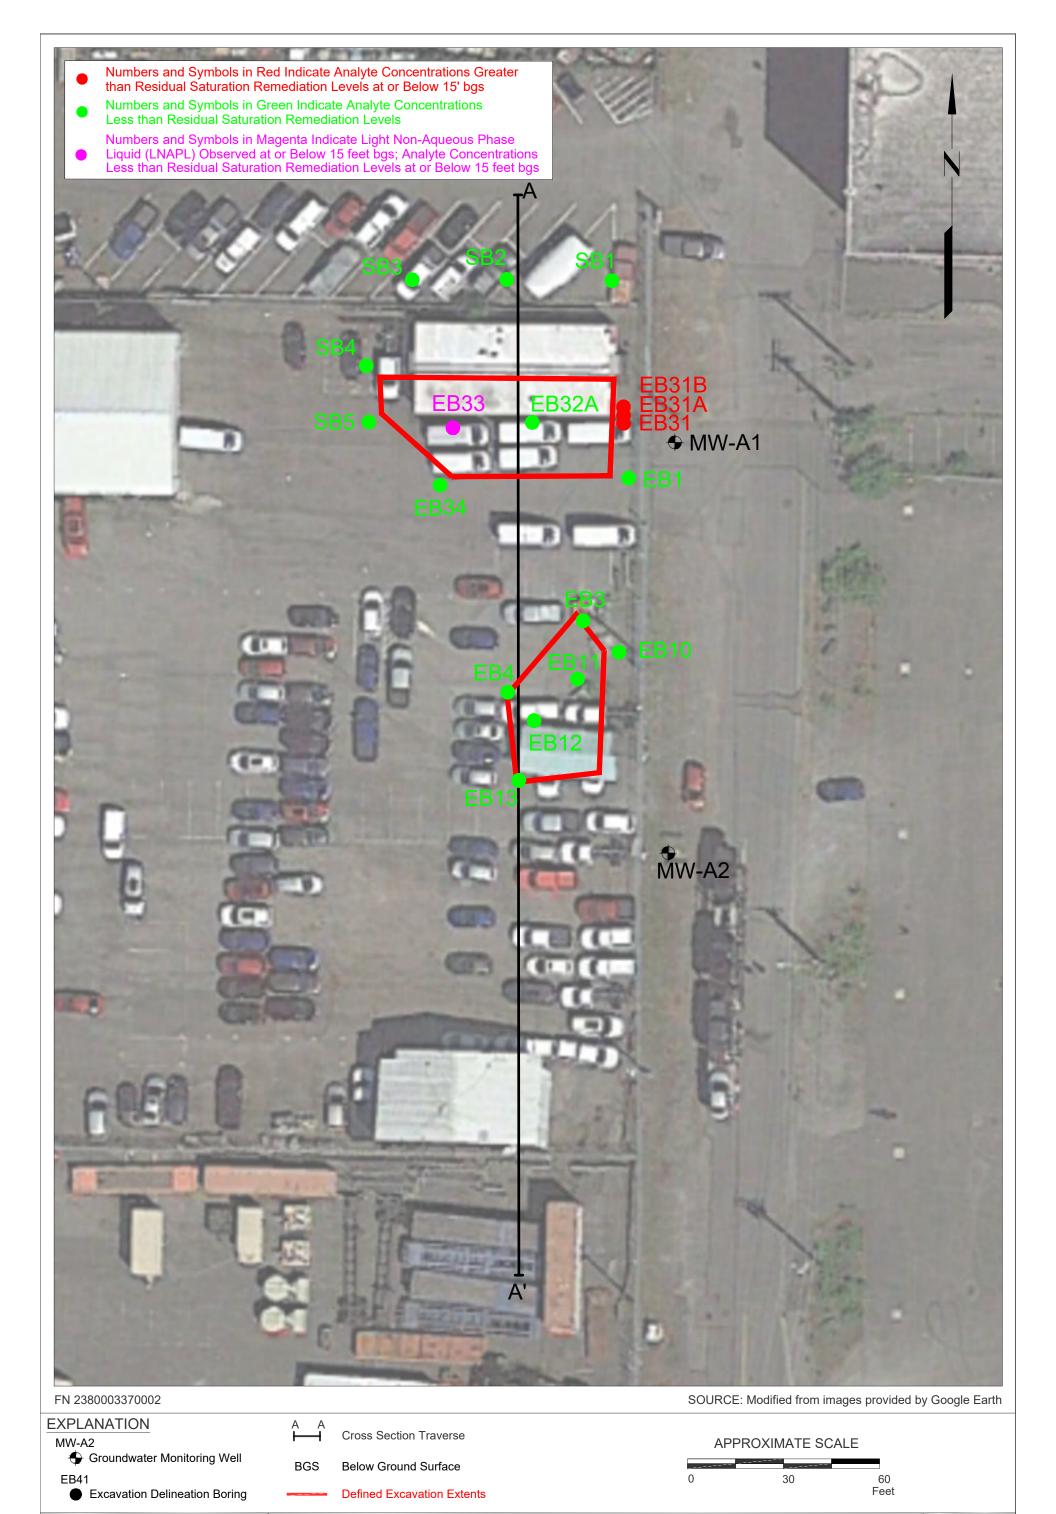
PLATE 11 LEC: 06/28/23

PORT OF EVERETT EXCAVATION DELINEATION MAP - 15 FEET BGS

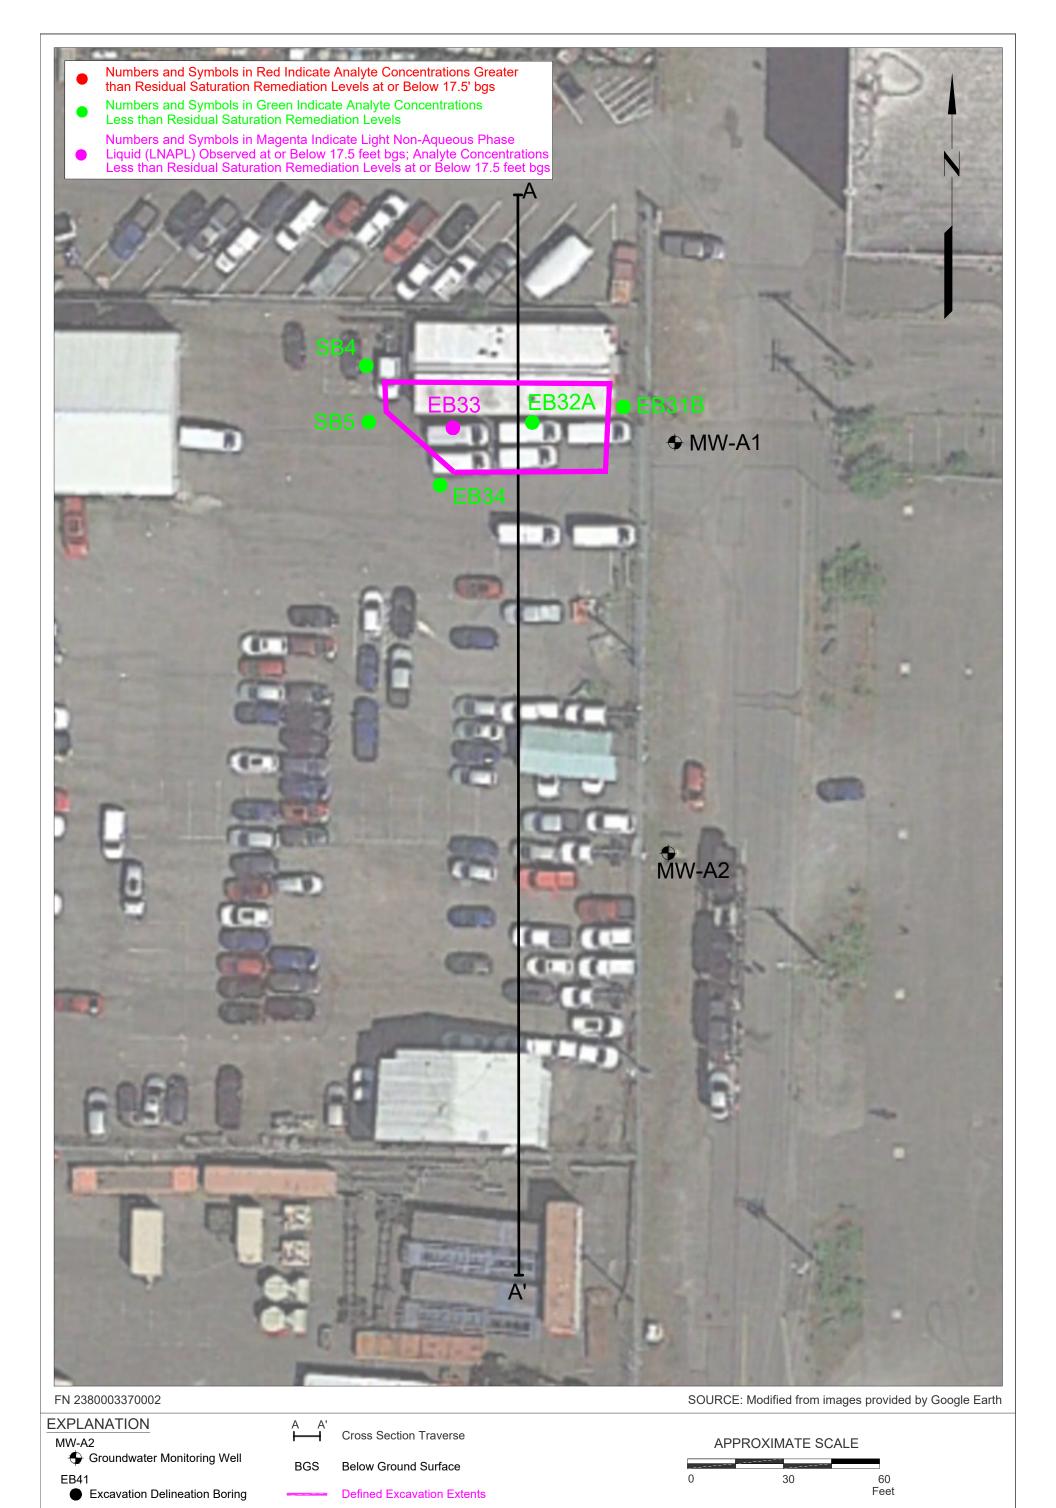
PLATE 12 LEC: 06/28/23

PORT OF EVERETT EXCAVATION DELINEATION MAP - 17.5 FEET BGS

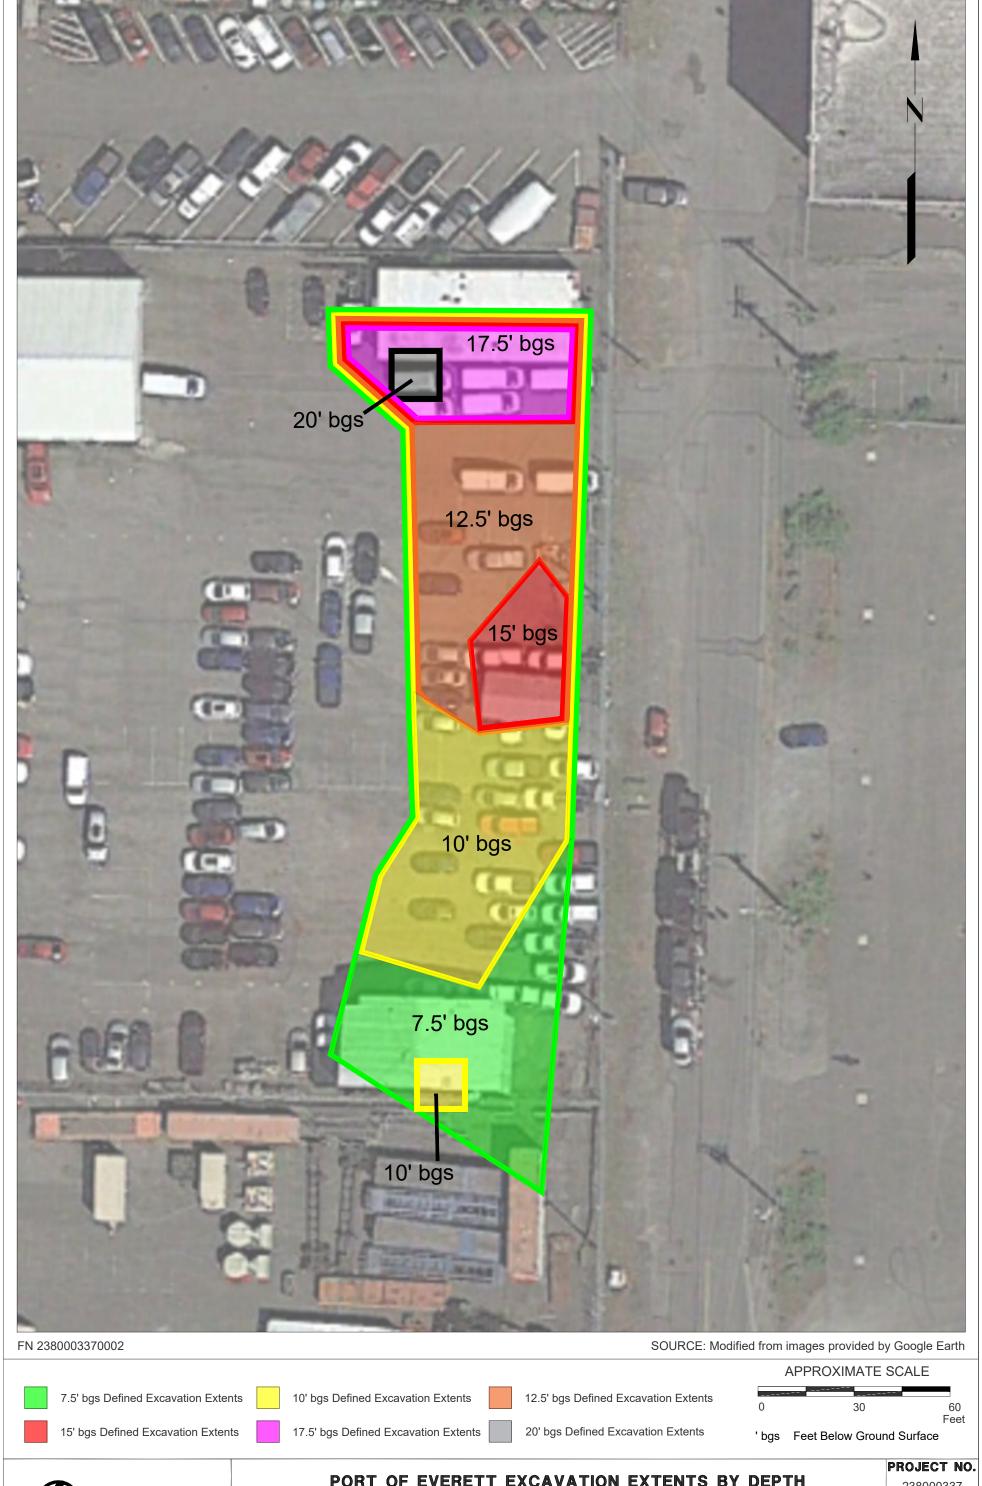
**PLATE** 14 LEC: 06/28/23

PORT OF EVERETT EXCAVATION EXTENTS BY DEPTH

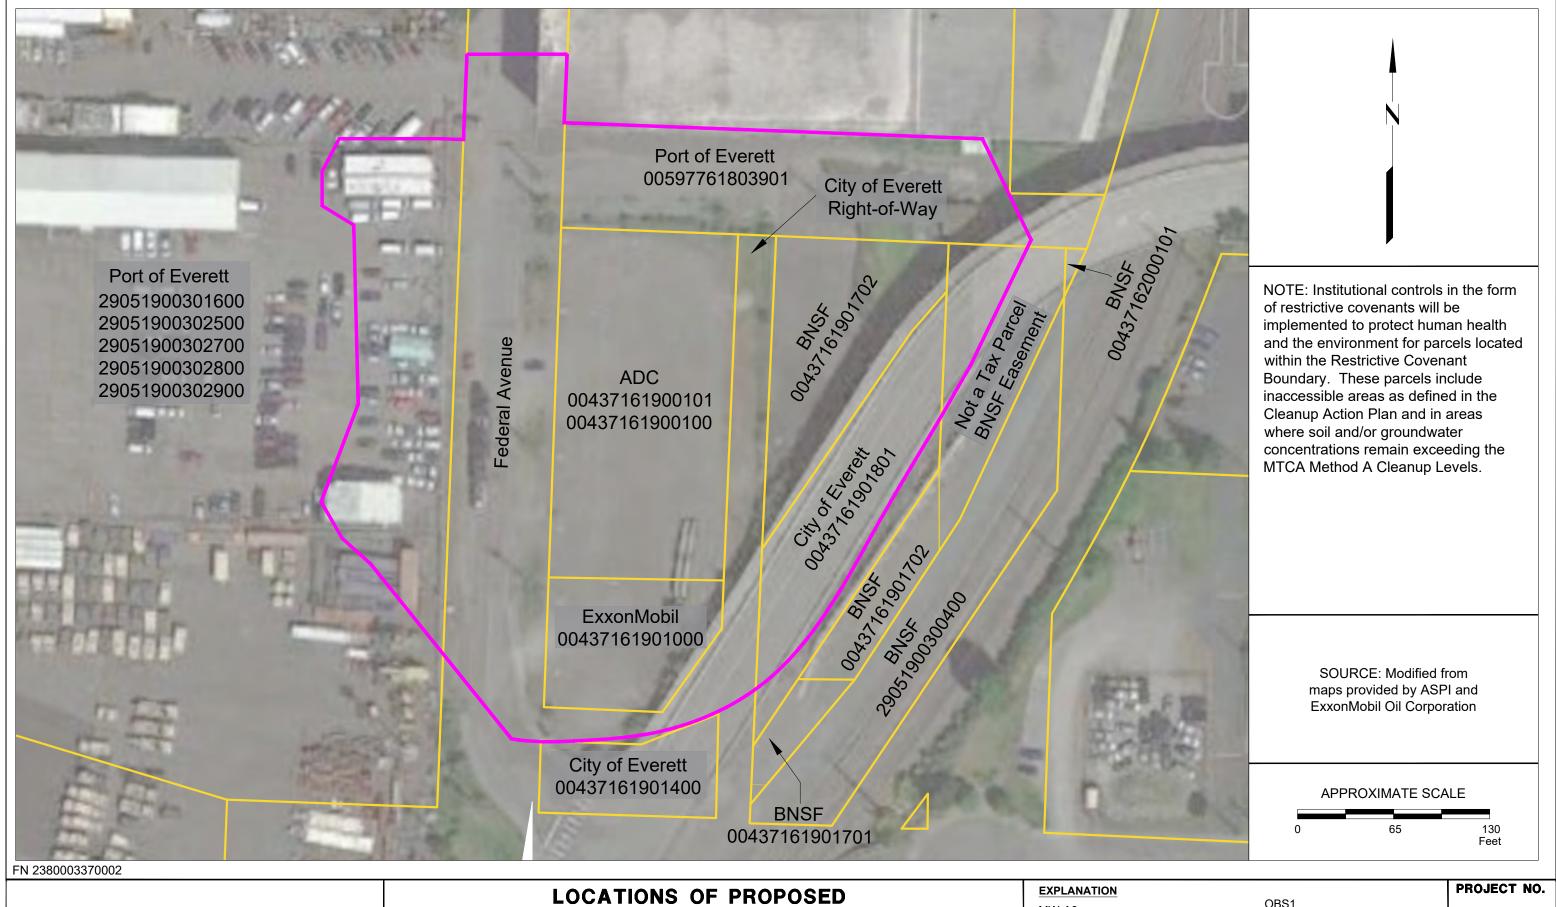
## LOCATIONS OF PROPOSED RESTRICTIVE COVENANTS

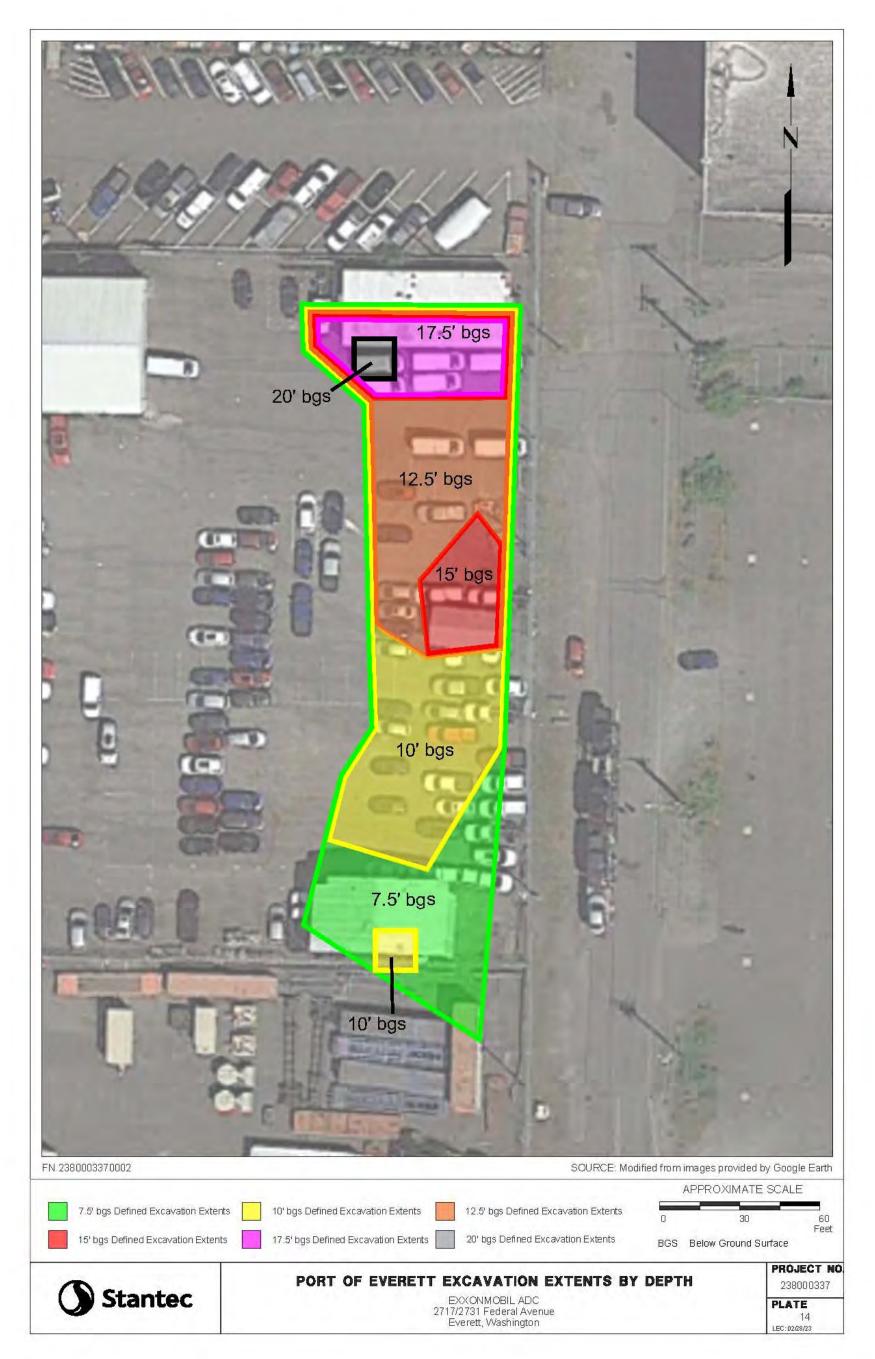
Figure 3 Proposed Excavation Extent on West Side of Federal Avenue

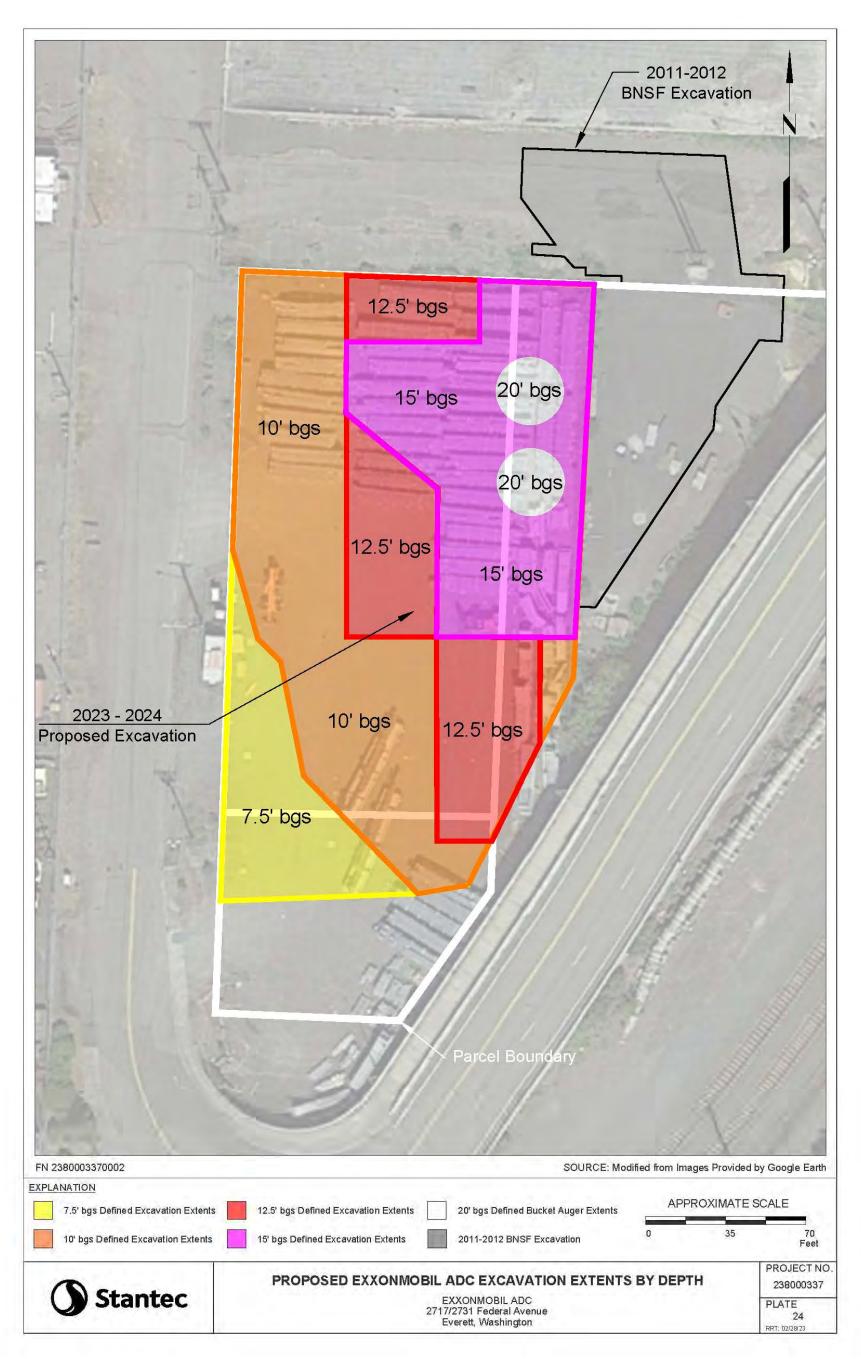
Figure 4 Proposed Excavation Extent on East Side of Federal Avenue

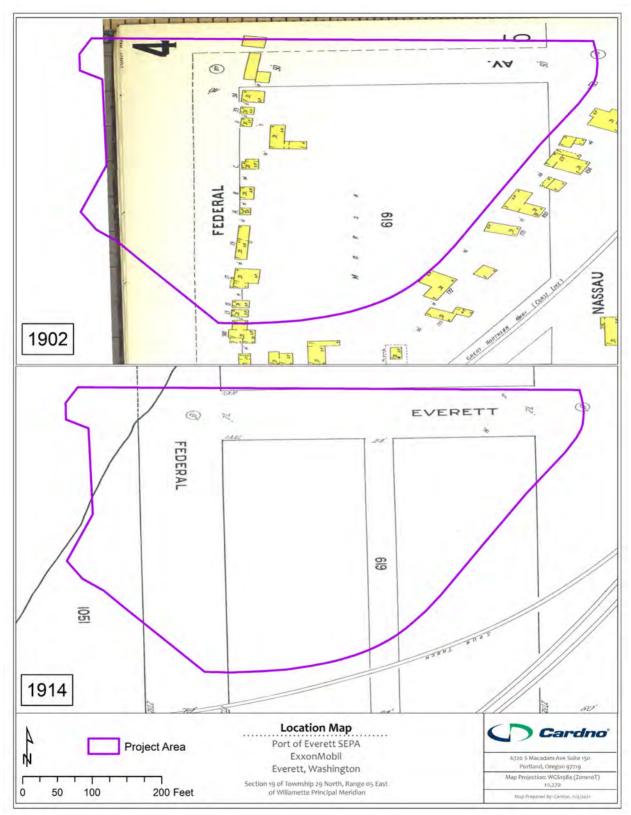
Figure 4. Details from 1902 and 1914 Sanborn Fire Insurance Maps (Sanborn Map Co. 1902, 1914).

The color-coded key indicates that within Block 619 within the project area, structures consisted of "frame building" (Sanborn Map Co. 1902). The detailed map page for Block 619 contains 30 frame structures, all dwellings and associated outbuildings, situated around a marshland at the center of the block (Figure 5). Within each dwelling, the maps include a notation of "S.P.," which is specially called out on the key map introduction: "NOTE Practically all dwellings with a "S.P" (Stove pipe) are cheap, unpainted shacks" (Sanborn Map Co. 1902: Key Map). Eleven additional "S.P." buildings consisting of dwellings, outbuildings, bath house, and boat house, are depicted within Block 618 to the north of the project area, and noted as "Squatters Shacks" (Sanborn Map Co. 1902).

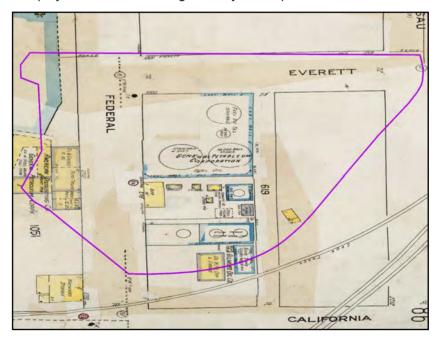
Figure 5. Project area displayed on 1939 Sanborn Fire Insurance Map. (Sanborn Map Co. 1939 [Revised through June 1955])

The warehouse complex contained automobile truck storage, an oil and grease warehouse, a wash rack room, a boiler room, and an oil in steel drum staging yard adjacent to a wooden bulkhead (Figure 5; Sanborn Map Co. 1939 [Revised through June 1955]). By 1947 development within the project area had been expanded significantly to the south (Figure 6). Additional infrastructure constructed included several cylindrical petroleum tanks each containing 25,000 gallons of gasoline, eight outbuildings including a wooden office building, pump room, and warehouses, and a steel filling rack (Figures 5, 7, and 8; Sanborn Map Co. 1939 [Revised through June 1955]). The shoreline has not been modified with fill since approximately 1950 (Figure 9). An Everett USGS map from 1953 shows the area developed with gasoline tanks and a pier directly adjacent to the company warehouse complex (Figure 10). It does not appear the eastern portion of the project area was ever significantly developed.

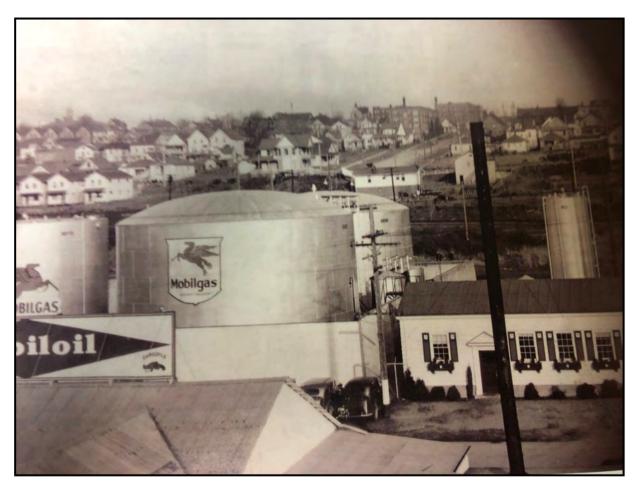
Figure 8. Undated photograph showing gasoline infrastructure after General Petroleum Corporation was rebranded to Mobilgas. The office building on the site is at the right. (Washington Department of Ecology 2014:65)
