**FINAL INTERIM ACTION REPORT**

**ALLEY AREA OF BLOCK 38 WEST SITE  
BETWEEN REPUBLICAN STEET AND MERCER STREET  
500 THROUGH 536 WESTLAKE AVENUE NORTH  
SEATTLE, WASHINGTON**

**Agreed Order No. DE 17963  
Facility Site Identification No. 62773  
Cleanup Site Identification No. 15008**

**Farallon PN: 397-019**

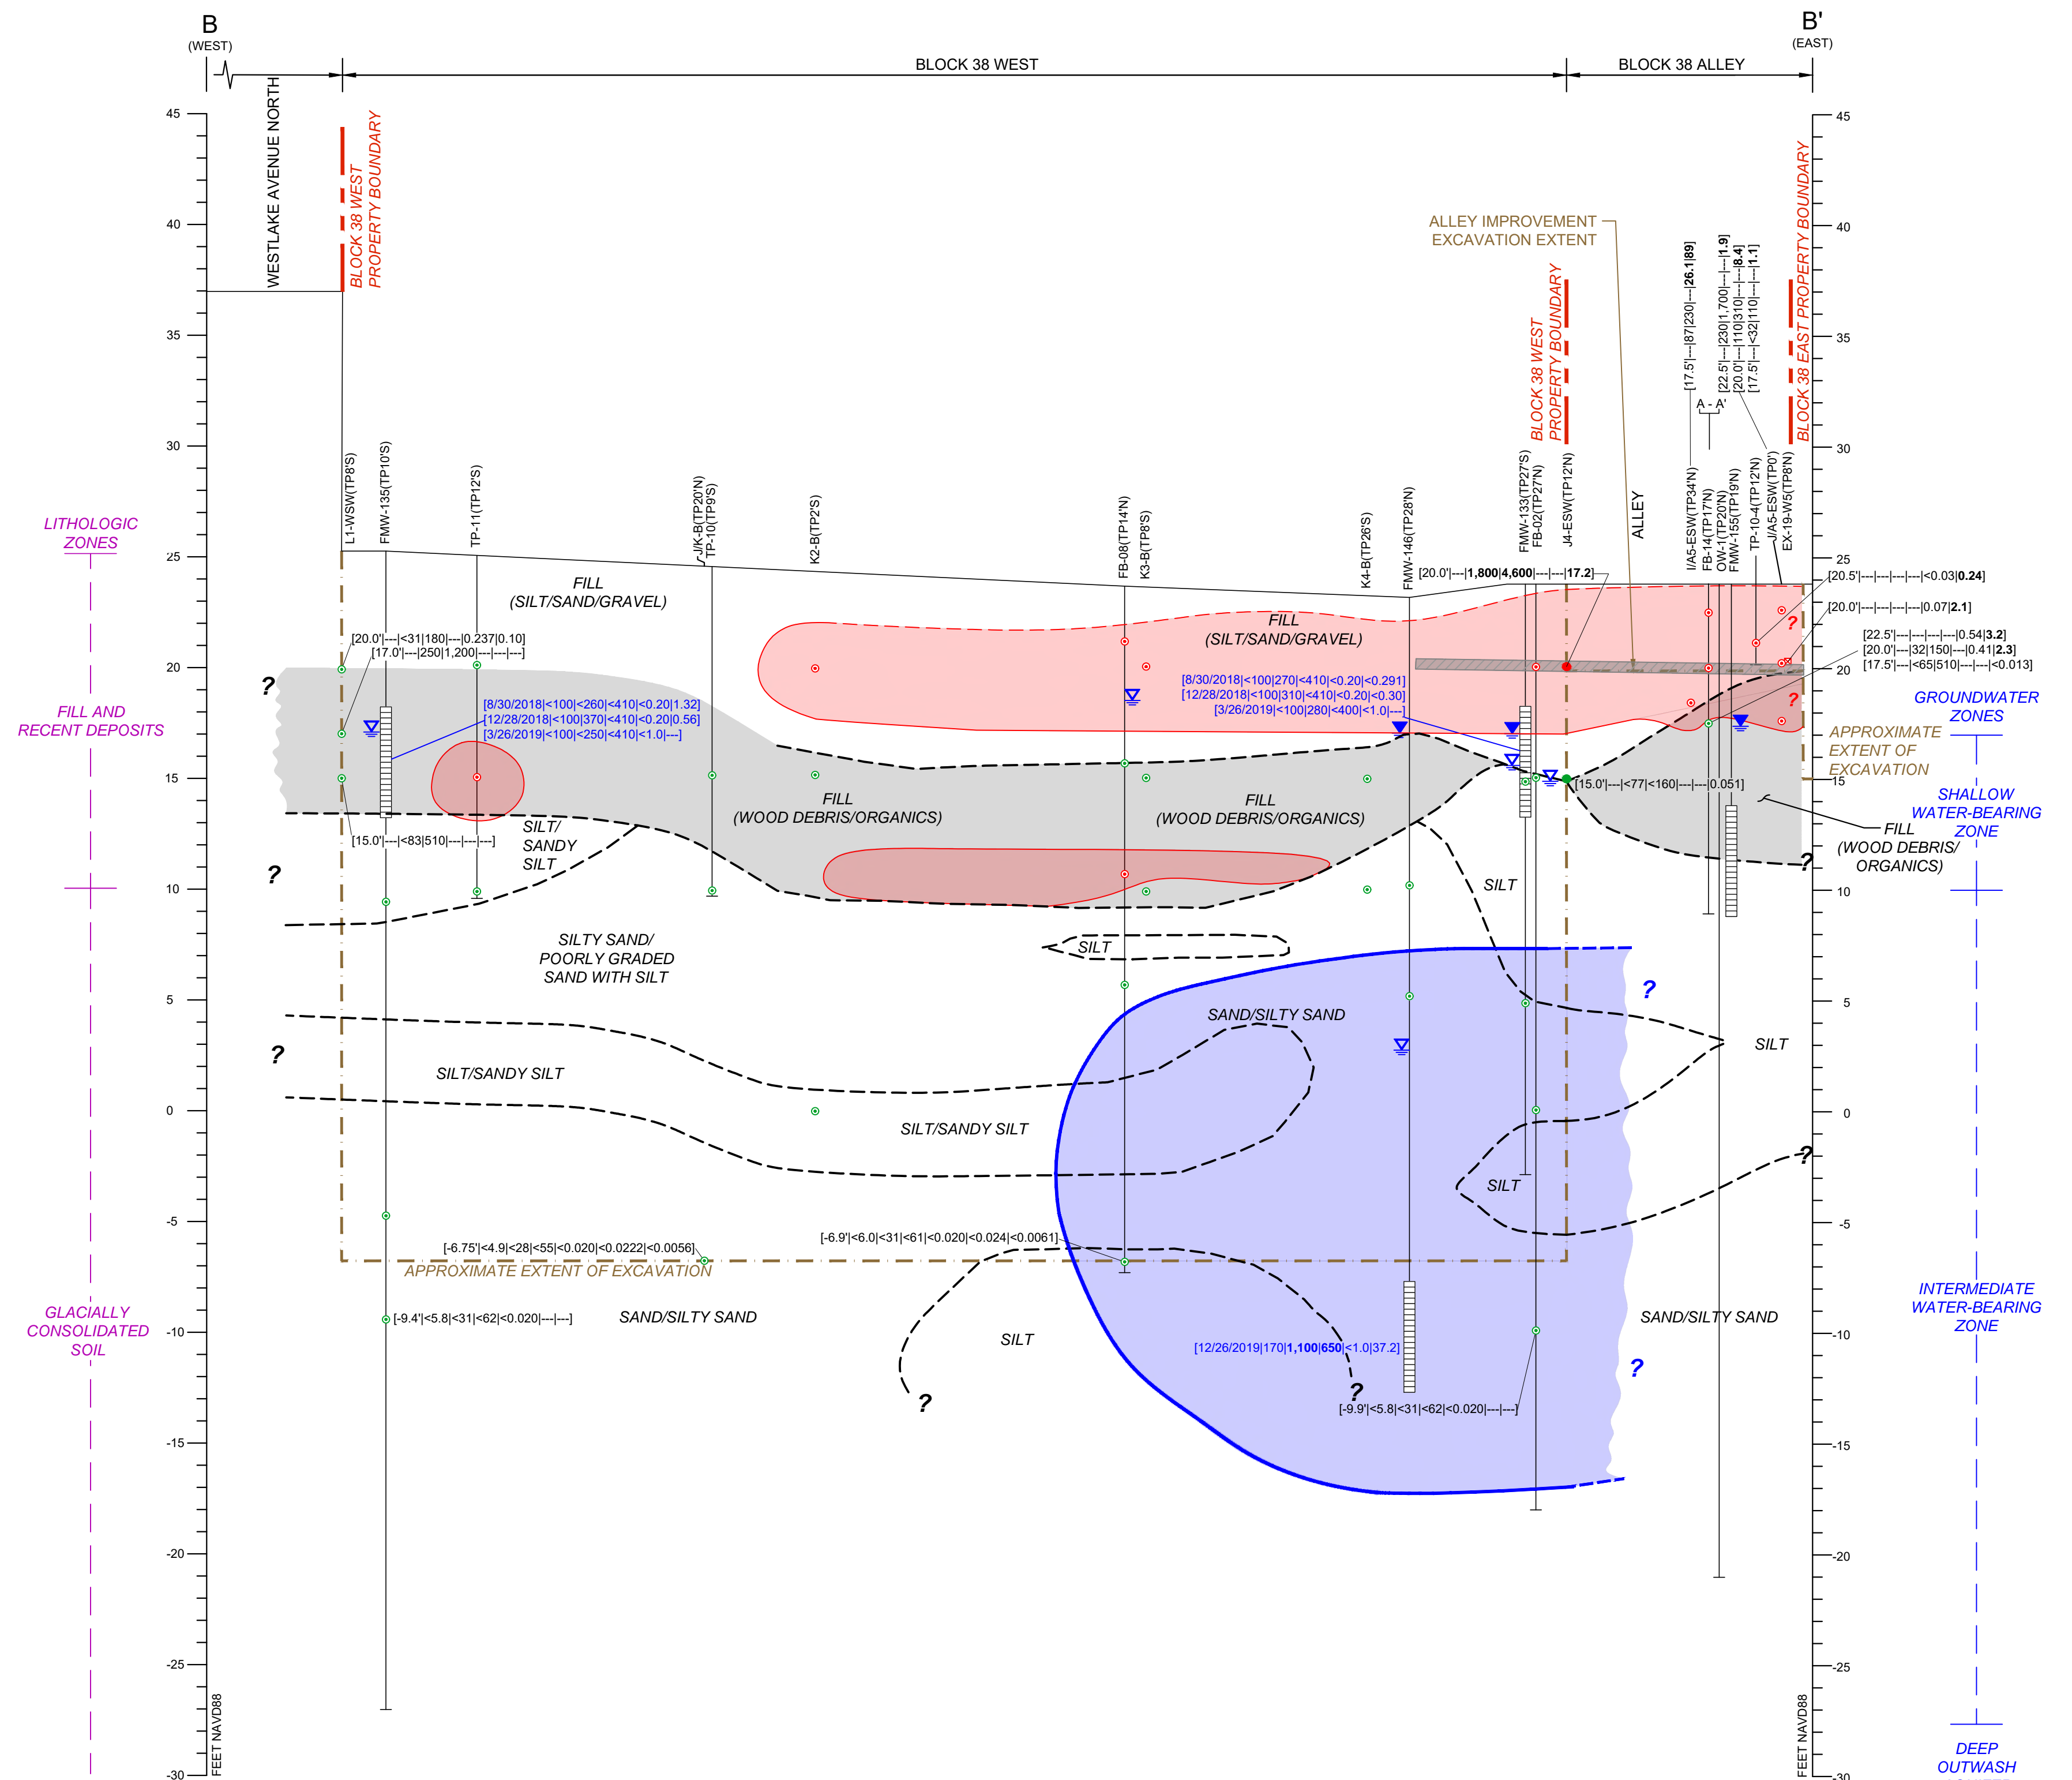
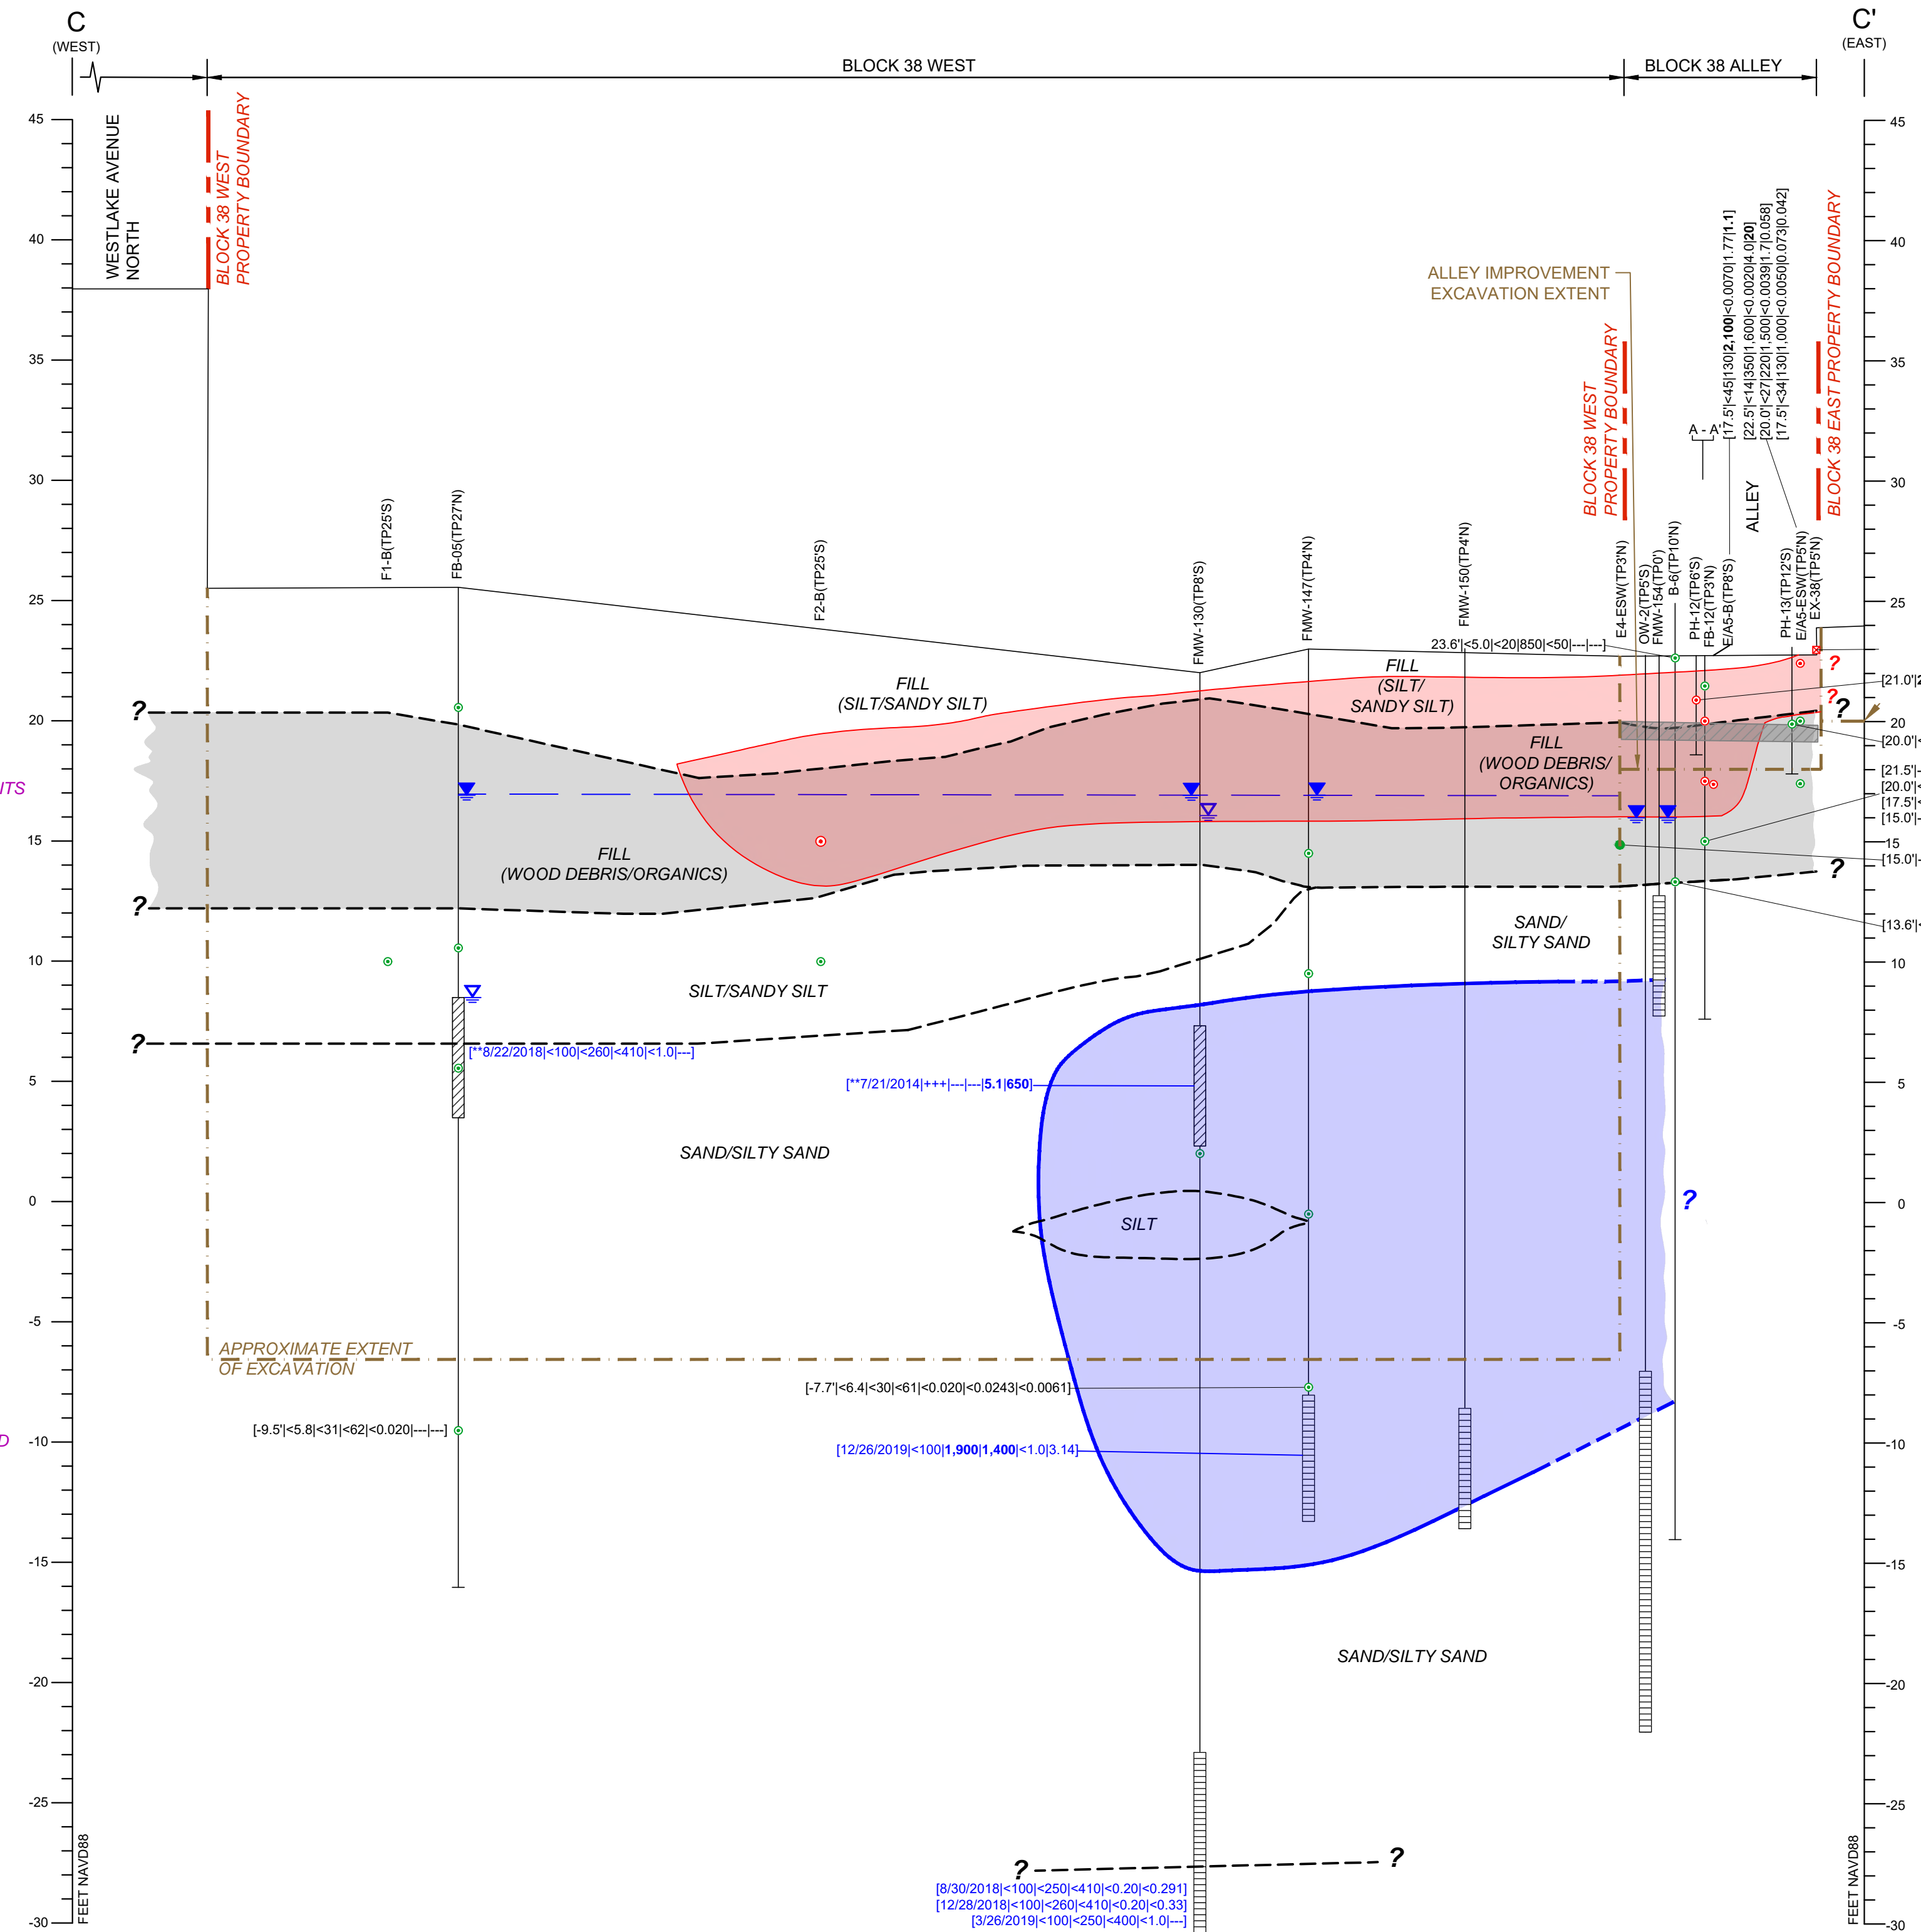
**FIGURE 12**  
 CROSS SECTION A-A'  
 BLOCK 38 ALLEY  
 SEATTLE, WASHINGTON

- - - APPROXIMATE AREA OF WOOD DEBRIS/ORGANICS LAYER  
 [Red Shaded Area] ESTIMATED EXTENT OF SOIL EXCEEDING SCREENING LEVELS  
 [Blue Shaded Area] ESTIMATED EXTENT OF GROUNDWATER EXCEEDING SCREENING LEVELS  
 [Hatched Area] ESTIMATED EXTENT OF COAL/CHARCOAL LAYER
