**Weyerhaeuser Company  
Tacoma Export Facility**

## **Operation Maintenance & Monitoring Plan**

## **Wood Debris Monitoring Results**

**June 30, 2009**

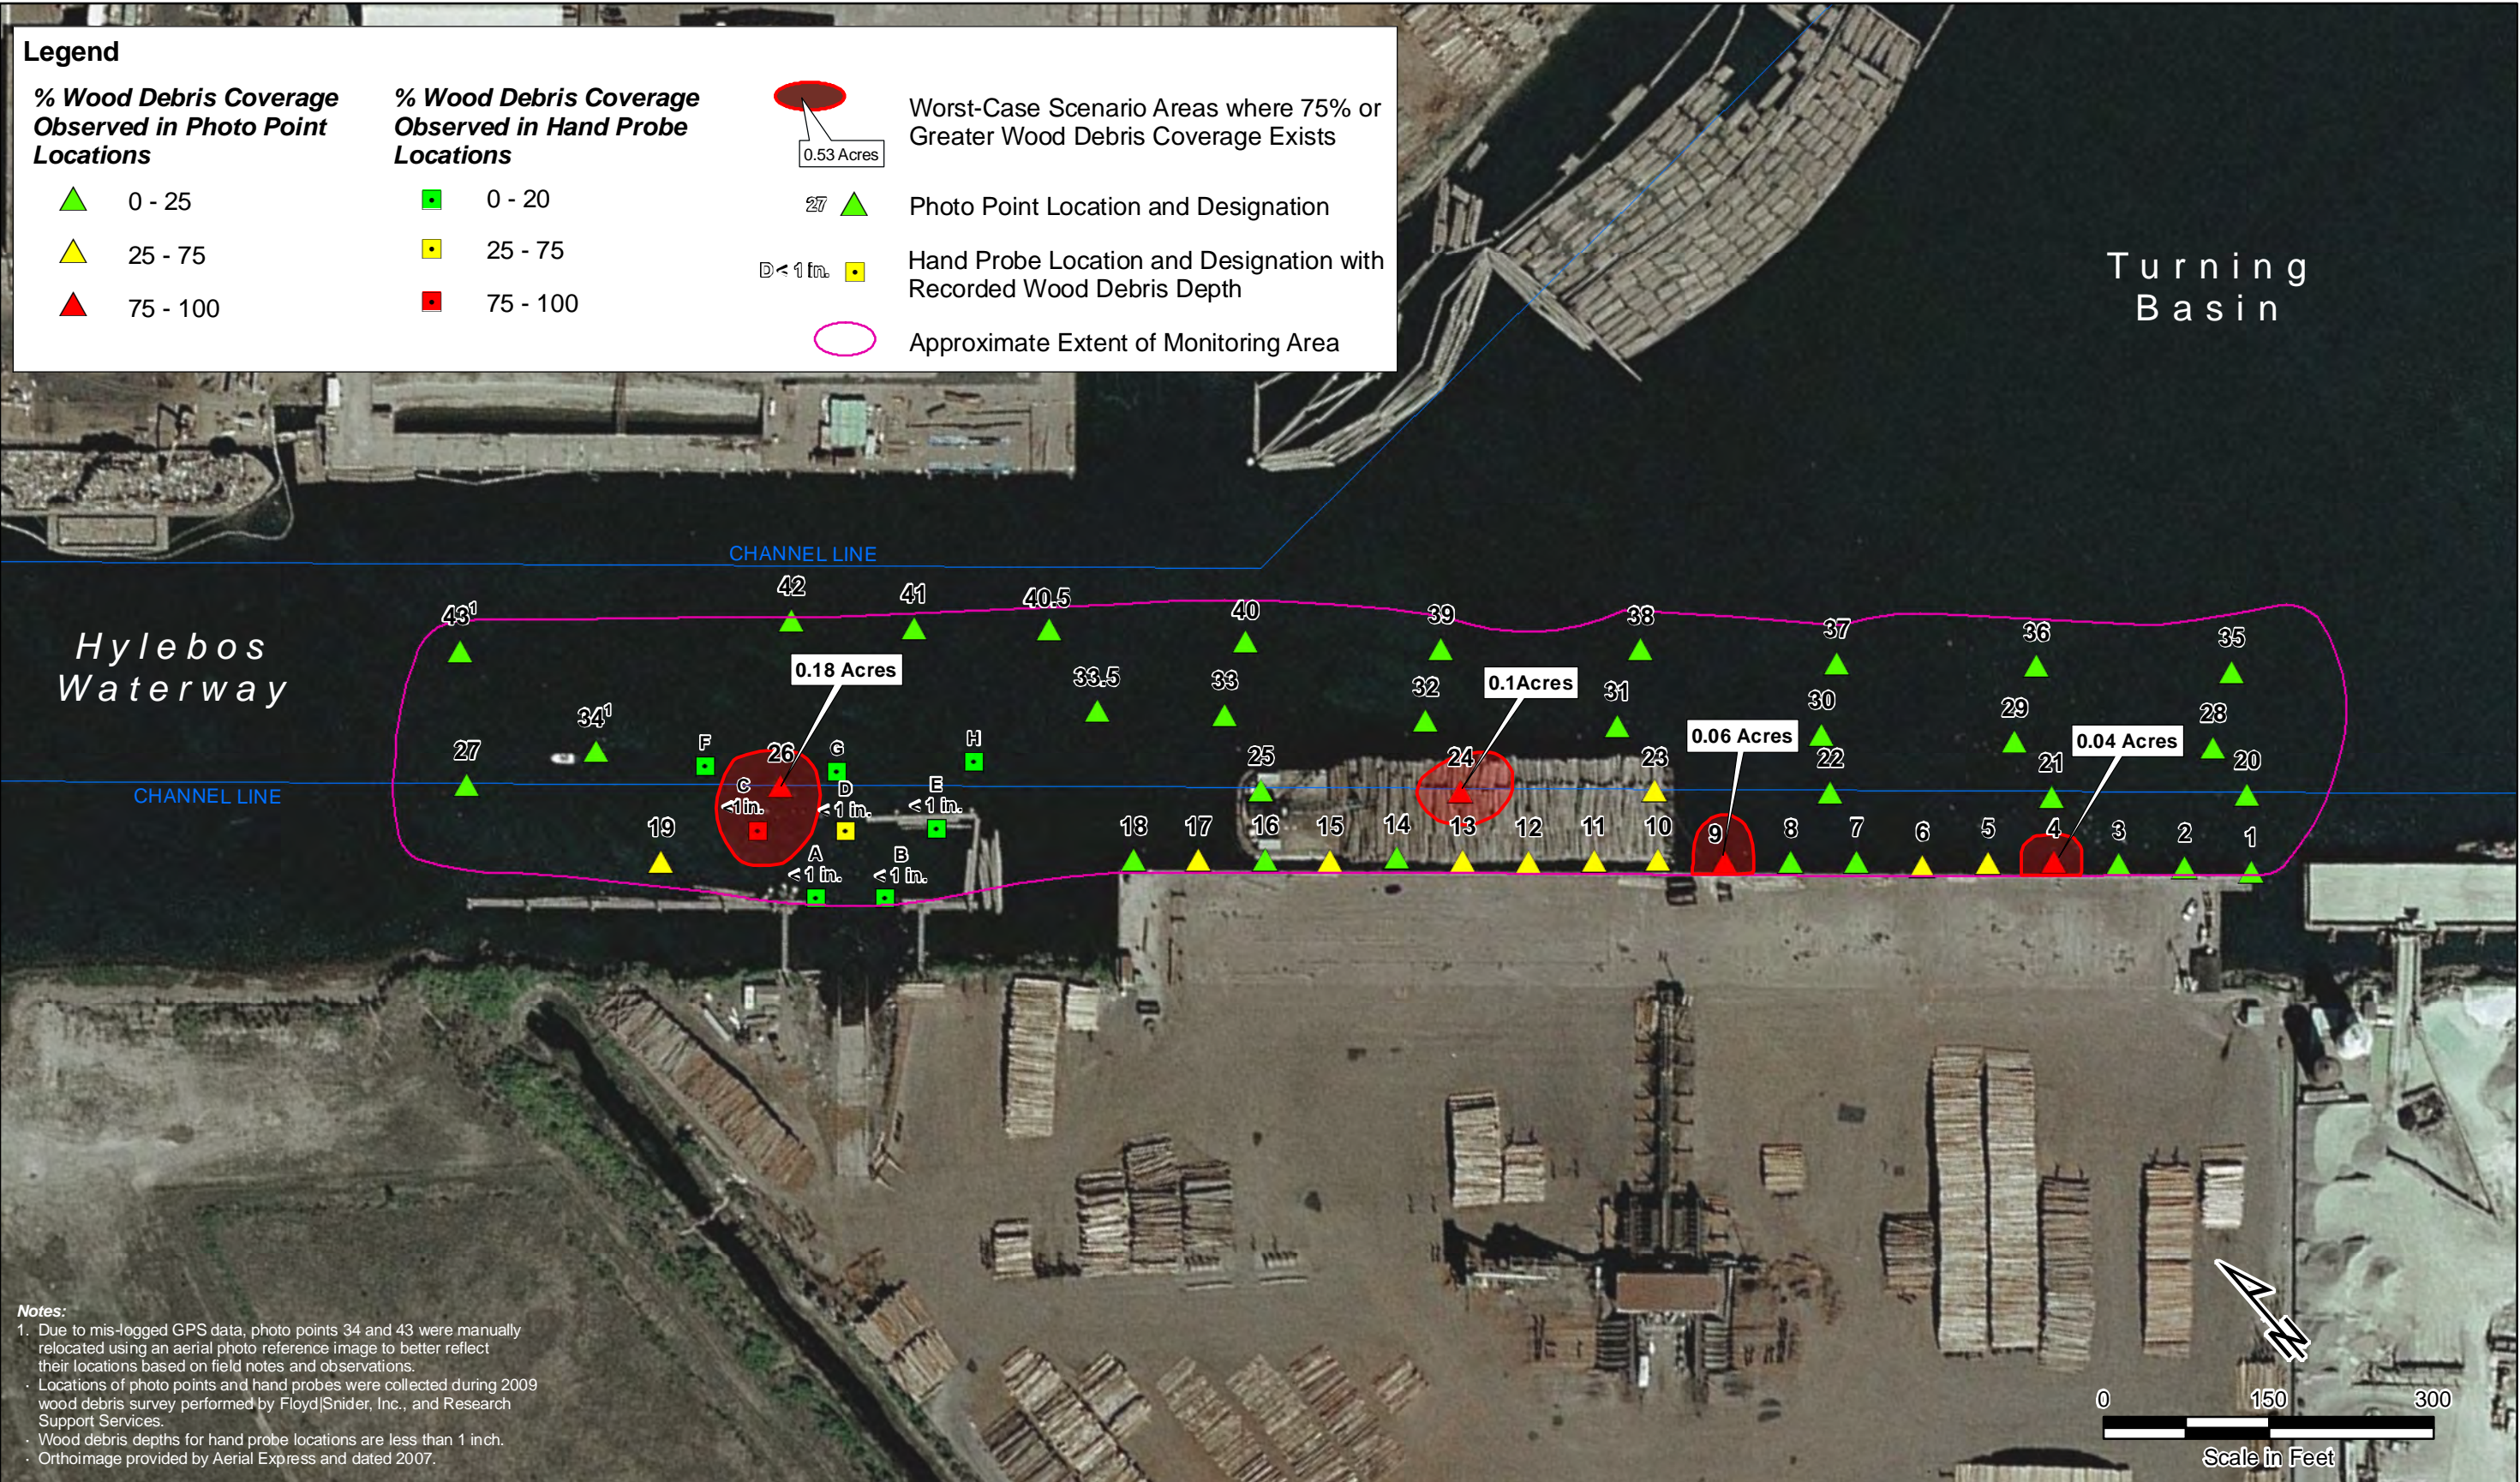
**Figure 3**  
**Wood Debris Coverage and**  
**Depth Monitoring Results**

Area B was monitored using seven photo points and eight probe points as shown in Figure 3 and the following chart, which depicts the Area B monitoring locations relative to each other, the shore, and channel line.

Area B is approximately 2.5 acres in size and wood debris was detected in 8 out of 15 monitoring locations, with an average coverage of 42 percent across all locations where wood was detected. Due to an error in global positioning system (GPS) logging, Points 34 and 43 had to be relocated on the GIS map, because the coordinates for those locations recorded on the primary GPS unit corresponded to locations that were not used during monitoring. During monitoring, a secondary GPS system and map were used to track monitoring locations and Points 34 and 43 were moved to reflect the locations recorded on the secondary system. The primary and secondary GPS systems recorded the same monitoring locations for all of the other 43 locations. The wood debris coverage score distributions indicate that Area B has only moderate surficial wood coverage limited to the area within 90 feet of the dock in front of the shore, and is punctuated by one location with high surficial wood coverage. Based on the spatial analysis conducted through GIS, there is no possibility that a contiguous acre of high wood coverage exists in Area B (Figure 3).

Area C was monitored using 38 photo points as shown in Figure 3 and the following chart, which depicts the Area C monitoring locations relative to each other, the shore, and channel line.

Area C is approximately 7 acres in size and wood debris was detected in 17 out of 38 photo points, with an average coverage of 44 percent across all locations where wood was detected. The wood debris coverage score distributions indicate that Area C has only moderate surficial wood coverage, which is limited to the area within 90 feet of shore, and is punctuated in three separate locations with high surficial wood coverage. Based on the spatial analysis conducted through GIS, there is no possibility that a contiguous acre of high wood coverage exists in Area C (Figure 4) or a combination of Areas B and C.

Wood debris depth was monitored in Area A at eight locations as shown in Figure 3. Wood debris was detected in five out of eight monitoring points in area, with an average depth of less than 1 inch across all locations where wood was detected. The wood debris depth score

distributions indicate that Area A has only a light covering of surficial wood, which is limited to the area within 90 feet of the shore.
