Memorandum

**Re: Monitoring Well Installation and Groundwater Monitoring Report
Former Wasser & Winters Log Sort Yard
Consent Decree No. 93-2-08684-4
Washington State Department of Ecology Facility Site ID #1218
Monitoring date: August 16, 2019**

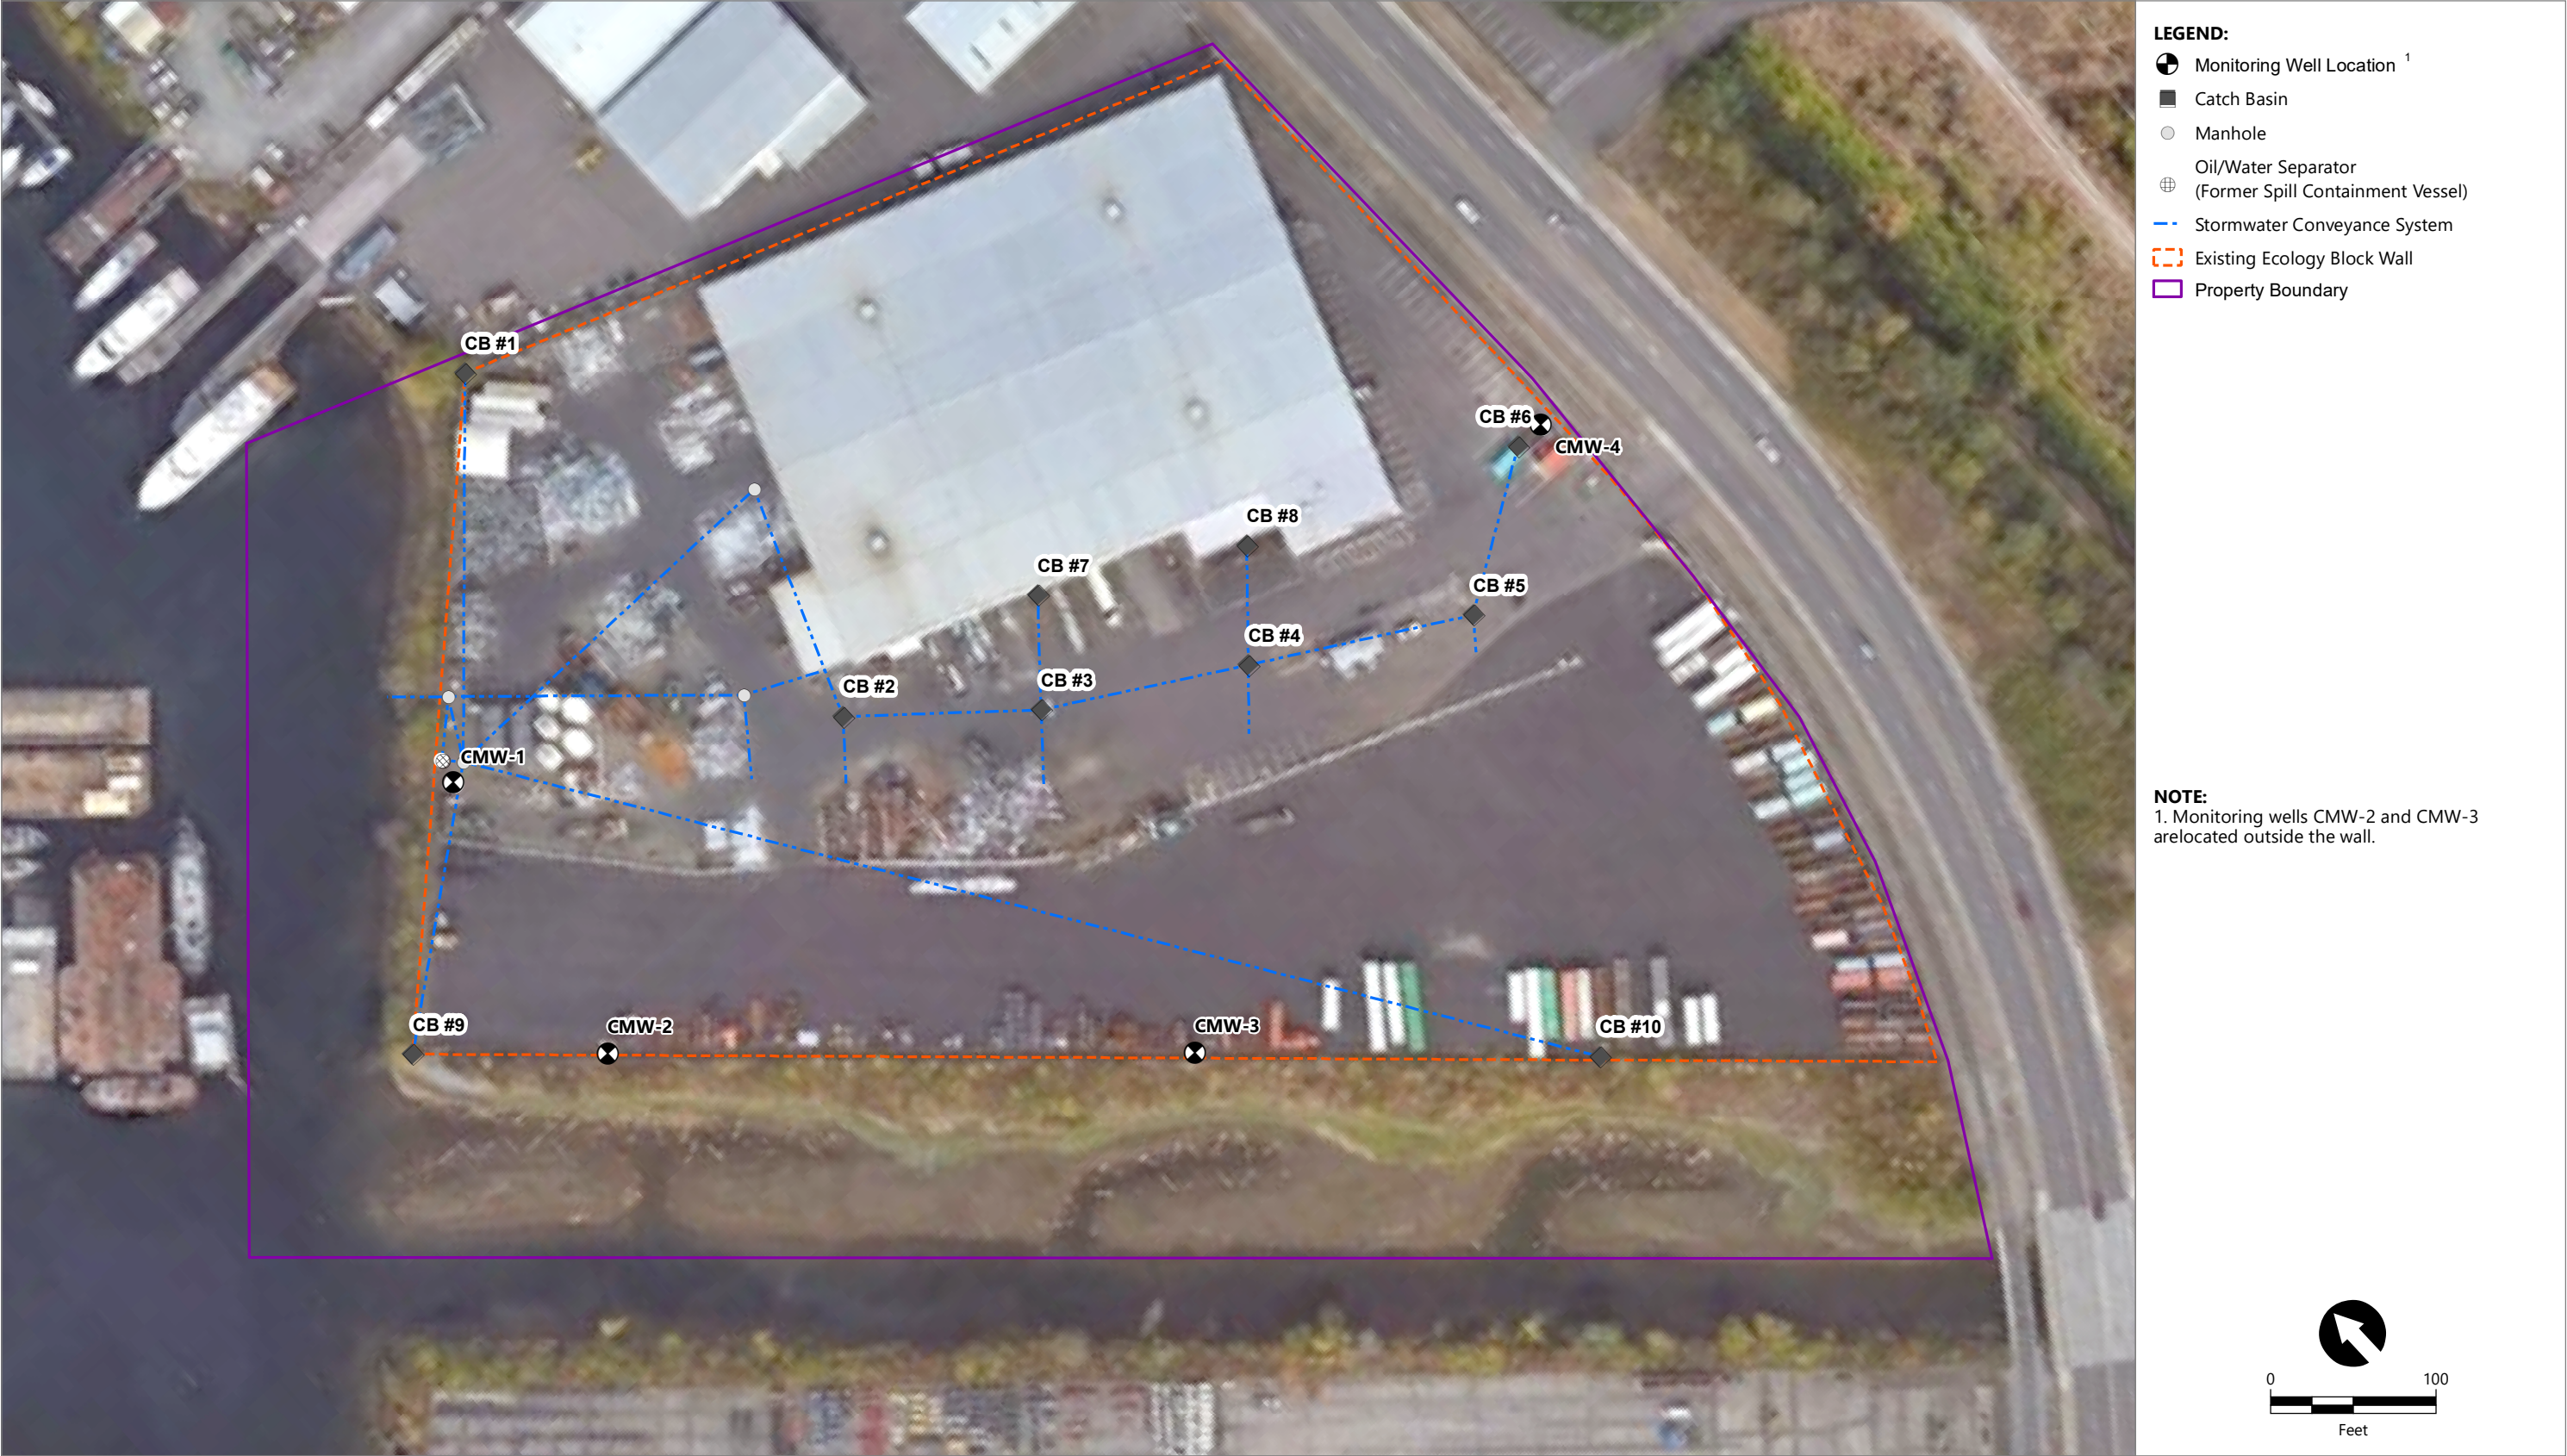
Figure 2
Site Plan
Monitoring Well Installation and Groundwater Monitoring Report
Former Wasser & Winters Log Sort Yard

The newly installed groundwater monitoring wells (CMW-1, CMW-2, and CMW-4; Figure 2) were developed prior to groundwater sampling on July 26, 2019, by surging the well screen followed by purging groundwater from the well casing using a typhoon pump. All three wells ran dry after removing less than 1.5 gallons preventing water quality parameters to be collected. The wells were surged, pumped dry, and allowed to recover, followed by another cycle of surging and pumping until the discharged water was visibly clear. The details of the well development are presented in the following list and the field forms are included in Attachment A. Well CMW-3 was redeveloped as part of sampling in February 2017 and was not redeveloped again this time.

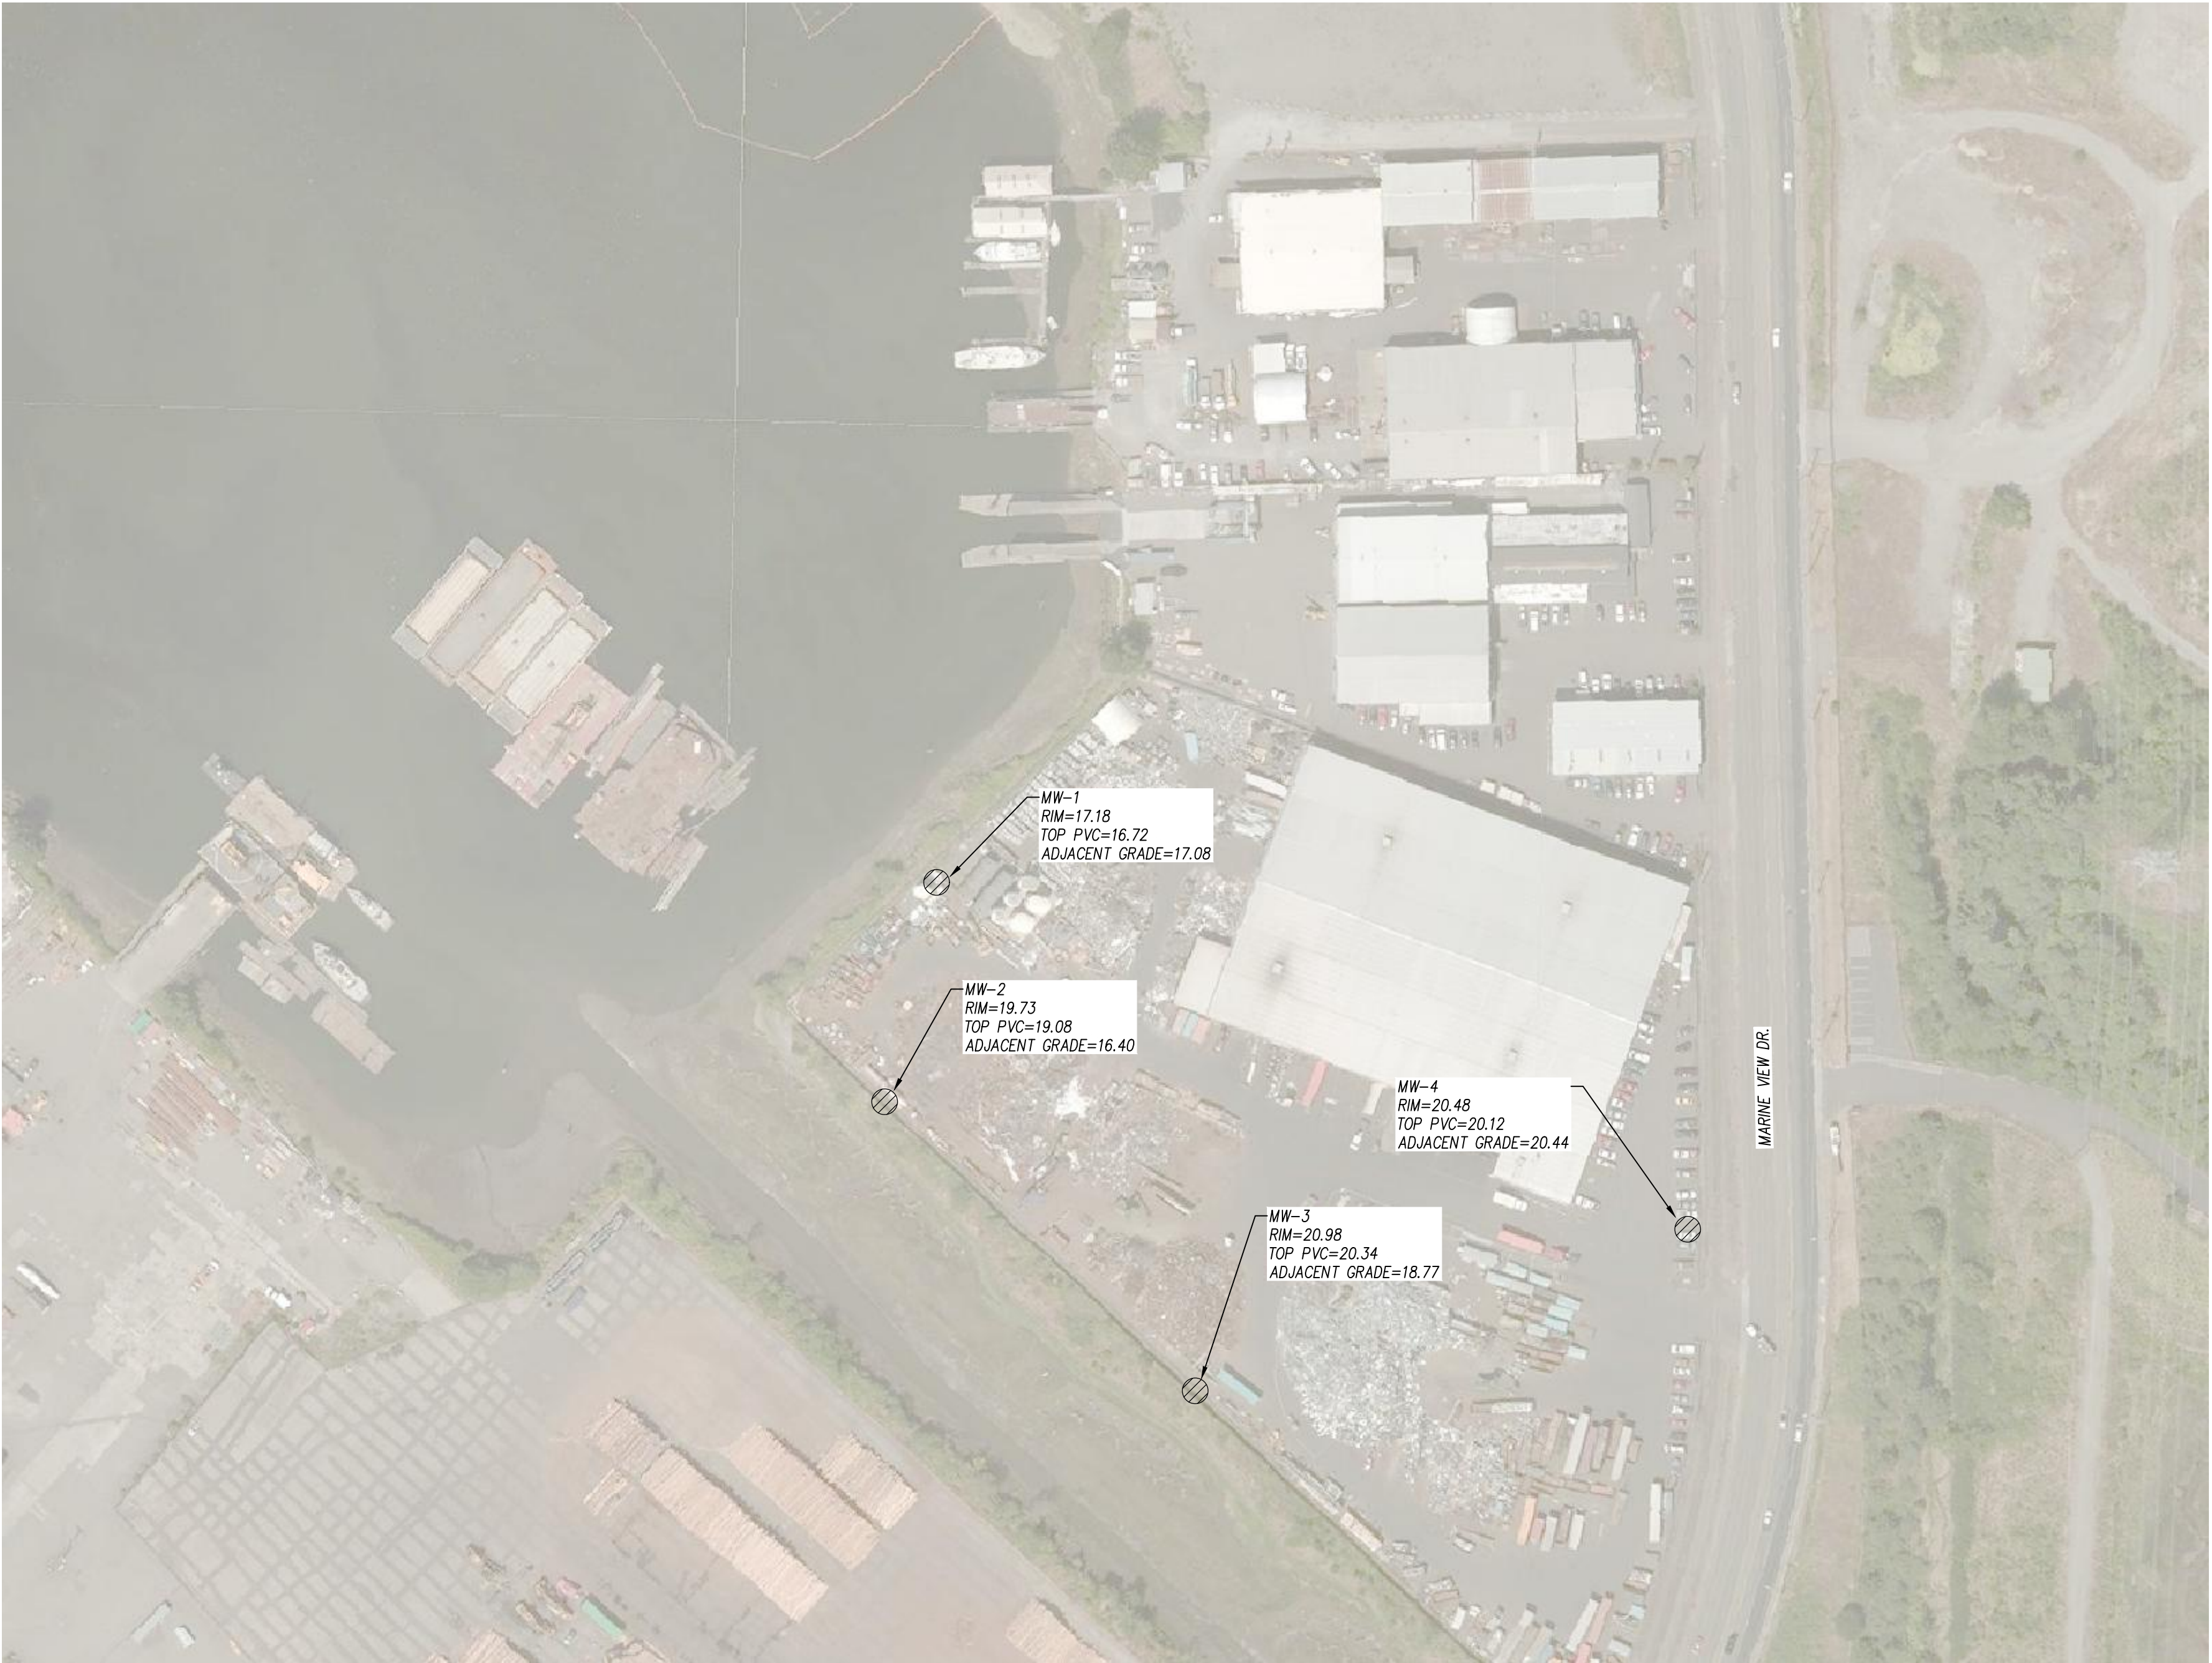
Well Survey

All monitoring wells (existing and newly installed) were surveyed for horizontal and vertical positioning on September 4, 2019, by Sitts & Hill, Inc., Tacoma, Washington. The summary of the survey details are presented in Table 1 and the survey map is included in Appendix B.

STA	NORTHING	EASTING	RIM ELEVATION	TOP OF PIPE	GROUND ELEVATION
MW - 1	708571.34	1178735.23	17.18	16.72	17.08
MW - 2	708387.88	1178691.70	19.73	19.08	16.40
MW- 3	708146.04	1178951.51	20.98	20.34	18.77
MW - 4	708281.23	1179363.61	20.48	20.12	20.44
