CARTY LAKE MAINTENANCE AND MONITORING PLAN

CARTY LAKE SEDIMENT MONITORING SAMPLING AND ANALYSIS PLAN

FORMER PACIFIC WOOD TREATING CO. SITE
FACILITY ID 1019, CLEANUP SITE ID 3020

March 2, 2016
Project No. 9003.01.40

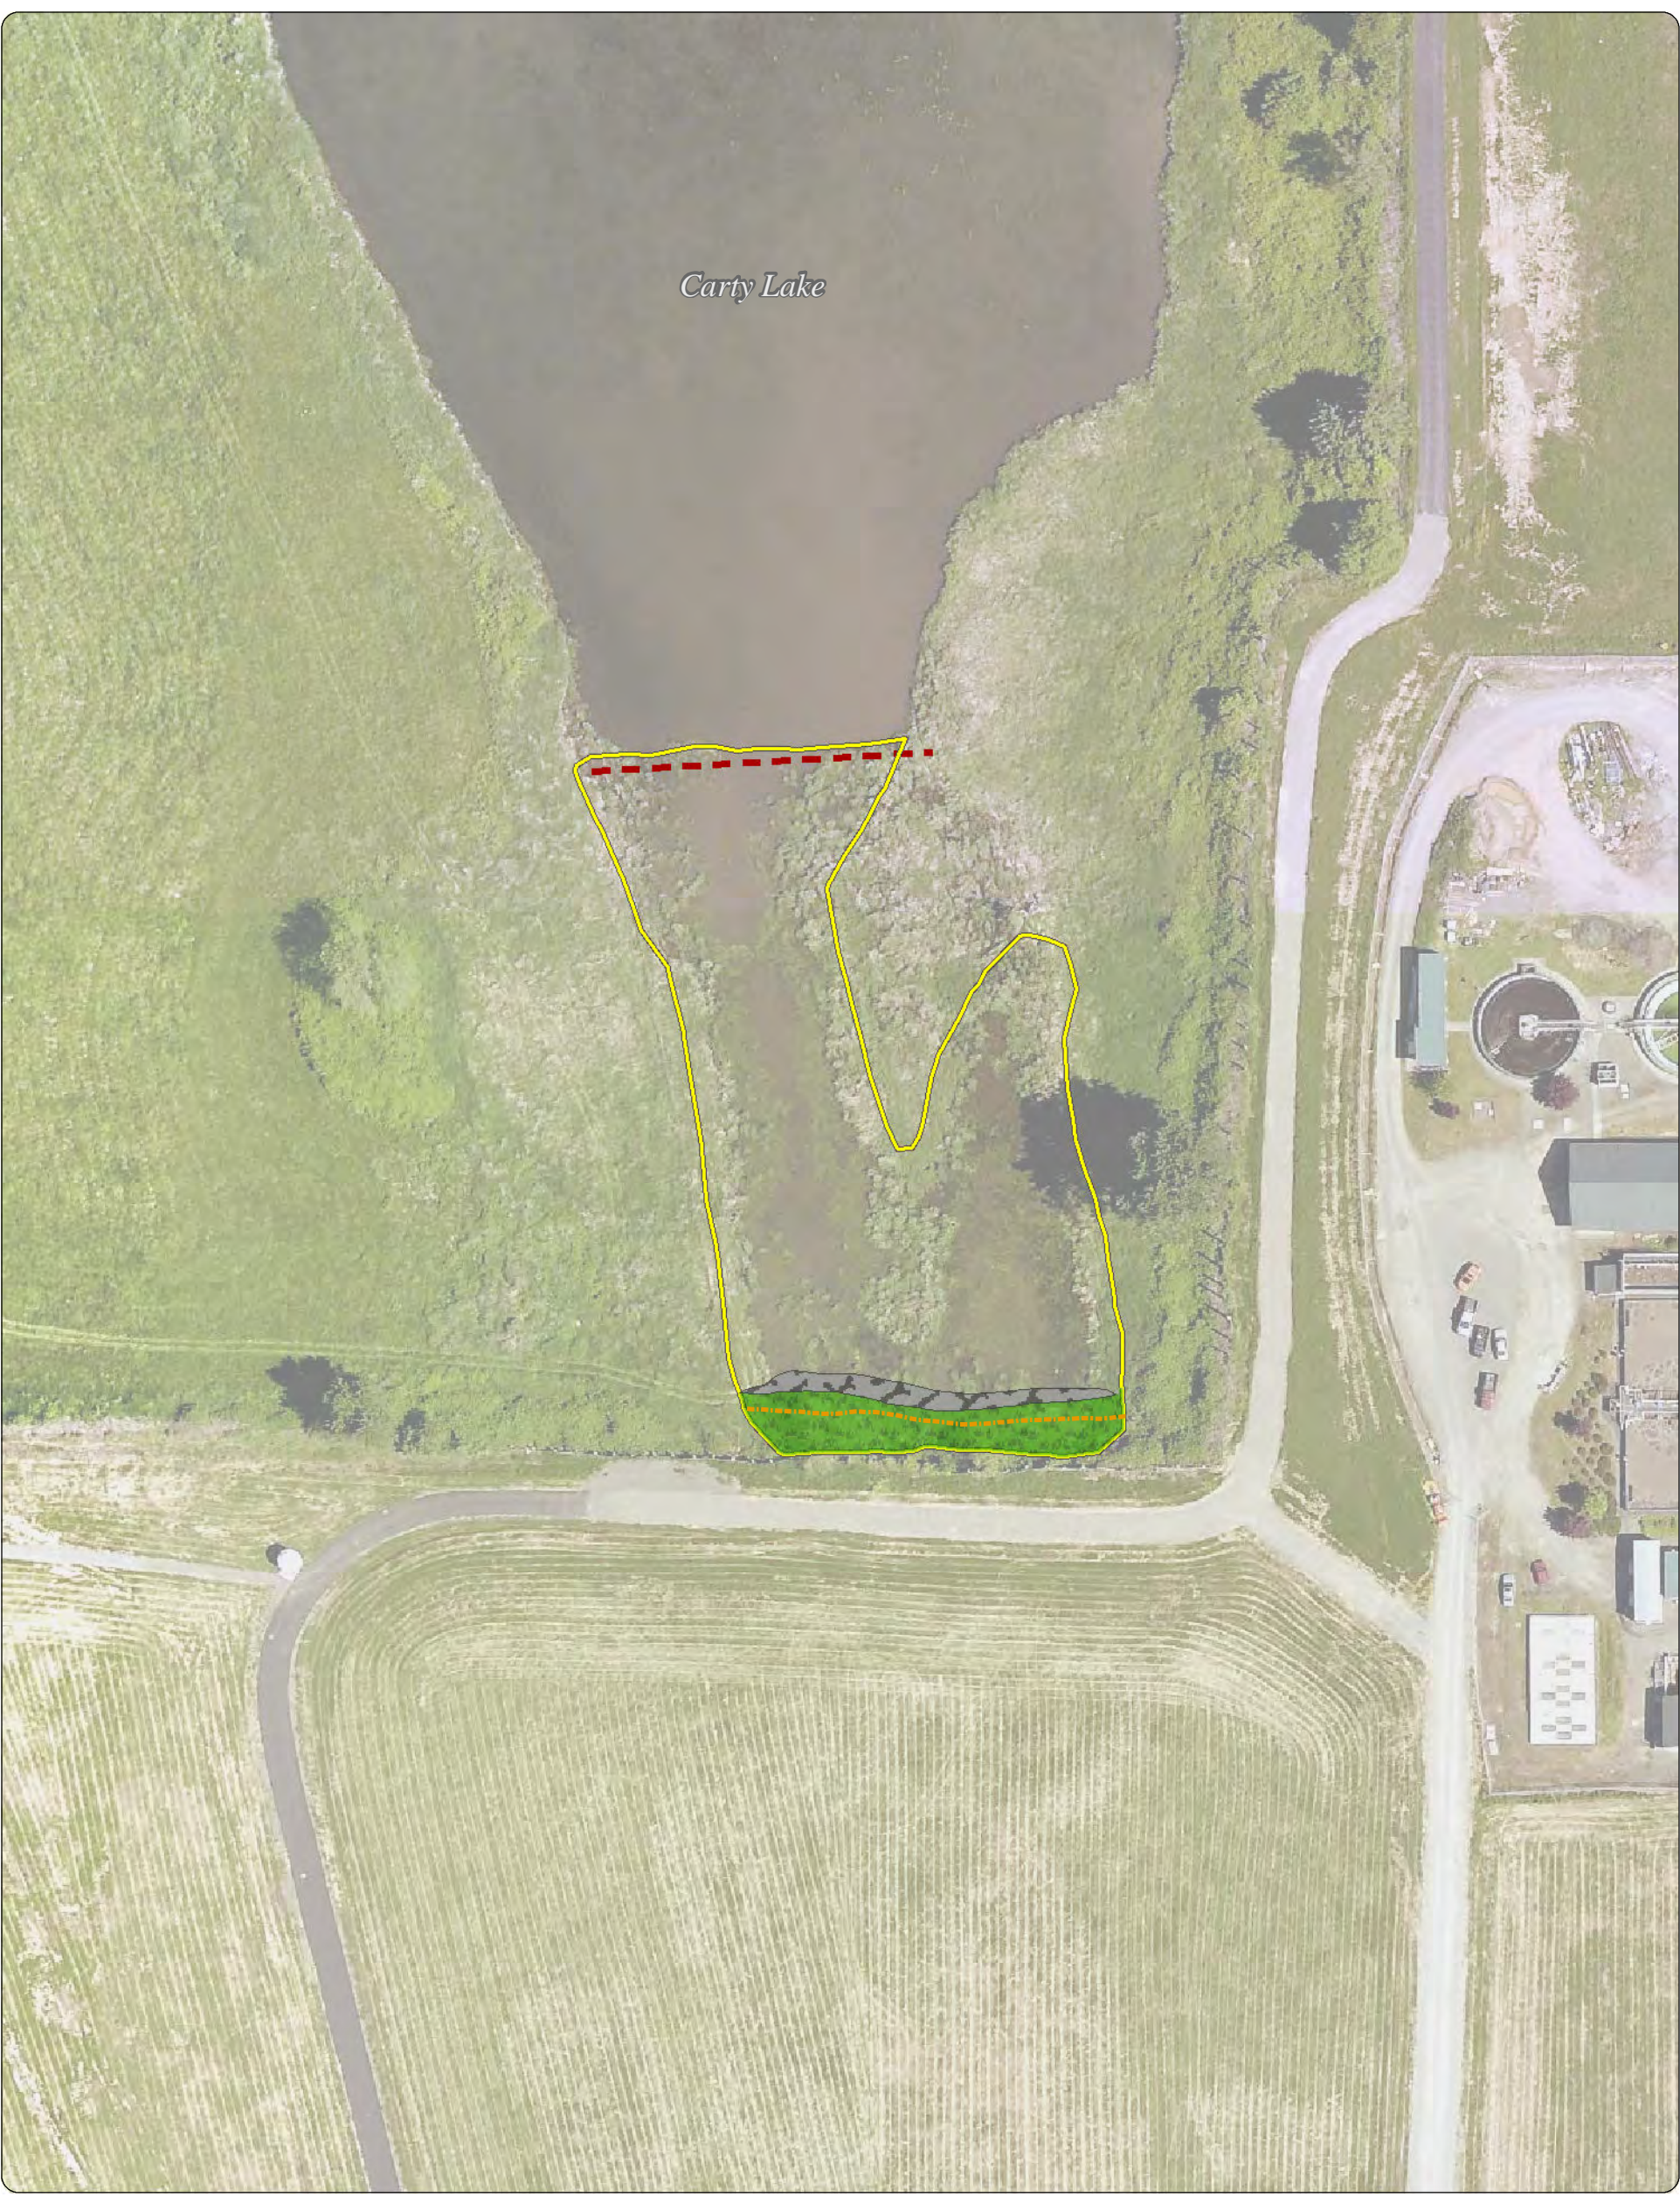
Figure 2-1
Post Excavation
Surface Sediment
 Former PWT Site
 Ridgefield, Washington

Source: Aerial photograph (2014) obtained from Clark County GIS. Site features and boundaries provided through a survey conducted by Minister & Glaeser Surveying in 2014 and 2015. All features are approximate.

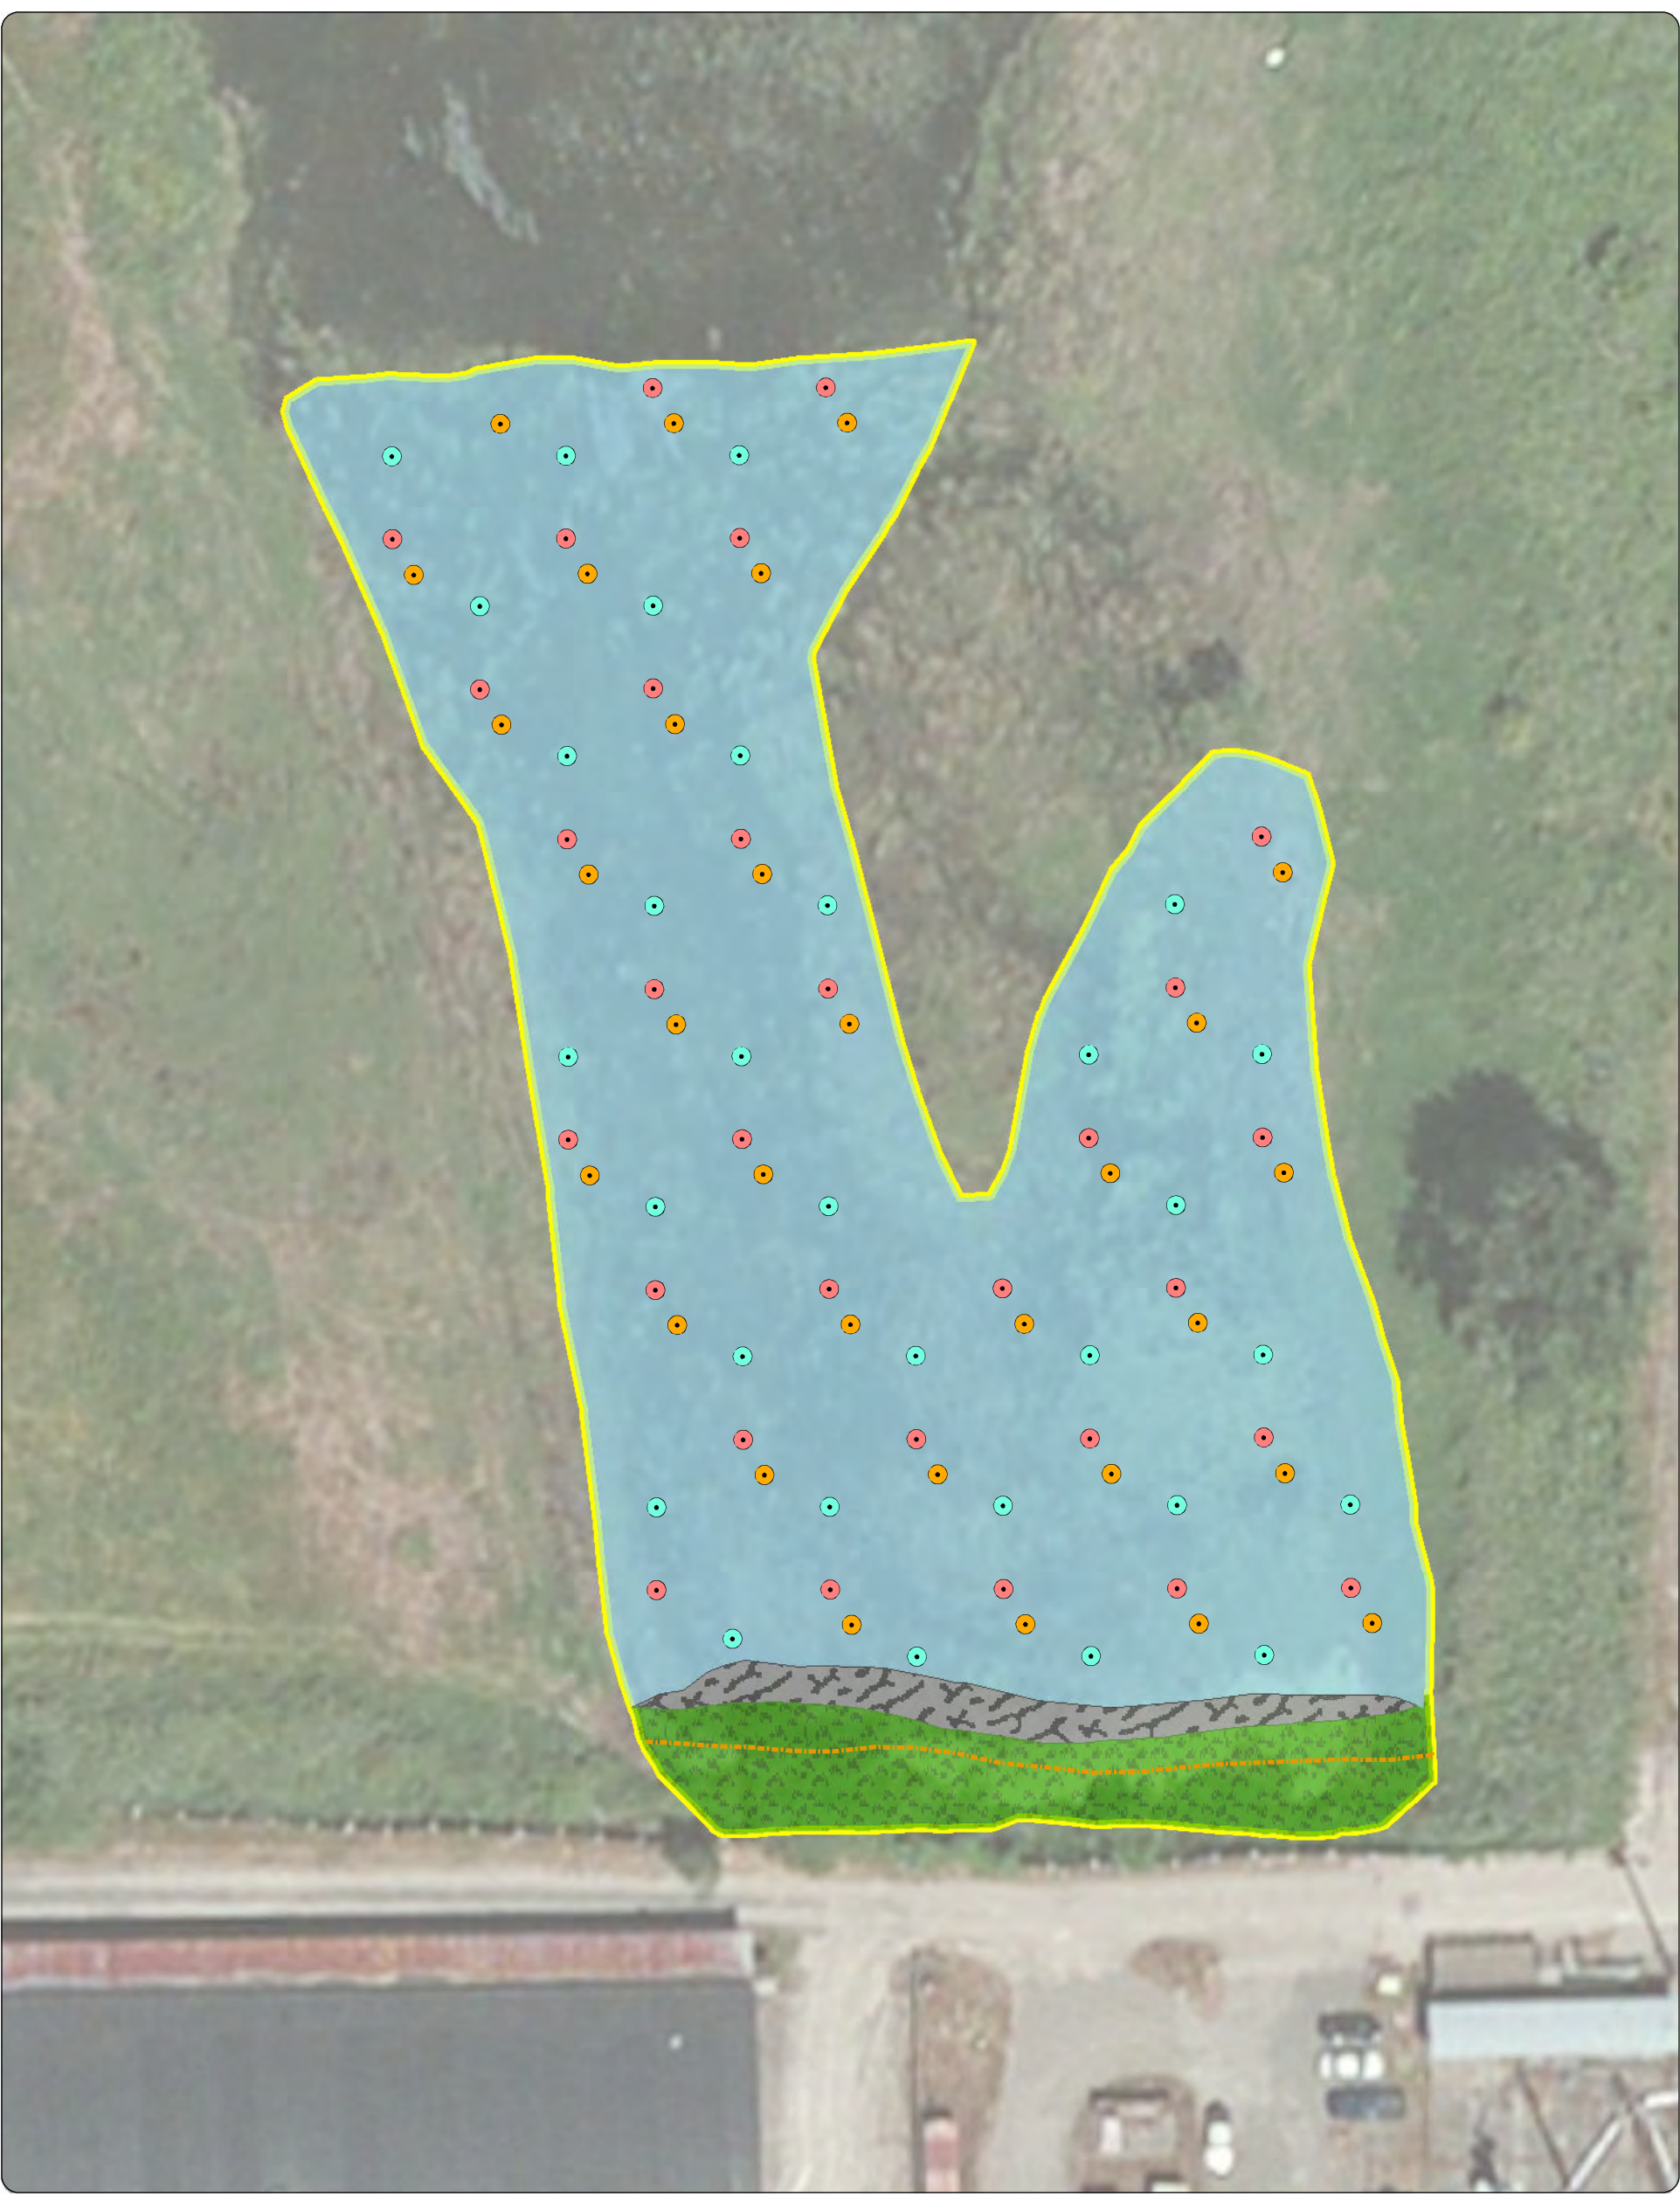
Source: Aerial photograph obtained from ESRI, Inc. ArcGIS Online (2010). Site features and boundaries provided through a survey conducted by Minister & Glaeser Surveying in 2014 and 2015. All features are approximate.

- Legend**
- Incremental Sample Location A
 - Incremental Sample Location B
 - Incremental Sample Location C
 - Ordinary High Water
 - Decision Unit
 - Excavation Extent
 - Bank
 - Fish-Mix Rock

Increment locations were selected based on a systematic random approach using a triangular grid (using ArcGIS 10 and Visual Sample Plan 6). Using a systematic random grid, as opposed to a simple random sampling approach, reduces the probability of missing areas with significantly elevated concentrations. Three ISM samples from 30 locations each (A, B, and C) are assigned for collection of the triplicate composite increment samples A, B, and C. Increment locations are shown on Figure 3-1. Subsequent monitoring events, if necessary, will be collected at location set A.

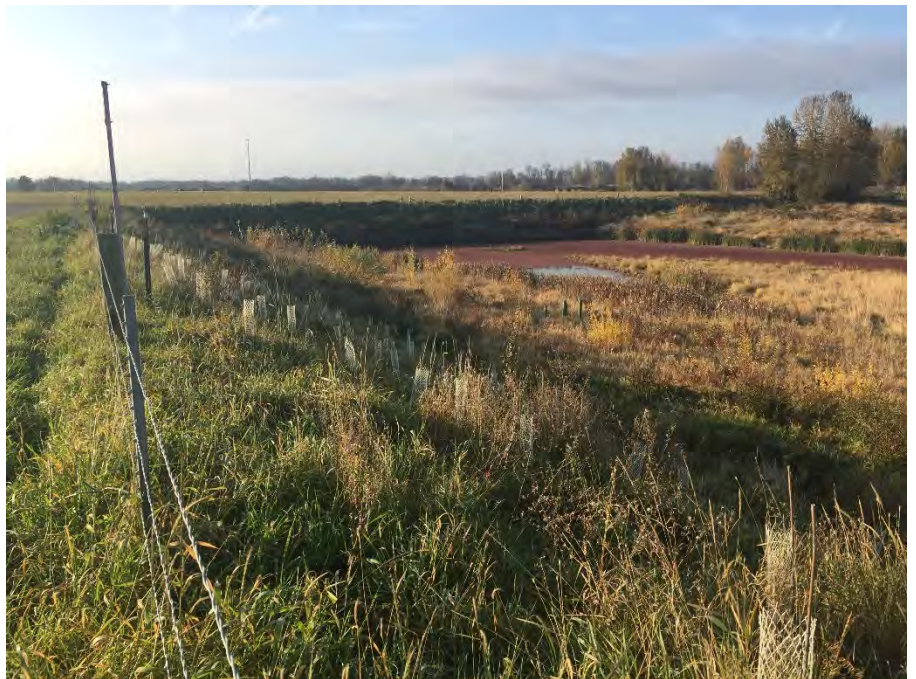
East bank facing
southwest

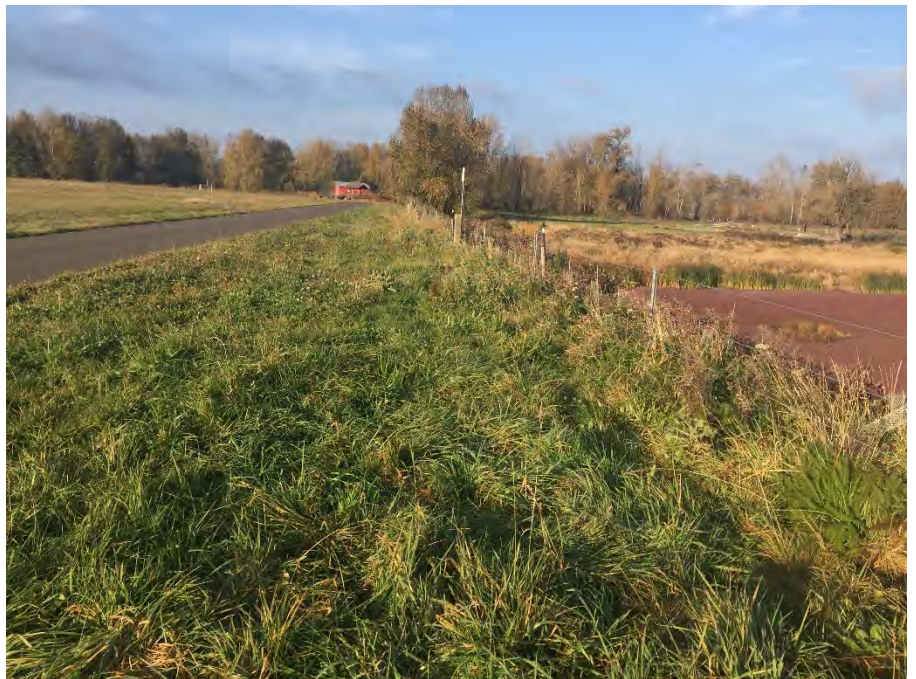
Top of southern bank (facing west)

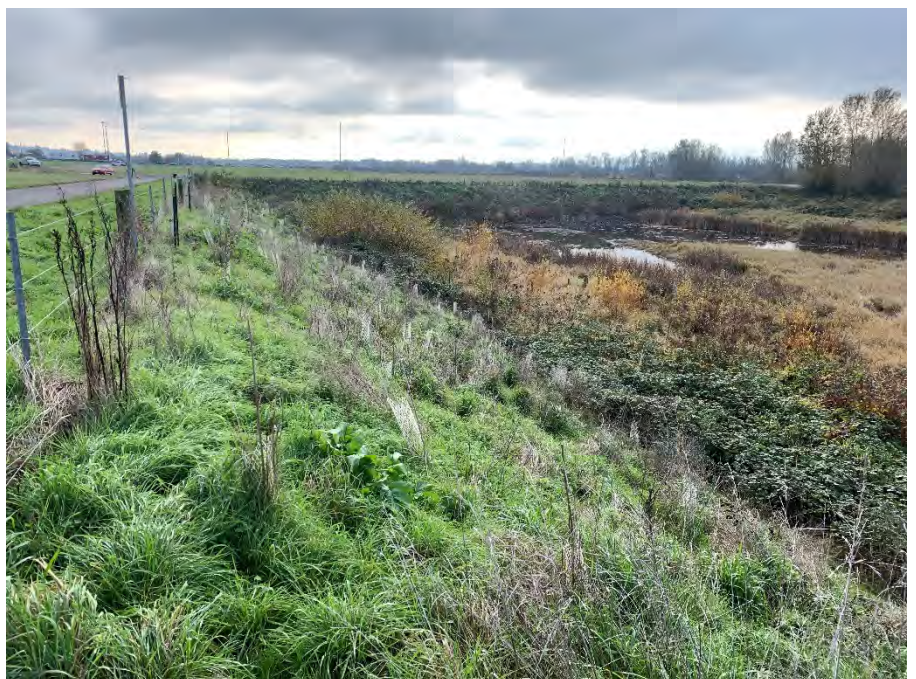
East bank facing southwest

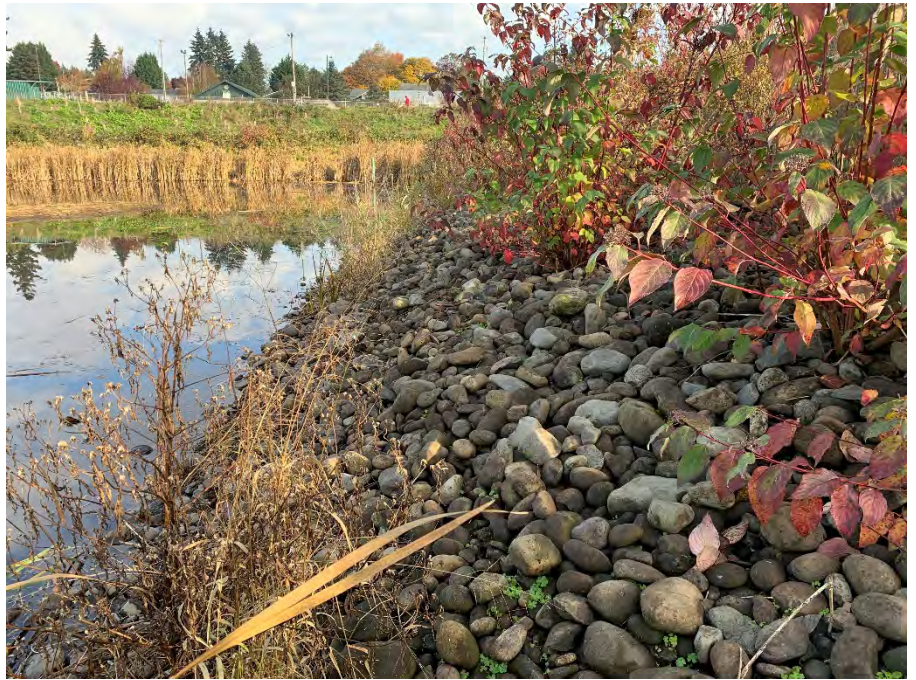
Southern bank (facing east)

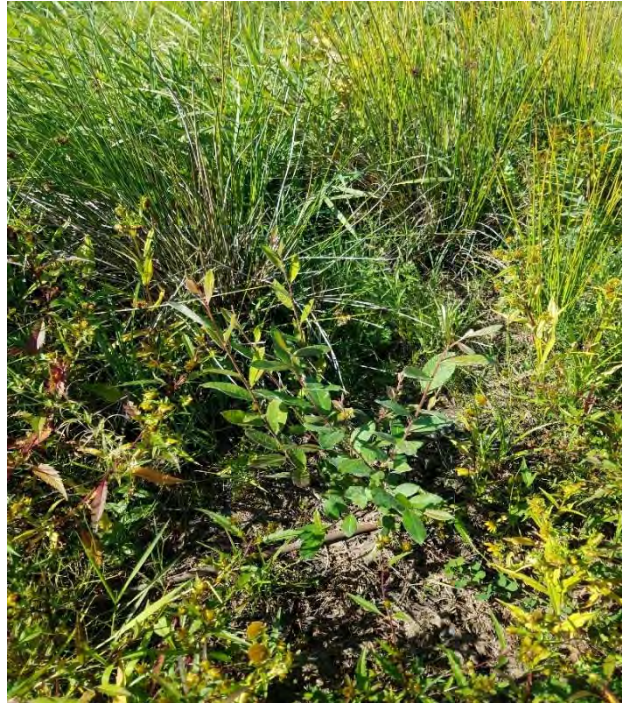
September 2017.
Photo point C1.
Marginal zone. Salix
species, spikerush,
Juncus, nodding
beggartick, and reed
canary grass
observed in vicinity.

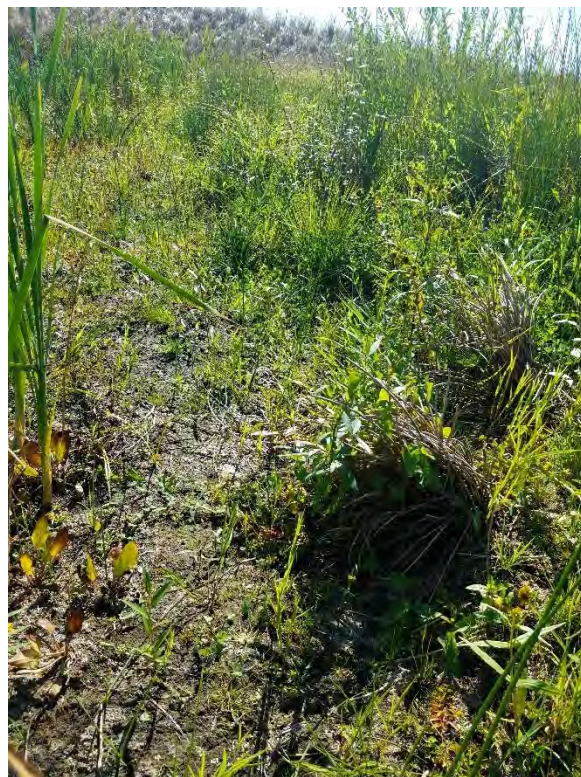
Photo No. 8

September 2017. Photo
point B1. Marginal
zone. American water
plantain, spikerush,
Salix species, Juncus,
sedges, wapato, cattail,
nodding beggartick, and
reed canary grass
observed in vicinity.

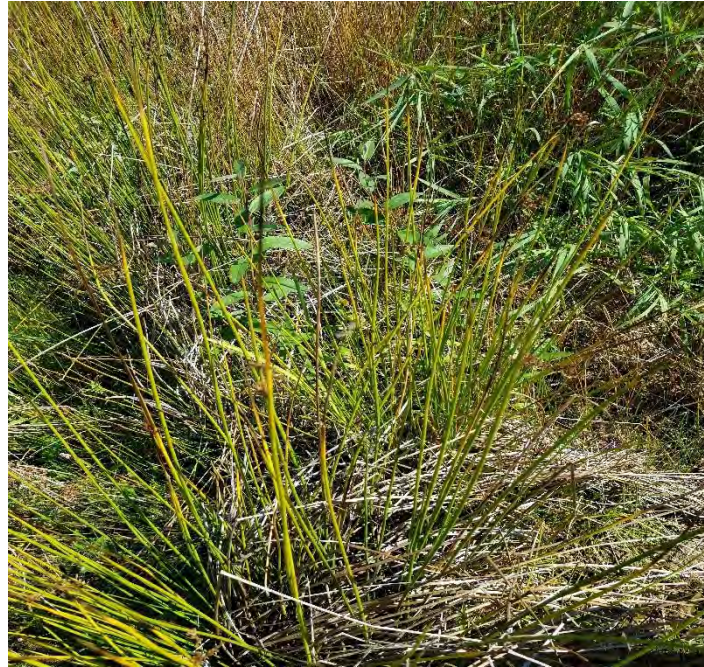
September 2017.
Photo point B18.
Marginal zone.
American water
plantain, spikerush,
Juncus, Salix species,
cattail, nodding
beggartick, and reed
canary grass
observed in vicinity.

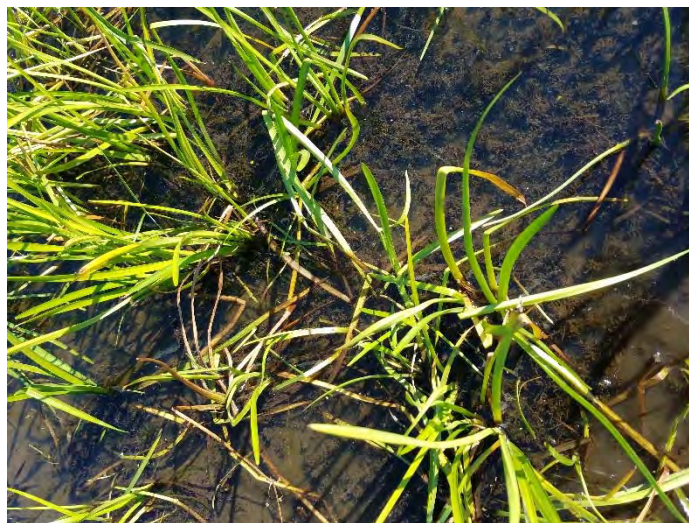
Photo No. 10

September 2017.
Photo point C5.
Emergent zone.
Bur-reed, wapato,
Canadian
waterweed, cattail,
and Eurasian
watermilfoil
observed in vicinity.

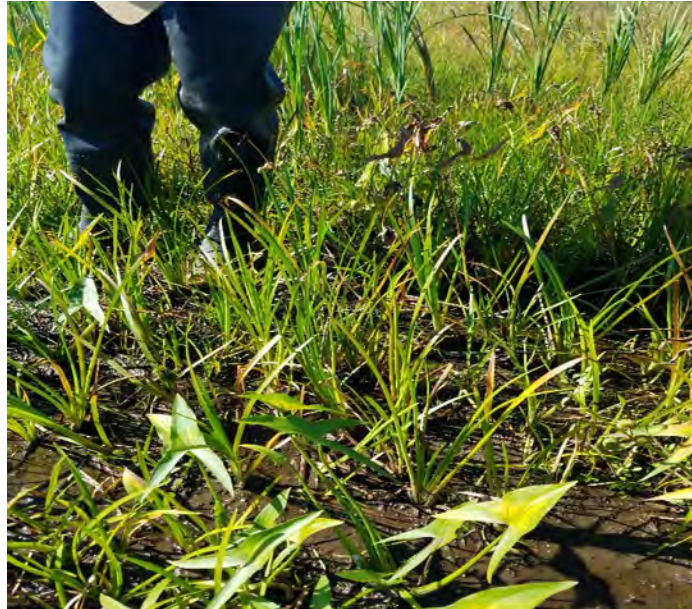
September 2017.
Photo point C15.
Emergent zone.
American water
plantain, spikerush,
bur-reed, wapato,
cattail, and reed
canary grass
observed in
vicinity.

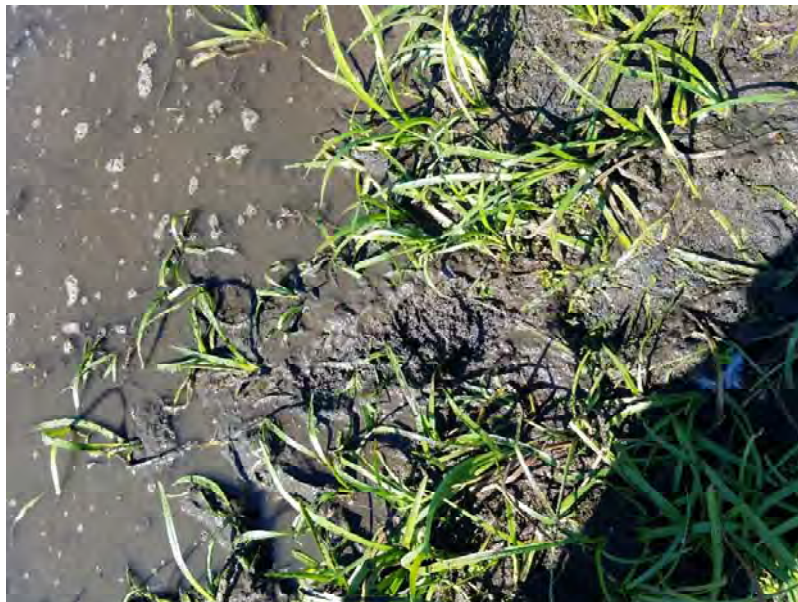
Photo No. 12

September 2017.
Photo point B11.
Emergent zone.
Spikerush, bur-reed,
curly dock, and reed
canary grass
observed in vicinity.

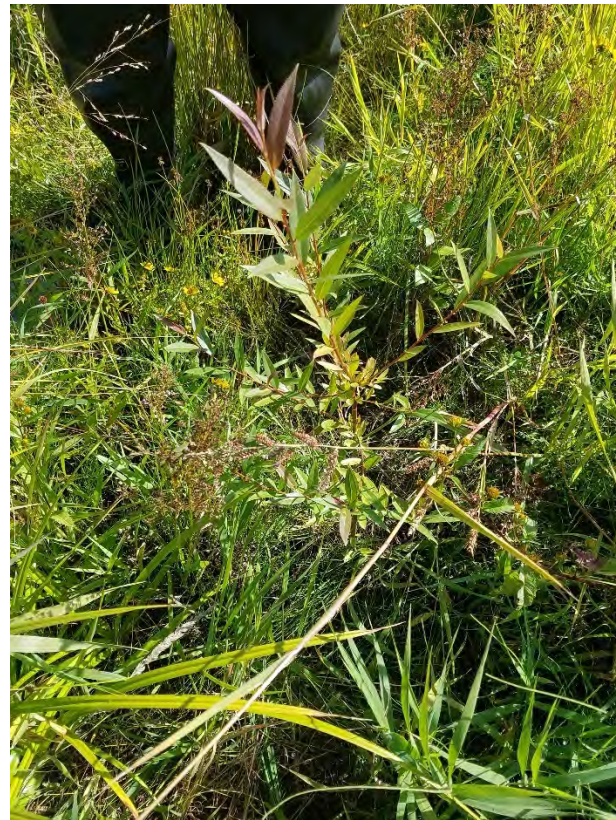
September 2018. Photo point C1. Marginal zone. Spikerush, *Salix* species, *Juncus* species, nodding beggartick, smartweed, and reed canary grass observed in vicinity.

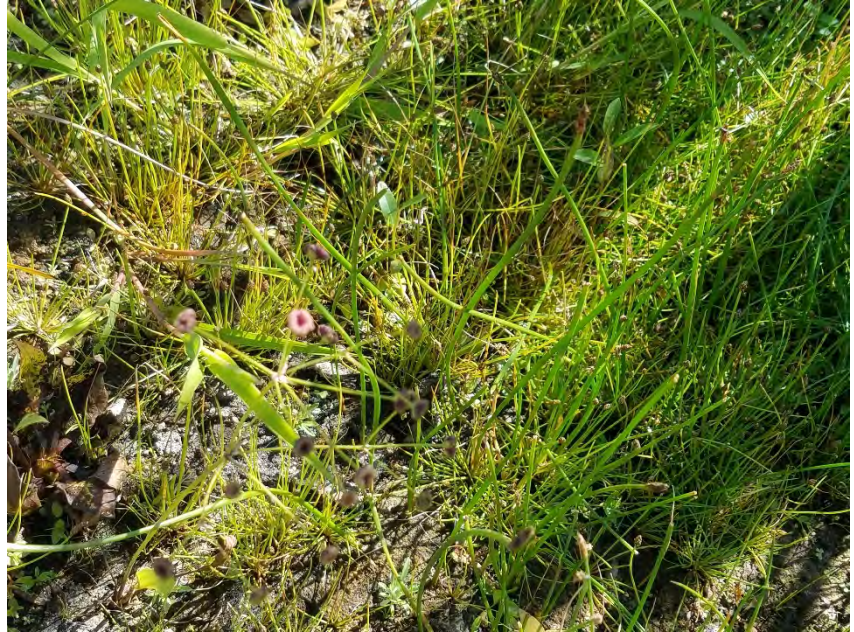
September 2018. Photo point B18. Marginal zone. American water plantain, spikerush, *Juncus* species, *Salix* species, cattail, nodding beggartick, smartweed, and reed canary grass observed in vicinity.

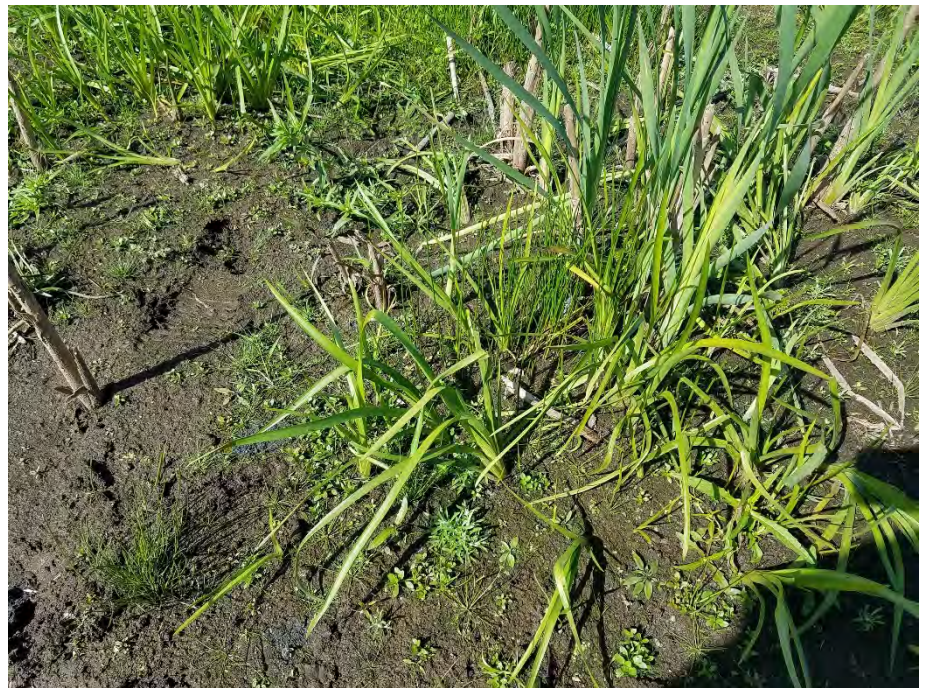
Photo No. 10.

September 2018. Photo point C5. Emergent zone. Bur-reed, wapato, cattail, nodding beggartick, and spikerush observed in vicinity.

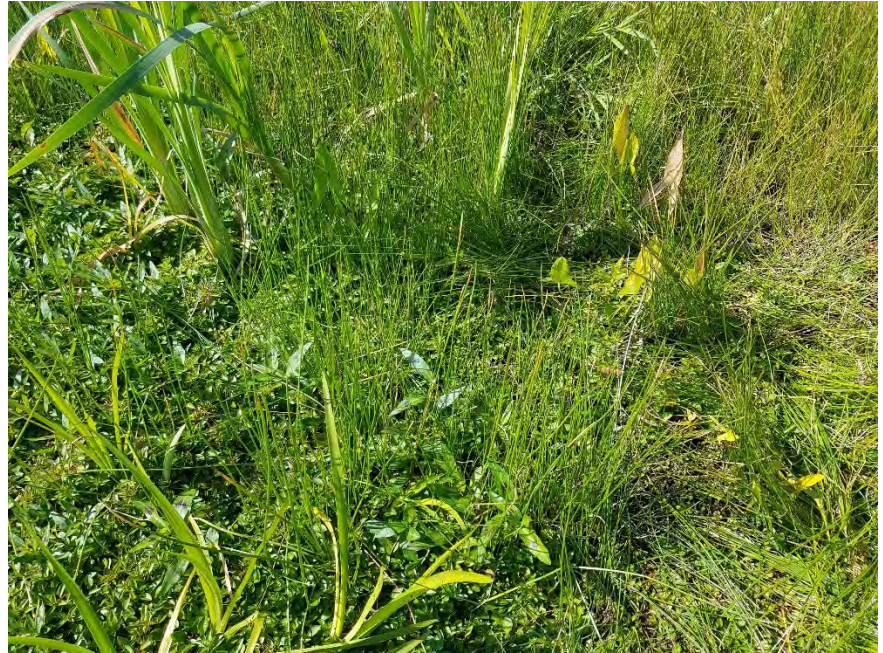
September 2018. Photo point C15. Emergent zone. Spikerush, bur-reed, wapato, cattail, smartweed, and reed canary grass observed in vicinity.

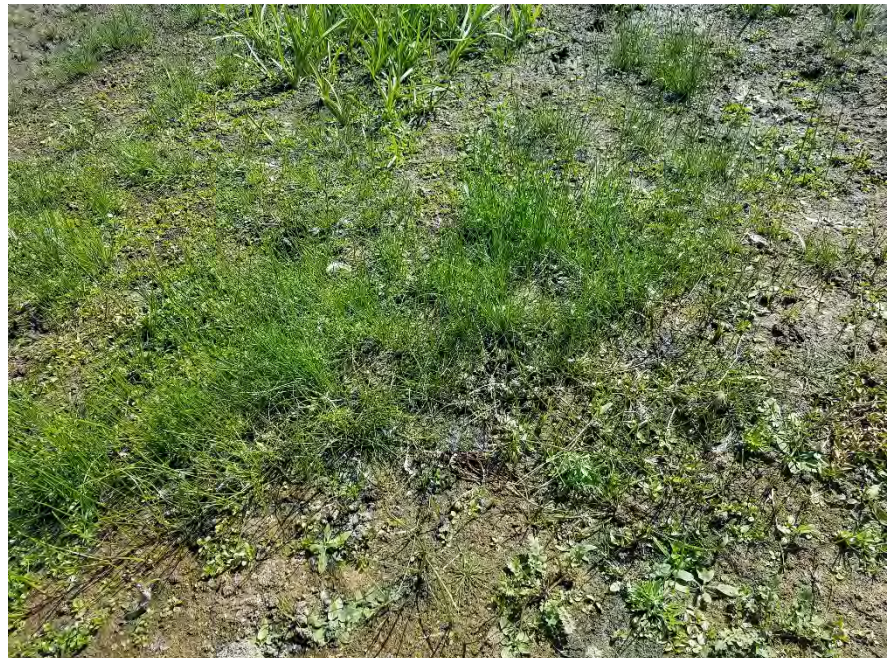
Photo No. 12.

September 2018. Photo point B11. Emergent zone. Spikerush, bur-reed, nodding beggartick, smartweed, and reed canary grass observed in vicinity.

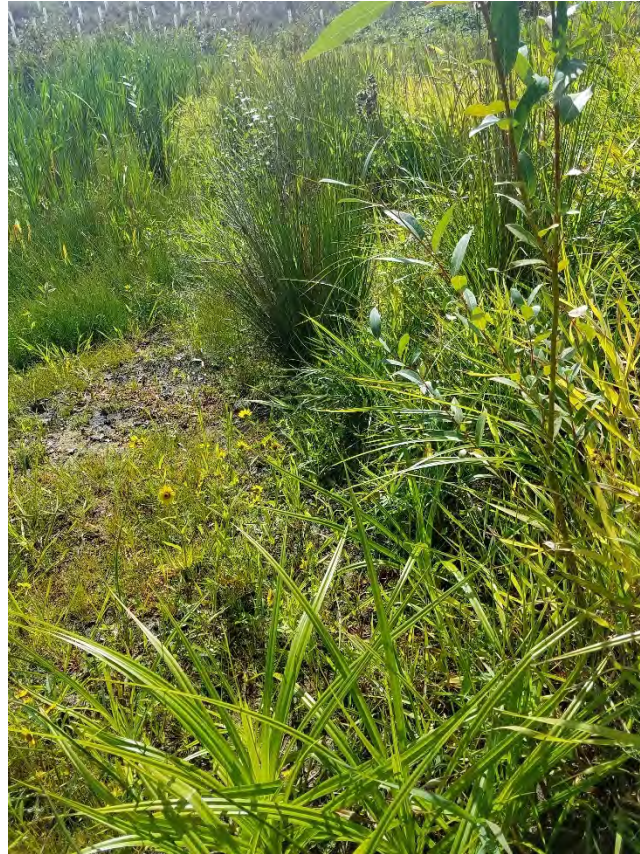
September 2018. Photo point B1. Marginal zone. American water plantain, sedges, spikerush, *Juncus* species, bur-reed, *Salix* species, wapato, cattail, nodding beggartick, smartweed, and reed canary grass observed in vicinity.

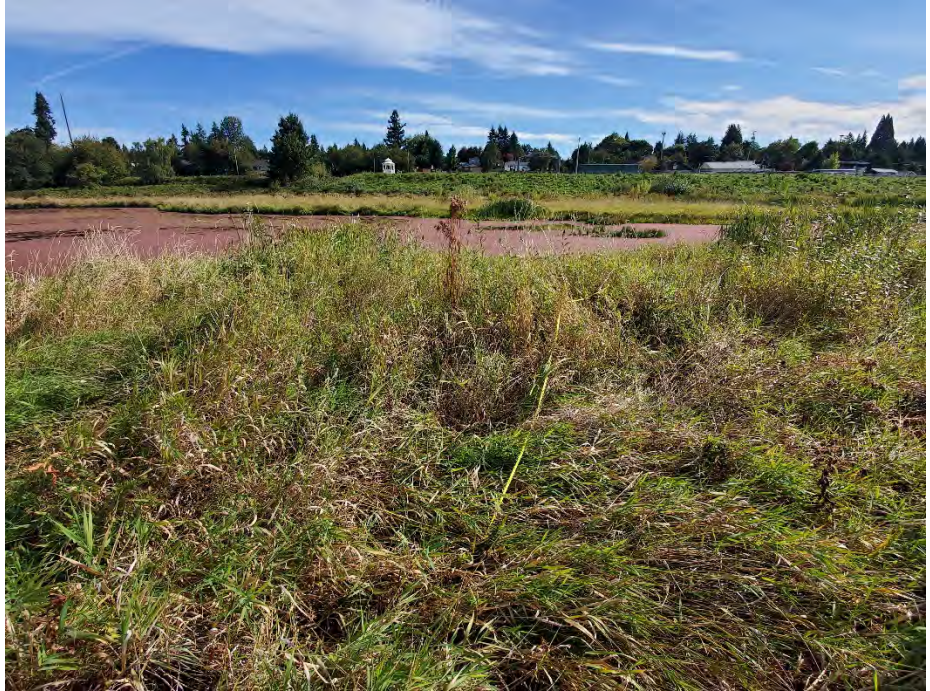
September 2019.
Photo point C1.
Marginal zone. *Juncus* species, waterpepper, and reed canary grass observed in vicinity.

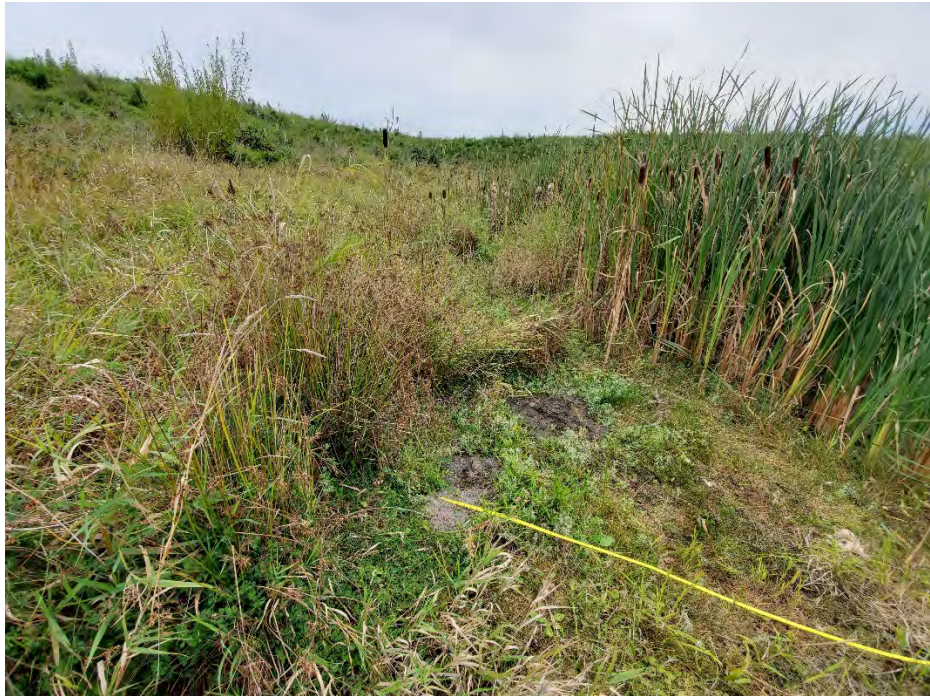
Photo No. 10.

September 2019.
Photo point B18.
Marginal zone. *Carex* species, spikerush, *Juncus* species, cattail, nodding beggartick, waterpepper, and reed canary grass observed in vicinity.

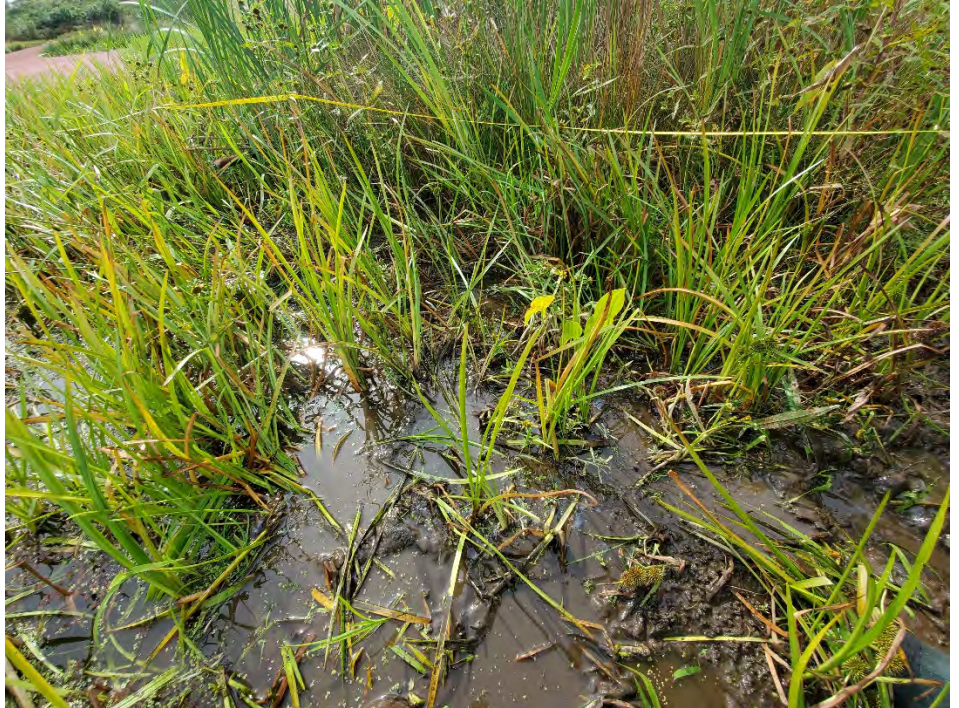
September 2019.
Photo point C5.
Emergent zone.
American water
plantain, bur-reed,
waterpepper, nodding
beggartick, and
spikerush observed in
vicinity.

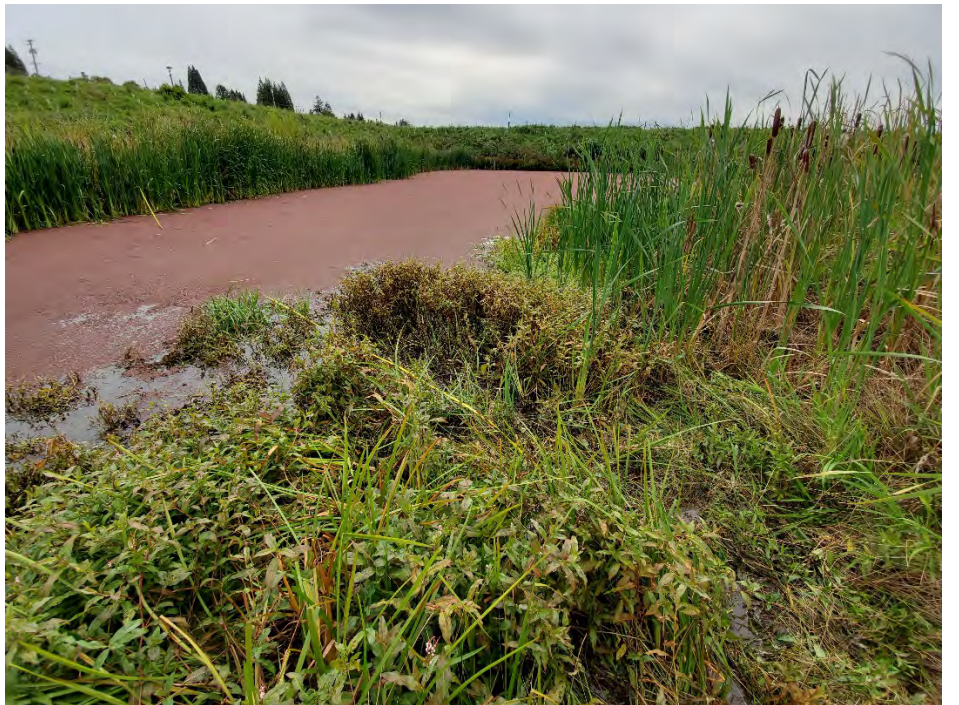
Photo No. 12.

September 2019.
Photo point C15.
Emergent zone.
Spikerush, bur-reed,
wapato, cattail,
waterpepper, and
reed canary grass
observed in vicinity.

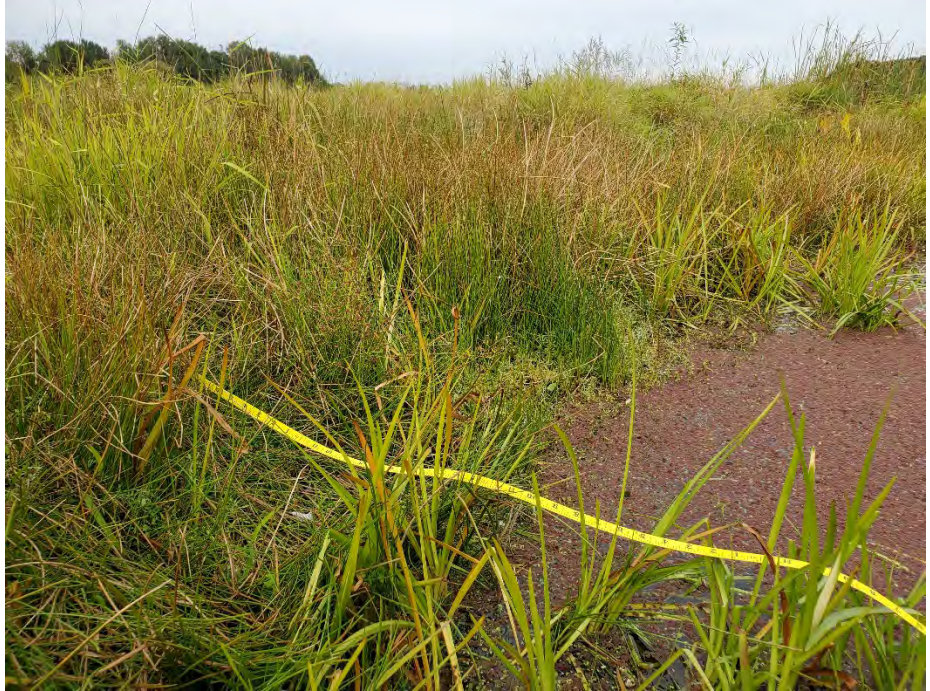
September 2019.
Photo point B11.
Emergent zone.
American water
plantain, Mexican
water fern, Spikerush,
bur-reed, nodding
beggartick, and reed
canary grass observed
in vicinity.

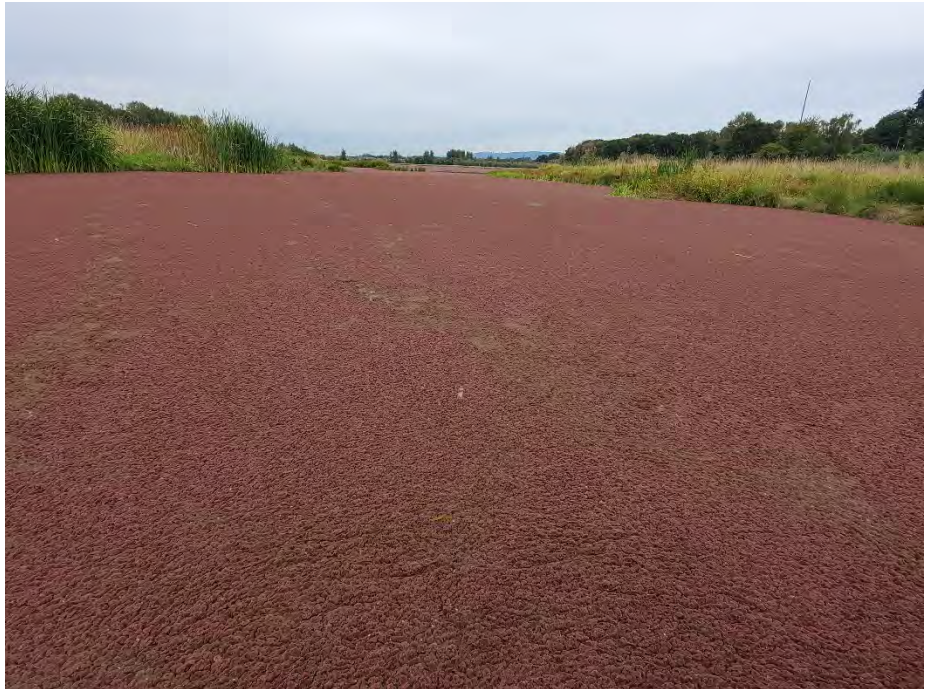
Photo No. 14.

September 2019.
Photo point B5.
Submergent zone.
Mexican water fern,
Canadian waterweed,
hornwort, duckweed,
and Eurasian
watermilfoil.

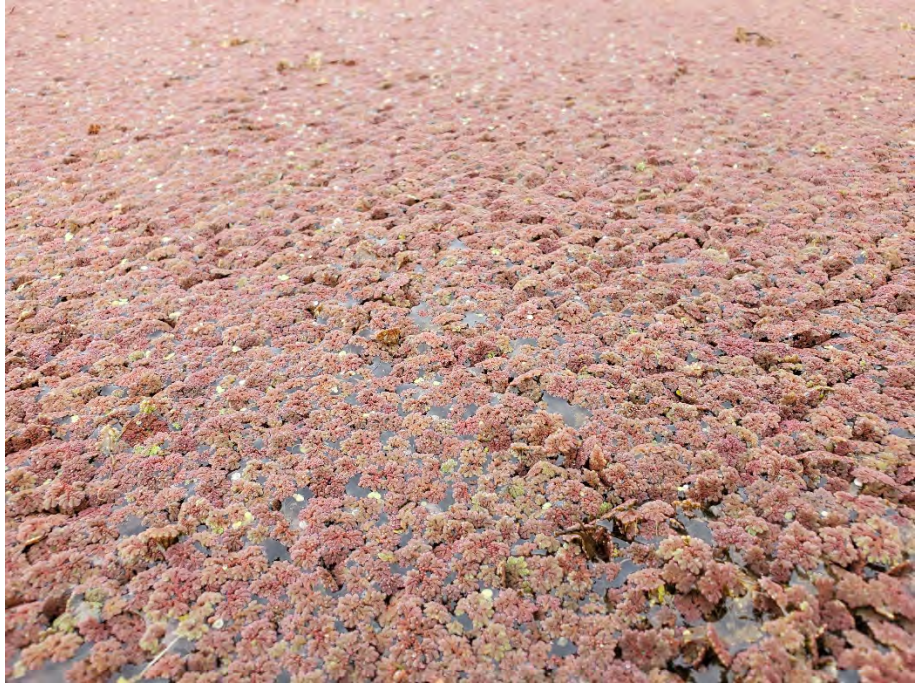
September 2019.
Photo point B16.
Submergent zone.
Mexican water fern,
duckweed, and
Eurasian watermilfoil.

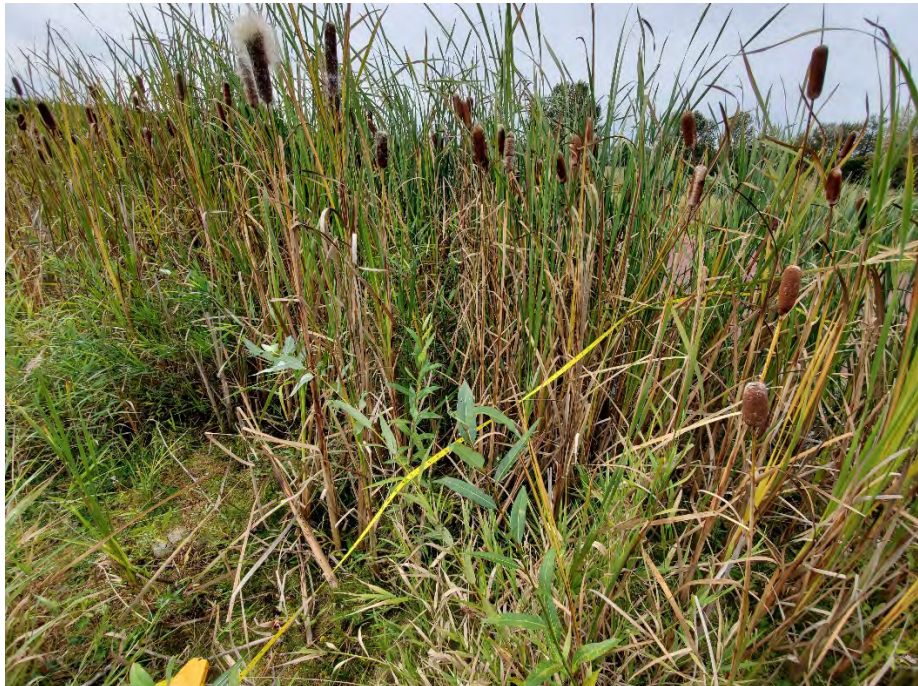
Photo No. 16.

September 2019.
Photo point B1.
Marginal zone.
American water
plantain, horsetail
reed, sedges,
spikerush, *Juncus*
species, cattail,
nodding beggartick,
and reed canary grass
observed in vicinity.

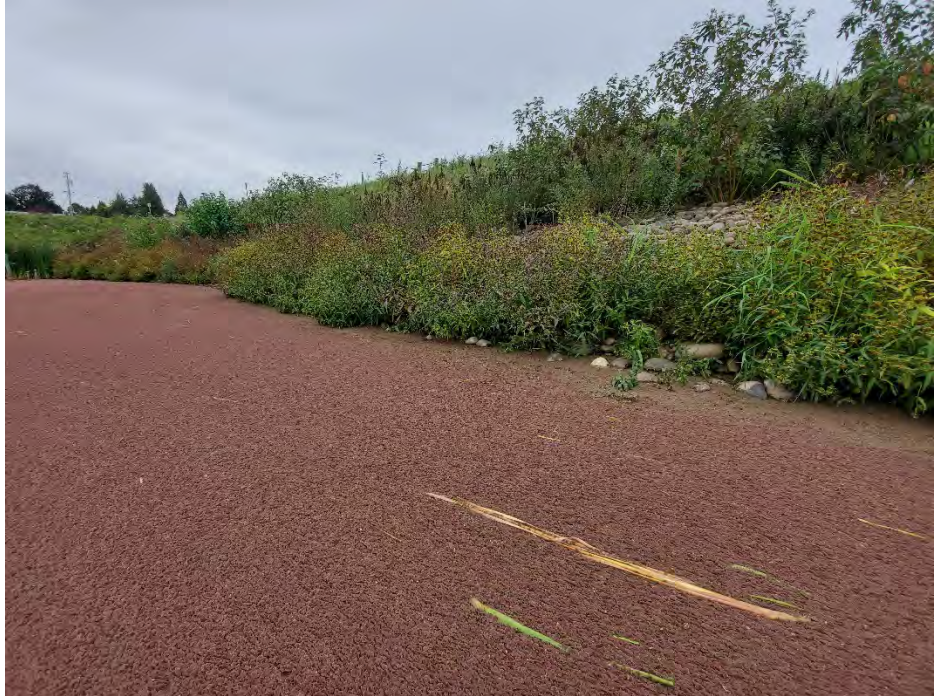
September 2019.
Photo point A5.
Submergent zone.
Mexican water fern,
floating leaf
pondweed, Canadian
waterweed,
duckweed, and
Eurasian watermilfoil.
