CARTY LAKE MAINTENANCE AND MONITORING PLAN

CARTY LAKE SEDIMENT MONITORING SAMPLING AND ANALYSIS PLAN

FORMER PACIFIC WOOD TREATING CO. SITE
FACILITY ID 1019, CLEANUP SITE ID 3020

March 2, 2016
Project No. 9003.01.40

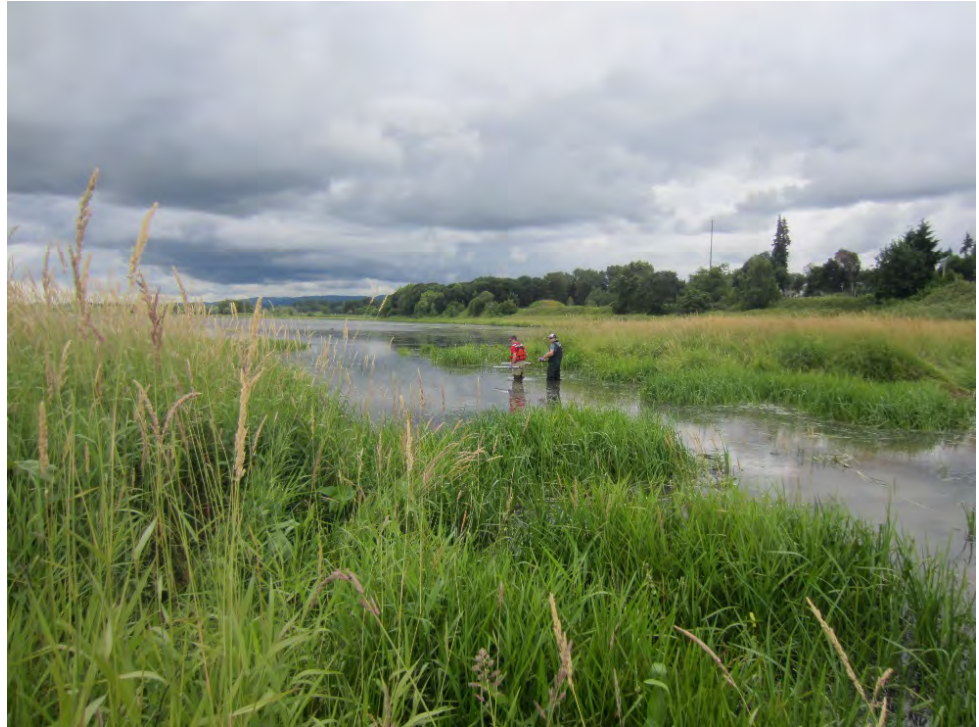
Fall 2013.
Mitigation area
before
remediation.
Reed canary grass
is dominant
vegetation.
Looking
northeast.

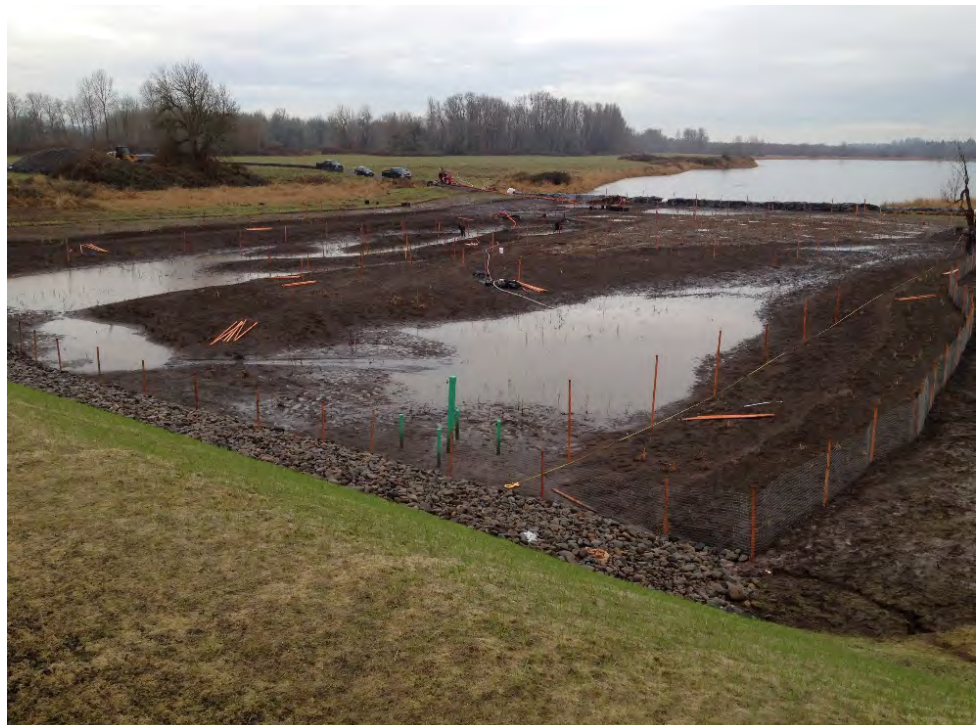
Photo No. 2.

Winter 2014/15.
Remediation area
before plantings
and temporary
dam removal.
Wildlife fencing
installed.
Looking
northwest.

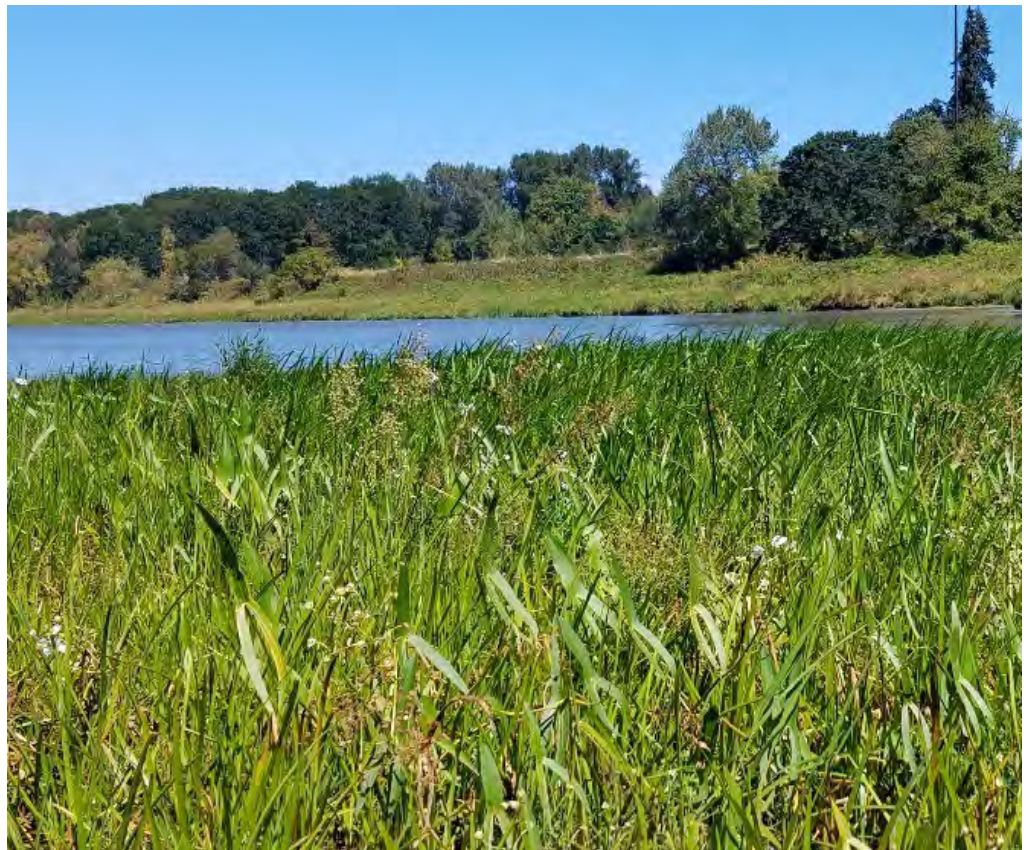
August 2016.
Mitigation area.
Flowering
wapato and bur-
reed. Looking
northeast.

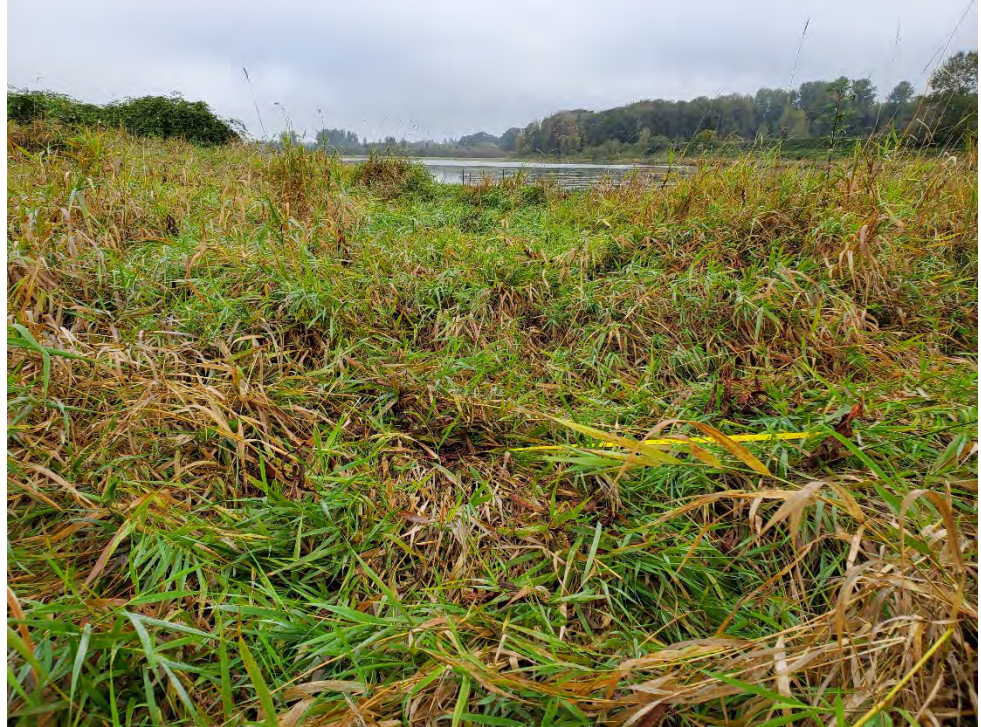
October 2020.
Photo point C1.
Marginal zone.
Waterpepper,
bird's foot, and
reed canary grass
observed in
vicinity.

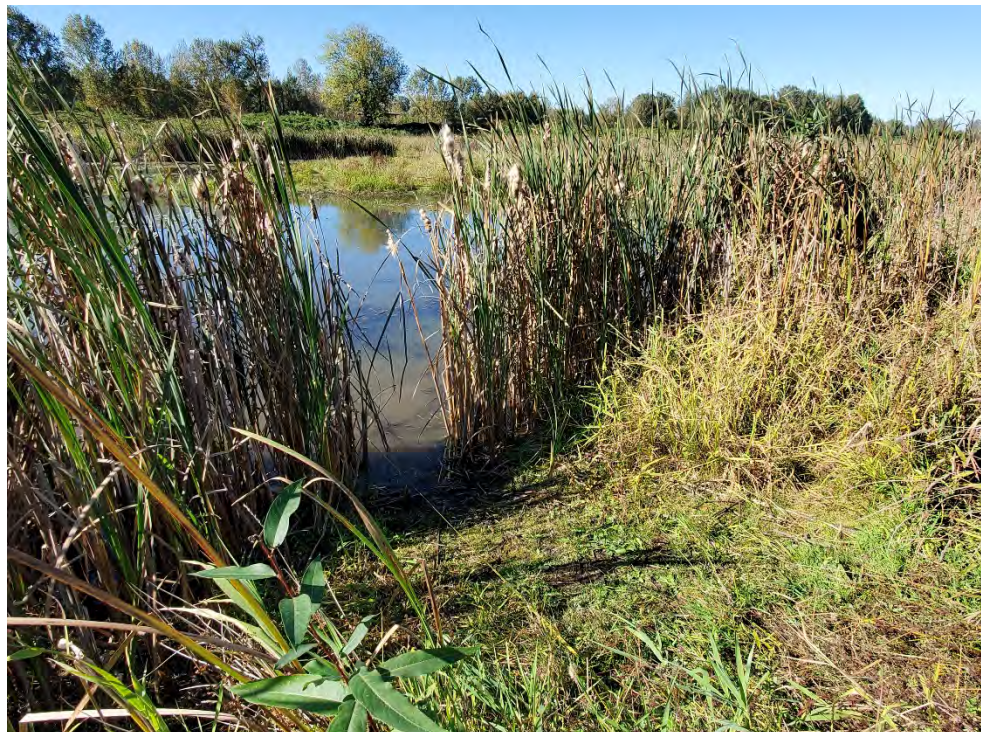
Photo No. 12.

October 2020.
Photo point B18.
Marginal zone.
Spikerush, *Juncus*
species, cattail,
bird's foot,
waterpepper,
willow species,
and reed canary
grass observed in
vicinity.

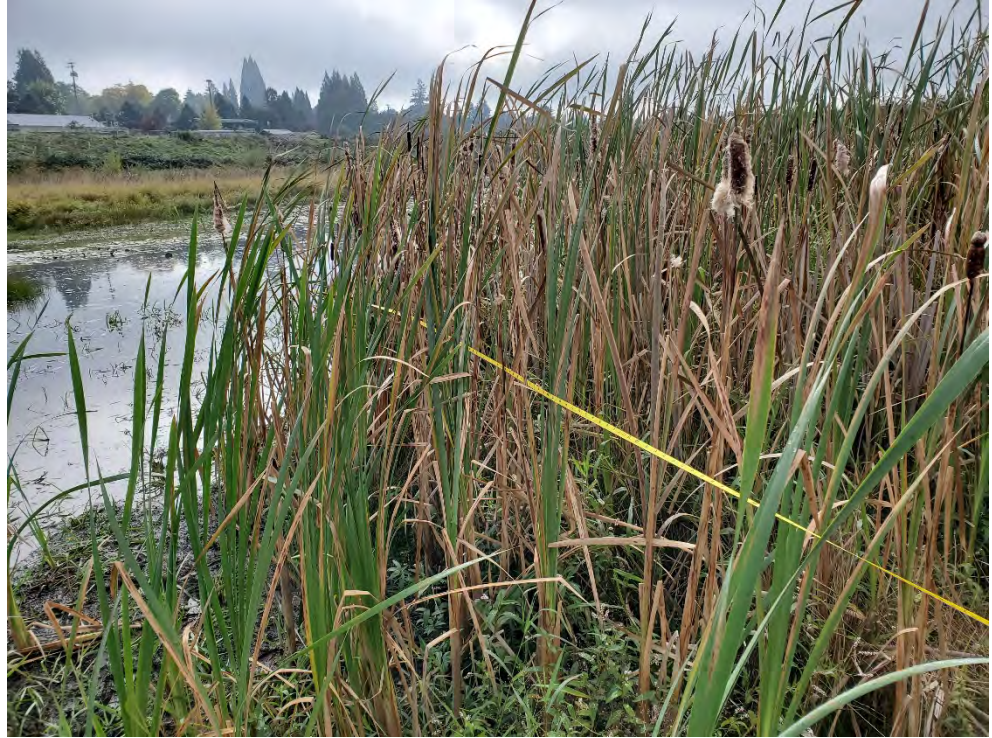
October 2020.
Photo point C5.
Emergent zone.
American water
plantain, bur-
reed,
waterpepper,
nodding
beggartick,
cattail, spikerush,
and reed canary
grass observed in
vicinity.

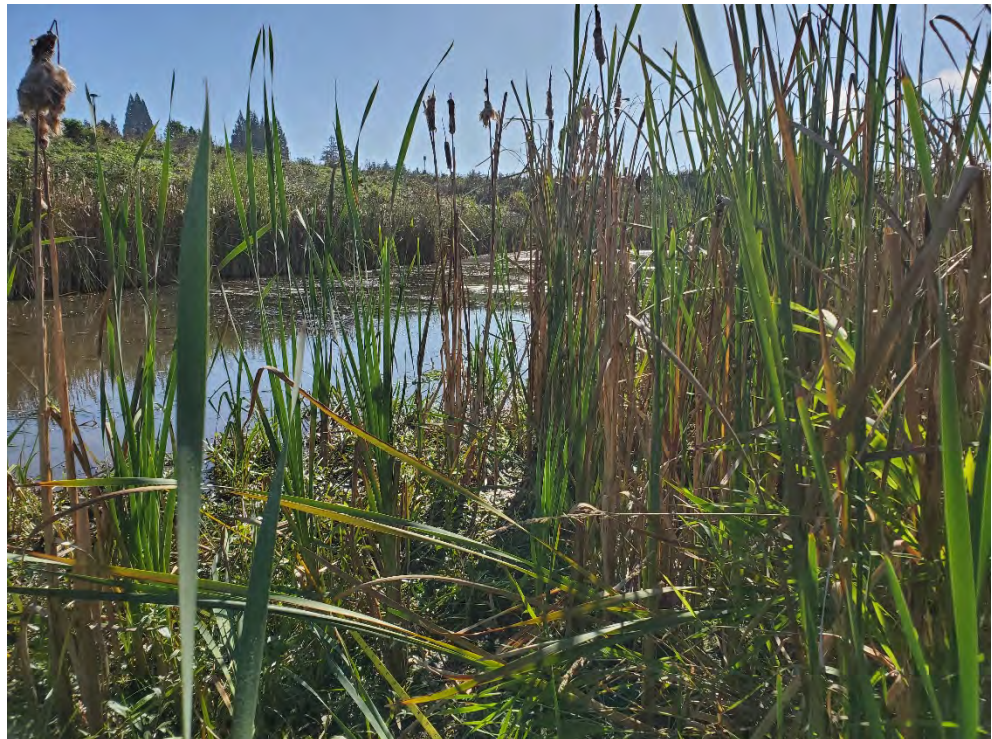
Photo No. 14.

October 2020.
Photo point C15.
Emergent zone.
Spikerush, bur-
reed, wapato,
cattail,
waterpepper, and
reed canary grass
observed in
vicinity.

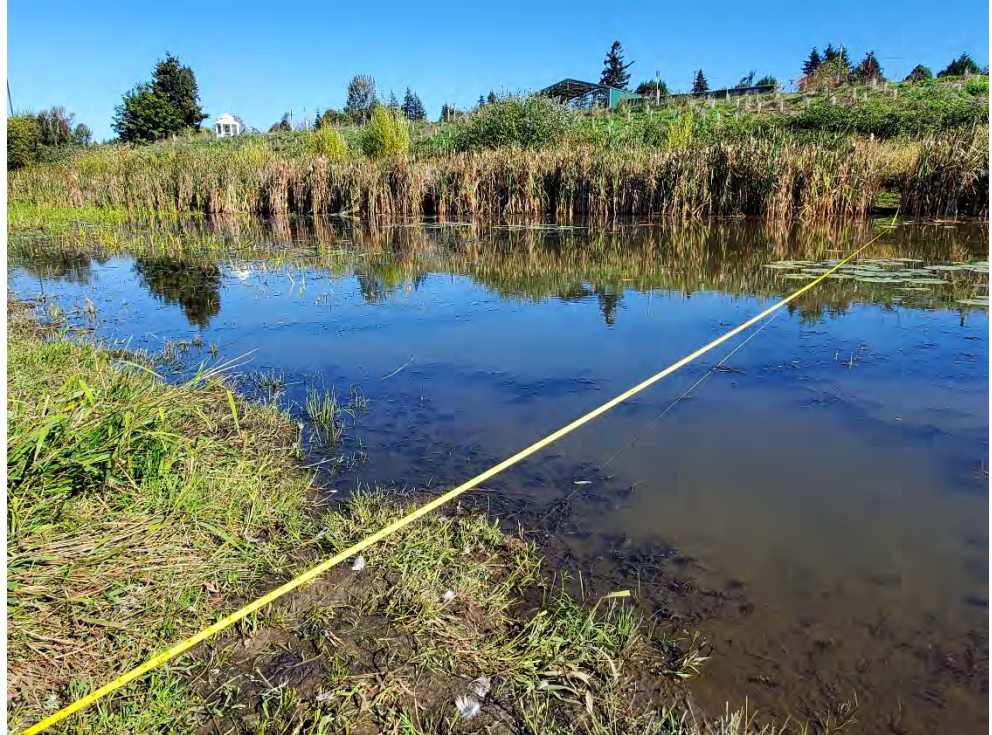
October 2020.
Photo point B11.
Emergent zone.
Spikerush, bur-reed,
waterpepper, and
reed canary grass
observed in
vicinity.

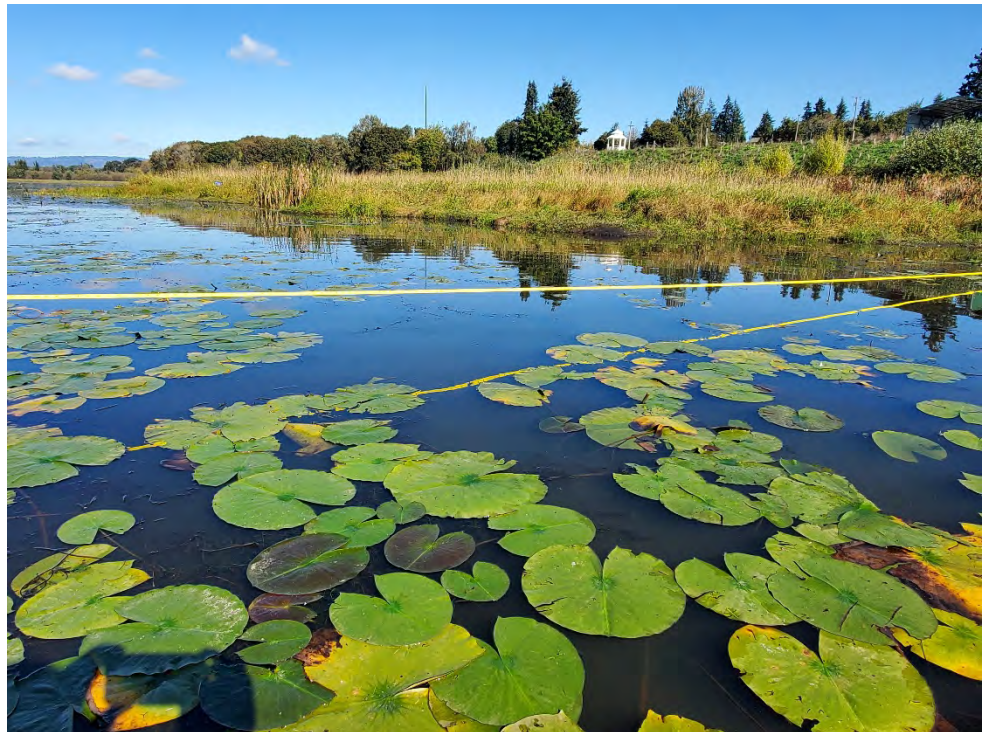
Photo No. 16.

October 2020.
Photo point B5.
Submergent zone.
Water lily,
Canadian
waterweed,
duckweed, and
Eurasian
watermilfoil.

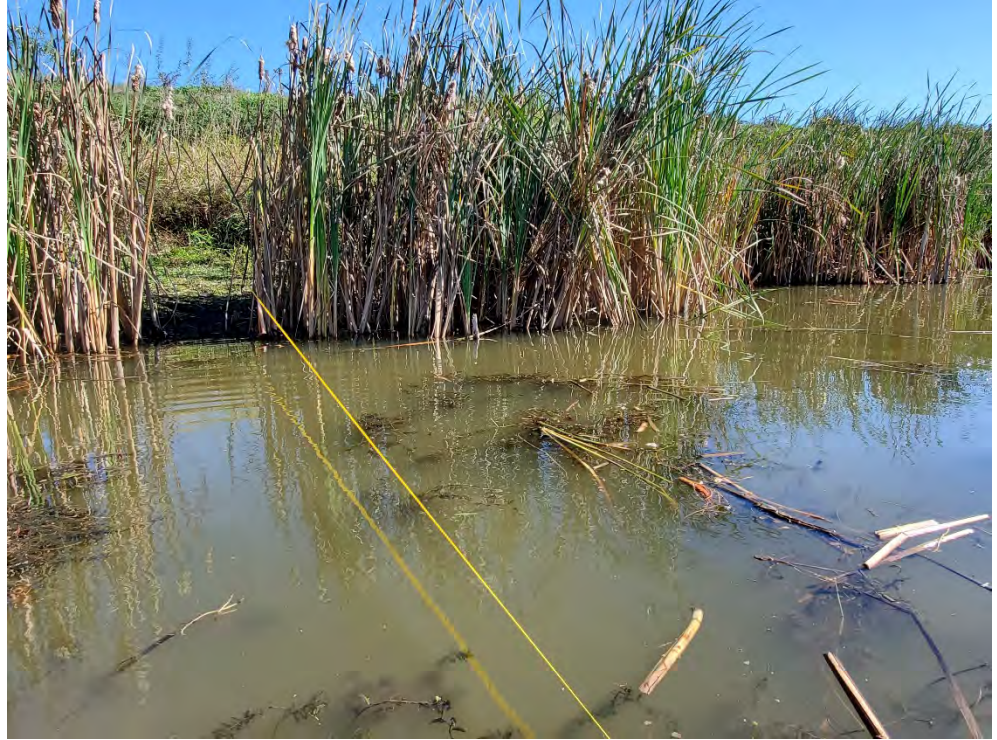
October 2020.
Photo point B16.
Submergent zone. Mexican water fern, Canadian waterweed, duckweed, and Eurasian watermilfoil.

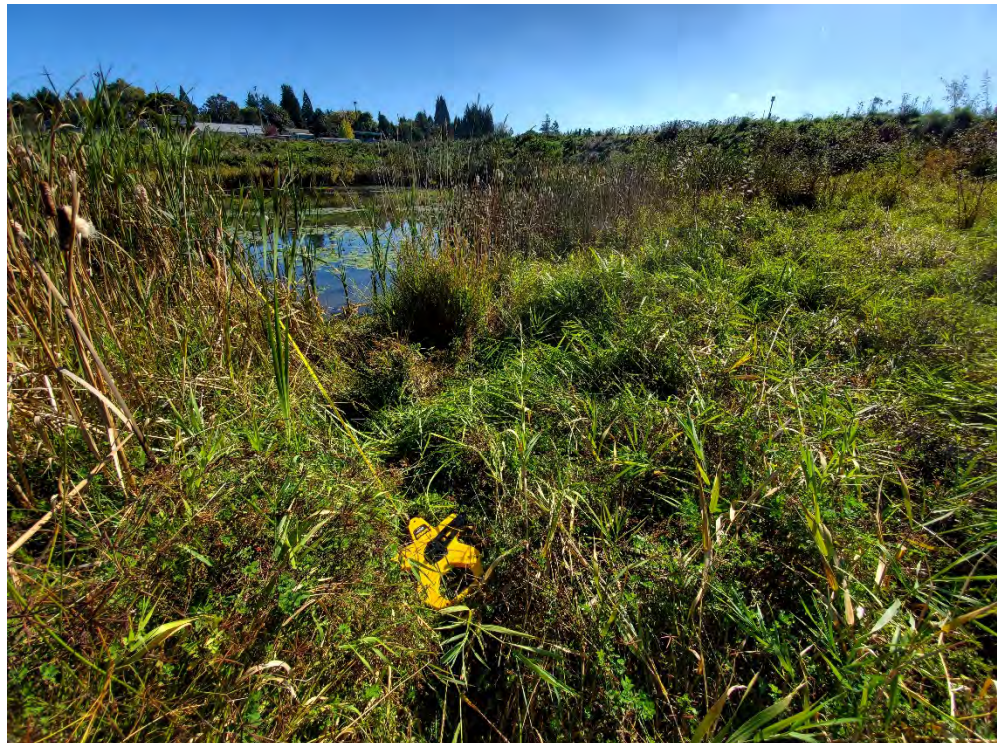
Photo No. 18.

October 2020.
Photo point B1.
Marginal zone. *Juncus* species, cattail, willow species, and reed canary grass observed in vicinity.

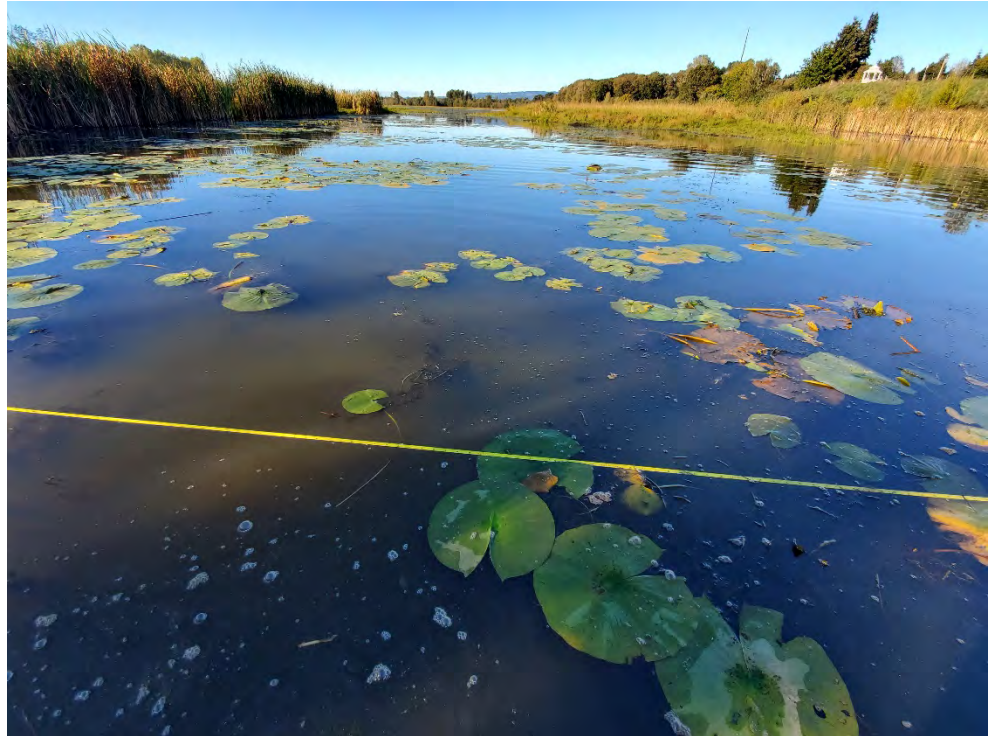
October 2020.
Photo point A5.
Submergent
zone. Water lily,
Canadian
waterweed,
duckweed, and
Eurasian
watermilfoil.
