REMEDIAL INVESTIGATION WORK PLAN

Dawn Foods Site
6901 Fox Ave South

January 31, 2024

Bridge Point Seattle 130, LLC

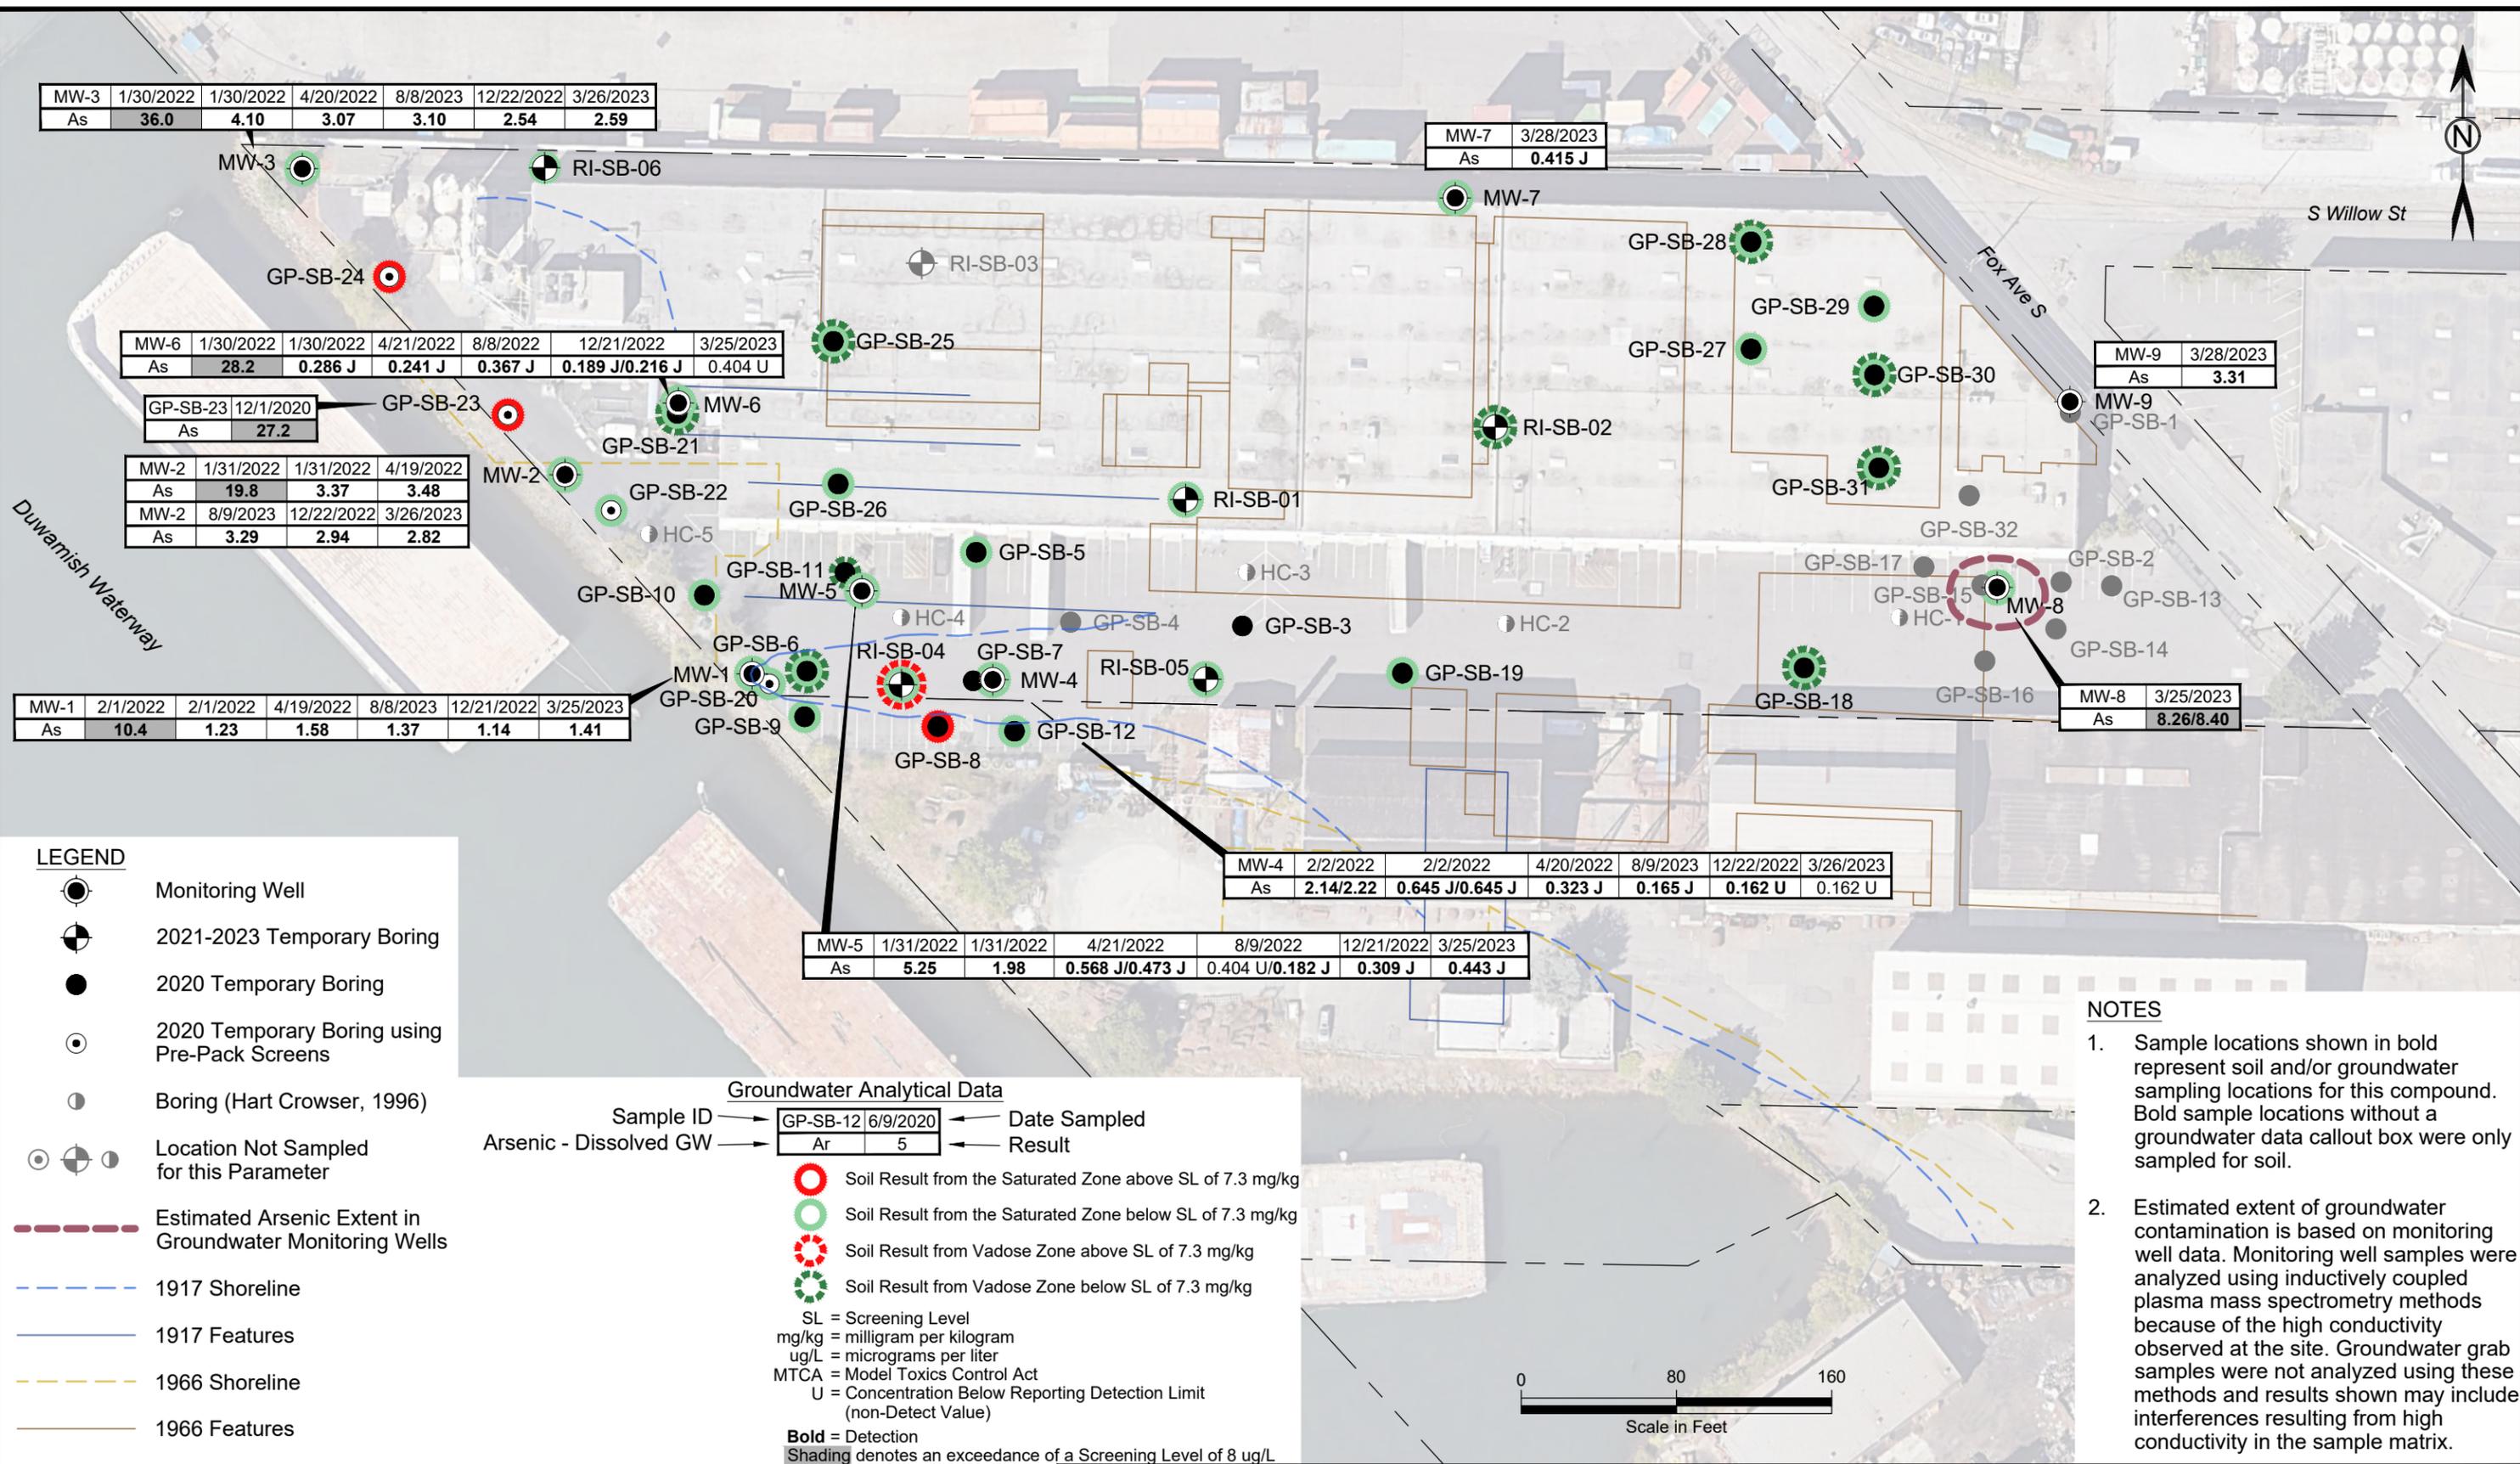
Figure 16
 Estimated Extent of Arsenic
 in Soil and Groundwater

Arsenic, copper, nickel, and zinc exceed screening levels at multiple locations on the Site (Figures 16 through 19). The bulk of these exceedances are concentrated near the waterfront in the vicinity of the former shipways. The isolated exceedances closer to Fox Avenue (GP-SB-30 through SB-31) are likely due to reducing groundwater conditions that are caused by the anaerobic degradation of the GWCC and TPH impacts (in the vicinity of MW-8).

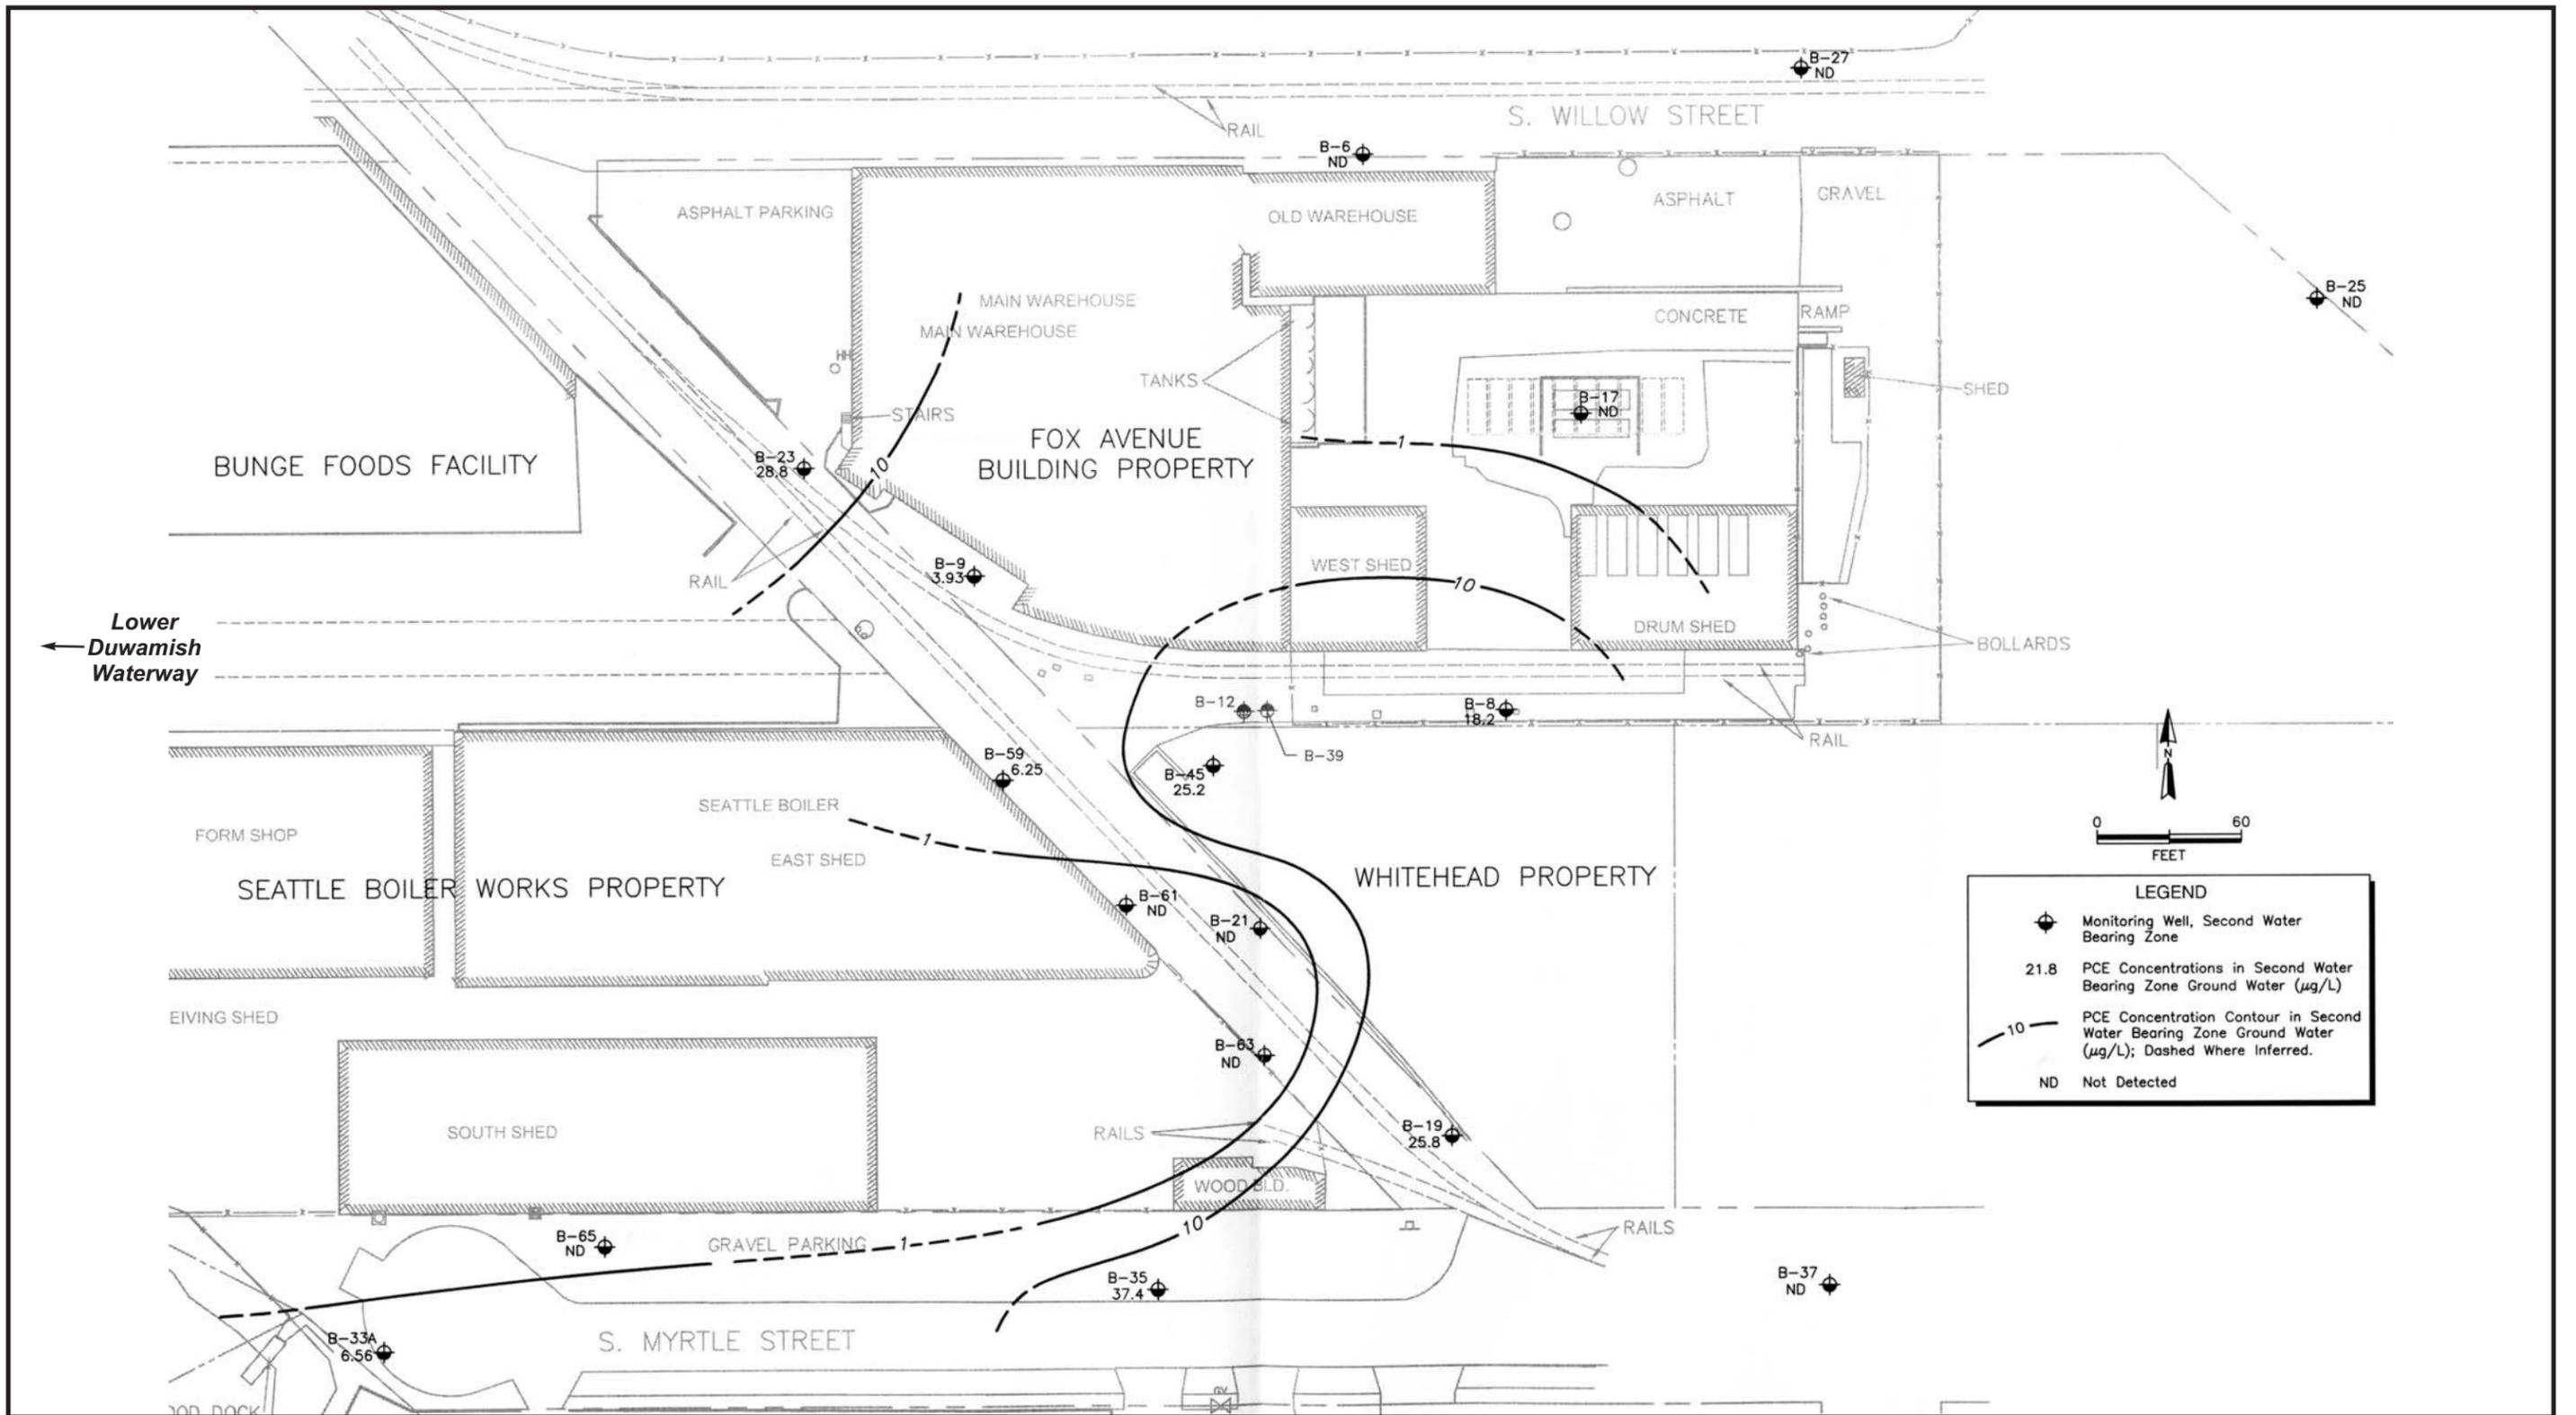
Figure 22
 PCE IN 2nd WBZ GROUNDWATER (FOX AVENUE PILOT STUDY) -
 CASCADE COLUMBIA DISTRIBUTION

- Monitoring Well, Second Water Bearing Zone
- 21.8 PCE Concentrations in Second Water Bearing Zone Ground Water ($\mu\text{g/L}$)
- PCE Concentration Contour in Second Water Bearing Zone Ground Water ($\mu\text{g/L}$); Dashed Where Inferred.
- ND Not Detected

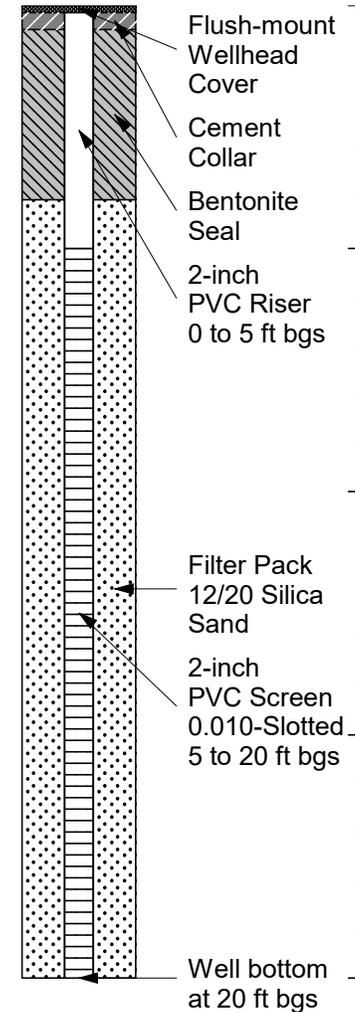
0			ASPHALT at surface.					
		SW	SAND with GRAVEL, medium to coarse-grained, medium brown, slightly moist		2.5 - 4 ft	0.8 8-12-13		
5			At 5 ft bgs: CONCRETE RUBBLE, brown to black sand.		5 - 6.5 ft	1.5 9-8-8		
		SW	POOR RECOVERY CONCRETE RUBBLE SAND, medium to coarse-grained with concrete aggregate, slightly moist to moist.		7.5 - 9 ft	2.3 6-10-6		
10			At 10 ft bgs: VERY POOR RECOVERY, medium to dark brown, wet to saturated.		10 - 11.5 ft	2.6 50/5"		
			At 12.5 ft bgs: Saturated	MW-1 13-14'	12.5 - 14 ft	2.2 1-3-4		
15		SP	SAND, fine to medium-grained, minor silty pockets, no gravel, medium to dark brown, wet.		15 - 16.5 ft	2.1 2-2-2		
			At 15 ft bgs: medium to coarse-grained, subround, dark brown to variable grain colors, saturated.		17.5 - 19 ft	2.2 1-6-5		
			At 17.5 ft bgs: No appreciable odors.		20 - 21.5 ft	2.6 3-4-9		
20			At 20 ft bgs: Uniform medium-grained, medium to dark brown.

NOTES: Southwest corner of parcel, adjacent to waterway.
 Lithology logged from split spoon core samples. Ecology tag # BNL-604

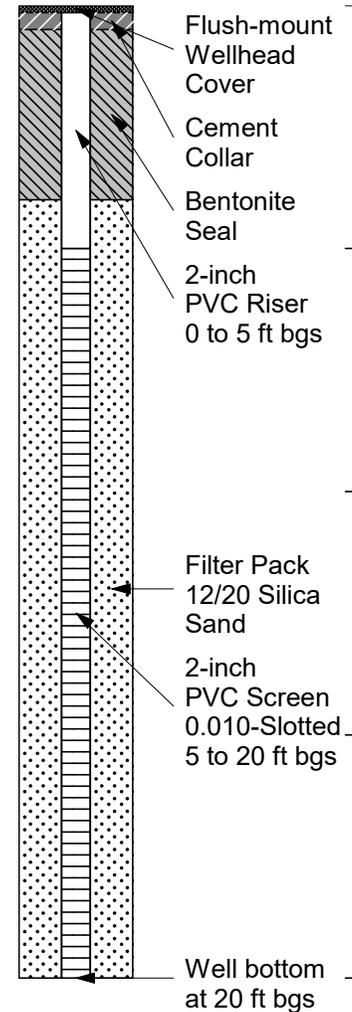
20	At 20 ft bgs: Fine to medium-grained, soft to loose, minor organic fines, dark brown to gray, saturated, reducing odors.			20 - 21.5 ft	6.9 0-0-0

NOTES: Western perimeter of parcel, adjacent to waterway.
 Lithology logged from split spoon core samples. Ecology tag # BNL-602
