Second Quarter 2023 Groundwater Sampling and Analysis Report

Camp Bonneville 23201 NE Pluss Road Vancouver, Washington 98682

Clark County, Washington, and Washington State Department of Ecology

September 2023 PBS Project 76151.011

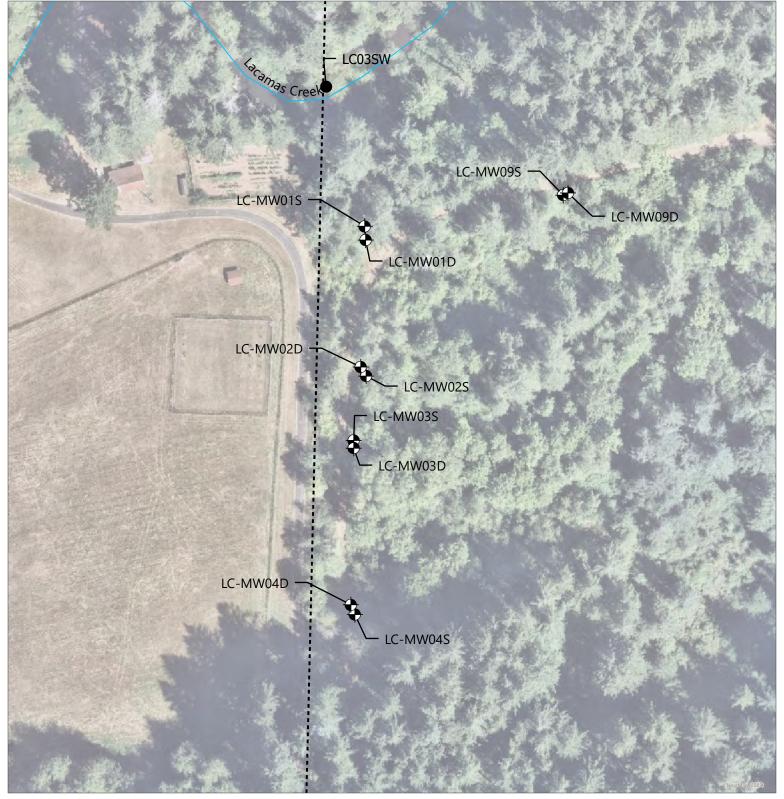
Monitoring Wells and Surface Water Sample Locations Near Base Boundary

Groundwater samples were collected from the 10 monitoring wells located at Base Boundary (Figure 3) on May 22 and 23, 2023. A field duplicate sample (labeled 02Q23LCMW140W) was collected from monitoring well LC-MW09S. An additional volume of groundwater was collected from monitoring well LC-MW09D for laboratory matrix spike/matrix spike duplicate (MS/MSD) analysis.

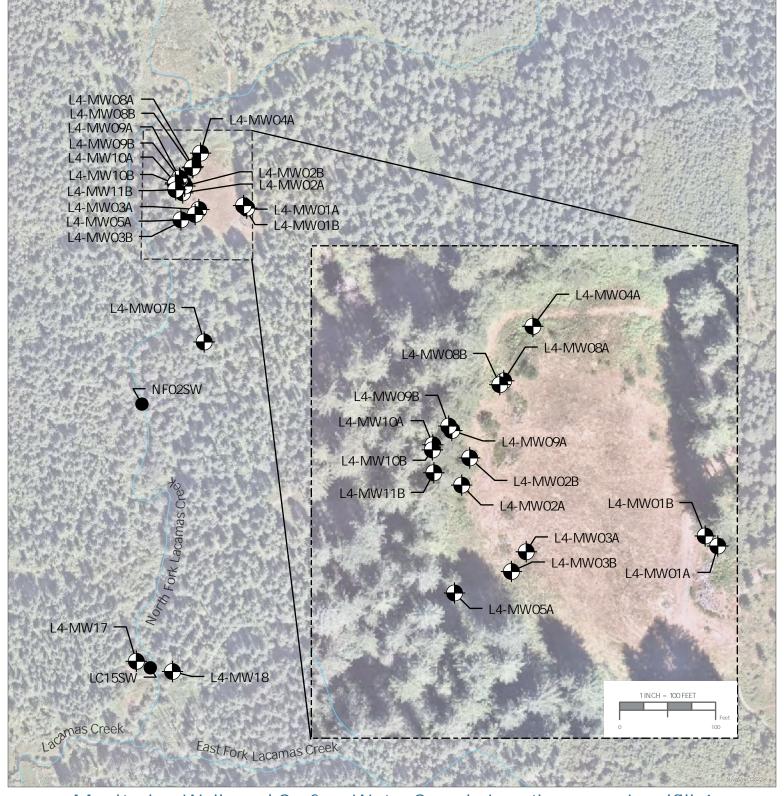
Monitoring Wells and Surface Water Sample Locations near Landfill 4

Groundwater samples were collected from 18 monitoring wells at Landfill 4/Demolition Area 1 (Figure 4) on May 24, 31 and June 1, 2023. Two field duplicate samples (labeled 02Q23L4MW145W and 02Q23L4MW150W) were collected from monitoring well L4-MW3A and L4-MW9B respectively. An additional volume of groundwater was collected from monitoring well LC4MW01B for laboratory MS/MSD analysis.

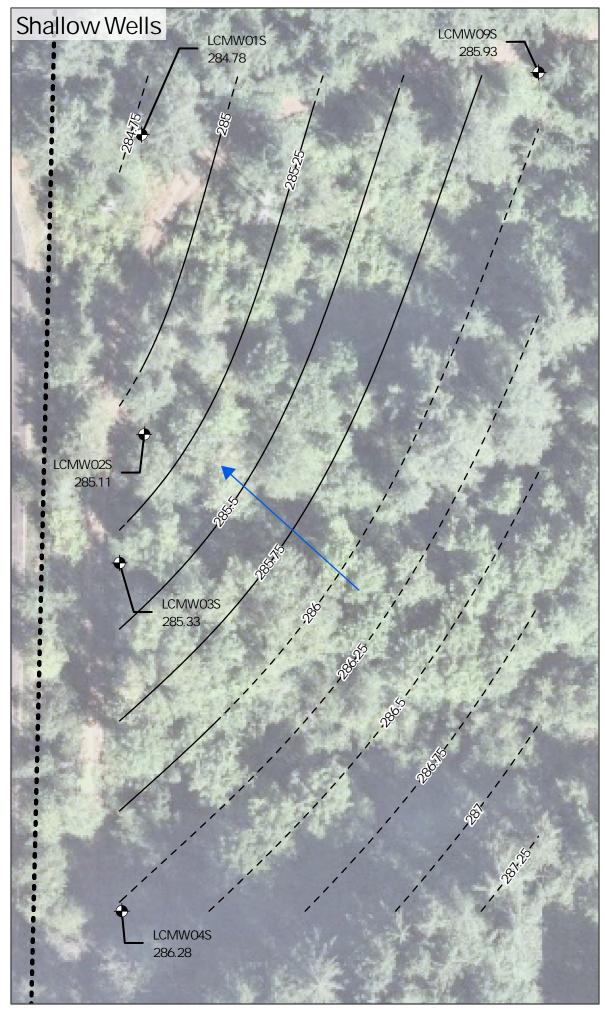
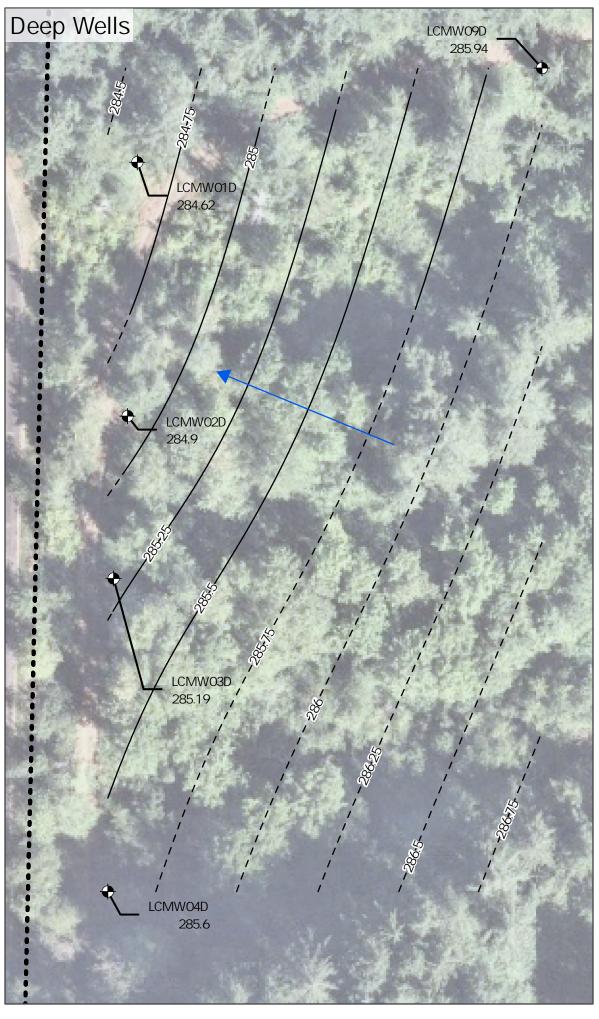
Base Boundary Monitoring Well **Groundwater Elevation**

Groundwater elevations and field parameters are provided in Table 2 for the second quarter 2023. Figure 5 illustrates groundwater contours and flow direction for the Base Boundary S and D (shallow and deep) wells.

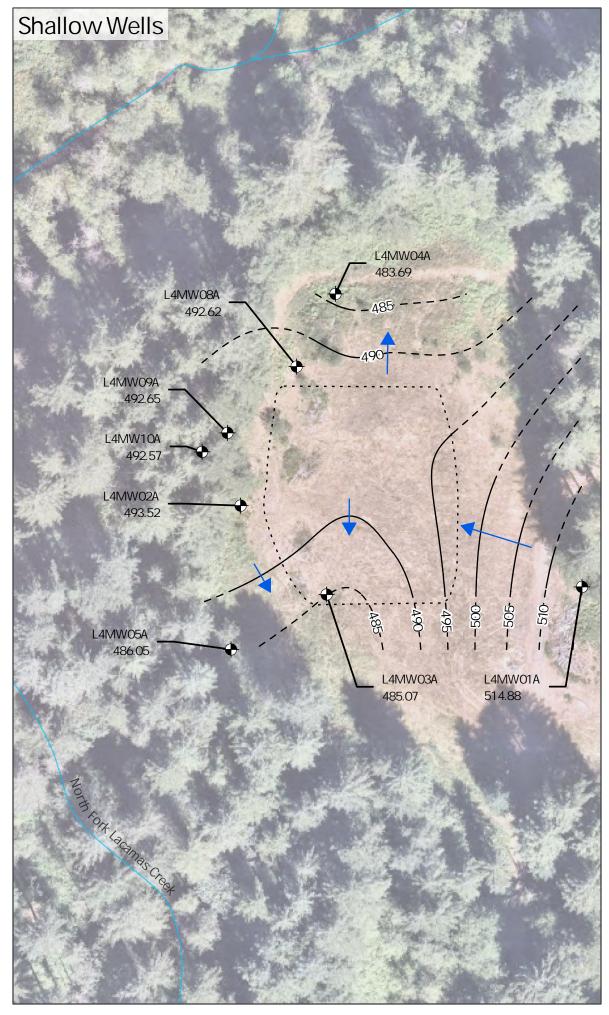
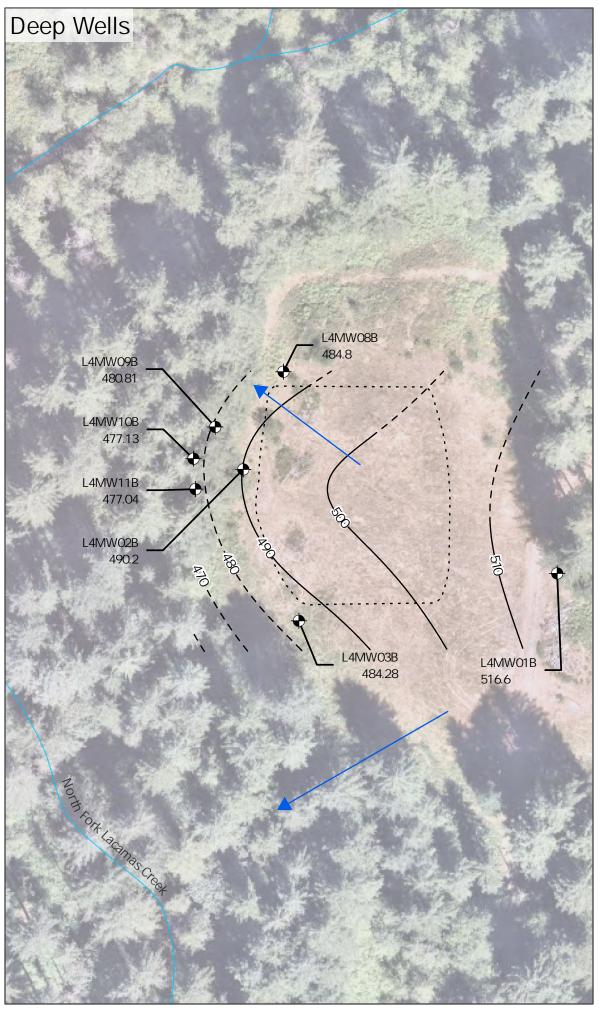
Landfill 4 Monitoring Well Groundwater Elevation

Groundwater elevations are provided in Table 2 for the second quarter 2023. Wells L4-MW17 and L4-MW18 are located topographically downgradient from the Landfill 4 area and are not included in groundwater flow discussion. Well L4-MW07B is screened in the same area of the aquifer as the other deep wells at the Landfill 4 area (above bedrock) and is included in the deep groundwater flow discussion. Figure 6 illustrates groundwater contours and flow direction for the Landfill 4 A and B (shallow and deep) wells.

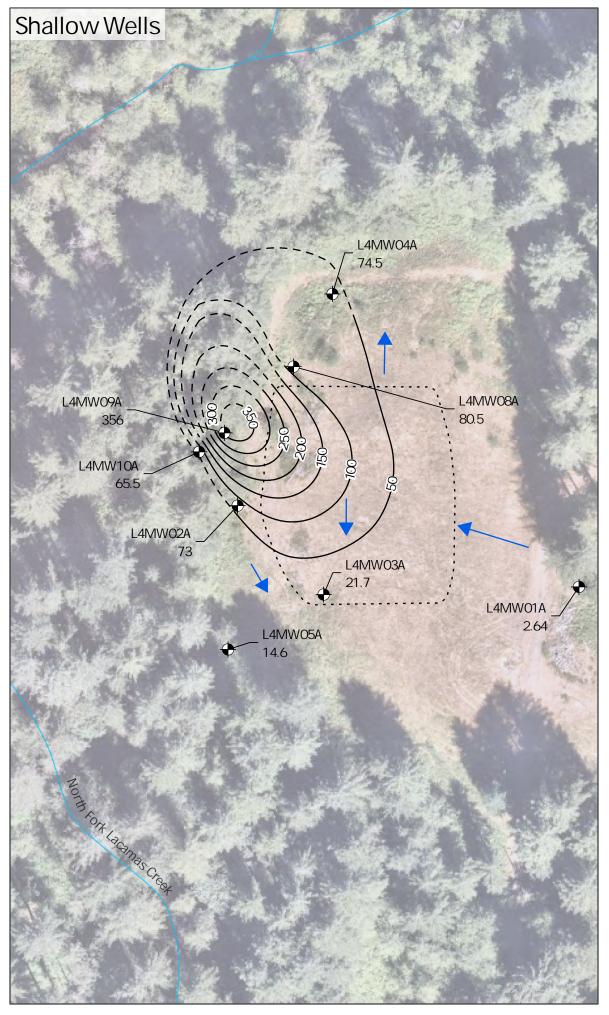
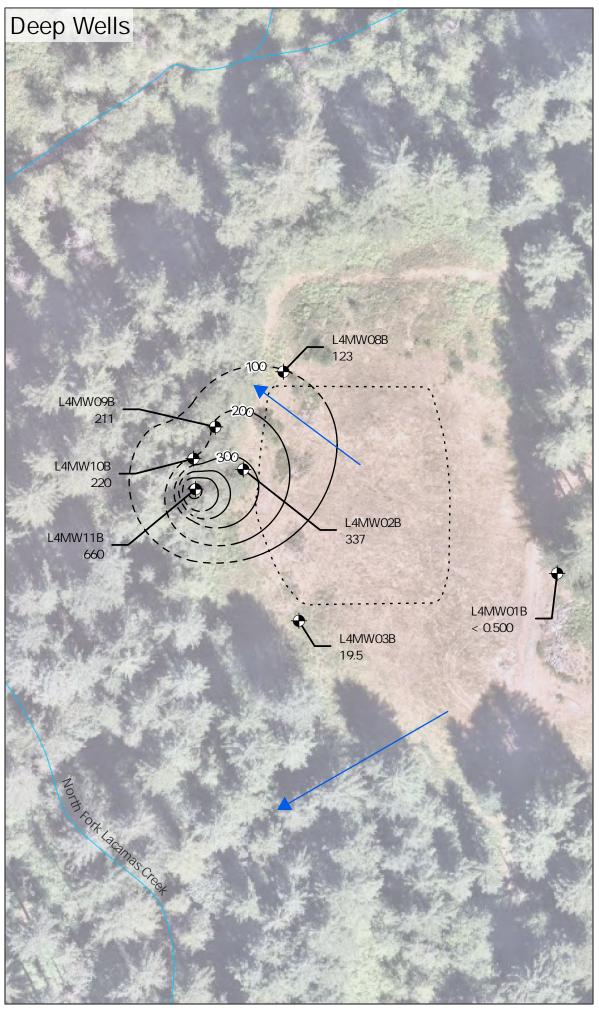
Landfill 4 Monitoring Well Perchlorate Concentration

Of the 18 wells in the Landfill 4/Demolition Area 1 area, 13 had one or more detections of perchlorate or RDX that exceeded MTCA Method B cleanup levels (see Table 3), and only one well had VOC detections. The results are discussed further in section 8.
