**2020 ANNUAL GROUNDWATER  
MONITORING AND SAMPLING AND SITE  
IMPROVEMENTS REPORT**

Nutrien Ag Solutions, Inc.  
3482 Glade Road North  
Pasco, Washington  
Agreed Order No. 03TCPER-5649

December 1, 2020

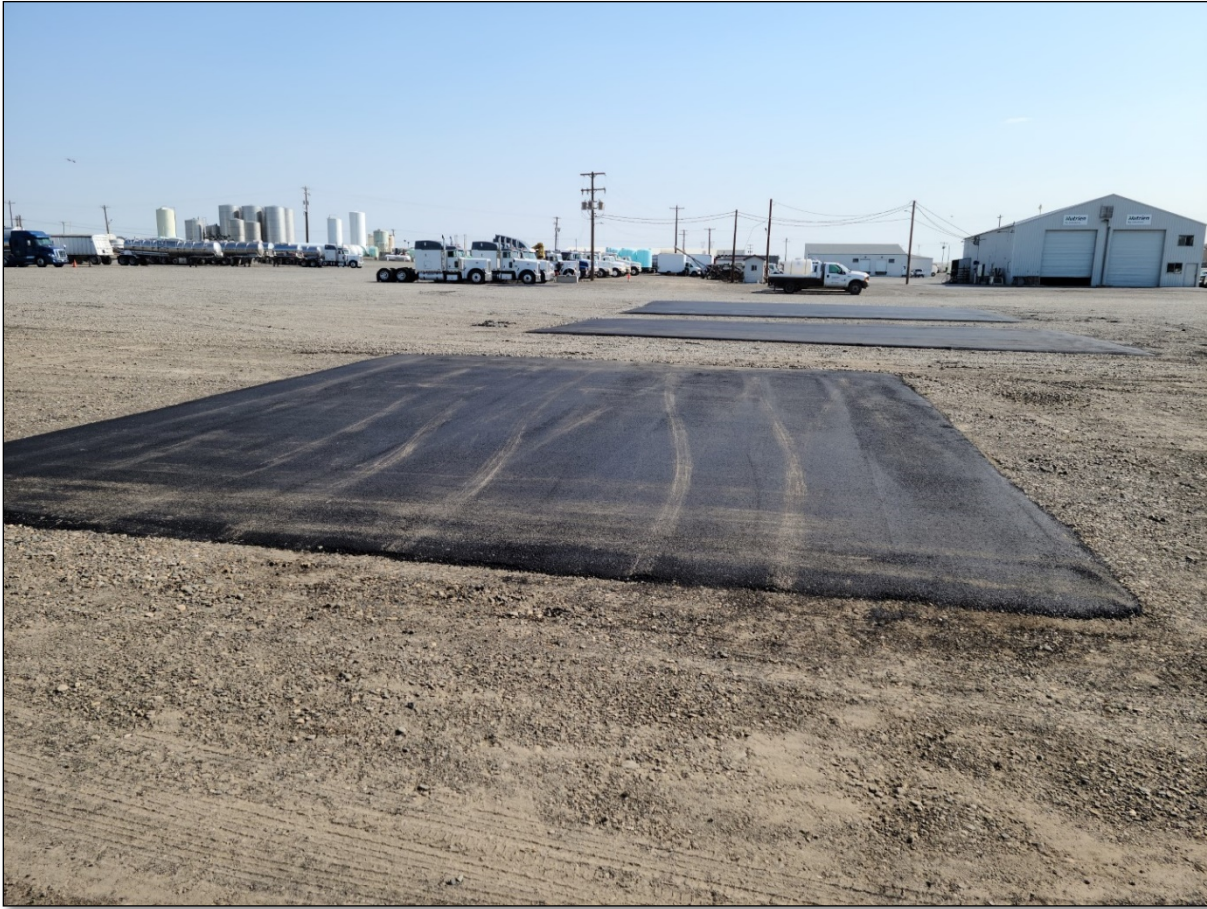
**Three Former Helicopter Pads**

Seven asphalt caps were constructed in 2004 and were due for scheduled maintenance. Per the DCAP, an asphalt overlay is required every 15 years to ensure the caps longevity and integrity. A Washington licensed contractor cleaned the caps of debris, applied tack coat for bonding purposes and overlayed the existing caps with a minimum of 1-inch of asphalt. Locations of the asphalt caps are shown on **Figure 2** and pictures of the completed overlay are presented in **Appendix A**.

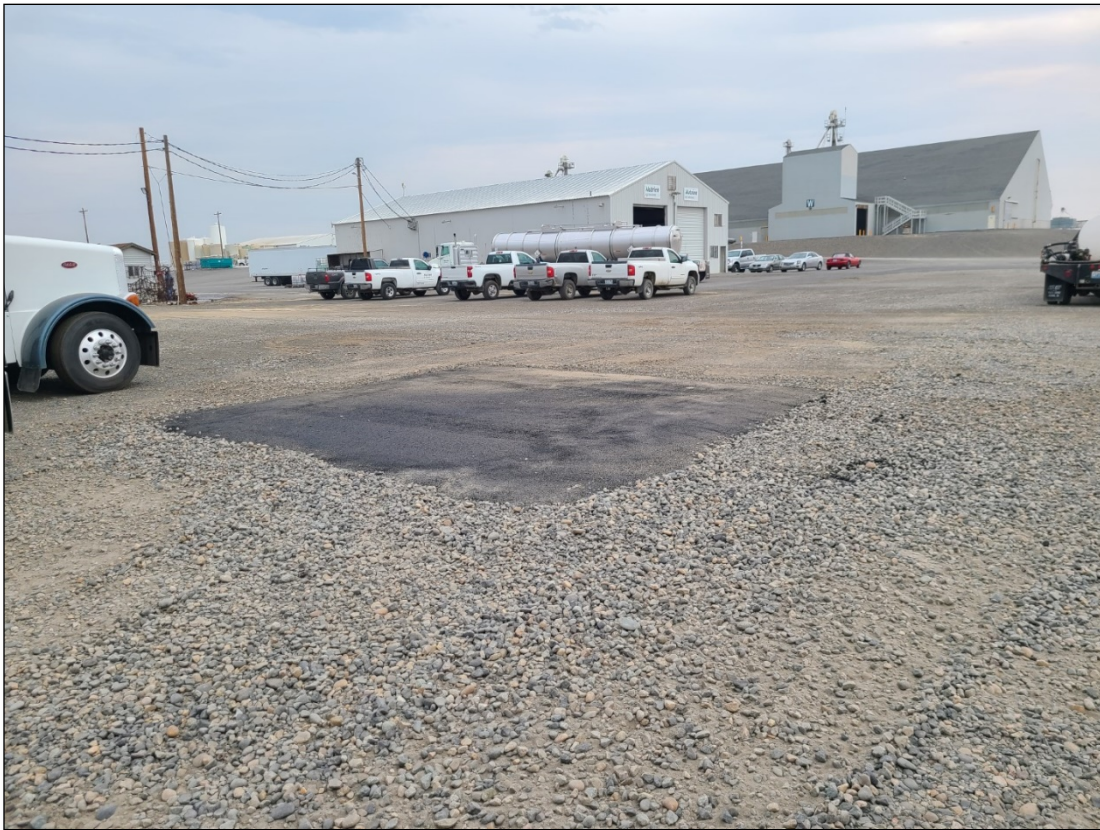
**Former Office**

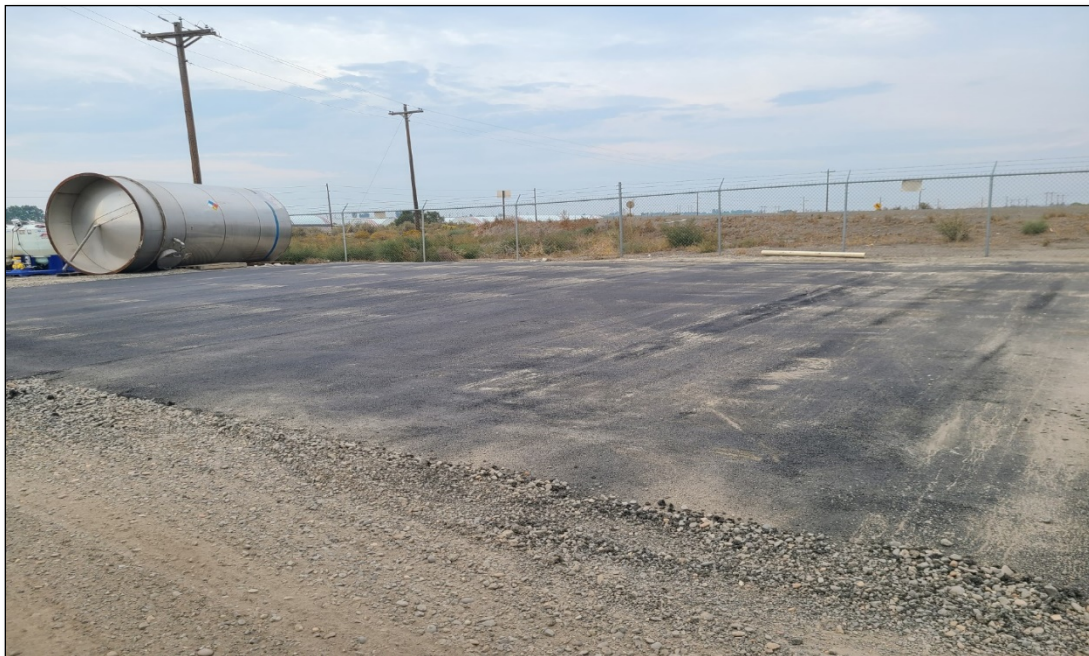
**Former wash pad near the north east corner of the property**

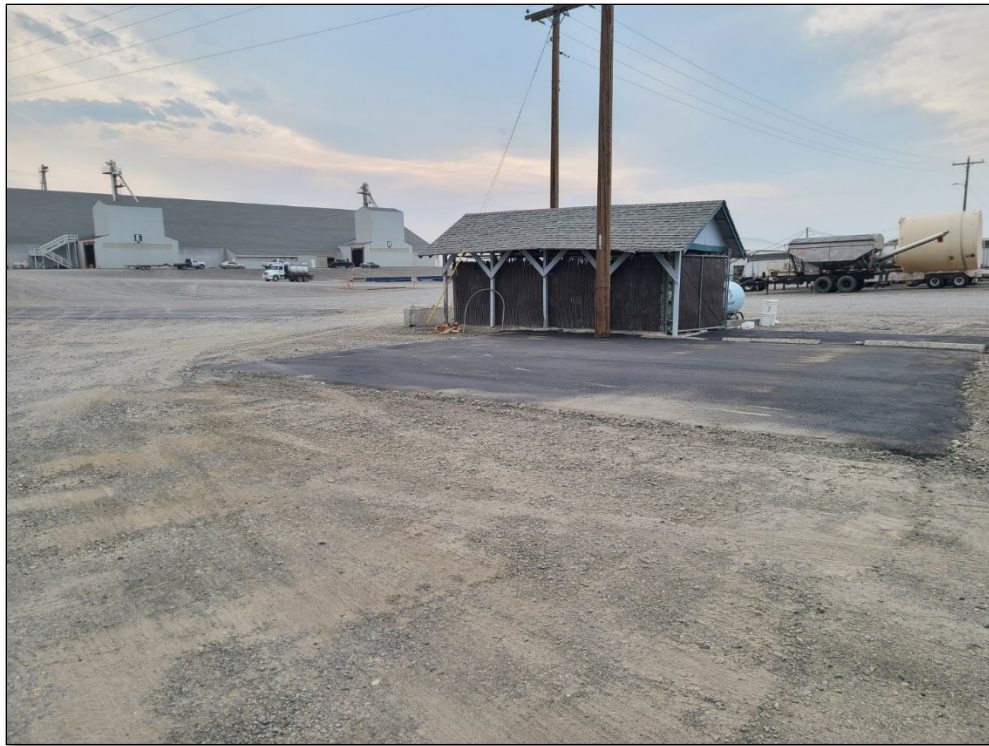
**Former Gasoline UST Area**

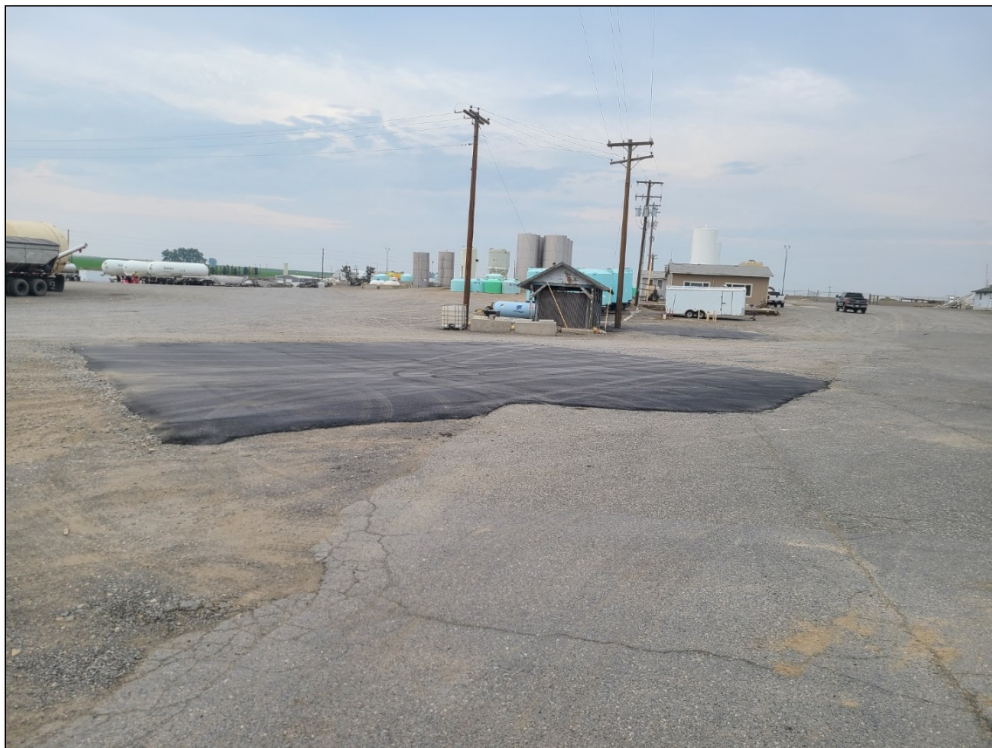
**21-0-0-7 Fertilizer Spill Area**

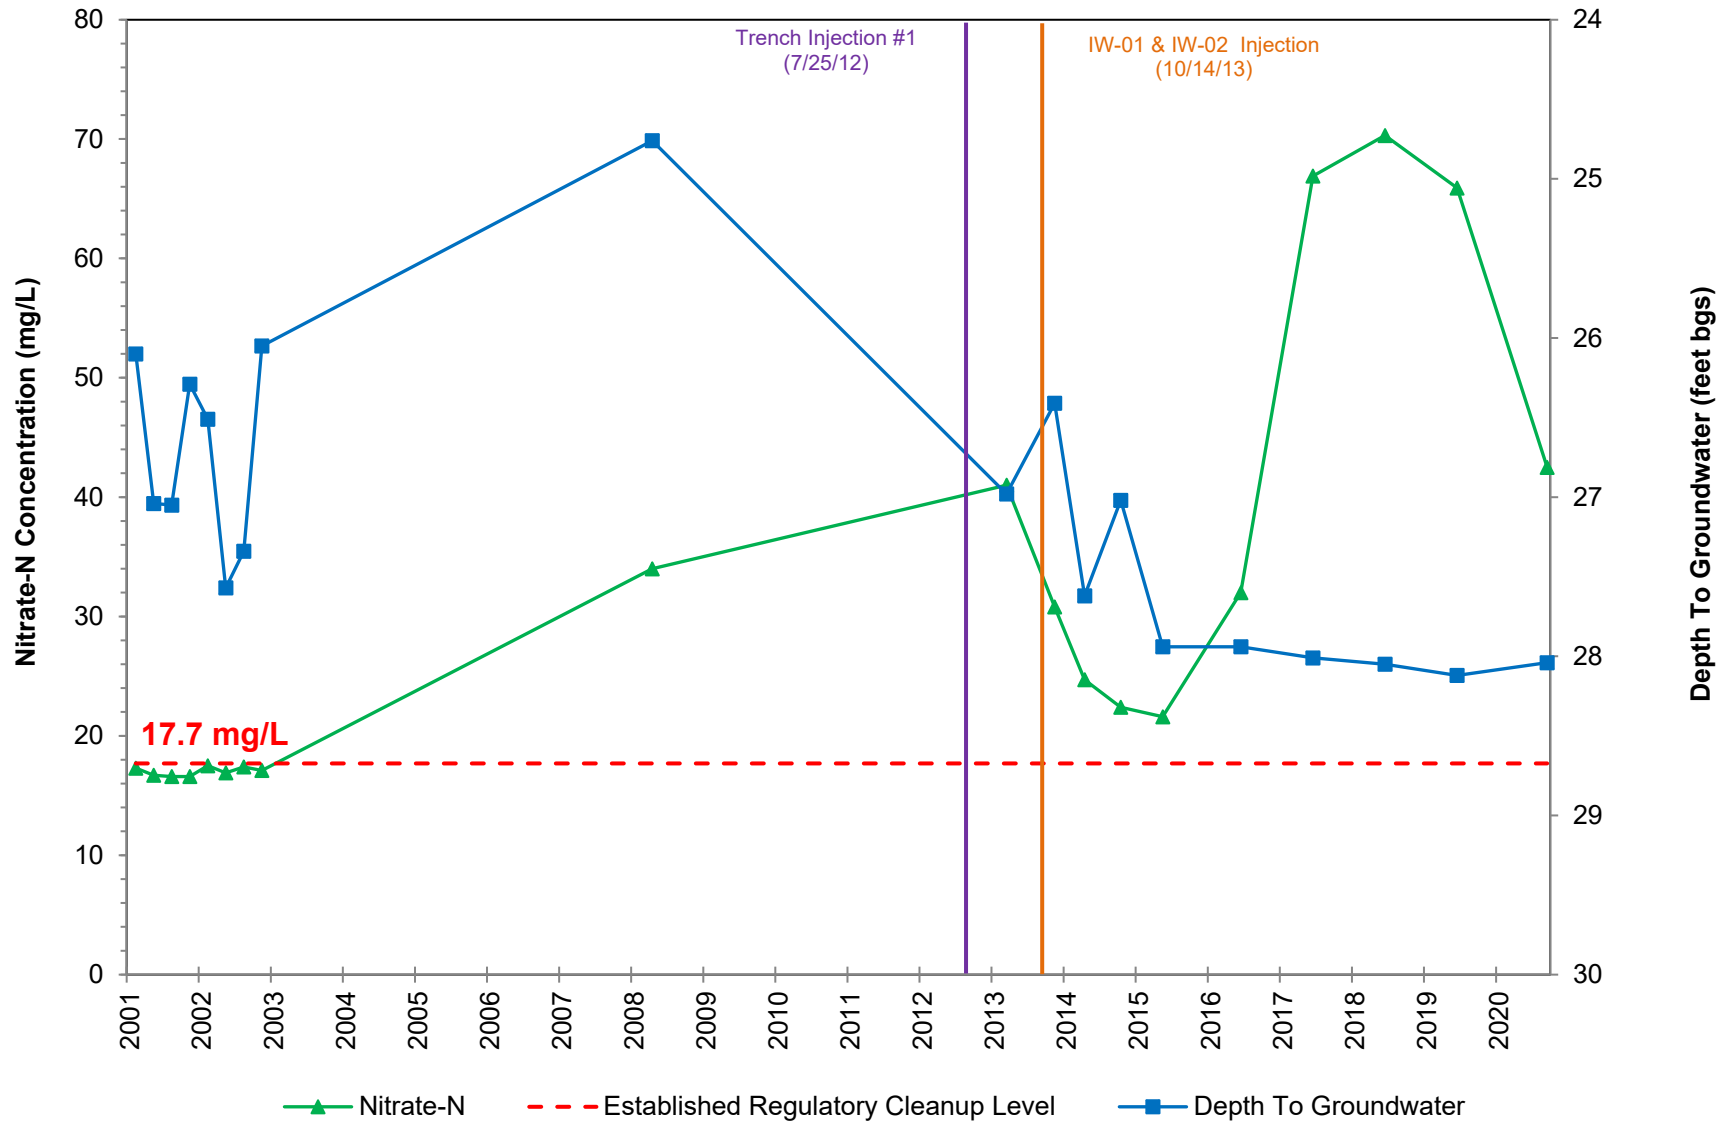
**Well MW-15**  
**Nutrien - Pasco, WA**  
**Nitrate-N and Groundwater Depth vs. Time**
