STATE OF WASHINGTON
DEPARTMENT OF ECOLOGY

Re: Opinion pursuant to WAC 173-340-515(5) on Remedial Action for the following Hazardous Waste Site:

- **Site Name:** Coit Services
- **Site Address:** 16750 Woodinville-Redmond Rd NE, Woodinville, WA 98072
- **Facility/Site No.:** 36189742
- **Cleanup Site ID No.:** 16672
- **VCP Project No.:** NW3377

Description and Diagrams of the Site

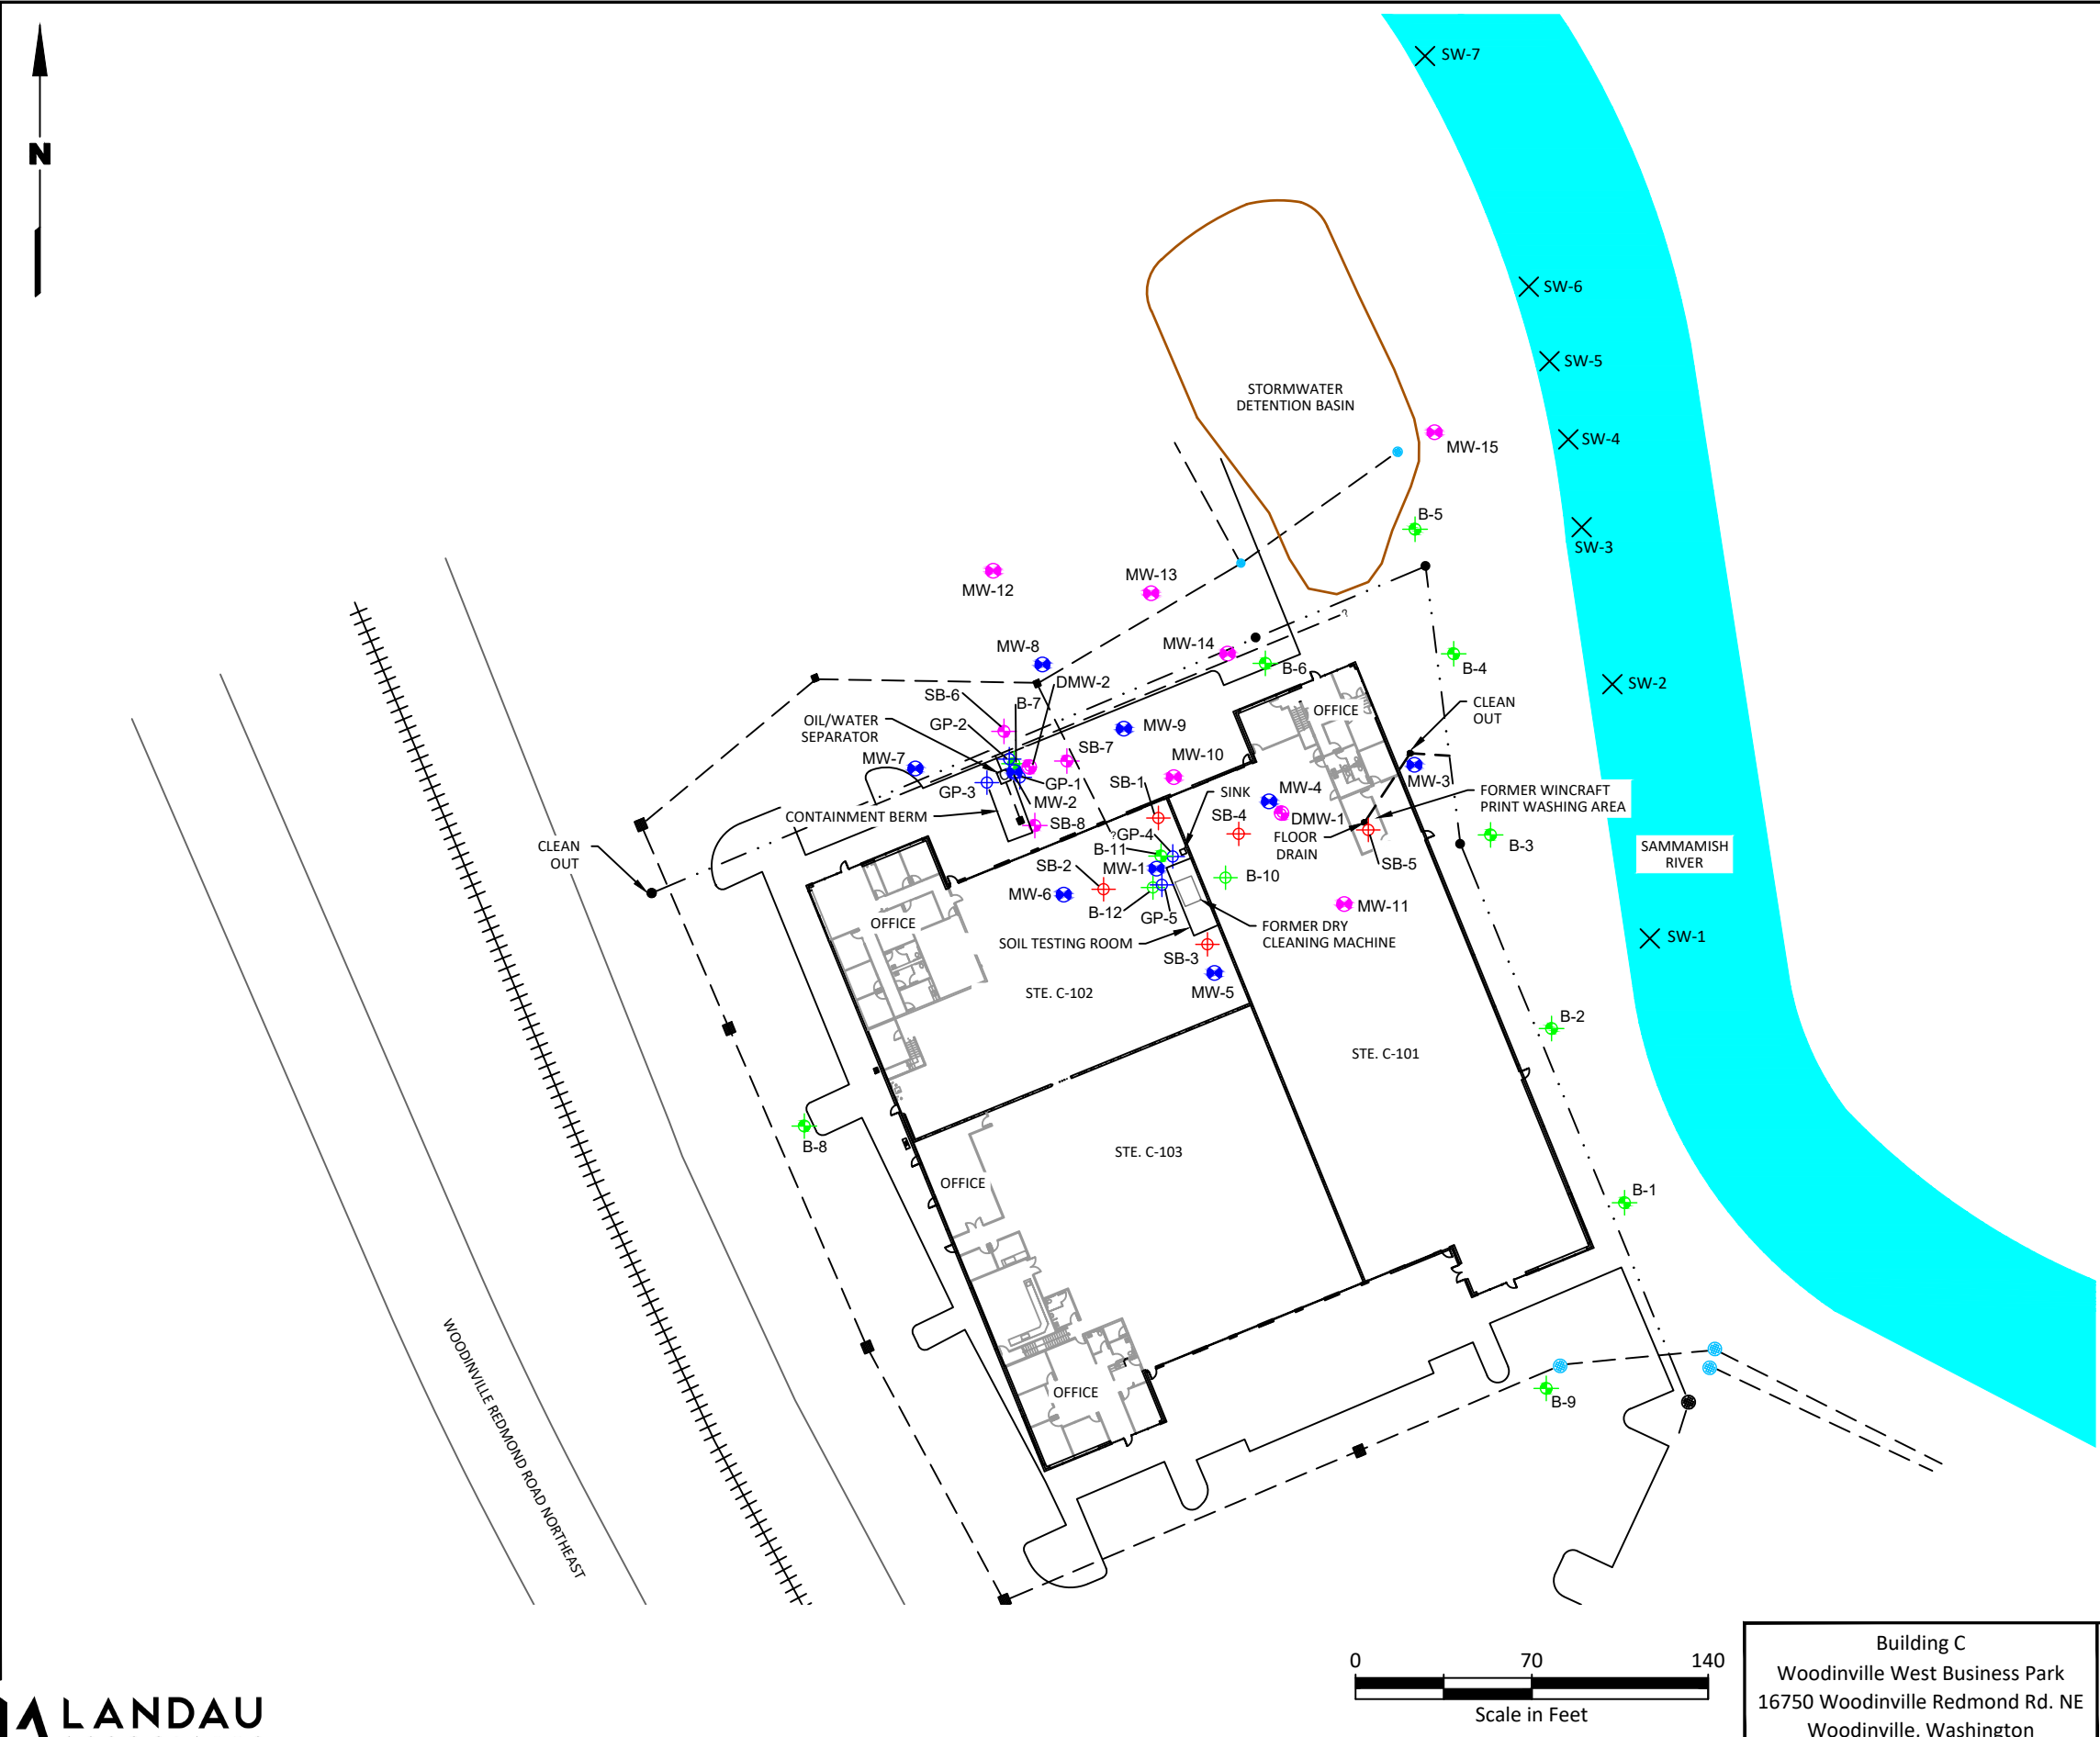
Enclosure A Figure 3

From 2019 to 2023, a total of 17 permanent monitoring wells were installed at the Site in two depth intervals: shallow (MW-1 to MW-15), and deep (DMW-1, DMW-2; **Figure 3**). Wells in the shallow interval are installed with 15- to 20- foot screens installed from 3 to 23 feet bgs. Depth to water in shallow wells ranges from 8.70 to 16.54 feet bgs (23.01 to 18.01 feet NAVD88⁷). Wells DW-1 and DW-2 are installed with 5-foot screens installed from 42.5 to 49 feet bgs. Depth to water in deep interval wells ranges from 11.01 to 16.54 feet bgs (20.92 to 19.86 feet NAVD88). Shallow groundwater flow at the Site is oriented to the east-northeast toward the Sammamish River (**Figure 6**).

A total of seven surface water samples were collected from the Sammamish River in August 2023 (**Figure 3**). Samples were collected at the midpoint between the thalweg and west bank of the river near the river bottom using a peristaltic pump. None of the surface water samples contained HVOCs above the laboratory reporting limits and applicable MTCA cleanup levels.

The source of PCE; cis-1,2-DCE; and vinyl chloride (collectively HVOCs) contamination at the Site is associated with the historical dry-cleaning operations (**Figure 3**). Contamination at the Site was initially found in 2019 as part of a Phase II Environmental Site Assessment. The sources of
