February 2, 2024

Re: Cap Integrity and Groundwater Monitoring Report
Former Walker Chevrolet Property, VCP No. SW1040
633 Division Avenue
Tacoma, Washington

TRC Project Number: 566091.0000

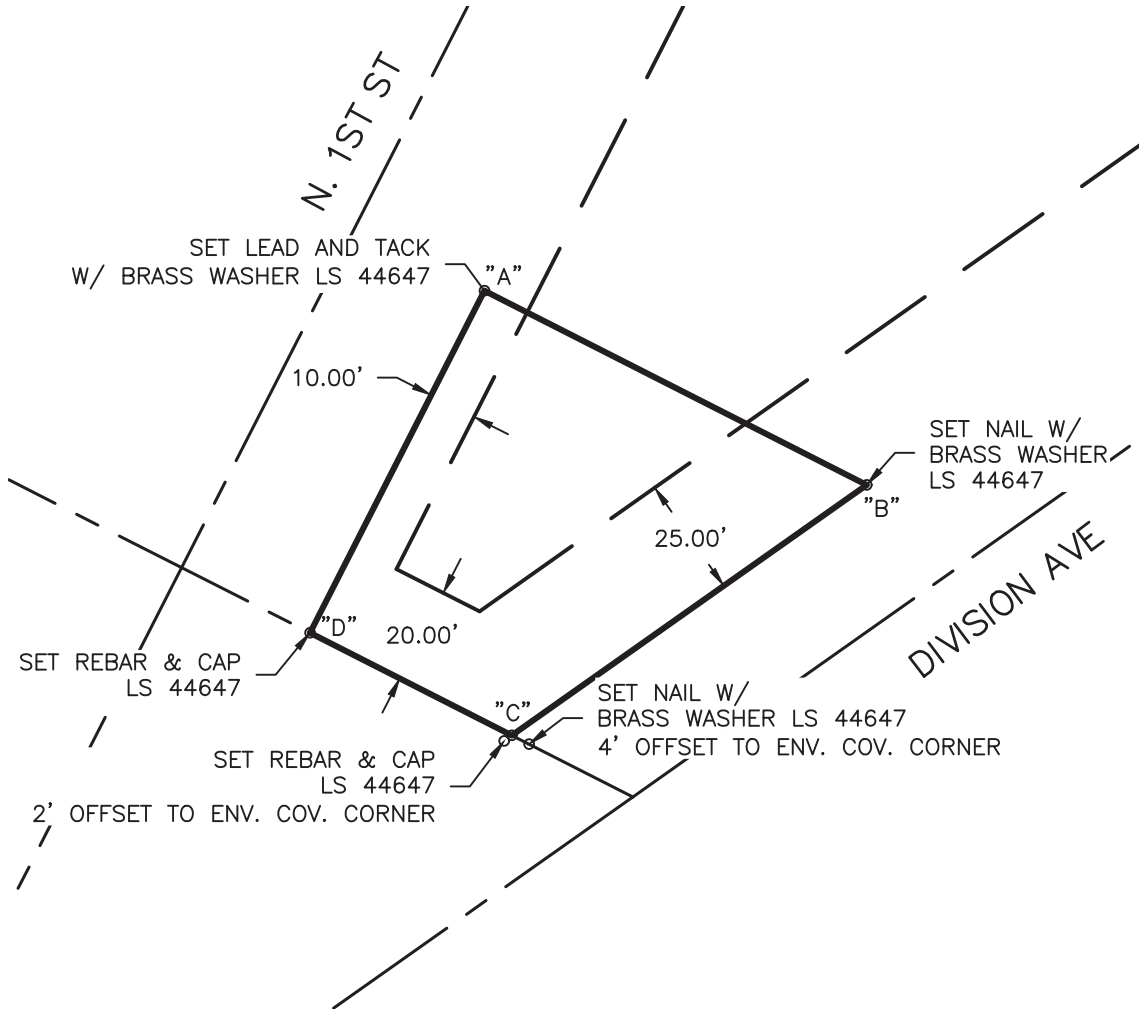
ENVIRONMENTAL COV. EXHIBIT

In December 2019, Pace Engineers (Pace), under the direction of Environmental Partners, Inc. (EPI)¹, permanently marked the exterior corners of the pavement cap to ensure that the extent of the pavement cap remained clearly delineated with monuments or other permanent corner markers as required per Section 1.f. of the EC. The interior corners of the pavement cap are defined by the exterior corners and perimeter of the building cap, which is intact and is not required to be delineated by markers. Pace surveyed and set four markers that identify the exterior corner boundaries of the property cap annotated “A” through “D” as shown on Figure 2 and in Attachment B. The pavement cap exterior corner boundary markers are described below.

- Marker “A” is set lead and tack with a brass washer with a northing of 709832.45 and an easting of 1156493.60.
- Marker “B” is set nail with a brass washer with a northing of 709791.98 and an easting of 1156573.25.

- Marker “C” is set nail with a brass washer with 4-foot offset to east southeast from EC corner with a northing of 709739.81 and an easting of 1156499.32.
- Marker “D” is set rebar and cap with a northing of 709761.18 and an easting of 1156457.26.

During the December 15, 2023, site visit, TRC field staff, along with Dean Malte, Cleanup Project Manager with Ecology, located, inspected, and photographed the pavement cap corner markers. Three of the four markers (Markers A, B, and C) identifying the exterior corners of the pavement cap area subject to conditions of the EC were noted to be in good condition and no maintenance or repairs are necessary at this time. The fourth marker (Marker D) was noted to likely be buried in landscaping present at the location. TRC and Ecology were able to identify the location of Marker D based on photographs from previous inspections, which allowed identification of the capped area. TRC confirmed with Ecology at the time of the inspection that further efforts to unearth the marker are unnecessary at this time. Photographs of the EC pavement cap markers are included in Attachment B. Refer to Figure 2 and the EC Exhibit prepared by Pace in Attachment B for marker locations and coordinates.

"A" NORTHING 709832.45
EASTING 1156493.60

"B" NORTHING 709791.98
EASTING 1156573.25

"C" NORTHING 709739.81
EASTING 1156499.32

"D" NORTHING 709761.18
EASTING 1156457.26
