Remedial Investigation Report

University of Washington—Tacoma Campus
Tacoma, Washington
Ecology Agreed Order No. DE 11081

June 30, 2023

GeoEngineers File No. 0183-109-13
University of Washington Project No. 205864

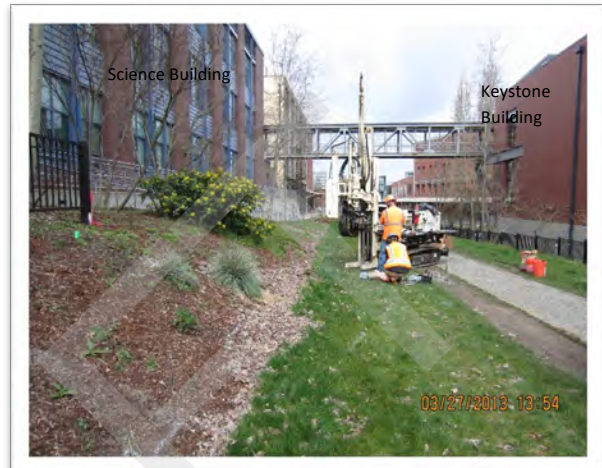
Photo 6-3. Circa 2013 photograph of Prairie Line Trail during investigation activities (looking north). Science Building to the left of the photograph occupies the majority of the former WOF Building footprint.

In 2013, additional investigation and remedial excavation activities were performed by GeoEngineers east of the former WOF building during the construction of the PLT Capital project as shown in Photo 6-3 (252). The investigation was completed east of the sanitary sewer pipe observed in the 2000 WOF remedial excavation. Nine DP borings (PLT-BA6-1 through BA6-8⁵ and PLT-B14) were advanced to depths ranging from approximately 10 to 15 feet bgs (approximate elevation 59 to 54 feet) east of the Science Building (former WOF building and 2000 excavation area) to further evaluate the nature and extent of residual petroleum-contaminated soil remaining in place at this location. In addition, a temporary well was placed in boring PLT-B14 for the collection of a perched groundwater sample (252). Groundwater was not encountered in the other soil borings completed at this location.

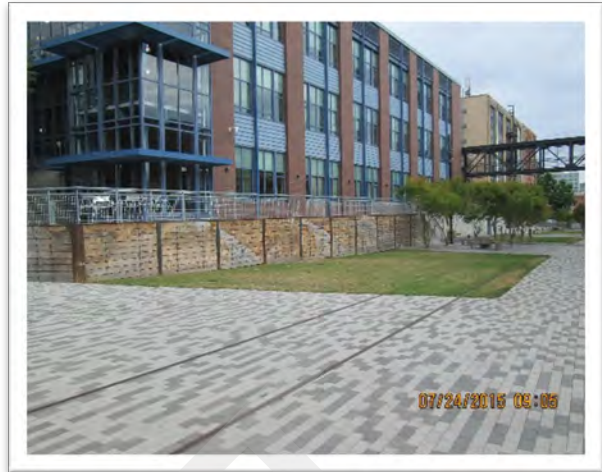
Photo 6-4. 2015 photograph of Science Building and final configuration of PLT looking northwest.

In addition to the investigation activities completed within PLT, construction of the PLT pedestrian corridor (further discussed in Section 7.0) resulted in the installation of a soldier pile (Photo 6-4) wall between the Science Building (approximate extent of WOF Building footprint) and the sanitary sewer (the eastern portion of 2000 remedial excavation). Following installation of the soldier pile wall, a small prism of soil was excavated to support regrading activities within PLT. A geotextile fabric and at least 1 foot of imported fill soil were then placed. Visual indicators of petroleum contamination were not observed during construction of the PLT. The new ground surface west of the soldier pile wall is approximately elevation 75 feet. Soil generated from the soldier piles was disposed of at a Subtitle D landfill.

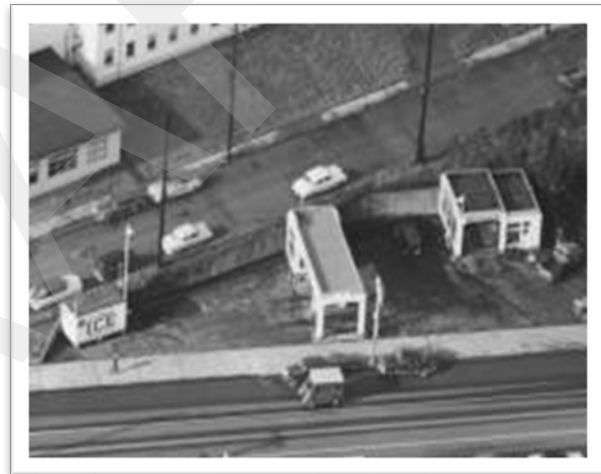
Photo 8-1. Circa 1951 photograph of the Standard Oil service station at 1742 Jefferson Avenue.

Three USTs connected to a pump island with fuel dispensers, a tire rack, and a service bay with a hydraulic lift and floor drain/sump were in use based on historical development plans. Aboveground structures associated with the former service station are no longer visible by 1979. Photo 8-1 provides an overview of the service station circa 1951.

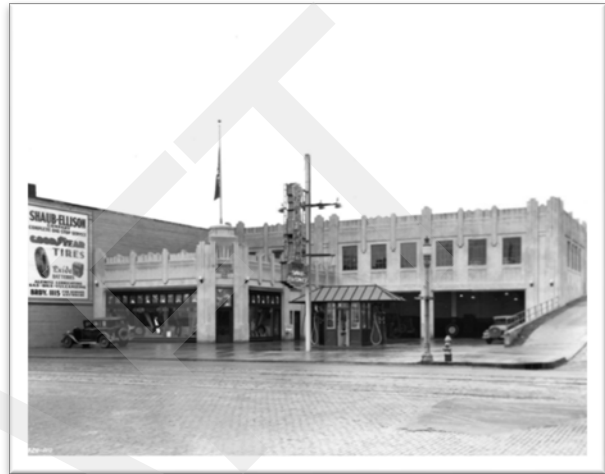
Photo 11-1: Circa 1932 photograph of the Shaub-Ellison building and associated dispenser island at the corner of former South 19th Street and Pacific Avenue.

Five USTs including three 500-gallon USTs, one 1,000-gallon UST and one 8,000-gallon UST, and a fuel dispenser were located within the northeastern portion of the property based on a review of historical documents. These features were removed between 1994 and 1995.

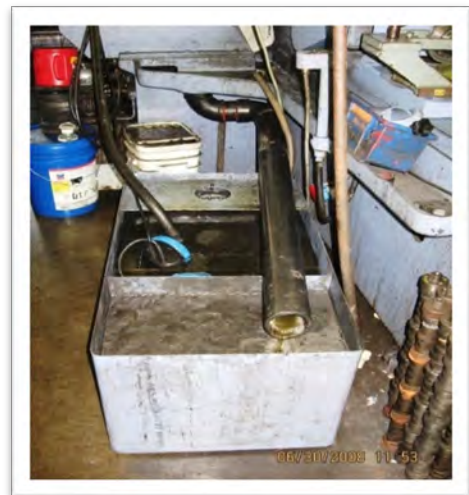
Photo 13-3: Circa 2008 photograph showing an example of the poor housekeeping practices with open containers and evidence of petroleum and solvent releases from the camshaft rinse areas.

Ecology and the City completed inspections of Delta Camshaft between 2008 and 2010 in response to a complaint filed with Ecology. Very poor housekeeping (see Photo 13-3) was noted by the City’s inspection records including multiple open drums and evidence of petroleum/solvent releases from the camshaft rinse areas during the inspections. A manhole of unknown use was also observed during the inspection in the parking area west of the main building. However, this manhole is no longer present. Inspection records indicate that process water from washing the floors was discharged to the sanitary sewer without a permit. The business was “red tagged” by the City in 2010 with the building subsequently demolished soon thereafter.

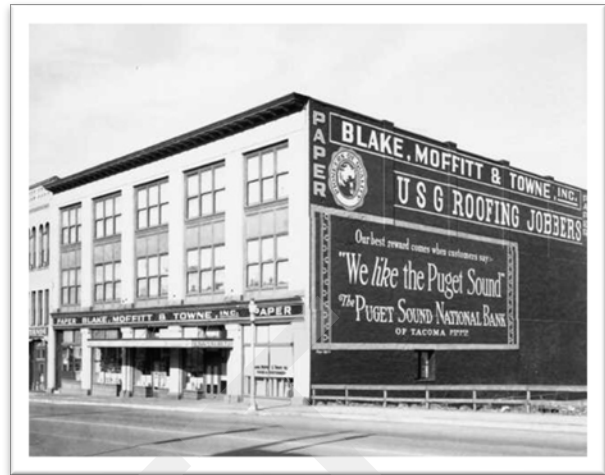
Photo 14-2. 1943 photo of TPS Building. (looking northeast).

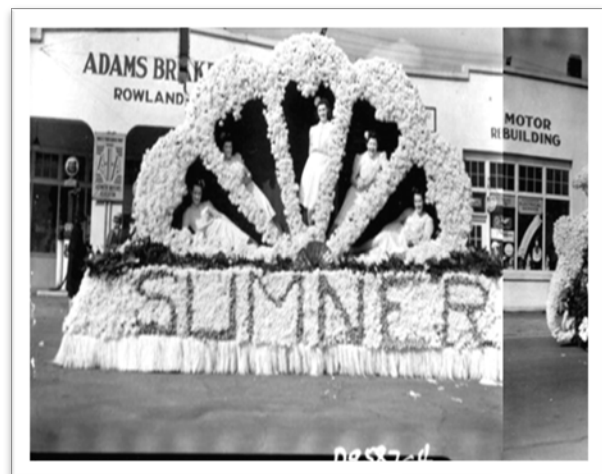
Photo 15-1. Circa 1940 photo of the 1934 Market Street buildings (looking west).

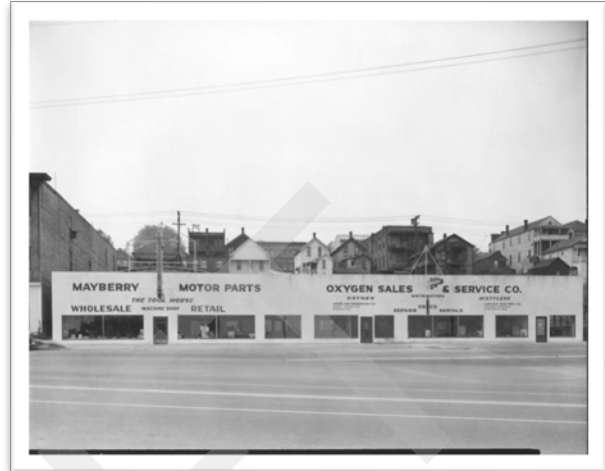
Photo 15-2. Circa 1950 photo of the 1934 and 1938 Market Street Buildings (looking west).

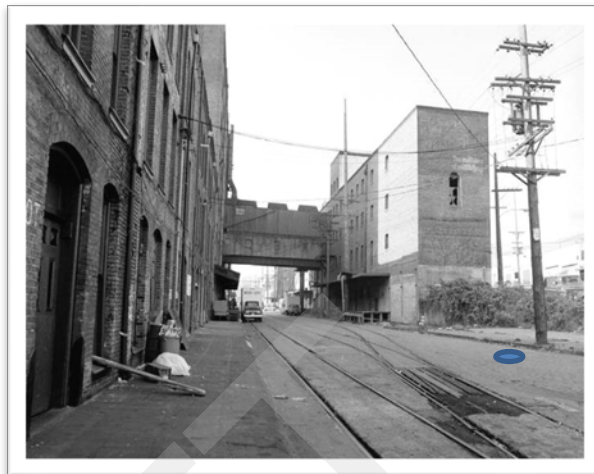
Photo 15-3. Circa 1979 photo of Commerce Street in the area of monitoring well CR-MW16 (looking south).

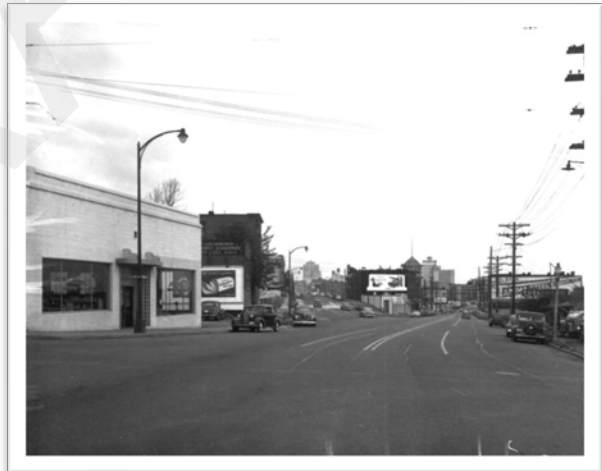
Photo 16-1. Circa 1951 photo from South 21st Street looking north. 1956 Jefferson Avenue is the white building on left and City Fuel/Jet Parking Lot is on the right.

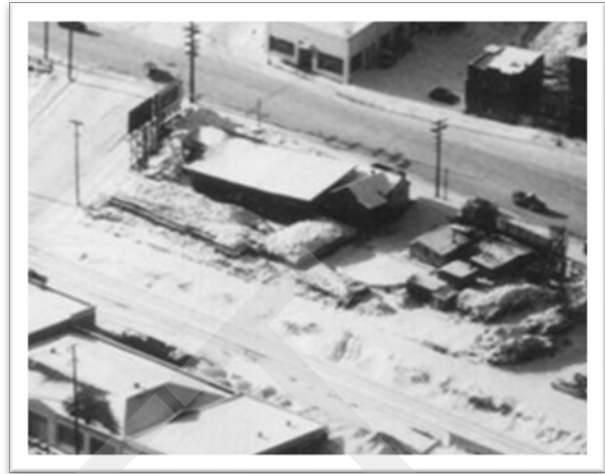
Photo 16-2. Circa 1949 photo of the Southern portion of Jet Parking (looking southwest). South 21st Street is located to the left and Prairie Line Trail at bottom of photo.

- **1942–1949.** City Fuel Company (see Photo 16-2).
- **1969 to present.** Predominantly used as a parking lot. Soil treatment activities for various UWT Campus projects were completed at the property in the mid-1990s (further discussed below).

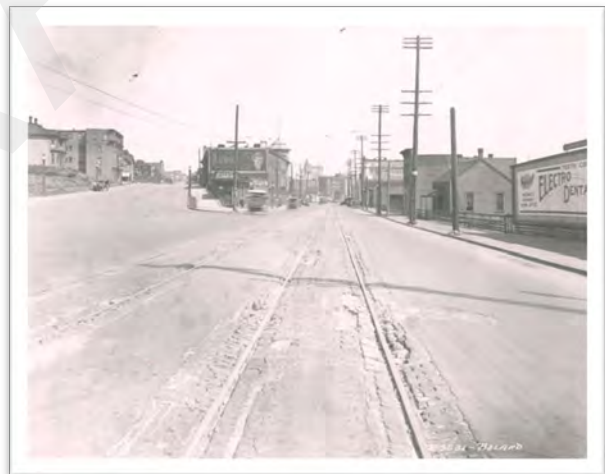
Photo 16-3. Circa 1920 Tacoma Railway & Power Company trolley tracks on Jefferson Avenue (right) and Market Street (left) looking north.

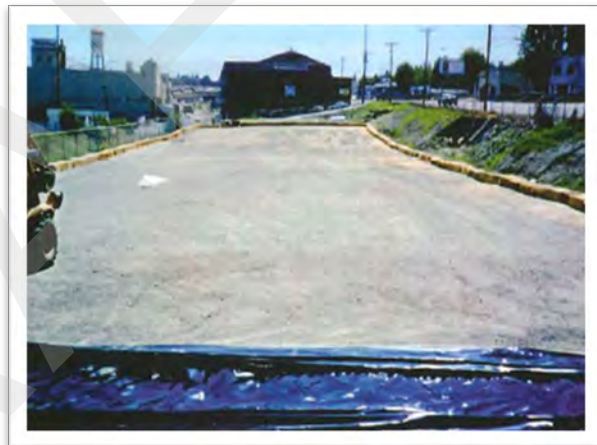
Photo 16-4. Circa 1997 photo of the southern portion of Jet Parking used as a treatment cell for petroleum-contaminated soil (looking north).

Contaminated soil was treated at Jet Parking within treatment cells constructed on top of the gravel-paved parking lot over 10- to 20-mil plastic sheeting. Straw bales wrapped with plastic sheeting lined the perimeter of the treatment cells. Soil placed into the treatment cell was mechanically screened to remove oversized material, mixed with reagents and land farmed on Jet Parking to promote enhanced ex-situ biological degradation of petroleum-related compounds sourcing from on- and off-property locations (described above). The soil was periodically aerated using angle dozing or tilling methods. Confirmatory soil samples collected from the treated soil verified that this material was suitable for reuse as fill material at Jet Parking and for other locations including Shaub-Ellison and Snoqualmie Library and during various redevelopment activities along Pacific Avenue.

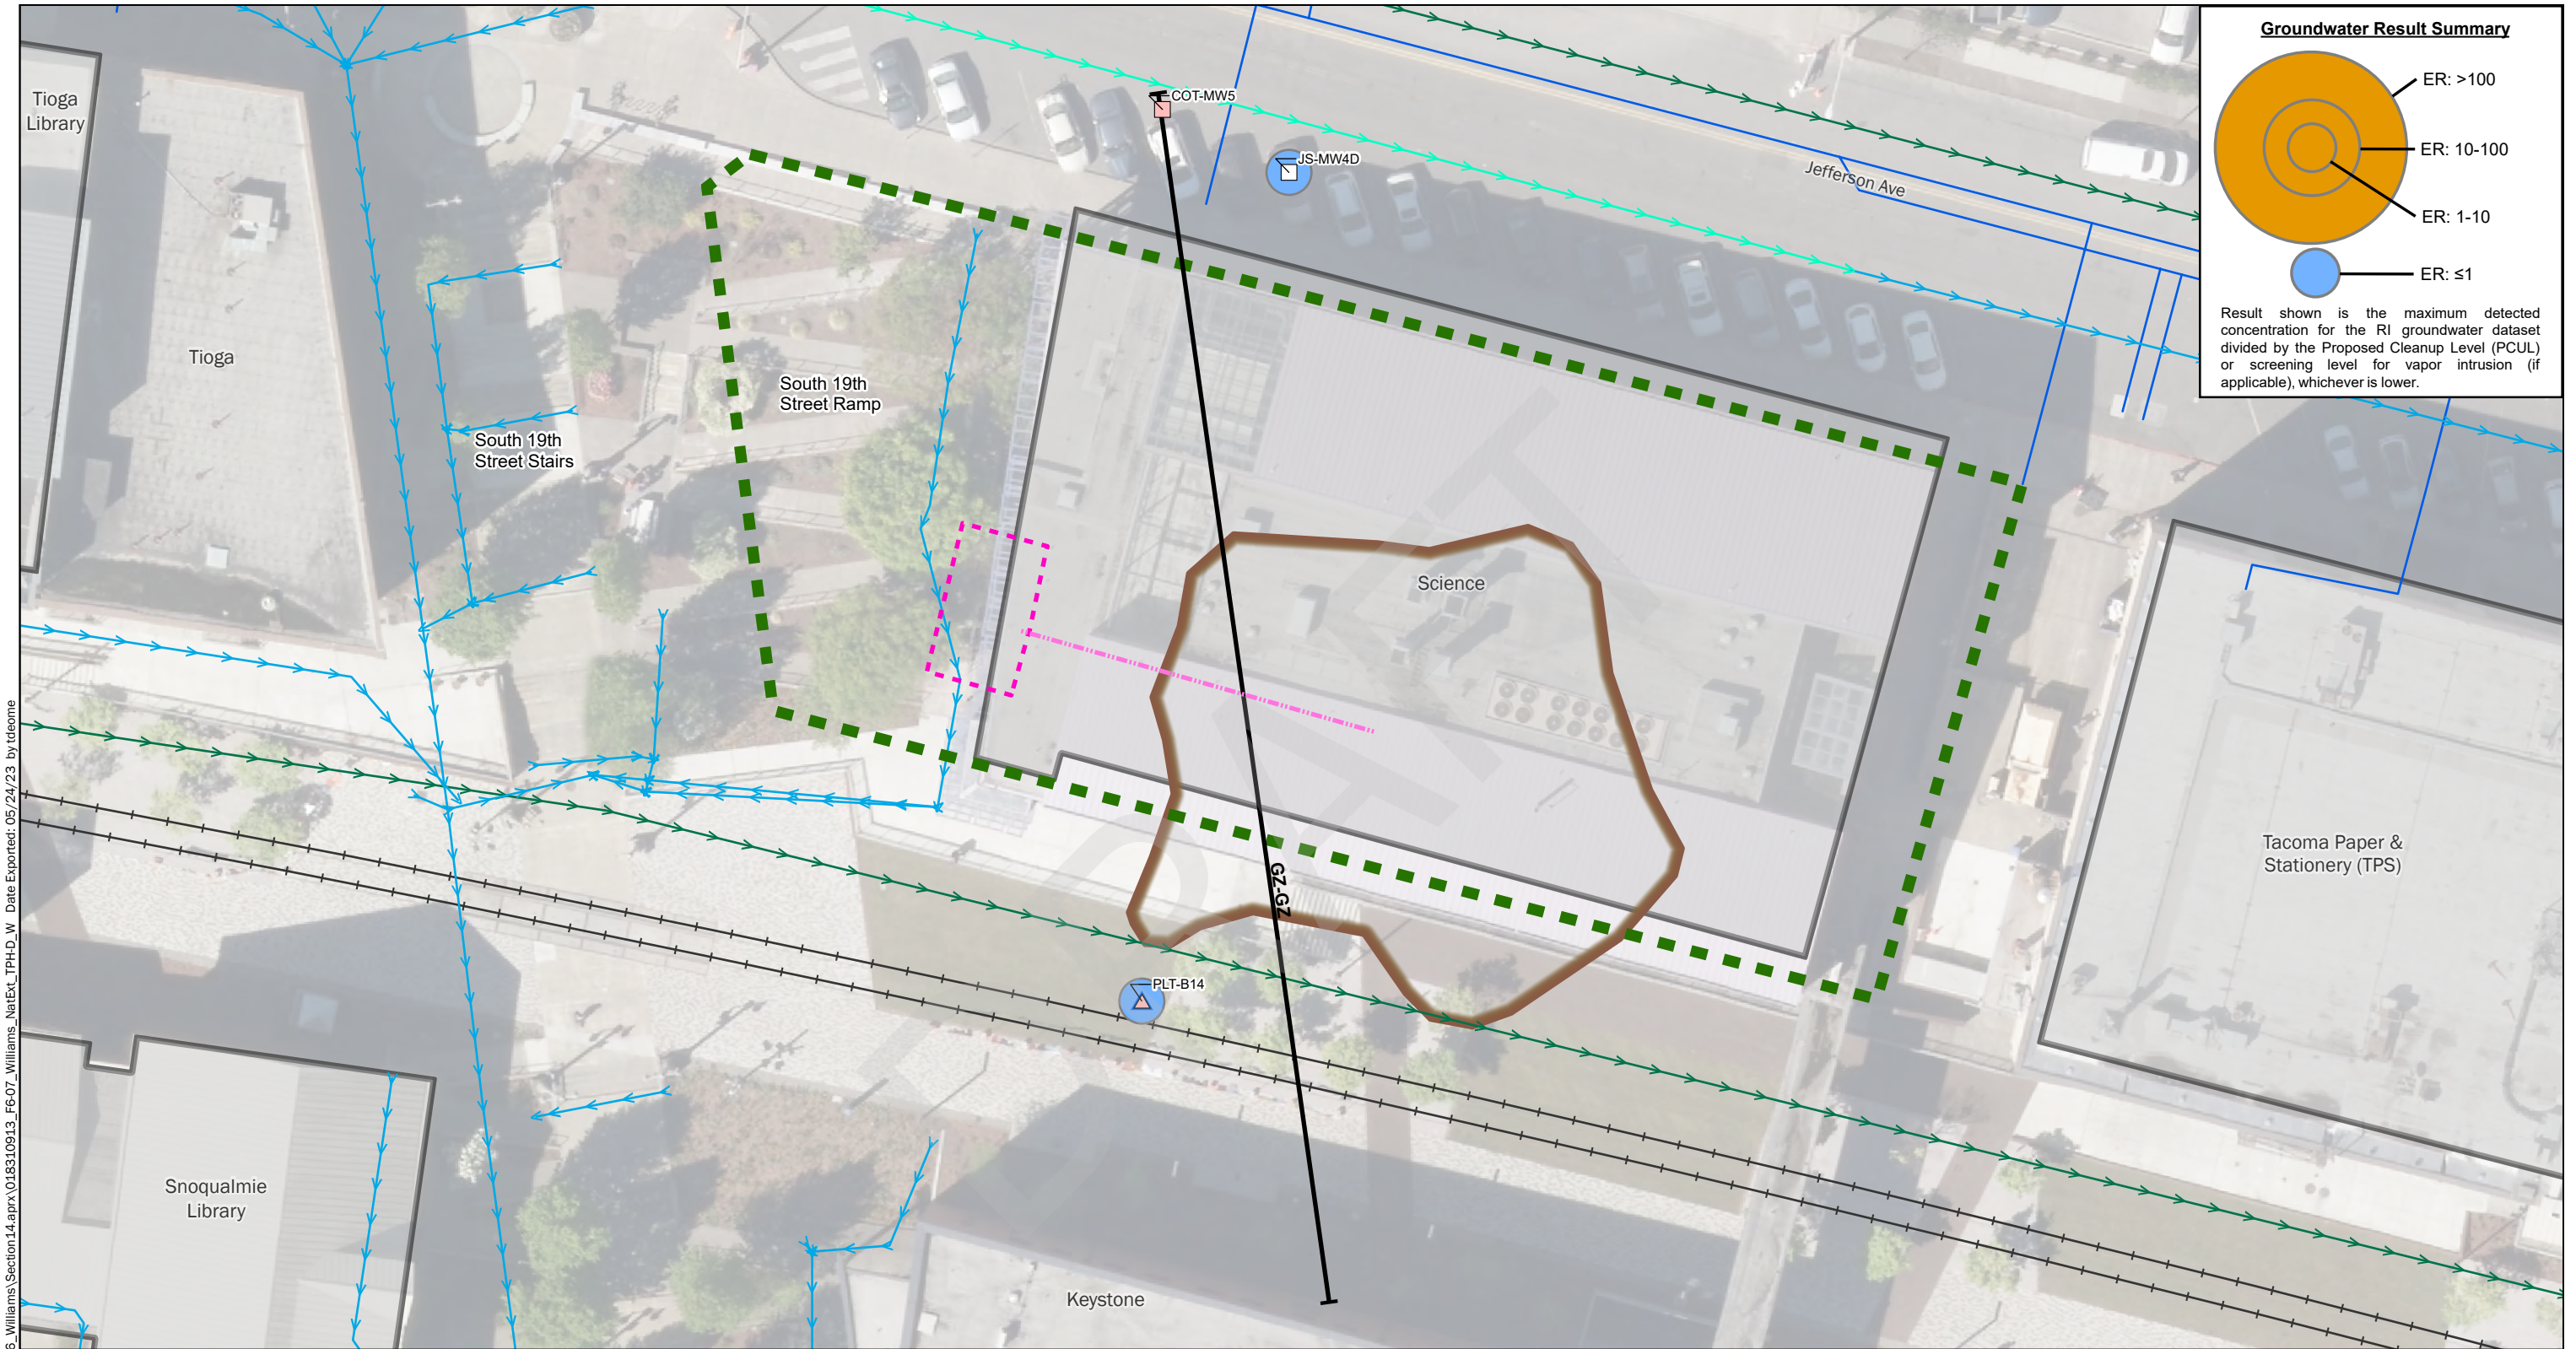
* = WOF-EW-10 was located within the excavation area and was removed. However, the 2000 remedial excavation report indicated that the WOF-EW-10 sample was representative of material left in place in the east sidewall and was not sampled.

Groundwater Result Summary
