**Re: Bioremediation Cell Decommissioning and Closure
Former Columbia Marine Lines Site
6601 NW Old Lower River Road, Vancouver, WA
SLR Project No.: 008.0205.00020**

Report
 BIOREMEDIATION CELL DECOMMISSIONING
 AND CLOSURE

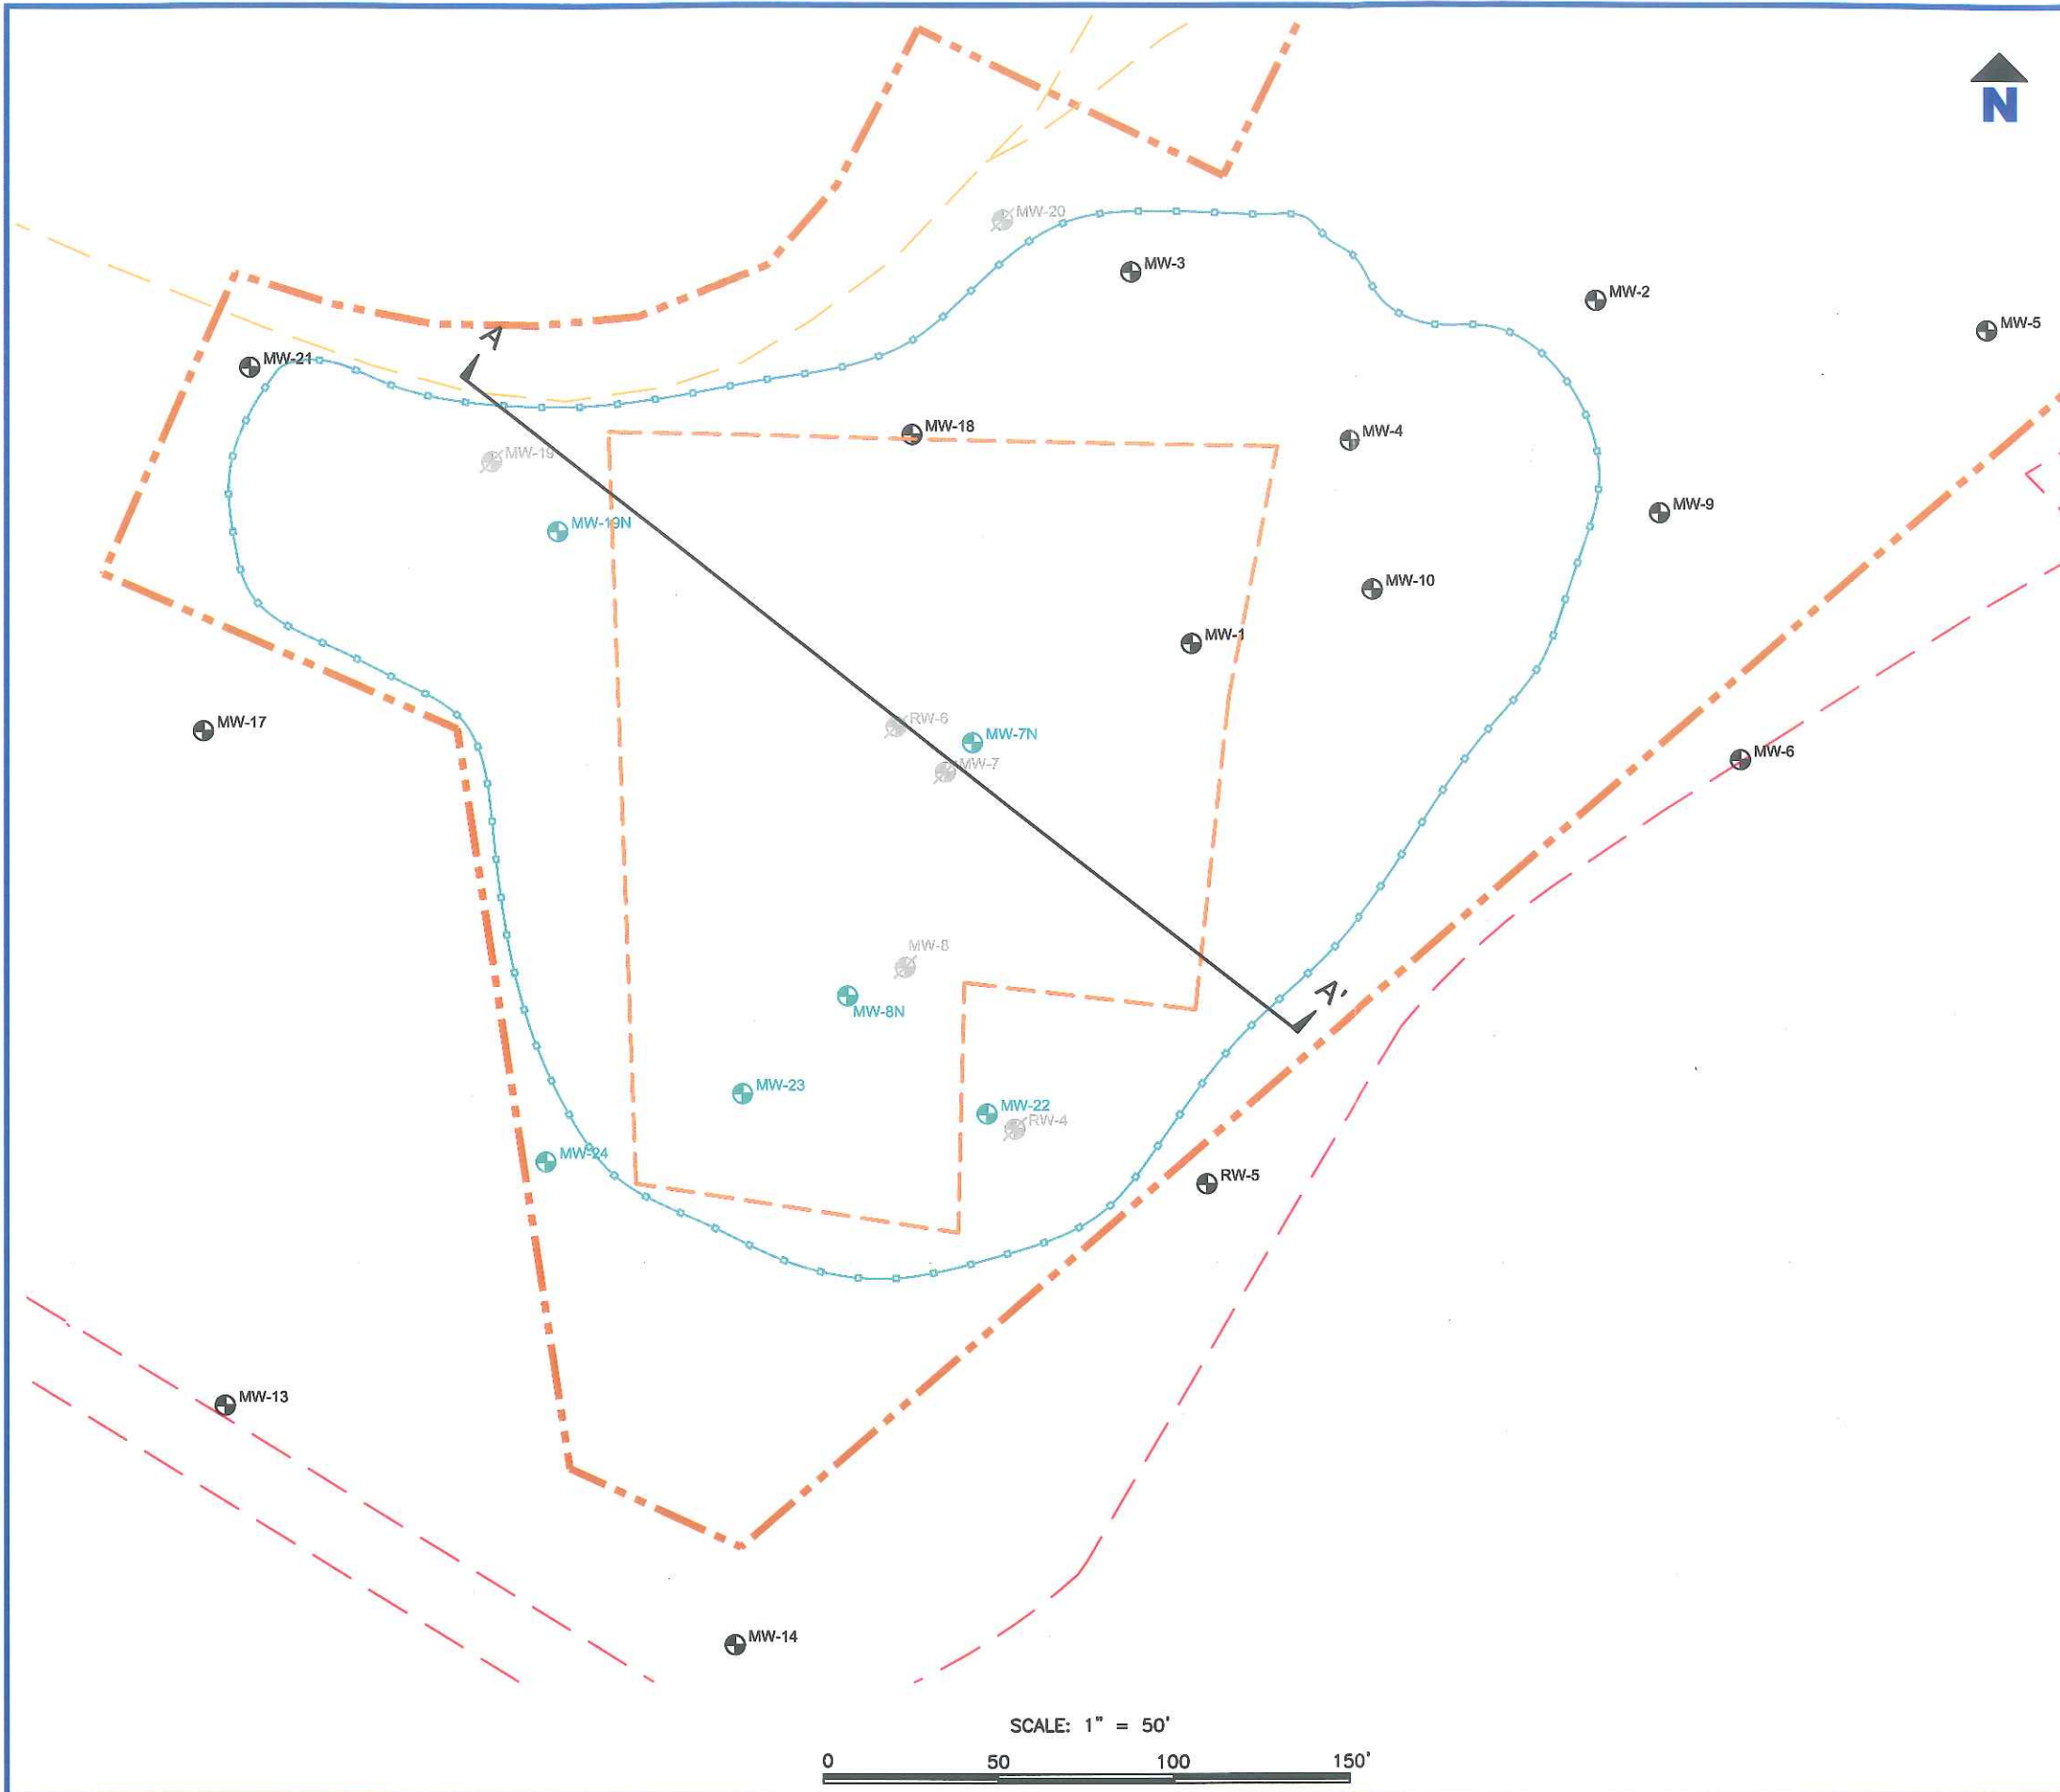
Drawing
 BIOREMEDIATION CELL AND ORGANOCLAY
 LINER CONFIGURATION

The site location is shown on **Figure 1**. For the purposes of this report, the Site is defined as the area illustrated on **Figure 2**, which includes portions of Clark County Tax Lot 153104000 and 152800000. The approximate area affected by the remediation activity is three acres. The Site is currently vacant. Prior to remediation, the Site was covered with grass, small trees, and other vegetation. The work was conducted under City of Vancouver Permit number GRD2008-00099. As of February 17, 2010, this permit has been closed by the City of Vancouver, all excavation work is complete, and the City of Vancouver has completed its final inspections as confirmed through a telephone conversation between the City of Vancouver and Steve Hammer with SLR.

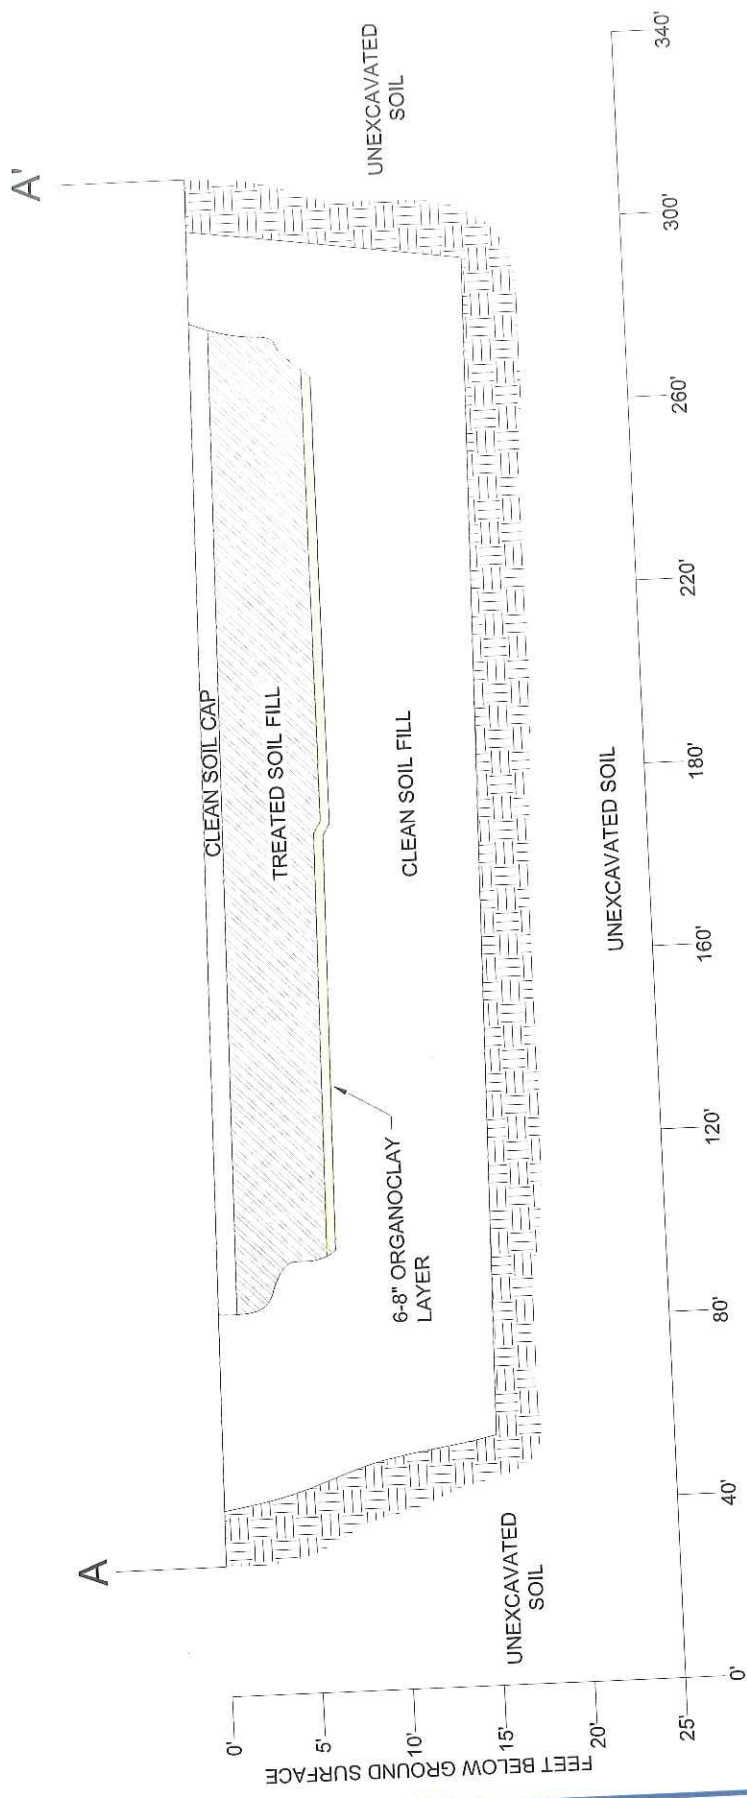
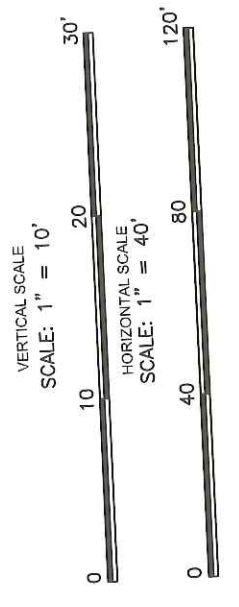
Drawing: **CROSS SECTION OF EXCAVATED AREA**

- Wyser finished final grading of the Site, grading the surface away from the center of the area so that stormwater would run off the area where the treated soil was placed. (See attached Photo Sheet 4). A cross section of the area has been included as Figure 3.

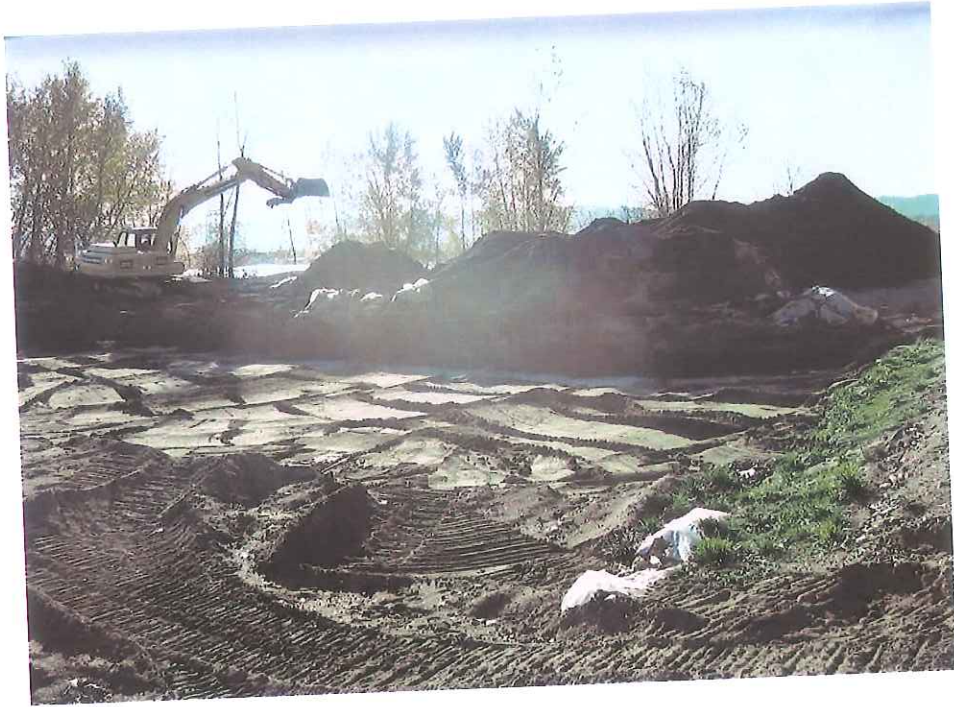
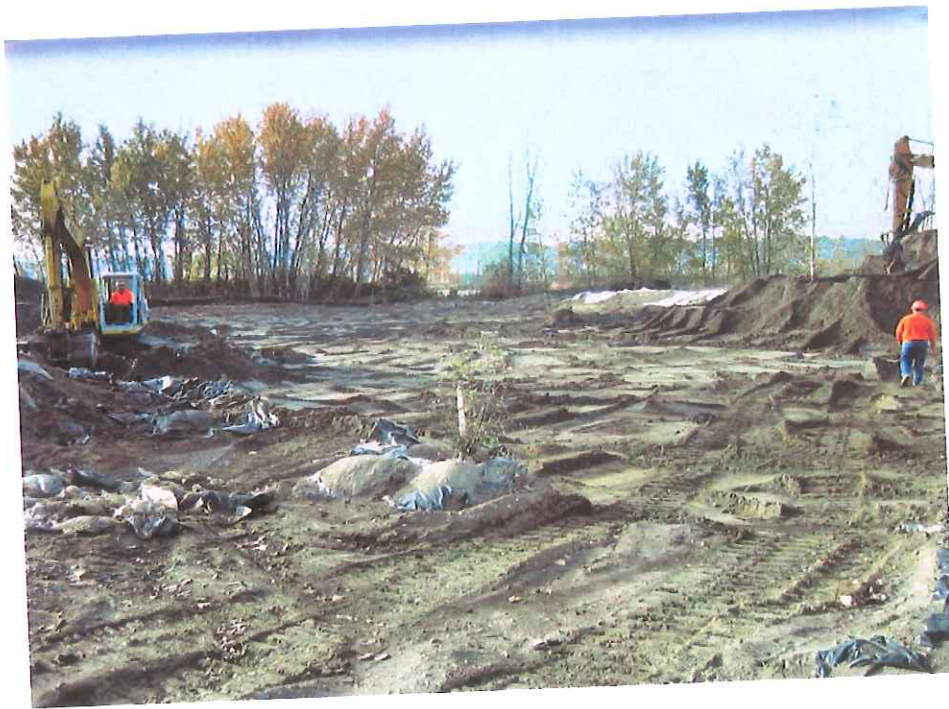
Photo Sheet 1
Biocell Closure
Former Columbia Marine Lines
Vancouver, WA

- Wyser removed and stockpiled the remaining treated soil to expose the HDPE liner. The total volume of soil moved was approximately 4,000 cubic yards (cy). An additional 4,000 cy had already been stockpiled following the first round of fertilization, mixing, and sampling of the bioremediation cell in September 2009. (See the attached Photo Sheet 1.)

Removal of remaining treated soil to expose HDPE liner

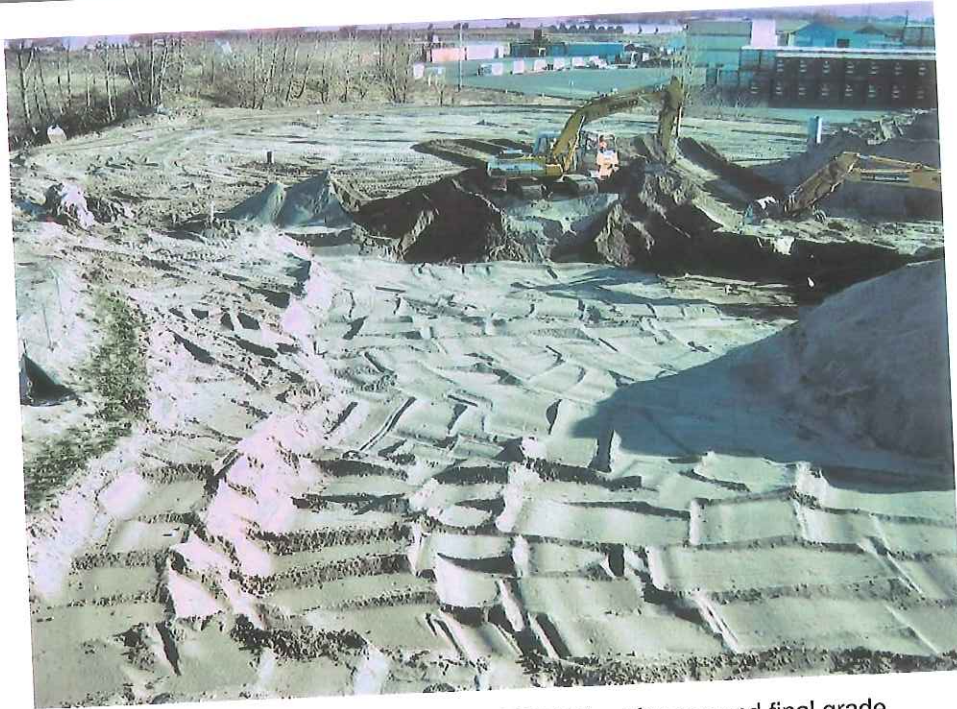
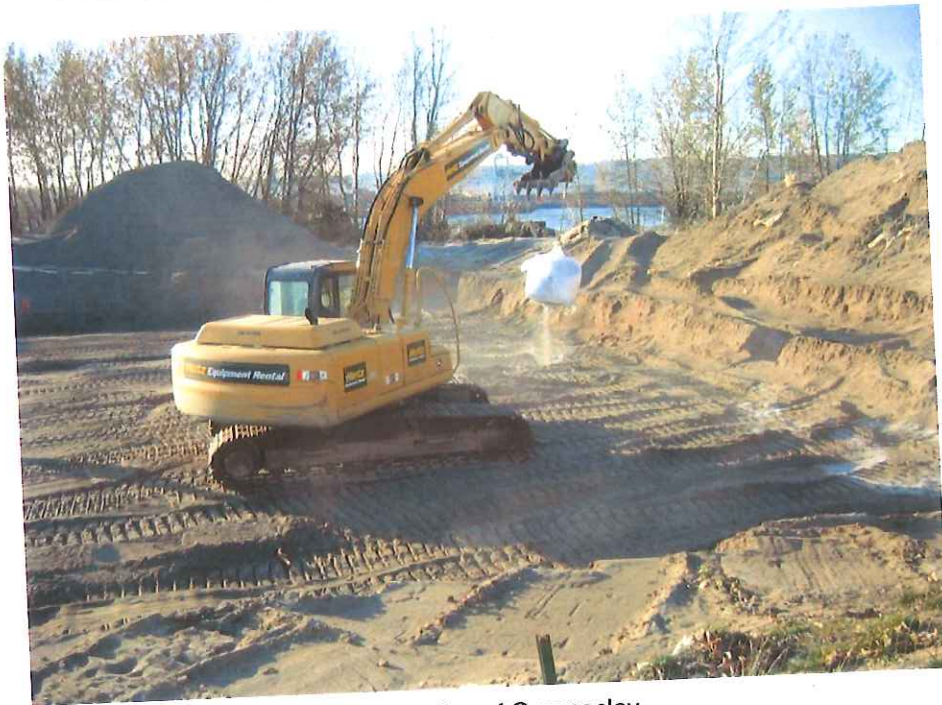
Photo Sheet 2
Biocell Closure
Former Columbia Marine Lines
Vancouver, WA

- Wyser excavated approximately two feet below the liner to clear an area for placement of the treated soil and stockpiled this soil to use as a cap above the treated soil and complete the final grade of the Site. (See attached Photo Sheet 2.)

- Wyser applied a layer of Organoclay oil-adsorbent product (manufactured and sold by Cetco) throughout the floor of excavation. The 7,500 lbs of Organoclay (delivered to the site in 5 super sacks) was mixed into the top six inches of the soil at the bottom of the area in a mixture of approximately one-percent by weight of Organoclay. (See attached Photo Sheet 2.) The organoclay is an oil-adsorbent material that was placed at the bottom of the excavation to limit possible migration of TPH due to infiltration of rainwater; it is not a “liner” or impermeable material.

Excavation of unimpacted soil below HDPE liner for cap and final grade

Application of Organoclay

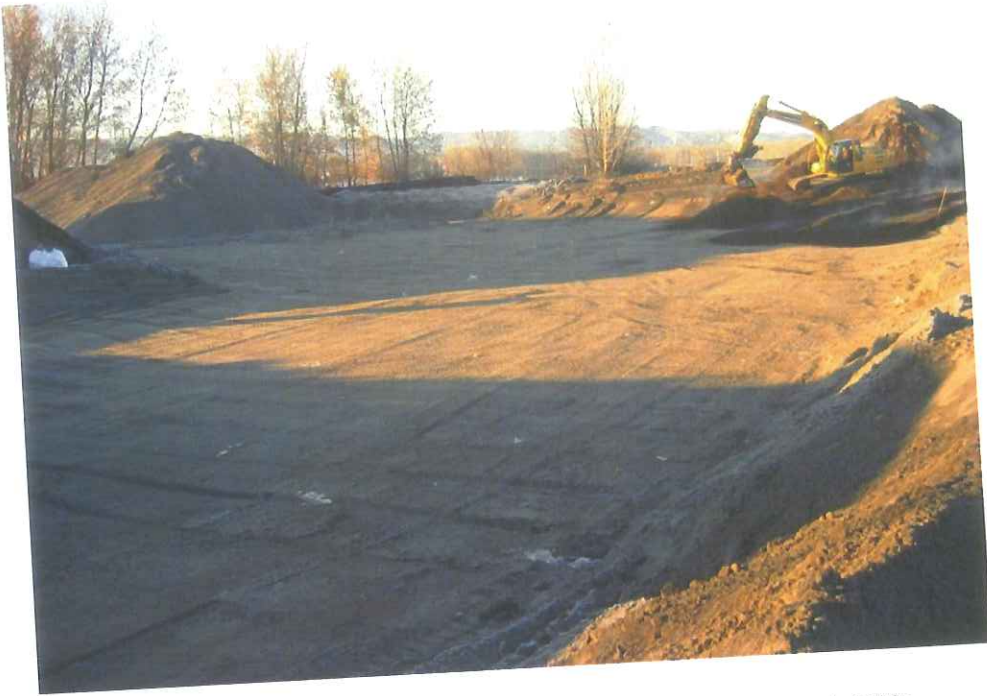
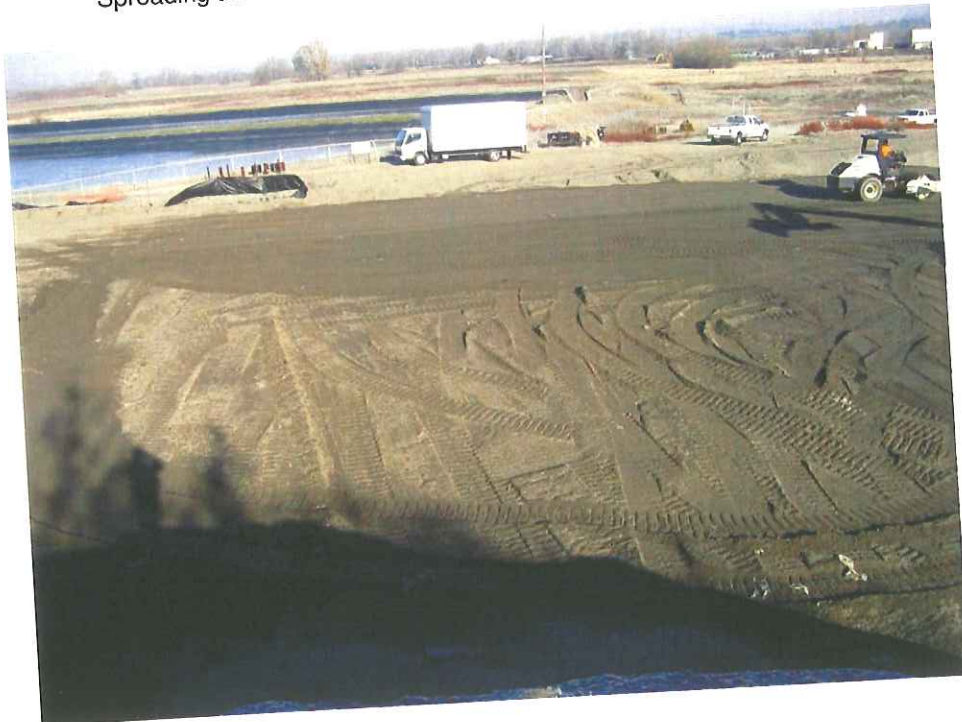
Photo Sheet 3
Biocell Closure
Former Columbia Marine Lines
Vancouver, WA

- Following application of the Organoclay layer, Wyser placed the treated soil in thicknesses up to five feet, depending on the initial and completed grade. The surface was graded so that the highest point would be in the center of the area. (See attached Photo Sheet 3.)

- Backfilled soil was compacted in two foot lifts with a requirement of 95% compaction for the top two feet and 90% compaction for other backfilled soil. (See attached Photo Sheet 3.) Compaction records have been included as Attachment 1 to this letter.

Spreading treated soil over Organoclay liner and compacting in 2' lifts

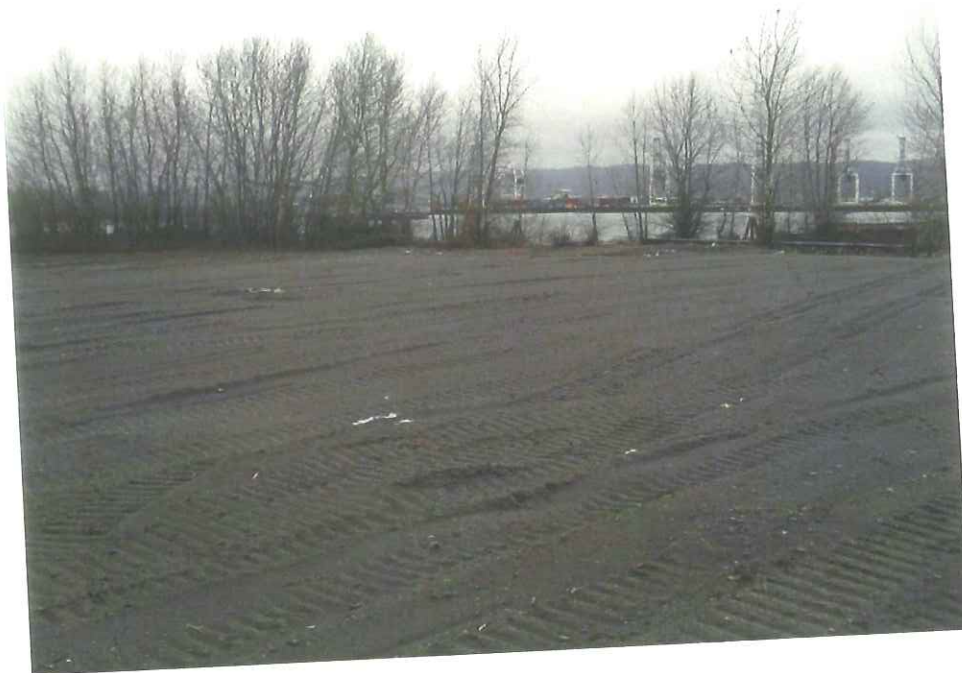
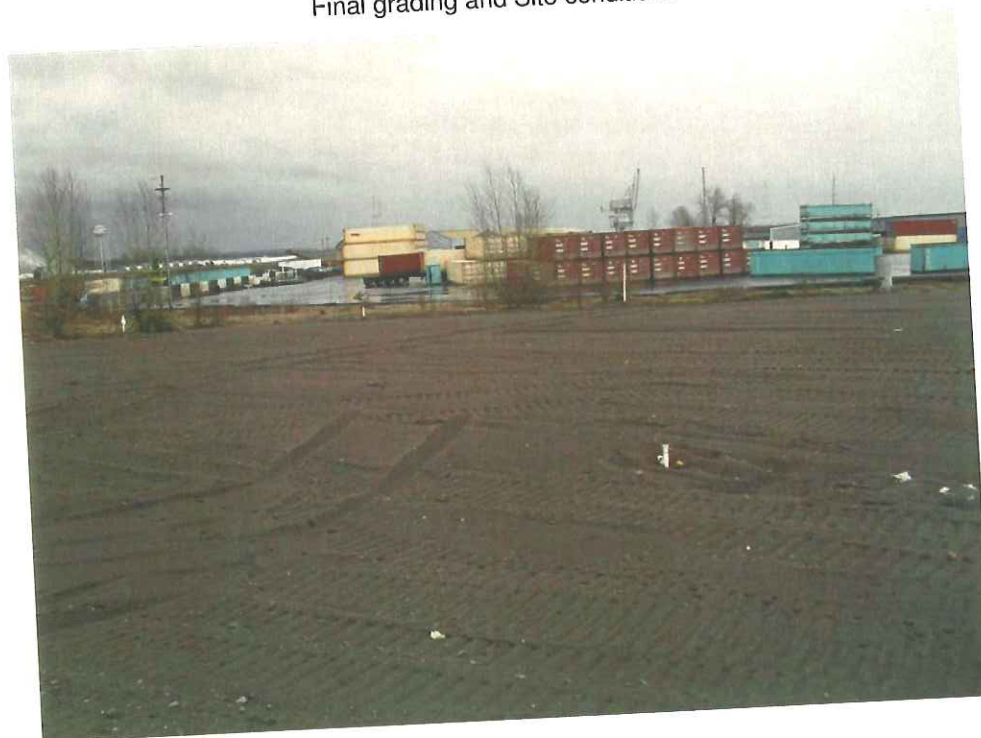
Photo Sheet 4
Biocell Closure
Former Columbia Marine Lines
Vancouver, WA

Final grading and Site conditions
