LIMITED “GOOD-FAITH” ASBESTOS SURVEY

**FOR THE
ACCESSIBLE SUSPECT ASBESTOS-CONTAINING IDENTIFIABLE
BUILDING MATERIALS ASSOCIATED WITH THE GRAY FOREST
FIRE UNCOVERED BUILDING MATERIALS DUMP SITE STOCKPILE
LOCATED ON THE FORESTED LAND WEST OF PINE LODGE
BETWEEN WEST MEDICAL LAKE ON THE EASTERN STATE
HOSPITAL CAMPUS ADDRESSED AT 850 MAPLE STREET
IN MEDICAL LAKE, WASHINGTON**

MCS Project No: 23-043.2

LIMITED ASBESTOS SURVEY; ACCESSIBLE MATERIALS; GRAY FOREST FIRE UNCOVERED; BUILDING MATERIALS DUMP SITE STOCKPILE; EASTERN STATE HOSPITAL CAMPUS; 850 MAPLE STREET; MEDICAL LAKE, WASHINGTON.

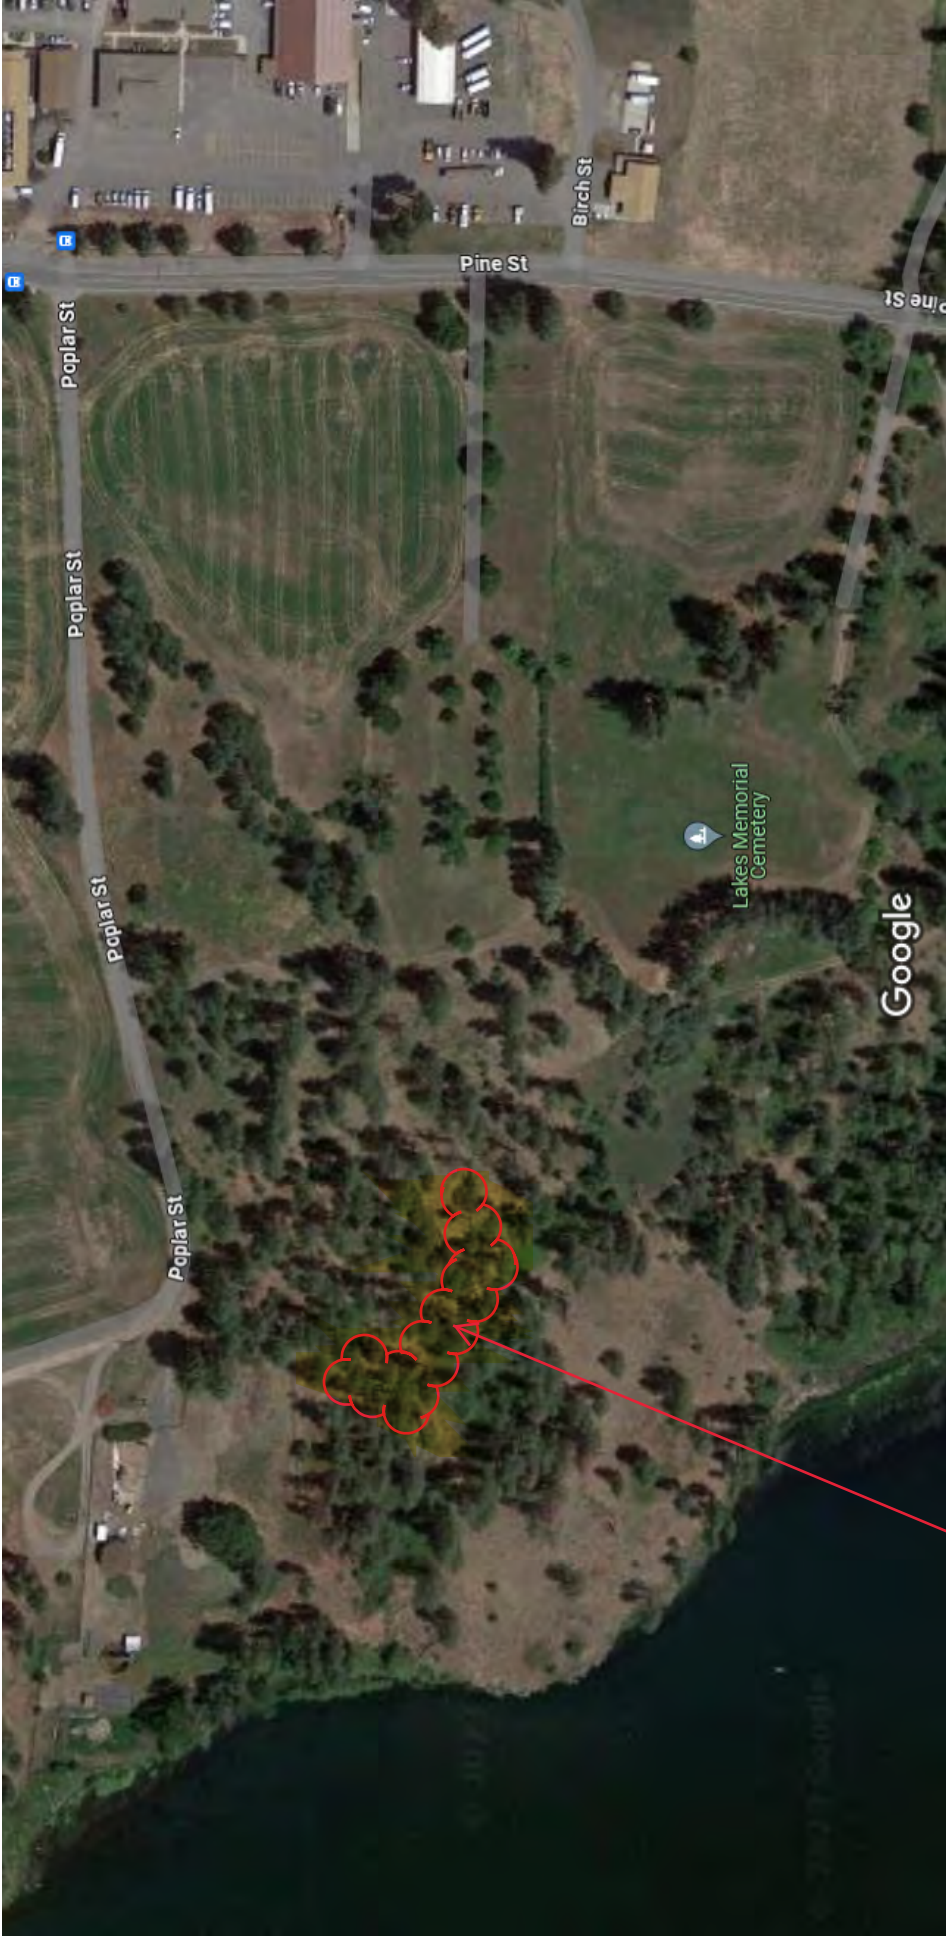
Mountain Consulting Services; Limited Asbestos Survey; Old Building Materials Dump Site Stockpile Situation; Site Location Layout Detail.

Materials Dump Site is Approx. 400' Long, by 50' Wide, by 30' Deep; Covering an Area of Approx. 20,000 SF, with approx. 600,000 cubic feet / or 2,225 cubic yards of Material Present.

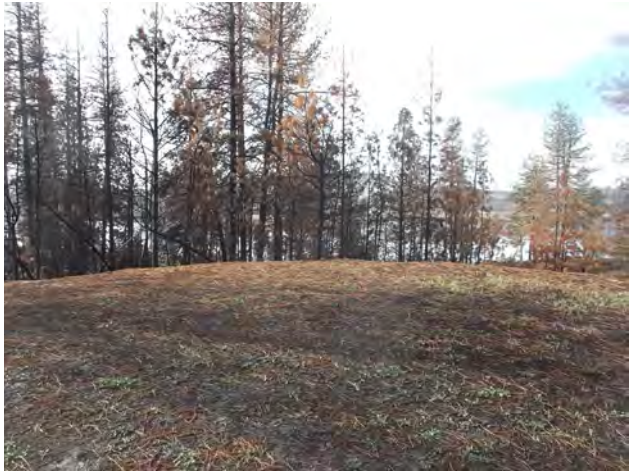
View of the Upper Flat Shelf Overlooking West Medical Lake; Where the Old Building Materials Dump Site Stockpile is Located to the South & West Sides of the Shelf.

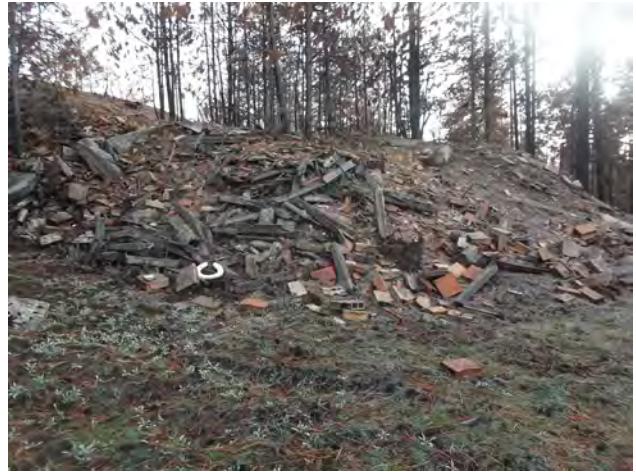
View of the Northwest End Area of the Old Building Materials Stockpile; Proven to be Contaminated with Regulated Asbestos Vermiculite Insulation.

Mountain Consulting recommends that the Regulated Asbestos-Containing Vermiculite Containing/Contaminated old building materials dump-site stockpile site, must be remediated/cleaned-up either by a certified asbestos-abatement contractor or an asbestos qualified demolition contractor under a properly prepared Asbestos - Alternate Work Method (*AWM*) remediation work plan.

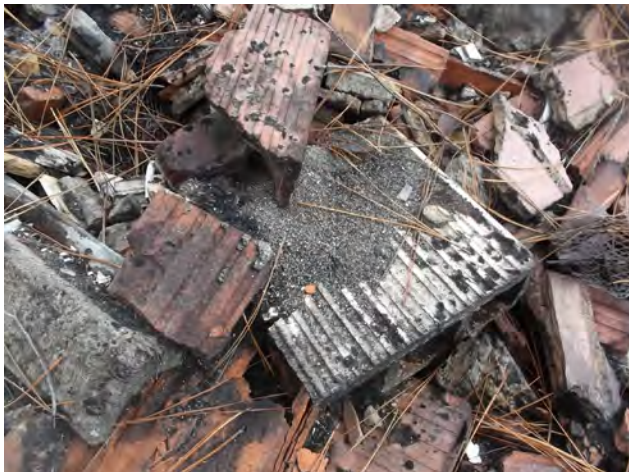
- **Vermiculite Loose-Fill Insulation** is present throughout the large old building materials dump-site stockpile located ESH Campus in Medical Lake Washington. This material is being ASSUMED Asbestos-Containing per local SRCAA Regulation, Article IX, Section 9.05(E). This material is classified as a class I, friable, Thermal Systems Insulation (TSI). This material is associated with approximately 600,000 cubic-feet of building materials waste (*or 2,225 cubic yards with a footprint of approximately 20,000 ft²*). **Represented by Bulk Samples 23-043.2-10, 11 & 12.**

The vermiculite insulation identified with the large building materials stockpile is considered to be Regulated Asbestos Material in accordance with SRCAA Regulation, Article IX, under Section 9.05 Asbestos Disturbance, Sub-section E.

Close-up View of the RACM Vermiculite Insulation Present with the Large Building Materials Debris Pile.

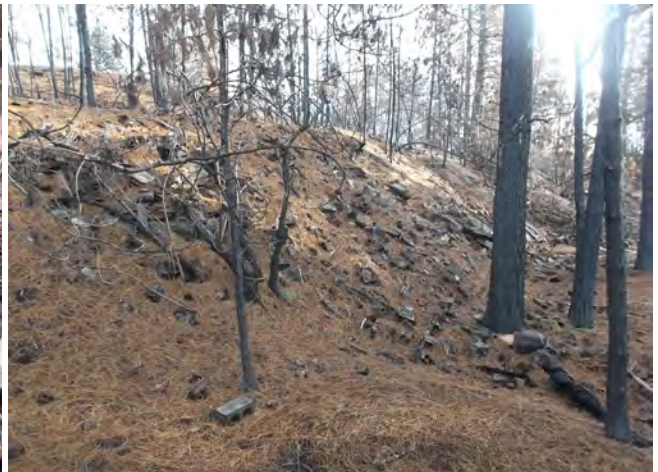
View of the Southern Side Area of the Large Building Materials Debris Stockpile Looking East.

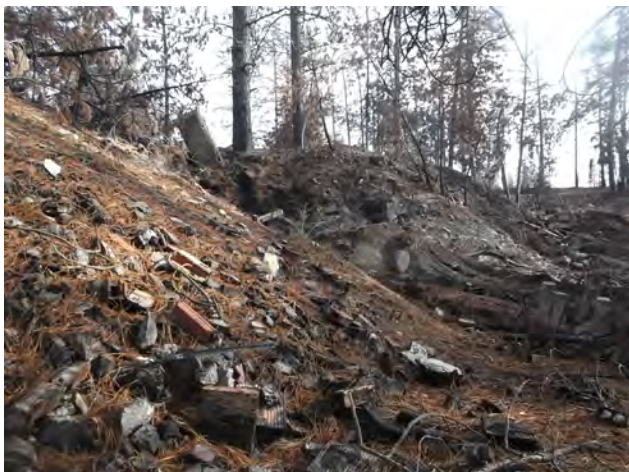
View of the Southeast End Area of the Large Building Materials Stockpile.

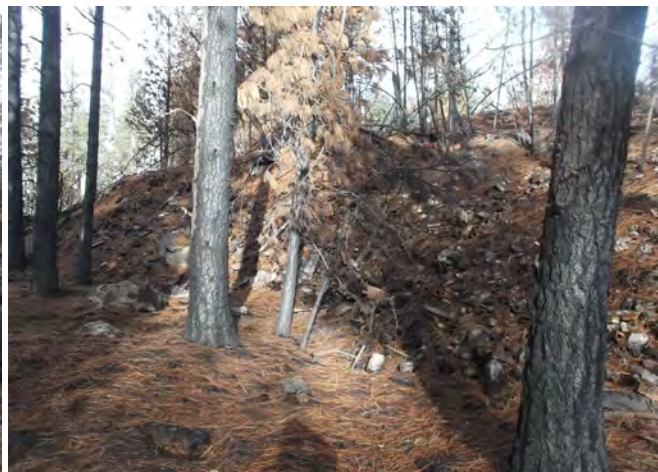
View of the South Side West End Corner Area of the Stockpile Where it Starts Wrapping to the North.

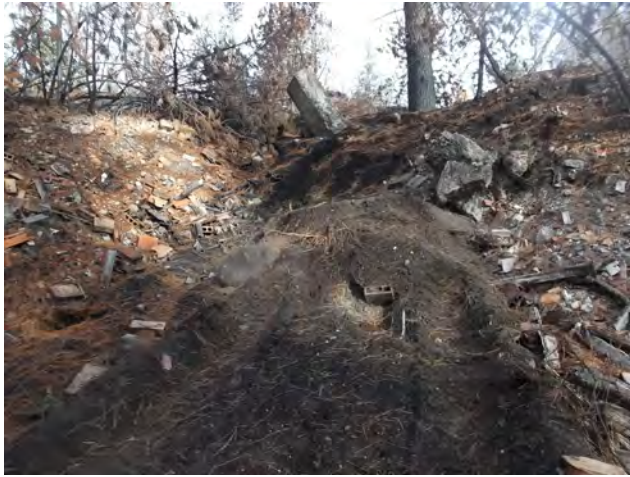
View of the Southern Side Central Area; Were the Large Deposit of Coal Waste is Present.

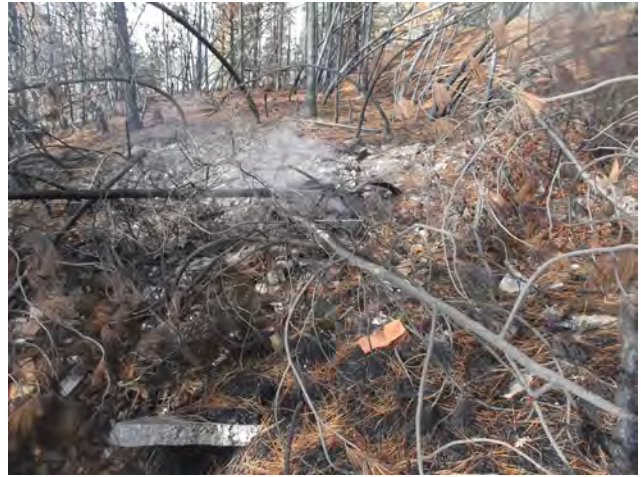
The identifiable building materials present with the debris stockpile consists mostly of concrete; plaster with expanded metal; red hollow voided wall block; ceramic tiling; and vermiculite loose-fill insulation. The approximate central area of the stockpile has a large deposit of coal waste, that is currently smoldering as a result of the Gray Forest Fire.

View of the Central Coal Top Shelf Area; Were the Coal is Still Smoldering from the Recent Past Gray Forest Fire Situation.

Mountain Consulting understands that the local fire department has been routinely dousing the smoldering coal area with water on a regular basis, until this site can be properly dealt with.

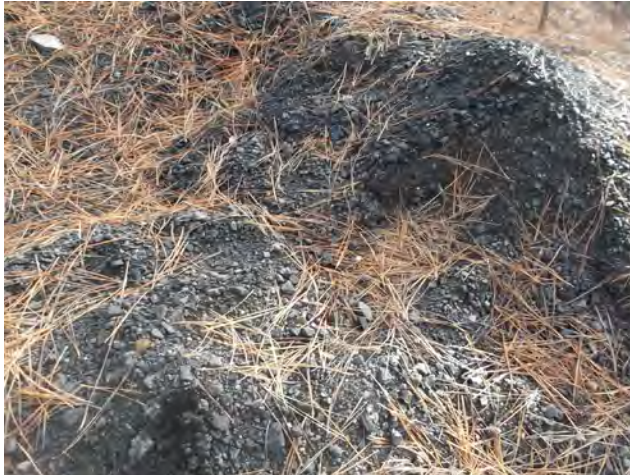
Close-up View of the Central Area Coal Waste Stockpile.

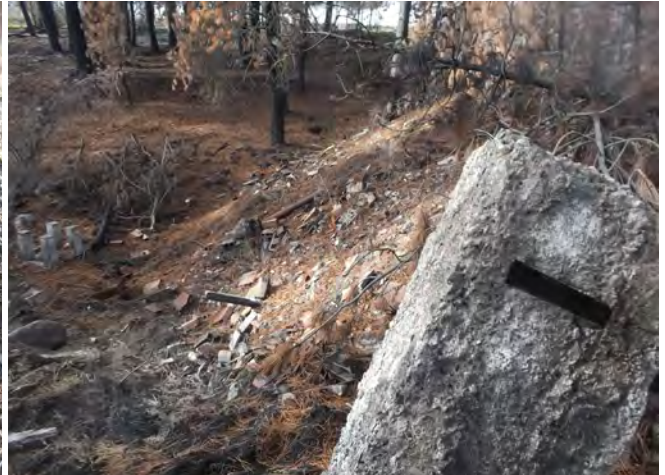
The dump site deposit is significant, rapping around and along the south and west sides of a flat shelf. The overall deposit of building materials/coal is approximately 400’ long, by approximately 50’ wide, by approximately 30’ in depth, with an estimated quantity of 600,000 cubic feet of material (*or approximately 22,225 cubic yards*).

Typical Side View of a Stockpile; Giving a Representation to the Depth of the Debris.
