GIG HARBOR SPORTSMAN'S CLUB

CITY OF GIG HARBOR, WASHINGTON

NET ENVIRONMENTAL BENEFIT ANALYSIS (NEBA)

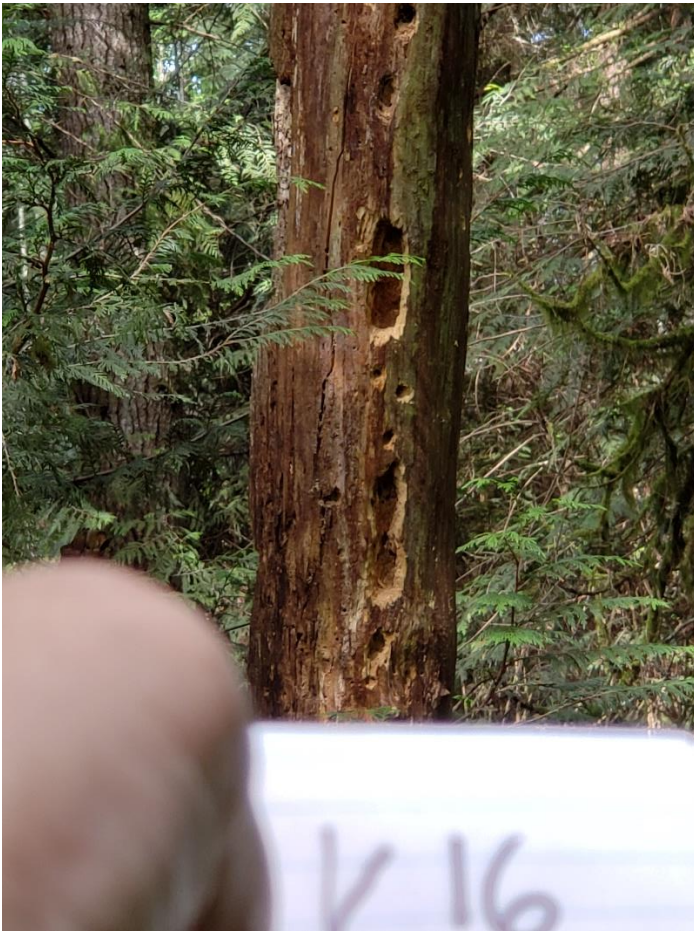
Photo 11. Pileated woodpecker feeding station at Sample V16

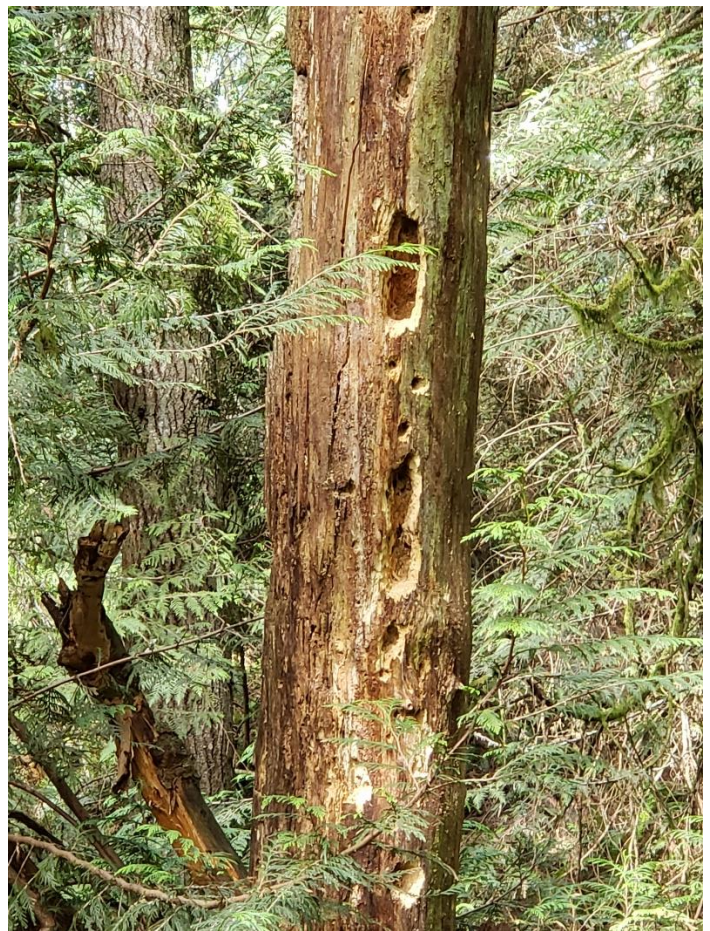
Photo 12. Pileated woodpecker feeding station at Sample V16

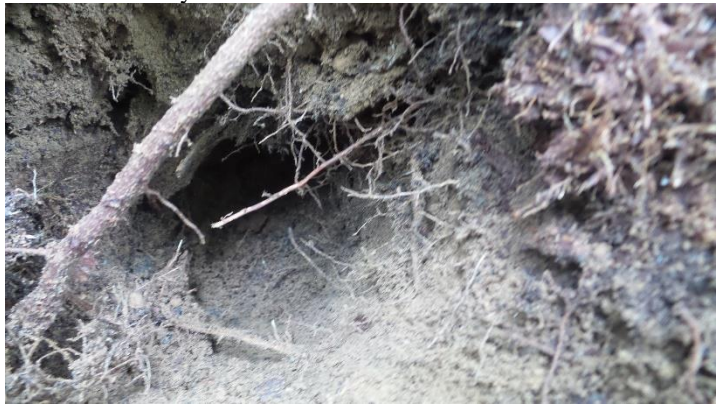
Photo 54. Healthy root structure located at TA-2

Root mass depths and soil biota numbers in Area D were comparable between samples in areas of contamination and paired locations. No obvious color change was observed in roots in areas of high contamination and soil biota was present and appeared healthy.

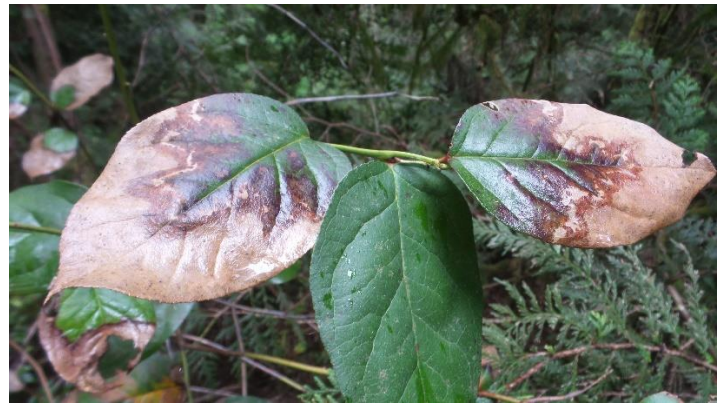
Photo 58. Some dried out salal leaves at Camera 1

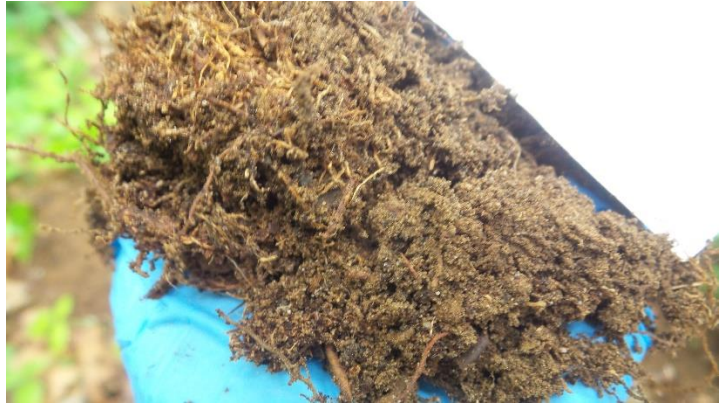
Photo 60. Healthy root structure at TP-2

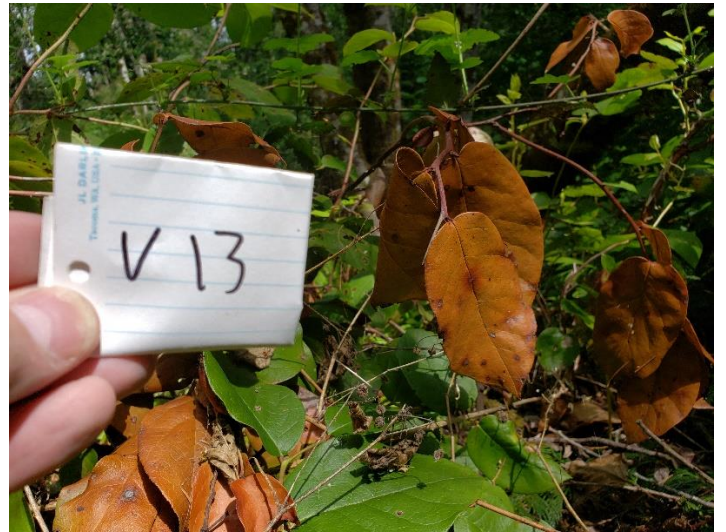
Photo 64. Some dried out salal leaves at V13

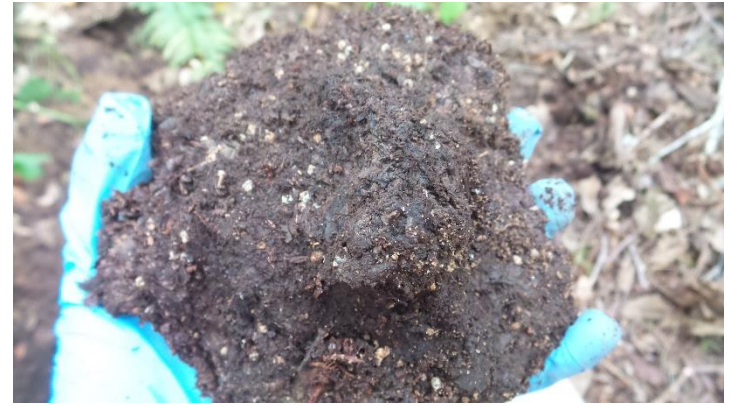
Photo 72. Lead shot present in soils at Camera 3
