***Final  
Conservation Measures and  
Monitoring Plan  
Custom Plywood  
Interim Action Phase II  
Anacortes, Washington***

***Prepared for  
Washington State  
Department of Ecology  
Toxics Cleanup Program***

***August 15, 2012  
17800-27***

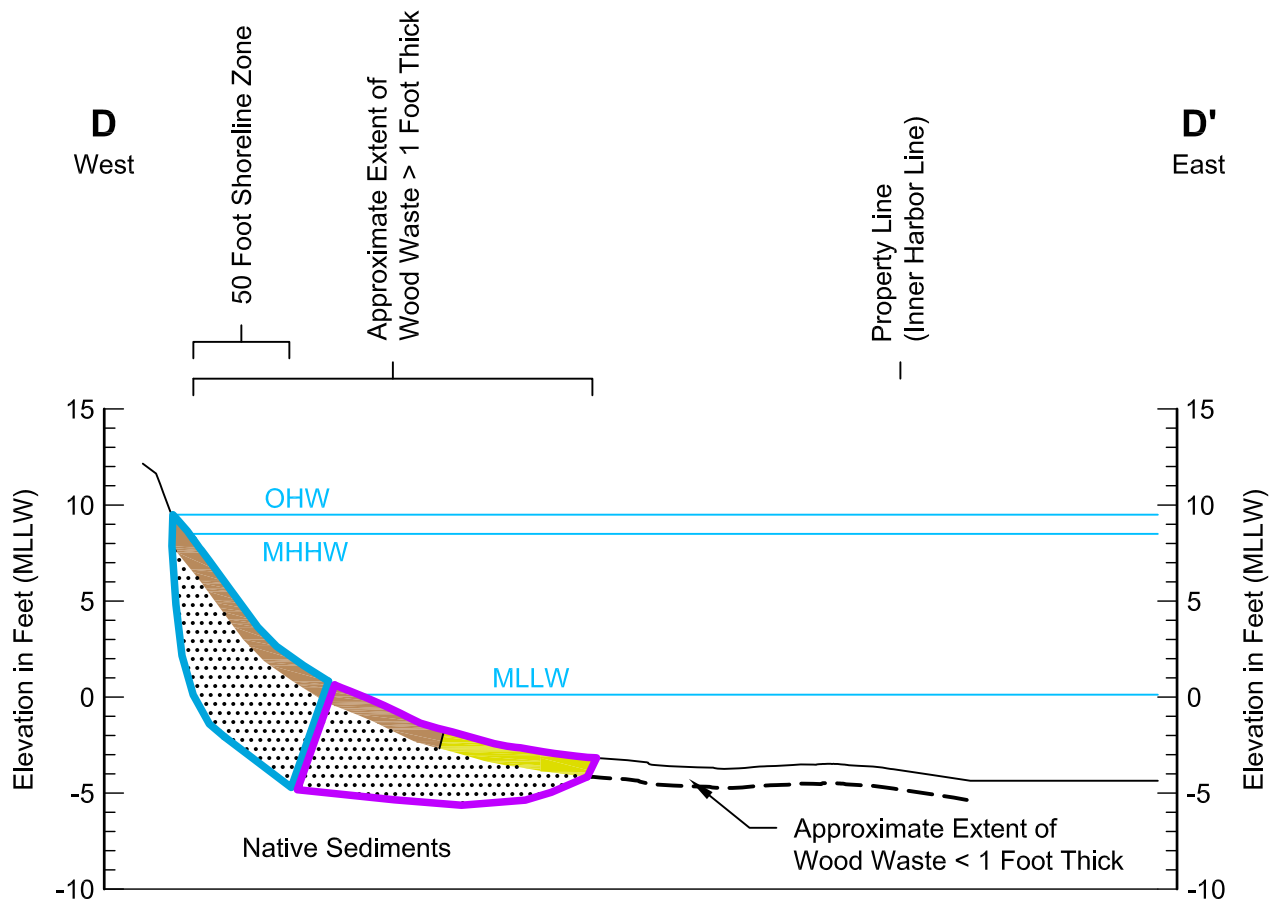
**8**

Excavate wood waste up to 6 feet below surface grade where dioxin and wood waste are present

Gravelly Sand Over Quarry Spalls\*

**Beach restoration and recontouring** – Excavation of the beach and upper intertidal areas with dioxin/furan concentrations between 10 and 25 parts per trillion (ppt) within the 50-foot shoreline cleanup zone will remove contaminated sediment and wood waste from the aquatic environment, reducing negative impacts to human health and the environment (Figures 2, 3, 4 and 8). This area
