2014 (Year 1) Monitoring Report
**Custom Plywood Interim
Remedial Action
Conservation Measures and
Monitoring
Anacortes, WA**

Prepared for
**Washington State Department of
Ecology**

June 2, 2015
17800-51

Prepared by
Hart Crowser, Inc.

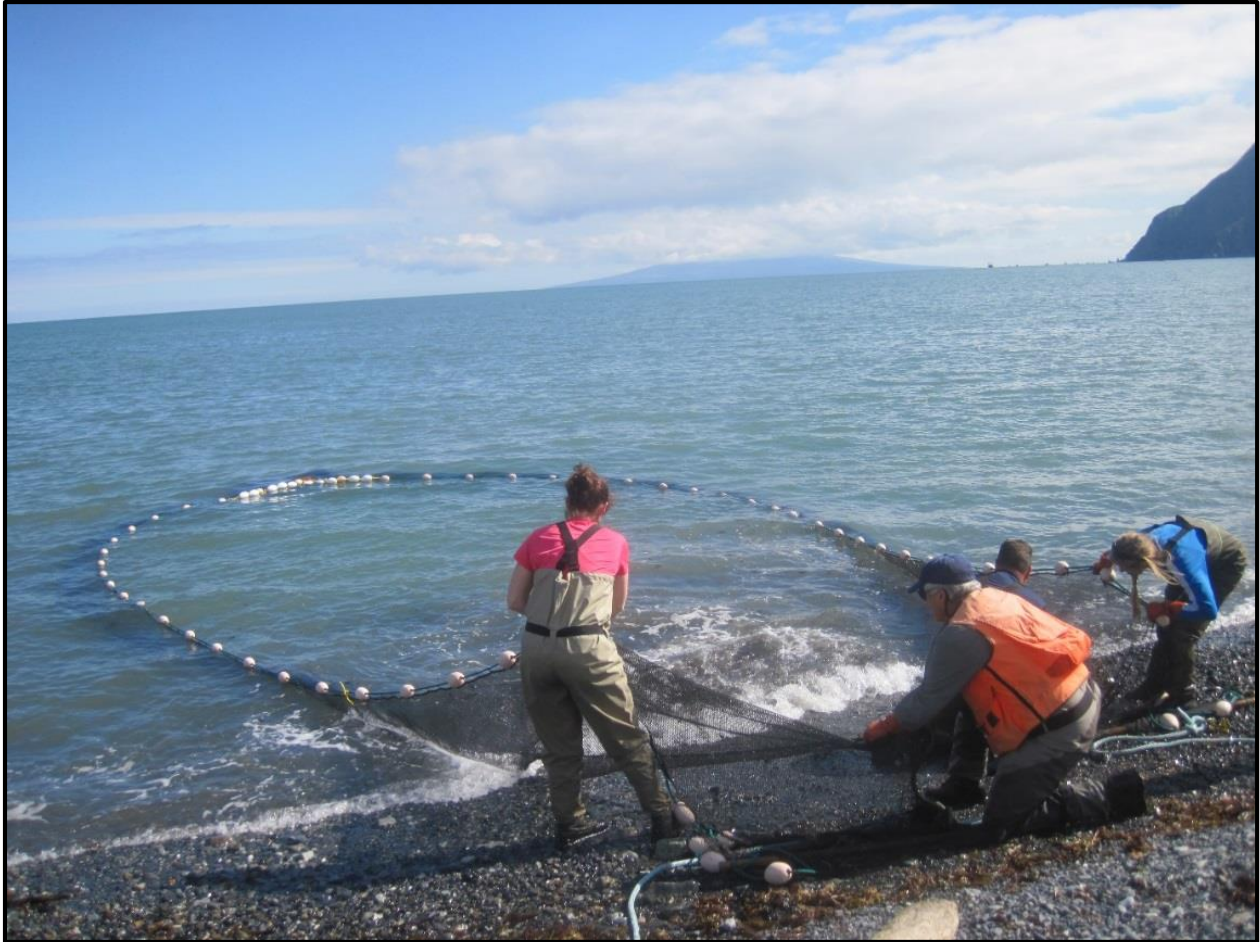
To determine use of the nearshore study area by juvenile salmonids and resident marine species, field teams collected nearshore fish samples using a standard 120-foot floating beach seine. The seine measured 120 feet in length, 10 feet deep at the bag, and 3 feet deep at the end of the wings. The wings were 60 feet in length with 0.375-inch bar mesh. The bag was 0.125-inch (bar) woven nylon mesh and measured 10 feet deep by 7.5 feet long. This net design was developed to capture smaller, surface-oriented fish, especially juvenile salmonids, in shoreline areas.

Photograph 1 – Field team collecting nearshore fish samples using a standard 120-foot floating beach seine

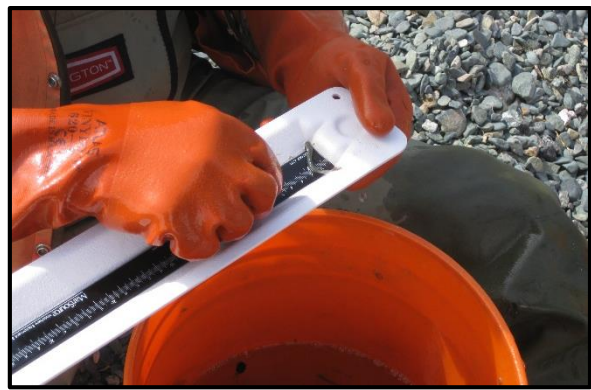
Upon retrieval of the seine, fish and invertebrates were removed from the net and placed in a bucket of ambient water. Lengths of most fish were measured and recorded in the field; however, when large numbers of the same species were captured, a representative subsample (at least 20 fish) was measured. Fork lengths were measured on species with homocercal (notched) caudal fins (tails), and total length was taken for all other species (Photograph 2). Fish from the first set were released back into the bay away from where the second set was going to occur. Selected fish and all invertebrates from both sets at a given site were retained in a single container and preserved in 10 percent formalin for laboratory identification and enumeration.

Photograph 2 – Field personnel measuring fish length.

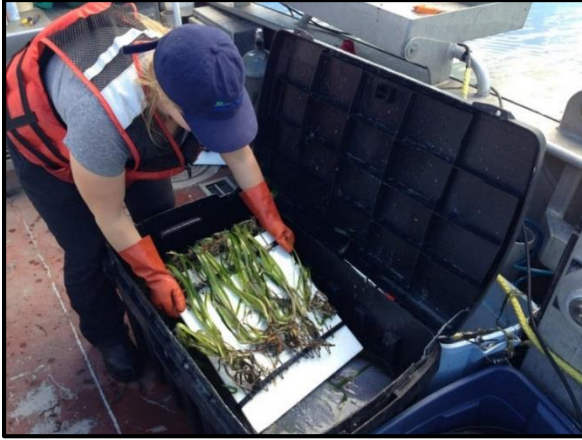
Harvested shoots and associated rhizomes were be bundled into groups of three shoots and loosely tied with biodegradable twine. Blades were be clipped to a uniform length of about 9 inches. A U-shaped, ungalvanized wire, about 6 inches long, was slipped inside the twine to serve as an anchor. Each 3-shoot bundle was considered to be a single planting unit (PU). All plant processing was conducted with minimal exposure time, and plants were stored in a seawater bath while awaiting processing (Photograph 3).

Photograph 3 – Bundled planting units (PUs) placed in seawater bath

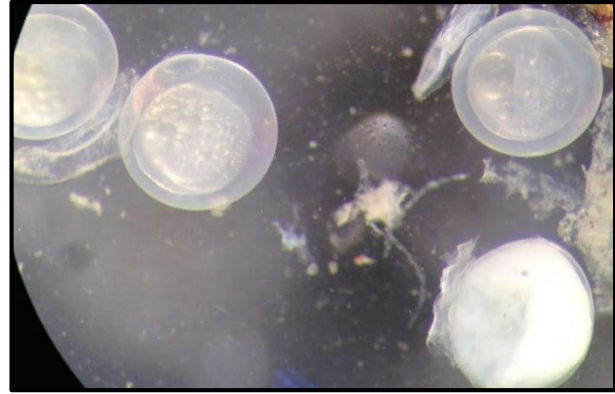
Photograph 5 – Eggs at 1 to 2 days of development, with gastrula, advanced embryo, or early larval development around the yolk. There is one non-viable egg. Site 2, July 21, 2014.

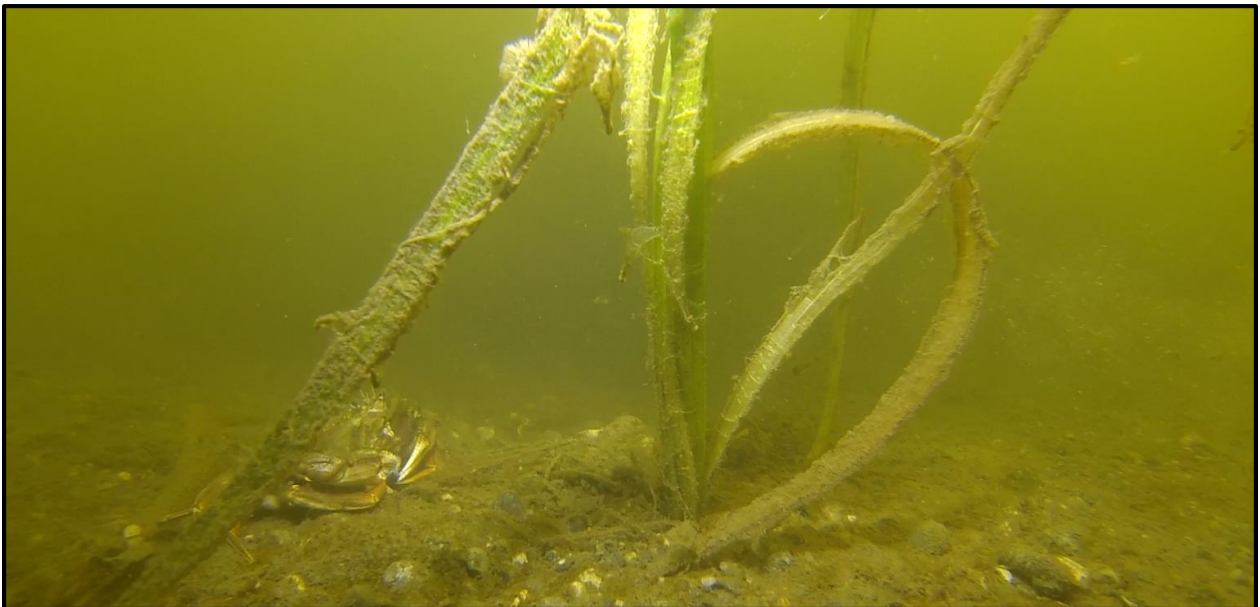
One month post transplanting, the transplant area was revisited in early August. Divers reported that the transplants appeared well established and that there was no loss of eelgrass. This was verified from footage taken by the diver and reviewed by a Hart Crowser eelgrass biologist. The diver noted epiphyte growth on the blades and several Dungeness crabs (*Metacarcinus magister*) using the newly established habitat.

Photograph 7 – Dungeness crab within the newly established eelgrass habitat

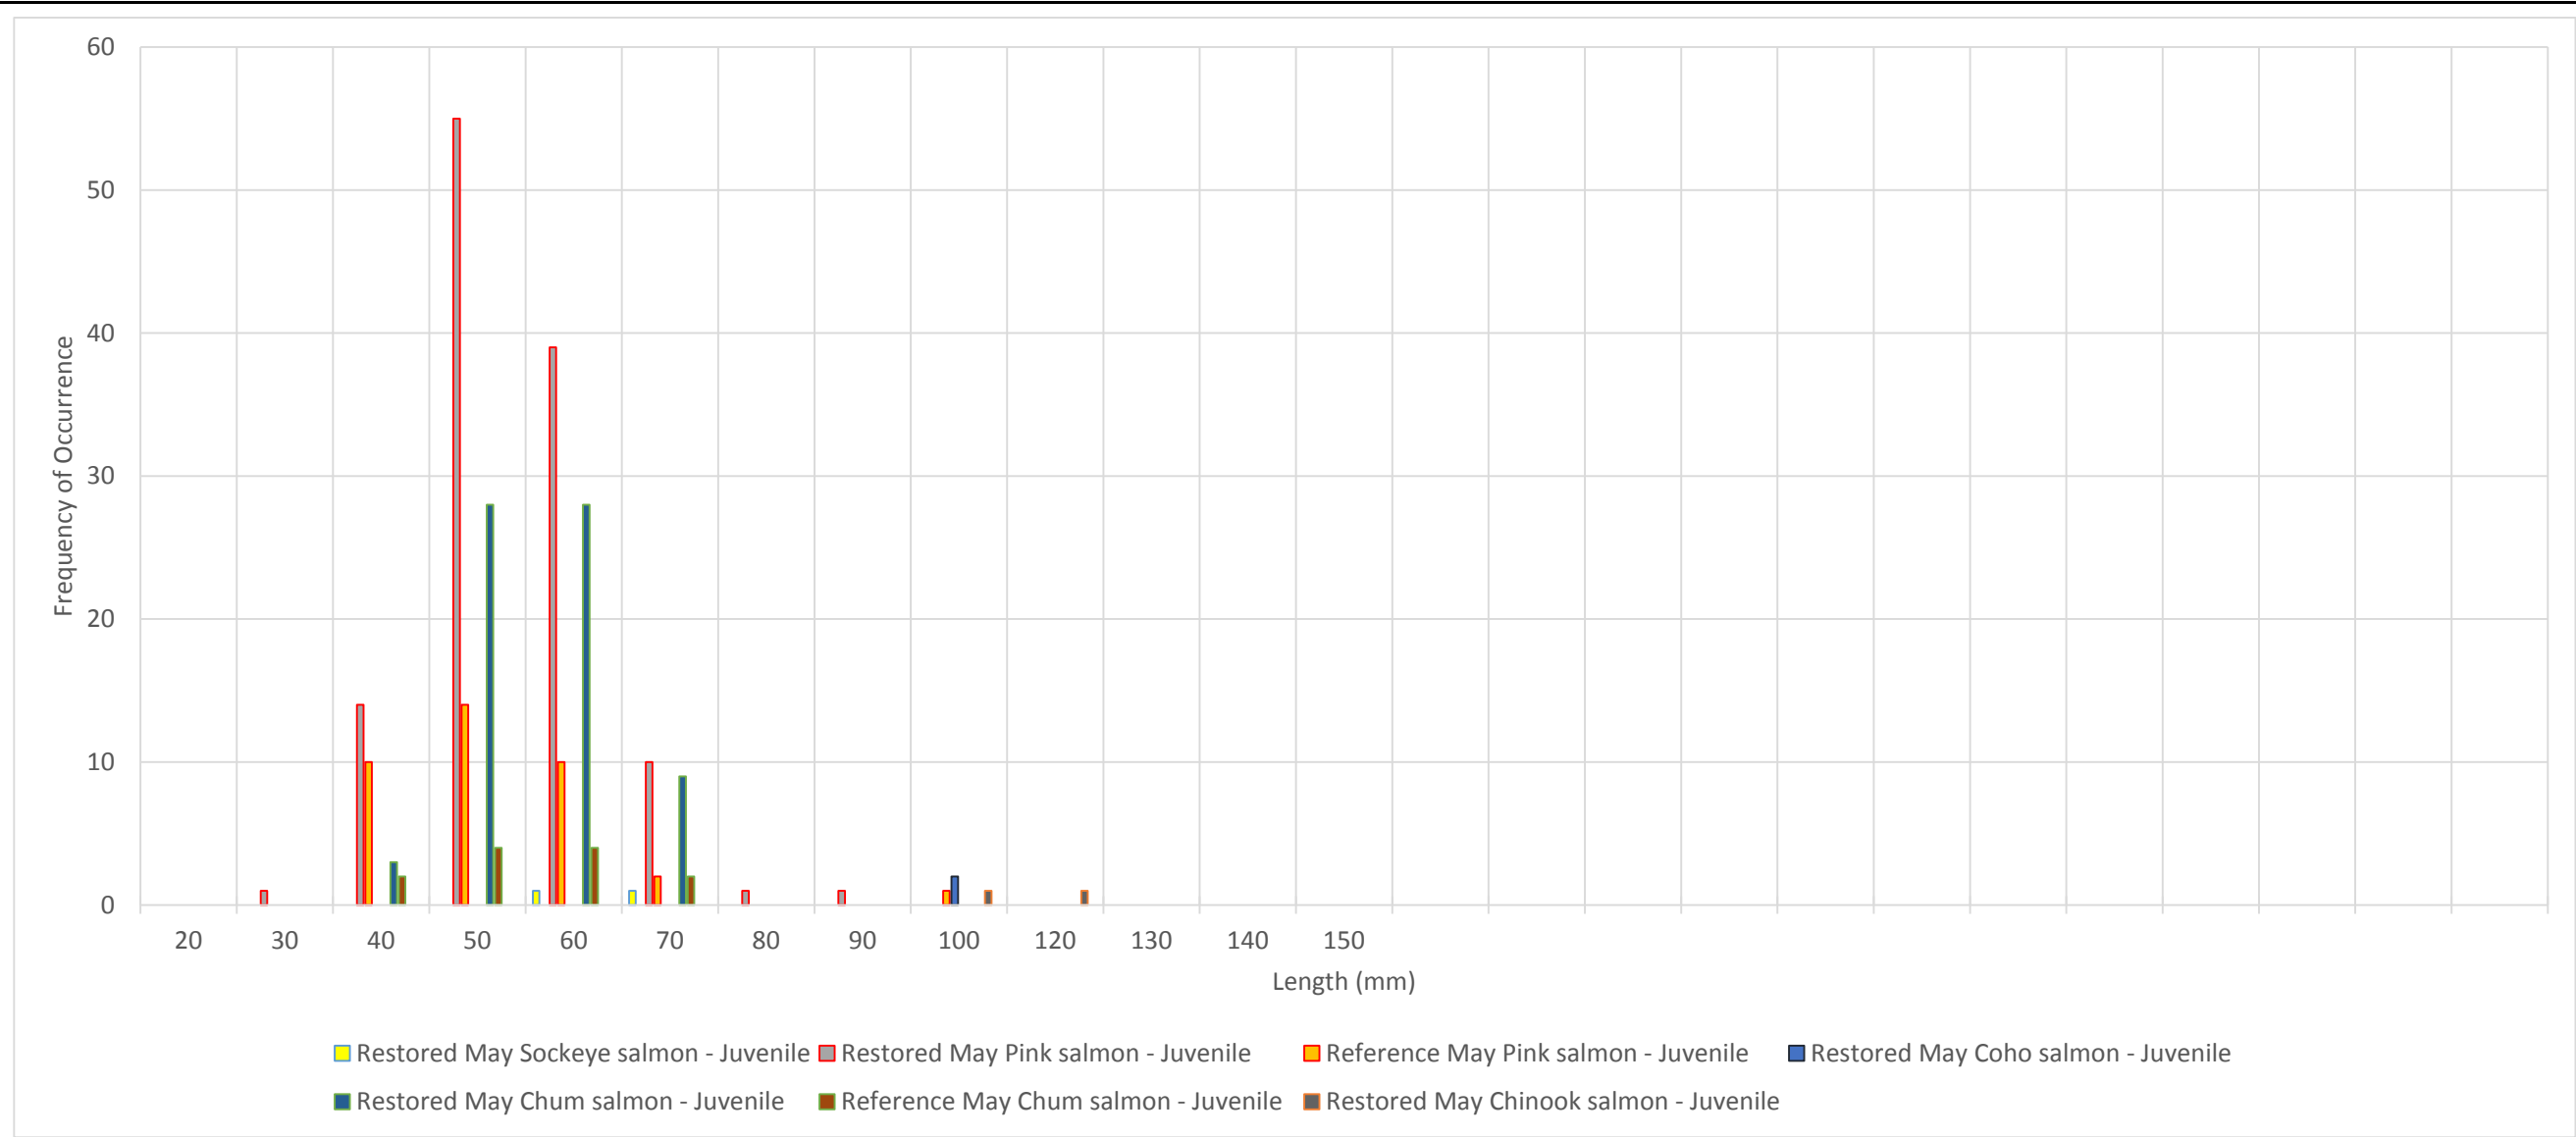
No recognizable differences in juvenile salmon size and age class patterns were observed between reference and restored beach sites (Figures 7 and 8). Length frequency data for pinks and chum in May show typical clusters of young-of-the-year fish, most between 40 and 60 mm (Figures 7 and 8). Young of the year sockeye in the 60- to 70-mm range were also observed in May, though in extremely low abundance ($n = 2$; Figure 7). In June, the abundance of pink salmon was substantially lower, though the two fish that did occur were in the 60- to 80-mm range (Figure 8). Chum and sockeye salmon did not occur in the study area at all in June (Figure 8). In contrast, juvenile coho were found mostly in June, though in low abundance, and only on the restored beach (Figure 8). Those coho caught appeared to be an age 1+ year cohort between 70 and 100 mm, typical of the larger and older juvenile coho outmigrants found in the Puget Sound nearshore. Juvenile Chinook were also found mostly in June, in low abundance, and only at restored sites (Figure 8). Of those caught, most were between 70 and 90 mm, and were likely young-of-the-year ocean-type migrants. After emergence from redds, these ocean-type migrants typically spend 90 days or less in freshwater before outmigrating to the marine nearshore. Three older specimens between 100 and 140 mm were also captured in May and June (Figures 7 and 8). These three were likely yearling stream-type migrants, which spend at least a year after emergence rearing in freshwater before migrating to the ocean, generally in the spring. Two of these yearling Chinook were unclipped, suggesting they were of wild origin.

Custom Plywood Anacortes, Washington	
Size distribution of juvenile salmon species (Oncorhynchus spp.) at restored and reference sites, May 2014	
17800-51	02/15
	Figure 7

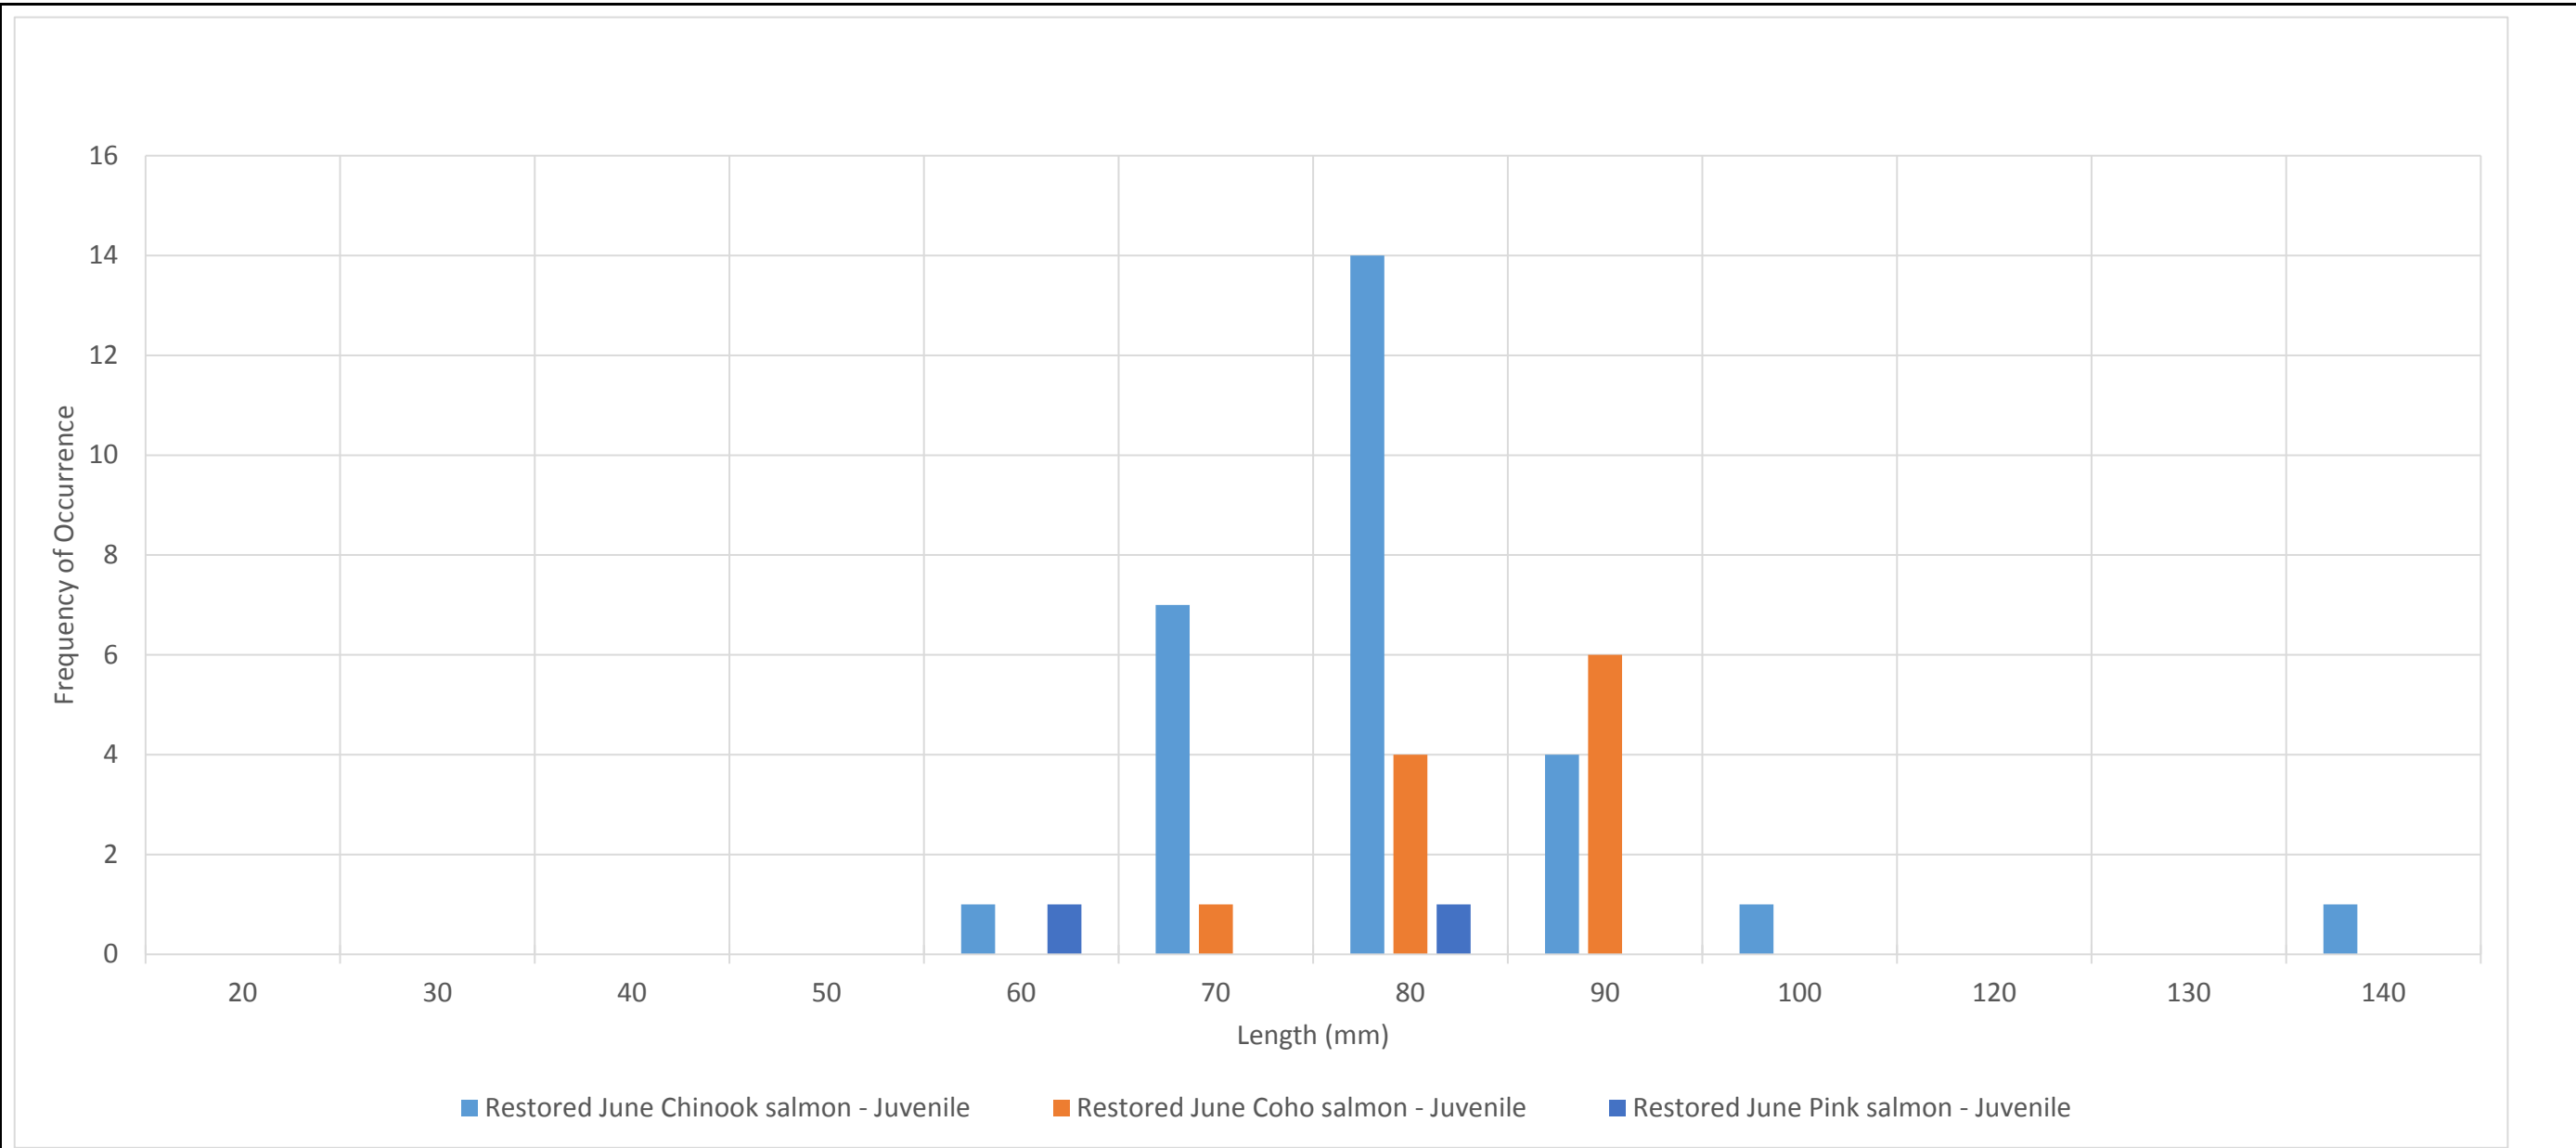
Figure 8

Custom Plywood Anacortes, Washington	
Size distribution of juvenile salmon species (Oncorhynchus spp.) at restored sites, June 2014	
17800-51	02/15
