2022 DICKMAN MILL SEDIMENT INVESTIGATION TACOMA, WASHINGTON

DRAFT REPORT

Washington State Department of Natural Resources
Aquatic Resources Division
Olympia, Washington 98504

**NewFields**

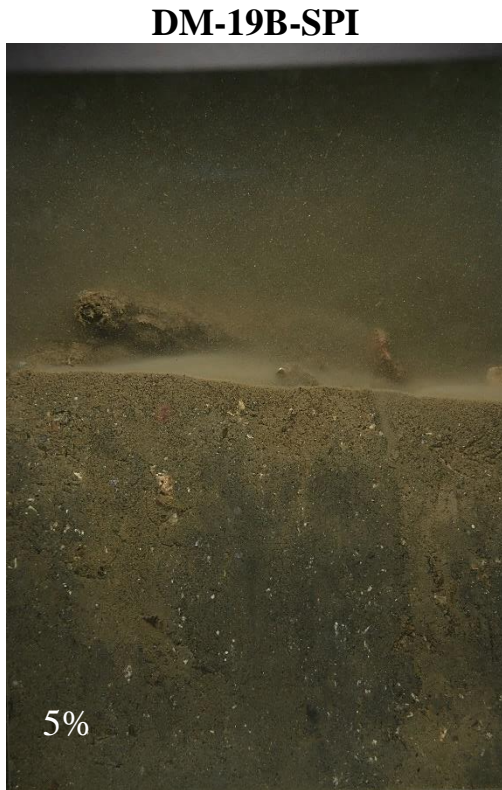
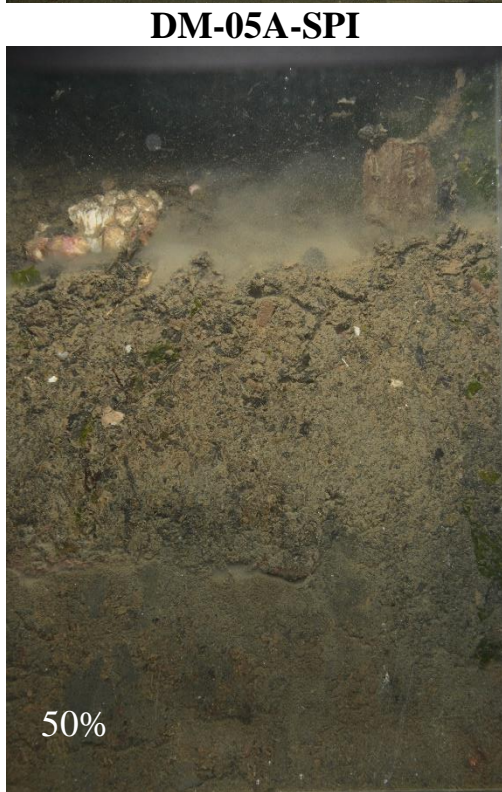
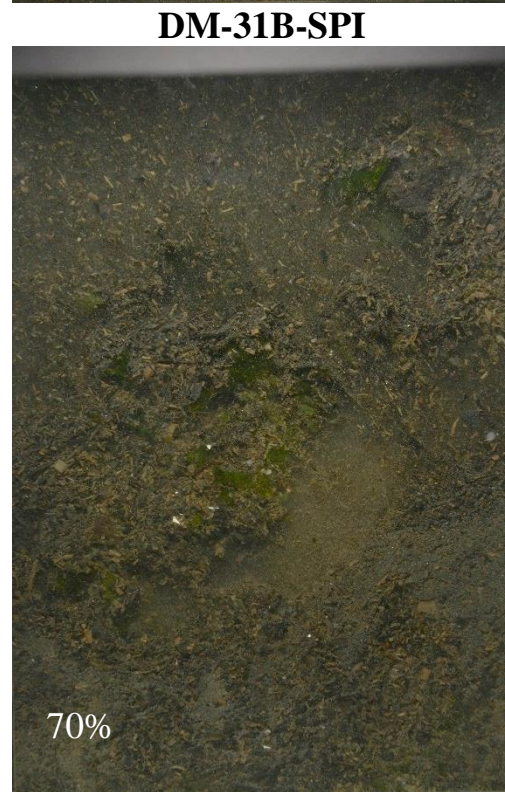
Figure 8. Dickman Mill SPI Images Showing Examples of Percent Wood Debris

Wood debris determined from SPI images at the Dickman Mill site consisted of very fine wood particles to larger wood pieces. The mean surface wood debris coverage at the Dickman Mill site is shown in Figure 7. Wood debris was observed at 67 percent of the SPI stations surveyed (22 of 33 stations) and ranged from trace amounts of small wood particles at several stations to a maximum of approximately 50 percent of fine wood particles on average at Station DM-31, within the Eastern Pile Field (Figure 8). The highest concentrations of wood debris (>20 percent by area in the SPI images) were observed at six stations, which included three stations in the Eastern Pile Field (DM-05, DM-07, and DM-31), one station in the Dense Pile Field (DM-39), one stations in the Outside Pile Area (DM-28), and one station in the Up/Down Current area (DM-27) (Figure 8).

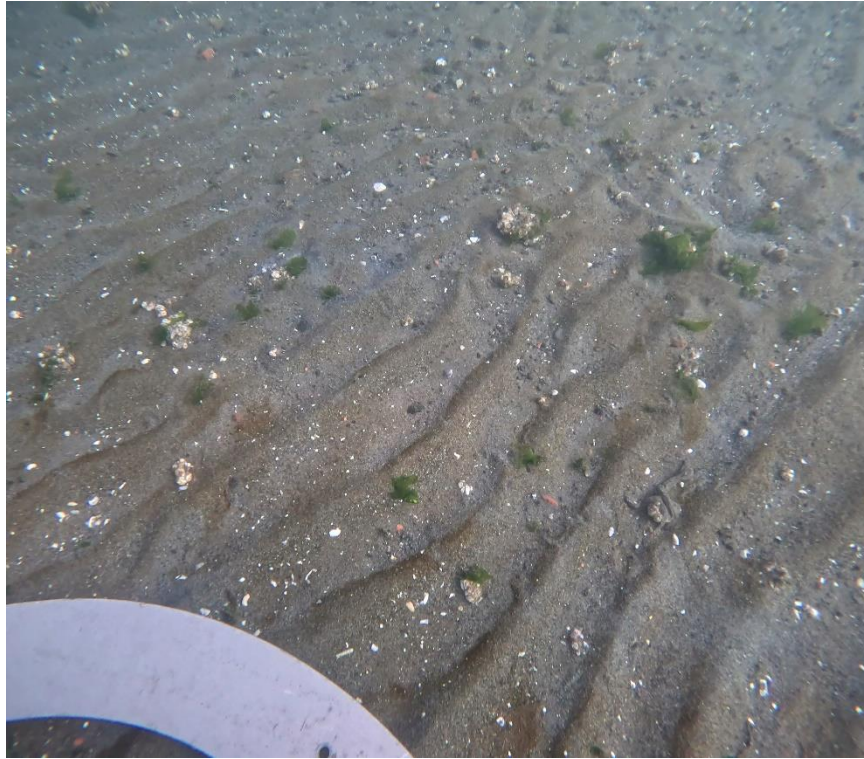
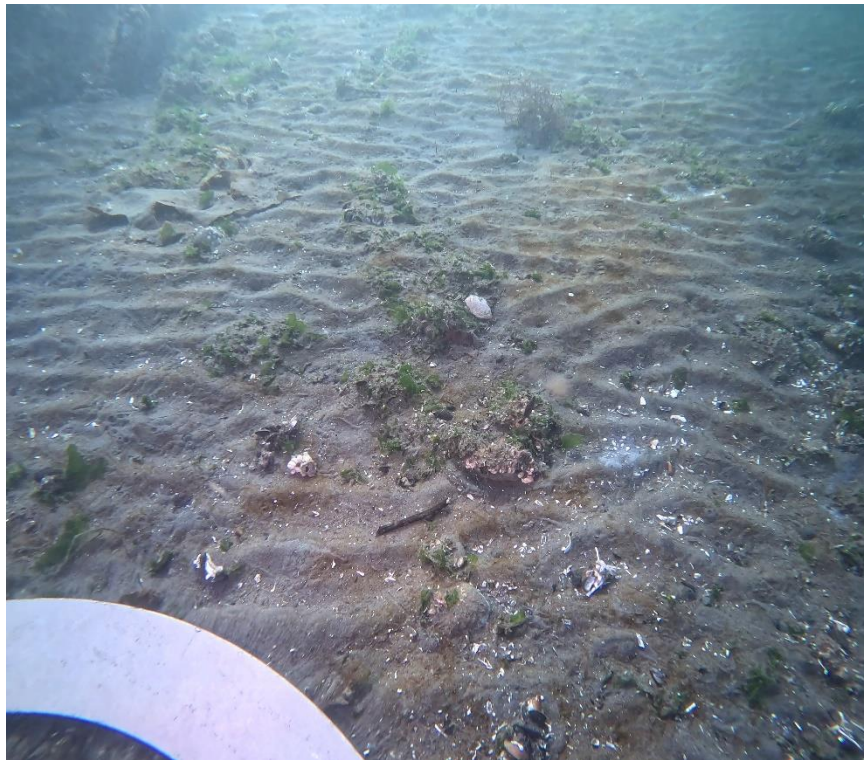
Figure 13. Dickman Mill PV Images in the Nearshore Showing Surface Ripples

Sedimentary features such as surface ripples are not always apparent in SPI imaging but can be captured in PV images. At the Dickman Mill site, surface ripples, which provide an indication of localized sediment bedload transport, were observed in the nearshore areas generally shoreward of the State Lands/Metro Parks property line. PV imaging showed evidence of surface ripples at 12 stations, with well-developed ripples observed at nine of the nearshore stations (DM-01, DM-02, DM-06, DM-13, DM-16, DM-18, DM-20, DM-22, and DM-32) (see Figure 13).

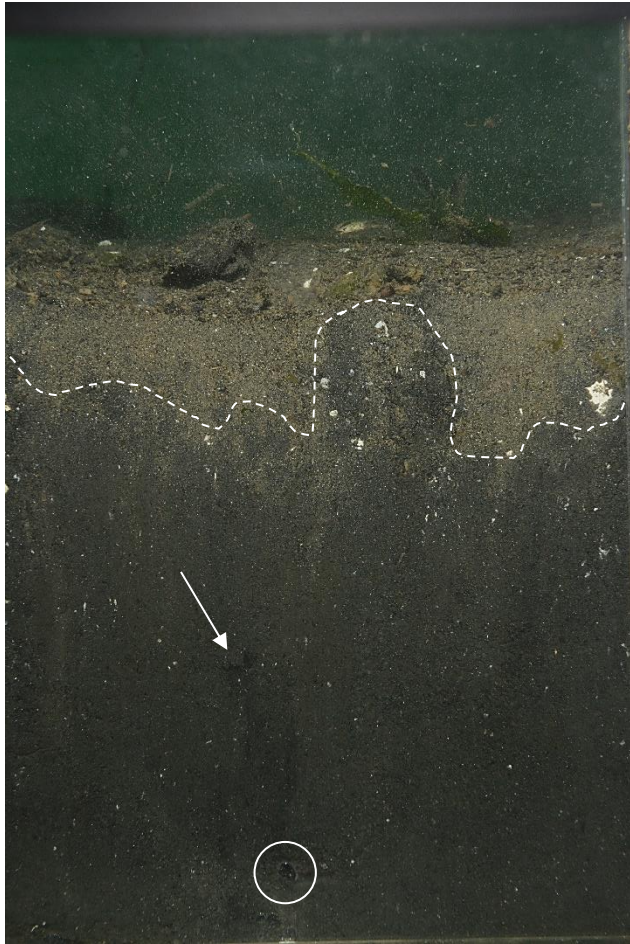
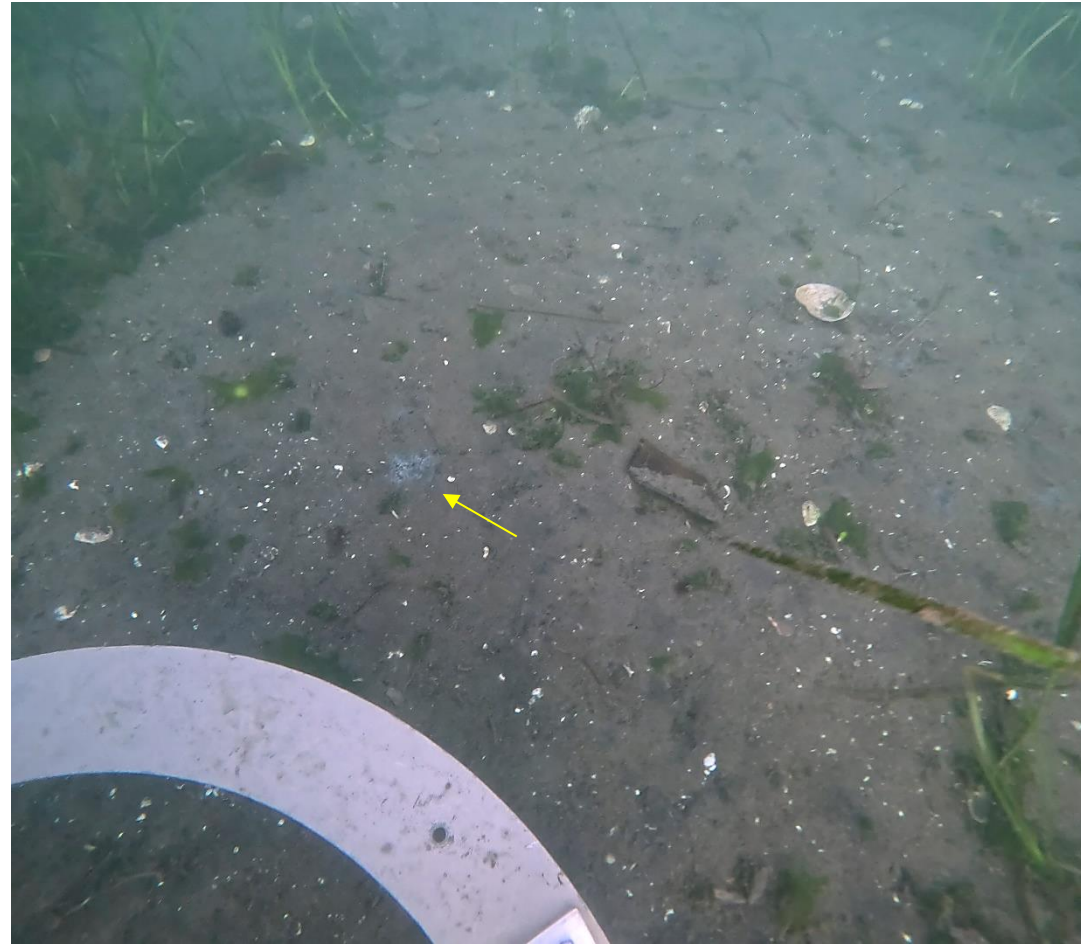
Figure 16. SPI and PV Images from Station DM-08 within the Eastern Pile Area

Sedimentary methane was not observed in Dickman Mill sediments with the exception of one SPI replicate image collected at Station DM-08 (Figure 16). The methane was observed as a gas-filled void within the sediment column, and the methane had a glassy appearance due to reflection from the camera strobe. Benthic habitat quality at DM-08 did not appear to be impacted by the presence of methane (i.e., apparent RPD depths were well developed and feeding voids were visible, indicating the presence of head-down deposit feeding organisms). This suggested that the organic loading from wood debris and other natural sources to Dickman Mill sediments, combined with existing hydrodynamic conditions at the site (currents, waves, and water exchange) does not result in degraded benthic habitat conditions.

Station DM-08, SPI replicate A, showed the only evidence of methane observed in Dickman Mill sediments. A feeding void (white arrow) was present indicating Stage III infaunal succession. The apparent RPD depth was relatively well developed and measured at approximately 2 cm (dashed white line). The PV image showed a small patch of *Beggiatoa* (yellow arrow) with algae, eelgrass, and shell particles present on the sediment surface. SPI image width is 14.6 cm.

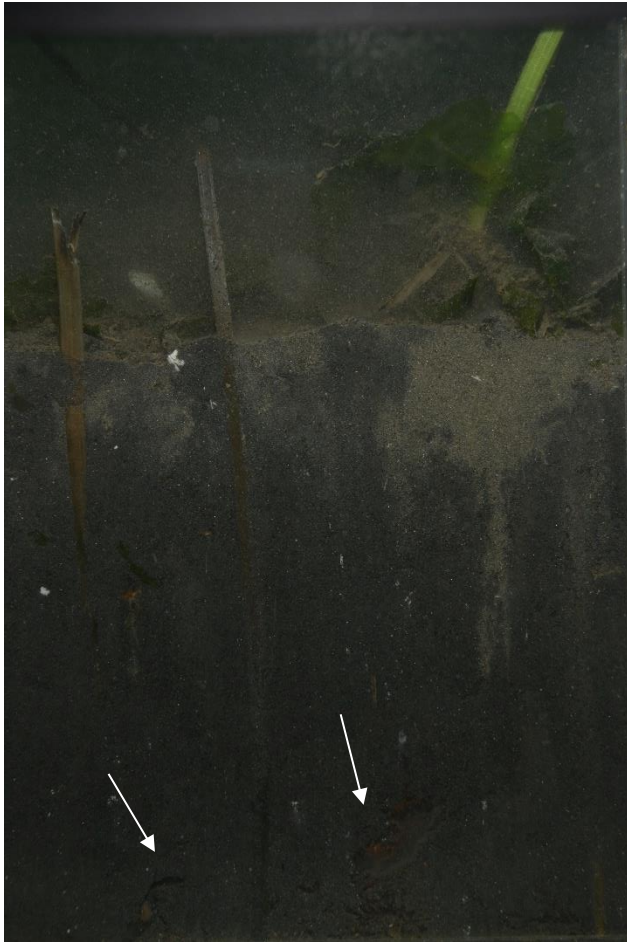
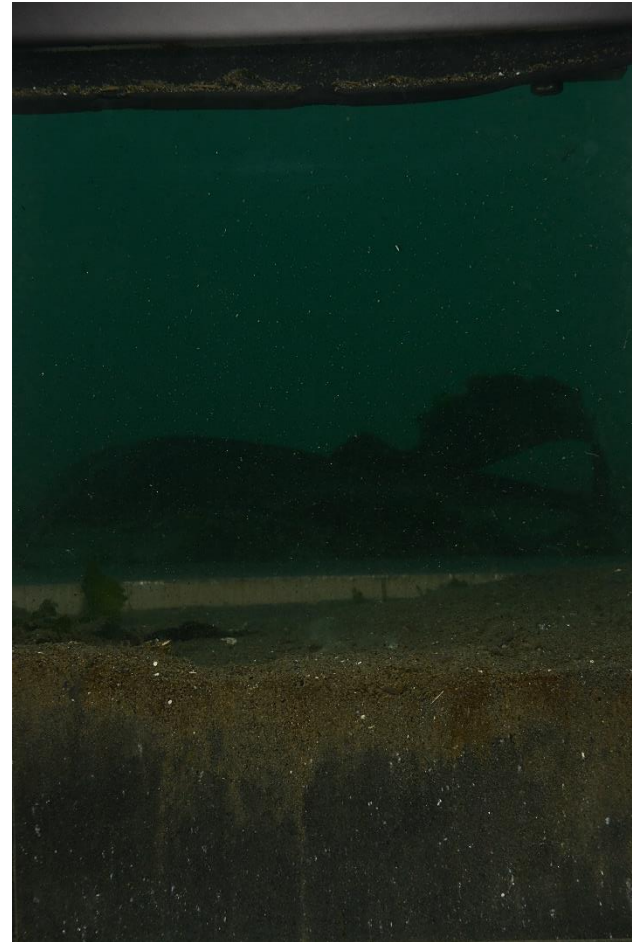
Figure 17. SPI Images from Stations DM-10 and DM-25 Showing High Apparent RPD Contrast

SPI images from stations DM-10 and DM-25 showed higher apparent RPD contrast but the presence of wood debris was not apparent. The high contrast was likely typical for this sandy substrate and location type. Eelgrass and feeding voids (white arrows) were visible at DM-10. SPI image width is 14.6 cm.

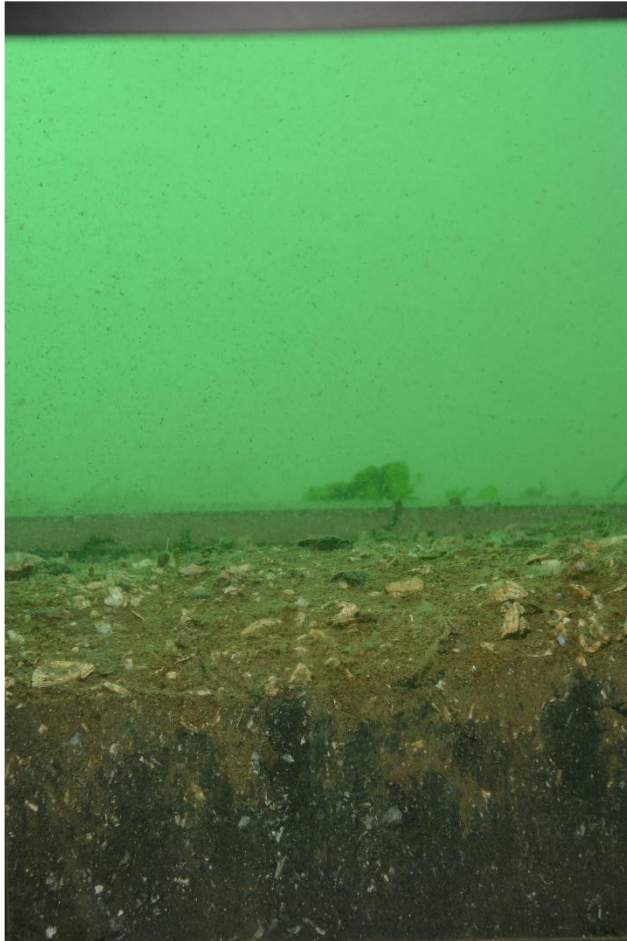
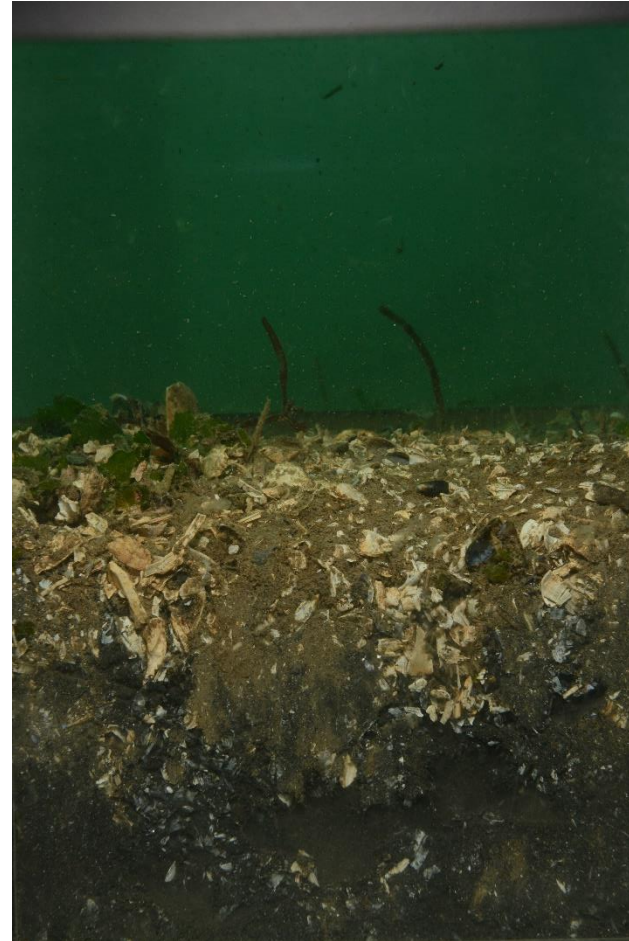
Figure 18. SPI Images from Stations DM-35 and DM-40 Showing High Apparent RPD Contrast

SPI images from stations DM-35 and DM-40 within the Dense Pile Field showed higher apparent RPD contrast in sediments with abundant shell debris. Wood debris was not apparent at DM-35 and trace amounts were present at DM-40. SPI image width is 14.6 cm.

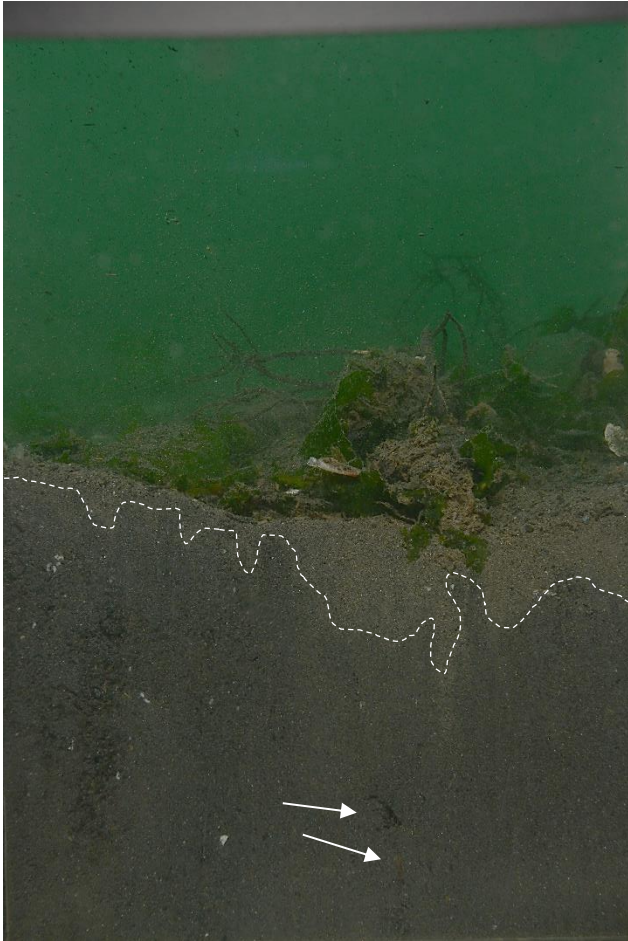
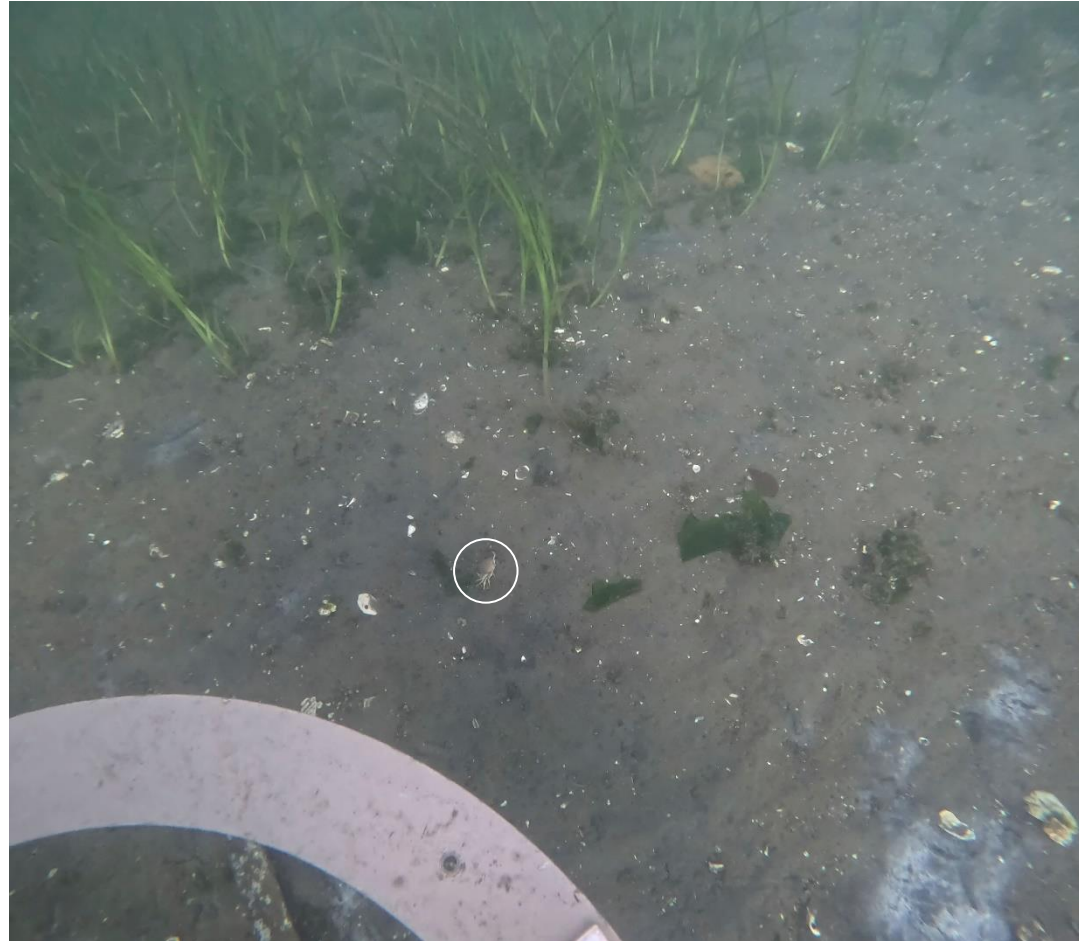
Figure 20. SPI and PV Images from Station DM-06 within the Eastern Pile Area

Station DM-06, SPI replicate H, showed fine sands with an apparent RPD depth of 1.0 cm (white dashed line) and a feeding void/polychaete at depth (white arrows) indicating Stage III infaunal succession. The PV image showed patches of *Beggiatoa* on the surface, algae (*Ulva*), eelgrass, and shell particles present on the sediment surface. A small crab (*Metacarcinus gracilis*, white circle) was also present. SPI image width is 14.6 cm.

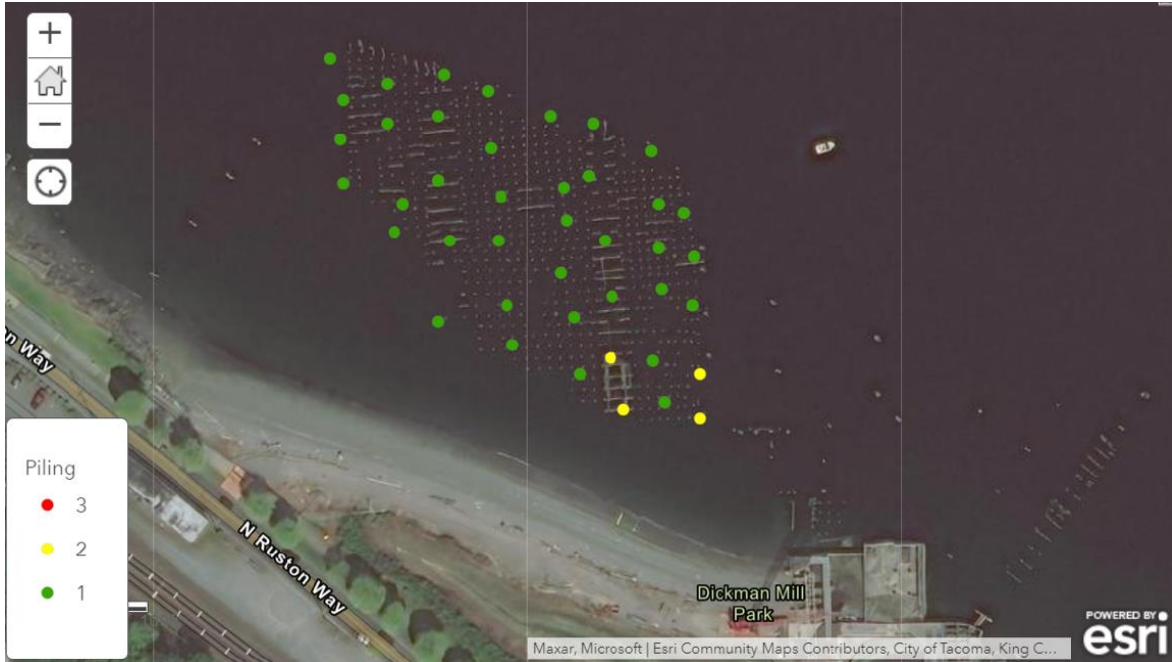
Figure 31. Pile Condition (top) and Debris (bottom) Observed During 2022 DNR Diver Survey

A subsampling of existing pilings within the northwest piling field were recently surveyed by DNR divers in support of characterizing the sediment, condition of pilings, and presence of eelgrass and benthic vegetation as well as any debris. More than 90 percent of the 42 pilings surveyed were observed to be intact and in good condition with minimal degradation (DNR 2022). The sediment type within the piling field was predominantly shell hash on either mud or sand substrate. Finer muds were predominant in the western portion of the piling field while the eastern portion was characterized by coarser sands with observations of a mixture of cobbles and shell hash in the shoreward edge of the piling field. Debris in the piling field included wood, metal rebar, and wood pieces with attached metal. Wood debris ranged in size from short stumps to whole pilings, with some large pieces silted in place on the sediment bed. Debris was present throughout the piling field but became more abundant proceeding southeastward across the field. The area

Piling condition rating: 1= not degraded, 2 = moderately degraded, 3 = very degraded

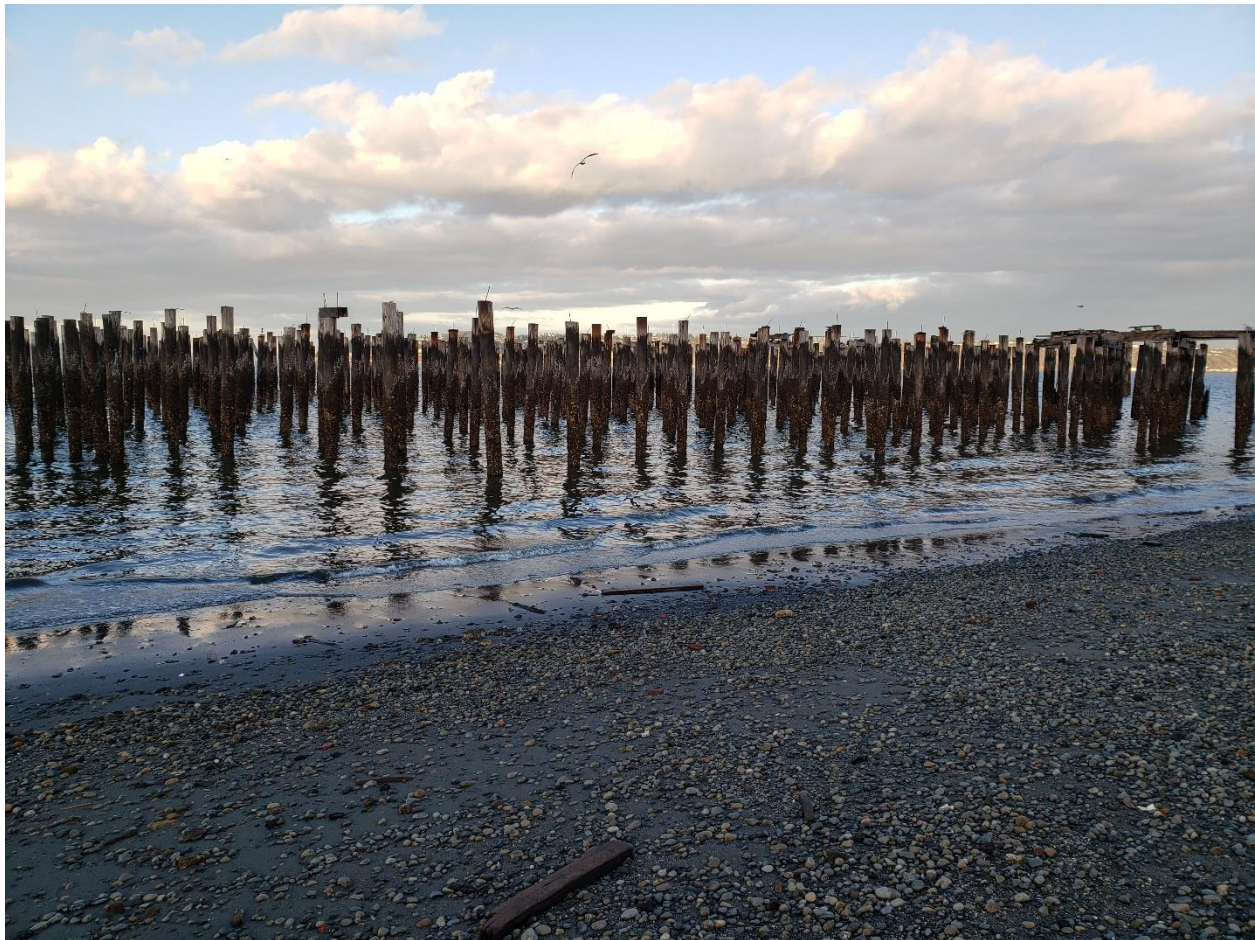
Figure 2. Wave Conditions During Low Tide Site Visit on February 14, 2023.

Based on our observations, wave heights were not significantly reduced by the pilings, partly because the fetch (nearly the maximum fetch, in this case) is aligned with the rows of piles. It is also important to mention that Google Earth images show that the beach has not significantly changed position since the regrading of the site and the placement of the cap 23 years ago. This is true both where the cap exists and west of the cap.

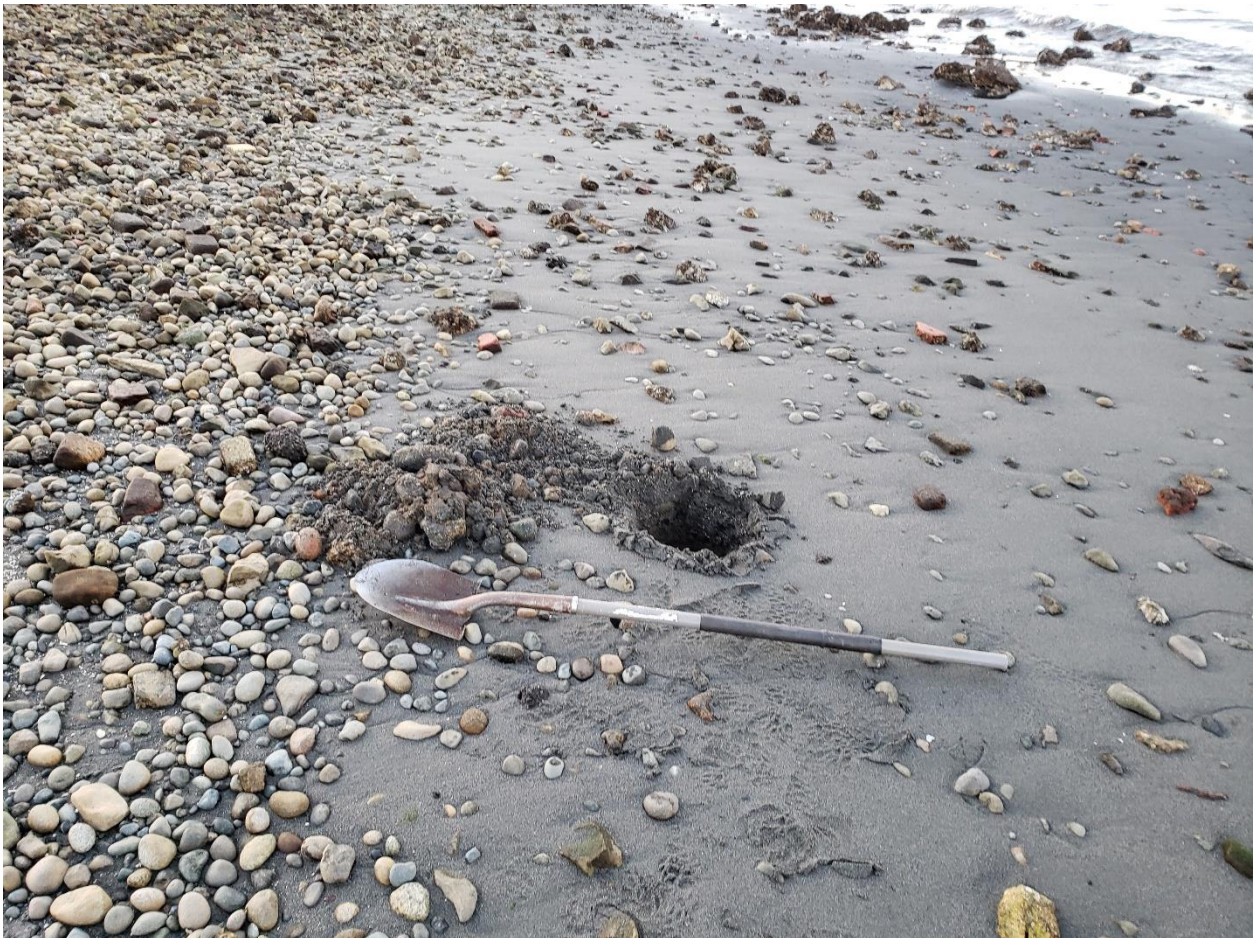
Figure 3. Beach Conditions at a Central Test Pit on the Site Visit.

Cap material was not generally apparent from the surface, though some patches could be seen (see upper left corner in Figure 3). The surface was dominated by sand in most areas, though some of the gravel/cobble on the surface in coarser patches may have been from the cap. But at the central two pits, cap material was obvious less than a few inches below the surface. The cap material at both these locations was mixed with beach sand and shell hash (Figure 4), indicating that the cap material is at least occasionally marginally mobile during large storm events. The bottom of the cap was not reached at either of these pits (i.e., cap material was present at the bottom of the pits), despite that Mott Macdonald (2020) suggest that the thickness was only 6 inches at its lower end. The disturbance found is consistent with the modeling of Mott Macdonald (2021), which showed that the largest events were sufficient to mobilize the cap material. However, wholesale erosion has not occurred in the 23 years since the cap was placed. It is important to note that there was a 38 percent chance of a 50-year event occurring during this period. Further, the Xbeach model was developed for sandy coastal sediments exposed to swell, where profile changes happen much more quickly than they do on coarse sediment along Puget Sound shorelines. The modeling results suggest that future disturbance of the cap is likely, but wholesale erosion would only be possible by events significantly larger than the 50-year event. The protection of the pile field is also modest, particularly since an event of this magnitude is likely to destroy many of the piles in the process of the event.

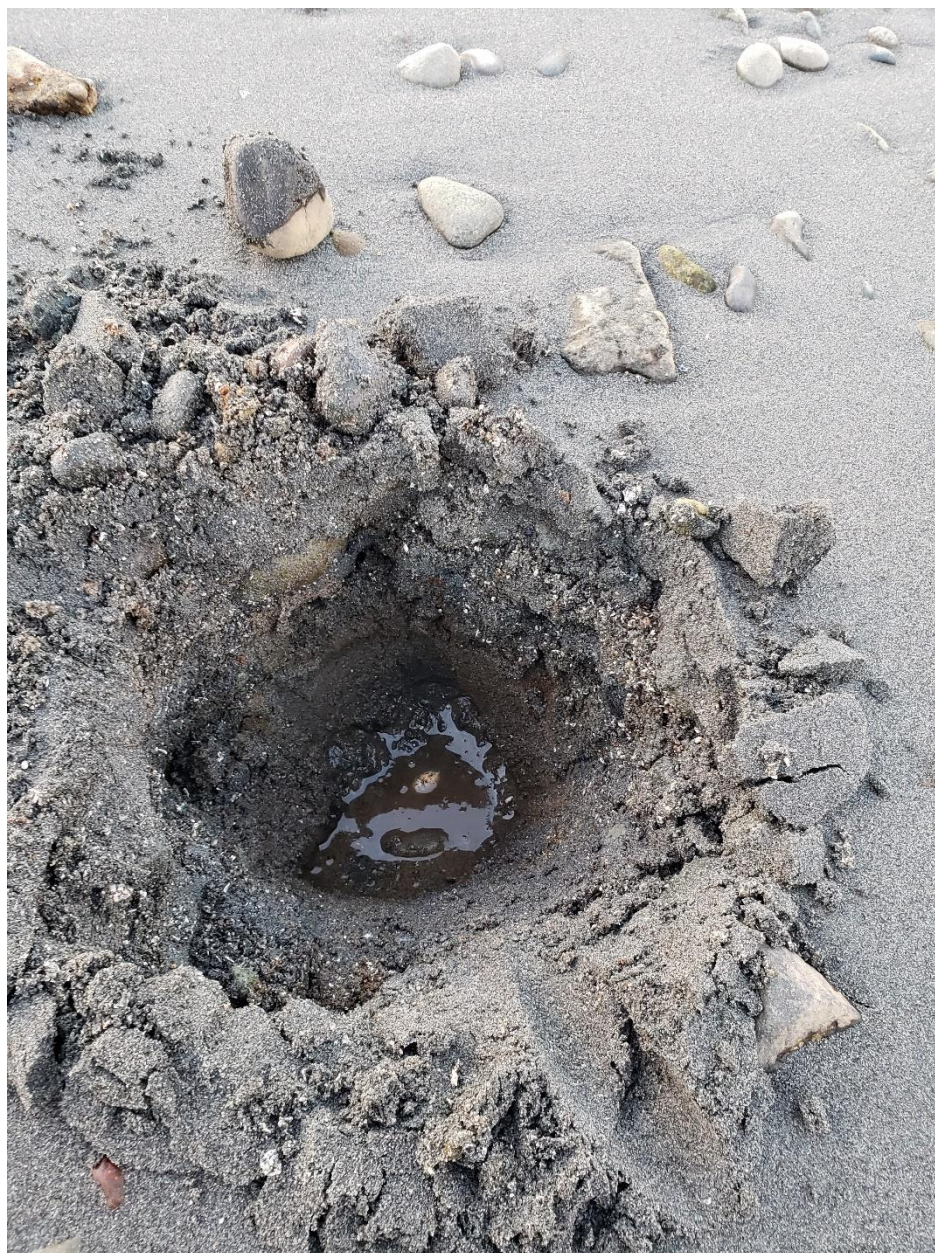
Figure 5. Westernmost Test Pit Outside of Cap

At the east end pit, anoxic sediment was found to the depth of the pit and no cap material was encountered. It is likely that the cap material was deeper than the bottom of the pit since this location was more protected than the other two sites and appeared to be generally finer grained than other locations. The west end pit contained a mix of debris (bricks), sand, and shell hash, but there was less shell hash at this site than the two central pits (Figure 5). The presence of shell hash indicates that the cap represents an erosional surface (i.e., the cap arrested erosion of the material from underneath it), whereas the west pit was primarily depositional. An erosional surface at the west pit, if there was one, was below the bottom of the pit.
