2023 ANNUAL REPORT
Remedy Implementation
Crownhill Elementary School Site
Prepared for: Bremerton School District

Project No. AS100094-J-012 • March 21, 2024 FINAL

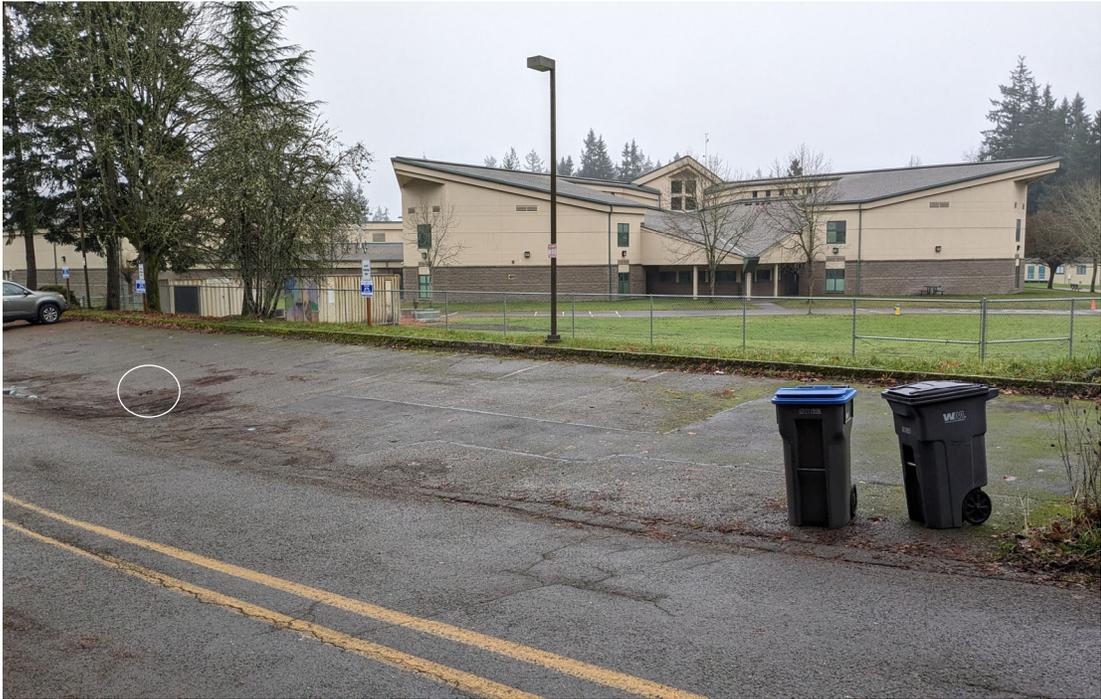
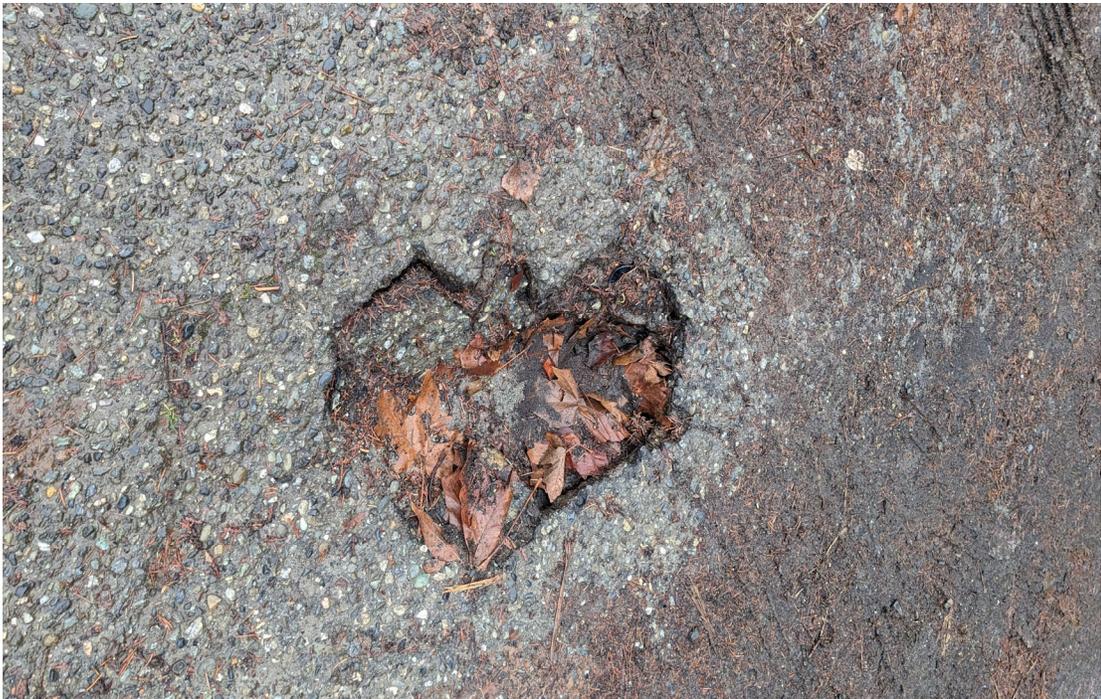
Photo Location 1. 12/21/2023 site inspection, pothole circled.

INSPECTION ITEM	YES	NO	COMMENTS/NOTES
1. North Environmental Covenant Area			
a. Building or pavement modifications since last inspection?		X	
b. Pavement deterioration/damage along Bertha Ave NW? ¹	X		There is one new pot hole in parking lot (pic)
c. Evidence of soil disturbance?		X	
d. Geotextile fabric visible in interim action area?		X	
2. South Environmental Covenant Area			
a. Building or pavement modifications since last inspection?		X	
b. Evidence of soil disturbance?		X	
c. Geotextile fabric visible in interim action areas?		X	
3. Other Inspection Items			
a. Are all wells (MW-1 through EW-17) accessible?	X		
b. Evidence of well monument damage/tampering?		X	
c. HVAC system operates continuously during school day? ²	X		HVAC runs continuously, heating/cooling as necessary

Photo Location 1. 12/21/2023 site inspection, pothole in photo above.

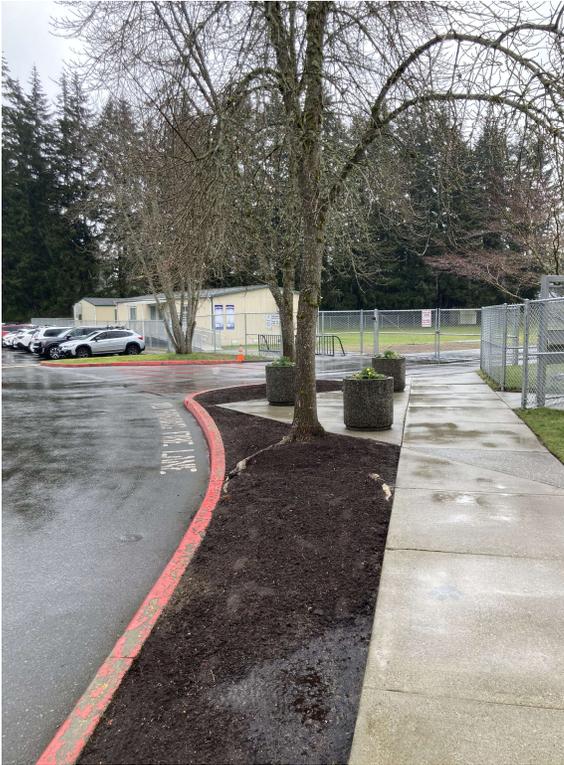
Photo 1. Trees prior to removal.

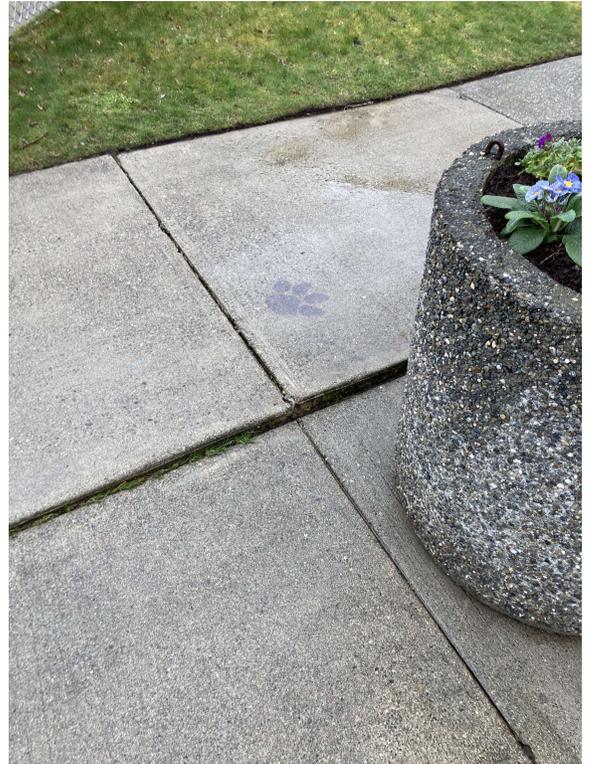
Photo 4. Damage to the sidewalk.

In March 2023, BSD removed two trees damaging nearby sidewalks at the school (see photographs in Appendix E). Prior to removal, Aspect submitted formal notification to Ecology via email on BSD's behalf notifying them of the planned work in accordance with Agreed Order No. DE11107 (also included in Appendix E). The trees were cut down by a licensed contractor and the stumps ground down to about 8 inches below ground surface. The work was supervised by the BSD facilities director and workers were notified of ground conditions. BSD has since replaced the trees with shrubs that will not impact the sidewalk.

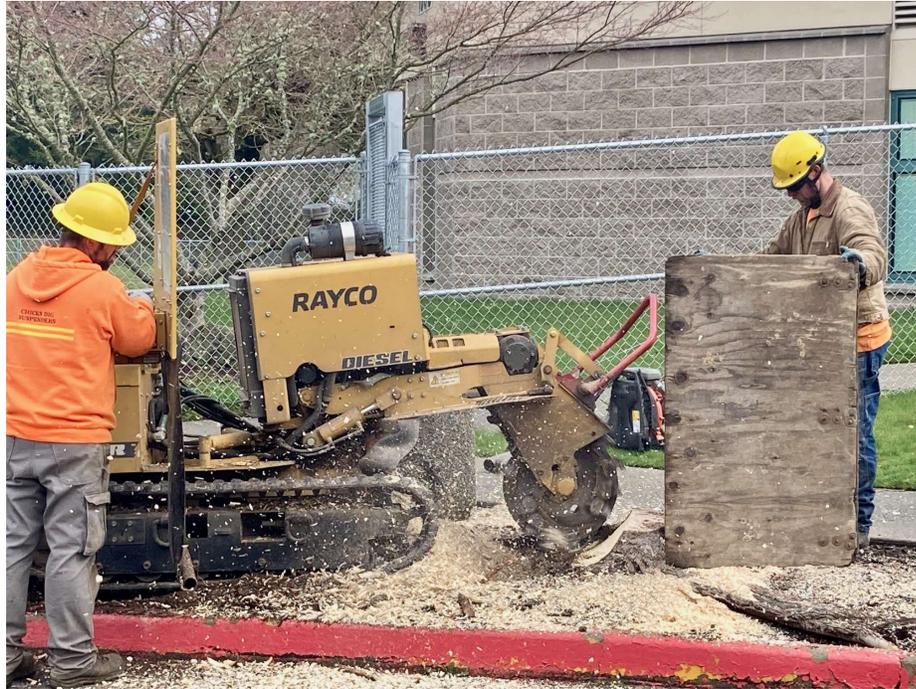
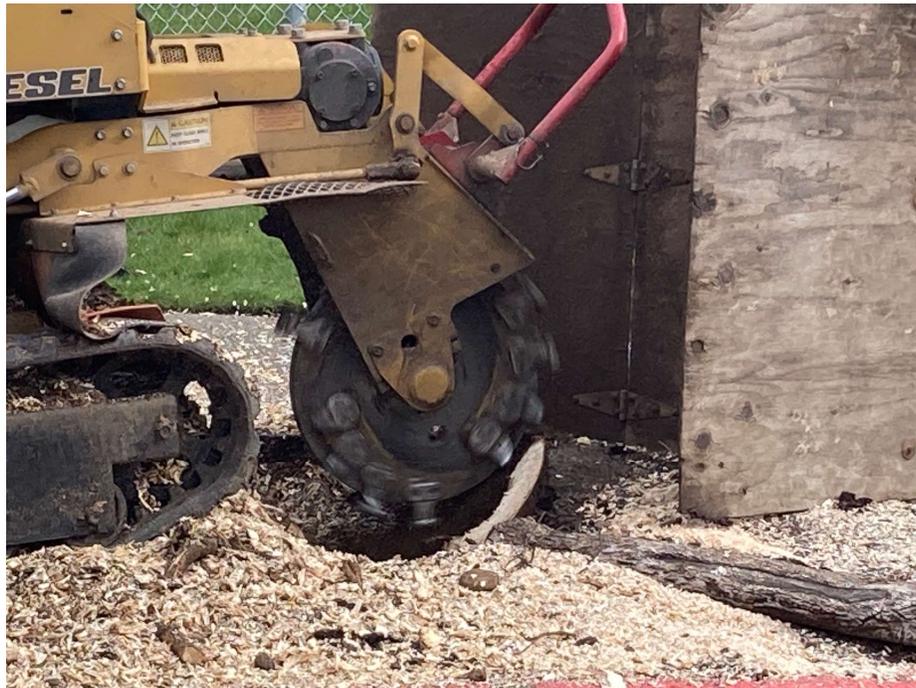
Photo 5. Contractor grinding the stumps.

Photo 6. Close up of stump grinding.

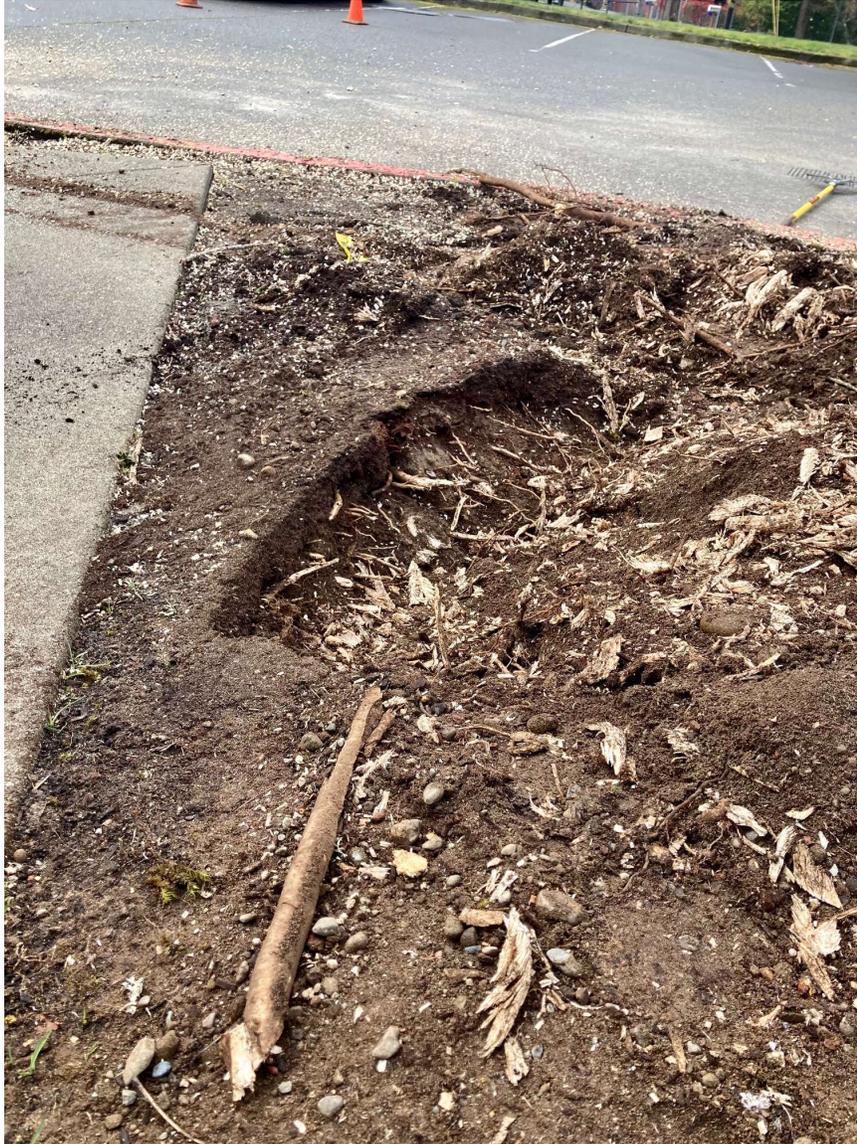
Photo 7. Ground conditions after tree removal.
