Subject: Status Report
Former Ballard Library
5711 24th Avenue NW
Seattle, Washington

The following is a status report of the soils remediation at the above referenced site.

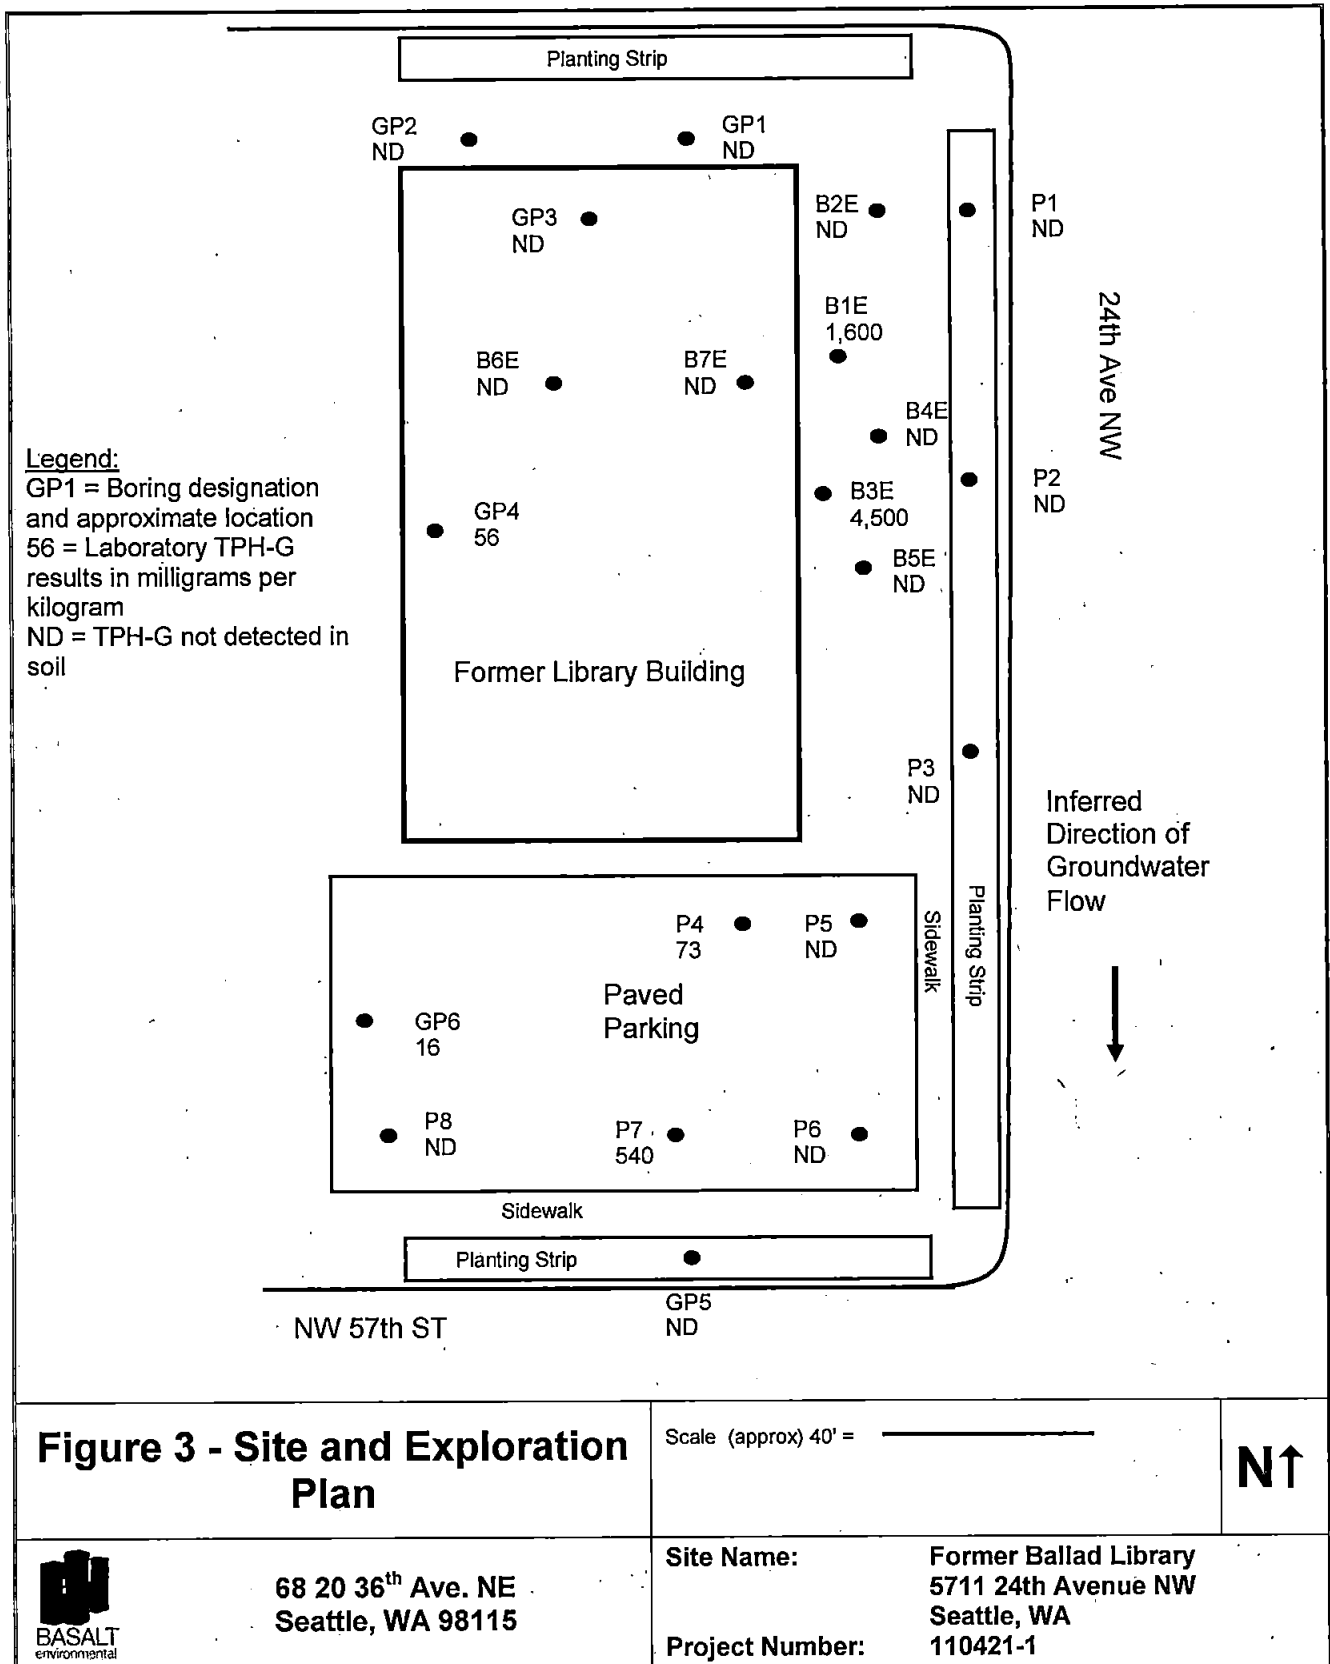
These studies detected concentrations of gasoline-range petroleum hydrocarbons exceeding the Model Toxics Control Act (MTCA) Method A cleanup criteria for unrestricted land use in two primary areas, specifically in the southern portion of the parking area and on the northeast side of the building. However concentrations of petroleum below MTCA Method A were also detected in other locations.

In fall of 2013, the building was demolished and soils were removed in November and December, 2013. As part of site preparation for future construction, all soils were removed to an average depths of about 13-feet below ground surface. As a construction expedient, any soils exhibiting staining or petroleum orders were excavated and disposed of off site. Field screening of soils was accomplished by means of by means of a photo-ionization detector, as well as visual and olfactory methods.

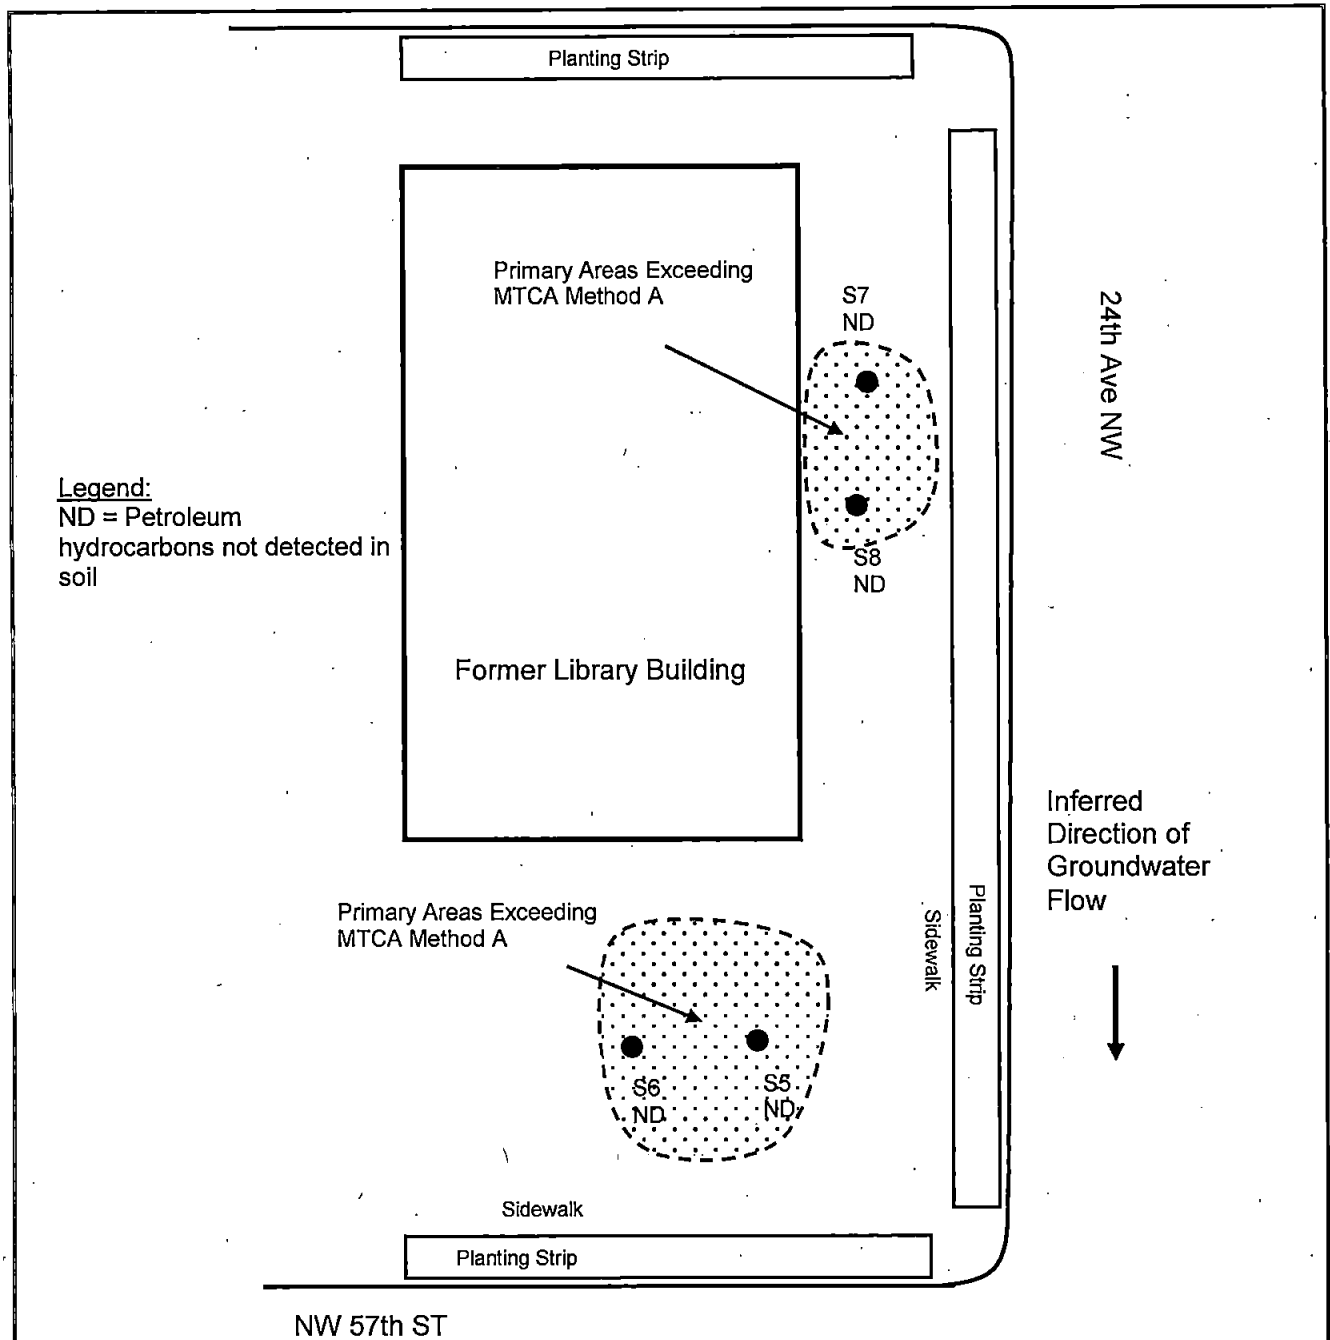
Figure 4 - Post Excavation Sampling Results

A environmental survey of the site was conducted on December 3, 2013. Remaining in-place soils were field screened at approximately 15 foot intervals across the site, with additional emphasis in previously identified suspect areas. At that time, no site soils remaining in place exhibited indications of petroleum impacts, such as staining or odors.

Four soil samples were collected for laboratory analysis. Each of the sample results were below laboratory method detection limits. The laboratory report is attached.

At the time of our December 3, 2013 site evaluation no site soils remaining in place exhibited visual or olfactory indications of petroleum products. Additionally, four soil samples collected from the areas most likely to be impacted were below laboratory method detection limits.

Based on these results, there are no indications that detectable concentrations of petroleum products remain on site. No further evaluation of site soils is warranted or necessary at this time.
