2020 ANNUAL REPORT
Remedy Implementation
Crownhill Elementary School Site
Prepared for: Bremerton School District

Project No. 100094-007-01 • March 3, 2021

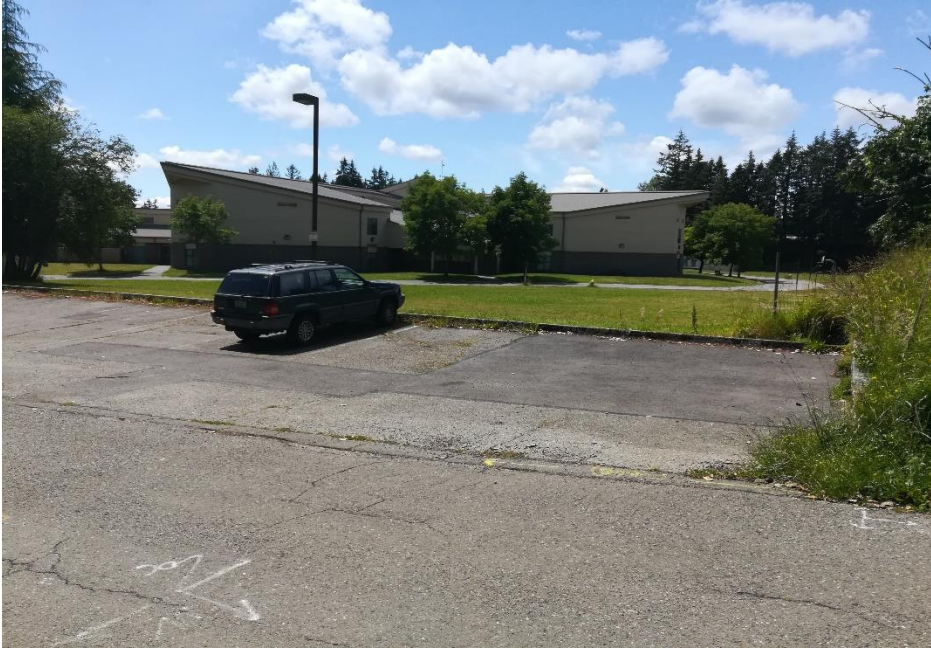
Photo Location 1. 6/11/2020 site inspection

- **Photo Location 1** – Pavement in the parking area along Bertha Avenue NW, where an RI soil sample collected from beneath the pavement (composite sample to 3-foot depth) contained lead at a concentration exceeding the cleanup level.
- **Photo Locations 2 and 4** – Soil/sod covers next to the portable classroom building and in the southeast corner of the School property, where lead cleanup

In July 2018, asphalt repairs were completed at three locations in the Bertha Ave NW parking area (Photo Location 1) after potholes were observed (documented in Aspect, 2019). The parking area appeared to be in excellent condition and the soil/sod cover at Photo Locations 2 through 4 appeared to be in good condition during both 2020 inspection events. The 2020 inspections did not identify any cover system deficiencies in other areas of the Site or other action items.

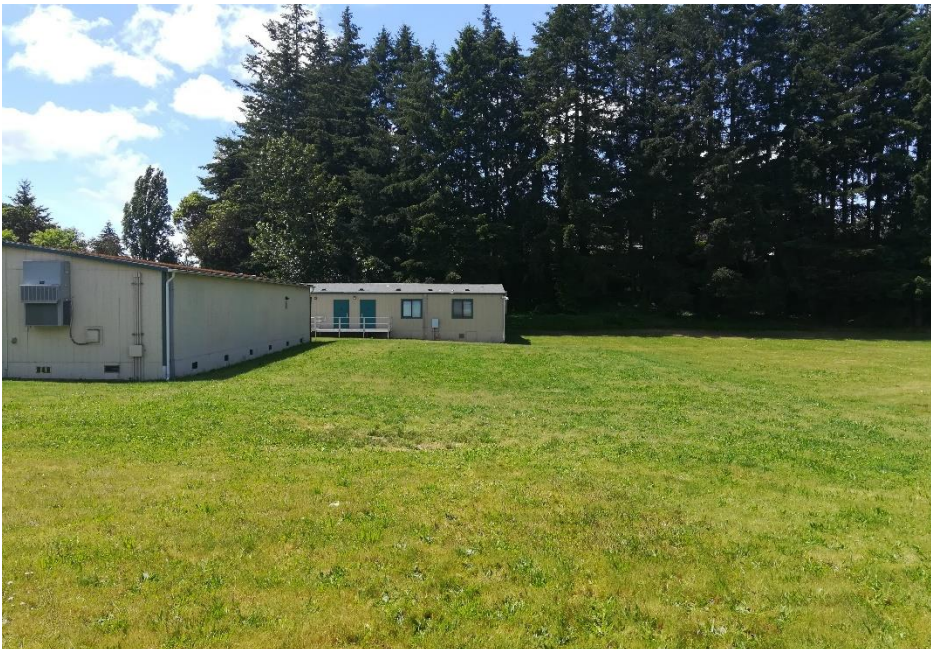
Photo Location 2. 6/11/2020 site inspection

level exceedances were identified in soil samples collected from the 1- to 3-foot depth range. In summer 2013, these two areas were covered with a geotextile fabric (placed directly on the undisturbed ground surface) and an additional 1-foot thickness of fill soil was imported and hydroseeded to supplement the pre-existing clean soil cover layer.

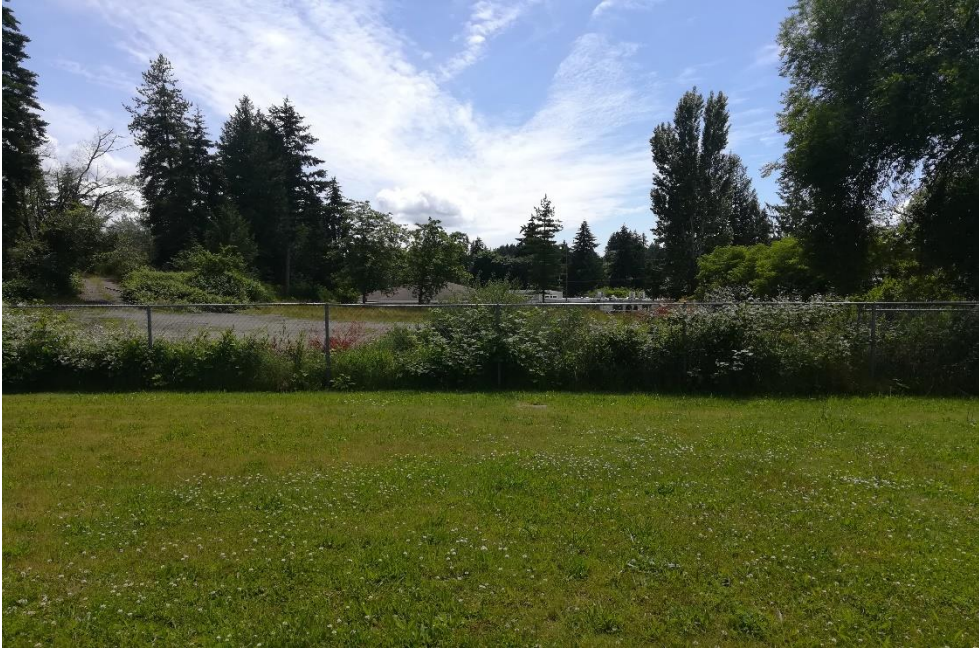
Photo Location 3. 6/11/2020 site inspection

- **Photo Location 3** – A soil/sod cover in the northwest corner of the BUMC property (and extending approximately 10 feet onto the School property), where an interim action was completed in spring 2012 in which contaminated surface soils were removed to a 1-foot depth, a geotextile fabric was placed on remaining contaminated soils, and a 1-foot thickness of fill soil was imported and hydroseeded.
