Re: DTG Yakima – Agreed Order No. DE 21624 – Monthly Progress Letter – March

Re: Monthly Data Assessment Report DTG Yakima Landfill Fire Incident – March 2024

DTG LPL LANDFILL FIRE INVESTIGATIONS AND MITIGATION

Monthly Monitoring Data Review

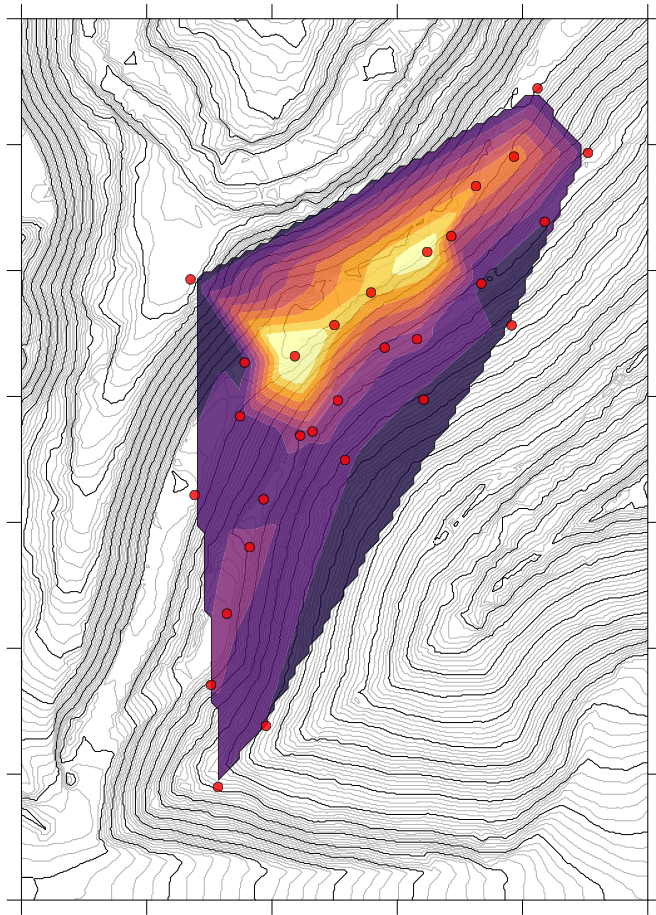
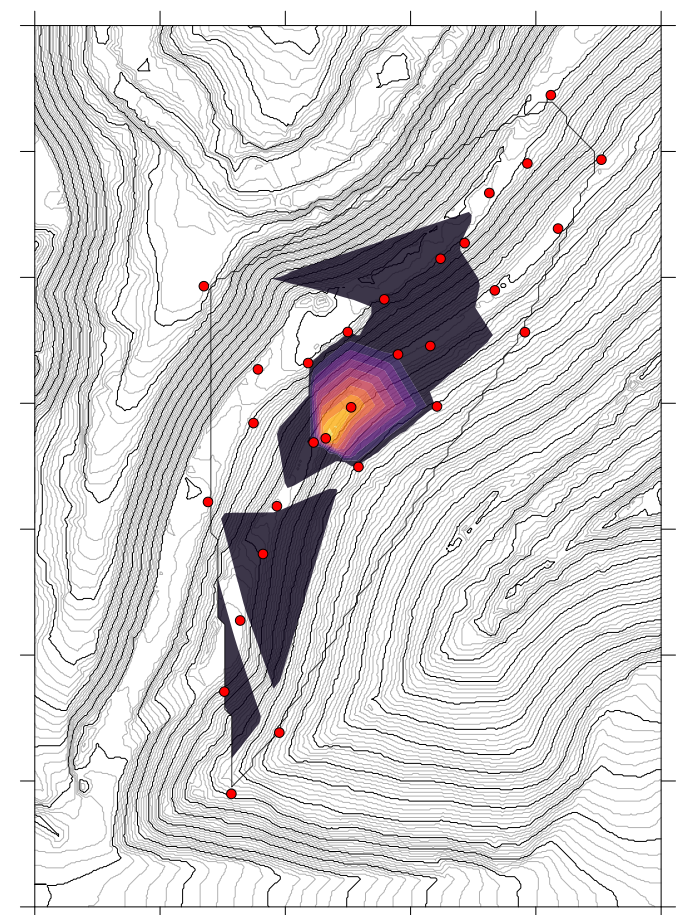
October 6, 2023
Before Cover Fill is Placed

- Note that the heat map is an approximation, due to limited number of datapoints available.
- Red dots represent the location of recorded measurements.
- Contour surfaces for November and April are based off design fill, not surveyed actual.

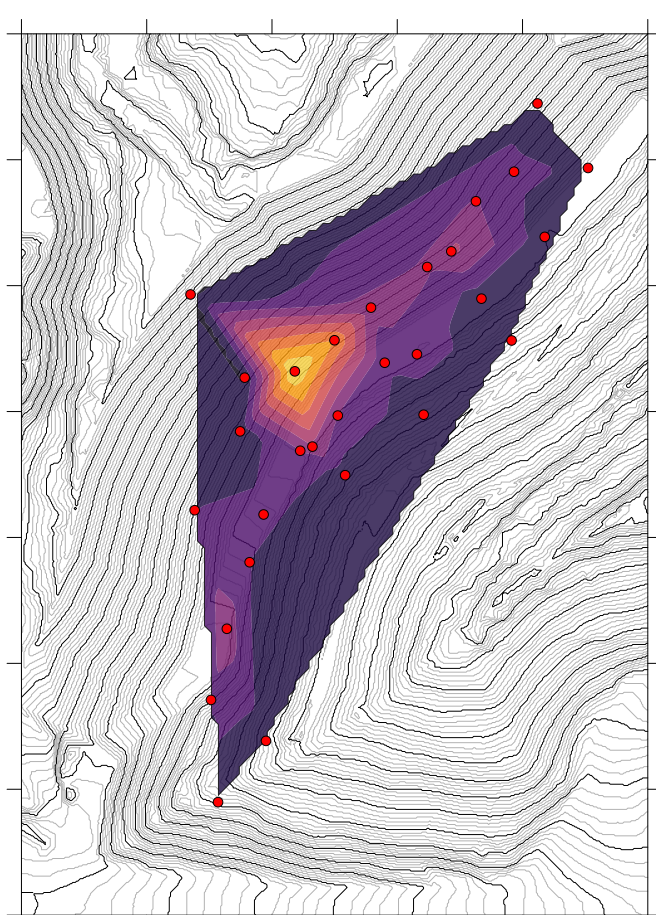
April 5, 2024
Latest Data From 2024

Plotting of the temperature and CO data in plan view clearly shows that the area affected by fire has markedly decreased over time. Based on the available data, LFCI believes that a small smolder continues to be active in close proximity to GP-3, and that the rate of combustion of the smolder is steadily decreasing.

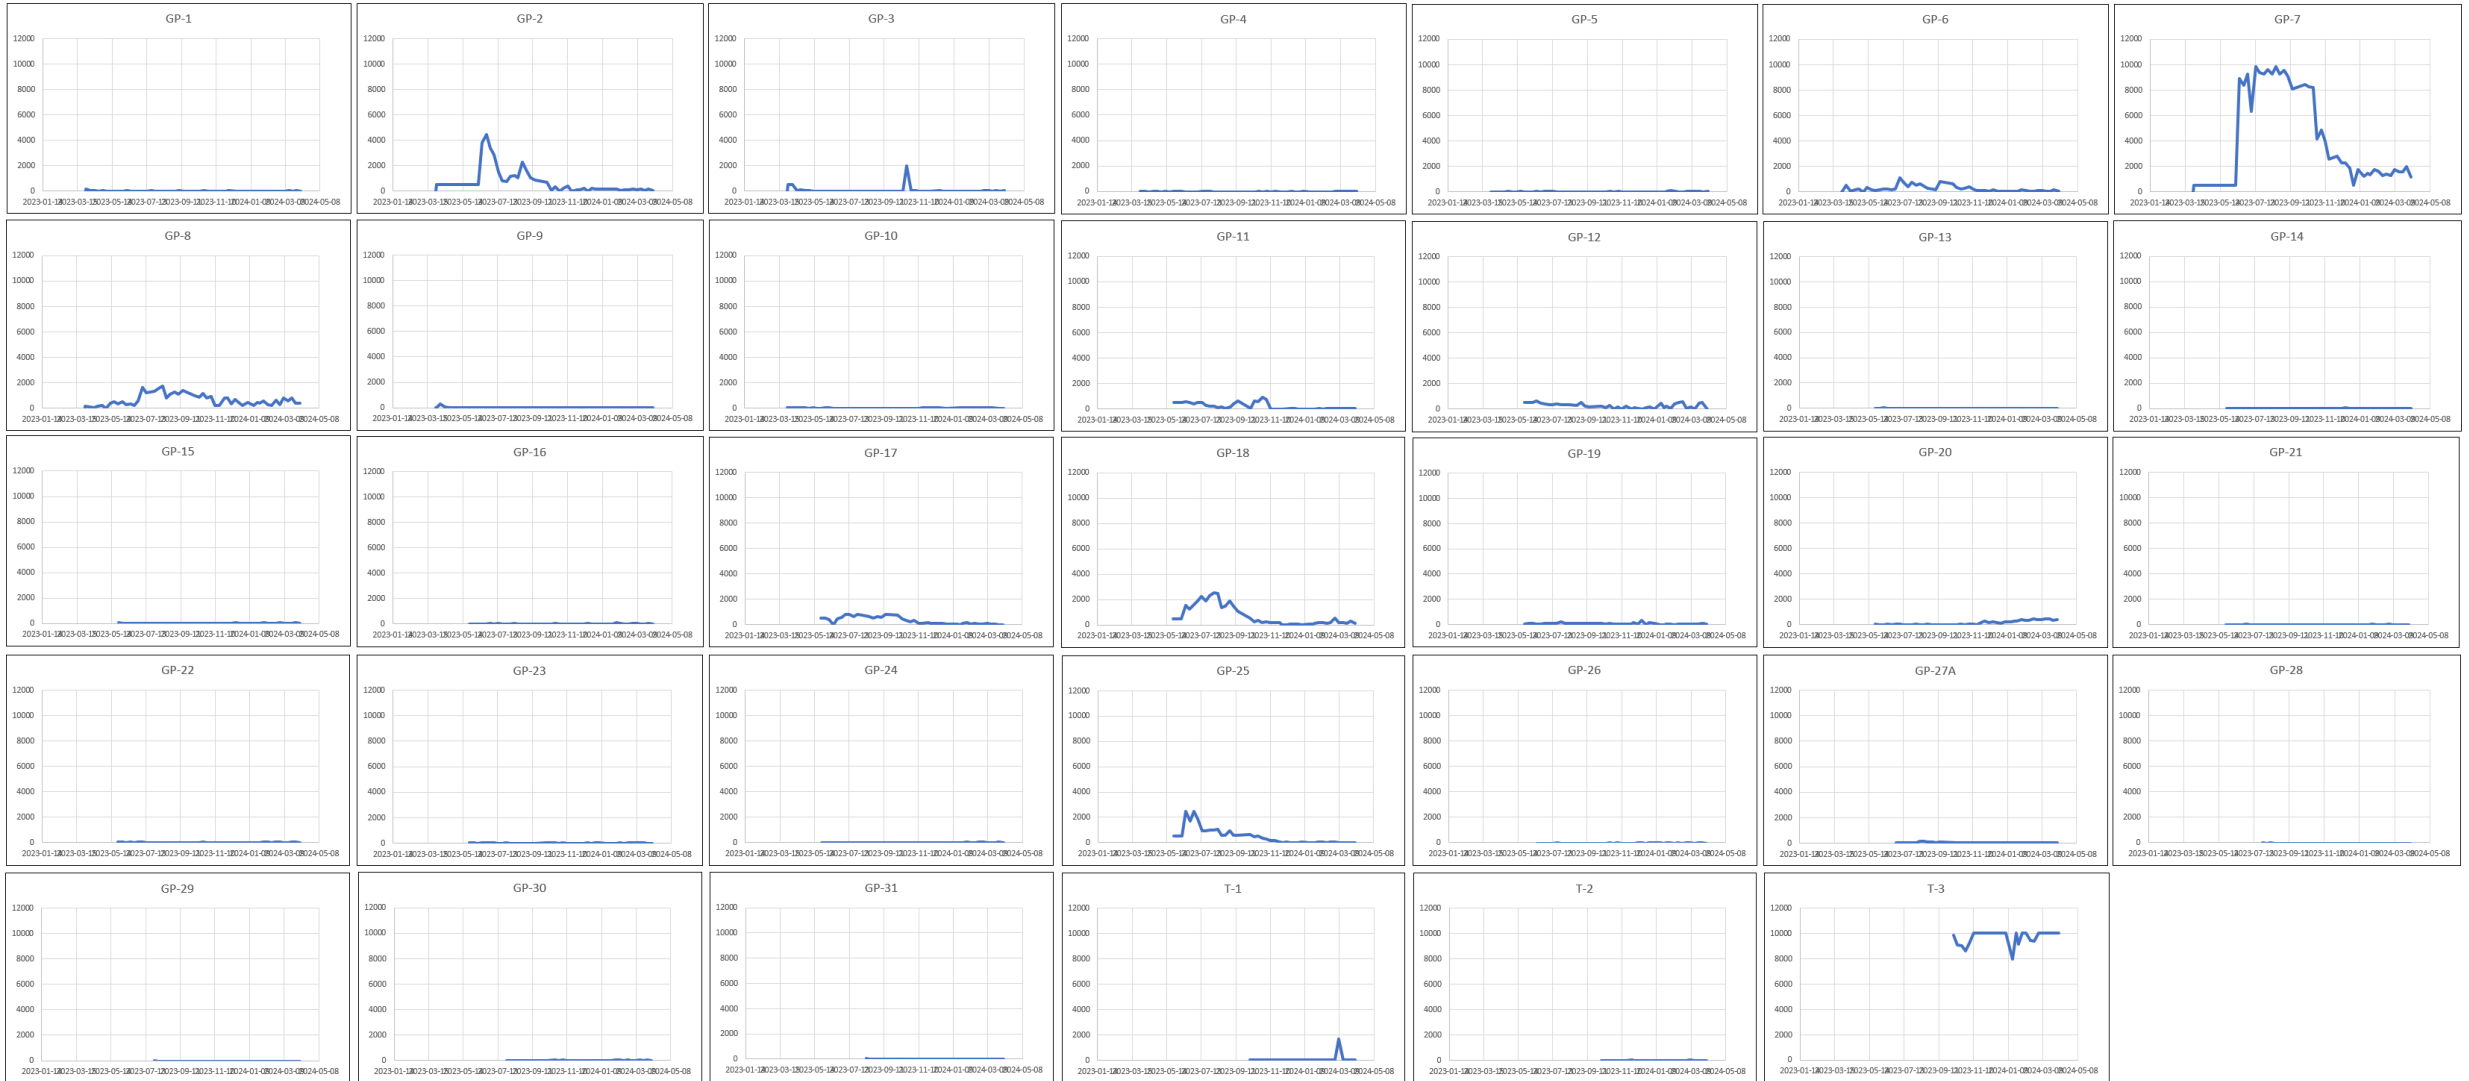
CO Levels by Individual Wells

In SHA experience, CO has been best indicator of suppression at other landfill sites. CO levels in GP-7 have dropped significantly in past few months. Waiting to see results in T-3, lab results should provide more insight.

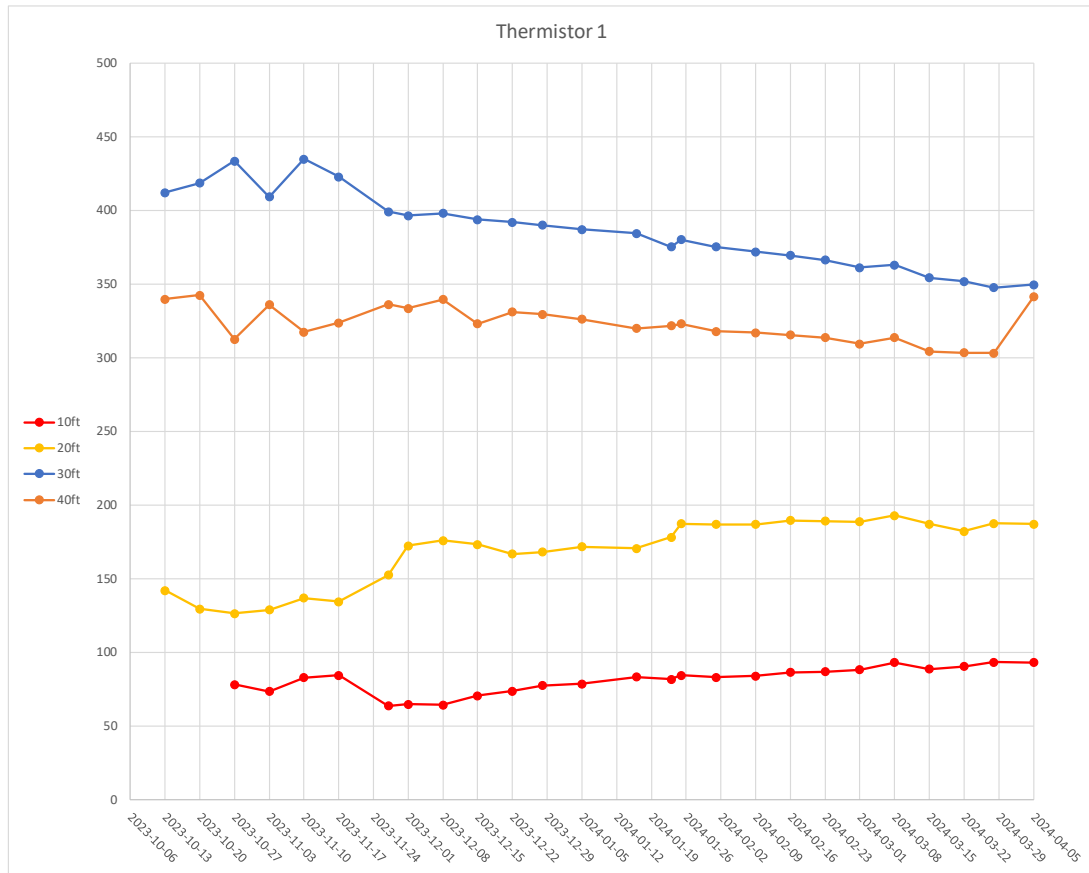
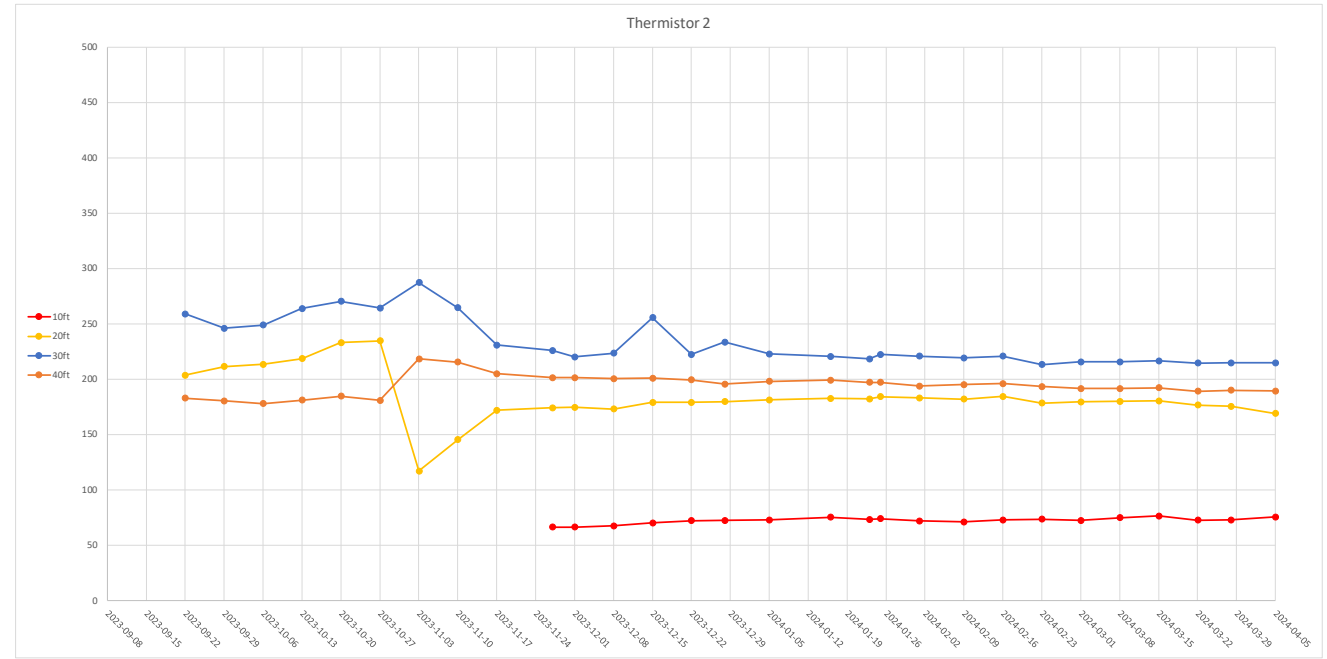
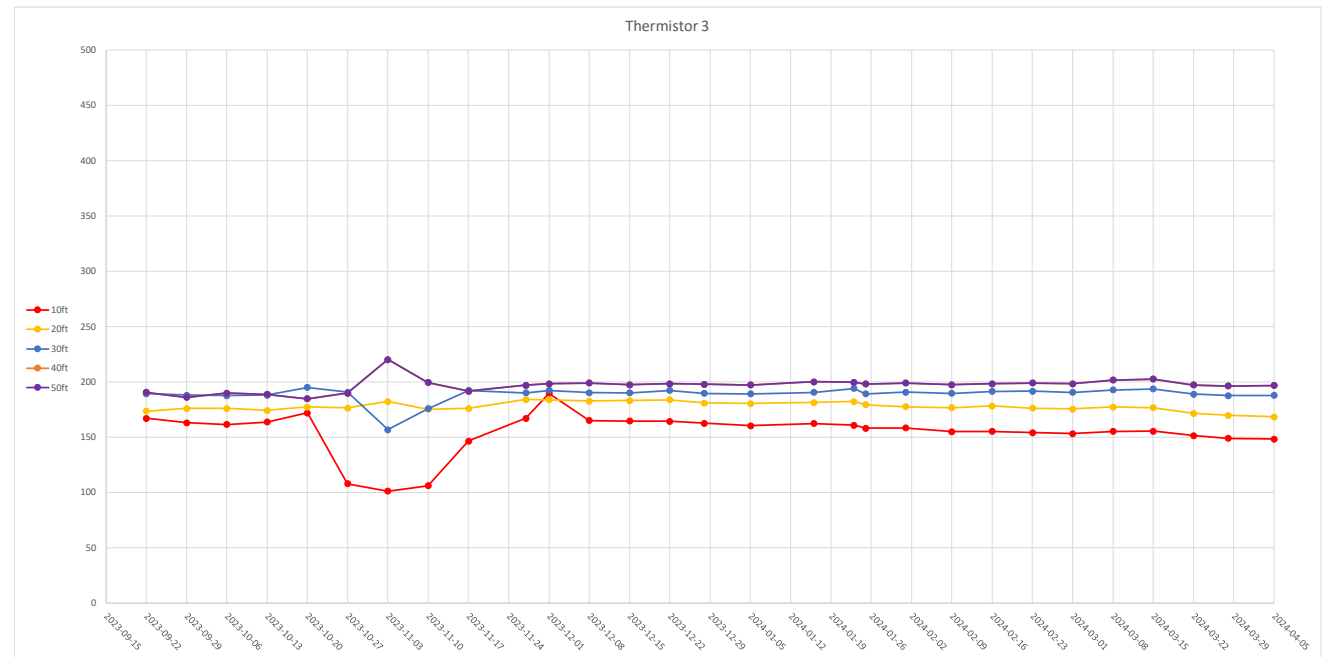
Thermistor Temperatures

Thermistor temperatures mostly stable. Elevated temperatures in Thermistor 1 around depths of 30-40ft. Spike in Thermistor 1 this week at 40ft.

Overall, it appears that the waste is smoldering underneath GP-3 and T-1 (elevated temperature) and a 'chimney' effect is occurring, causing high CO and VOC's in T-3 and GP-7.

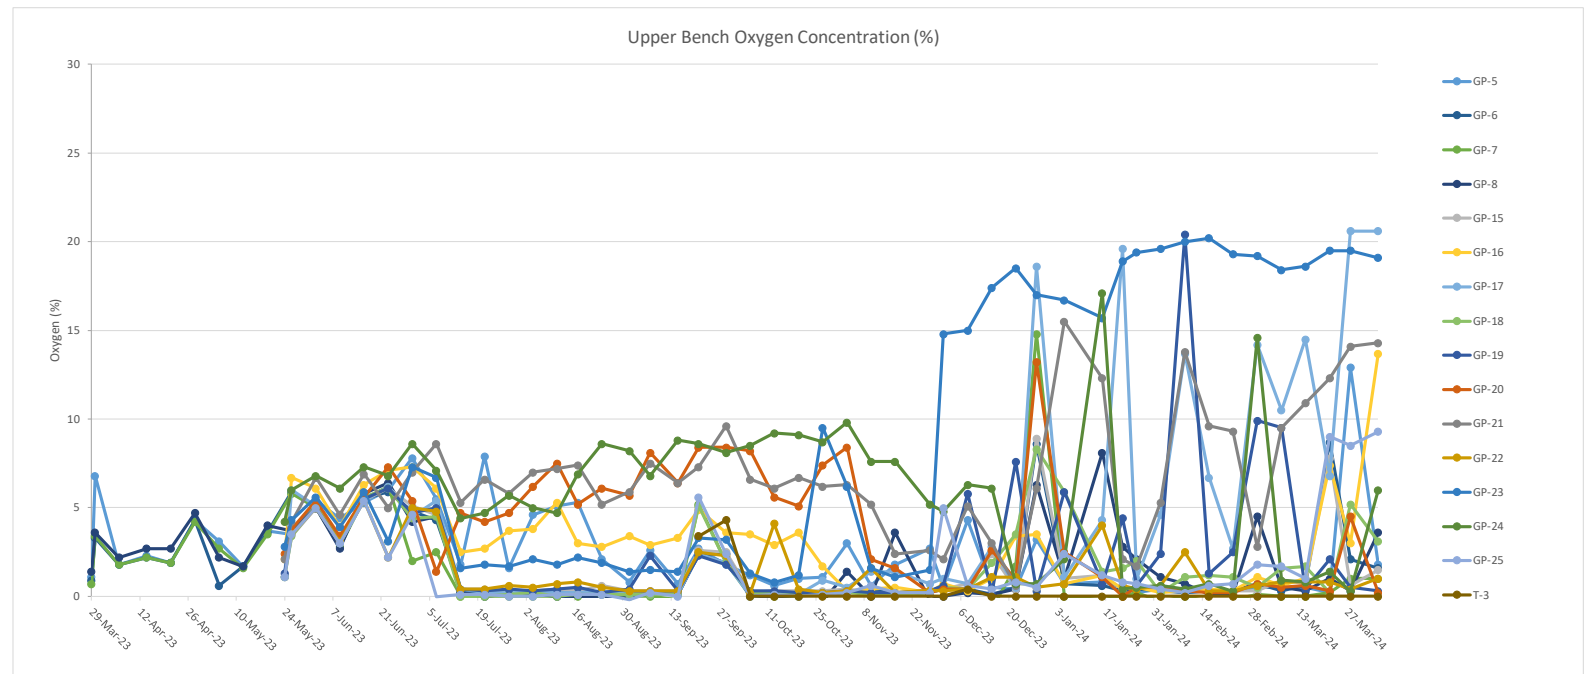
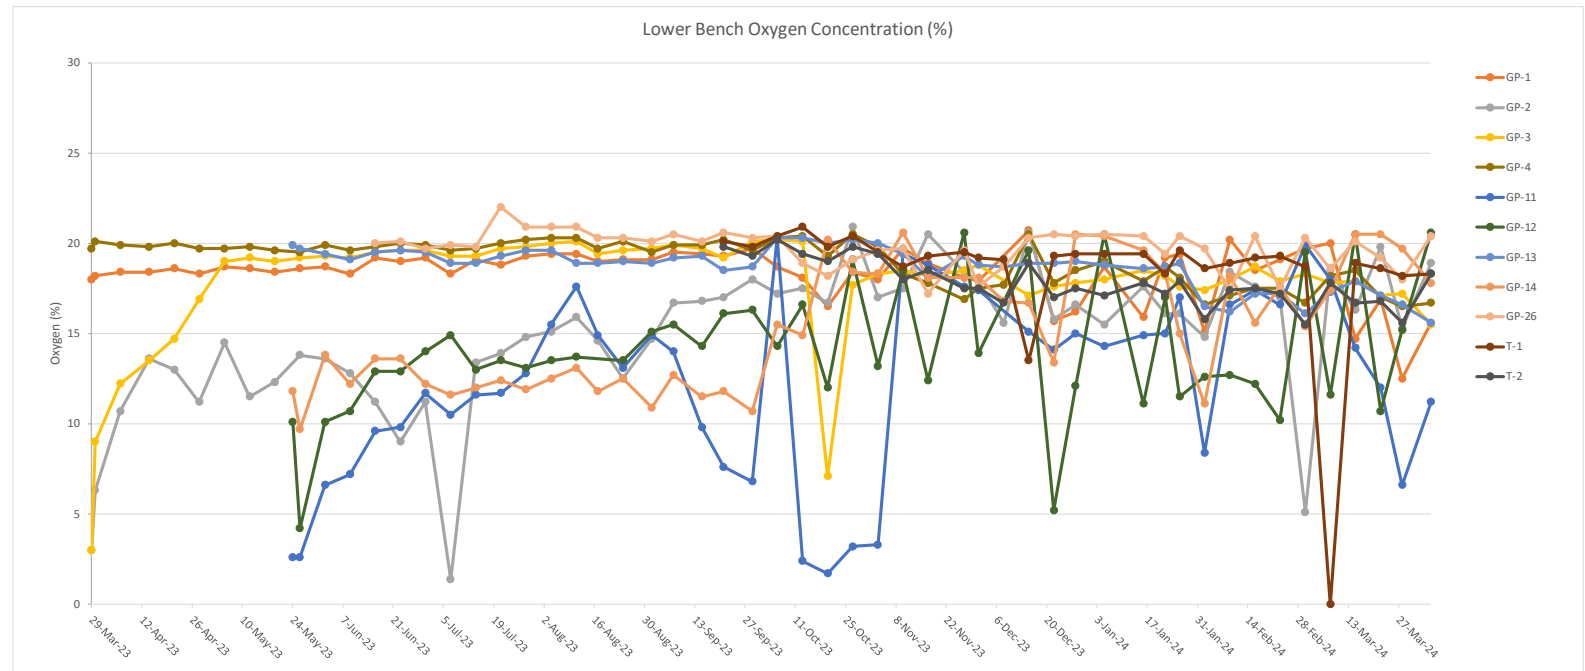
Lower bench is reading approximately atmospheric oxygen. Starting to see some downward trends.

Upper bench has very low (<5%) concentration.

Oldest portion of Landfill is probably relatively inert and biologically inactive, producing very little methane. As a result, pore space is full of atmospheric air.

Some GPs likely susceptible to swings in pressure – LFCI believes this is causing the spikes.

High O₂ below lower bench road continues, this is likely due to pervious waste mass allowing entry of ambient air.

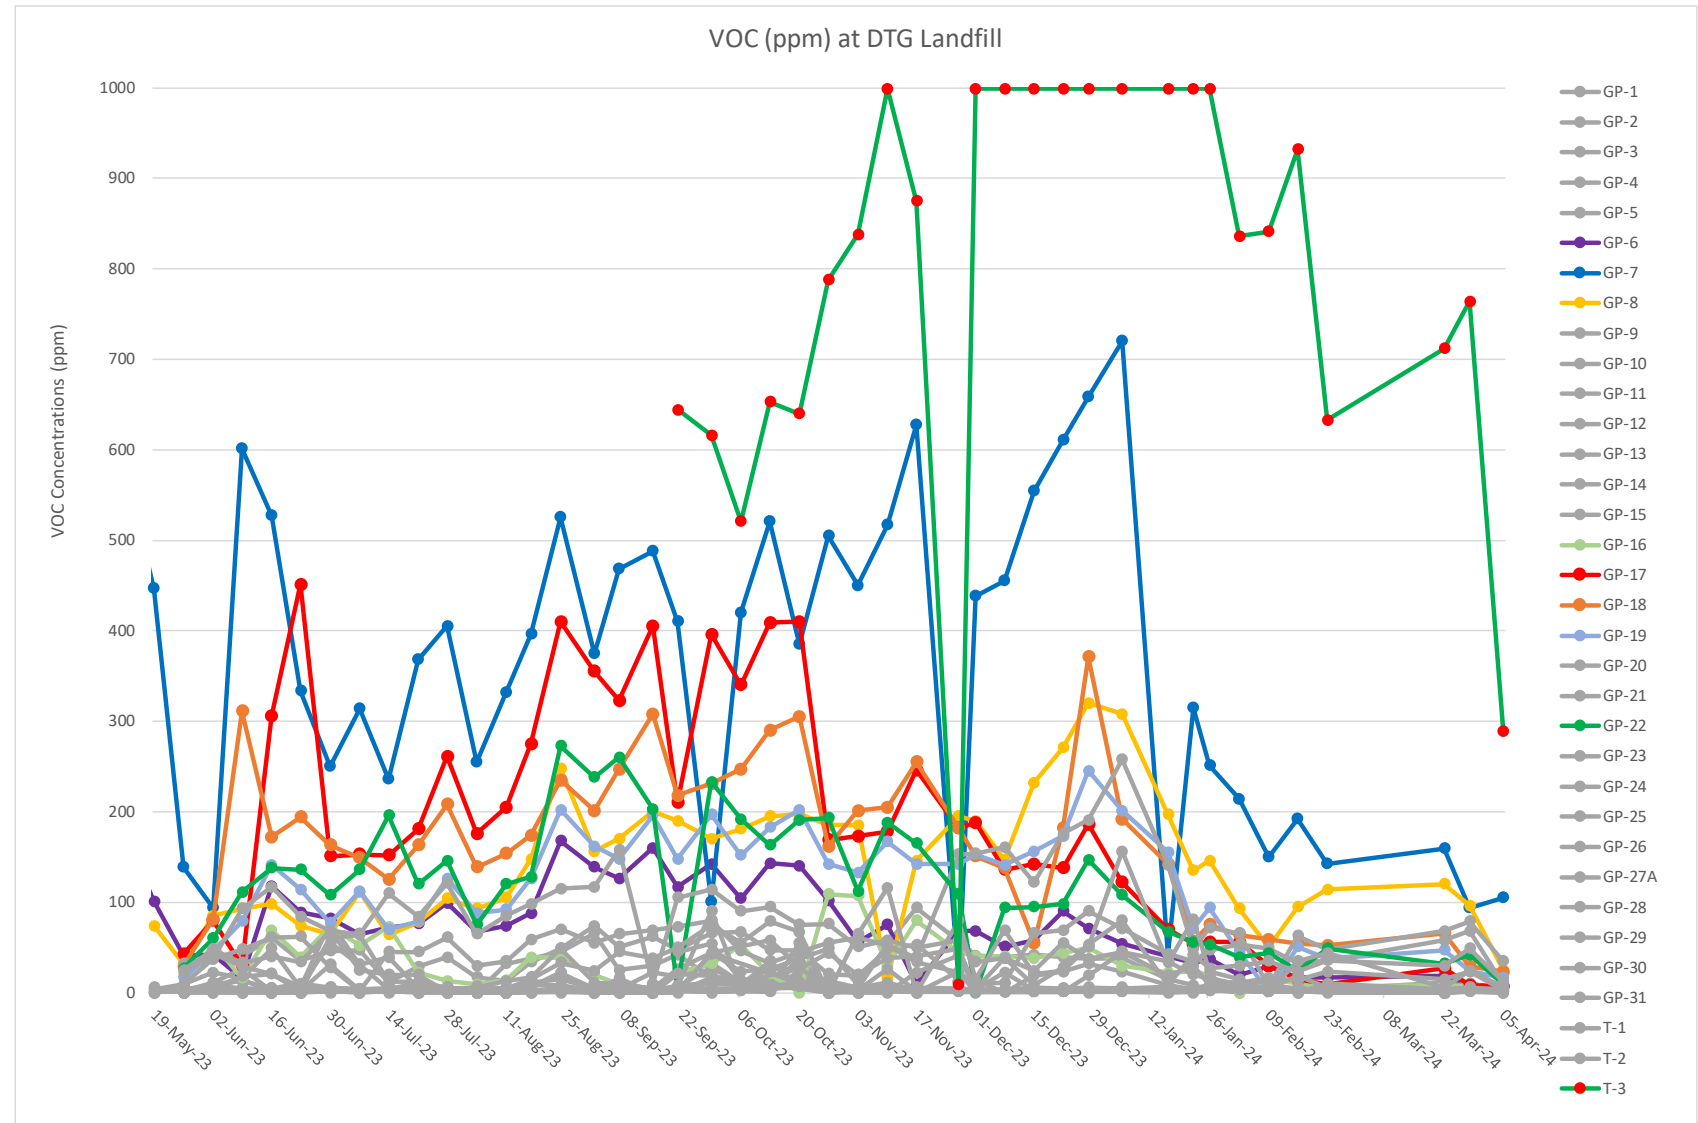
VOC's

T-3 has now decreased significantly over past month.

Decreasing trend visible in all locations in past few months.

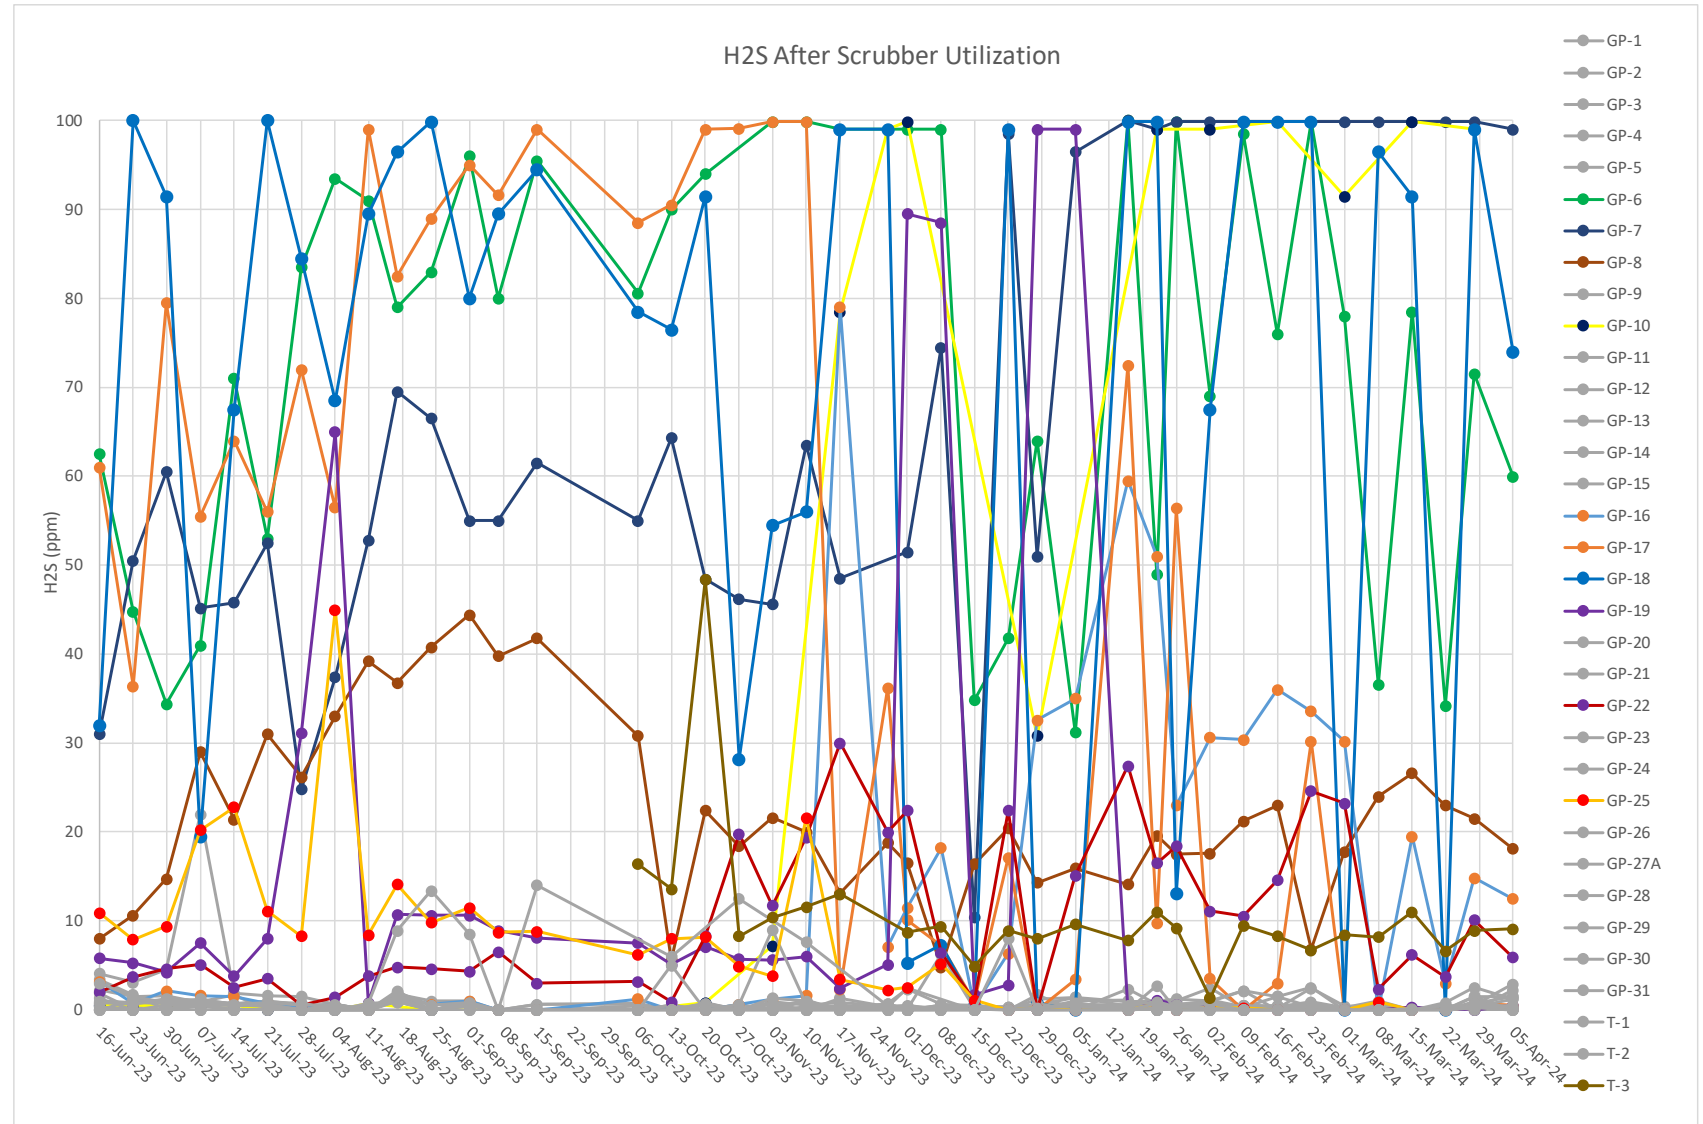
H₂S data continues to be noisy, likely affected by atmospheric pressure fluctuation.

Of note, GP-7 has remained high for past few months, and GP has remained stable around 10ppm.

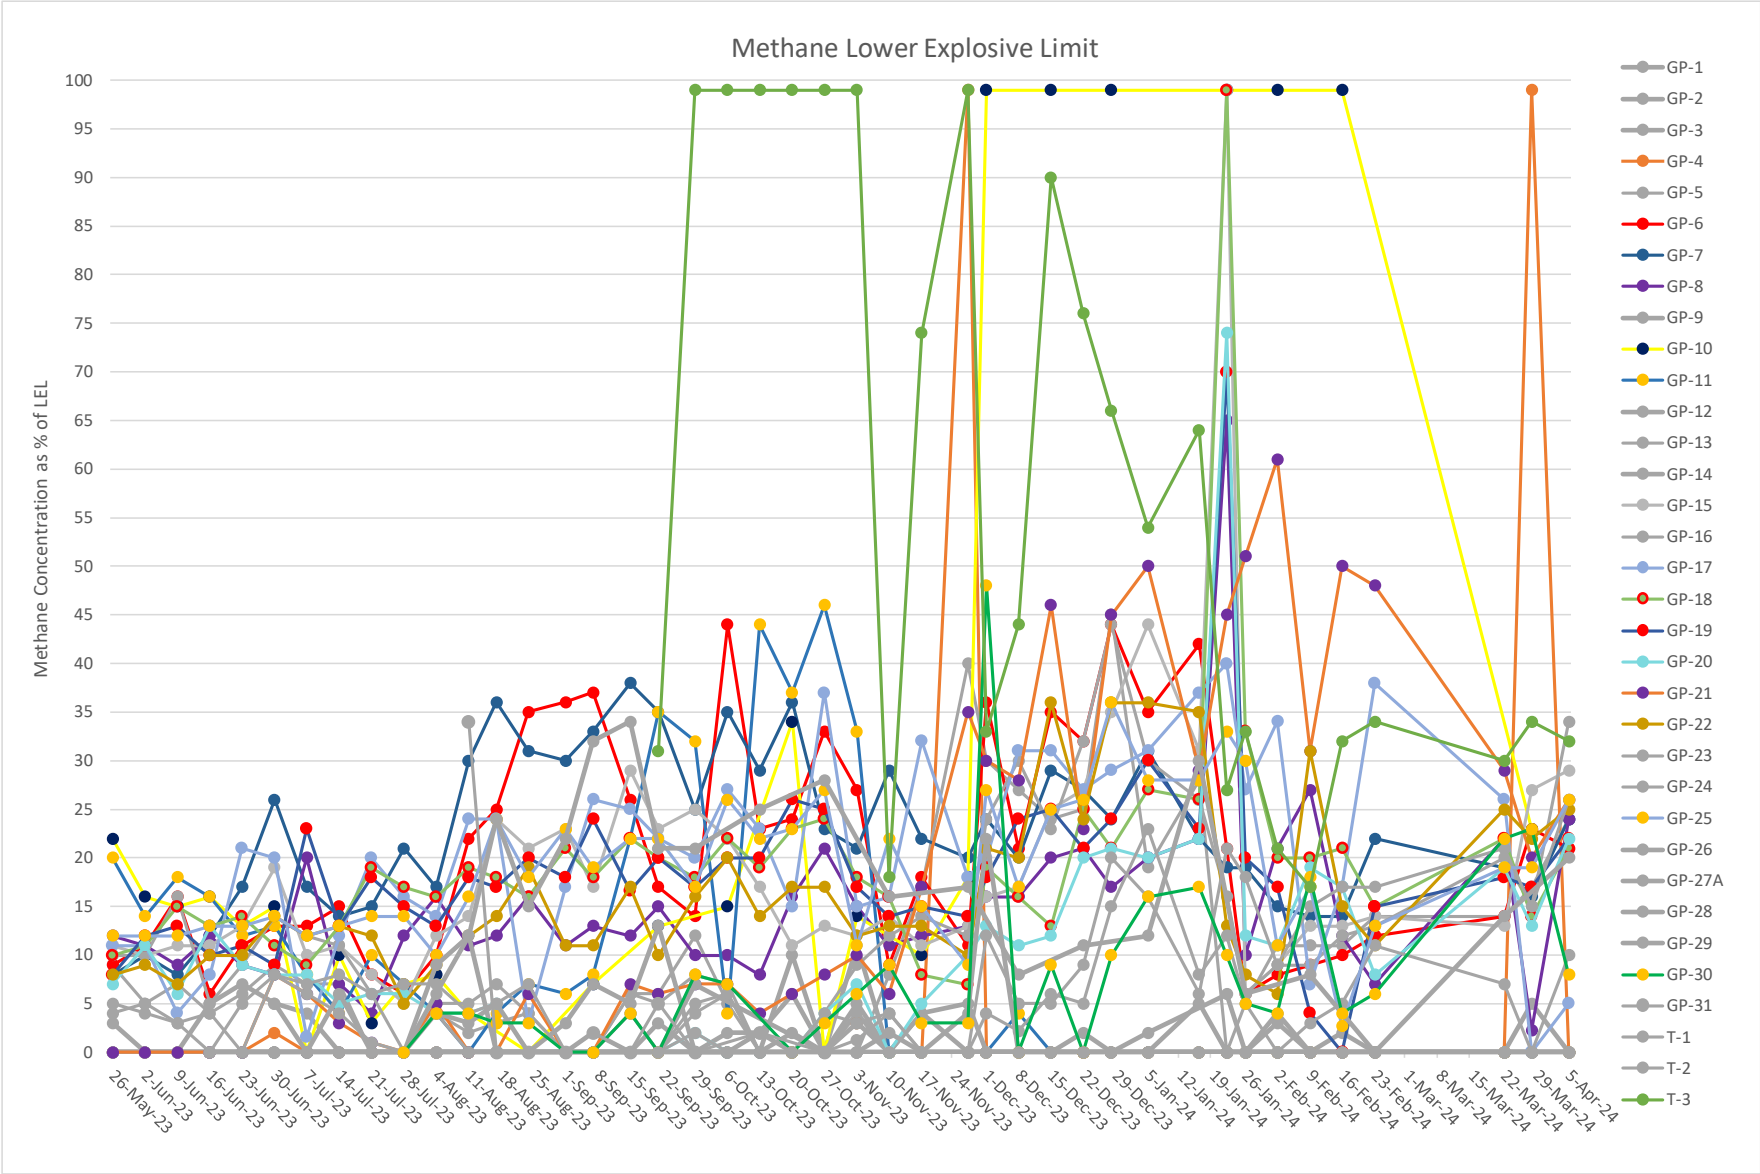
Lower Explosive Limit

Many data points fluctuating wildly.

GP-10 has now declined.

Upward trend in methane visible.

LEL and CH₄ are slowly increasing, indicating less air entry into landfill.

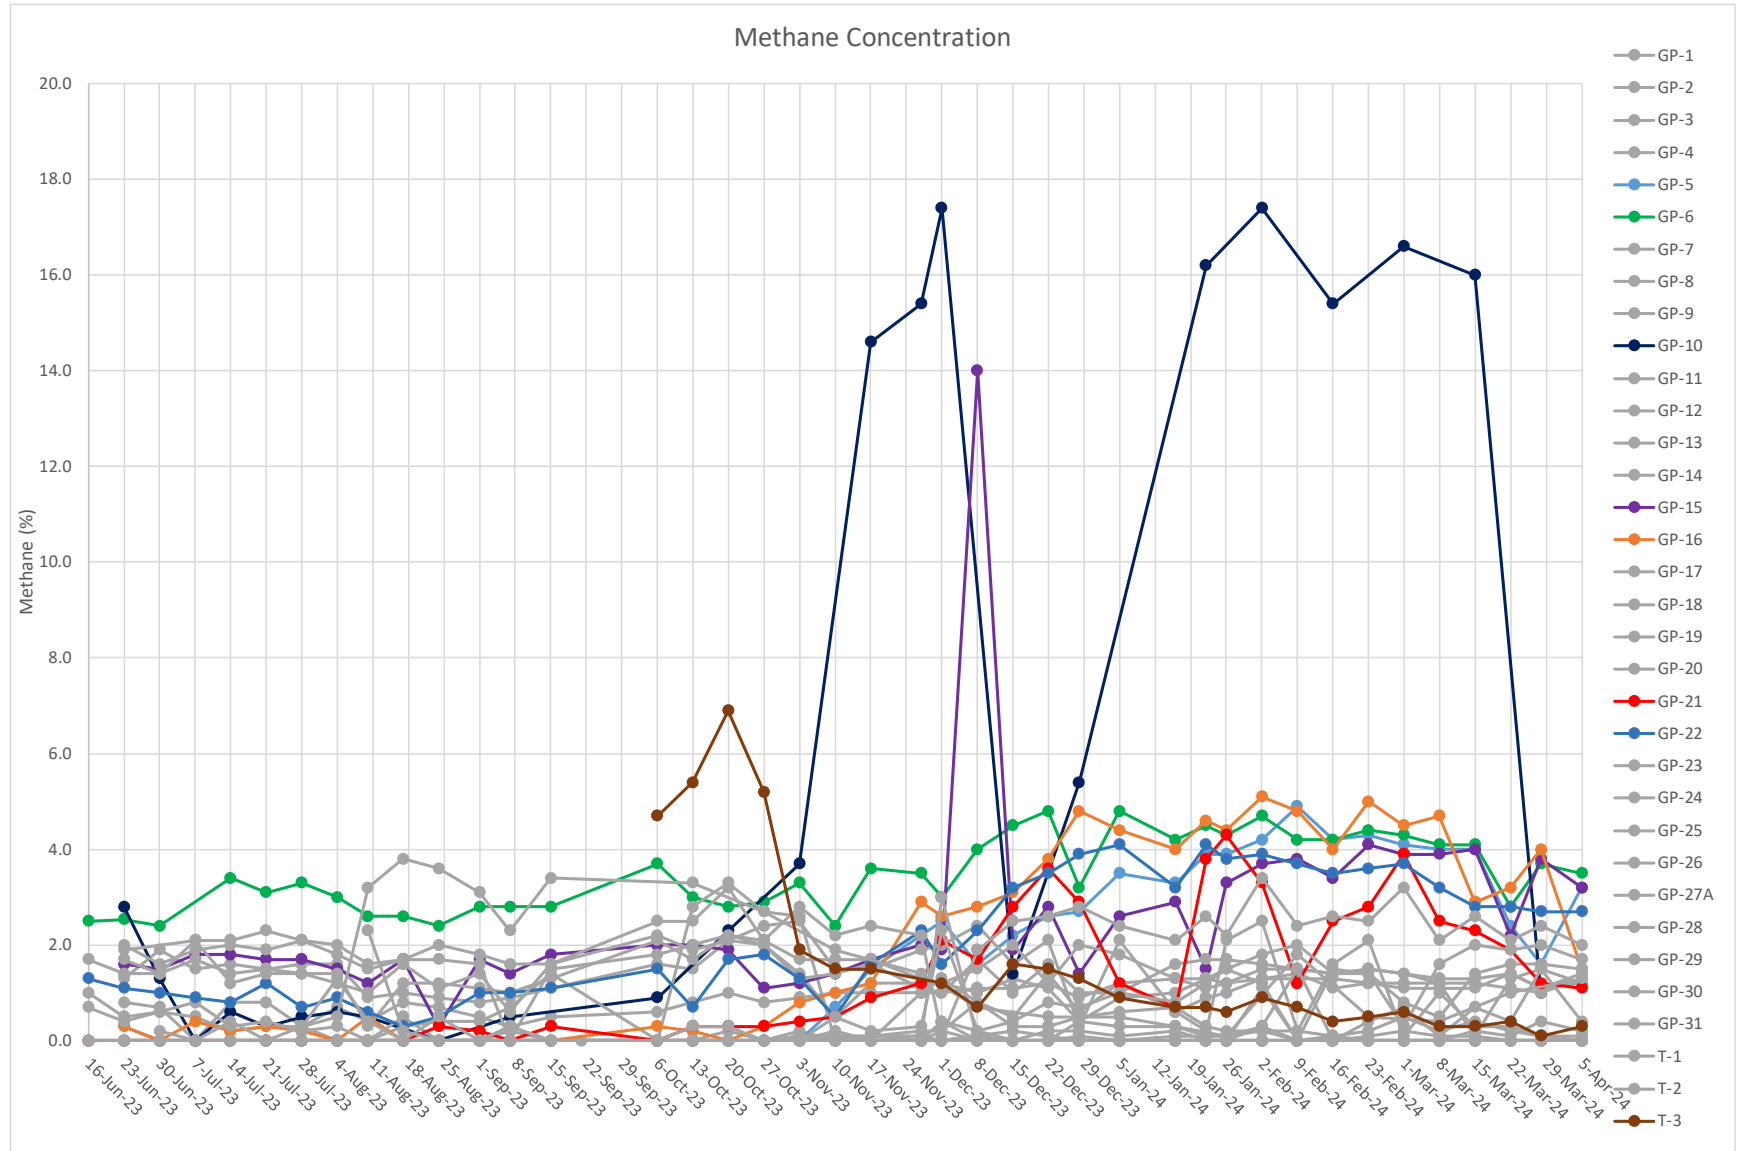
CH₄ (%)

GP-10 has decreased for last monitoring event measured.

South upper bench area slightly elevated, at around 2-4%.

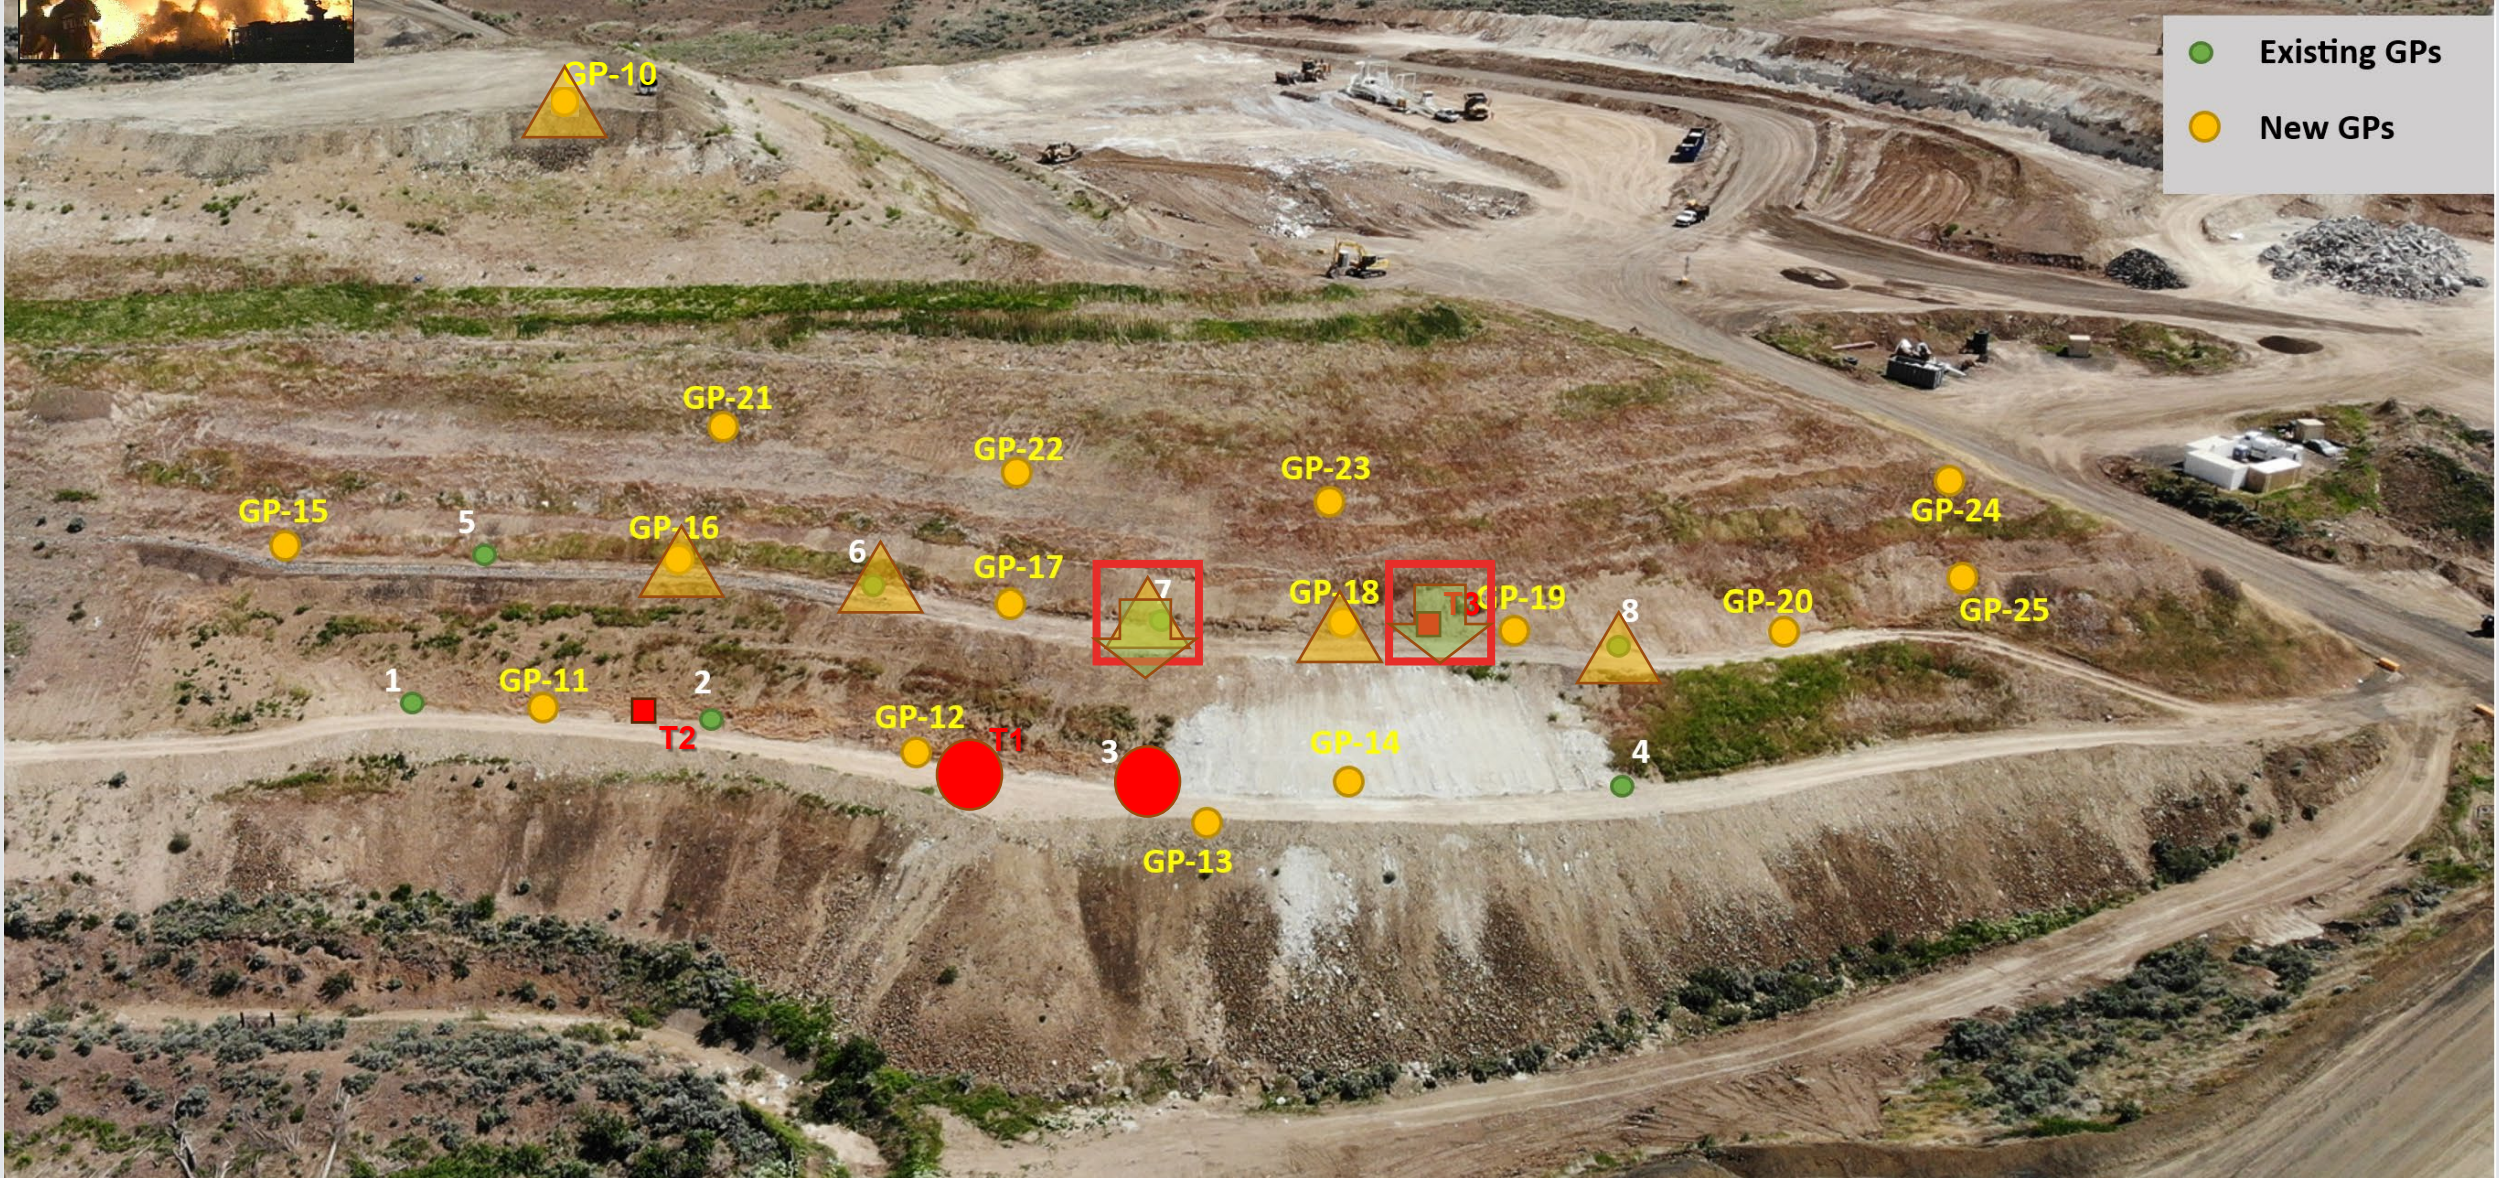
Fire Path

▼ High VOC

● Existing GPs
● New GPs

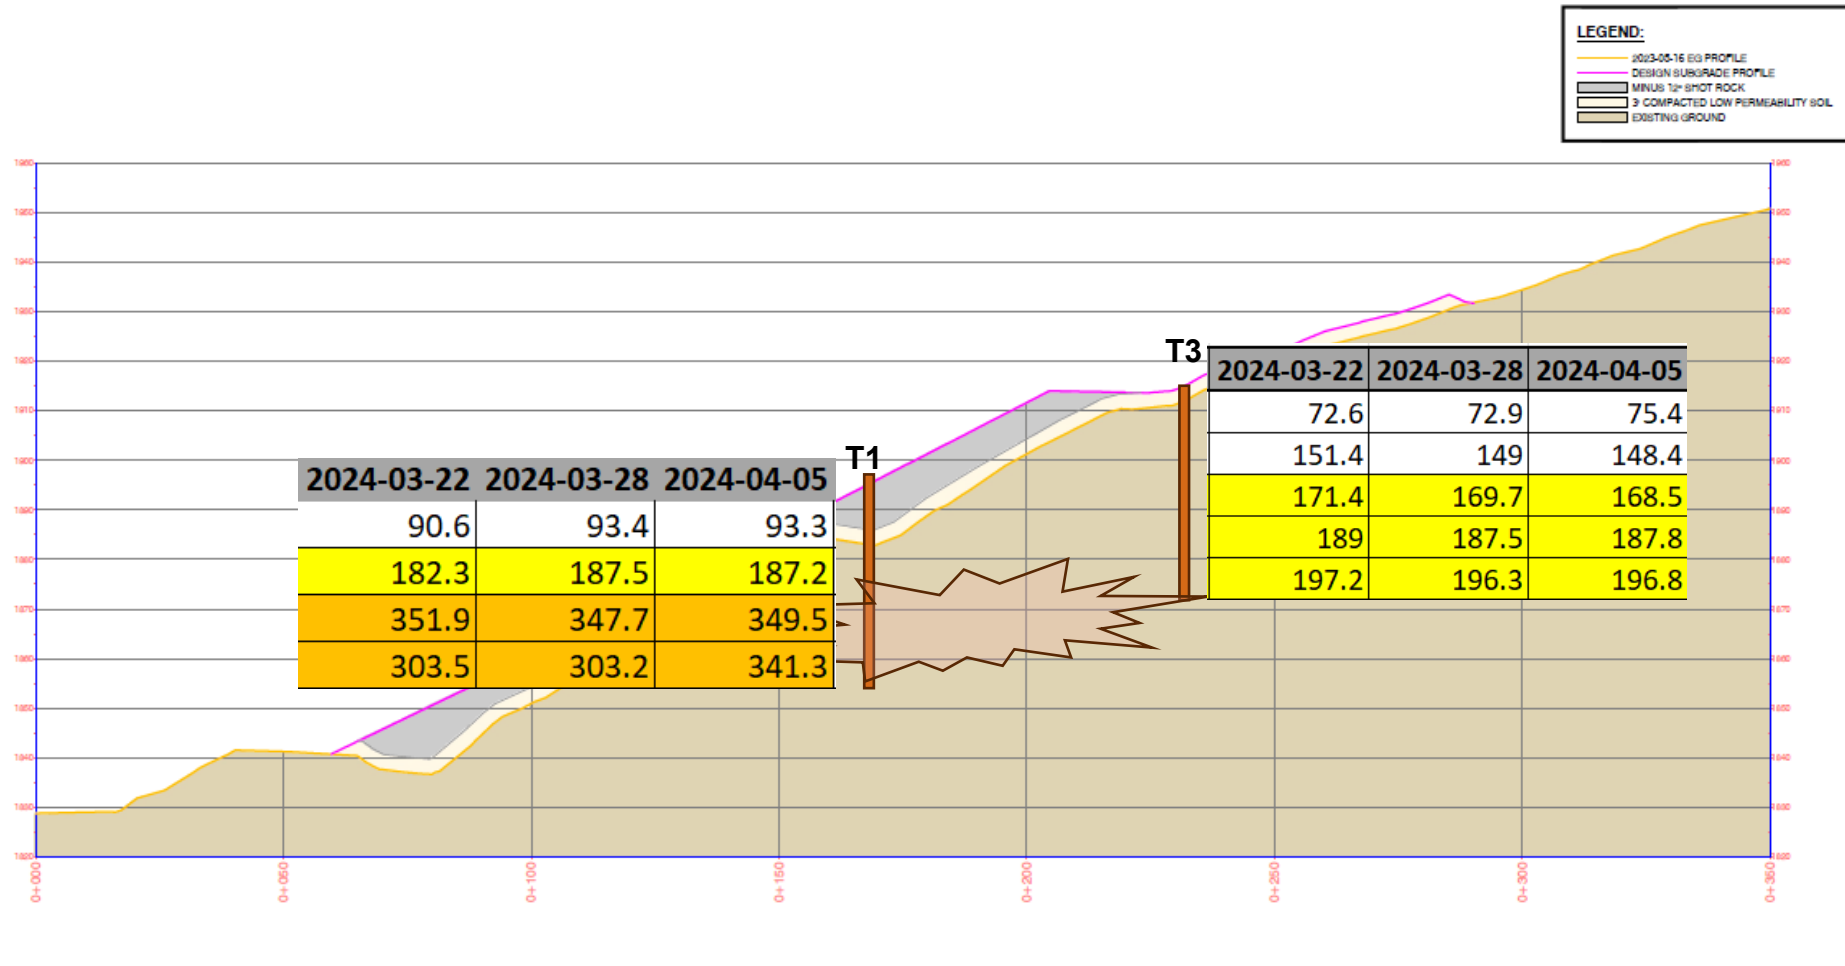
DTG RECYCLE LANDFILL FILE		
SECTION B-B'		
DRAWING NO.	REV	SHEET
2023-001-005	-	005

2024-03-22	2024-03-28	2024-04-05
	90.6	93.4	93.3
	182.3	187.5	187.2
	351.9	347.7	349.5
	303.5	303.2	341.3

2024-03-22	2024-03-28	2024-04-05
	72.6	72.9	75.4
	151.4	149	148.4
	171.4	169.7	168.5
	189	187.5	187.8
	197.2	196.3	196.8

SECTION B - B'
 H - 1" : 25'
 V - 1" : 25'
