# Remedial Action Completion Report

## Valley 15 Poulsbo RV Site

SR 509 Completion, Stage 1B

SR 509 Completion, Stage 1B  
Poulsbo RV  
23051 Military Road South  
Kent, Washington

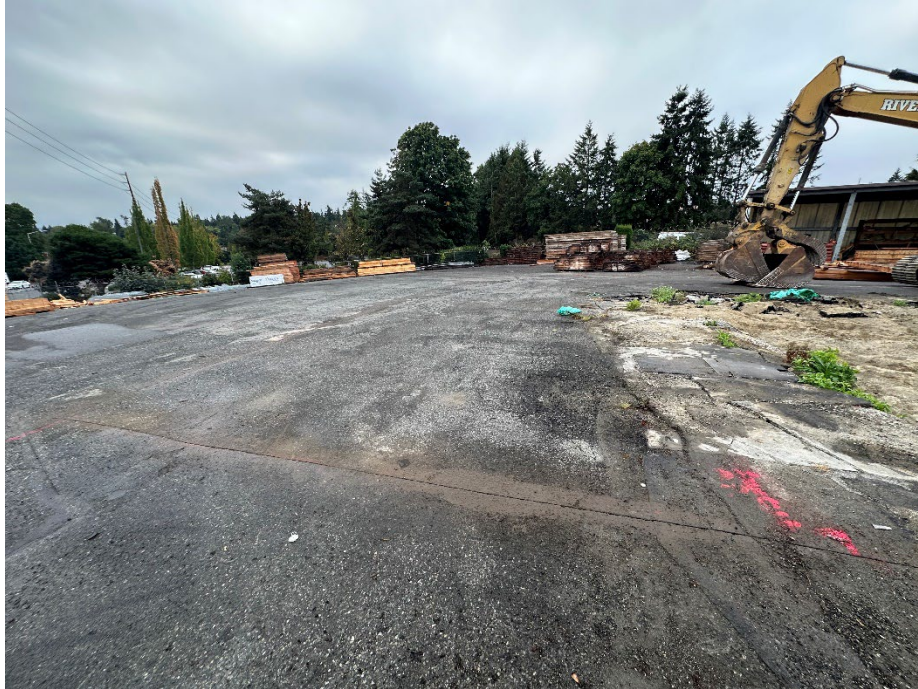
Photo 1. Excavation area as seen looking south on September 24, 2023.

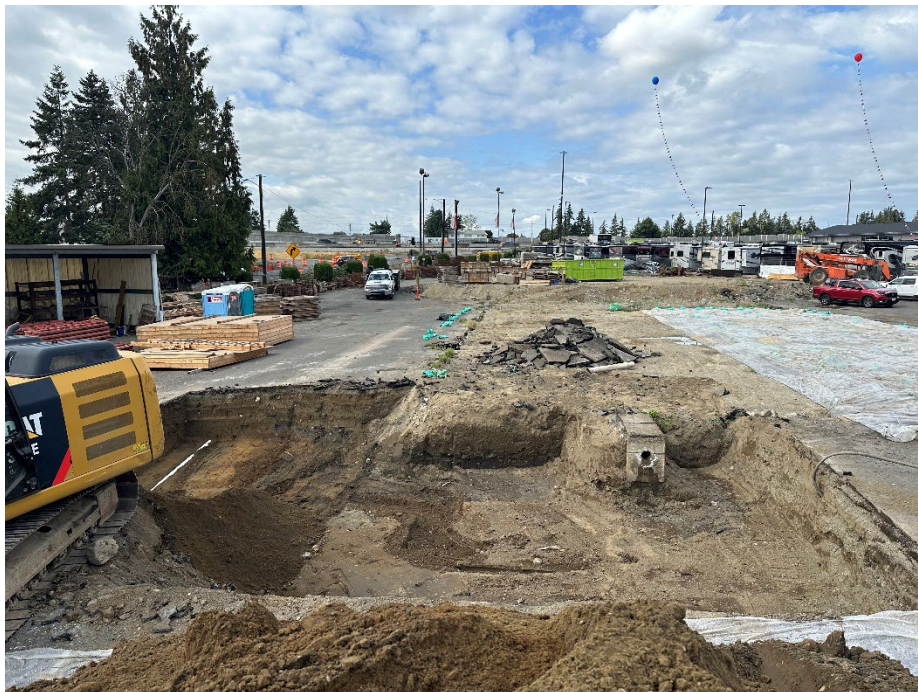
Photo 2. Remedial excavation as seen looking northwest on September 24, 2023. Oil Water separator visible in right center of frame.

An oil water separator was unearthed and removed. Soil directly below the separator exhibited PID readings of approximately 80 parts per million (ppm). The oil water separator was noted in previous reports as the suspected source of release at the Site. Soil removed from beneath the oil water separator was placed in a contaminated soil pile for profiling and offsite disposal. Indications of contaminated soil from the historical UST's were first observed in the excavation between approximately 10 and 12 feet bgs with PID readings between 23 and 102 ppm. Native soil as gray silty sand with rounded gravel and cobbles was observed at a depth of 11 feet bgs in the excavation with PID readings between 86 and 852 ppm observed at depths between 11 and 14 feet. Clean soil was encountered at depths between 14 and 15 feet based on field observations. The excavation was advanced to a total depth of 15 feet bgs.

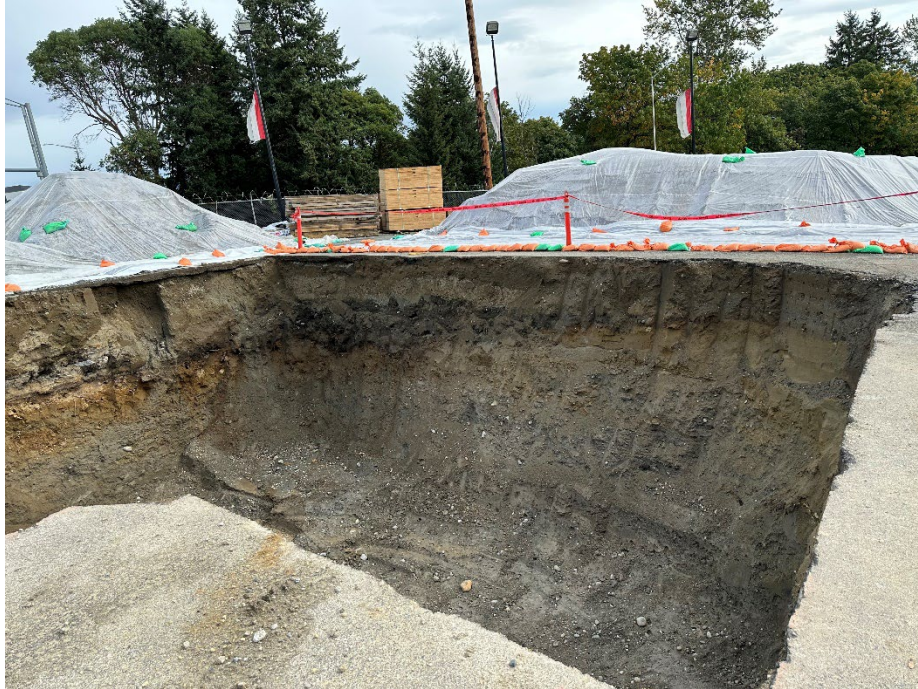
Photo 3. Remedial excavation as seen looking southeast on September 26, 2023. Clean overburden pile covered by white plastic visible top right of frame. A portion of the petroleum contaminated soil pile covered by white plastic is also visible top left of frame.

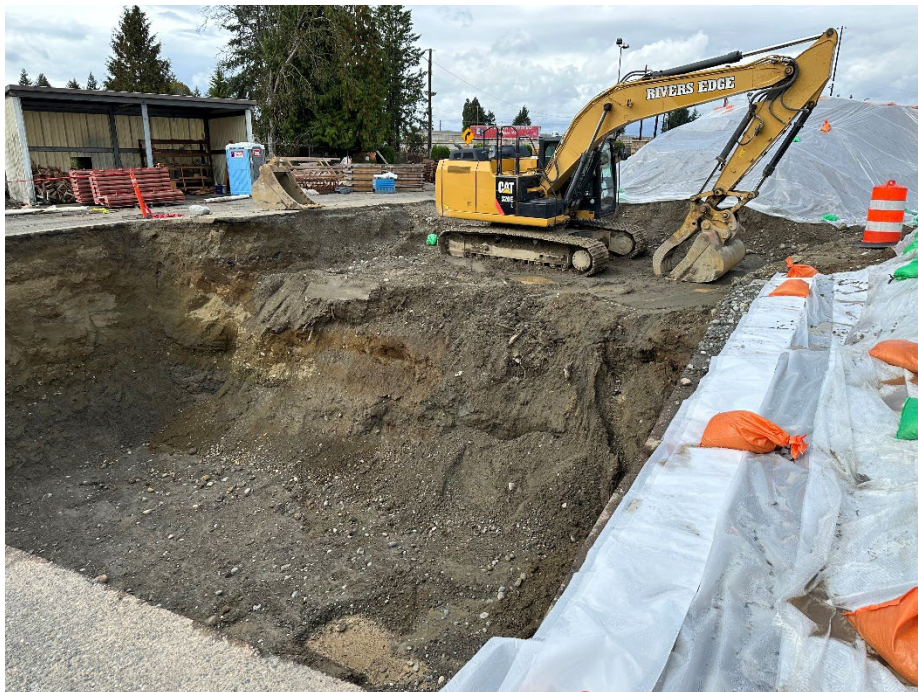
Photo 4. Remedial excavation as seen looking northwest on September 26, 2023.

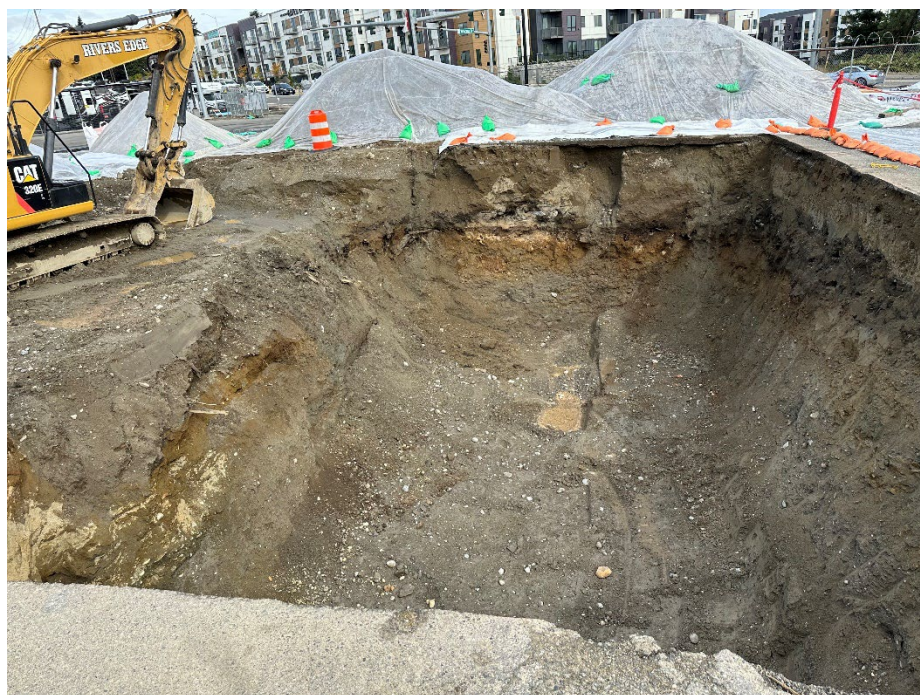
Photo 5. Remedial excavation as seen looking northeast on September 26, 2023.
