April 2024  
SeaPort Seattle Terminal  
(Former ARCO/BP Harbor Island Terminal)  
Cleanup Site ID 4426  
Consent Decree No. 00-2-05714-8SEA

## 2023 ANNUAL SITE REPORT

## 2023 Annual Report

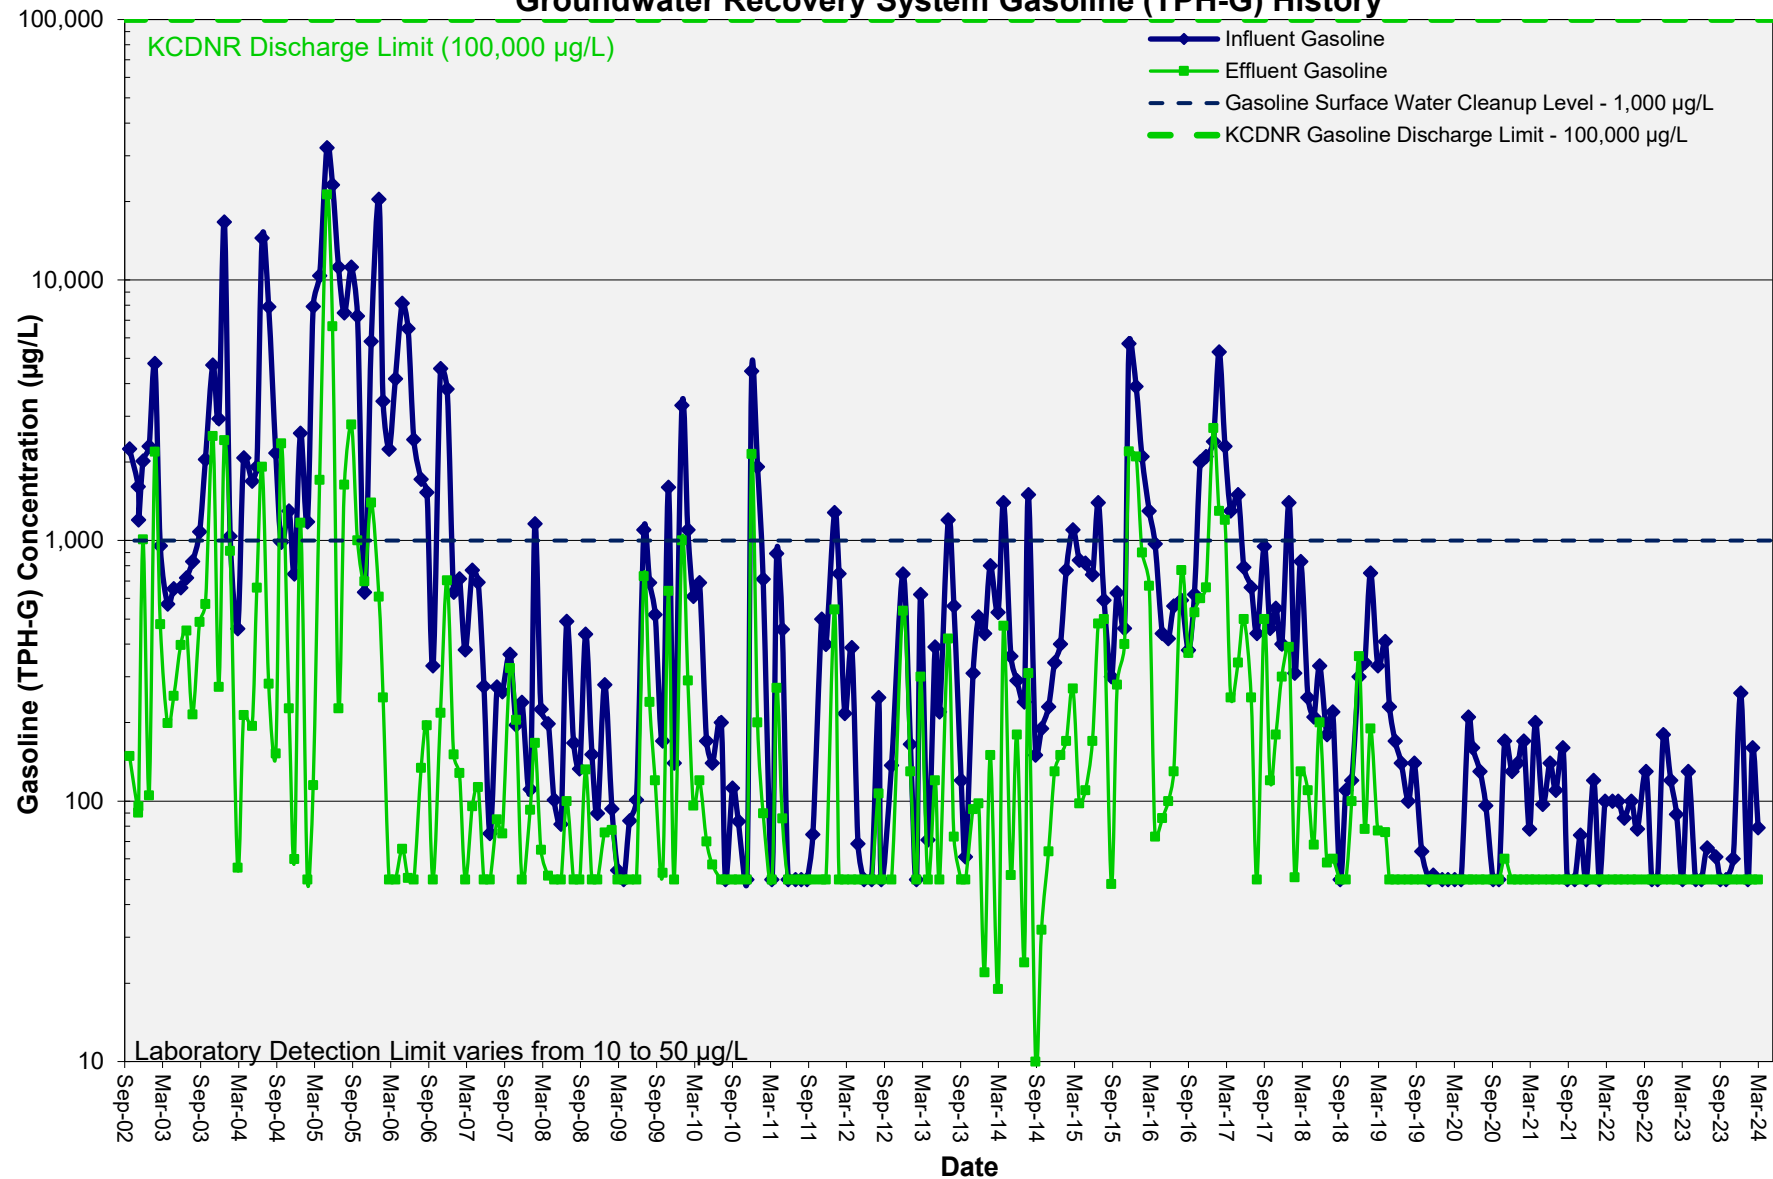
**Figure 5. Final System Influent vs. Effluent Gasoline Concentrations**  
**October 2002 through March 2024**  
**Site: SeaPort Seattle Terminal (Former ARCO/BP Harbor Island Terminal)**  
**Groundwater Recovery System Gasoline (TPH-G) History**

Note: Data is included since startup of the final groundwater and product recovery system in 2002.

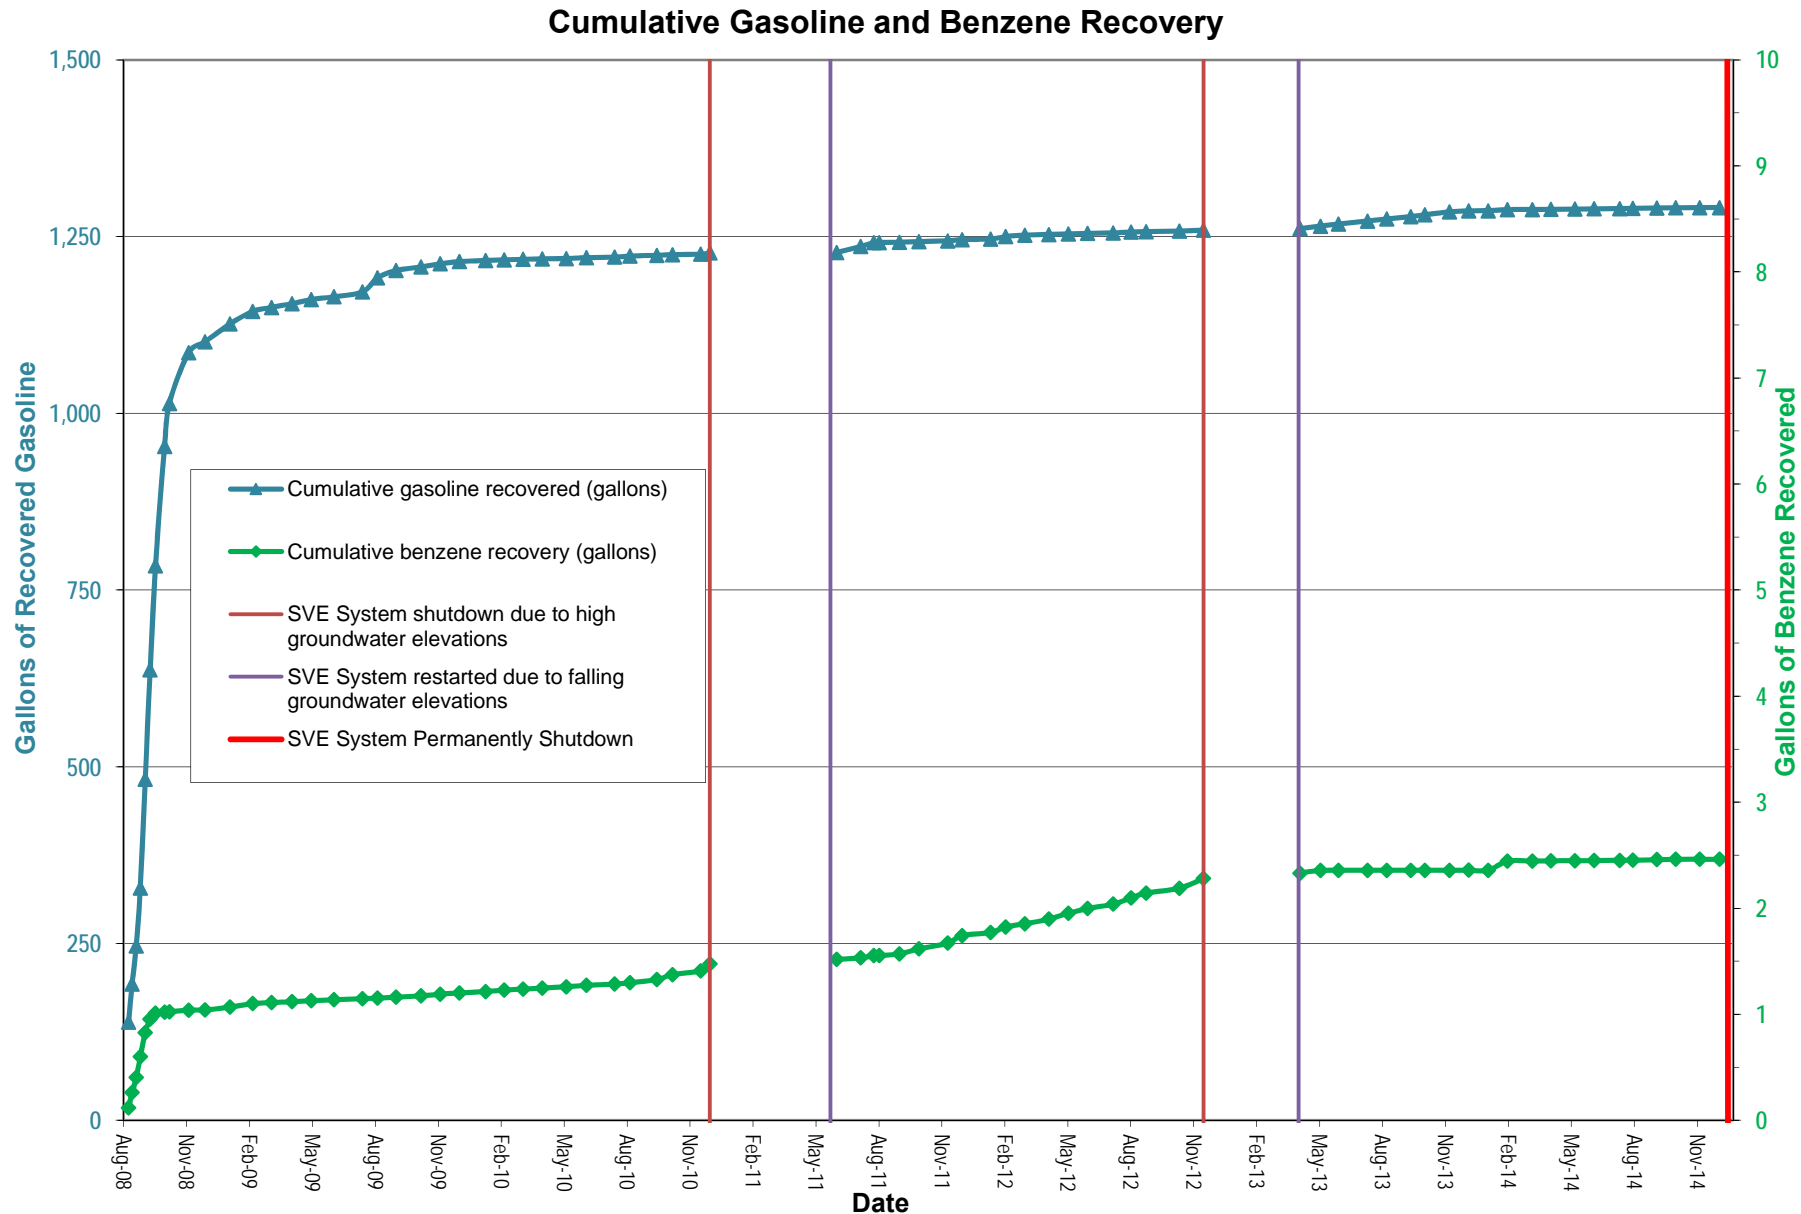
**Figure 14. Inland SVE System Cumulative Hydrocarbon Recovery**  
**Site: SeaPort Seattle Terminal (Former ARCO/BP Harbor Island Terminal)**

Note: Benzene and gasoline recovery are biased high as recovery is calculated assuming that benzene and gasoline are present at the laboratory detection limit for all samples reported as non detections from the laboratory.
