APPENDIX J
Interim Action Completion (As-Built) Report

Construction Completion (As-Built) Report

Weyerhaeuser Mill A Former Cleanup Site
Interim Action
Everett, Washington

January 16, 2018

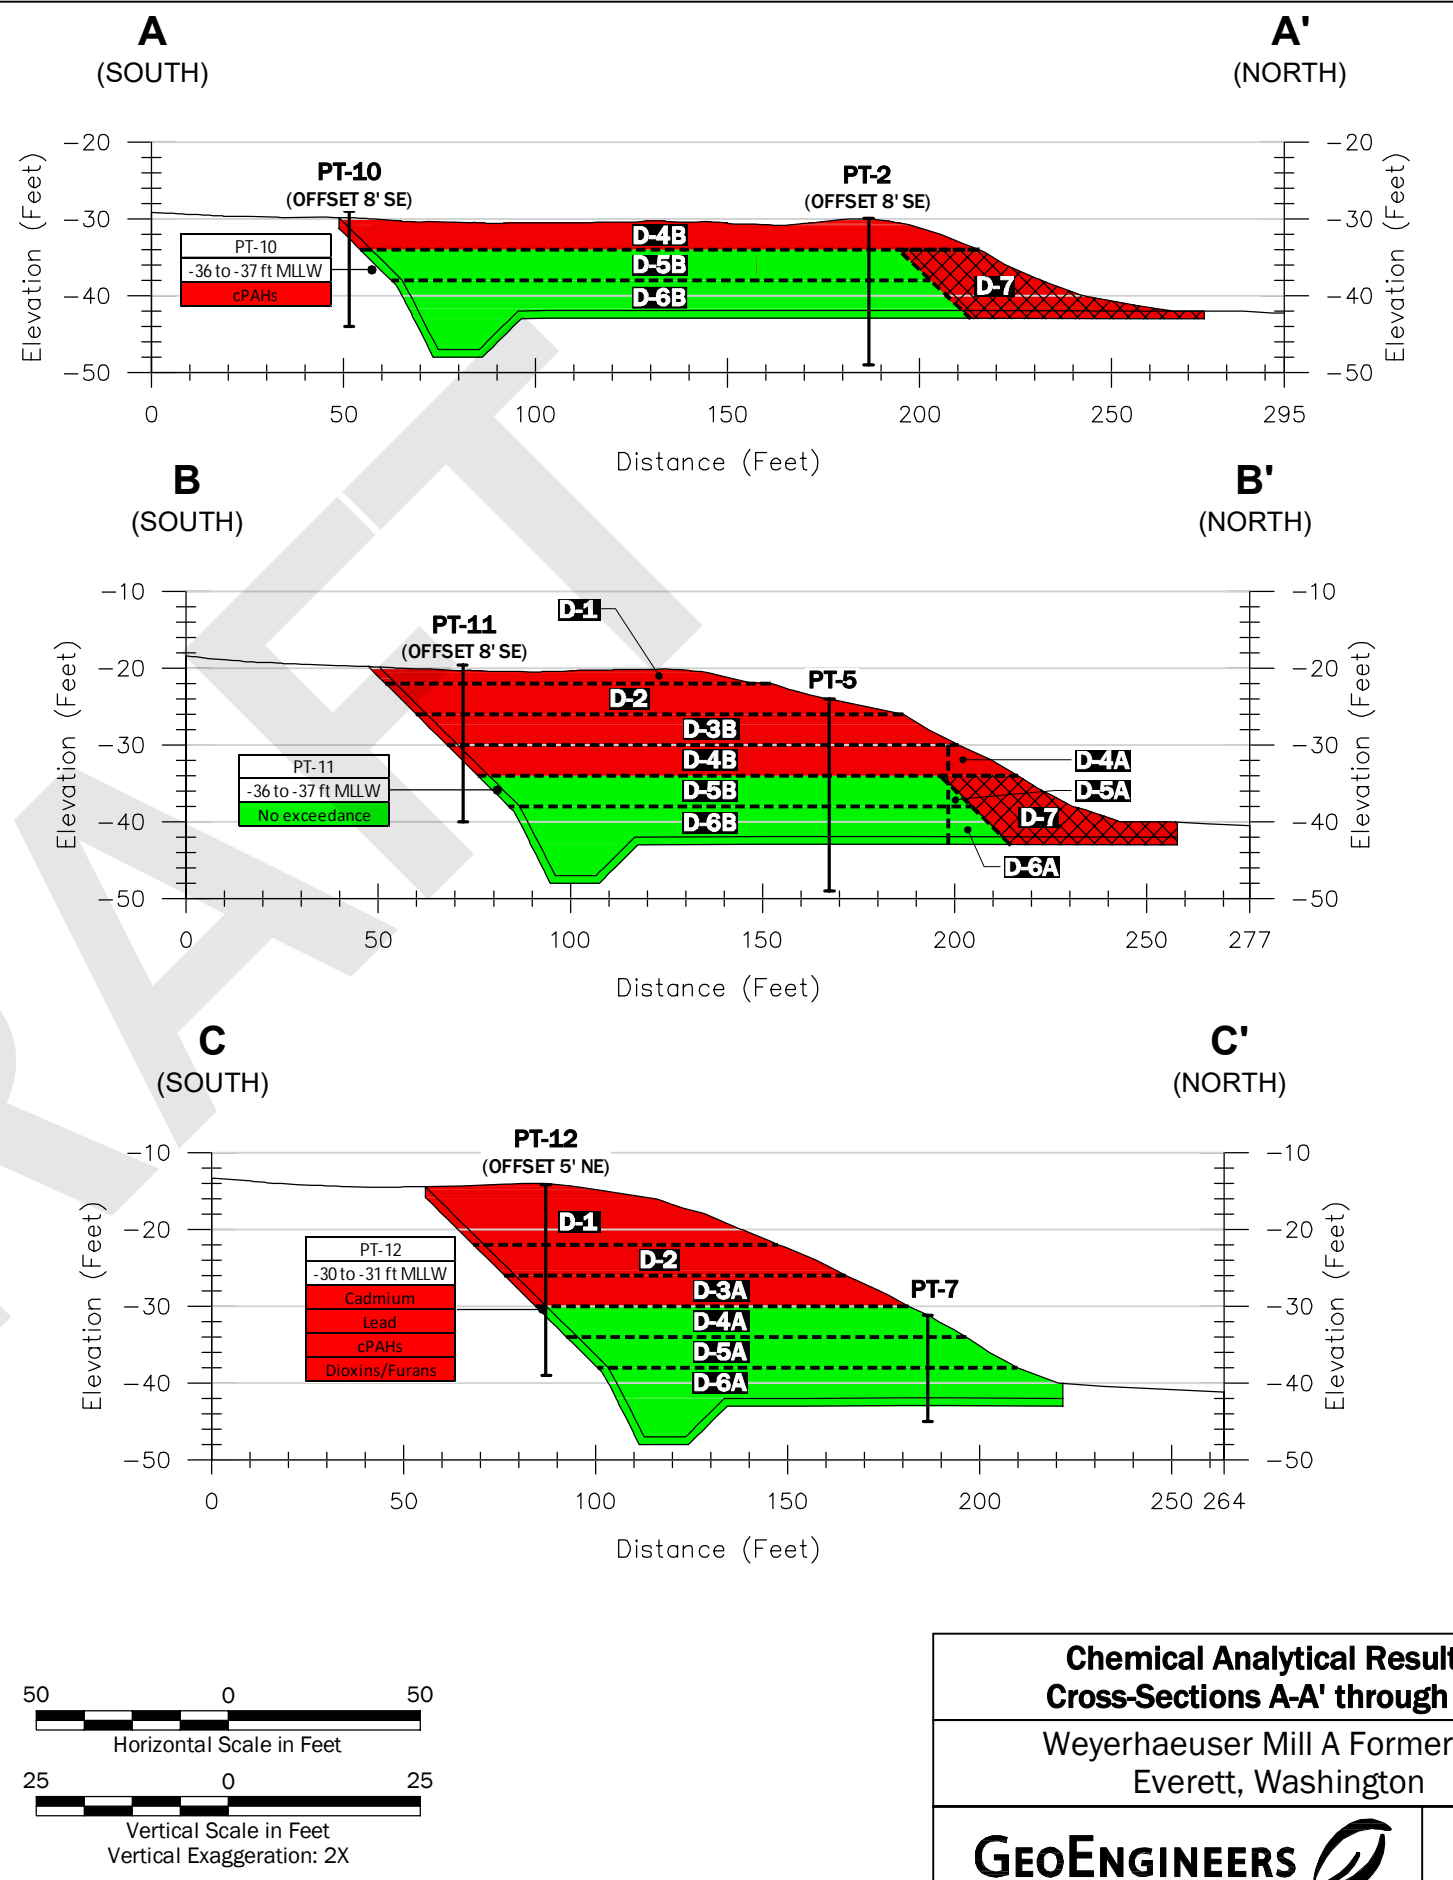
Figure 14

**Chemical Analytical Results -
Cross-Sections A-A' through C-C'**

8. **Chemical Analysis.** The approved SAP was followed and the resulting analytical data were deemed adequate to characterize the proposed dredged material. The sediment conventional and chemistry results can be found in Tables 5 and 6, in which contaminant concentrations are compared to the DMMP guidelines and MTCA preliminary cleanup screening levels respectively. Figures 14-17 show the results of chemical comparisons to DMMP and MTCA.

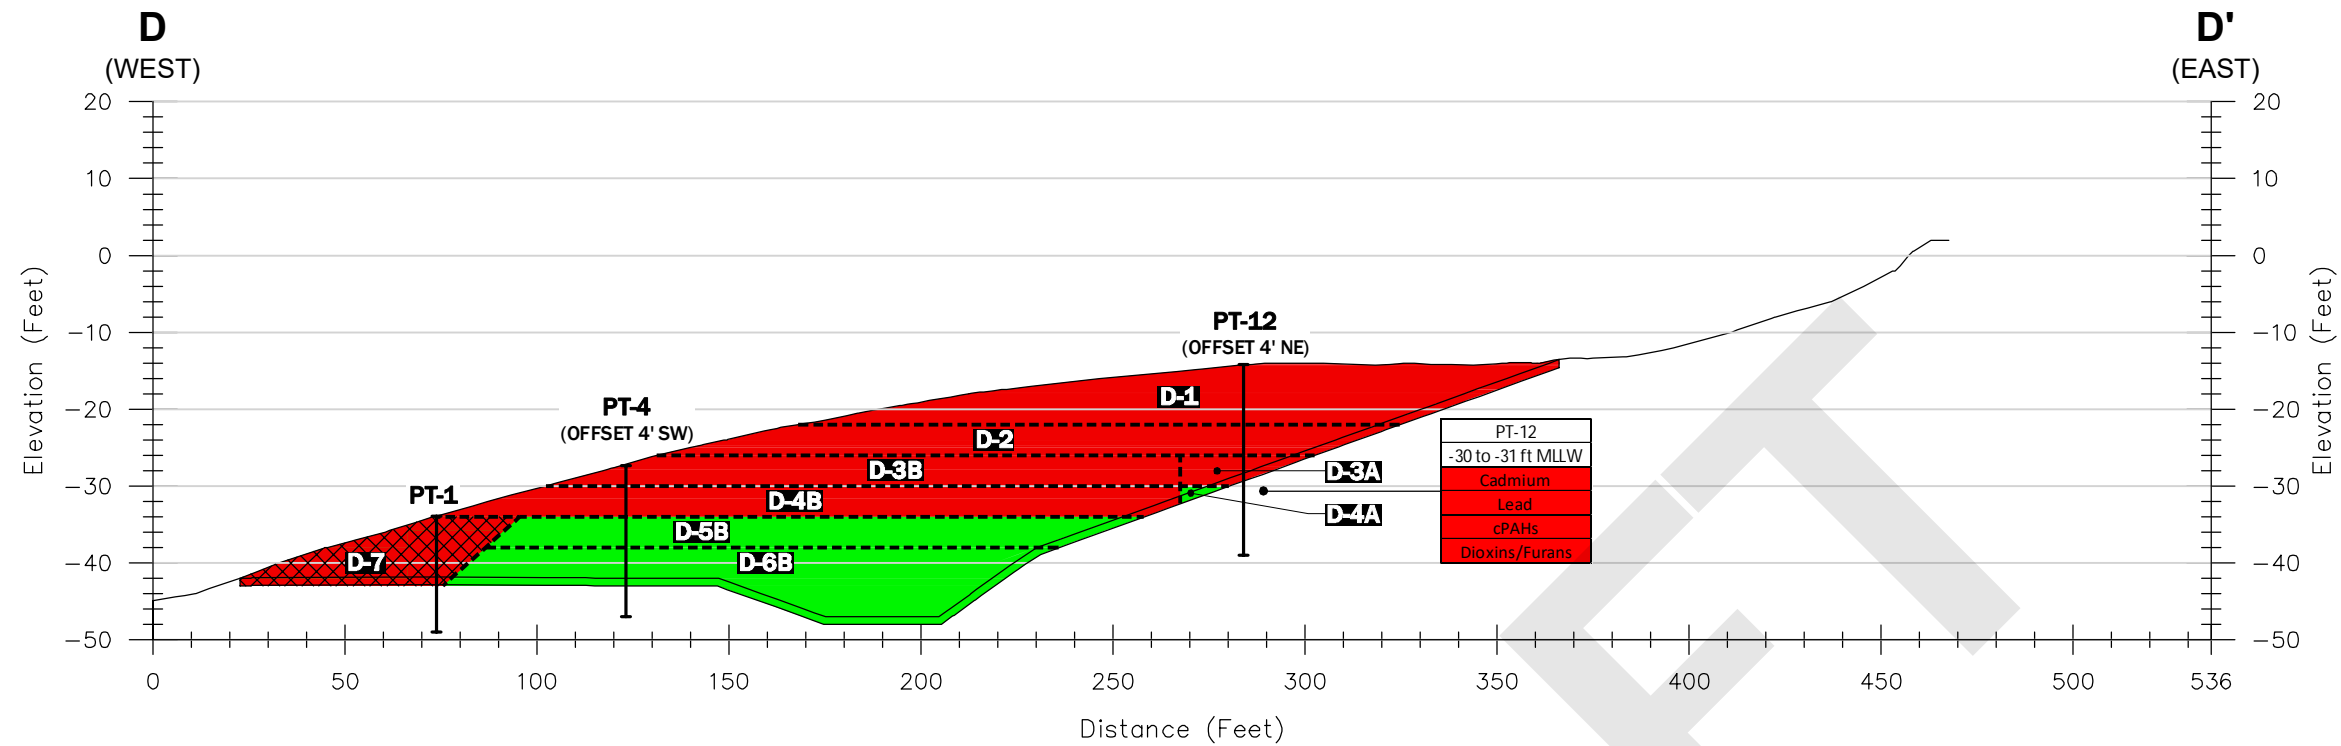
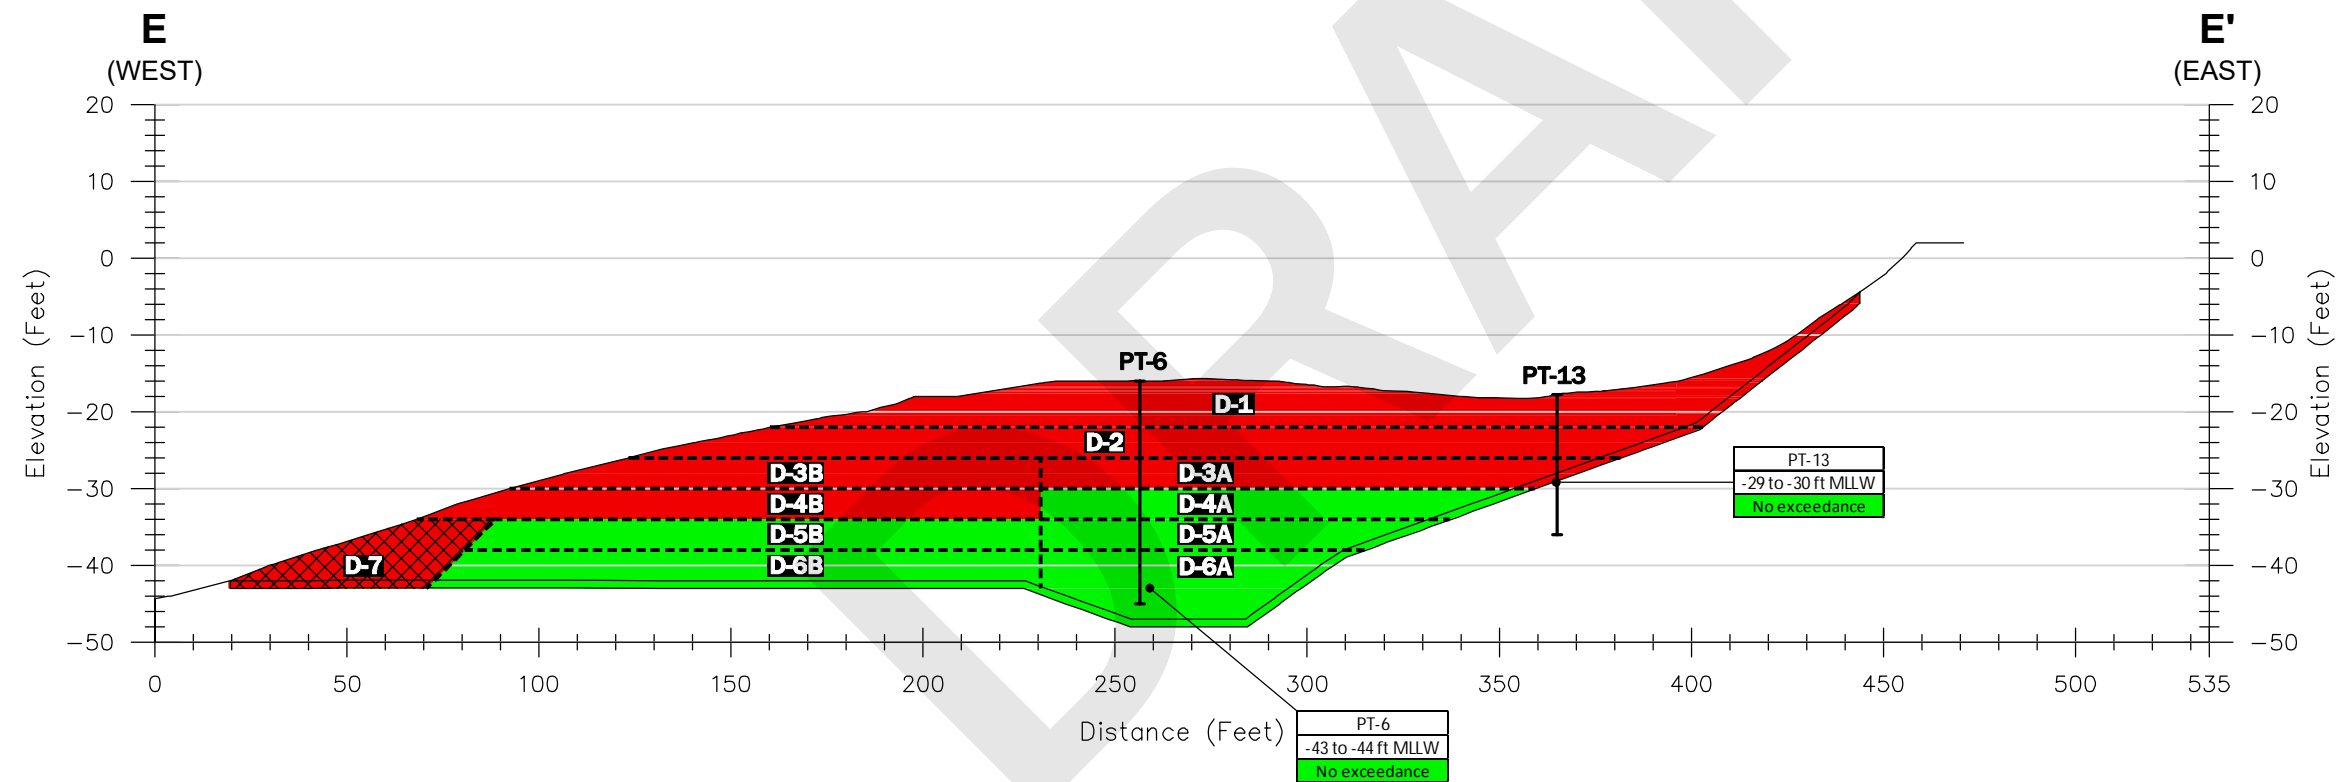
Chemical Analytical Results - Cross-Sections D-D' and E-E'	
Weyerhaeuser Mill A Former Site Everett, Washington	
GEOENGINEERS	Figure 15

- Legend**
- DMMU Boundary
 - D-1** DMMU Identification
 - █ Chemical analytical results indicate one or more analytes exceeding screening levels.
 - █ Chemical analytical results indicate no exceedances of screening levels.
- DMMU Elevation Boundaries**
- D-1** Existing Grade to -22 feet MLLW
 - D-2** -22 to -26 feet MLLW
 - D-3A & D-3B** -26 to -30 feet MLLW
 - D-4A & D-4B** -30 to -34 feet MLLW
 - D-5A & D-5B** -34 to -38 feet MLLW
 - D-6A & D-6B** -38 to -43 feet MLLW
 - D-7** Surface DMMU -34 to -43 feet MLLW

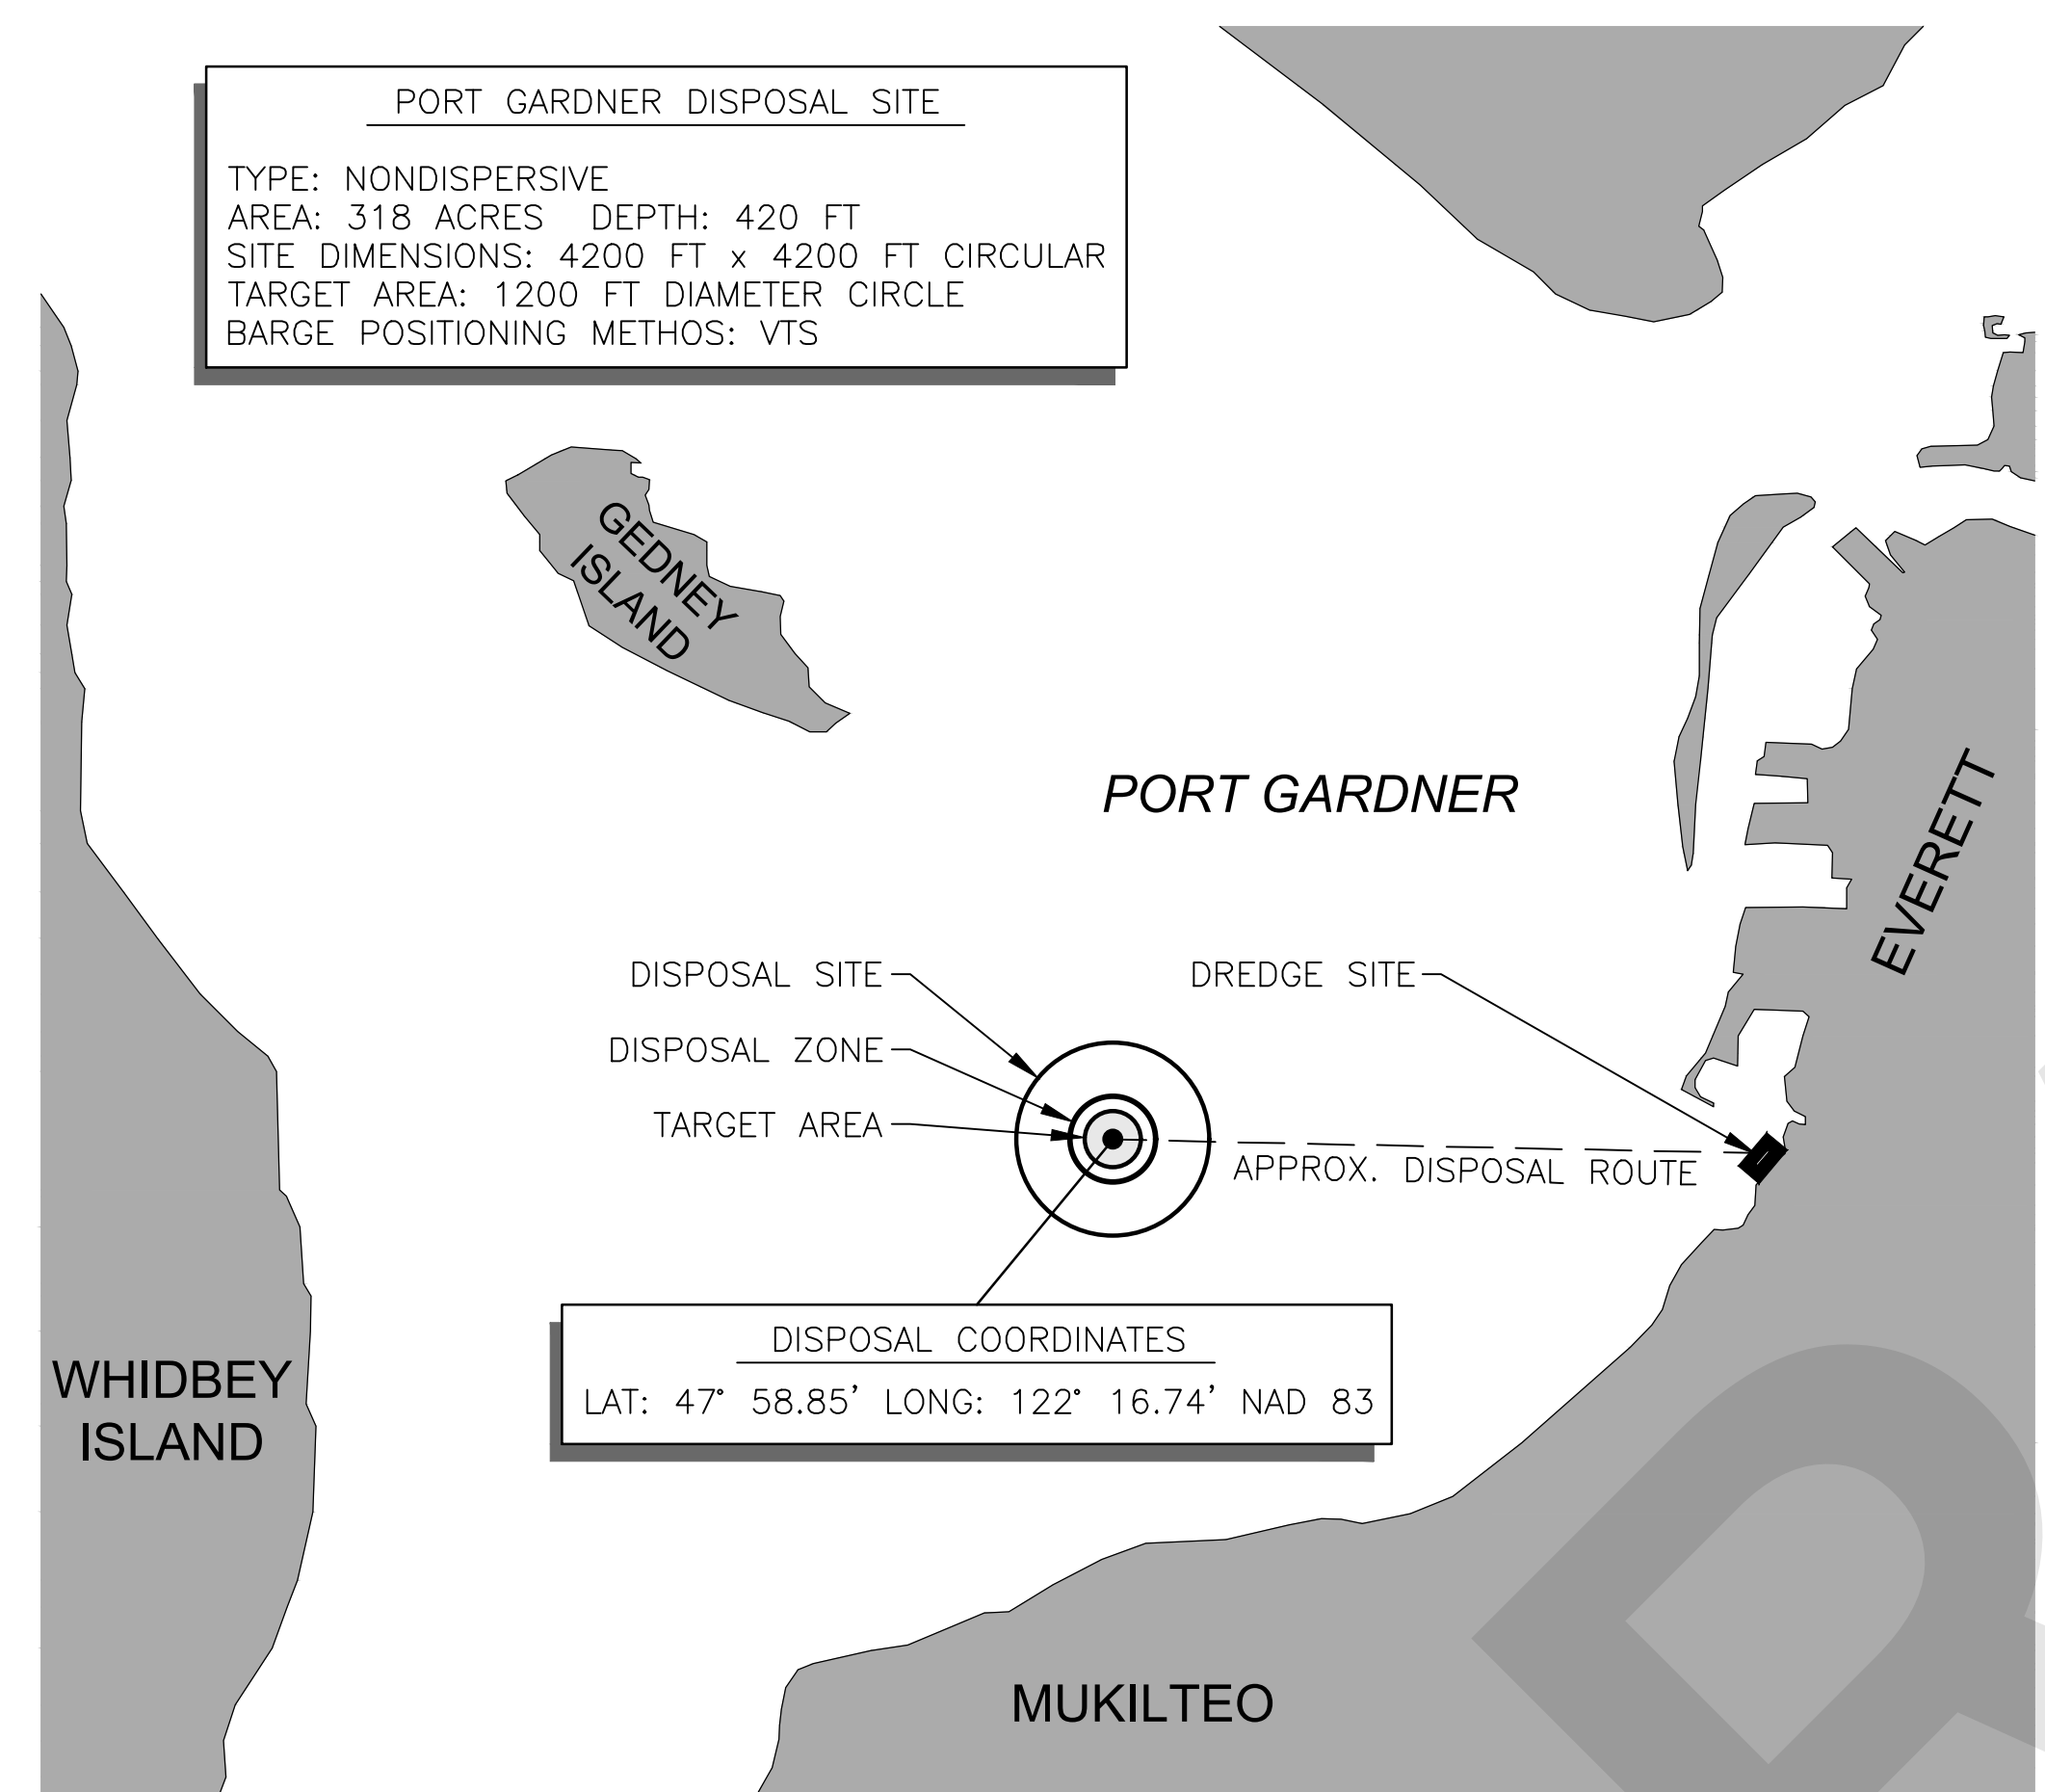
PORT GARDNER DISPOSAL SITE
 TYPE: NONDISPERSIVE
 AREA: 318 ACRES DEPTH: 420 FT
 SITE DIMENSIONS: 4200 FT x 4200 FT CIRCULAR
 TARGET AREA: 1200 FT DIAMETER CIRCLE
 BARGE POSITIONING METHOS: VTS
