Construction Completion Report
Phase II Interim Intertidal
and Selected Subtidal
Remedial Action
Custom Plywood Site
Anacortes, Washington

Prepared for
Washington State
Department of Ecology

May 12, 2014
17800-40

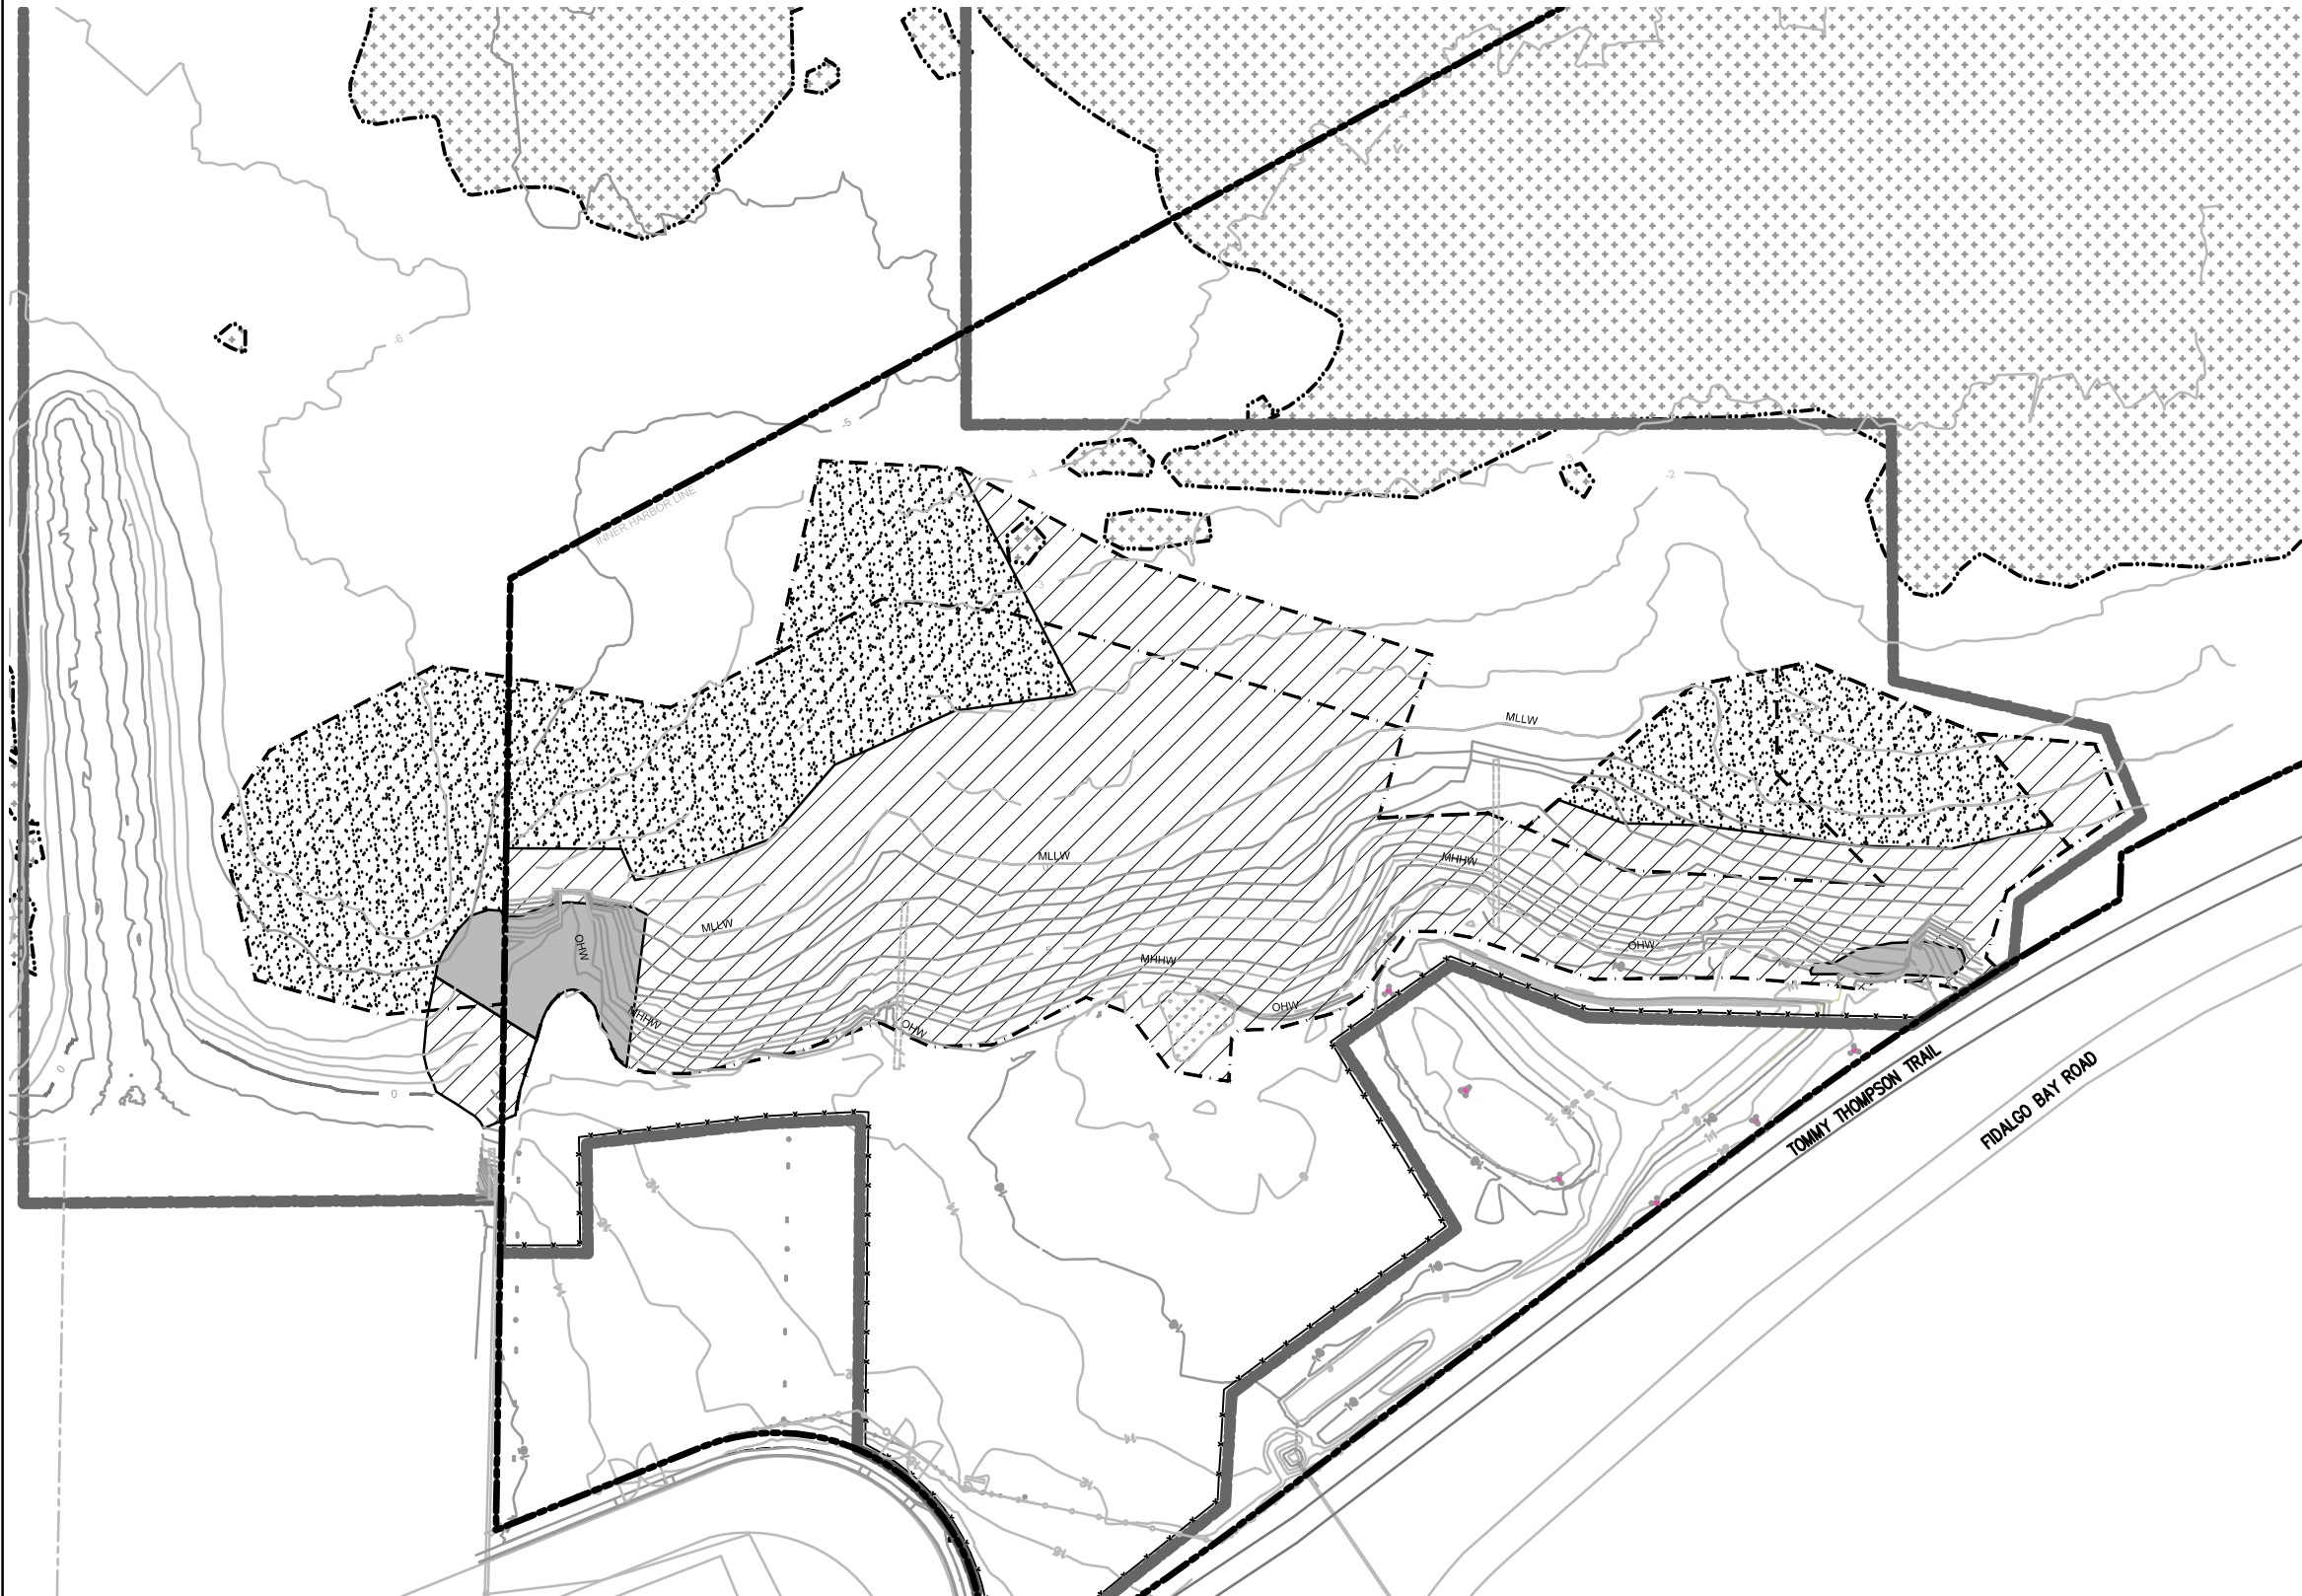
Custom Plywood Site Anacortes, Washington	
Excavation and Dredging Plan	
17800-40 (CCR)	5/14
	Figure
	3

Source: Drawing No. G1.2 Remedial Design Plan prepared by KPFF Consulting Engineers, dated 3/4/13.

- Nearshore subtidal areas containing wood waste and/or affected by dioxin/furan contamination were dredged to native material or to the prescribed design depth, whichever was reached first (Figure 3). The extent of wood waste and historical dioxin/furan TECs measured in this area served as the basis for determining the design excavation and dredging depths.

Dredging and excavation were performed in the subtidal and intertidal areas at the site to remove sediment affected by wood waste and dioxins/furans. A total of 44,994 CY of sediment were dredged and excavated (Table 1). The planned extents and target depths for dredging and excavation are shown on Figure 3, and post-construction as-built drawings are provided in Appendix A.

Orion's derrick barge was equipped with a differential global positioning system (DGPS) to position the vessel in the dredging area (Figure 3). Software was used that allowed real-time tracking of the horizontal position of the barge and dredging bucket. Background templates and overlays were uploaded to the software that allowed the dredge operator to see the position of the equipment relative to the planned dredging extent, shoreline, and proposed sediment sampling points. The software was also used to track dredging progress, designating areas that had been completed as the work progressed. During dredging, the depth of the cut relative to target depth was tracked by the dredge operator using a combination of bucket wire marks, a physical tide board, and an electronic tide gauge. The same systems were used to track the placement of backfill material (Section 5.4).

Intertidal excavation was performed using land-based earthwork equipment. Planned excavation boundaries (Figure 3) were located and staked by Orion's subcontracted surveyor, Pacific Survey and Engineering (PSE). Excavated depths were estimated during digging and subsequently verified through topographic surveys conducted by PSE, which were submitted as progress surveys to Ecology for review and approval. The final disposed tonnage of excavated and dredged material was determined through the scale tickets received for the loads received at the disposal facility.

Dredging and excavation reached native material in several locations at depths less than the 6-foot target depth. In the southernmost extent of dredging and excavation at the south end of the site (Figure 3), the native clay layer was encountered at depths of approximately 4 feet below existing grades. Similar conditions were encountered in the region north of the protective spit, where the native clay layer was encountered at less than 6 feet deep. Near the bulkhead area at the north end of the site, native clay was detected at approximately the 6-foot target depth. The final excavation and dredging elevations that were attained and documented in progress surveys are provided in Appendix A.
